Canyon Country Club Estados Conservation Review Report

Submitted on July 1, 2016 by Jessyca Frederick, CEO of Water Wise Now, LLC
WaterWiseNow.com | jessyca@waterwisenow.com | Toll free: 844-LESS-H2O x 700

Project Summary

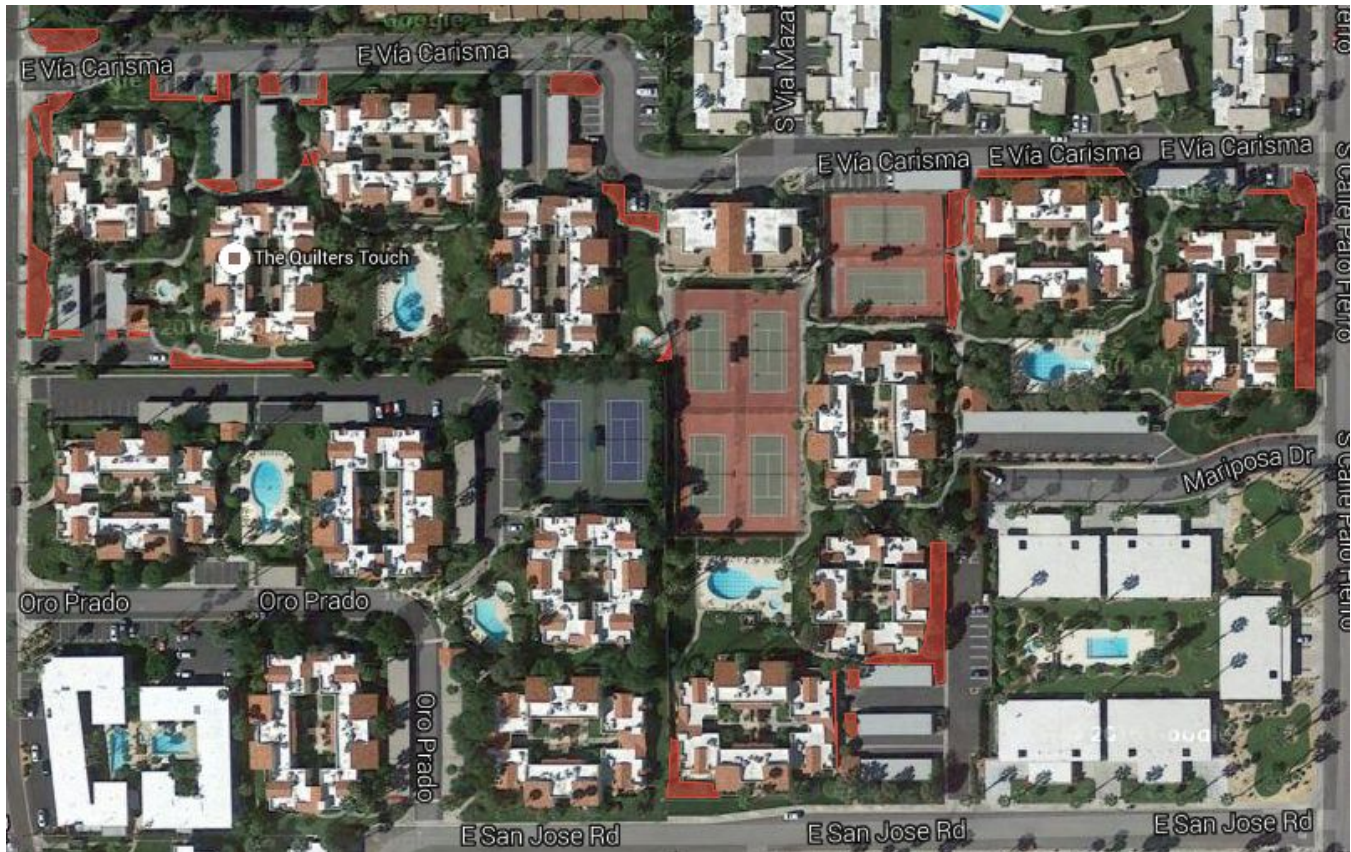
There are a few different types of turf removal projects that should be considered on site. Currently there is a great deal of overspray onto sidewalks (slip-and-fall hazard) and onto parked cars. These recommendations seek to reduce those problems.

1. Areas which face the rest of the South Palm Springs community (along Palm Canyon and Palo Fierro in particular).
2. Areas that are too narrow to be watered without creating runoff.
3. Steep areas near sidewalks where watering is challenging and much runoff is being created.

Here is a map of all the places we think turf should be removed. It's best understood by looking at the digital map we created.

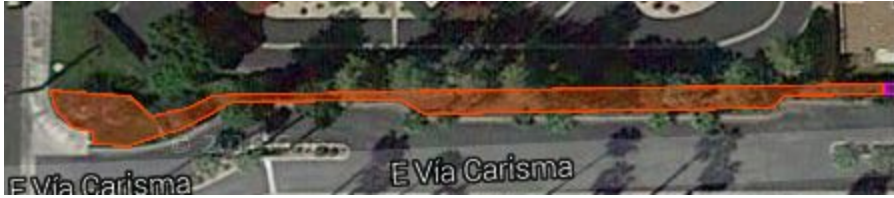
Zone 1

North of Via Carisma, entryway and shrubs along the road

- Pressure was 33 psi
- This valve took 2 minutes to shut down. It is one of the 11 that must be replaced. Since we are recommending drip irrigation in this zone, it should be replaced with a high-volume low-flow valve with a pressure regulator and filter. The valve itself could not be located, as it is buried under the grass. We believe Jose from GrandMark might know where it is located.

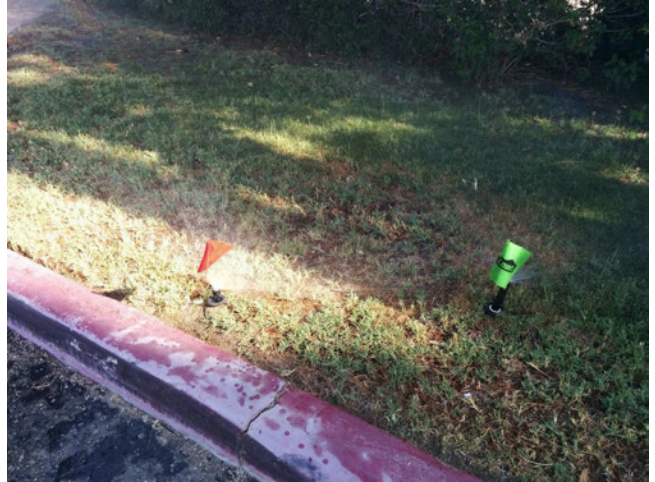
Overspray onto sidewalk

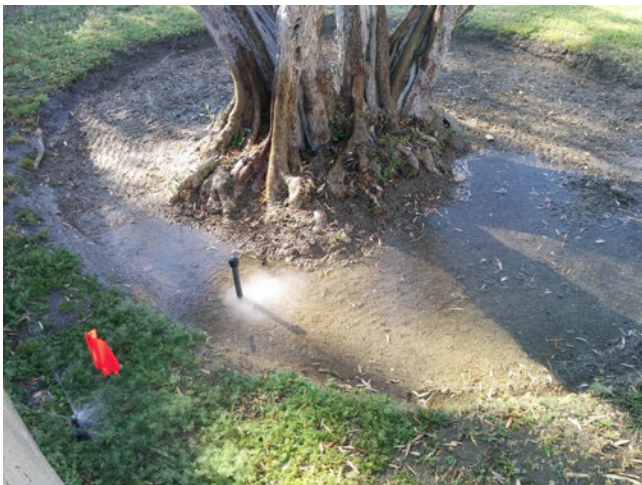
Poor (redundant) sprinkler placement

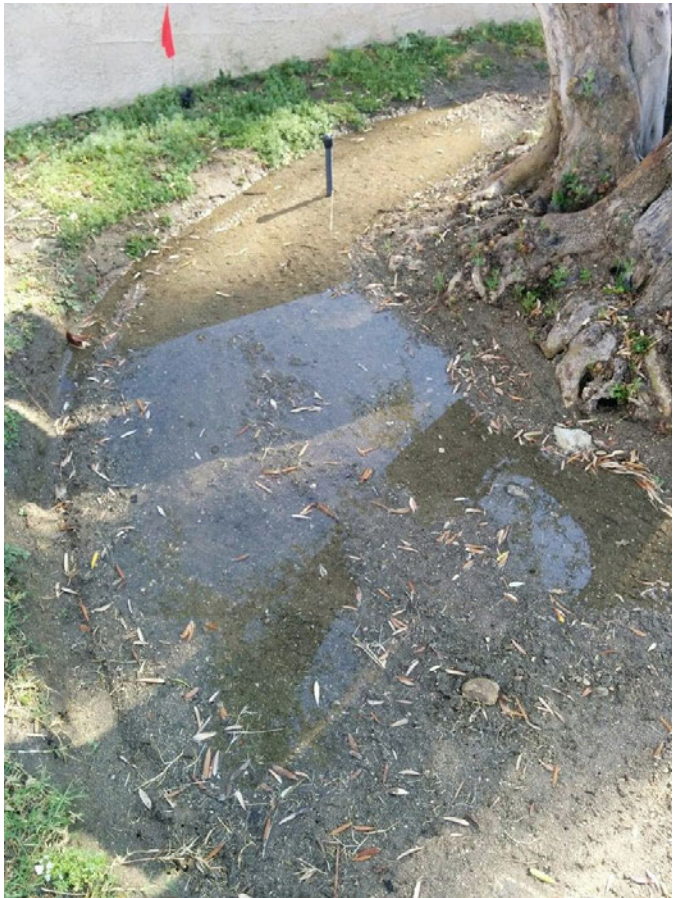
Flood bubblers almost being used correctly (the sprinkler run time is incorrect for this method of watering, but it's right next to a sprinkler on the same valve, so this isn't good design).

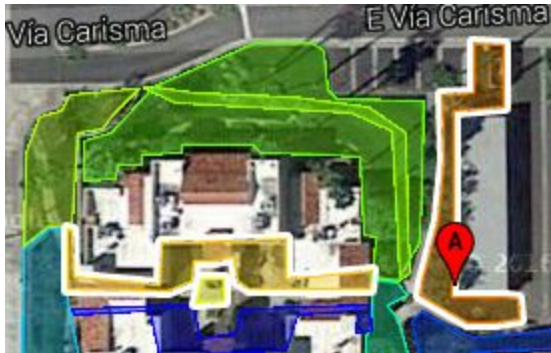
Zone 2

Along west side of carport next to Building 2160, North side and center of Courtyard in Building 2160

- Pressure was 37 psi
- Zones 2 and 6 are co-wired, see Zone 6 for repair information
- 23 sprinklers to be replaced, 8 to be upgraded or replaced

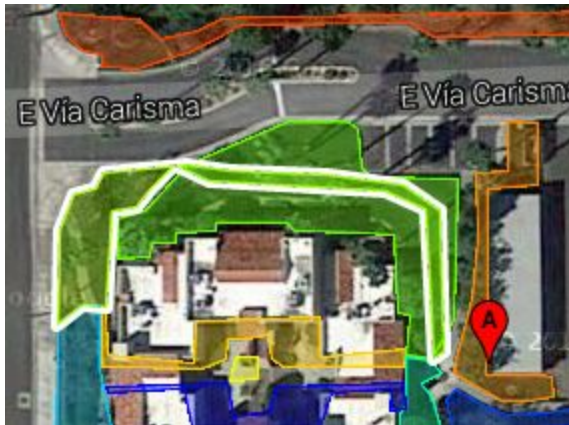
Zone 3

Turf area on the Southeast corner of S. Palm Canyon and Via Carisma, center of the turf around the north and northeast perimeter of Building 2160.

- Pressure was 35 psi
- This valve took 30 seconds to shut down. It needs to be replaced.
- 21 sprinklers to be replaced, 7 to be upgraded or replaced
- **There is a suspected water leak by the gas meter on the west side Building 2160.**
See photo below

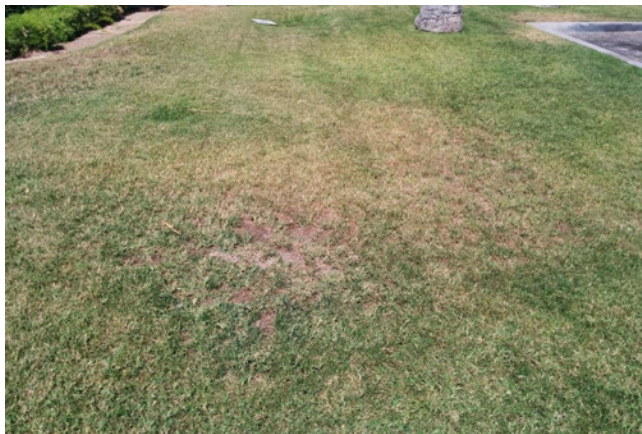
Brown patchy areas are from poor efficiency

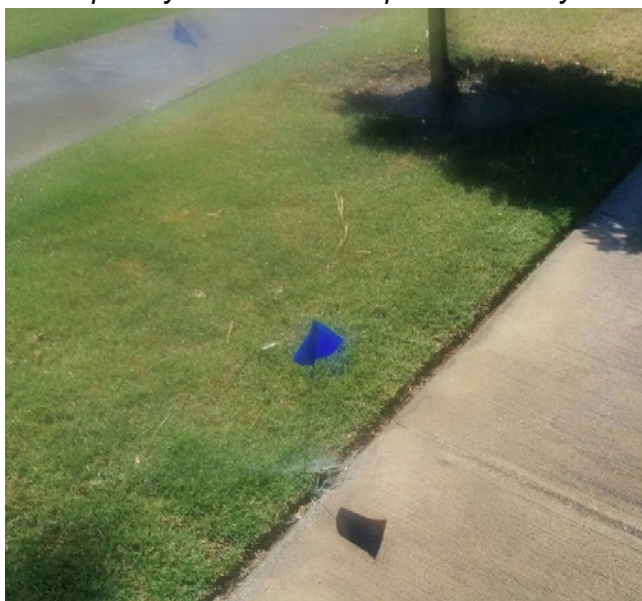
A lot of overspray onto public sidewalks, some from poorly aligned sprinklers

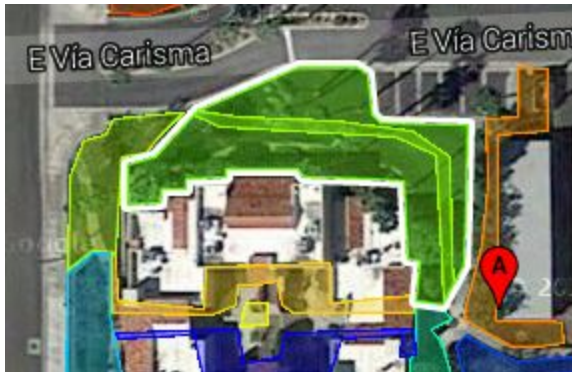
Zone 4

Turf around the north and northeast perimeter of Building 2160, and hedges, some planters.

- Pressure was 25 psi
- 19 sprinklers to be replaced; spacing is inconsistent and should be visited before nozzles are selected. 12 sprinklers to be converted to drip irrigation.

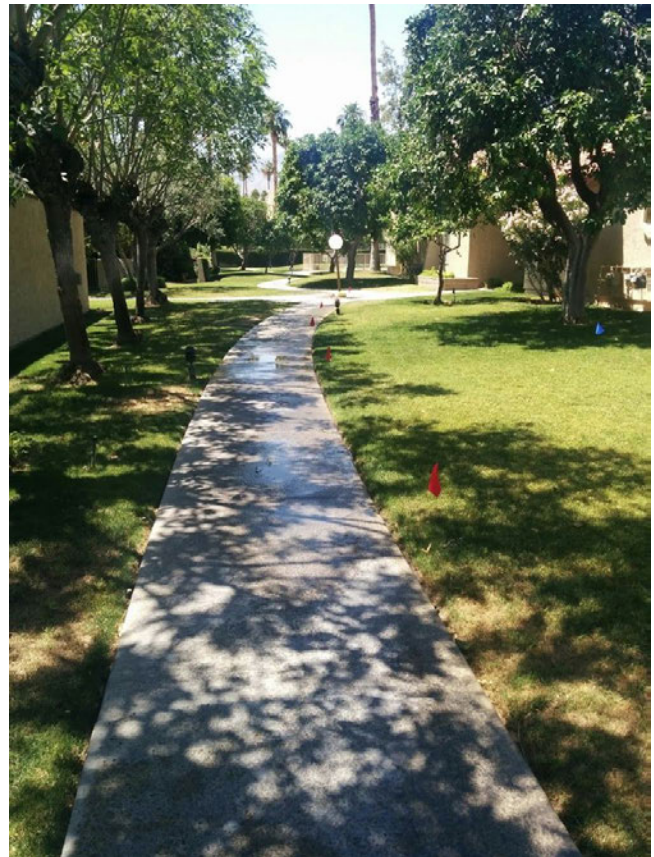
Overspray onto sidewalks. Turf on left side should be removed.

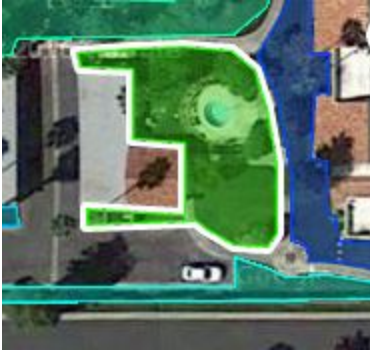
Zone 7

Turf and desertscape around Spa 1, Laundry Room 1, and the adjacent carport.

- Pressure was 25 psi
- 18 sprinklers to be replaced, 16 to be upgraded or replaced.
- Area by the grills should be converted to drip irrigation from spray. Turf should be removed around the carport and dumpster.

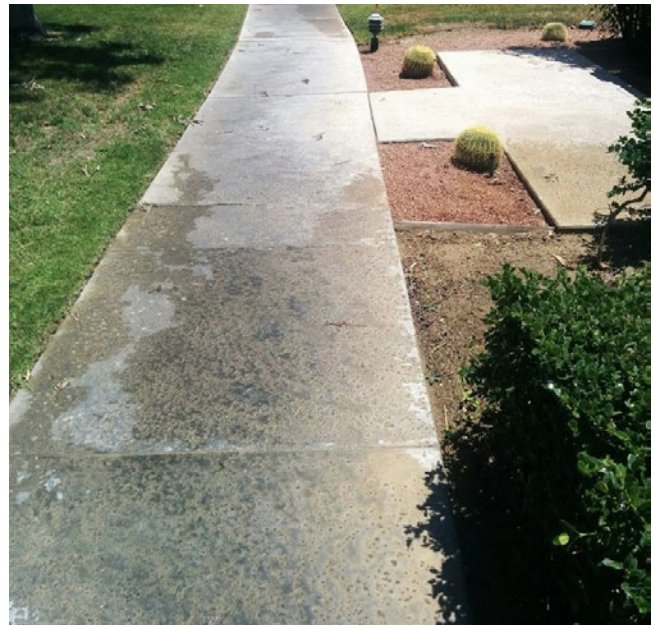
Should be drip, instead of sprinklers here.

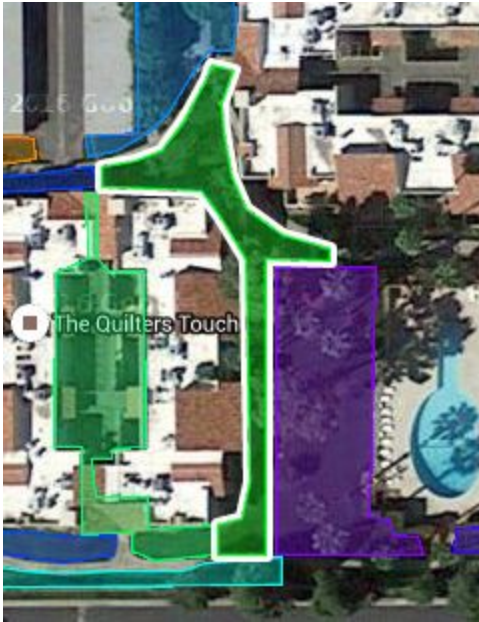
Zone 8

Hilly turf area northeast of Building 2170, hedges along eastern perimeter of Building 2170.

- Pressure was 40 psi
- This valve took 30 seconds to shut down. It needs to be replaced.
- 21 sprinklers to be replaced, 11 sprinklers to be upgraded or replaced. Spacing is inconsistent and should be visited before nozzles are selected. Several sprinklers to be converted to drip irrigation.

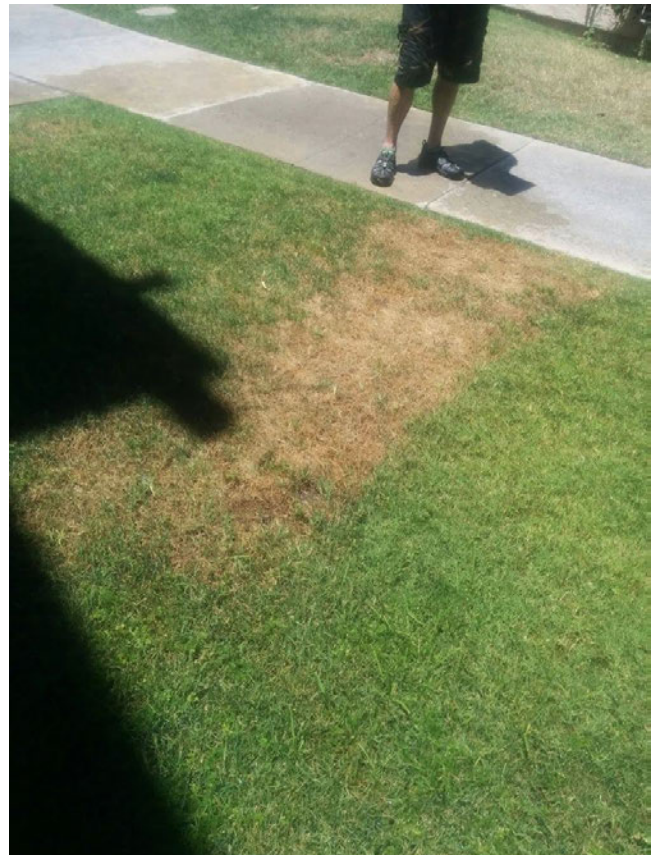
Brown area from inefficiency and poor spacing

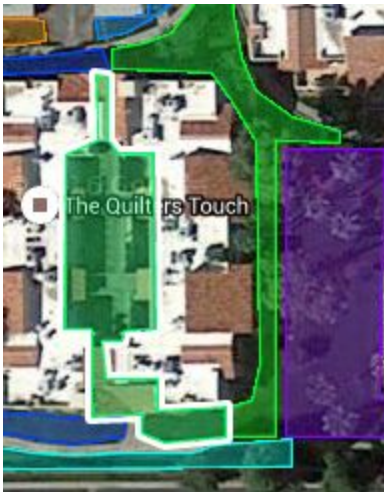
Zone 9

Courtyard in Building 2170, as well as planter area and turf area on the southeast corner of Building 2170.

- Pressure was 43 psi
- In turf areas: 10 sprinklers to be replaced, 6 sprinklers to be upgraded or replaced. In courtyard, 51 sprinklers to convert to drip irrigation.
- We recommend moving the turf watering to Zone 8 so the irrigation schedule can be better aligned with the plant's needs and there will be only one irrigation type on the valve.
- Given the current state of this courtyard's planting and irrigation system, it is recommended that the landscape maintenance crew remove the sprinklers in this area and cap them until construction can begin. Sprinklers should be replaced with bubblers for the pygmy palms and the bougainvillea. Everything else should be cleared in preparation for the new installation.

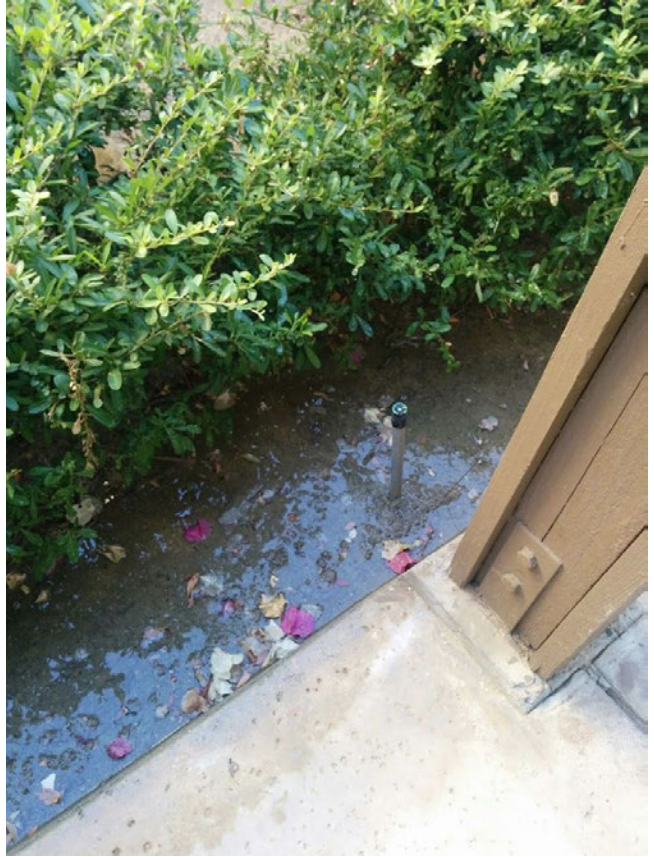
Flooding from blocked spray heads. This is a good place for drip tubing.

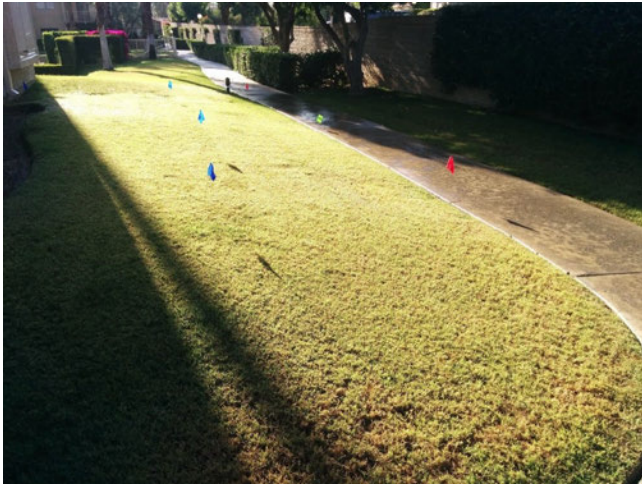
A lot of overspray near the lawn area, too.

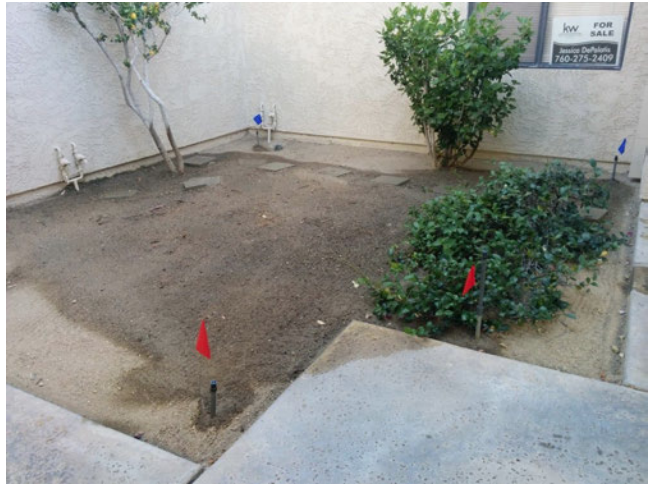
Large areas with no plants are being watered

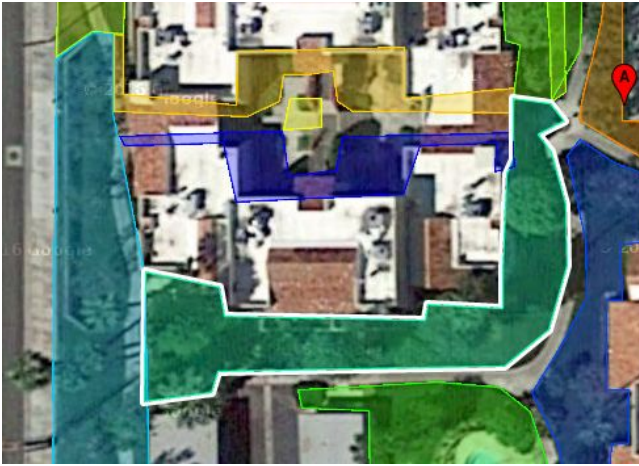
Zone 10

Turf, hedges, and planters along the south and southeast perimeter of Building 2160.

- Pressure was 38 psi
- This valve took 30 seconds to shut down. It needs to be replaced.
- 26 sprinklers to be replaced, 9 sprinklers to be upgraded or replaced. Spacing is inconsistent and should be visited before nozzles are selected. Several sprinklers to be converted to drip irrigation.
- **There is a suspected water leak by perimeter wall at southwest corner of the building.**

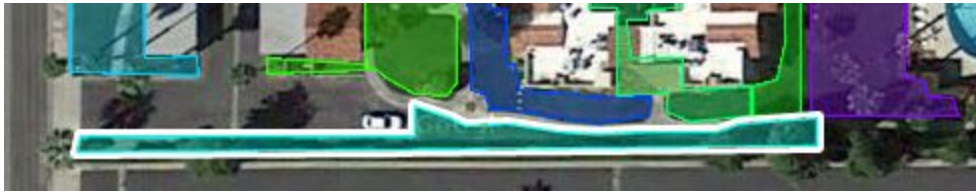
Zone 11

Turf, hedges along south perimeter wall, ends at east side of building 2170.

- Pressure was 30 psi
- 36 sprinklers to be converted to drip irrigation.
- We recommend all of the turf in this zone be removed.
- We recommend replacing the hedges along this entire boundary wall, as they are overgrown and the sprinklers can not be properly maintained.

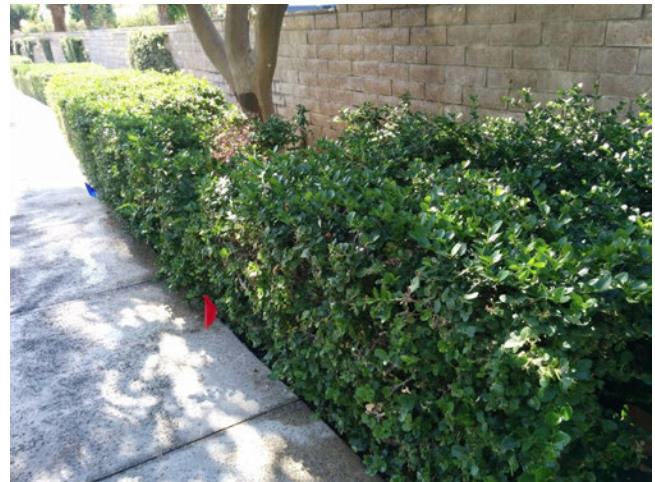
Overgrown hedges make it hard to maintain sprinklers in this area. These are bubblers, but you can see from the spray on the tree that there are also spray heads mixed in.

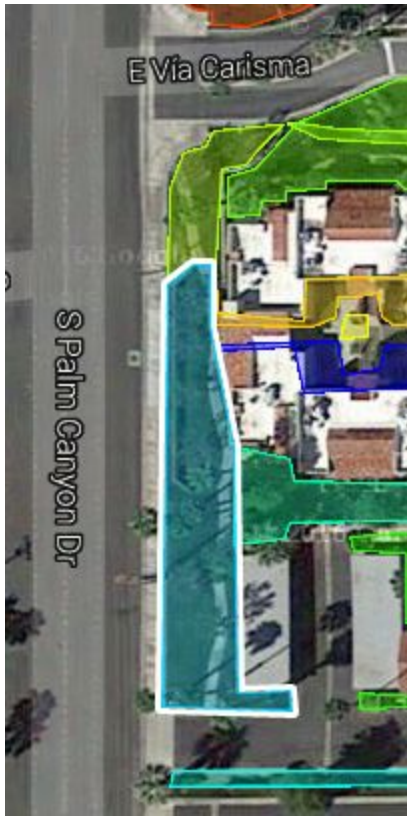
Zone 12

Turf, hedges along S. Palm Canyon, wraps around carport.

- Pressure was 30 psi
- 65 sprinklers and bubblers to be replaced. Irrigation is in very poor condition in this area and turf removal plans will dictate whether these sprinklers are upgraded/replaced or converted to drip irrigation.
- Turf removal recommended by carport. Turf removal recommended outside the wall. If keeping turf inside the wall, the zone should be split into two zones (one for turf, one for desertscape).

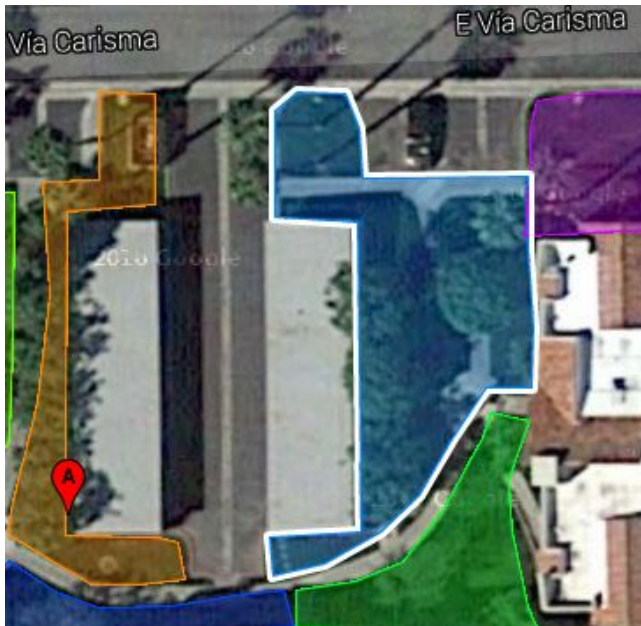
Zone 13

Turf and trees between carport and Building 2180.

- Pressure was 44 psi
- This valve took 1 minute to shut down. It needs to be replaced.
- 23 sprinklers to be replaced, 17 sprinklers to be replaced or upgraded, 3 bubblers. Spacing should be visited before upgrades are made. This zone's irrigation is in poor condition and repairs depend on turf removal plan.
- Turf removal recommended by carport and parking area.

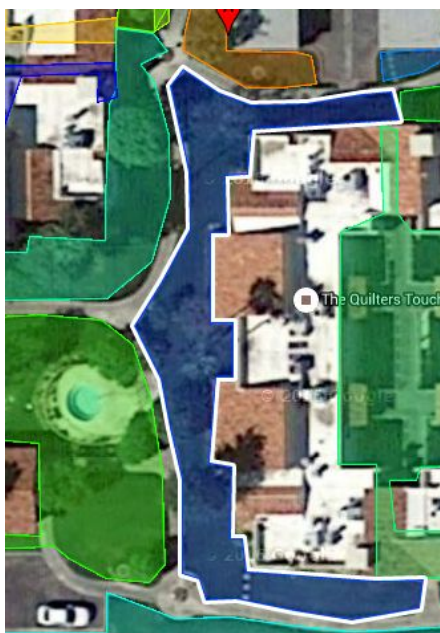
Zone 14

Turf, hedges surrounding western half of Building 2170.

- Pressure was 40 psi
- This valve took 1 minute to shut down. It needs to be replaced.
- 17 sprinklers to be replaced, 8 sprinklers to be replaced or upgraded, 1 bubbler.

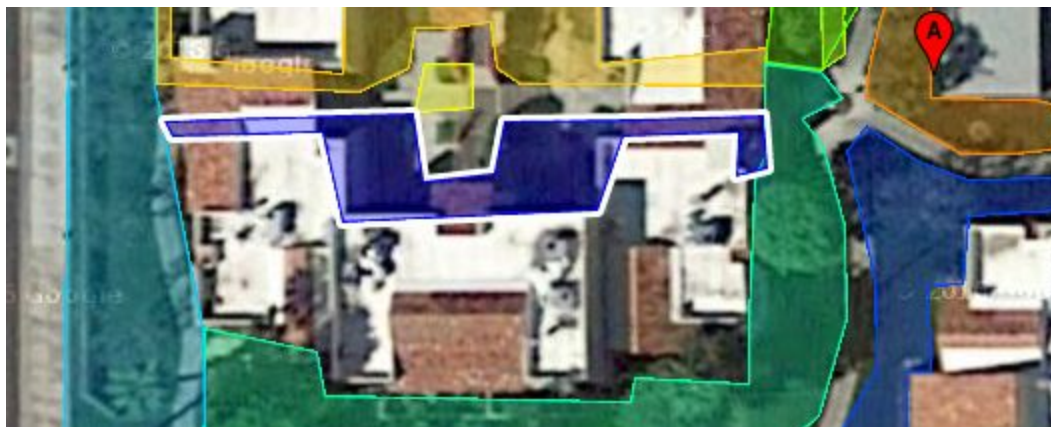
Zone 15

South portion of courtyard in Building 2160.

- Pressure was 65 psi
- 3 sprinklers to be replaced, 20 sprinklers to be replaced or upgraded, 2 bubblers. Also, 11 risers should be capped and replaced with drip tubing.

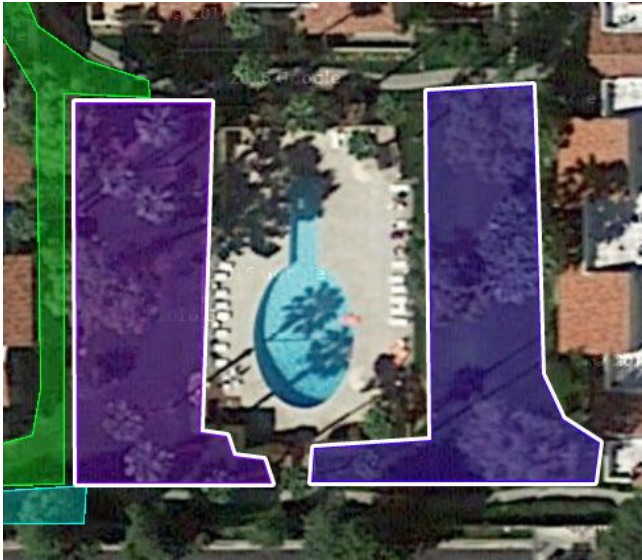
Zone 16

Large turf areas east and west of Pool 2.

- Pressure was not measured in this zone.
- 5 Maxi-Paw sprinklers to be replaced with Hunter PGP Rotors.
- The spacing in this area is a little off and should be adjusted.

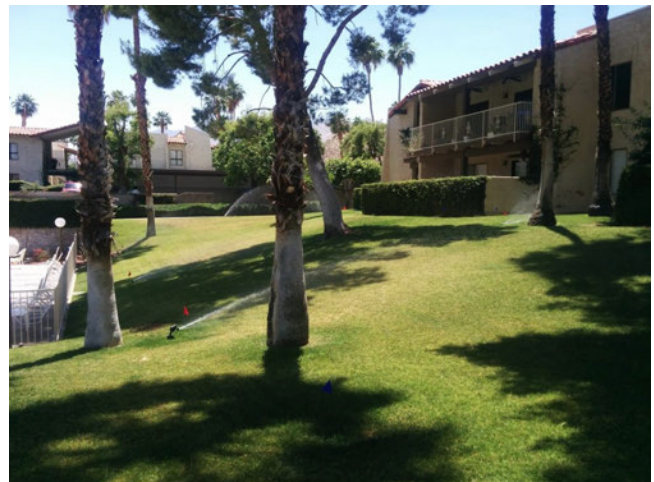
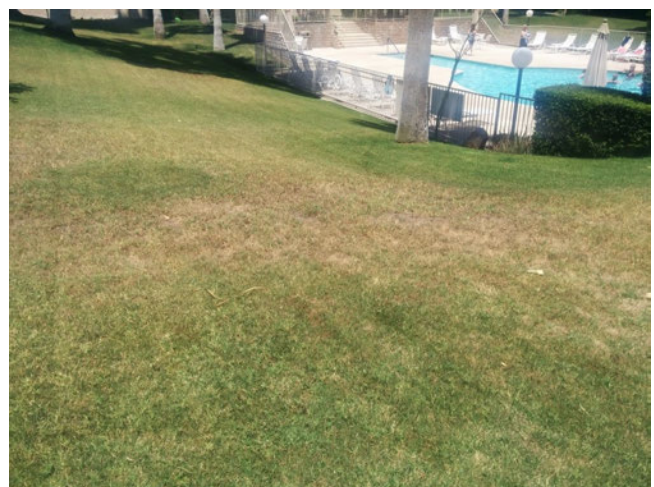
Patchy areas in turf related to poor coverage. Adjustments need to be made to spacing and sprinkler types.

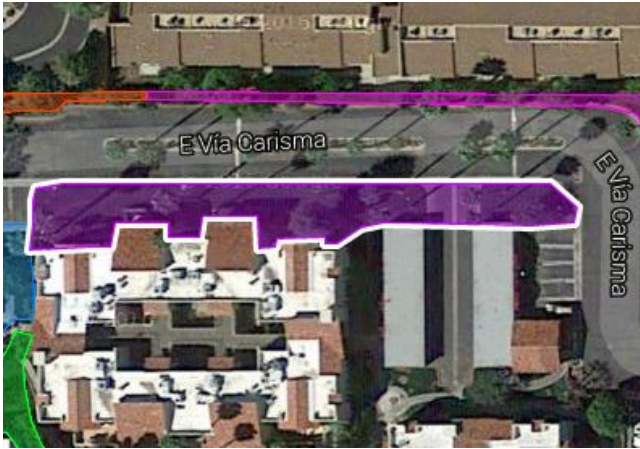
Zone 17

Turf area along Via Carisma from Building 2180 east to the end of the end of the parking area.

- Pressure was 35 psi (possibly impacted by big break in the line repaired while we were on site)
- 36 sprinklers to be replaced, 21 sprinklers to be upgraded.
- It is recommended that the sprinklers in this section be moved 12 inches in from the curb to reduce runoff.

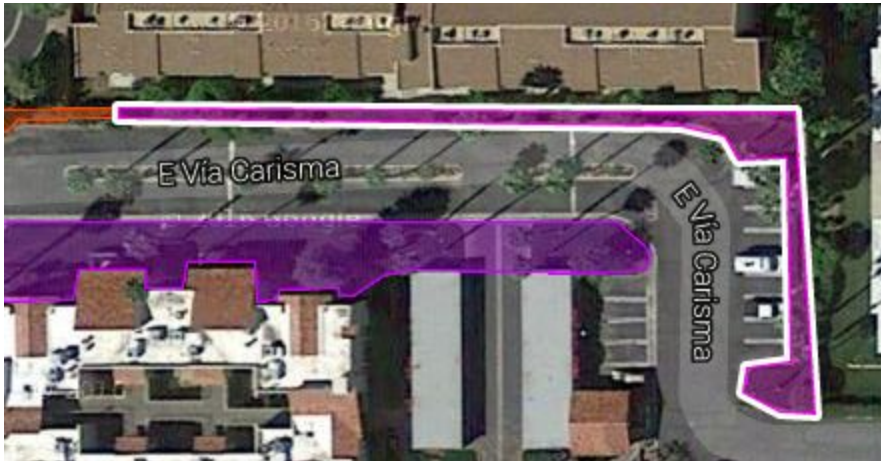
Zone 18

Hedges along the north and east side of Via Carisma.

- Pressure was 43 psi
- This zone should be converted to drip irrigation. The turf in this zone will be replaced, and the current shrubbery is all in a narrow planting bed.
- 44 sprinklers and bubblers to be removed and capped at the PVC or converted to drip irrigation.

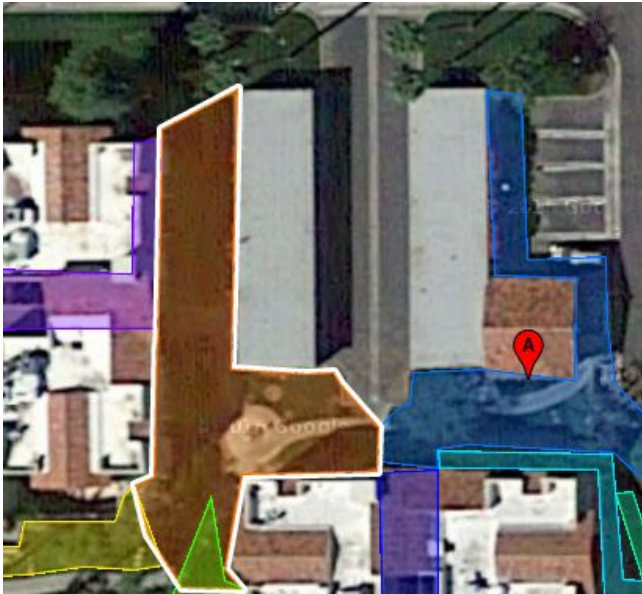
Zone 1

East side of Building 2180, and area between Building 2190 and the west carport.

- Pressure was 63 psi
- 4 sprinklers to be replaced, 12 sprinklers to be upgraded, 3 bubblers.
- There is a large sunken area (trip hazard) on the east side of the building, between the building and the carport.

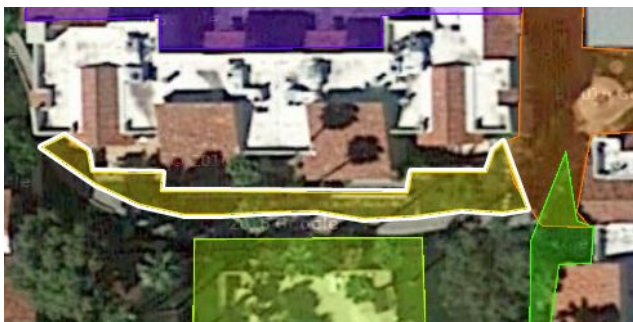
Zone 2

South perimeter of Building 2180.

- Pressure was 47 psi
- 4 sprinklers to be replaced, 12 sprinklers to be upgraded, 3 bubblers.
- The planters with mixed sprinklers are showing erratic watering. Some areas are dry and some are wet, so these areas should be evaluated carefully.
- In the turf area, there is too much overspray on the sidewalk. The cause is a mix of poor placement and out-of-date technology. Most of this area is too narrow to really be watered effectively with overhead sprinklers. Either selective or complete turf removal recommended in this area, north of the walkway.

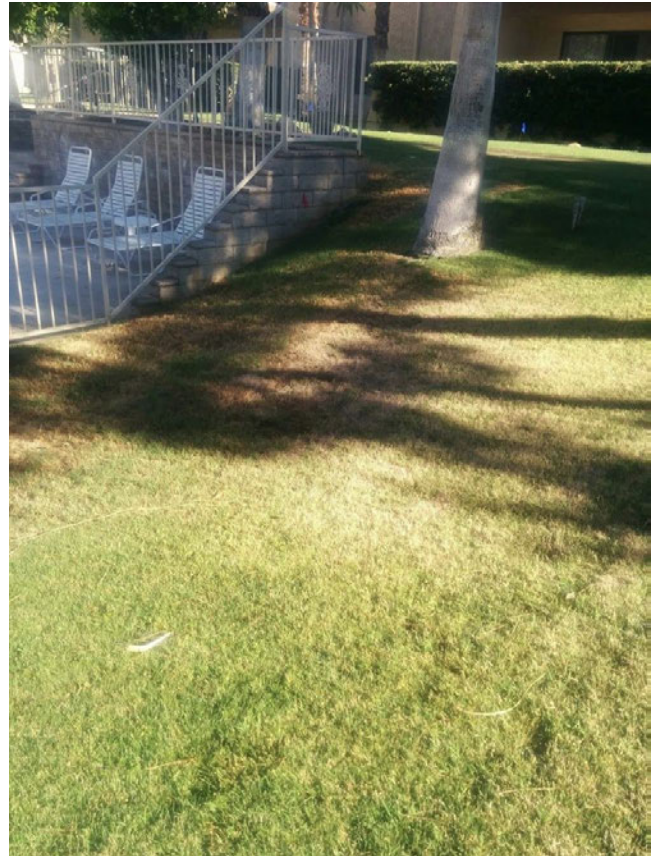
Patchy areas from poor sprinkler coverage and efficiency. Possibly also affected by shade, may need a blend of fescue and bermuda in this area for a greener look.

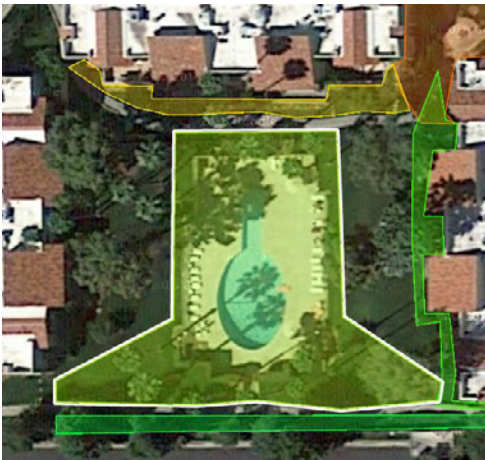
Zone 3

Perimeter of Pool 2 as well as most of the turf in the south portions of lawn and trees around Pool 2.

- Pressure was 20-25 psi
- 25 sprinklers to be replaced, 29 sprinklers to be upgraded, and 12 bubblers.
- There is low volume in this area because there are too many sprinklers on one valve. Parts of this zone should be relocated to other zones OR some sprinklers should be removed and capped. Longer-range nozzles or Hunter PGP Rotors should be installed in place of the remaining sprinklers.

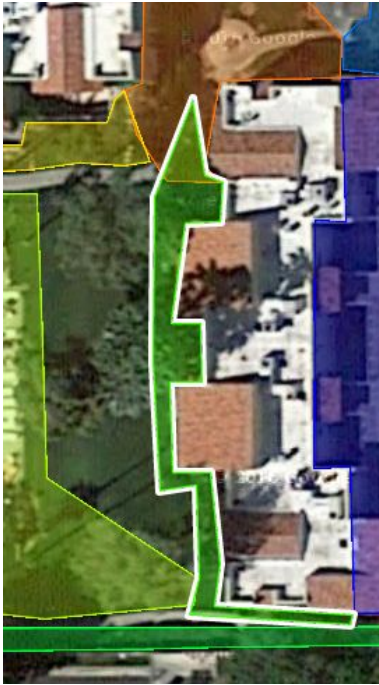
Zone 4

West and southwest perimeter of Building 2190, turf and hedges.

- Pressure was 50 psi
- 15 sprinklers to be replaced, 17 sprinklers to be upgraded, and 9 bubblers/drip emitters.
- The drip emitters are 2 GPH. Given that these are installed on cactus that are being watered on the turf's schedule, it might make sense to cut these back to 1 GPH.

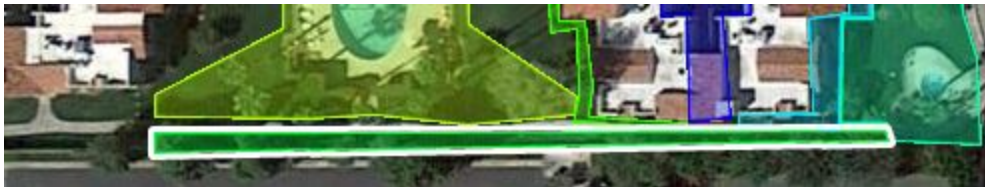
Zone 5

Hedge along south side of walkway from Building 2170 east to the end of Building 2190.

- Pressure was 25 psi
- 4 sprinklers to be replaced, 22 sprinklers to be upgraded.
- The hedge is overgrown and the sprinklers could not all be located. This also means they can't be repaired. It is recommended that this entire hedge is removed (it's all Natal Plum) and replaced with a variety of plants set up on proper drip irrigation.

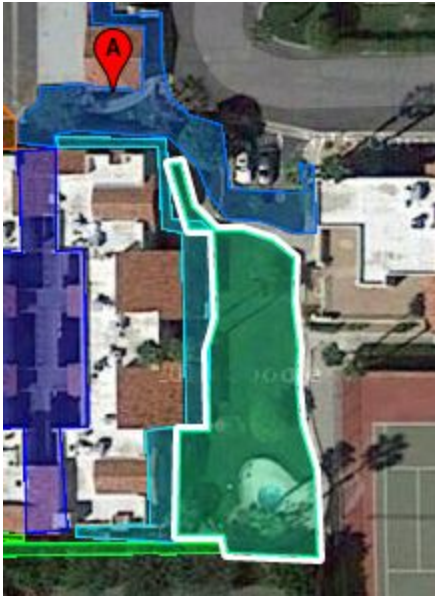
Zone 6

Turf area east of Building 2190.

- Pressure was 30 psi
- 14 sprinklers to be replaced, 13 sprinklers to be upgraded, and 10 drip emitters.

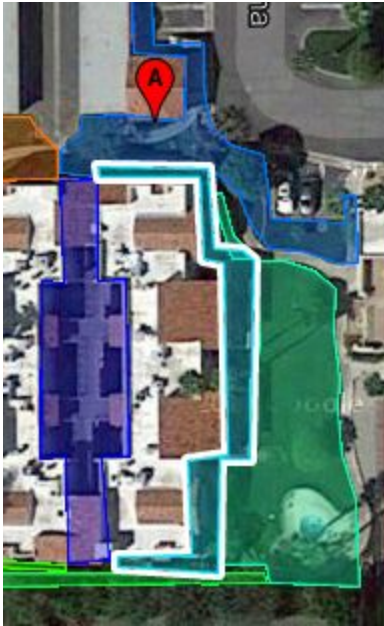
Zone 7

Perimeter on eastern half of Building 2190, turf and hedges.

- Pressure was 40 psi
- This valve took 35 seconds to shut down. It needs to be replaced.
- 8 sprinklers to be replaced, 29 sprinklers to be upgraded, and 2 bubblers.

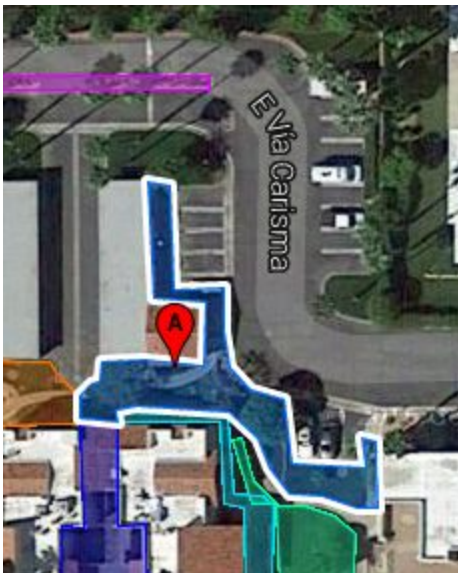
Zone 8

Corner of Via Carisma, turf and hedges wrapped from carport, around to the north east portion of building 2180, and around to the clubhouse.

- Pressure was 45 psi
- 15 sprinklers to be replaced, 14 sprinklers to be upgraded, and 13 bubblers.
- We recommend removing much of the turf in this area. It's steeply hilly and in some places dangerous. The bubblers need to be replaced with fixed-emission bubblers.

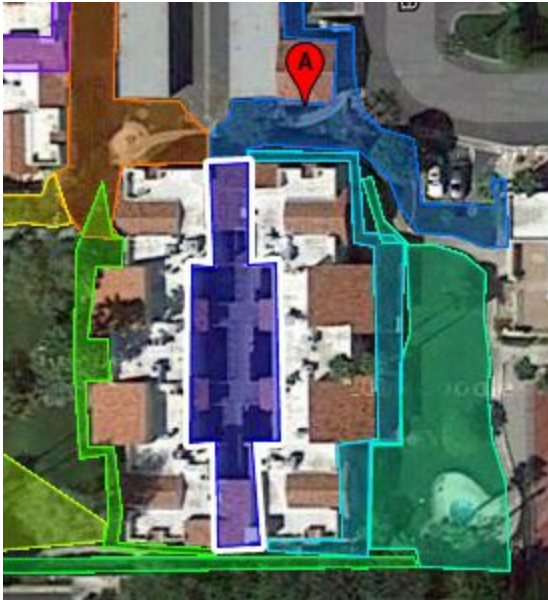
Zone 9

Courtyard of Building 2190.

- Pressure was 55 psi
- 2 sprinklers to be replaced, 36 sprinklers to be upgraded, and 13 bubblers.

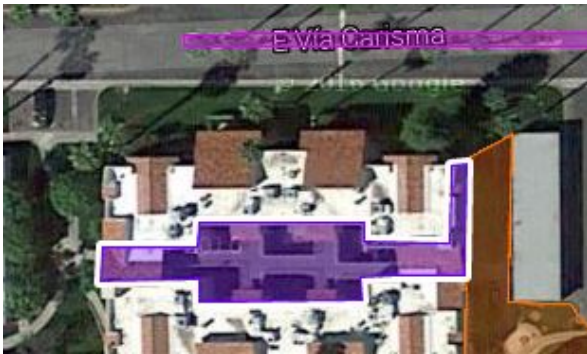
Zone 10

Courtyard of Building 2180 and northeast planter.

- Pressure was 55 psi
- 6 sprinklers to be replaced, 33 sprinklers to be upgraded, and 6 bubblers.
- 2 capped risers were leaking.

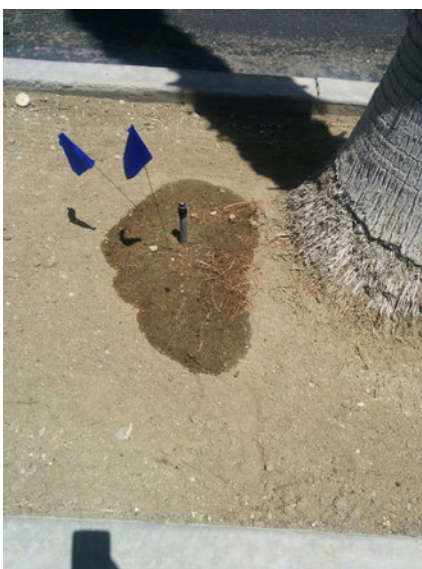
Bubbler not providing enough water for this palm tree. This was common in the median.

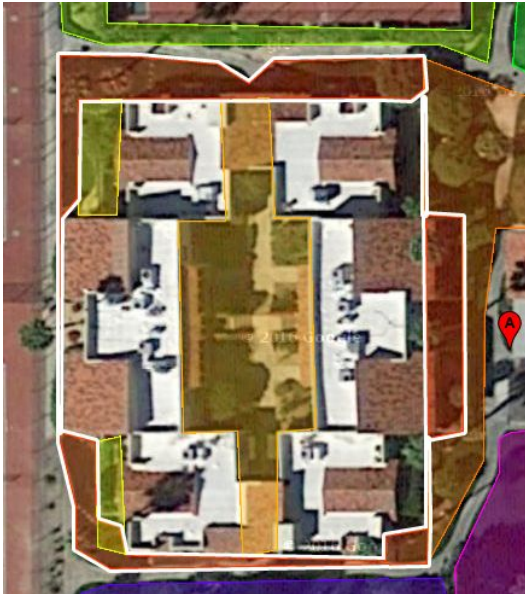
Zone 1

Perimeter of Building 351, turf and hedges.

- Pressure was 17 psi.
- This valve took 30 seconds to shut down. It needs to be replaced. It should also be split into two zones, separating the turf from the other plants.
- 31 sprinklers to be replaced, 31 sprinklers to be upgraded, 16 bubblers.
- There are an unknown number of sprinklers under the lavender hedge. This means they can't be maintained. This bed should be refreshed with new lavender plants or something else.

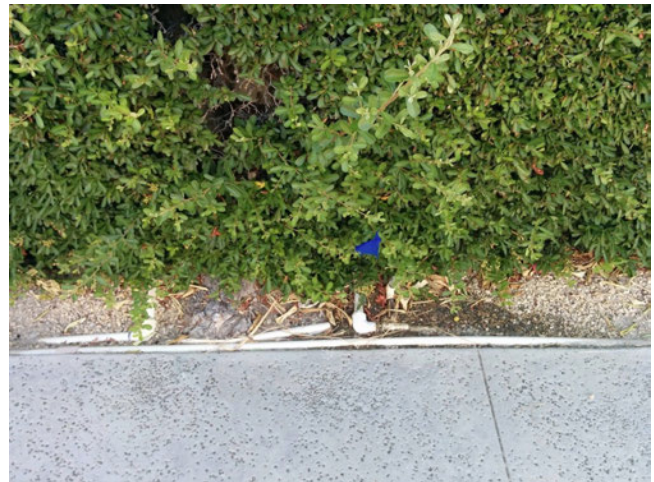
Exposed pipe shortens its lifespan and is not attractive. This area should be watered with drip tubing and the pipe buried when the renovation work is performed.

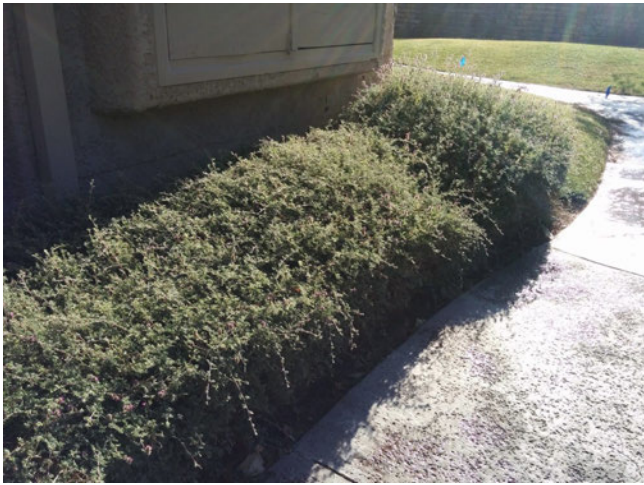
The mature lavender under which the sprinklers can't be located or maintained.

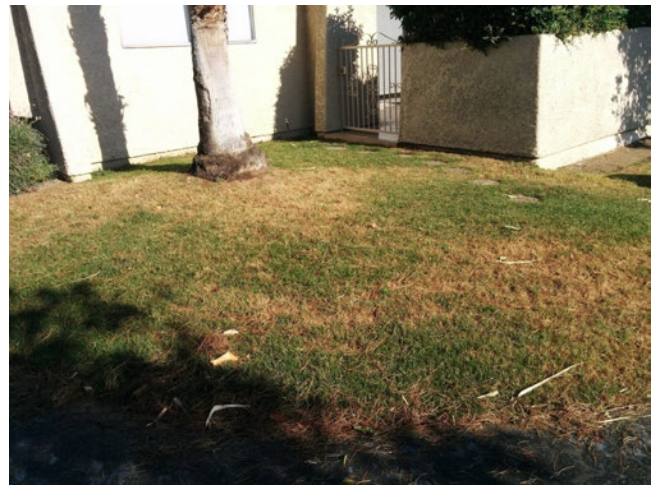
Grass is brown here because the sprinkler is blocked by the palm tree. This is an area where a small amount of turf removal would be beneficial.

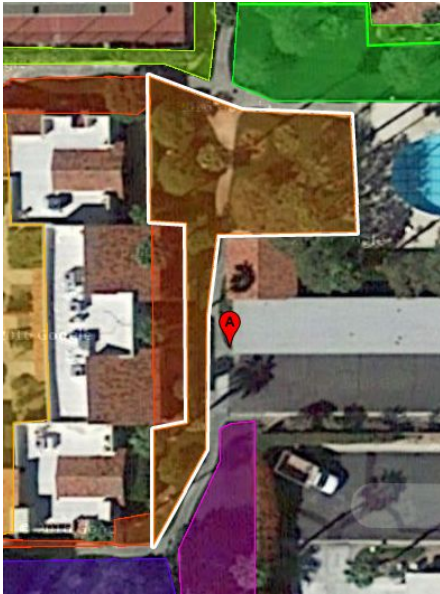
Zone 2

Turf east of Building 351 and west of Pool 5.

- Pressure was 22 psi.
- 14 sprinklers to be replaced, 17 sprinklers to be upgraded, 2 bubblers.
- Sprinkler spacing in this zone is very poor and needs to be addressed.

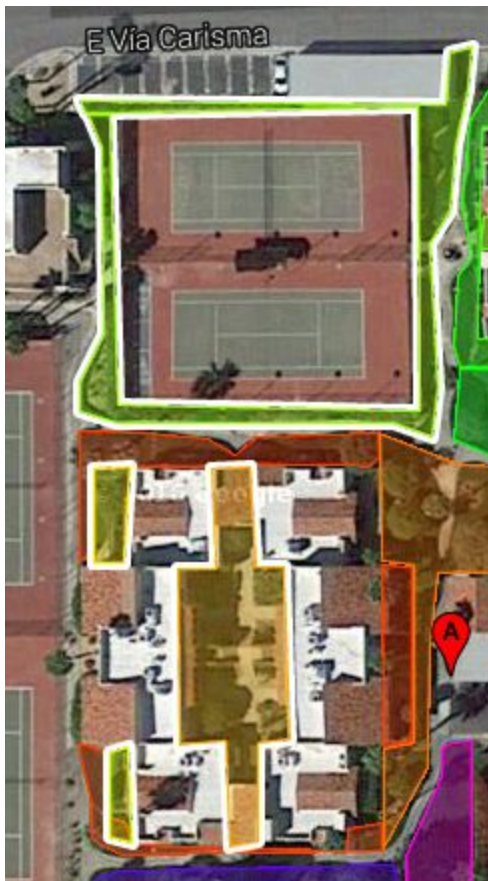
Zone 3

Courtyard and portion of west perimeter of Building 351, entire perimeter of east tennis courts.

- Pressure was 25 psi in the courtyard and 35 psi around the tennis courts.
- 135 sprinklers and risers to cap for conversion to drip tubing (water was on tennis courts from spray heads).
- This zone is too large (too many sprinklers, too large of an area). It should be split into two zones (at least).
- **Broken lateral suspected between tennis court and carport on Via Carisma.** This is in a low-traffic area. Jose was informed to look for the leak, but we don't know if it was repaired.

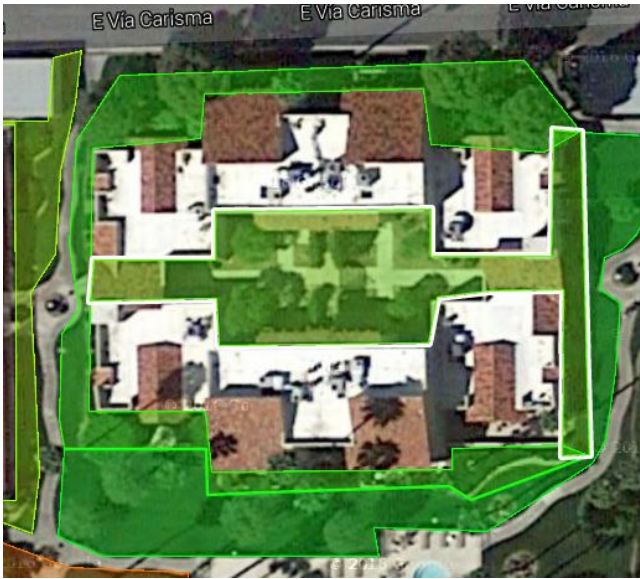
Zone 4

Courtyard and eastern perimeter of Building 451.

- Pressure was 65 psi.
- 72 sprinklers and risers to cap for conversion to drip tubing.
- Watering was highly erratic and many sprinklers were not in the right location for the plants. This will all be moot after switching to drip irrigation.

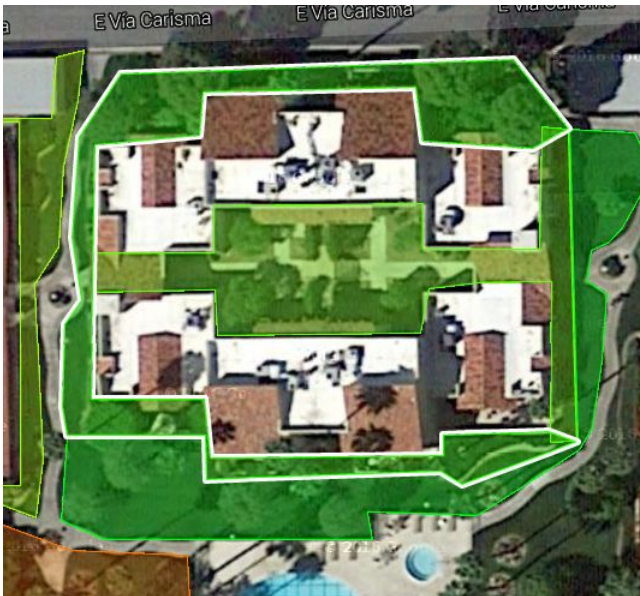
Zone 5

North, west, and south perimeter of Building 451, hedges and turf.

- Pressure was not measured.
- This valve took 21 seconds to shut down. It needs to be replaced. It should also be split into two zones, separating the turf from the other plants.
- 32 sprinklers to be replaced, 41 sprinklers to be upgraded, 3 bubblers.
- **Corroded electrical conduit along boundary between hedge and turf on south side of building.**

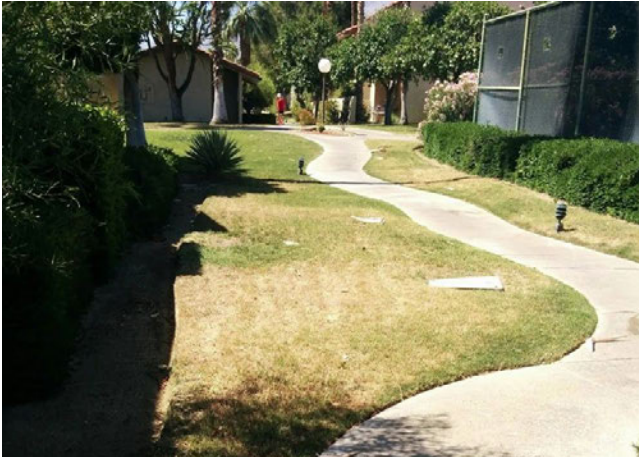
Patchy brown grass is from sprinkler inefficiency and underwatering. These shapes are difficult to water efficiently and should probably undergo turf removal.

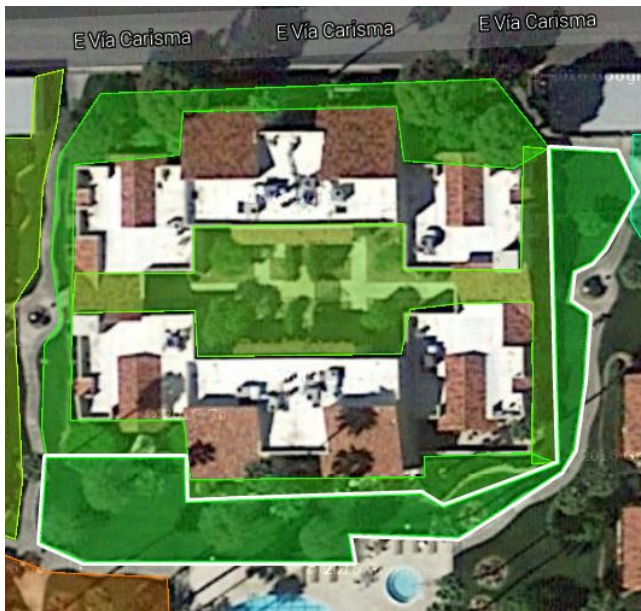
Zone 6

East and south perimeter of Building 451, hedges and turf.

- Pressure was 60 psi.
- 8 sprinklers to be replaced, 11 sprinklers to be upgraded.

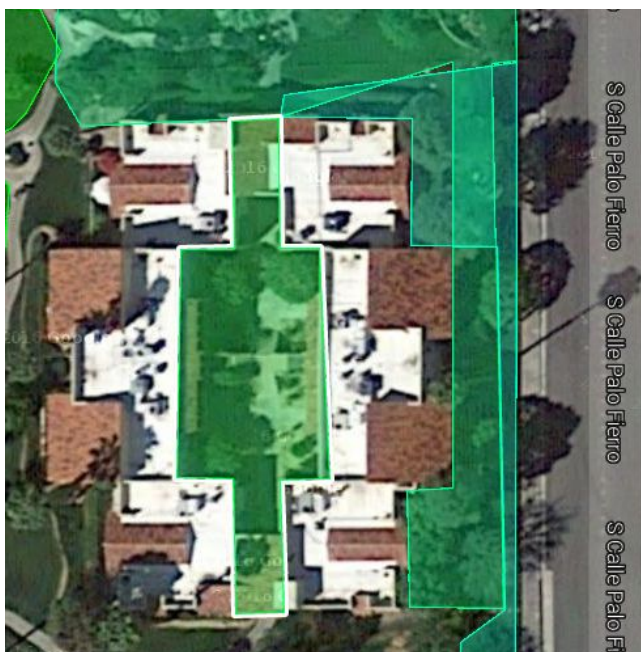
Zone 9

Courtyard of Building 2255.

- Pressure was not measured.
- 98 adjustable bubblers, many of which were the wrong choice for the plant. This zone needs to be converted to fixed-emission bubblers or drip-tubing (better solution).

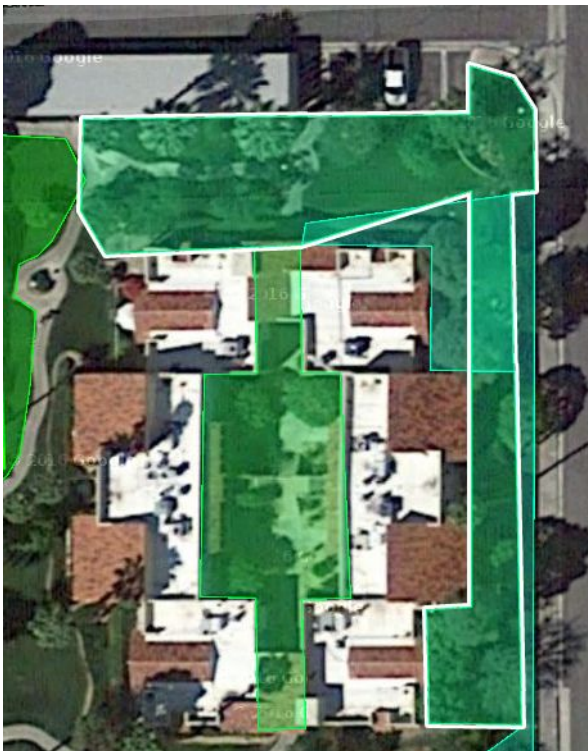
Zone 11

North and east perimeter of Building 2255 (includes the circle of desertscaping).

- Pressure was 20 psi.
- 26 sprinklers to be replaced, 27 sprinklers to be upgraded, 4 bubblers.
