Canyon Country Club Estados Conservation Review Report

Submitted on July 1, 2016 by Jessyca Frederick, CEO of Water Wise Now, LLC
WaterWiseNow.com | jessyca@waterwisenow.com | Toll free: 844-LESS-H2O x 700

Project Summary

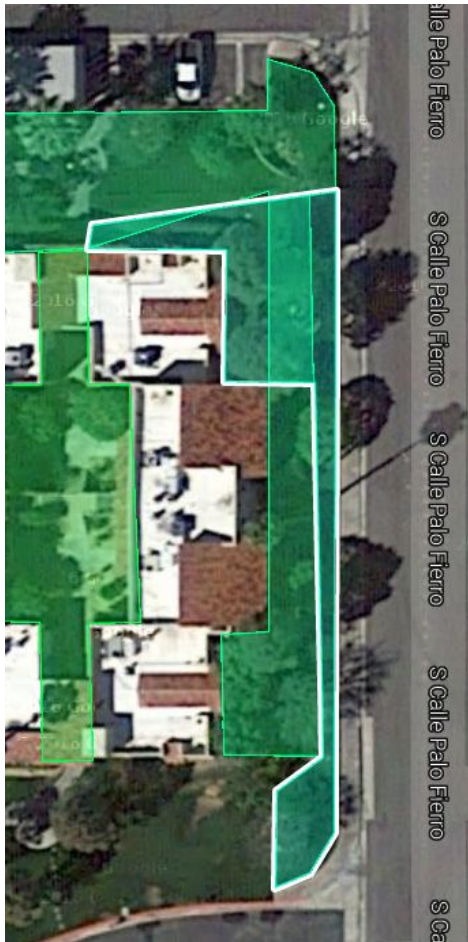
Zone 12

East perimeter of Building 2255 down to Mariposa Dr.

- Pressure was 25 psi.
- 34 sprinklers to be replaced, 7 sprinklers to be upgraded, 1 bubbler.
- This area should be considered for turf removal, especially along Palo Fierro where the grass is heavily shaded and on a steep slope.

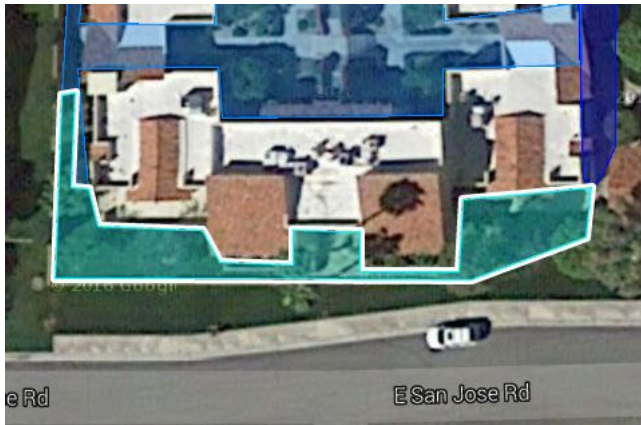
Zone 13

Lower south perimeter of Building 310.

- Pressure was 50 psi.
- 6 sprinklers to be replaced, 18 sprinklers to be upgraded, 3 bubblers.
- **Broken lateral suspected in southwest corner, against the building.** This is in a low-traffic area. Jose was informed to look for the leak, but we don't know if it was repaired.

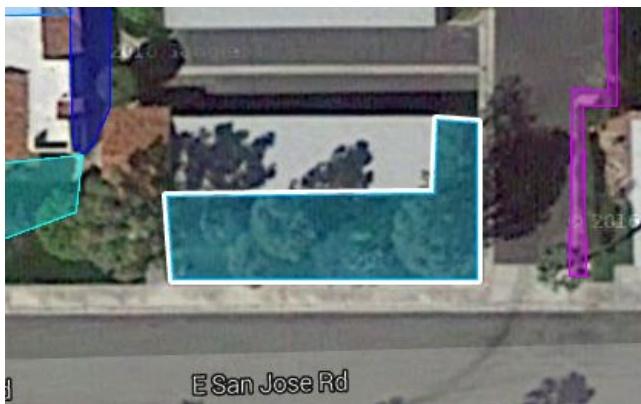
Zone 14

Lower south perimeter of the carport along San Jose.

- Pressure was not measured.
- 11 sprinklers to be replaced, 18 sprinklers to be upgraded, 8 bubblers.
- **Broken sprinkler during test.** Jose was repaired it while we were still there.

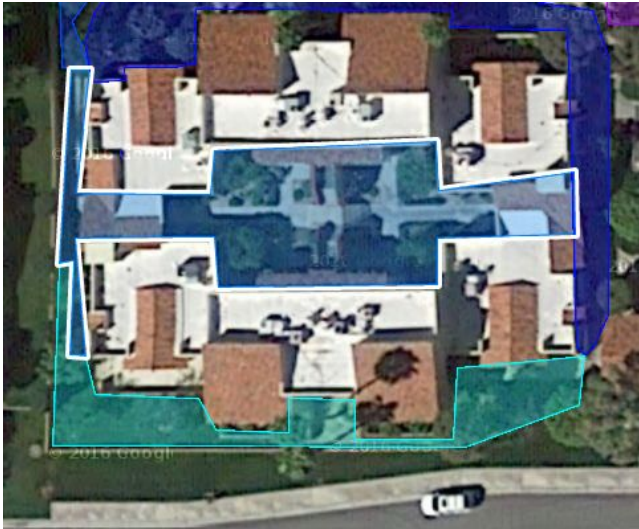
Zone 15

Courtyard and west perimeter of Building 310.

- Pressure was 40 psi.
- 74 sprinklers and risers to cap for conversion to drip tubing. This area is significantly overwatered.
- Two capped risers are leaking.

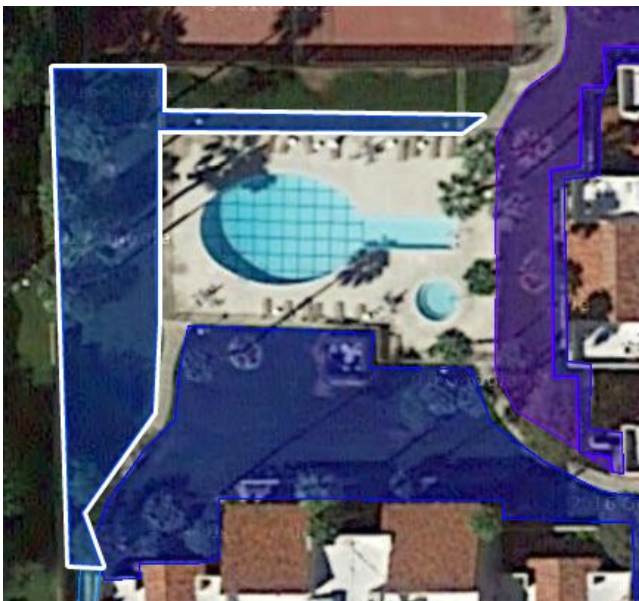
Zone 17

Turf area west of Pool 4 and south row of sprinklers on north side of pool area.

- Pressure was 17 psi (very low, possibly indicating a lateral break somewhere).
- 21 sprinklers to be replaced, 23 sprinklers to be upgraded.
- Spacing is poor and should be addressed, specifically aligned for hillside watering.

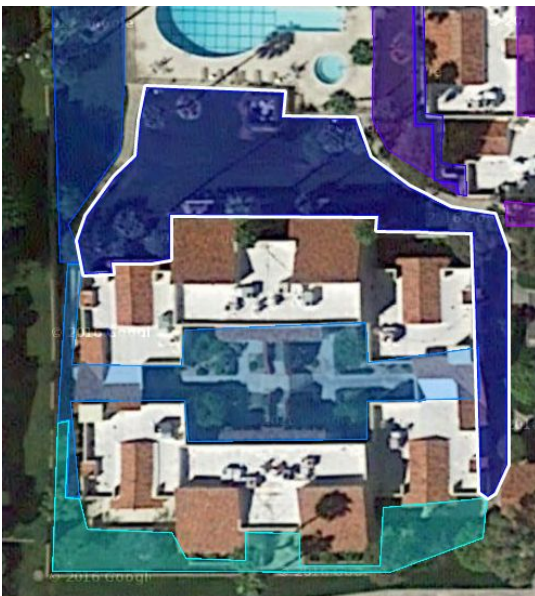
Zone 18

Turf area south of Pool 4 and east perimeter of Building 310.

- Pressure was 10 psi (very low, possibly indicating a lateral break somewhere).
- This valve took 20 seconds to shut down. It needs to be replaced.
- 21 sprinklers to be replaced, 23 sprinklers to be upgraded.
- Spacing is poor and should be addressed, specifically aligned for hillside watering.

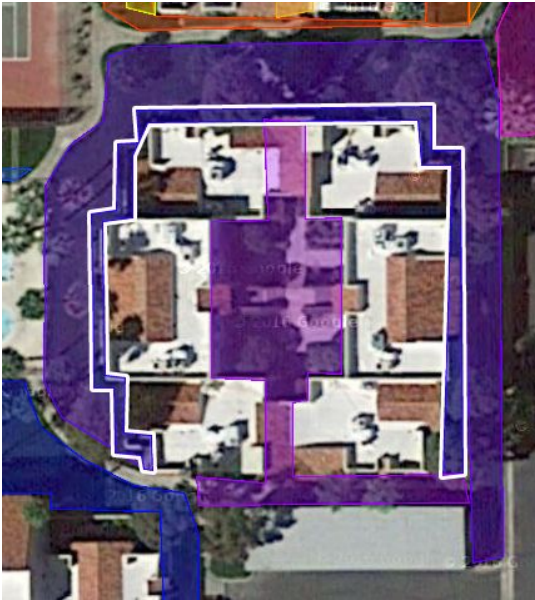
Zone 19

West, east, and north perimeter of Building 340, hedges only.

- Pressure was 20 psi (very low, possibly indicating a lateral break somewhere).
- 45 sprinklers and risers to cap for conversion to drip tubing. As an example, this should cost around \$625 in materials.

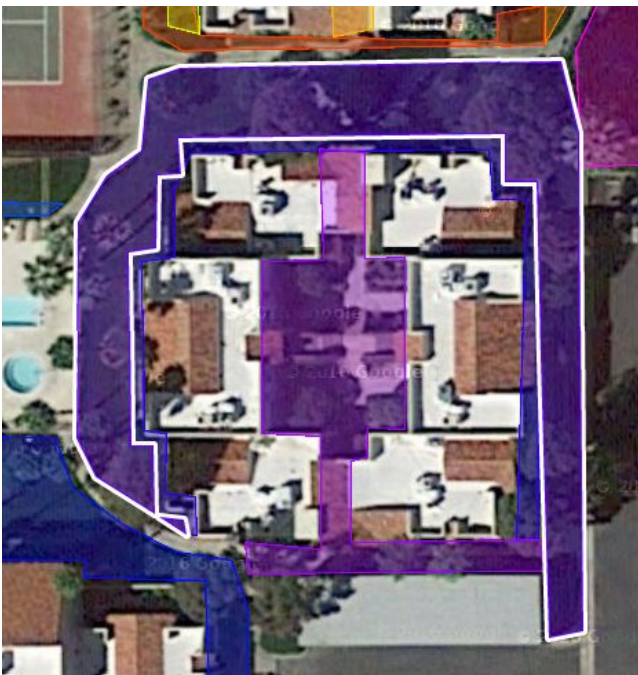
Zone 20

West, east, and north perimeter of Building 340, turf and trees.

- Pressure was 40 psi.
- 16 sprinklers to be replaced, 25 sprinklers to be upgraded, 13 bubblers.
- Sprinklers are poorly spaced and need to be adjusted.

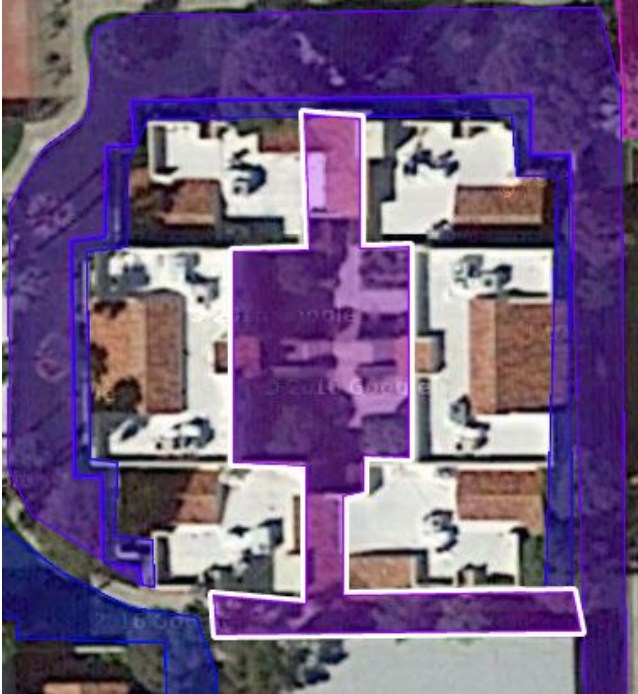
Zone 21

Courtyard and south perimeter of Building 340.

- Pressure was 50 psi.
- 6 sprinklers to be replaced, 31 sprinklers to be upgraded, 34 bubblers.
- Many plants are getting too much water in the courtyard. Fixed-emission bubblers should replace the existing bubblers.

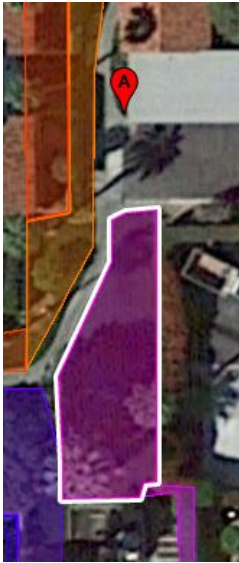
Zone 23

Turf area west of Building 340, along wall.

- Pressure was not measured.
- 3 sprinklers to be replaced, 15 sprinklers to be upgraded, 11 bubblers.

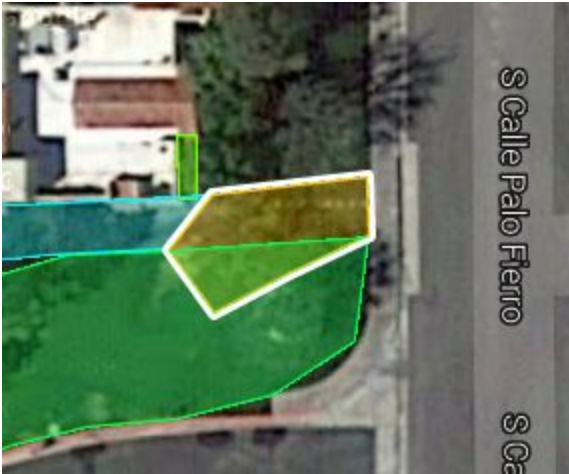
Zone 1

Southeast corner of Building 2255, trees and turf.

- Pressure was not measured.
- 11 Maxi-Paws to be replaced, 1 Hunter PGP rotor.
- The spacing in this area is very poor and should be addressed. It should be designed in context with Zones 3 and 4 on Controller #4 and Zones 11 and 12 on Controller #3 which also water this area. Ideally the zones would be reconfigured to have this area only watered by one or two zones.

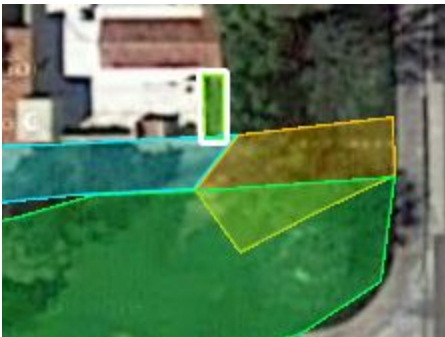
Zone 2

Southeast corner of Building 2255, appears to only water the owner's patio. It's being drastically overwatered for what is there.

- Pressure was not measured.
- Unknown sprinklers as we didn't go on the private property

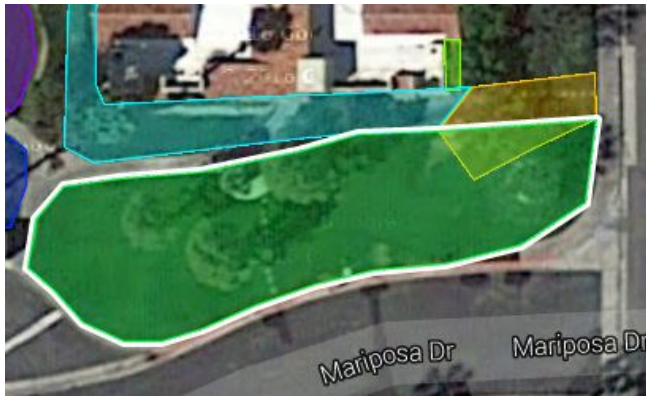
Zone 3

Majority of the lawn and trees at Palo Fierro and Mariposa, west to the carport. This area was not being watered when we visited the site and we called in for repairs.

- Pressure was not measured but it was very low.
- 21 sprinklers to be replaced, 19 sprinklers to be upgraded, 3 bubblers (on trees).

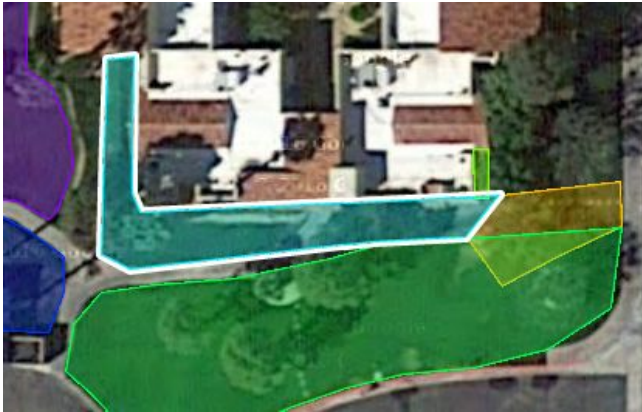
Zone 4

Area of lawn and hedges which wraps around the southwest corner Building 2255.

- Pressure was not measured but it was very low due to a broken lateral.
- 9 sprinklers to be replaced, 2 sprinklers to be upgraded, 1 bubbler.
- **Broken lateral was discovered on the east side of the sidewalk at the south entrance to the courtyard** and reported to Desert Management. We do not know if it has been repaired.

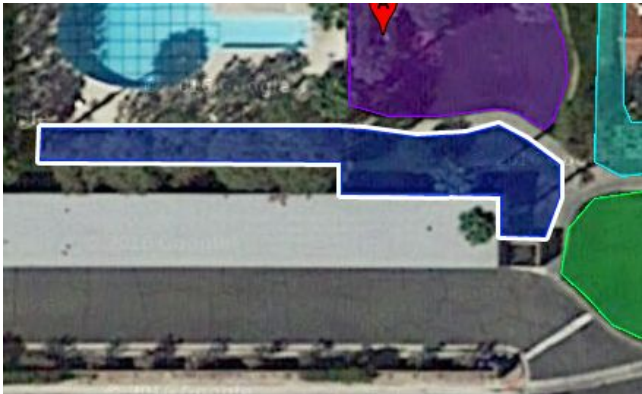
Zone 5

Area of lawn and trees around between carport and Pool 5.

- Pressure was not measured.
- 15 sprinklers to be replaced, 15 sprinklers to be upgraded.

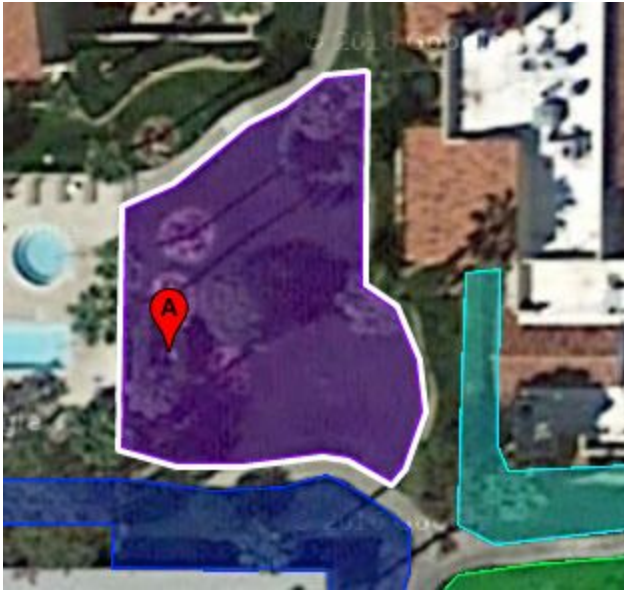
Zone 6

Area of lawn and trees between Building 2255 and Pool 5.

- Pressure was not measured but it was very low.
- 1 sprinklers to be replaced, 23 sprinklers to be upgraded, 1 bubblers (on tree).

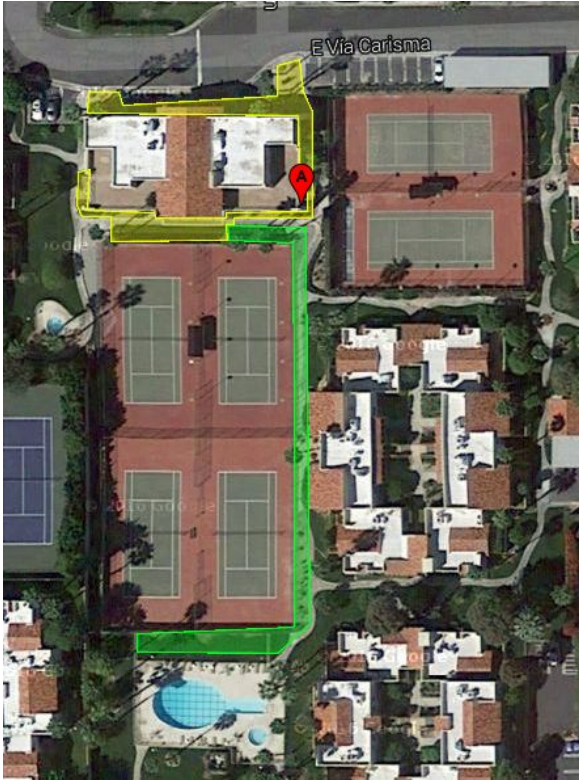
Controller 5 (Rain Bird ESP-Me)

This is a modern Rain Bird ESP Modular controller. It was in good operating condition.
