SOMMERS HOME INSPECTIONS, LLC

## HOME INSPECTION

1234 Main Street  
Beaverton, OR 97005

Buyer Name  
07/14/2024 9:00AM

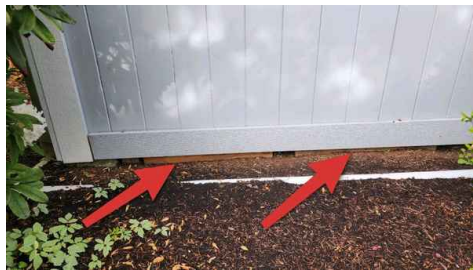
Avoid wood to soil contact as it will cause rot overtime and invite wood destroying organisms.

Wood to soil contact

Create a clearance

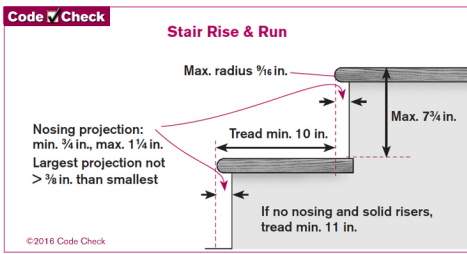
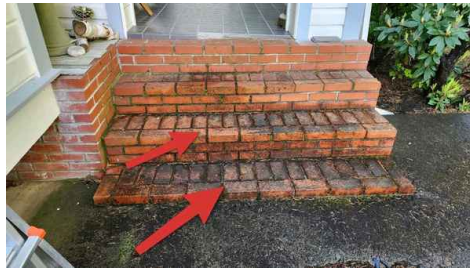
2.2.4 Decks, Balconies, Patios & Steps

The steps are uneven and should be upgraded so they won't pose a trip hazard.

Uneven height

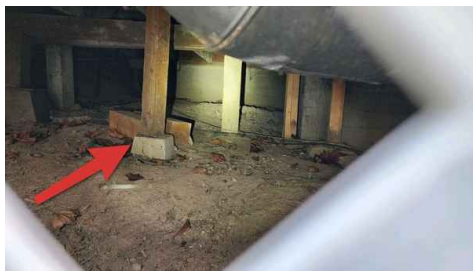
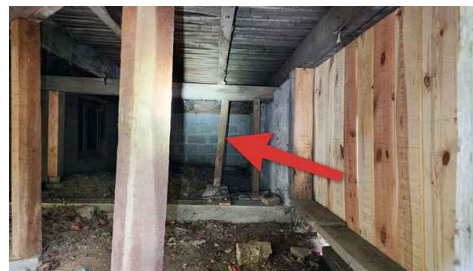
Some of the concrete stone supporting the posts appear to have settled. Some posts are tilted and no longer straight. I was not able to get up close. The slats need to be removed to gain access. Support the posts where needed. Newer wood is visible and some upgrades were already made.

Possible settlements

Tilted

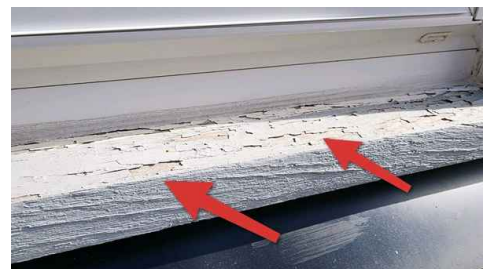
2nd Floor South

Maintain the paint on the siding to keep the wood protected. Any loose paint needs to be sanded and primed before repainting.

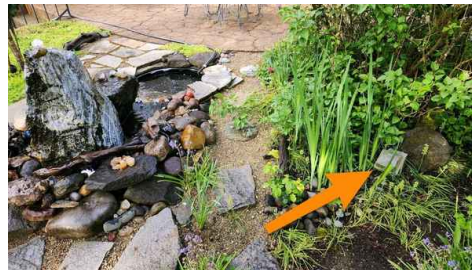
By todays standards, all exterior outlets should be GFCI protected. I recommend upgrading for safety. Since most of the outlets are not grounded, they also need to be labeled as such.

Verify GFCI protection

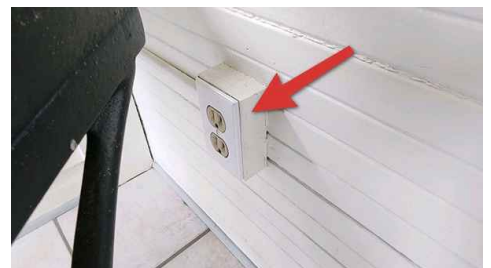
FRONT OF HOUSE

Make sure all exterior outlets have proper covers installed. Otherwise your risk that water can seep into the outlet, leading to potential shock.

Add cover

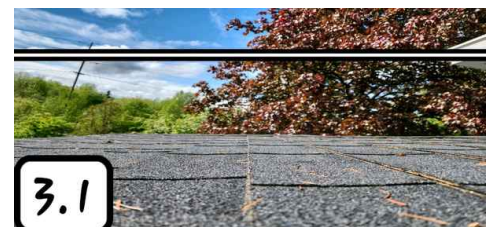
COVERED BACK PORCH

This roof has a fairly low slope. The Western States Roofing Contractors Association (WSRCA) has published a bulletin advising that laminated-asphalt shingles not be specified for roof slopes less than 4:12. There have been issues with premature failures and leaks even though the roofs were installed to current building standards. I did not see any issues at this time but advise you to monitor for leaks and consider installing a different material whenever the roof needs to be replaced. The shingles may also not last a full 25 or 30 years, which ever they are rated for.

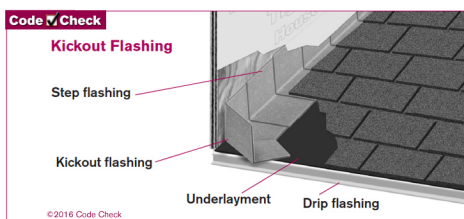
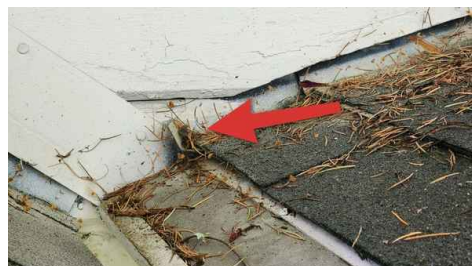
Adequate kick out flashing should be installed where the roof meets the house so water is less likely to run down between the gutter and the wall, eventually causing damage to the structure. It is supposed to be 4" long and 4" high.

Too short

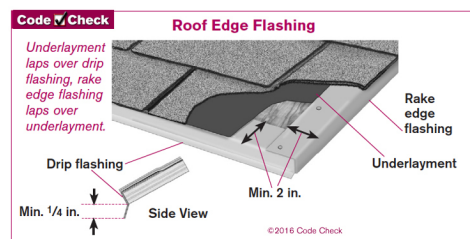
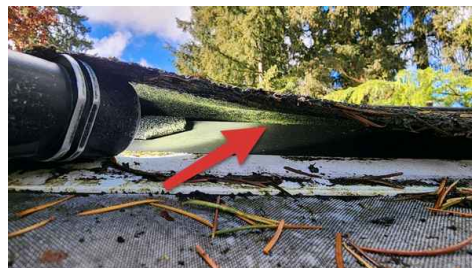
The roofing membrane underlayment is supposed to be installed on top of the drip edge flashing and not below. This may cause moisture intrusion and potential damage to the sheathing. A repair would be difficult and it is best to monitor those areas and have it done correctly when the roof is being replaced.

Underlayment below flashing

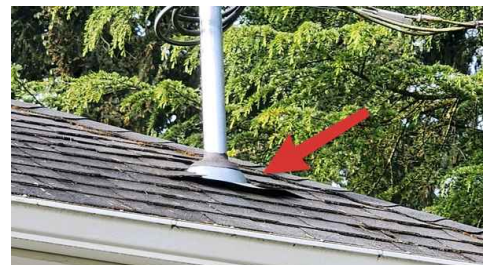
Service entrance mast

Any lifted flashing needs to be properly secured so wind driven rain cannot get pushed underneath.

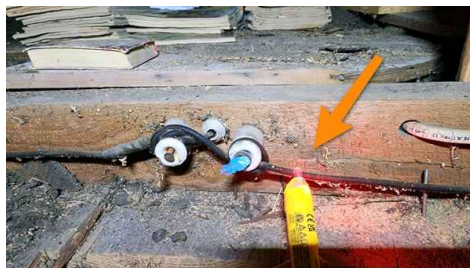
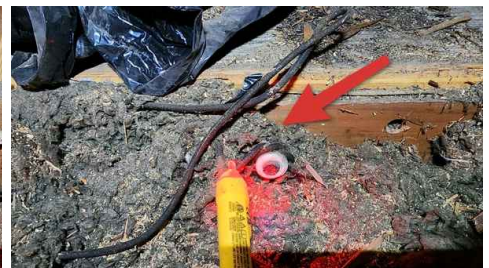
Live in attic

Covered with insulation

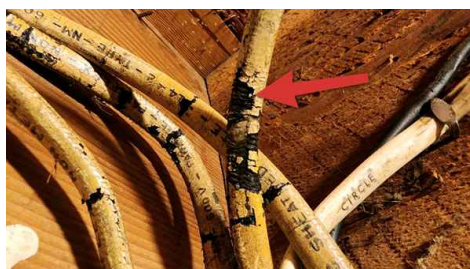
Deterioration

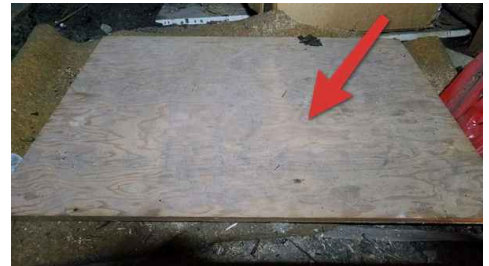
The access hatch should be insulated. You could mount a piece of fiberglass onto it.

Insulate access

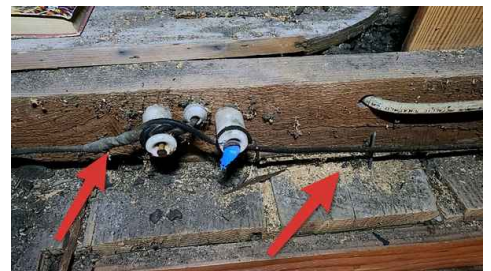
Wiring within 6' of the attic access should be protected with guard strips.

Next to attic access

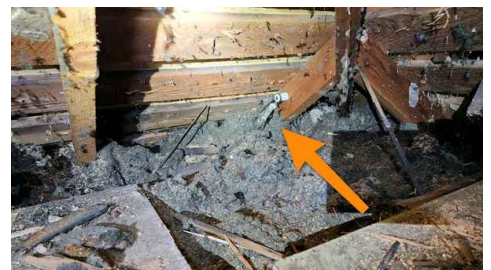
Active knob and tube wiring is present in the attic. See electrical section of this report.

Active knob and tube

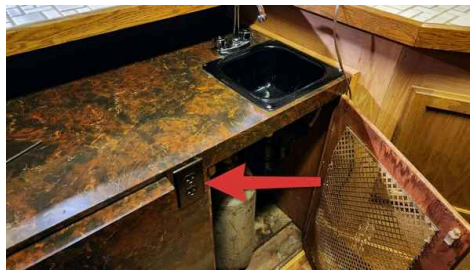
Add GFCI

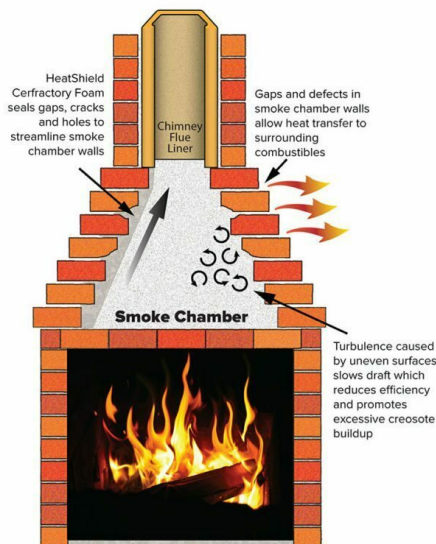
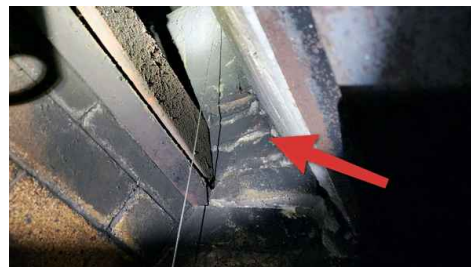
BASEMENT

Overexposed brick in the smoke chamber (visible brick corners) need to be sealed and parched smooth for safety. Have this evaluated and upgraded by a licensed fireplace contractor.

Exposed brick

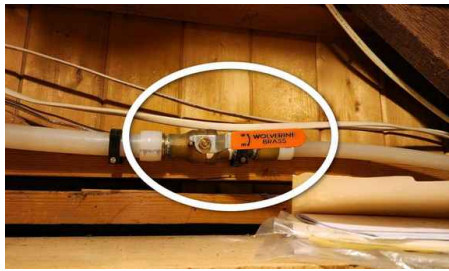
Basement shut off

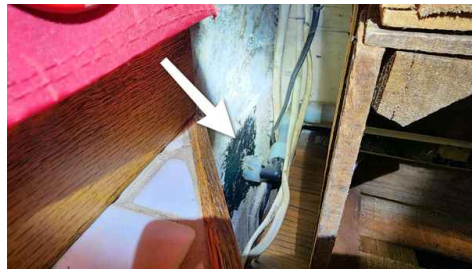
Entering near wet bar

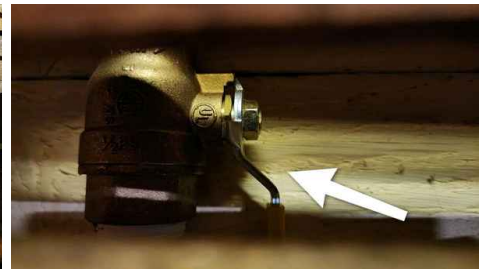
Another shut off near wet bar

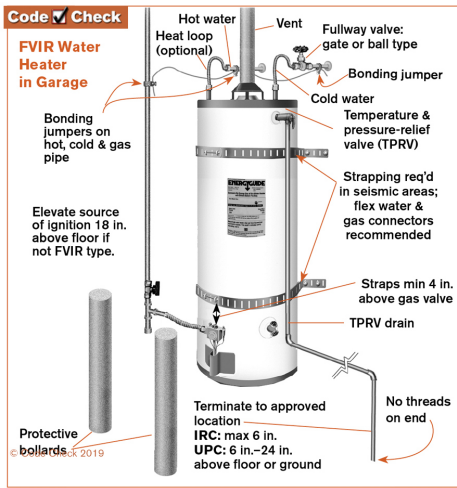
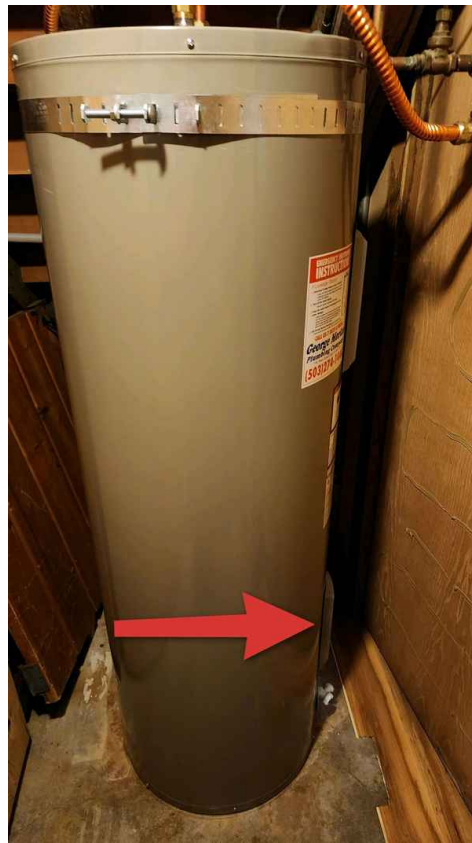
Earthquake Straps

I recommend adding a second earthquake strap for safety. There should be one in the upper and one in the lower third of the tank.

Add second strap

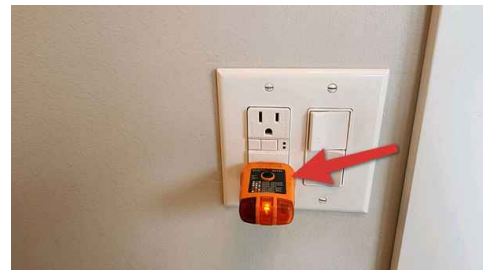
1ST FLOOR

The outlet is not grounded and needs to be labeled as such.

Label as not grounded

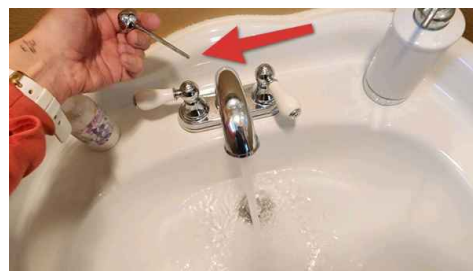
Handle pulls out

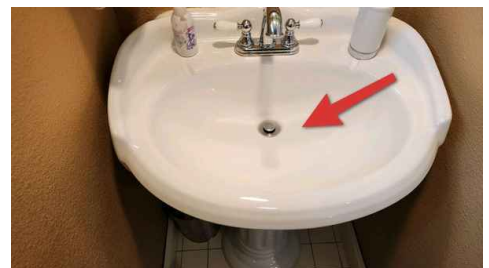
BASEMENT

The sink drains a bit slow and the drain pipe may need to be cleaned. This will hopefully take care of the issue.

Slow draining

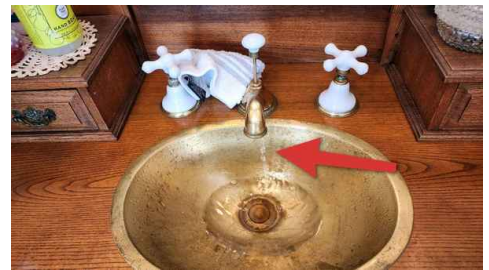
There is barely any cold water coming out of the sink. Have the valves adjusted and hopefully this will help. Otherwise consult with a plumber.

Cold water trickle

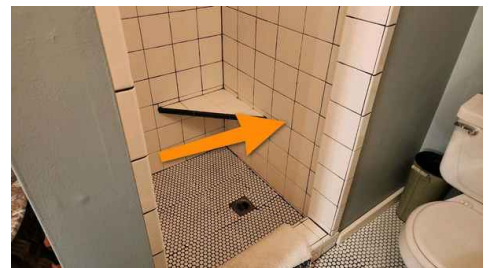
2ND FLOOR BATHROOMS, 1ST FLOOR BATH

Consider installing a glass door if you find that too much water is splashing out while showering.

Consider adding glass doors

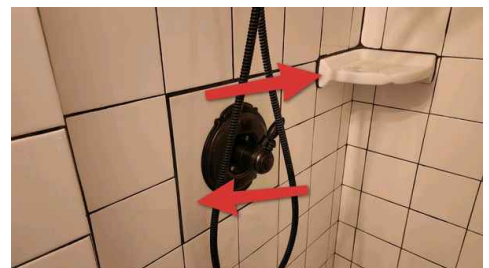
2ND FLOOR PRIMARY BEDROOM

The hot and cold water are reversed. Hot should always be on the left side. This should be corrected to prevent accidental scalding.

Hot and cold reversed

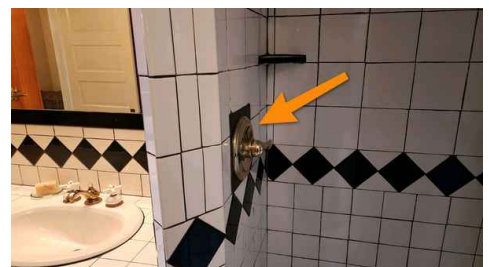
2ND FLOOR HALLWAY SHOWER

The mixing valve needs to be adjusted. The hot water is not very hot which might be a nuisance when you're trying to take a hot shower.

Adjust mixing valve

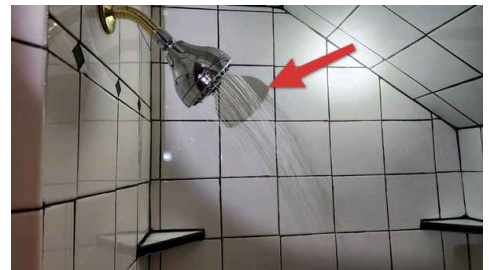
The water flow is fairly limited which might be a nuisance when you're trying to rinse out hair. Consult with a plumber to see if this can be changed.

Limited flow

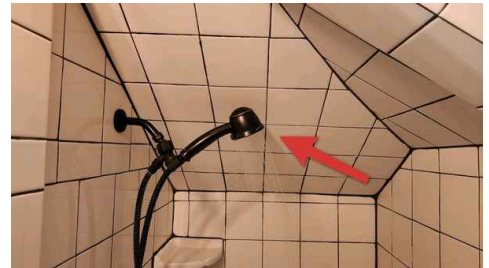
2ND FLOOR PRIMARY BEDROOM

There is very limited clearance in the shower. Use caution.

Low height

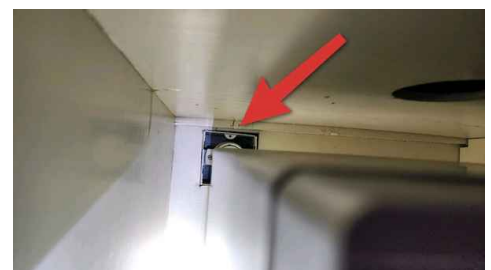
BELOW COOKTOP

There is a 220 volt outlet below the cooktop which would allow you to upgrade to an induction stove for example. The outlet does however need a cover plate. I was not able to get close to it and test it because the microwave is in front.

Add cover plate

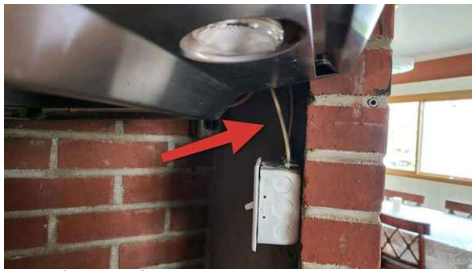
NEAR OVEN

Any exposed wiring needs to be placed in conduit.

Needs conduit

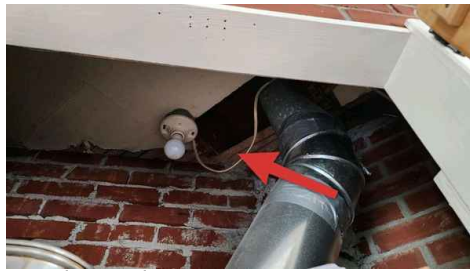
Needs conduit

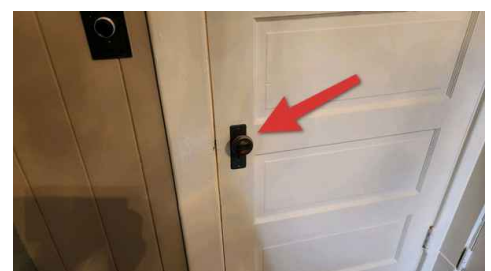
Any lose hardware should be properly tightened or adjusted.

Tighten hardware

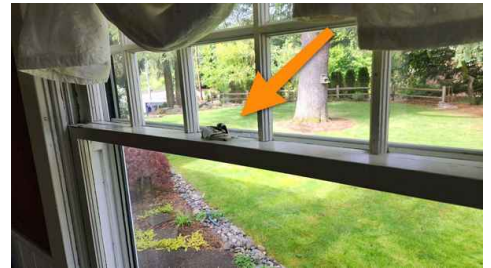
1ST FLOOR

Older windows are still present on the first floor. Consider gradually upgrading to more energy efficient windows.

Older

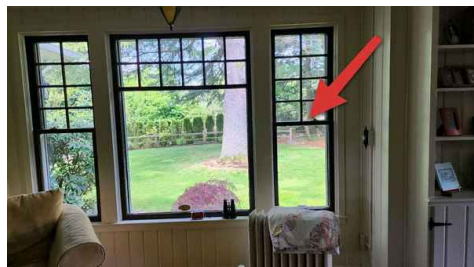
WEST LIVING ROOM

The latching mechanism is too close to the lock which makes it difficult to open and close the window. Move it back a little bit further for ease of use.

Adjust latch

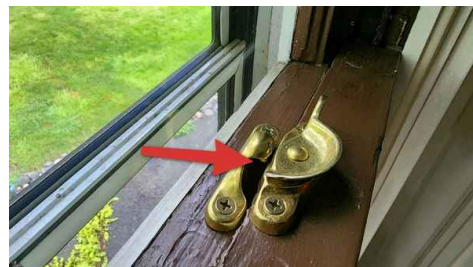
Too close

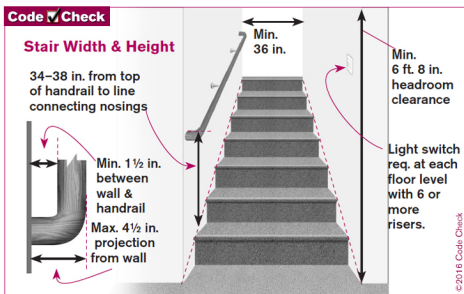
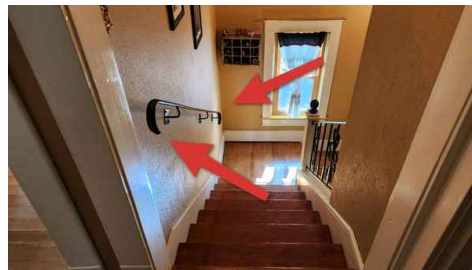
Handrail Return

**MISSING RETURN**

All handrails need to have a return at the top and bottom for safety.

Add return

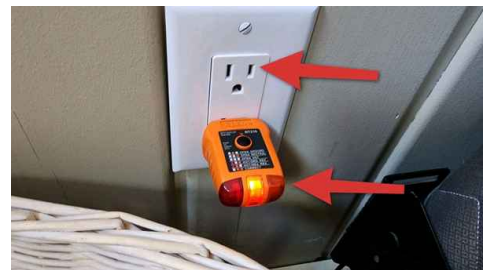
Ungrounded outlets are still in use. It is not allowed to add a 3 prong outlet to an ungrounded circuit as this gives a false sense of protection. Consult with a licensed electrician about options of making the circuits safer. GFCI protected outlets can be installed for example but they still need to be labeled as not grounded. However, GFCI outlets and/or GFCI breakers on ungrounded circuits do not provide true grounding. Ungrounded GFCIs do offer protection to personnel, even without a grounding connection. Without the grounding connection, a fault in the appliance will not trip the circuit breaker (which is essentially the reason for the ground), but it will still trip the GFCI device when an unbalanced load is detected. Surge protectors will also not work with ungrounded outlets.

Ungrounded three prong
