**FINAL INSPECTION REPORT**

**PRIMARY REFERMER FURNACE 101-B**

**RISER AND CATALYST TUBES**

**NORTH COMPANY FOR FERTILIZERS (NCF)-BAIJI**

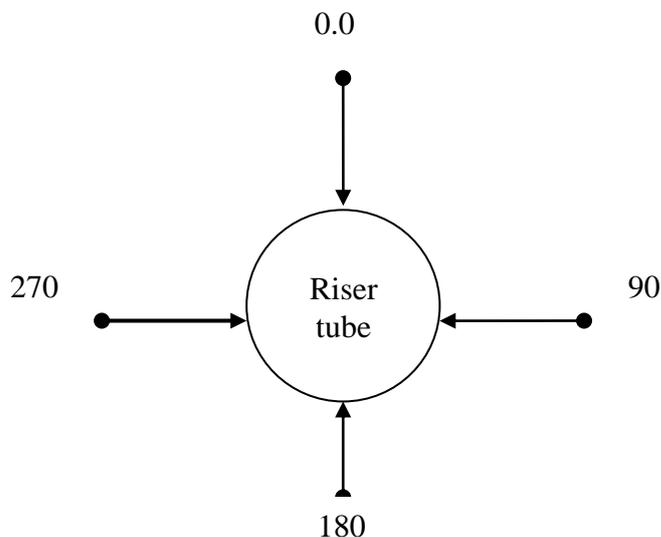
Examination was performed by scanning of four right angled areas (50 mm width X 500 mm long) on each riser tube as shown below. These areas located on the tubes surfaces at the vicinity of the flame dome (furnace top section) especially the tube section subjected to the largest diametrical growth.
