## Confidential Inspection Report

LOCATED AT:  
26875 Rancho Grande  
Laguna Niguel, CA 92677

INSPECTED ON:  
Tuesday, May 23, 2017

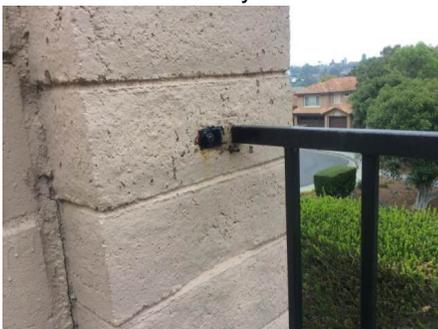
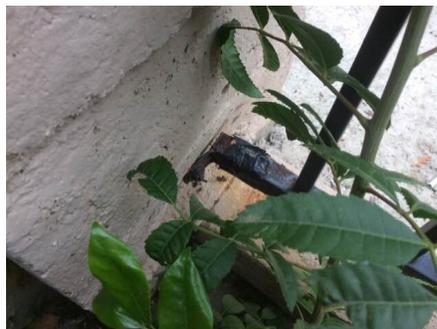
**CORR** 3: - • Sections of the wrought iron fence are deteriorated or rust damaged. This includes broken or rusted rails and connections. Recommendation: Evaluation and repair by a qualified specialist to secure and repair or replace the affected sections as necessary

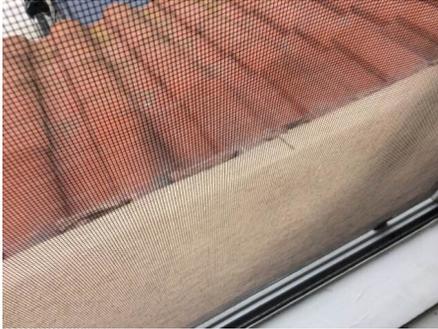
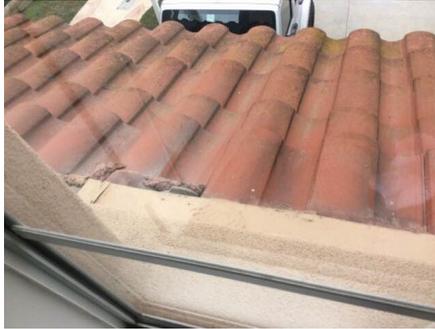
**CORR 4:** - • There are a number of displaced or broken tiles that have exposed the waterproof membrane. These areas will be subject to damage to the roof surface and potential leaks. Damage is noted at the front lower roof outside the bonus room, and missing tiles at the rear roof. Recommendation: Inspection of the exposed membrane, and repositioning or replacement of the missing and broken tiles as necessary, by a qualified roofing contractor

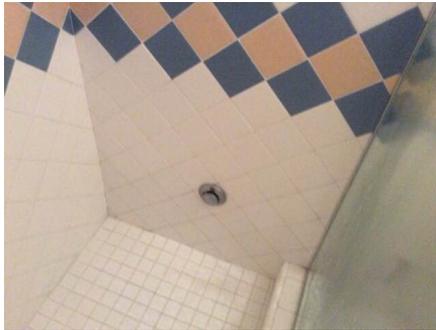
**CORR** 12: - • The steam shower is damaged, incomplete or not functional. There is no power to the controller, and it could not be activated. The pan under the steam unit in the garage is full of water, indicating a water leak from the heat exchanger or water connections. Recommendation: Service or replacement as necessary by a qualified specialist to restore operation of the steam shower. I unplugged and turned the water valve off to help prevent further leaking and damage

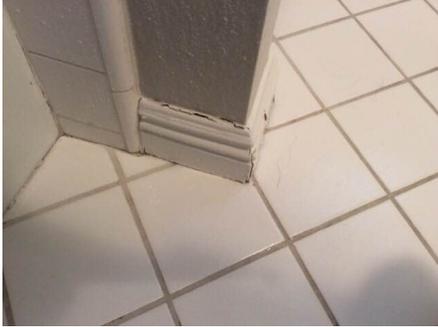
**CORR** 14: - • The wall is moisture damaged adjacent to the tub. This is not uncommon, typically caused by water splashing out from the enclosure or curtain. However, continued exposure to water can lead to significant damage. Recommendation: The wall be repaired, and the enclosure serviced to help prevent such water splash-out

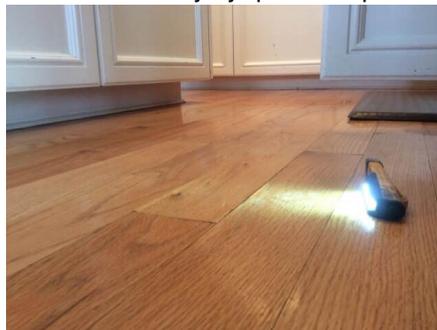
**CORR** 16: - • The hardwood floor in the kitchen is cupped, or moisture damaged, noted mostly in front of the dishwasher. Cupping occurs when the hardwood absorbs excessive moisture on the underside, which causes the expansion that results in cupping. If moisture is entering the floor under the hardwood, it may be from a slab leak, improper moisture barrier under the floor, or another condition that we cannot visually confirm. Recommendation: Further evaluation to determine the cause of this damage, and repair or replacement of the floor as necessary by qualified specialists

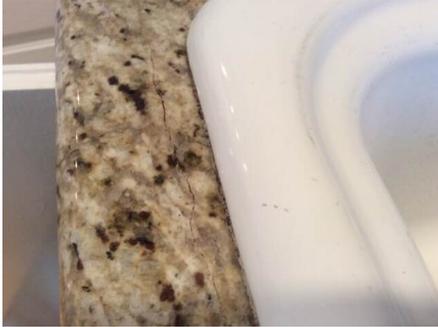
**CORR** 17: - • There is one or more crack in the granite, noted around the kitchen sink. This indicates improper installation or lack of support for the heavy slab. Recommendation: The countertop should be serviced or replaced as necessary by a qualified specialist

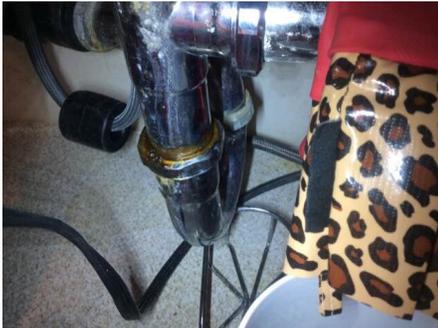
**CORR** 19: - • The drain lines below the kitchen sink have temporary or amateur repairs. We noted sealant on the trap connection, and signs of leaking, which can lead to improper or unsafe draining, or can lead to leaking and damage. Recommendation: Service as necessary to restore proper drain engineering and connections, by a licensed, qualified plumbing contractor

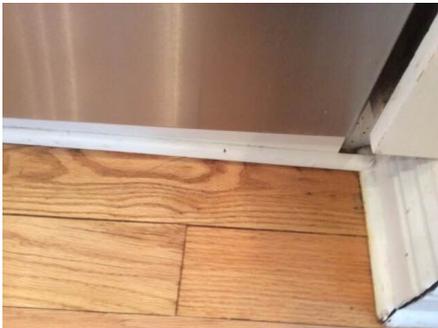
**CORR** 21: - • Pooling water was found on the kitchen floor during operation of the dishwasher. This indicates a leak in a supply or drain line, or from the door seal on this appliance. Water damage is possible, and this appliance should not be used. Recommendation: Repair or replacement of this appliance by a qualified specialist

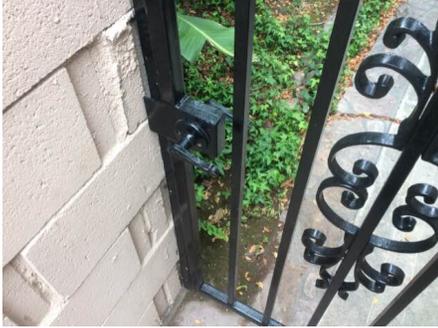
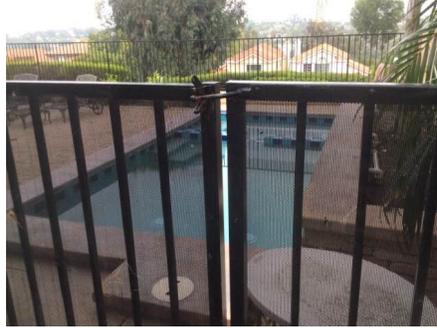
**SFTY** 25: - • The gate or gates that gives pool access does not fully comply with safety standards. Any gate that gives pool or spa access is required to self-close and include a latch at fifty-four inches, and should open away from the pool or spa, so that a toddler could not simply push open an unlatched gate. Further, there are newer requirements for door and window alarms that help alert the homeowner if a toddler were to exit the home. Recommendation: We recommend compliance with all safety requirements for gates, barriers and alarms

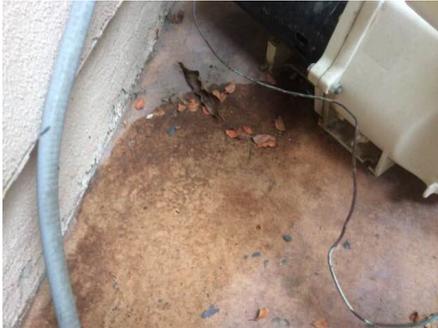
**CORR** 27: - • There is a leak at the impeller housing of the spa boost pump motor. This indicates a loose or broken connection or housing. Recommendation: Service as necessary by a qualified pool specialist to restore leak-free operation

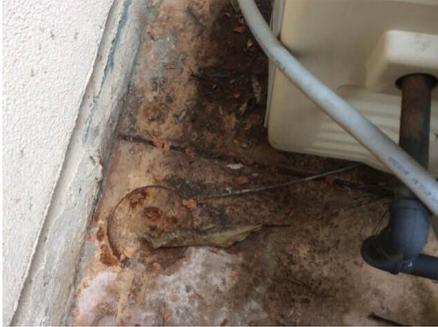
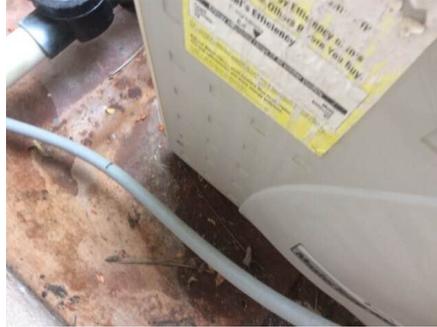
**CORR** 28: - • There is water leaking from under the heater housing. This may be a drain plug or a more significant leak from the heat exchanger, as the water connections to this heater appear to be dry. Recommendation: The source of this water located and repairs made by a qualified pool contractor

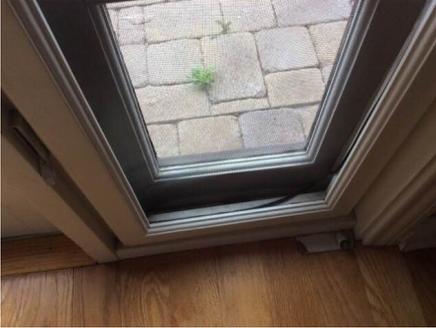
- A few of the window screens are missing or damaged, and you may wish to have them repaired or replaced

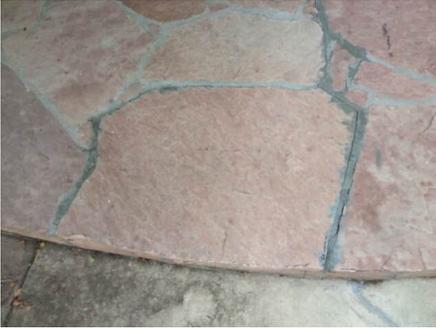
- ATTN** • There are loose pavers or tile in the walkway or porch surfaces located at the front porch that could prove to be trip-hazards, and particularly for children or the elderly, which you may wish to evaluate for yourself. We recommend correction for safety

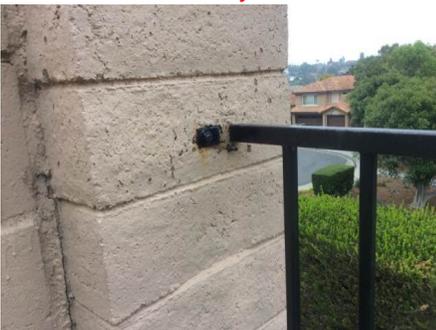
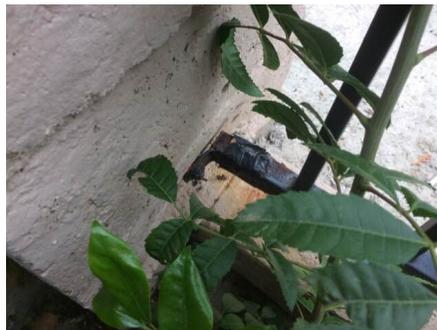
- CORR** • Sections of the wrought iron fence are deteriorated or rust damaged. This includes broken or rusted rails and connections. Recommendation: Evaluation and repair by a qualified specialist to secure and repair or replace the affected sections as necessary

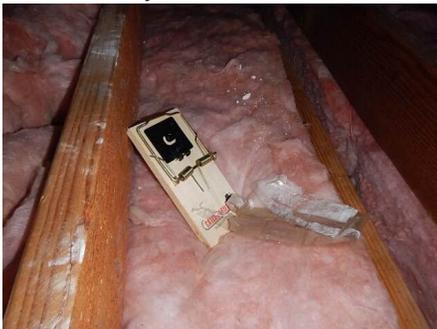
**ATTN** • There is a small amount of rodent activity observed in the attic. We could not determine the age of this activity, but we recommend you have this condition corrected. Rodents and their droppings can be a health hazard

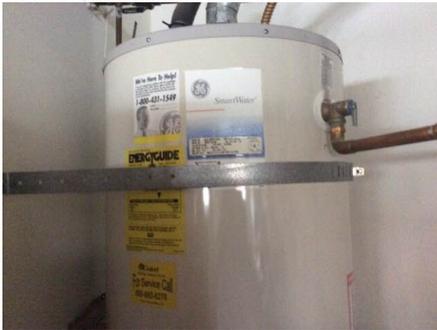
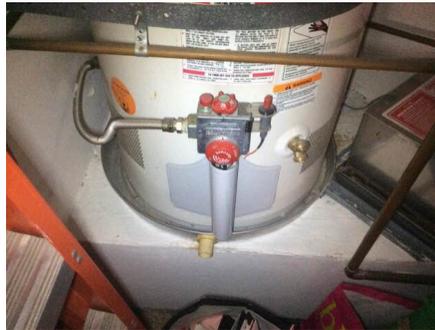
**ATTN** • The gas water heater is at or beyond the end of its expected useful life of eight to twelve years. For this reason, it will be more prone to leaks, or failure. Popping or banging noises are common at this age during burner operation, and indicate a build-up of sediment in the tank. This reduces the efficiency and available hot water in the tank. We recommend it be monitored closely, and if any signs of leaking are noted, it be replaced as soon as possible to prevent moisture or water damage. It would also be prudent to maintain a home protection warranty to help cover the cost of a replacement, which will be likely in the near future

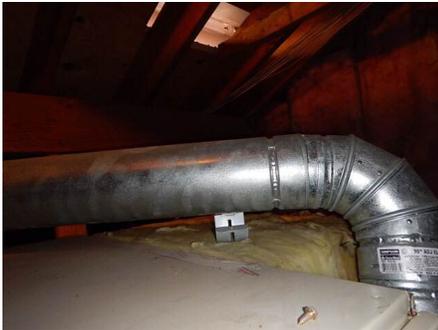
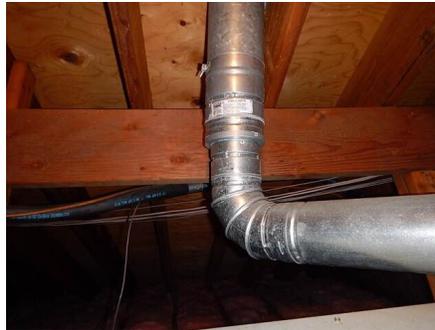
## FURNACE VENT

- The furnace vent pipe is functional

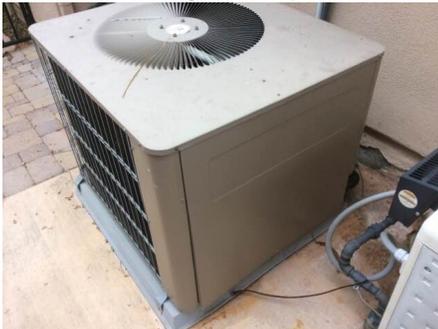
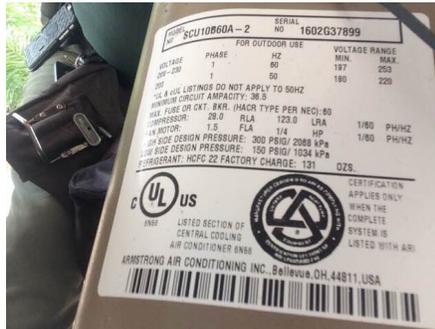
## CONDENSING UNIT/COIL

- The condensing unit responded to the thermostat and is functional

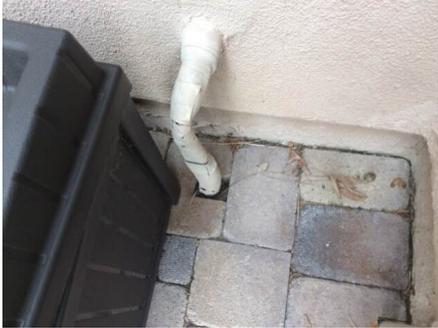
## REFRIGERANT LINES

**ATTN** • You should be aware that a portion of the refrigerant lines, from the condensing coil to the evaporator coil, pass below grade without a sleeve. This indicates a likely relocation of the coil, and is not recommended by the manufacturers. The underground and unprotected lines can lead to a slight energy loss, increase the possibility of corrosion, leaking or damage to the lines, and make any repairs that could become necessary more difficult. You may wish to have a specialist comment further

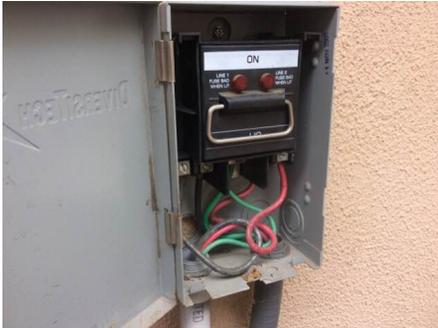
## SERVICE DISCONNECT

• The electrical disconnect at the condensing coil is functional

**ATTN** • The service disconnect is located directly above the coil. This is generally not recommended, as the disconnect should be accessible without reaching over the coil for safety. You may wish to have a specialist comment about this condition, or have it corrected

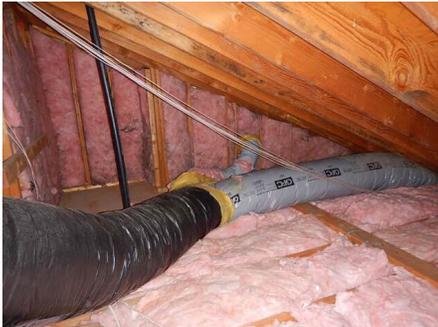
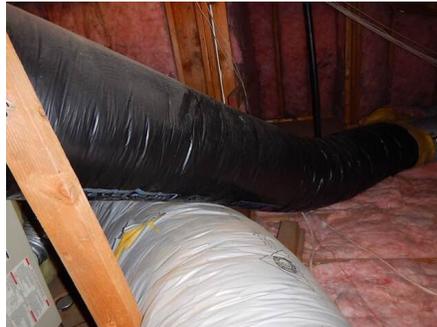
- The supply ducts are a modern, flexible type, comprised of a dark-gray, plastic, outer sleeve and a clear inner liner that encapsulates fiberglass insulation, and are in acceptable condition

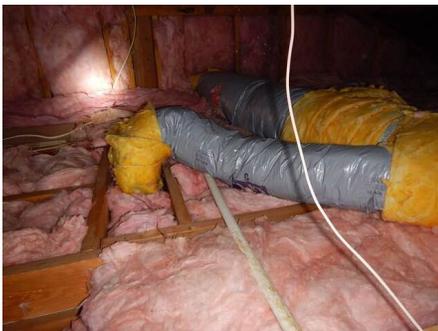
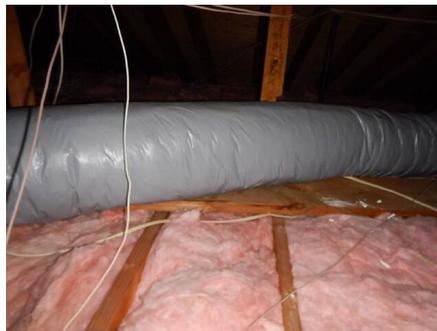
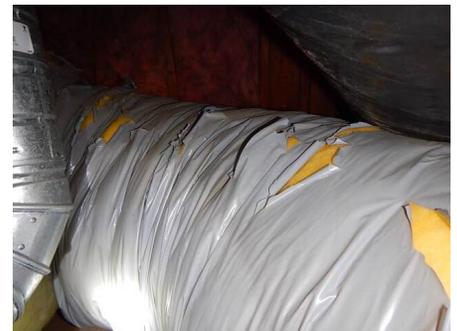
- The supply ducts are a modern, flexible type, comprised of a light-gray, plastic, outer sleeve and a clear inner liner that encapsulates fiberglass insulation, and those that were visible to us are in working order. However, the outer sleeve has been found to be susceptible to ultra-violet contamination, which causes the outer sleeve to deteriorate, and we recommend they should be monitored

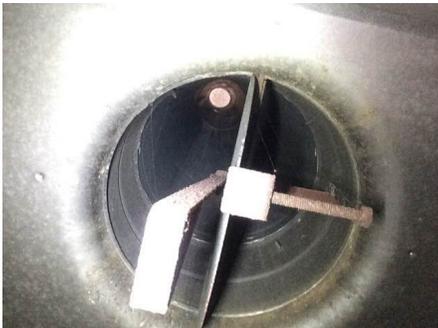
### FLUE

• The portions of the flue that are visible appear to be in acceptable condition

**ATTN** • A complete view of the fireplace and chimney flue is not possible. Because of the potential dangers of fireplaces, it is recommended by the NFPA 211 Standards, (National Fire Protection Association, ) that a Level II Inspection be conducted whenever there is a transfer in ownership. Our inspection does not constitute a Level II fireplace inspection, as it is beyond our scope of services. We recommend you contact a fireplace inspector who is qualified in NFPA Standards to conduct a Level II inspection. For more information, you can go to [www.NFPA.org](http://www.NFPA.org), or [www.fireplaceinspections.com](http://www.fireplaceinspections.com)

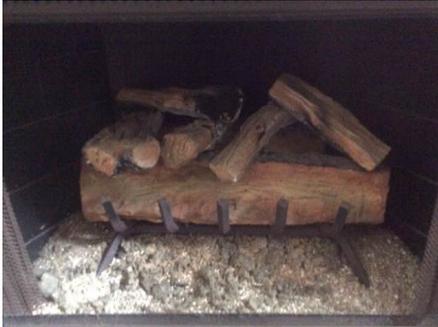
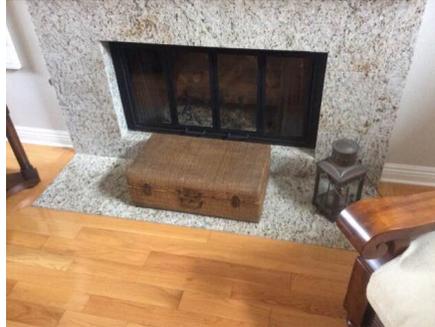
## **FIREPLACE**

- The fireplace is in acceptable condition

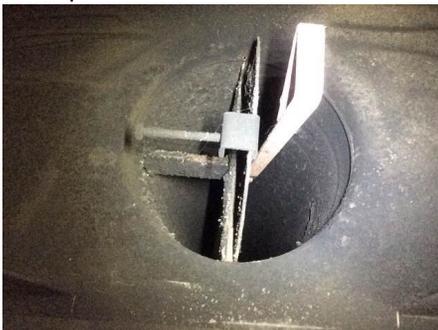
## **FLUE**

- The portions of the flue that are visible appear to be in acceptable condition

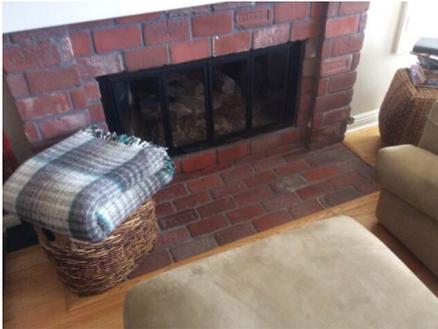
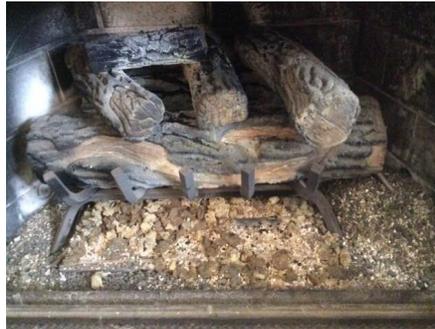
## FIREPLACE

- The fireplace is in acceptable condition

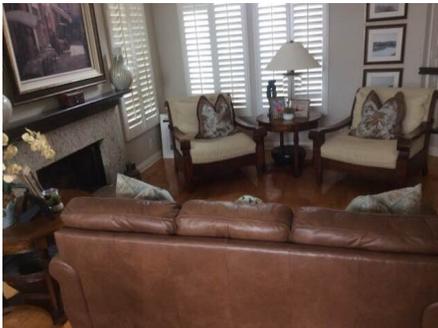
### LIVING ROOM

• The living room is located off the entry

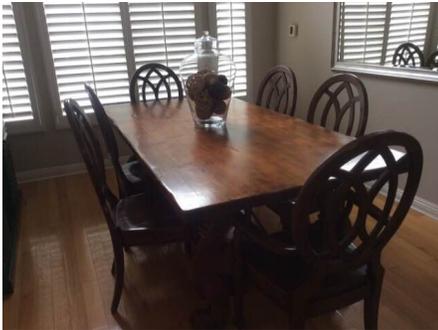
### DINING ROOM

- The dining room is located at the right rear

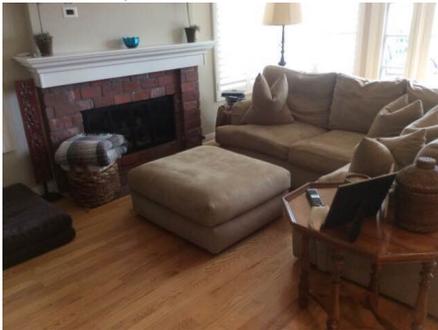
### FAMILY ROOM

- The family room is located at the left rear

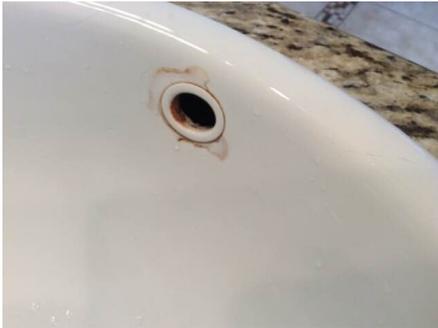
## SINK AND FAUCET

- ATTN** • The enamel on steel bathroom sink has signs of corrosion around the drain and/or overflow opening. This is an indication the the sink is nearing the end of its life, which is not as durable as porcelain material. Further corrosion can lead to sharp edges and injury, and leaking underneath at the drain overflow raceway. If concerned, we recommend you consider replacement of the sink

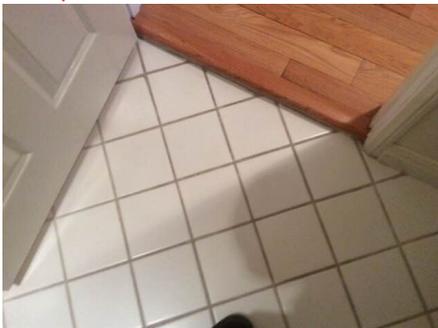
## DOORS

**CORR** • The interior bathroom entry door hits the floor, which prevents proper operation, it does not close and could lead to entrapment. Recommendation: The door or flooring needs to be adjusted, shaved or trimmed, to open and close easily

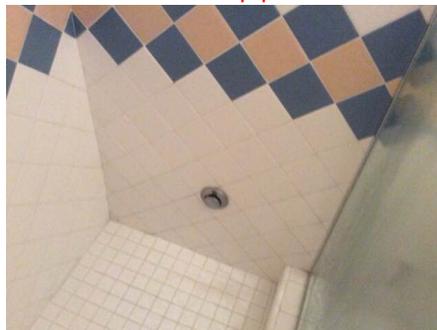
## STEAM SHOWER

- CORR** • The steam shower is damaged, incomplete or not functional. There is no power to the controller, and it could not be activated. The pan under the steam unit in the garage is full of water, indicating a water leak from the heat exchanger or water connections. Recommendation: Service or replacement as necessary by a qualified specialist to restore operation of the steam shower. I unplugged and turned the water valve off to help prevent further leaking and damage

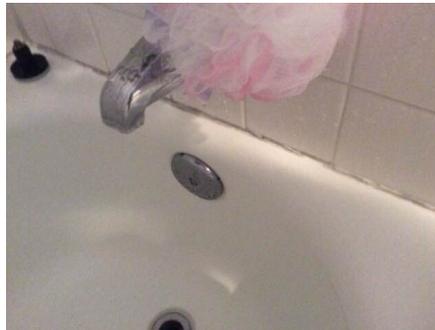
### TUB/SHOWER

- ATTN** • The tub-shower enclosure needs to be cleaned and caulked, to forestall moisture damage

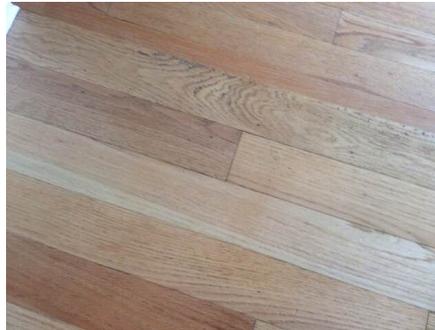
**ATTN** • The floor in the kitchen has cosmetic damage, which you may wish to evaluate for yourself

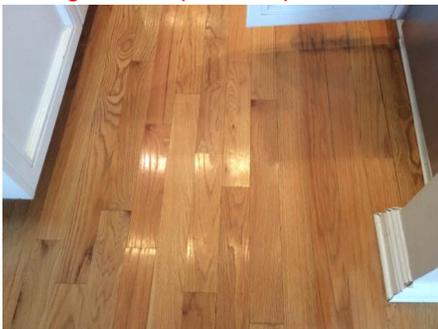
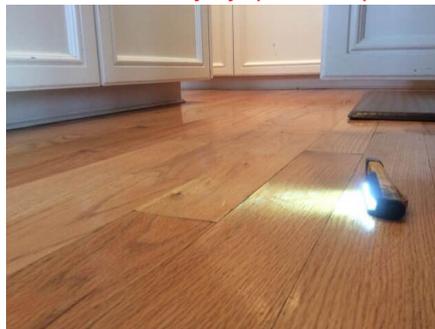
**CORR** • The hardwood floor in the kitchen is cupped, or moisture damaged, noted mostly in front of the dishwasher. Cupping occurs when the hardwood absorbs excessive moisture on the underside, which causes the expansion that results in cupping. If moisture is entering the floor under the hardwood, it may be from a slab leak, improper moisture barrier under the floor, or another condition that we cannot visually confirm. Recommendation: Further evaluation to determine the cause of this damage, and repair or replacement of the floor as necessary by qualified specialists

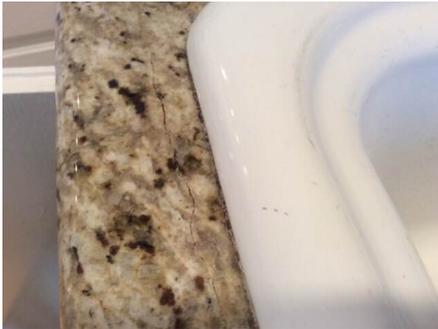
- CORR** • There is one or more crack in the granite, noted around the kitchen sink. This indicates improper installation or lack of support for the heavy slab. Recommendation: The countertop should be serviced or replaced as necessary by a qualified specialist

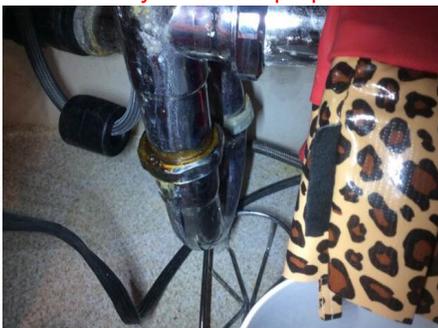
## TRAP & DRAIN

- CORR** • The drain lines below the kitchen sink have temporary or amateur repairs. We noted sealant on the trap connection, and signs of leaking, which can lead to improper or unsafe draining, or can lead to leaking and damage. Recommendation: Service as necessary to restore proper drain engineering and connections, by a licensed, qualified plumbing contractor

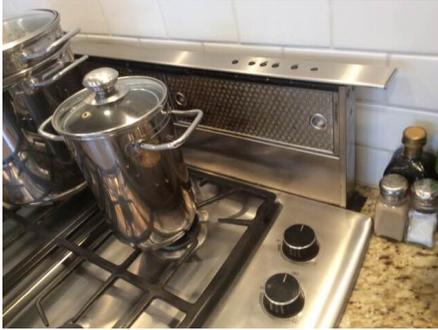
### EXHAUST FAN/DOWNDRAFT

- The kitchen downdraft exhaust fan is functional

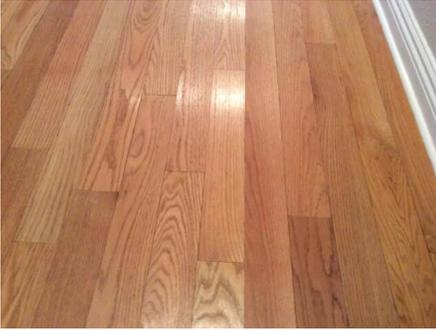
- CORR** • The hardwood floor in the hallway has cupping and damage, noted between the laundry and downstairs guest bath.  
Recommendation: Evaluation and service to repair this damage, by a qualified flooring specialist

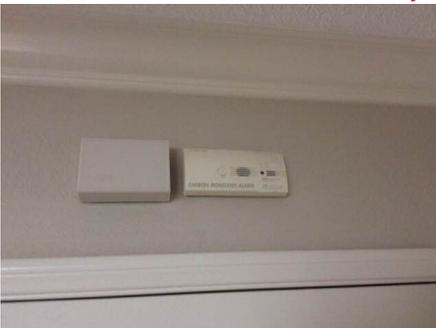
### CO ALARMS

**SFTY** • New requirements are now in effect requiring the installation of Carbon Monoxide Detectors on each level. There is one present upstairs but not downstairs. Recommendation: Regardless of the law, we recommend installation of one or more of these devices on each floor for safety

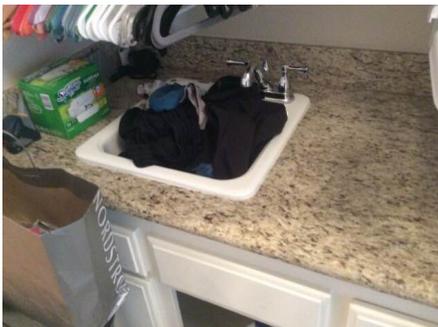
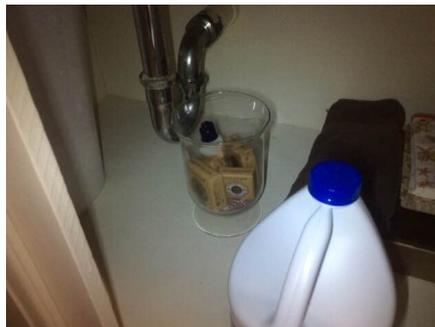
### LAUNDRY SINK & FAUCET

- ATTN** • The laundry sink is full of personal items. It cannot be tested for operation, drainage or leak-free operation. We recommend this sink be tested or demonstrated once cleared of items

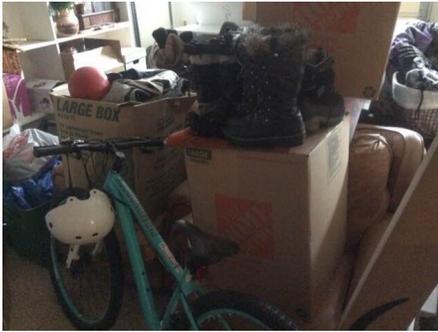
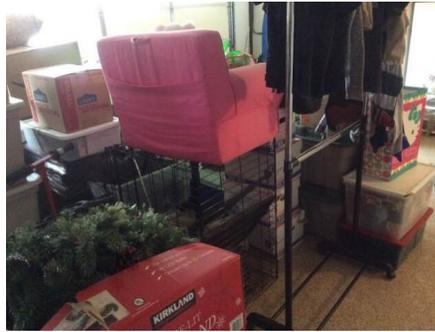
- The garage slab is in acceptable condition. Small cracks are common and result as a consequence of the curing process, seismic activity, common settling, or the presence expansive soils, but are not structurally threatening. Also, you may notice some salt crystal formations that are activated by moisture penetrating the slab

- The garage is too full to permit a clear view of the slab and other components

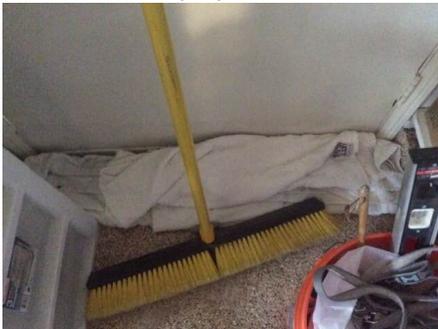
**ATTN** • There is no threshold or weatherproofing installed at the base of the side garage door. While this may have been built in this condition, this can permit water and rodent intrusion into the garage, where damage can occur. We recommend the installation of a proper threshold and weatherstripping at this door to help prevent this occurrence

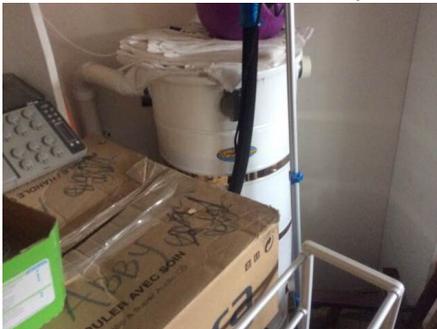
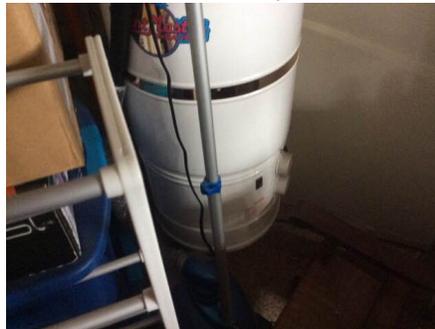
## CENTRAL VACUUM

- This home is equipped with a central vacuum system. It is beyond the scope of this inspection to determine the adequacy of the system, or its ability to vacuum debris. We suggest verification of adequacy and demonstration by seller, and the availability of the hose and other attachment accessories, prior to transfer
- The central vacuum motor only was tested and was found to be operational

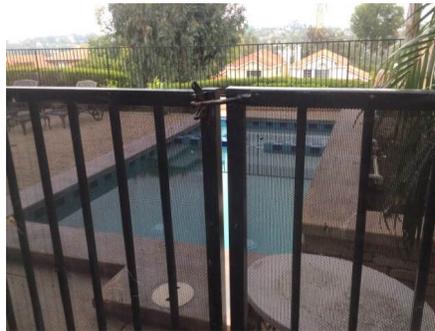
- SFTY** • The gate or gates that gives pool access does not fully comply with safety standards. Any gate that gives pool or spa access is required to self-close and include a latch at fifty-four inches, and should open away from the pool or spa, so that a toddler could not simply push open an unlatched gate. Further, there are newer requirements for door and window alarms that help alert the homeowner if a toddler were to exit the home. Recommendation: We recommend compliance with all safety requirements for gates, barriers and alarms

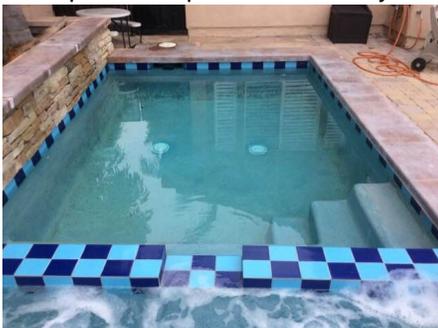
- ATTN** • The pool plaster is colored and mottled by calcium and other minerals leeching through to the surface, which is not uncommon with dark finishes. You may wish to discuss this condition with a pool contractor to determine if correction is warranted

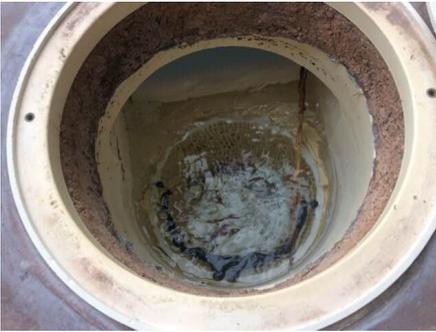
- The skimmer box and its cover are functional

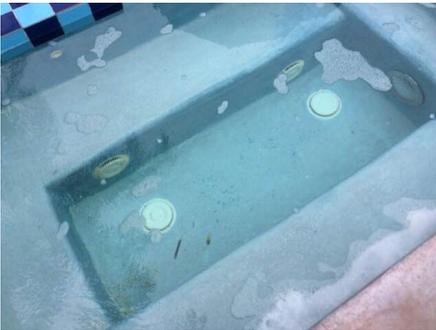
- There are either two suction line covers in the spa, or one that is an anti-entrapment type. These are designed to help prevent entrapment by holding a swimmer against the cover or pulling hair into the suction lines. However installation standards continue to change, and some covers may still represent a hazard

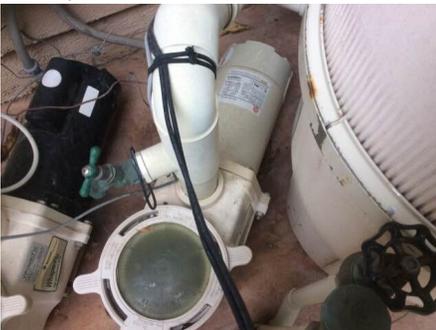
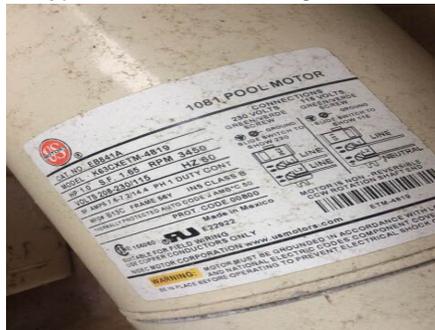
- Pool pump motors have a design life of between five and ten years, but can be expected to become noisy over time, and may fail prematurely if not maintained, exposed to exterior moisture and corrosion, or if operated dry
- The pool motor is newer and functional, of a type with a metal casing

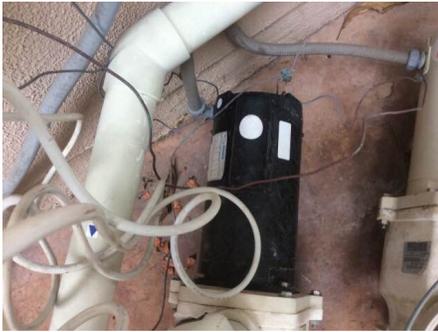
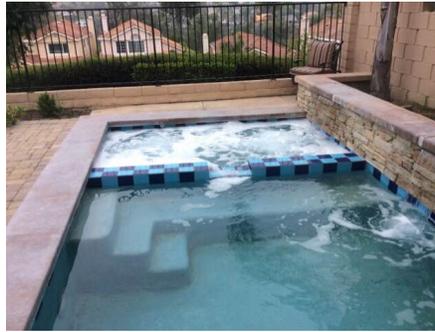
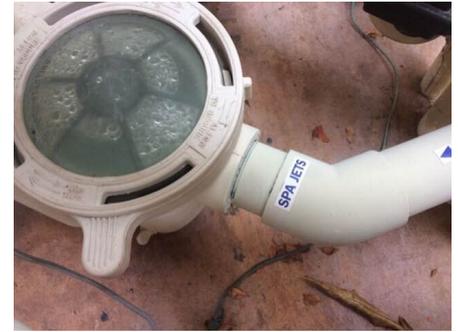
- CORR** • There is a leak at the impeller housing of the spa boost pump motor. This indicates a loose or broken connection or housing. Recommendation: Service as necessary by a qualified pool specialist to restore leak-free operation

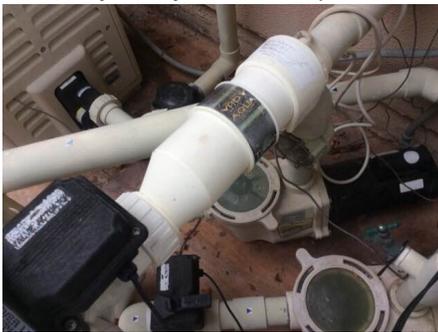
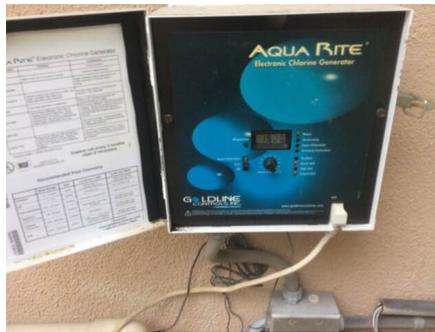
- ATTN** • There is a salt water system installed for this pool and spa for chlorination of this water. The full evaluation of the water chemistry is beyond our scope

- ATTN**
- There is an error message on the salt chlorination system indicating one or more faulty condition. This includes check salt and inspect cell, which may indicate a lack of recent maintenance. We recommend this condition be corrected by the pool service personnel for water chemistry and proper chlorination

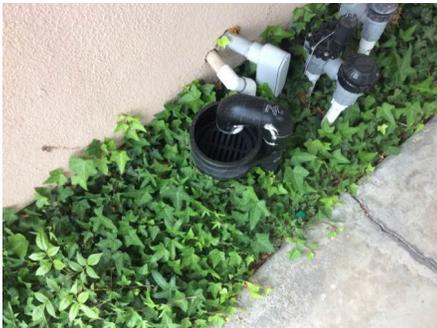
- The pool/spa filter is a Diatomaceous Earth or DE type filter
- The filter backwash drain is located at the front entry and discharges into the sewer system as required. This is the location for the drain when the diatomaceous earth filter is cleaned by backwashing it. We do not backwash or test this drain, as it is beyond the scope of this inspection

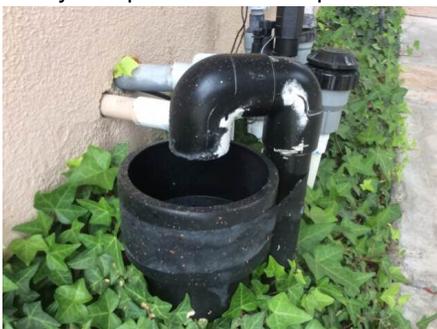
- ATTN**
- The drain for the filter backwash is required to have an air-gap of at least two inches above the flood rim of the drain. The discharge pipe enters the drain, and could cause a backflow condition. We recommend correction of this condition for safety and protection of the potable water supply

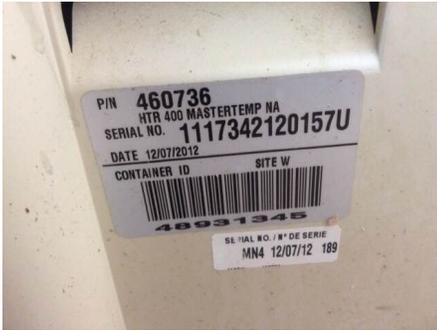
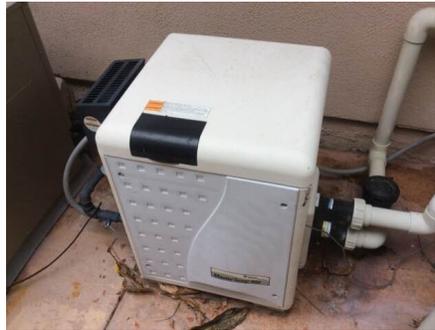
- The pool-spa heater is five years old, and is functional. However, it should be kept clean and serviced seasonally

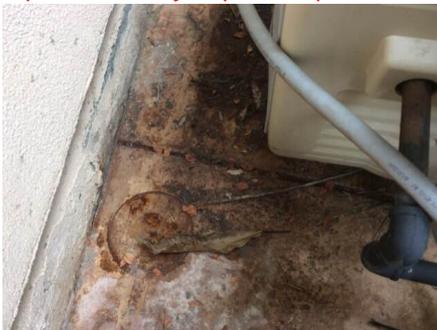
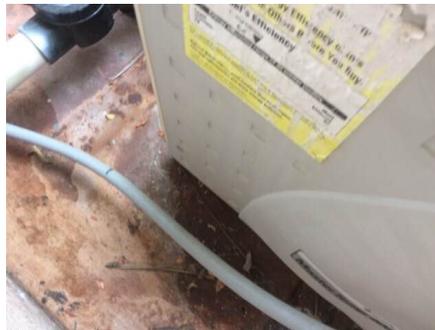
- CORR** • There is water leaking from under the heater housing. This may be a drain plug or a more significant leak from the heat exchanger, as the water connections to this heater appear to be dry. Recommendation: The source of this water located and repairs made by a qualified pool contractor

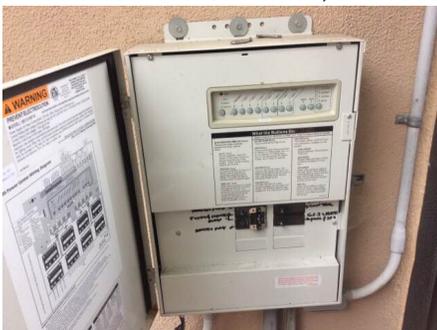
- The pool/spa has an electronic control panel. This automated system allows custom and remote operation of pump filtration timing, heater, lights, water features and accessory operation, including optional features such as yard lighting. Due to the variety of such controllers, we operate all components from the outside panel using "Service" mode. This permits operation of all features that are installed, and does not change any programming that is present
