Property Inspection Report

Property address: Windermere, FL 34768

Inspection date: October 21, 2015 8:54 am

Report ID: R20151021085452

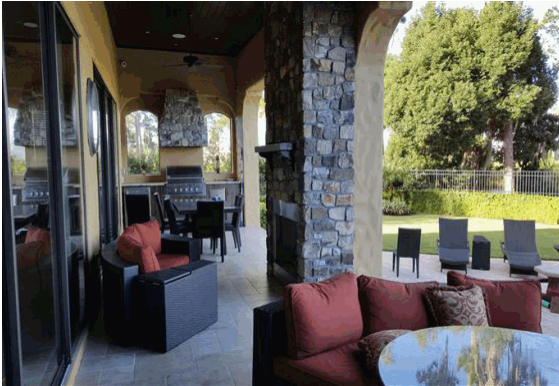
Deck

Status: **Repair/Replace**

Comment: **Loose Pavers**

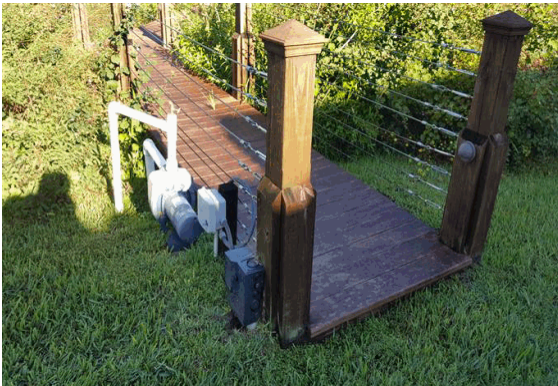
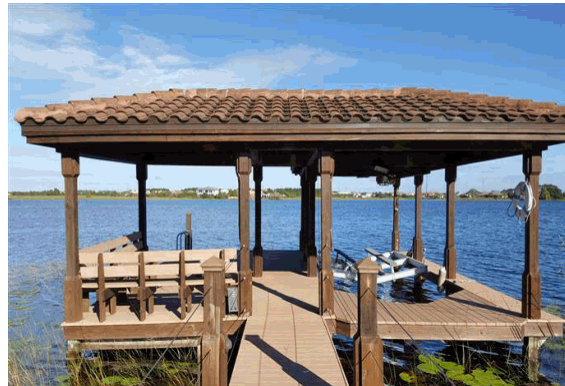
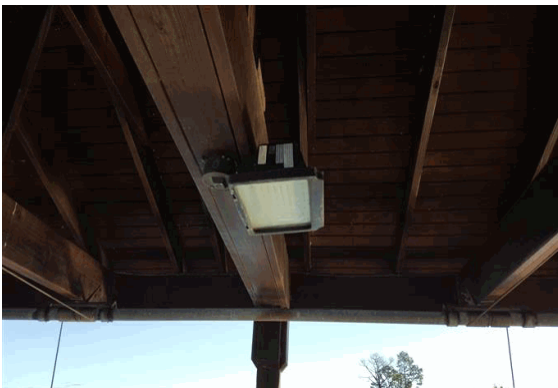
Location: **Dock**

Repair/Replace: ([Grounds / dock](#)) Lighting not functional over boat lift. [Location: Dock](#)

Status: **Repair/Replace**

Comment: **Lighting not functional over boat lift**

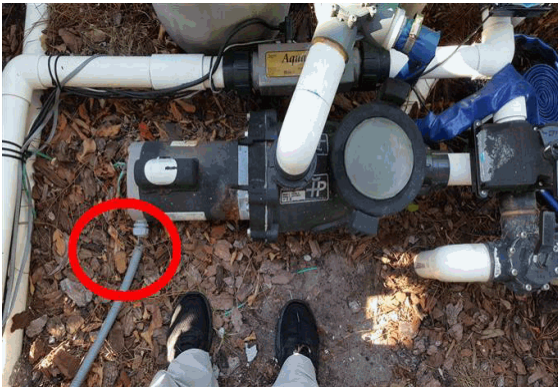
Location: **Side Yard**

Repair/Replace: ([Swimming Pool / Pump](#)) Electrical to pump motor not secure. [Location: Side Yard](#)

Status: **Repair/Replace**

Comment: **Electrical to pump motor not secure**

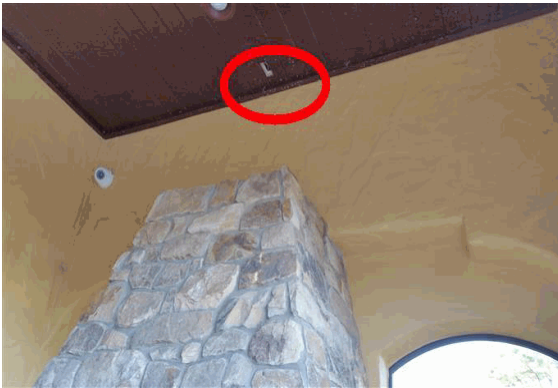
Location: **Back**

Comment: **Open Jcnction box above grill at ceiling**

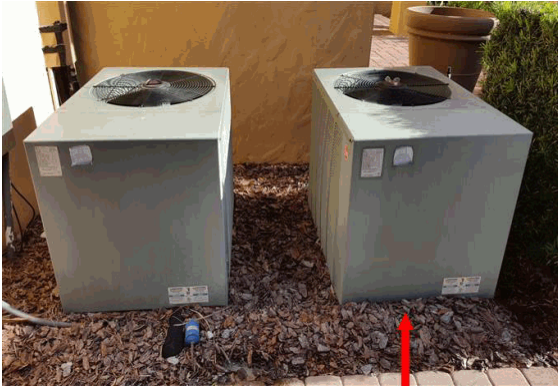
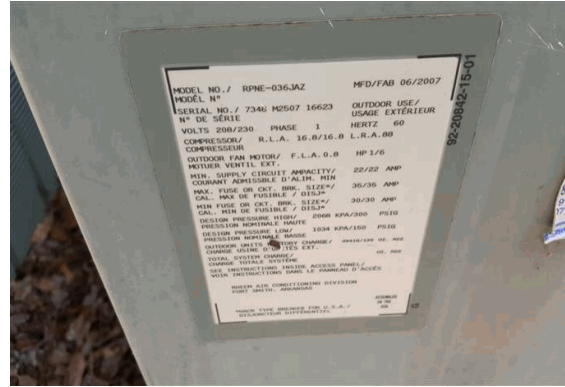
System Type (3)

Status: **Description Only** Description: **Central Air Electric Heat Pump**
Location: **2nd floor** Comment: **Forced Air**
Additional comments: Manufacturer: Rheem Tons: 3 Mfg Date: 2007

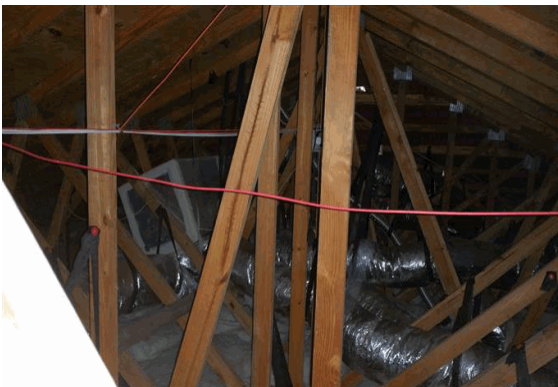
Distribution System

Status: **Acceptable** Description: **Flex duct**
Comment: **Good Condition**

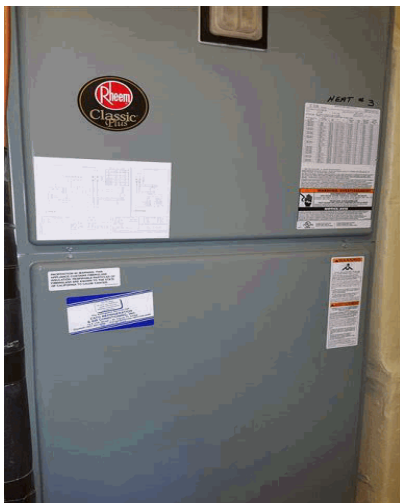
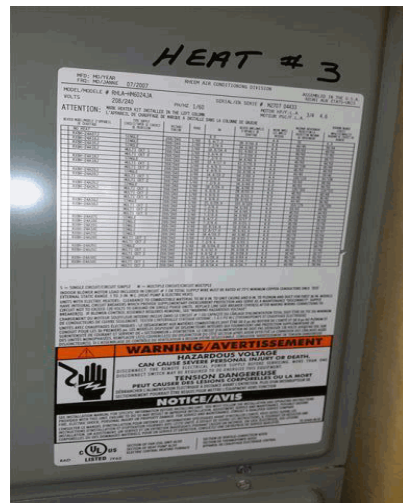
System Type

Status: **Description Only** Description: **Electric Heat Pump**
Location: **Master bed side** Comment: **Forced Air**
Additional comments: Manufacturer: Rheem Mfg Date: 2007

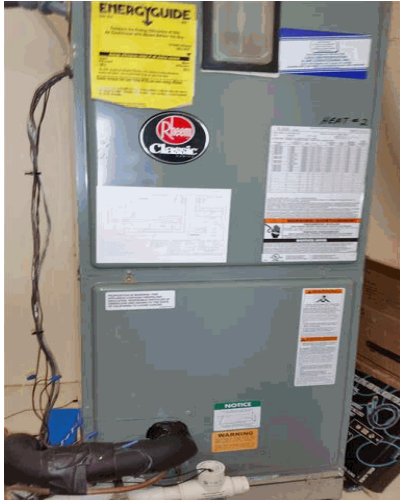
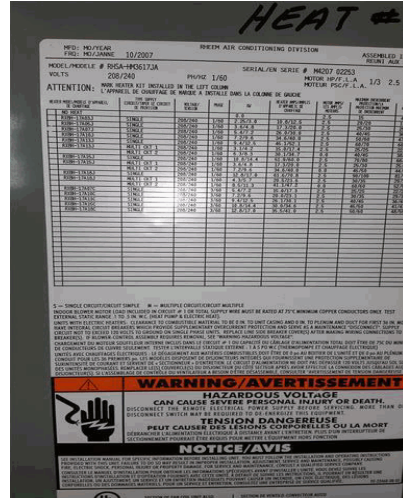
System Type (2)

Status: **Description Only** Description: **Electric Heat Pump**
Location: **2nd floor** Comment: **Forced Air**
Additional comments: Manufacturer: Rheem Mfg Date: 2007

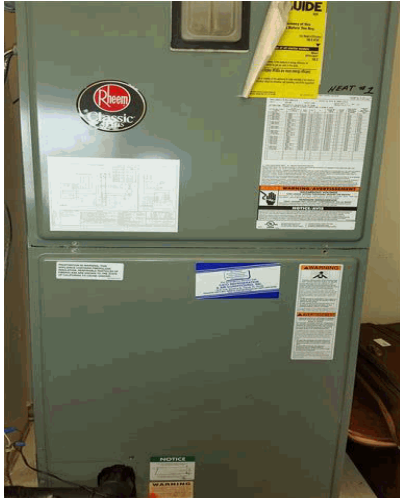
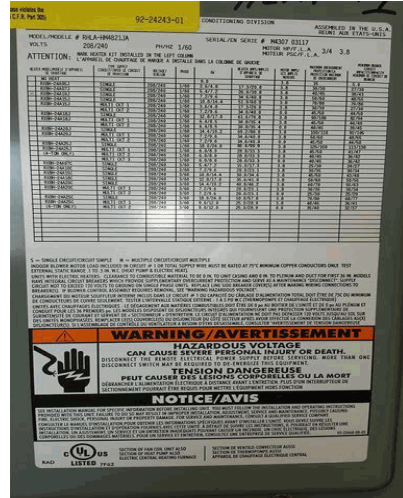
System Type (3)

Status: **Acceptable** Description: **Electric Heat Pump**
Location: **Downstairs unit** Comment: **Forced Air**
Additional comments: Manufacturer: Rheem Mfg Date: 2007

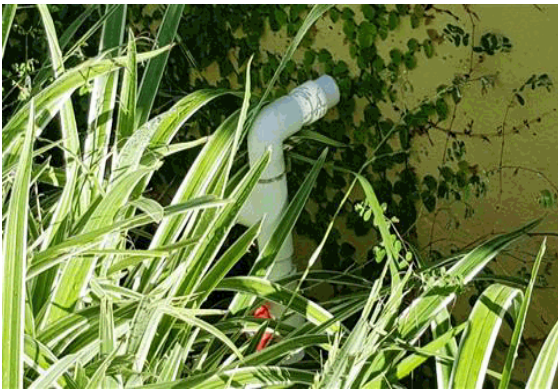
Comment: **Good condition**

Main water shut-off location: Exterior Left side of house

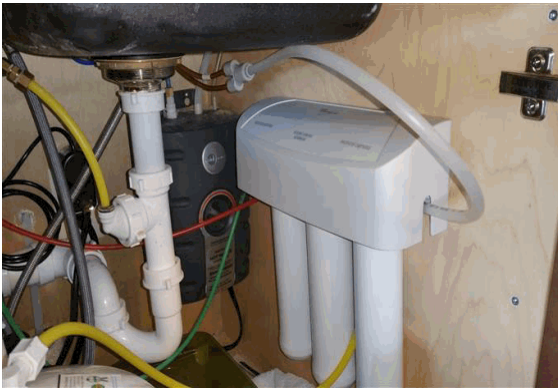
Drainage Pipes

Comment: **Good condition**

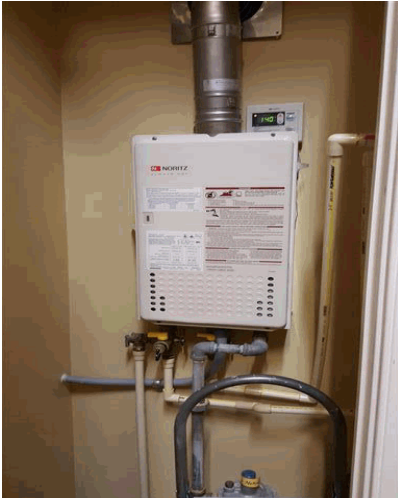
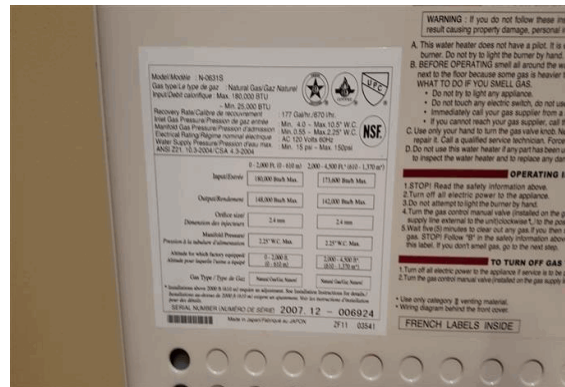
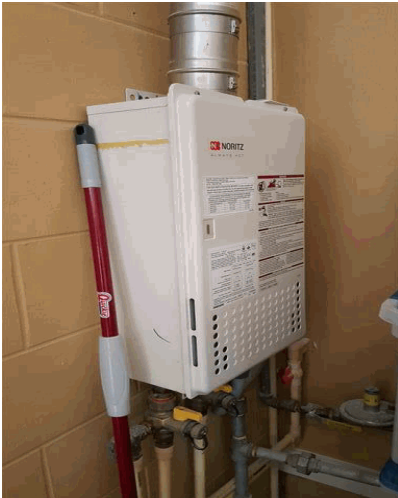
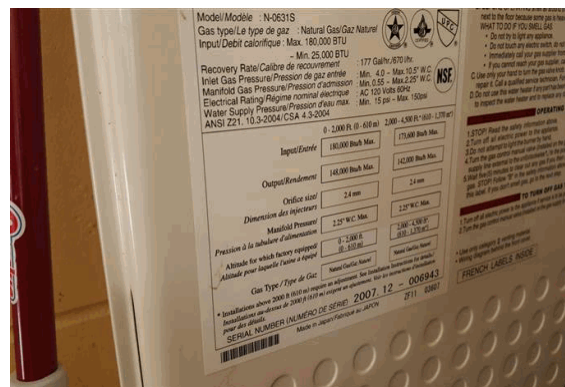
Status: **Acceptable**
Location: **Garage/ Closet**
Additional comments: Mfg 2007

Description: **Gas Tankless**
Comment: **Good condition**

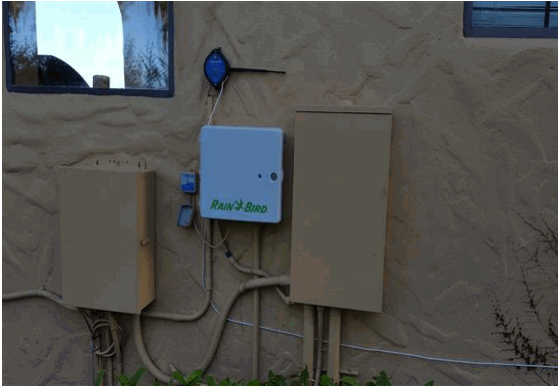
Status: **Not Inspected**

Comment: **System Locked**

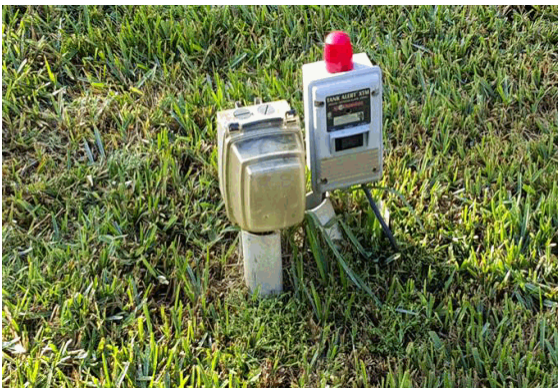
Septic Tank Pump

Status: **Not Inspected**

Evaluation of any septic system should be performed by a qualified company and certified

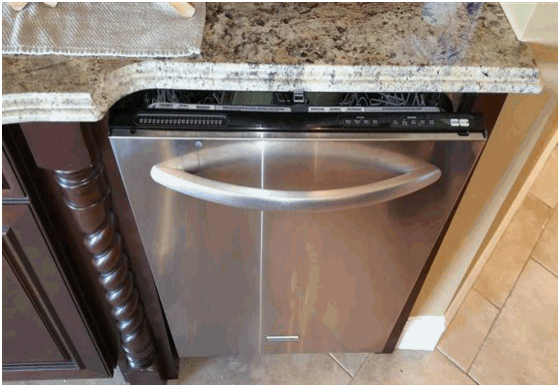
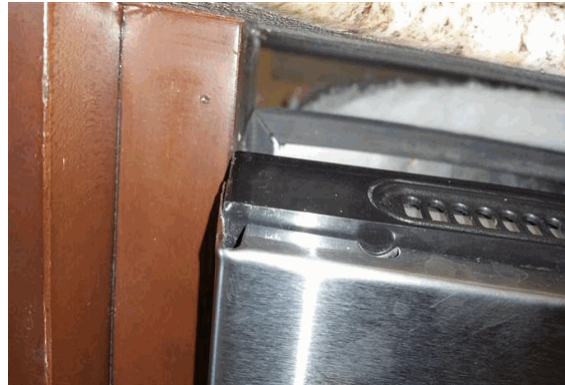
Location: **Kitchen**

Status: **Repair/Replace**

Comment: **Dishwasher door hits cabinet**

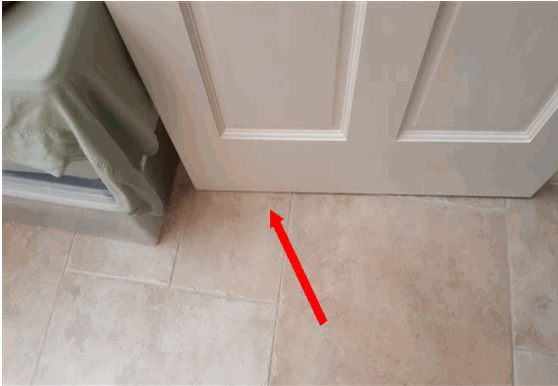
Location: **Upstairs Utility room**

Status: **Repair/Replace**

Comment: **Scrapes on the tile**
