Confidential Inspection Report

LOCATED AT: 123 Creia Street
Rancho Santa Margarita, CA 92688

INSPECTED ON: Tuesday, May 22, 2018

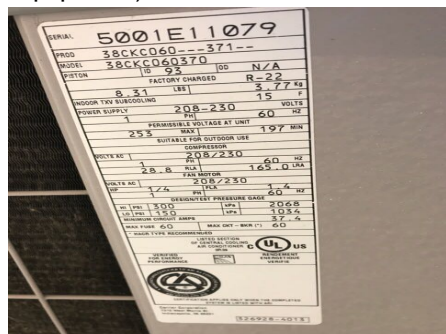
COMPRESSOR UNIT

145: - Air conditioning compressor unit was manufactured by unknown (logo missing / not displayed anywhere on equipment).

146: - Air conditioning system currently uses R22 refrigerant.

147: - Approximately "5 Tons."

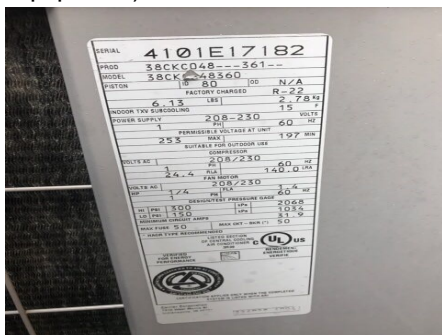
COMPRESSOR UNIT

166: - Air conditioning compressor unit was manufactured by unknown (logo missing / not displayed anywhere on equipment).

167: - Air conditioning system currently uses R22 refrigerant.

168: - Approximately "4 Tons."

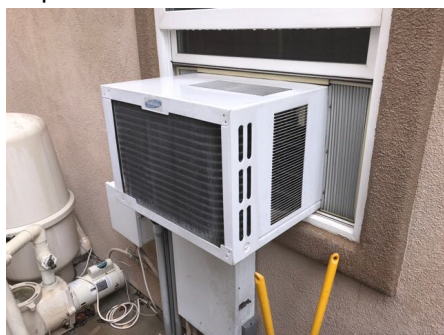
A/C SYSTEM

187: - The air-conditioning consists of a single, plug-in, window unit. This appliance is beyond the scope of the inspection. Ask seller to demonstrate at final walk through.

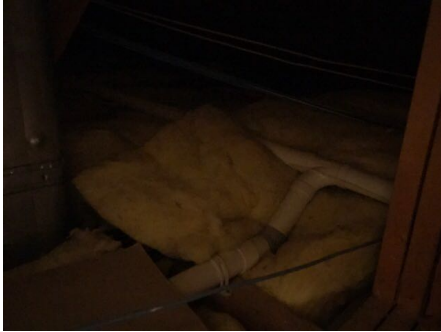
ATTIC INSULATION

302: - Fiberglass batts present.

303: - Insulation averages about 8-10 inches in depth.

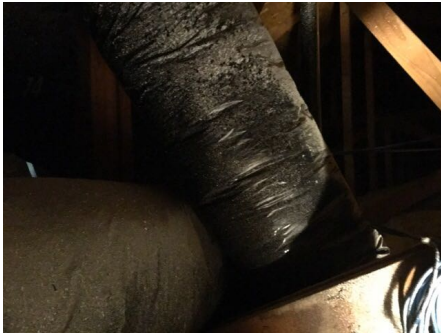
ATTIC DUCTING

307: - Visible portions of the air ducting appears functional.

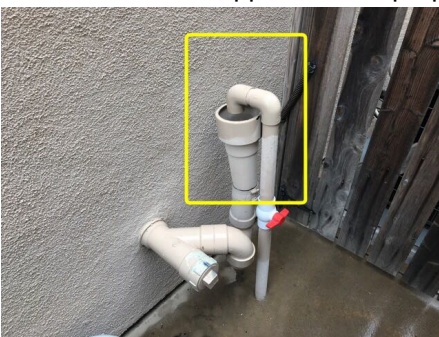
374: - Backwash appears to be properly plumbed to city sewer.

375: - No air gap present. This is a cross contamination hazard. Recommend installing an air gap prior to the P Trap where backwash connects to the city sewer, by a plumbing or pool and spa contractor.

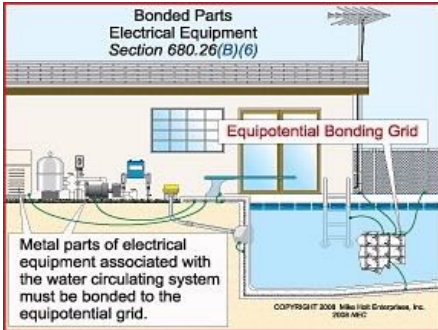
392: - No major system safety or function concerns with pool bonding. All metallic items within 5' of the pool and at the pool equipment, area were properly bonded.
