Fan Housing Vibration Caused by Resonance

Application of Modal & Vibration Analysis

Ken Singleton
KSC Consulting LLC

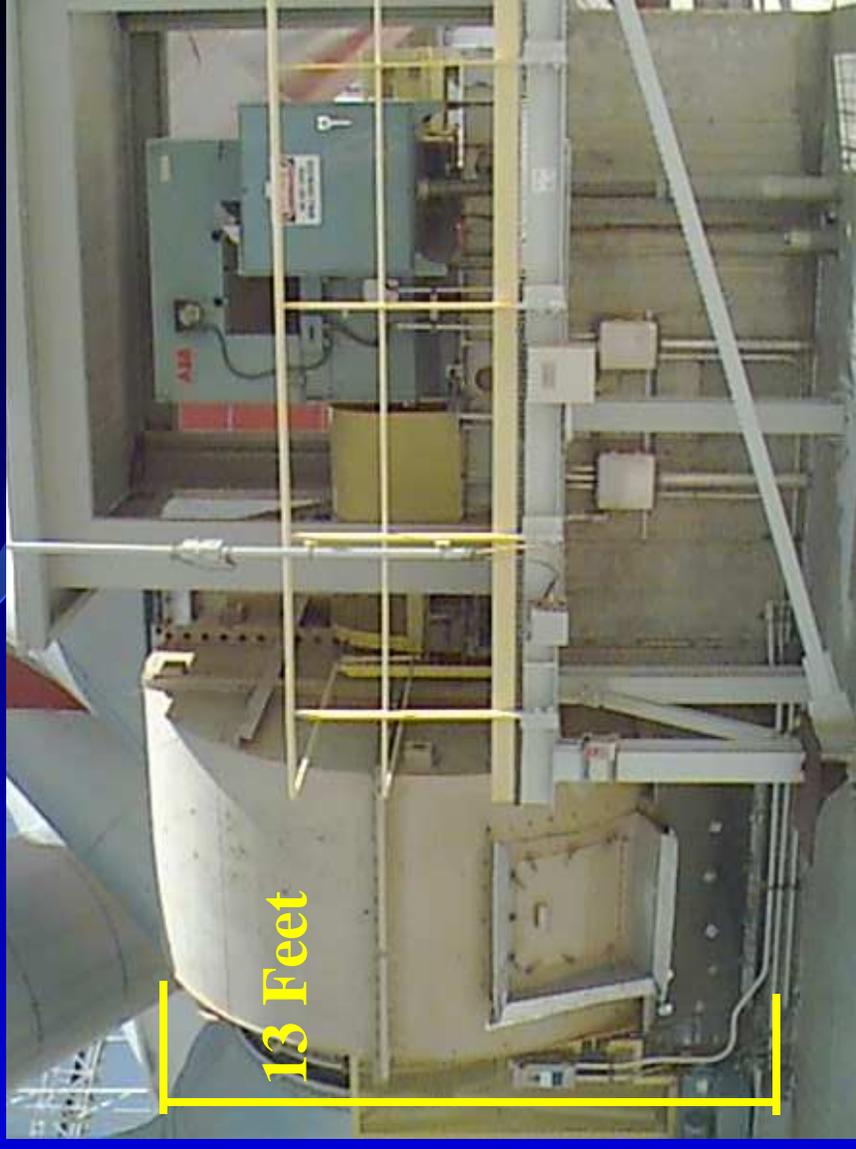
Illustration A. Overview of Scrubber Fans Evaluated
11B-4

- Recommendation to perform fan housing modal test was accepted and scheduled for Sept 11-12, 2002.
- Insulation was removed to provide access to the fan housing.
- The fan housing was inspected for cracking as well as general design and fabrication methods.
- No cracks were found.

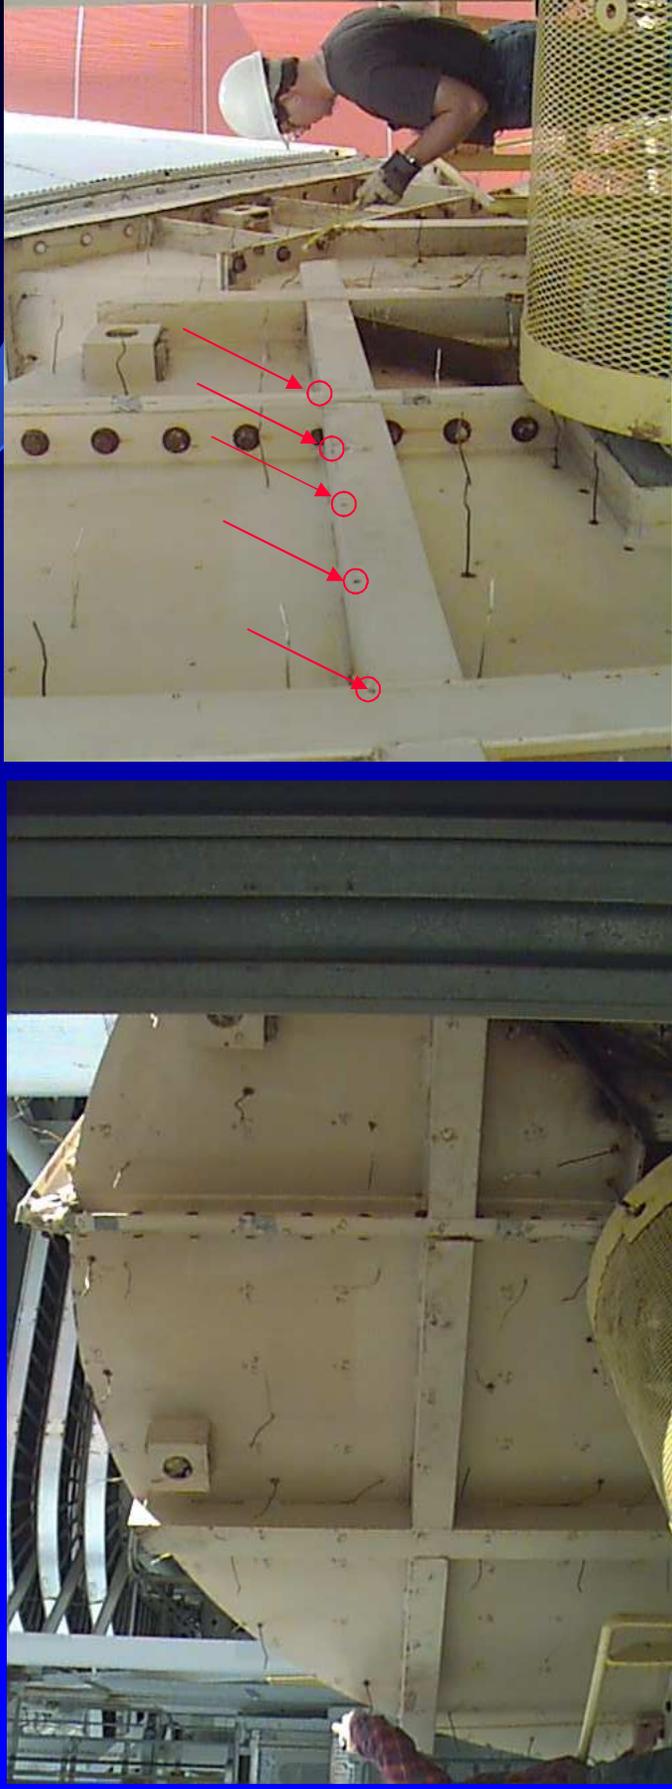
Figure 7.

- 195 Test measurement points (DOF) were laid out in a mesh as shown in the photos.
- Excitation was by impact using a PCB Instrumented 12 lb Sledge Hammer. 5 Accelerometers were roved to each DOF.

Mitch France - Laying Out
Modal Test Points on Fan
Housing, Shaft Inlet Side

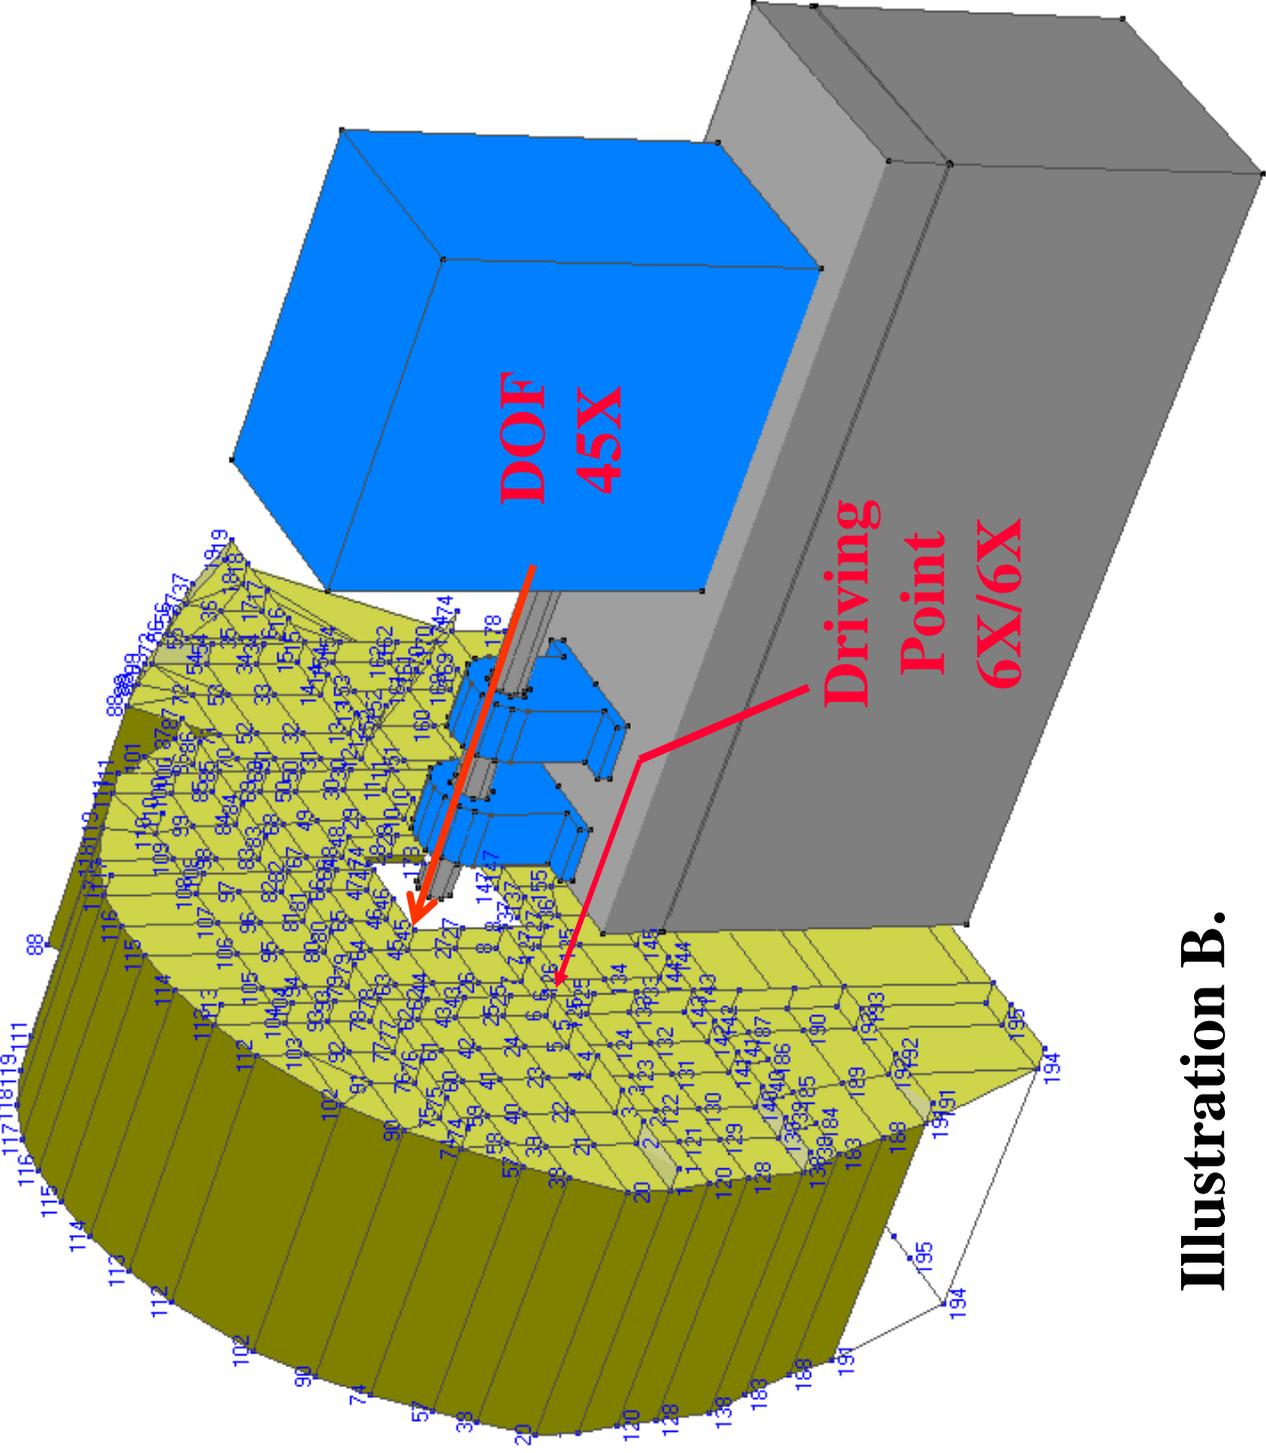
Illustration B.

Driving Point Frequency Response Function (FRF) taken on the fan housing showed many Natural Frequencies.
