Phase I Environmental Site Assessment Addendum

US 30 Corridor Improvements Project – Western Section

**North Versailles and North Huntingdon Townships
Allegheny and Westmoreland Counties, Pennsylvania**

Markosky Project File 15-003B

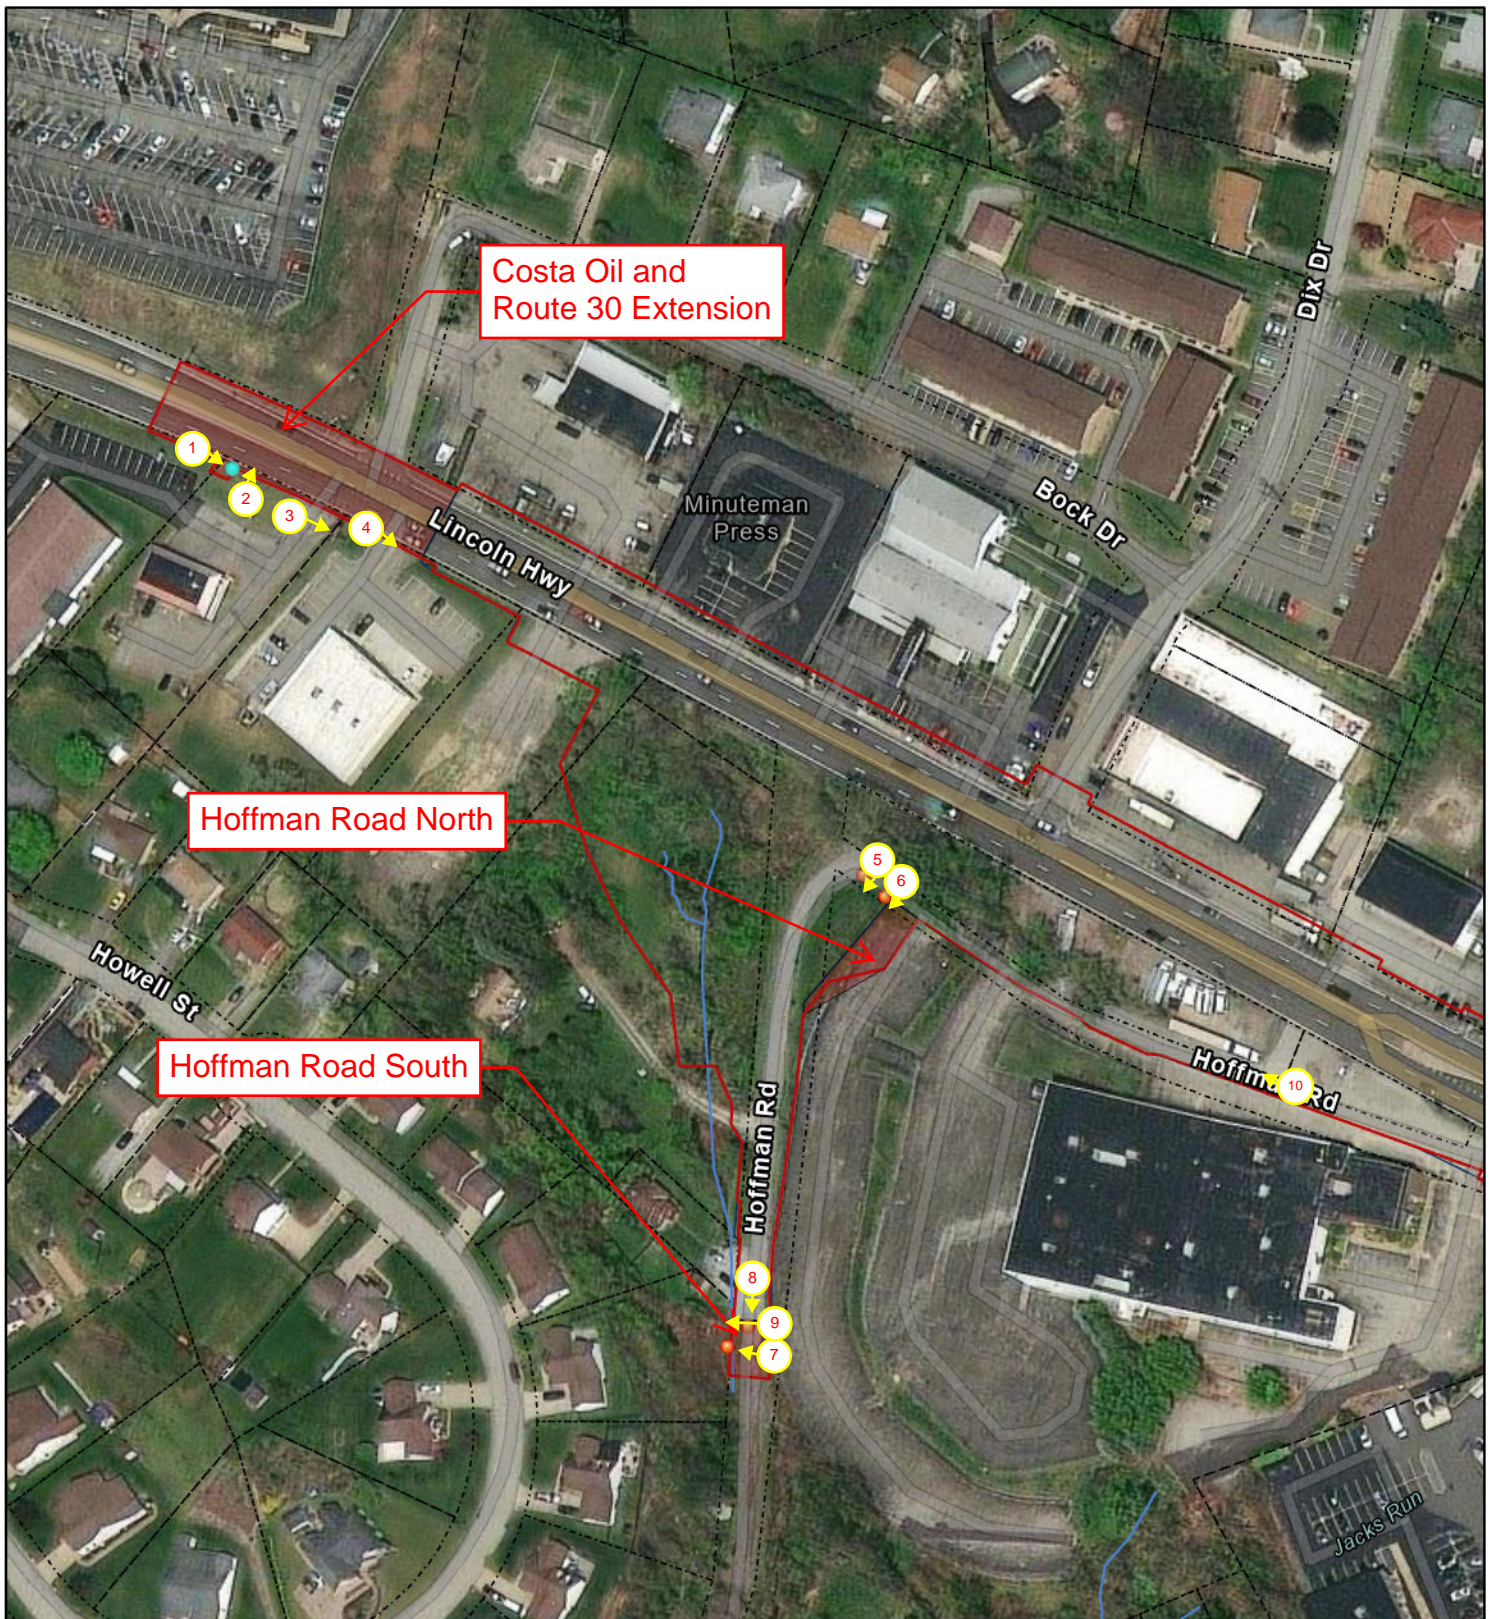
Sheet Description: Costa Oil
 and Hoffman Rd Areas

The study area was extended north to include a segment of Route 30 adjacent to Costa Oil (a quick oil-change business) and a bump-out between the business sign and power pole on the west side of the road. The extension contained a stormwater drainage grate and sewer access cover on the east side of the road; two stormwater drainage grates were present in the Costa Oil driveway, and one was present in the O'Reilly's driveway, all outside of, but adjacent to, the study area. A water line access point was located on the west side of Route 30 in the study area bump-out.

Two sewer access covers were located near the road bend as the road turned west, adjacent to the expanded area where a vacant lot was, with the cover to the south inside the study area and the cover to the north outside the study area. The vacant asphalt lot documented in the previous field visit was not present, having been removed and replaced with soil and grass seed. Filter socks were placed along Hoffman Road on the south and west side along the embankment. A gas line was located near the former driveway into that lot.

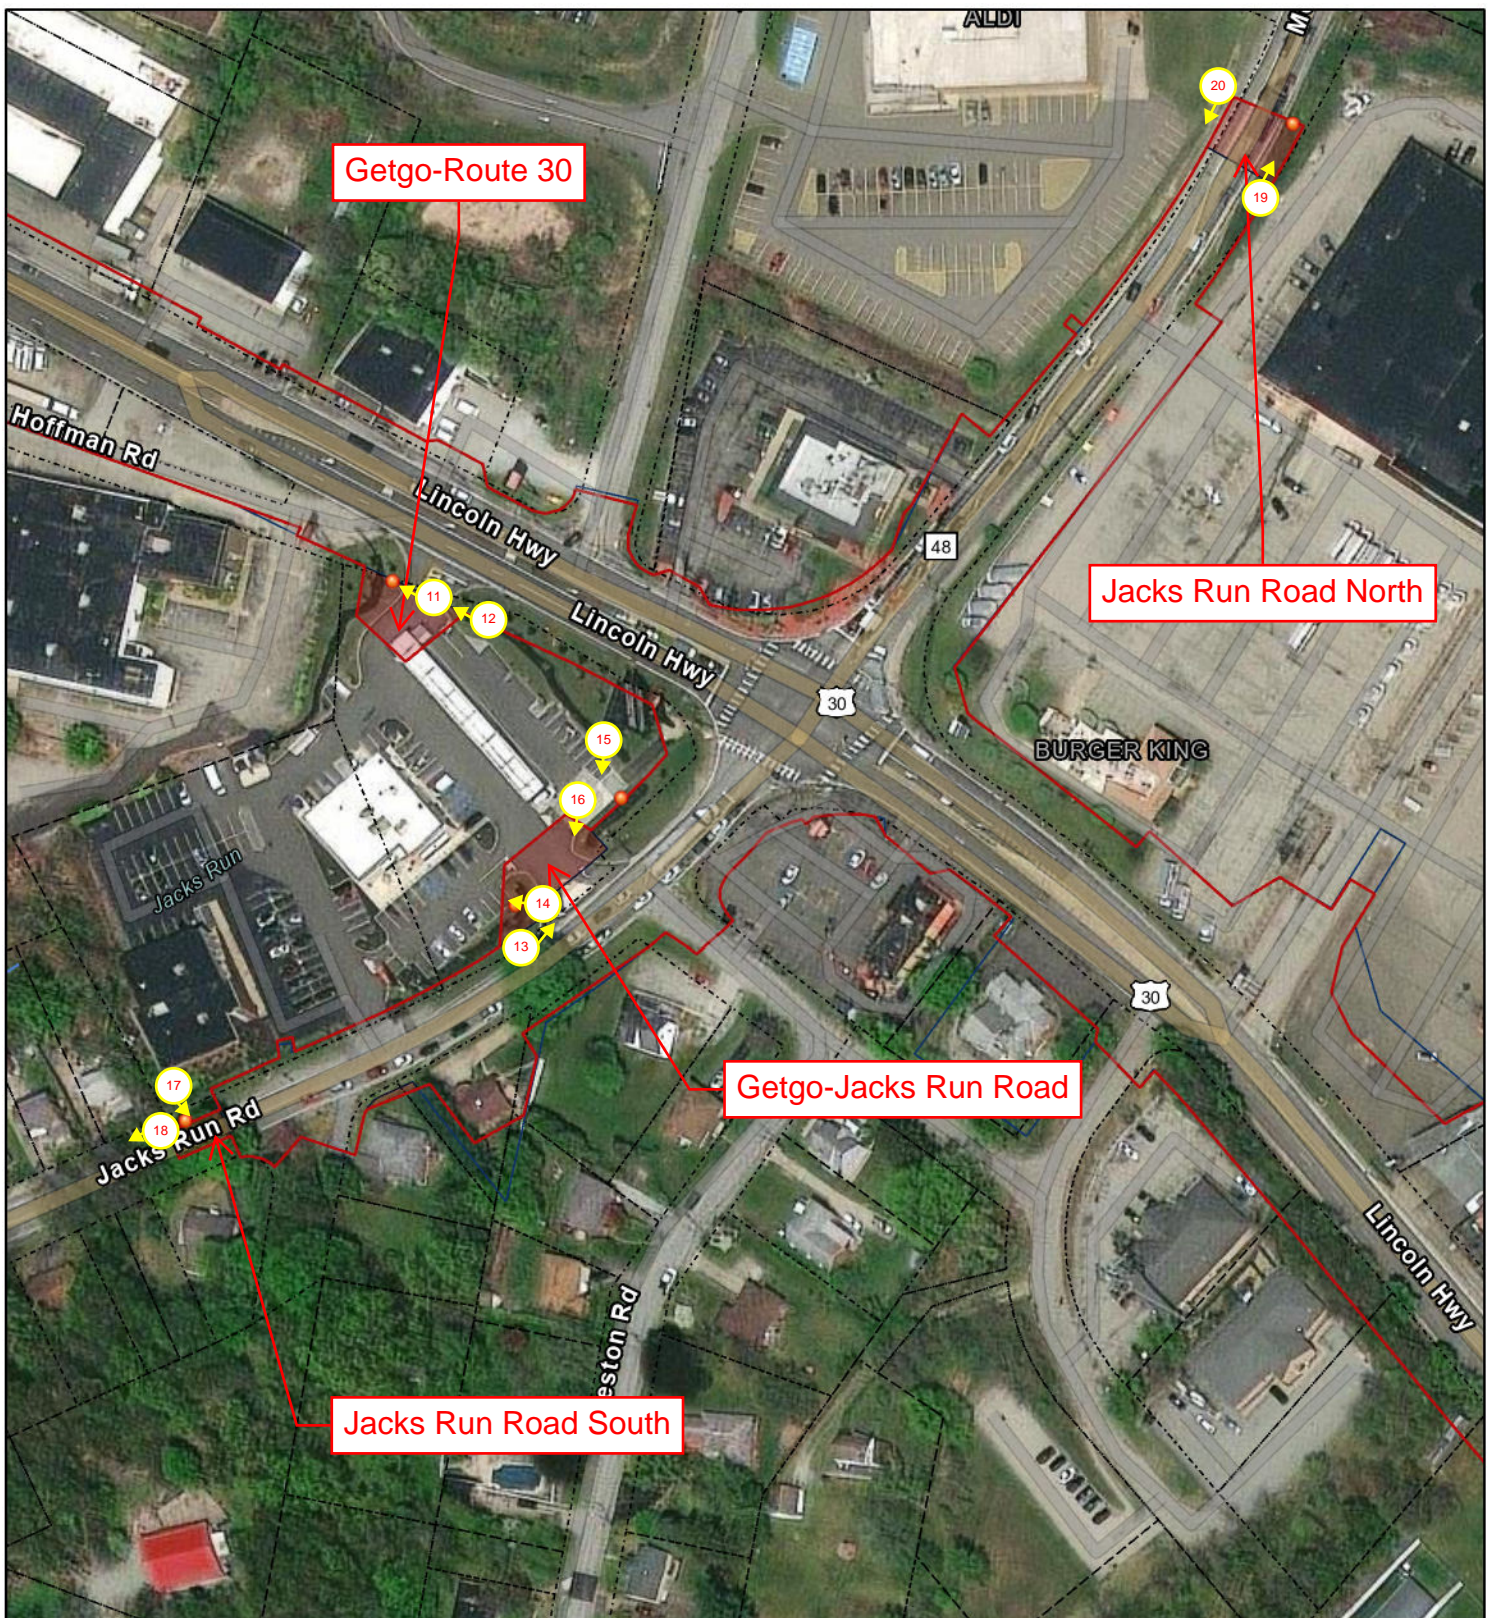
Sheet Description: Getgo,
 Jacks Run Road North and
 South Areas

Records for the permitting of the underground storage tanks located at the site (Site ID: 842239, Permit 1309750) included a 20,000-gal gasoline underground storage tank (UST), a 6,000-gal gasoline UST, and a 6,000-gal diesel UST. The records for the facility are limited, as the facility was still under construction at the time of the original field investigation (then labeled "Marathon/GetGo Construction Site in the field photographs). Two violations are listed for the facility in the DEP eFacts database, one for a failure to comply with UST system monthly operation and maintenance walkthrough inspections and another as failure to meet performance standards for new/upgraded tanks, both of which show a status of "corrected/abated".

A portion of the study area branching off down Jack's Run Road travelling east from the intersection with Route 30 contained a pole-mounted transformer on the south side of the road, and a gas line access. The roadway and the included roadside areas were all low grasses and maintained greenspace. No other features were noted.

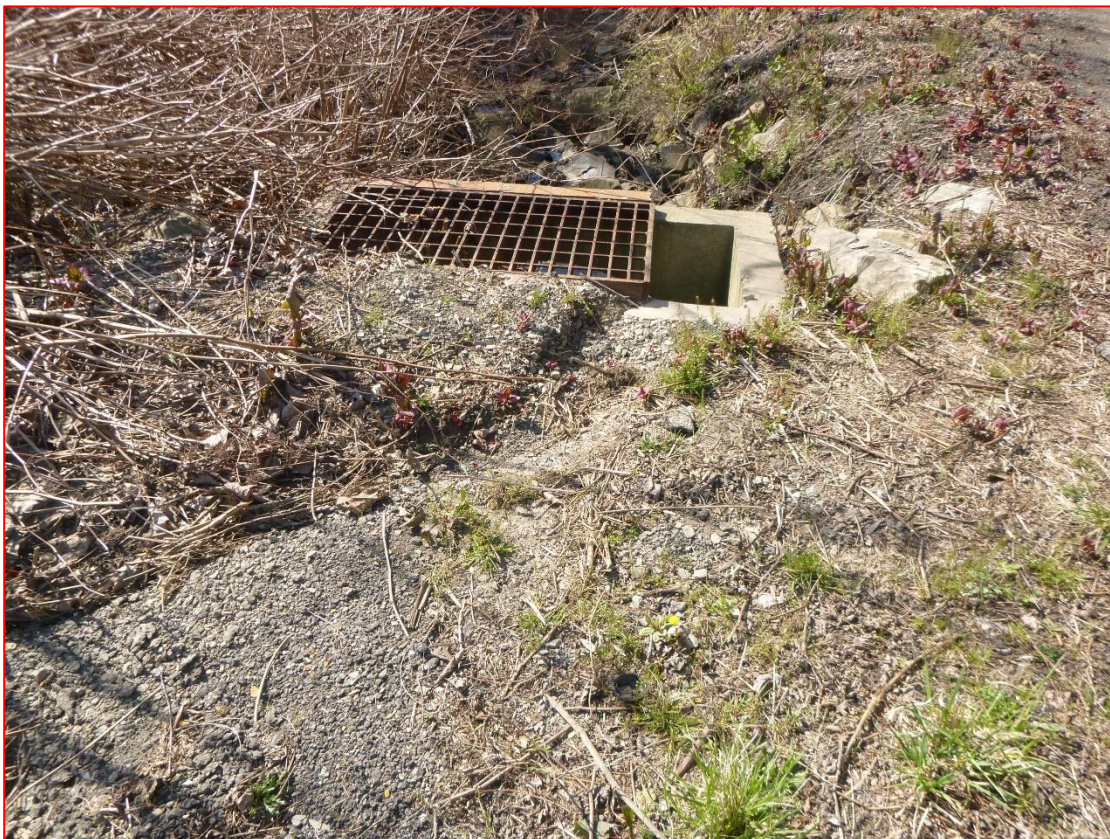
Several stormwater drainage grates were present along the road, with two of the grates within or adjacent to the expanded study area. One sewer access cover was observed at the end of the paved section of the road.

Photo 7: Hoffman Road Stormwater Drainage grate adjacent [east of] to the southern extent of the Hoffman road study area – Facing Northwest (04.12.2023)

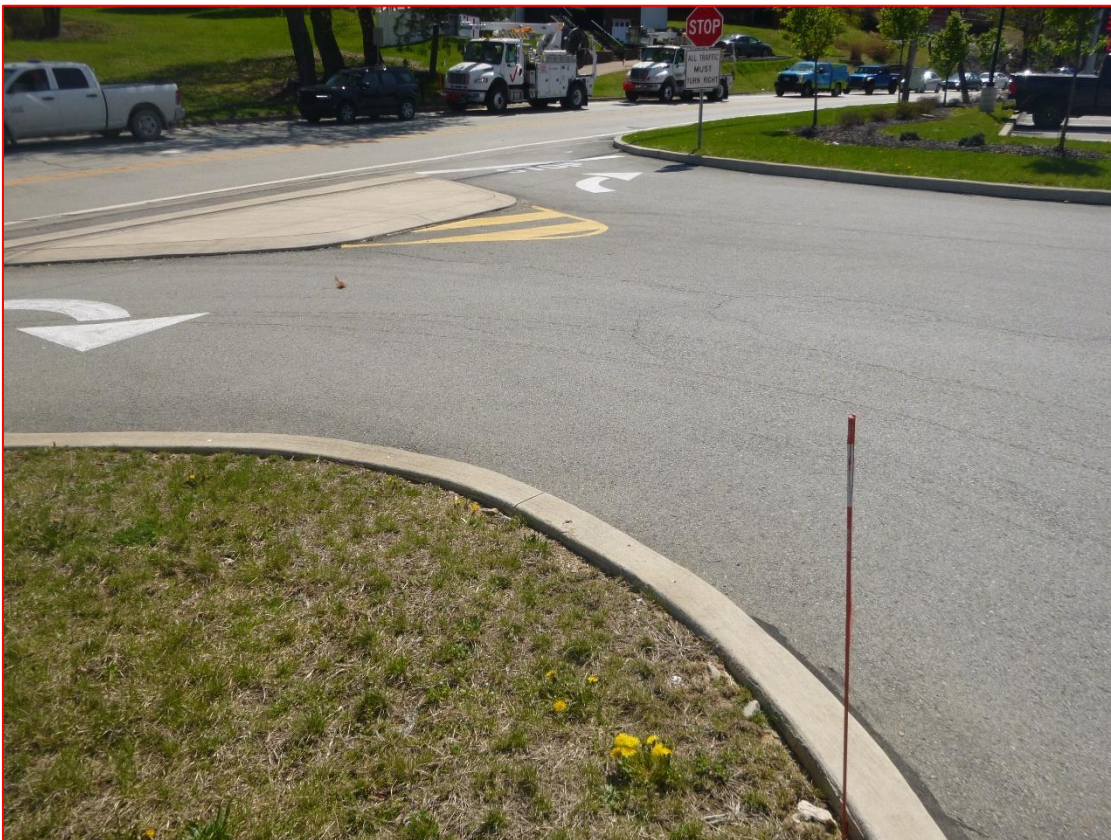
Photo 16: Getgo driveway from Jacks Run Road – Facing South (04.12.2023)
