Field Observation Report

Arby's
4948 Highway 42
Louisville, KY
Reference Purchase Order 64430

Date:
5/4/2011

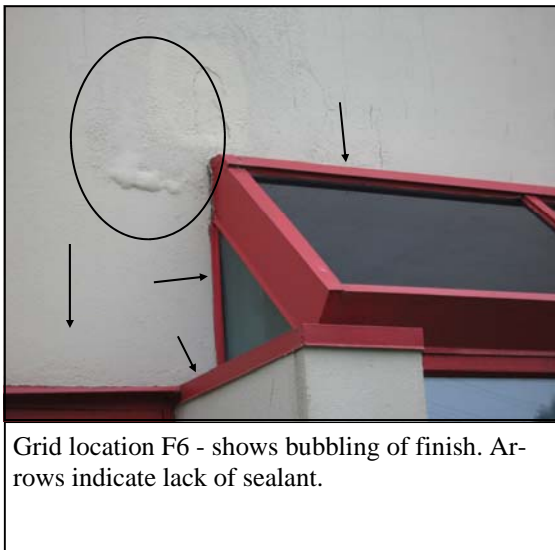
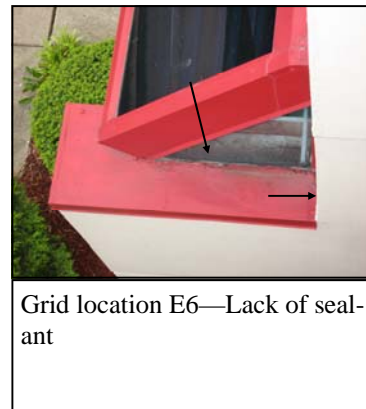
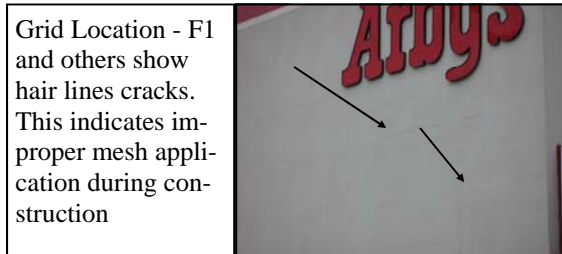
○ Red Circle corresponds to severe interior water damage.
