CHAPTER TWO

Inventory and Analysis

Pike River Maintenance Plan

Mount Pleasant, Wisconsin

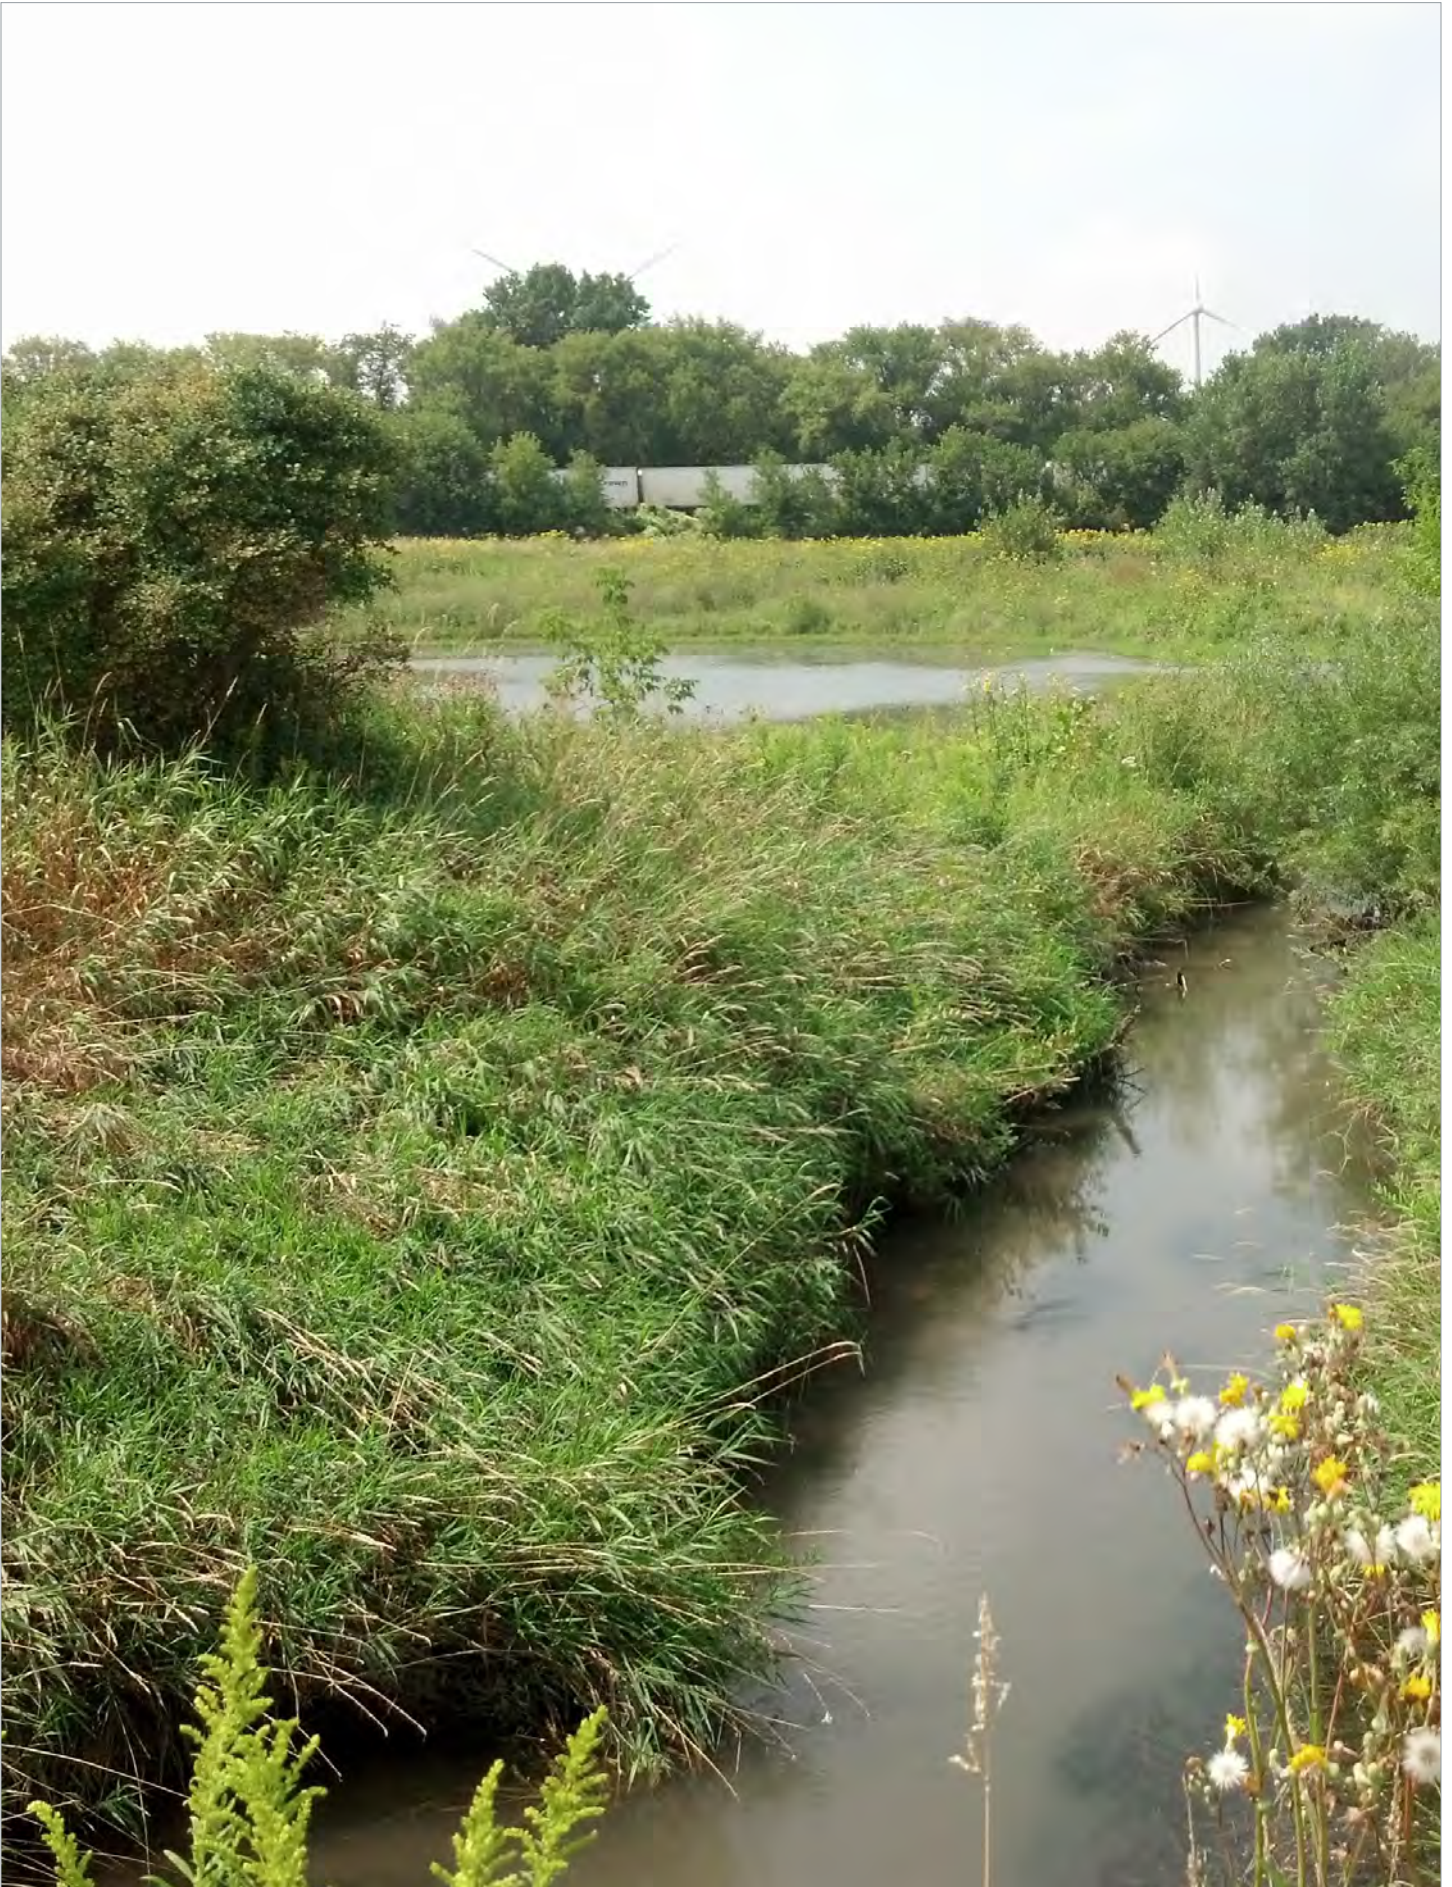
Stormwater culvert from Hwy 20 draining into Phase 3, showing erosion where rip-rap and boulders were blown out by high flows.

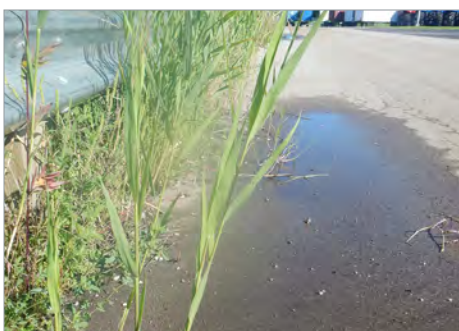
Phragmites australis, giant reed grass - an aggressive grass capable of puncturing asphalt on Phase 6!

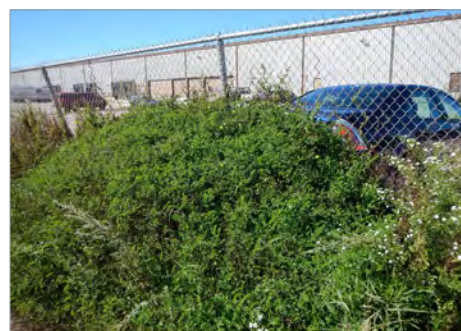
Securigera varia Crown vetch invades prairie plantings on Phase 6.

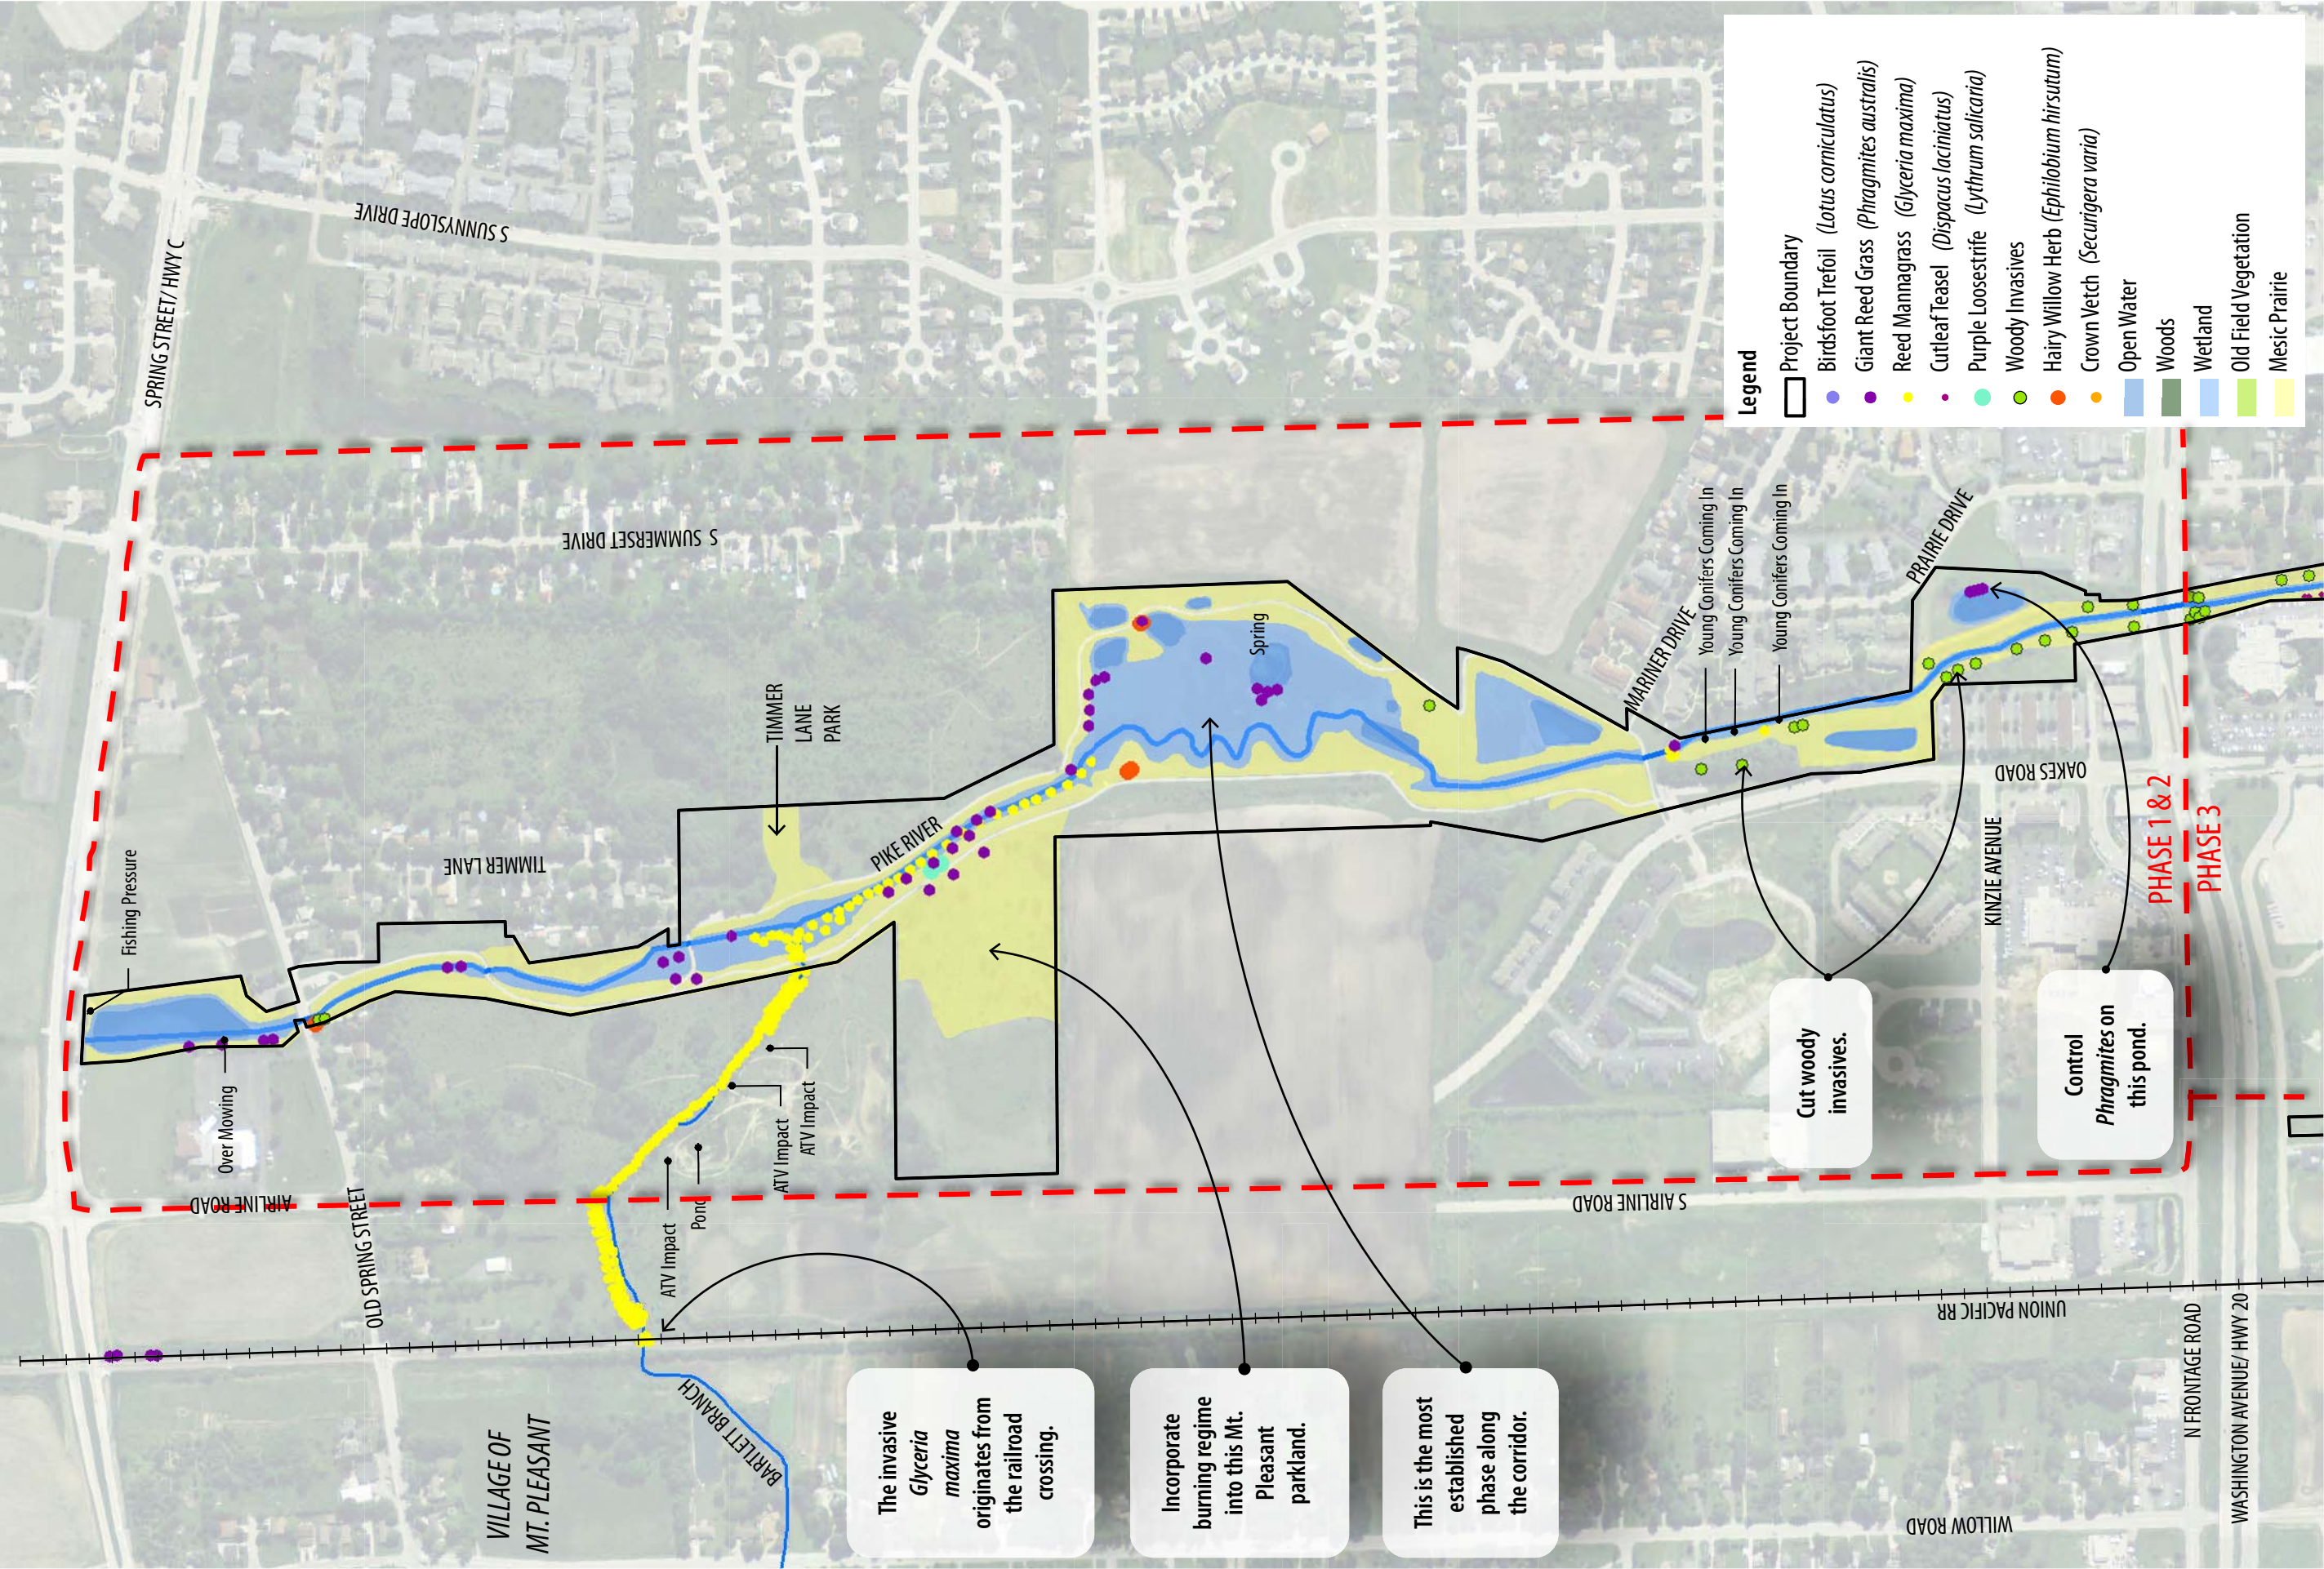
Vegetation/Management Issues Phase 1 & 2

HELPFUL <i>(positive)</i>	HARMFUL <i>(negative)</i>
INTERNAL <i>(current)</i>	Strengths <ul style="list-style-type: none"> Provides continuation of habitat between Phase 1 and Phase 3 Enjoyed by Condominium residents and Dairy Queen customers Easily viewed by public from sidewalk along STH 20 Ready for a fire regime 	Weaknesses <ul style="list-style-type: none"> Poor access for management activities; steep Needs a management trail (proposed location shown on maps) Young willows and other woody invasive species becoming small-tree size Tight - narrow, steep corridor
EXTERNAL <i>(future)</i>	Opportunities <ul style="list-style-type: none"> Needs ownership; opportunity for Condo "adoption" Buffer opportunity east of Knight's Inn and Dairy Queen and install dog waste stations/signage Stormwater pond on southeast corner could be buffered with native vegetation and managed for <i>Phragmites</i> 	Threats <ul style="list-style-type: none"> Difficult crossing at STH 20 between Phase 2 and Phase 3 Trash is blown in from STH 20/surrounding businesses Stormwater inputs from surrounding ponds may carry <i>Phragmites</i> (giant reed grass) and other invasive species Dog waste east of Knight's Inn and Dairy Queen in mowed grass area

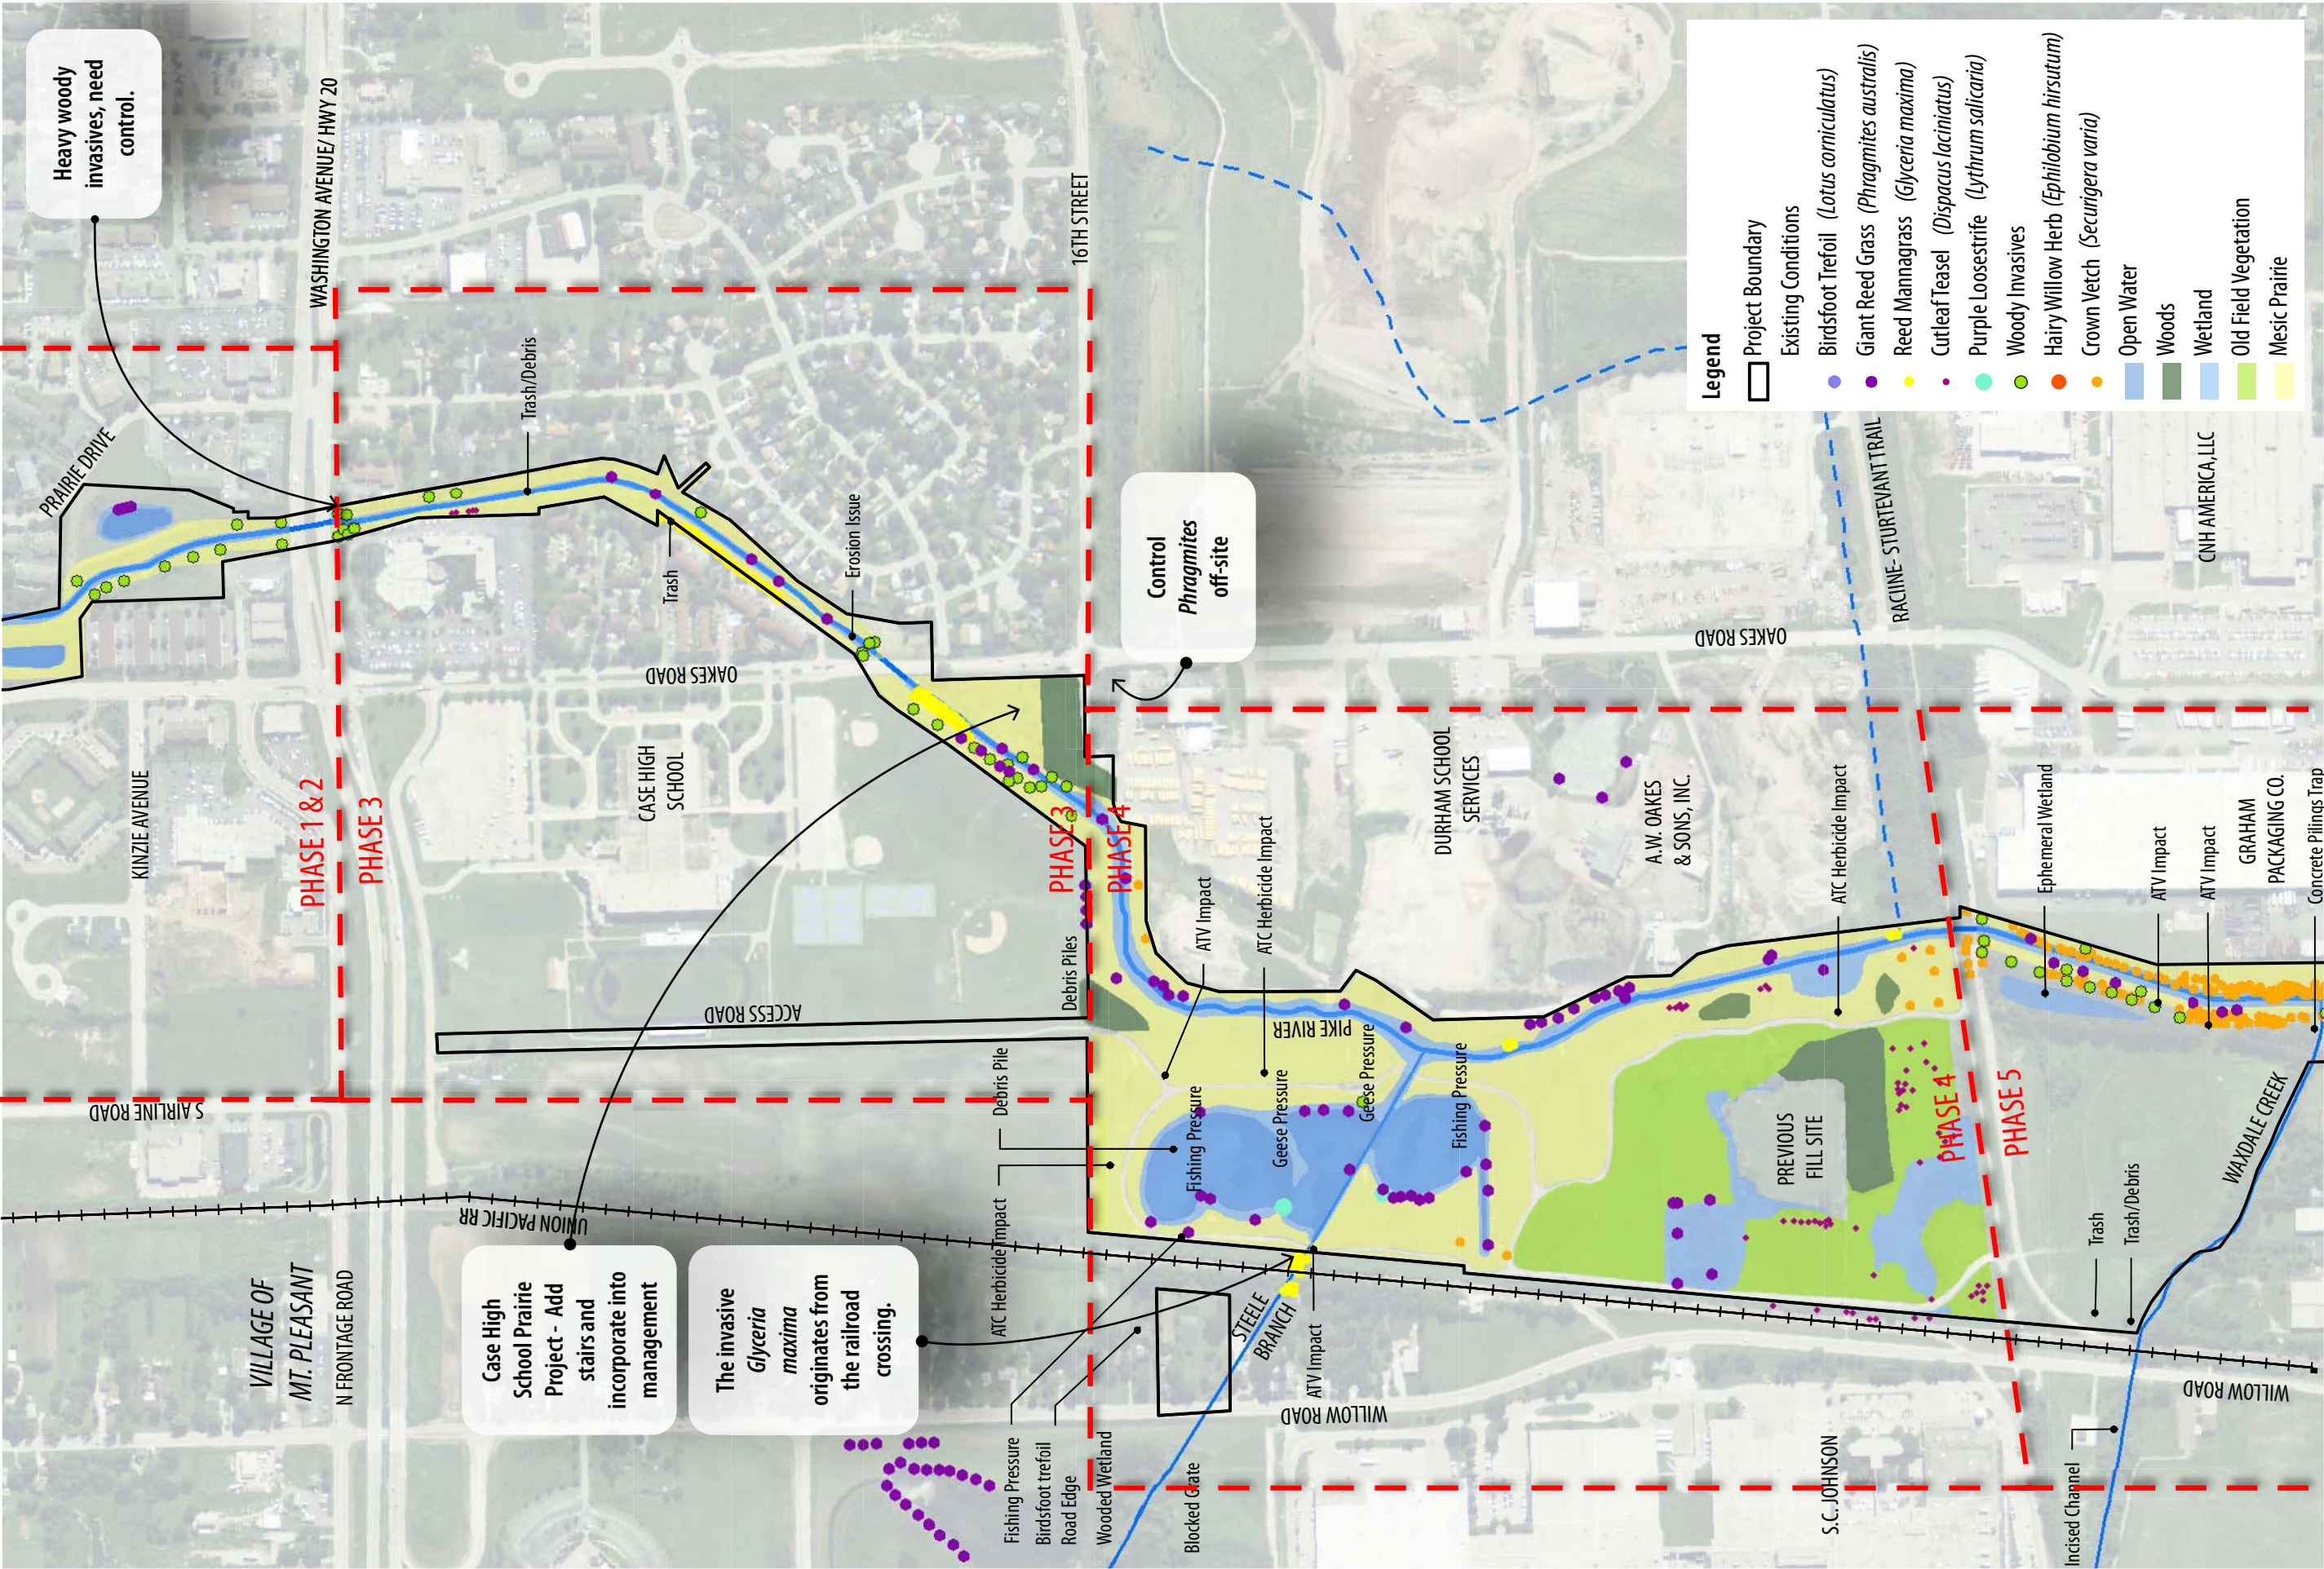
Vegetation/Management Issues Phase 3 & 4

- Ongoing inputs of *Glyceria maxima* from the Steele branch at RR tracks
- *Phragmites* at Steele Branch headwaters and SC Johnson ponds (connect with waterway)
- Blocked grate at Willow Road, impounding water west of Willow Road

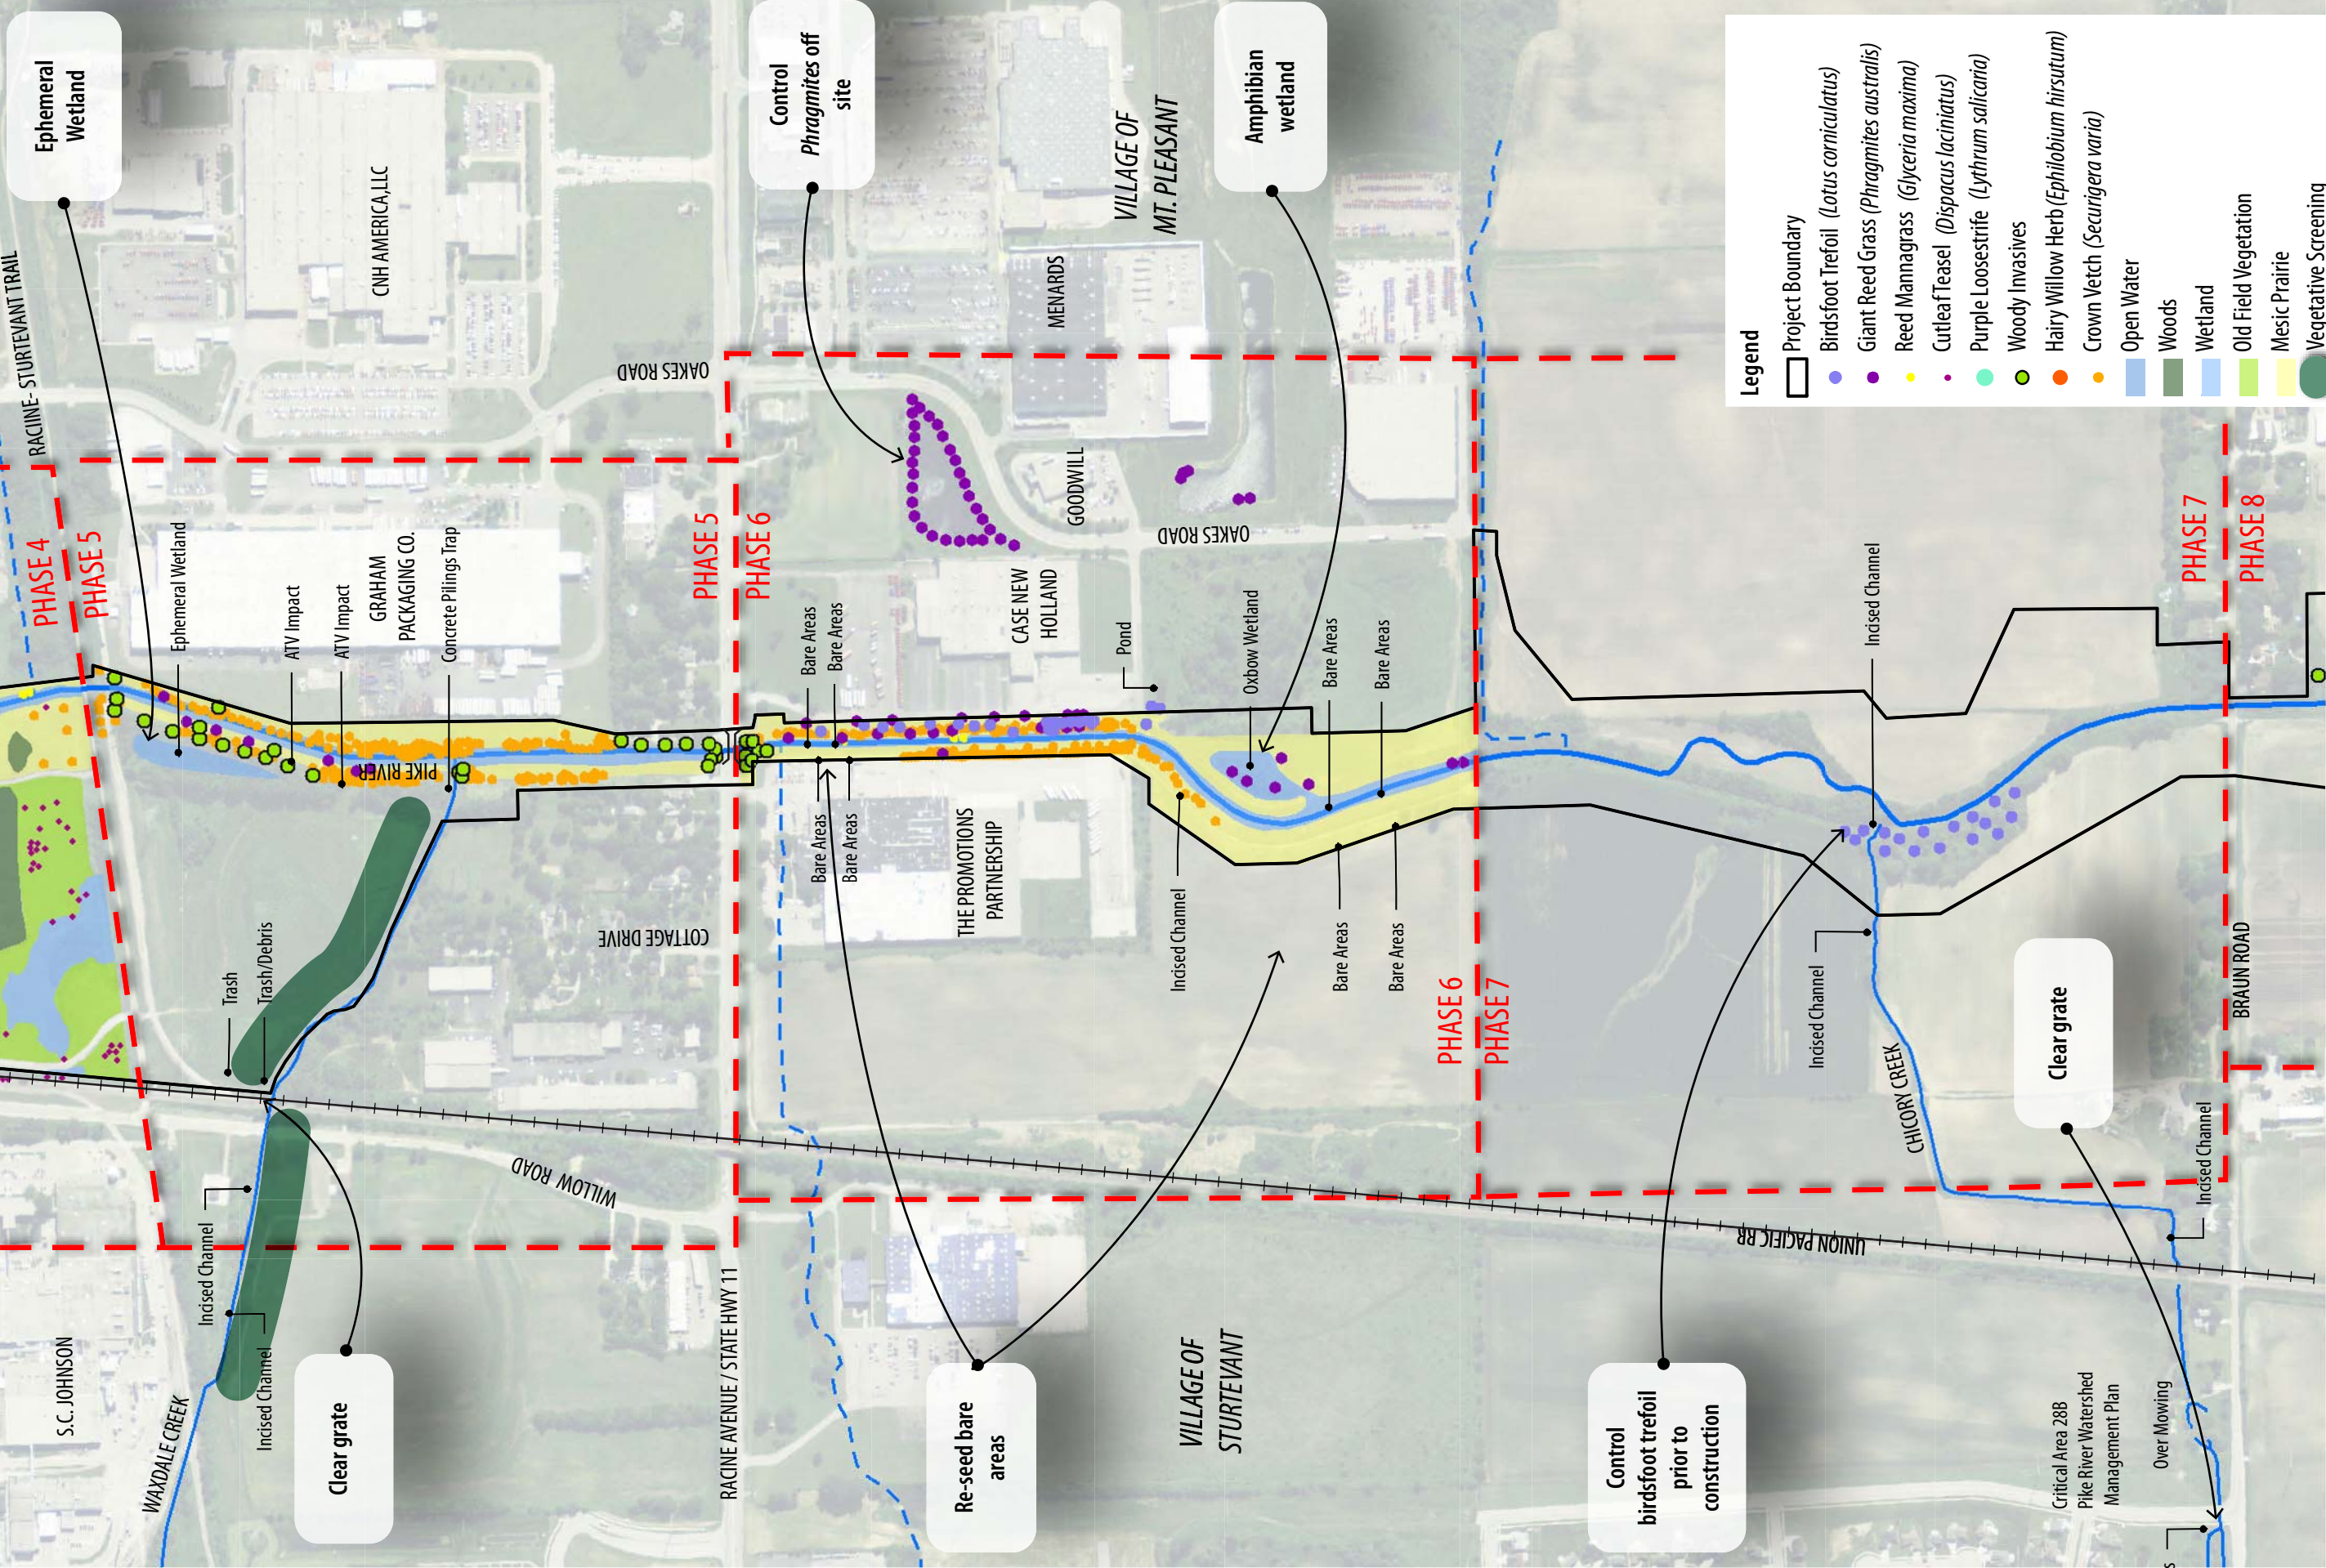
Vegetation/ Management Issues Phase 5, 6 & 7

HELPFUL (positive)	HARMFUL (negative)
INTERNAL (current)	INTERNAL (current)	Strengths <ul style="list-style-type: none"> Good buffers to Pike River Significant wildlife habitat and corridor adjacent Phase 6 Burn control possible- schedule burn within first 5 years 	Weaknesses <ul style="list-style-type: none"> Birdsfoot trefoil on banks of unrestored Pike River (near Chickory Creek) No management access on east side of project Future concern of ATV damage with restoration corridor based on current practice at Biex-Ramcke
	EXTERNAL (future)	Opportunities <ul style="list-style-type: none"> Be early on crown vetch/birdsfoot trefoil control, start the first year post-construction Educate neighbors on project, especially on the ATV damage issue - signage, and boundary markers Educate contractors on cleaning equipment before construction 	Threats <ul style="list-style-type: none"> Future ATV damage possible due to neighboring properties Agricultural runoff/inputs to project corridor Future development and stormwater inputs

Chickory Creek Tributary <ul style="list-style-type: none"> Opportunities to buffer/restore along the tributary, especially in the agricultural fields east of Willow Road. On-line pond west of Willow Road - may be caused by trash impeding flow - investigate 	Chickory Creek Tributary <ul style="list-style-type: none"> Chickory Creek outlet has significant invasive input, especially birdsfoot trefoil at the mouth of the Pike River Trash (chair, box springs) in box culvert impeding flow just west of Willow Road <i>Phragmites</i> patch east of 90th St- small and manageable at this point

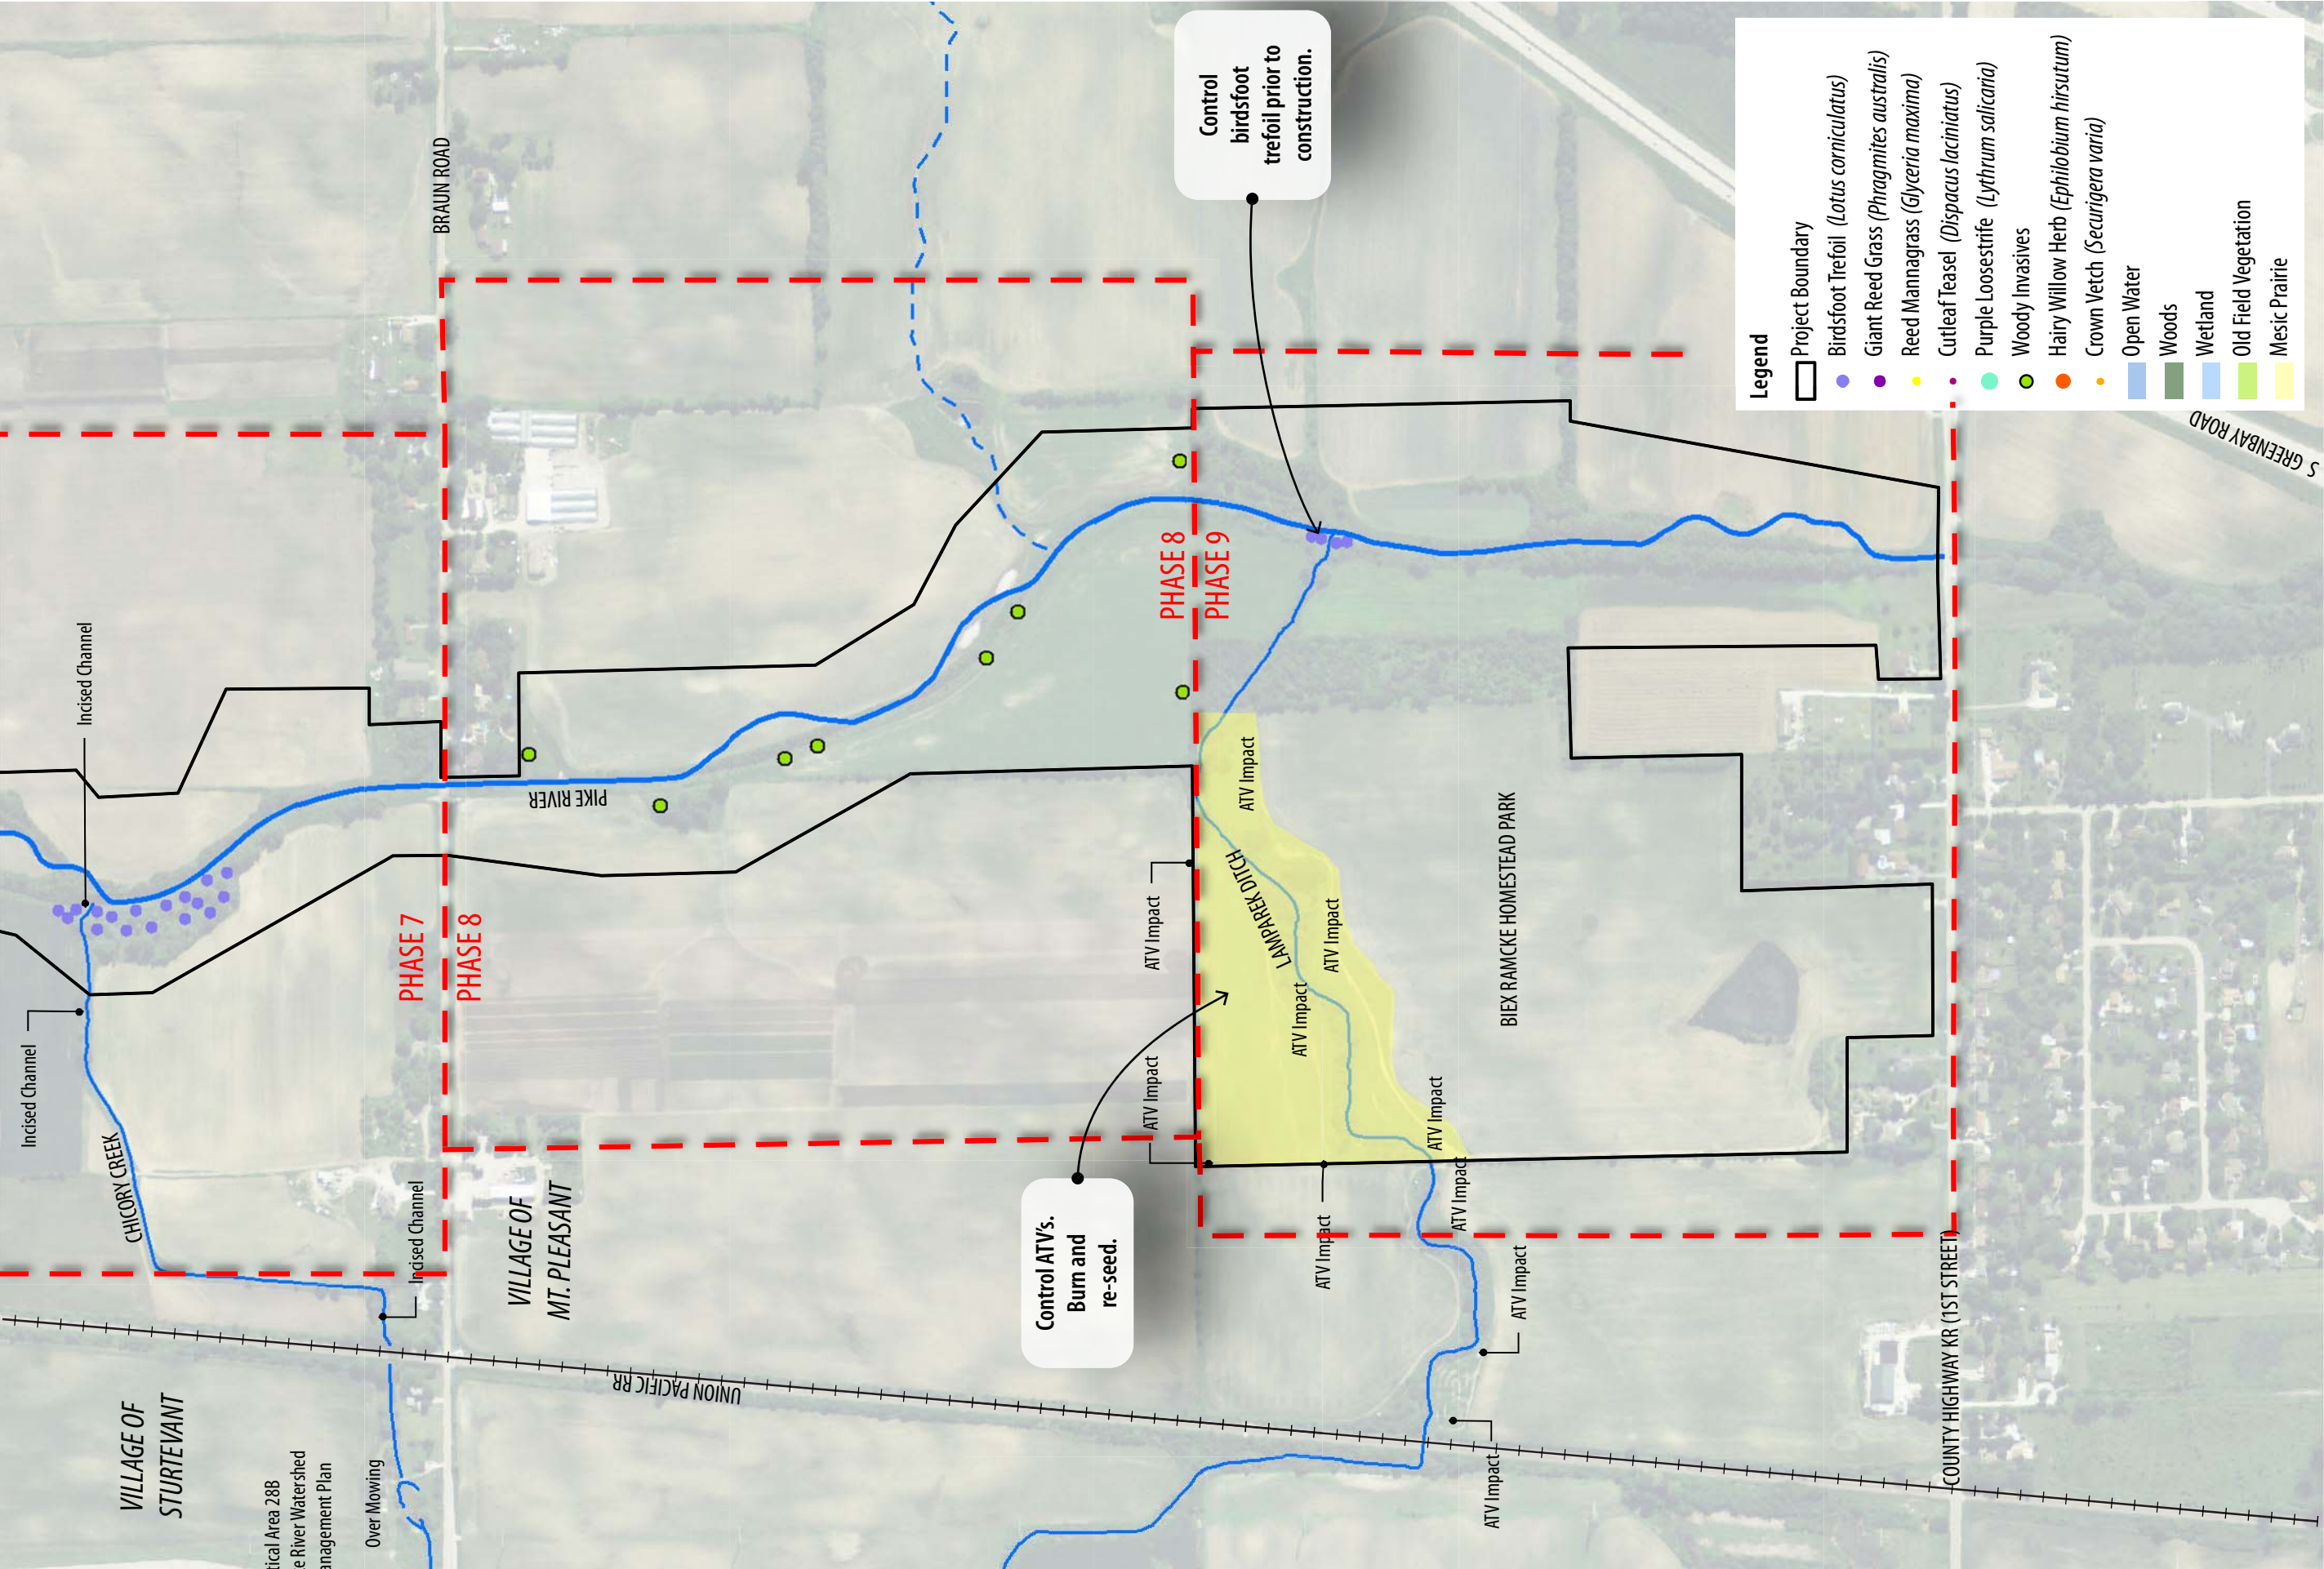
Vegetation/Management Issues Phase 8 & 9

HELPFUL (positive)	HARMFUL (negative)
INTERNAL (current)	INTERNAL (current)	Strengths <ul style="list-style-type: none"> Good buffers to Pike River are included in the construction plans Biex-Ramcke Prairie Planting (seeded in 2009) needs a burning regime Wide prairie buffers with significant wildlife habitat being planned/constructed Burn control possible - schedule burn within first 5 years Pike-spawning habitat is included in the planned restoration 	Weaknesses <ul style="list-style-type: none"> Significant ATV damage in Biex-Ramcke prairie, needs signage, discussion with local landowners Birdsfoot treefoil and crown vetch in project area - need to herbicide in advance of construction and control in first year following construction Will need management access on east side of project corridor Be early on crown vetch/ birdsfoot trefoil control. Start the first year post-construction Educate contractors on cleaning equipment before and during construction

Opportunities <ul style="list-style-type: none"> Educate neighbors to stop ATV traffic at Biex-Ramcke site, need signage at site boundaries 	Threats <ul style="list-style-type: none"> Agricultural inputs, potential over-cropping into project area Potential ATV damage into the project corridor from the Biex-Ramcke site Future development and stormwater inputs
EXTERNAL (future)	EXTERNAL (future)	Lamparek Ditch Tributary <ul style="list-style-type: none"> Lamparek Ditch well buffered by Biex-Ramcke prairie planting Significant opportunities to buffer/restore along Lamparek ditch from CTH H to Biex-Ramcke Buffer included in Pike River Watershed Plan AG-05 Potential wetland restoration west of Railroad, south of Lamparek 	Lamparek Ditch Tributary <ul style="list-style-type: none"> ATV damage in farmland adjacent Lamparek Ditch Poor farm buffers (actively farmed to top of bank) adjacent Lamparek except at Biex-Ramcke site (Village owned)
