CHAPTER TWO

Inventory and Analysis

Pike River Maintenance Plan

Mount Pleasant, Wisconsin

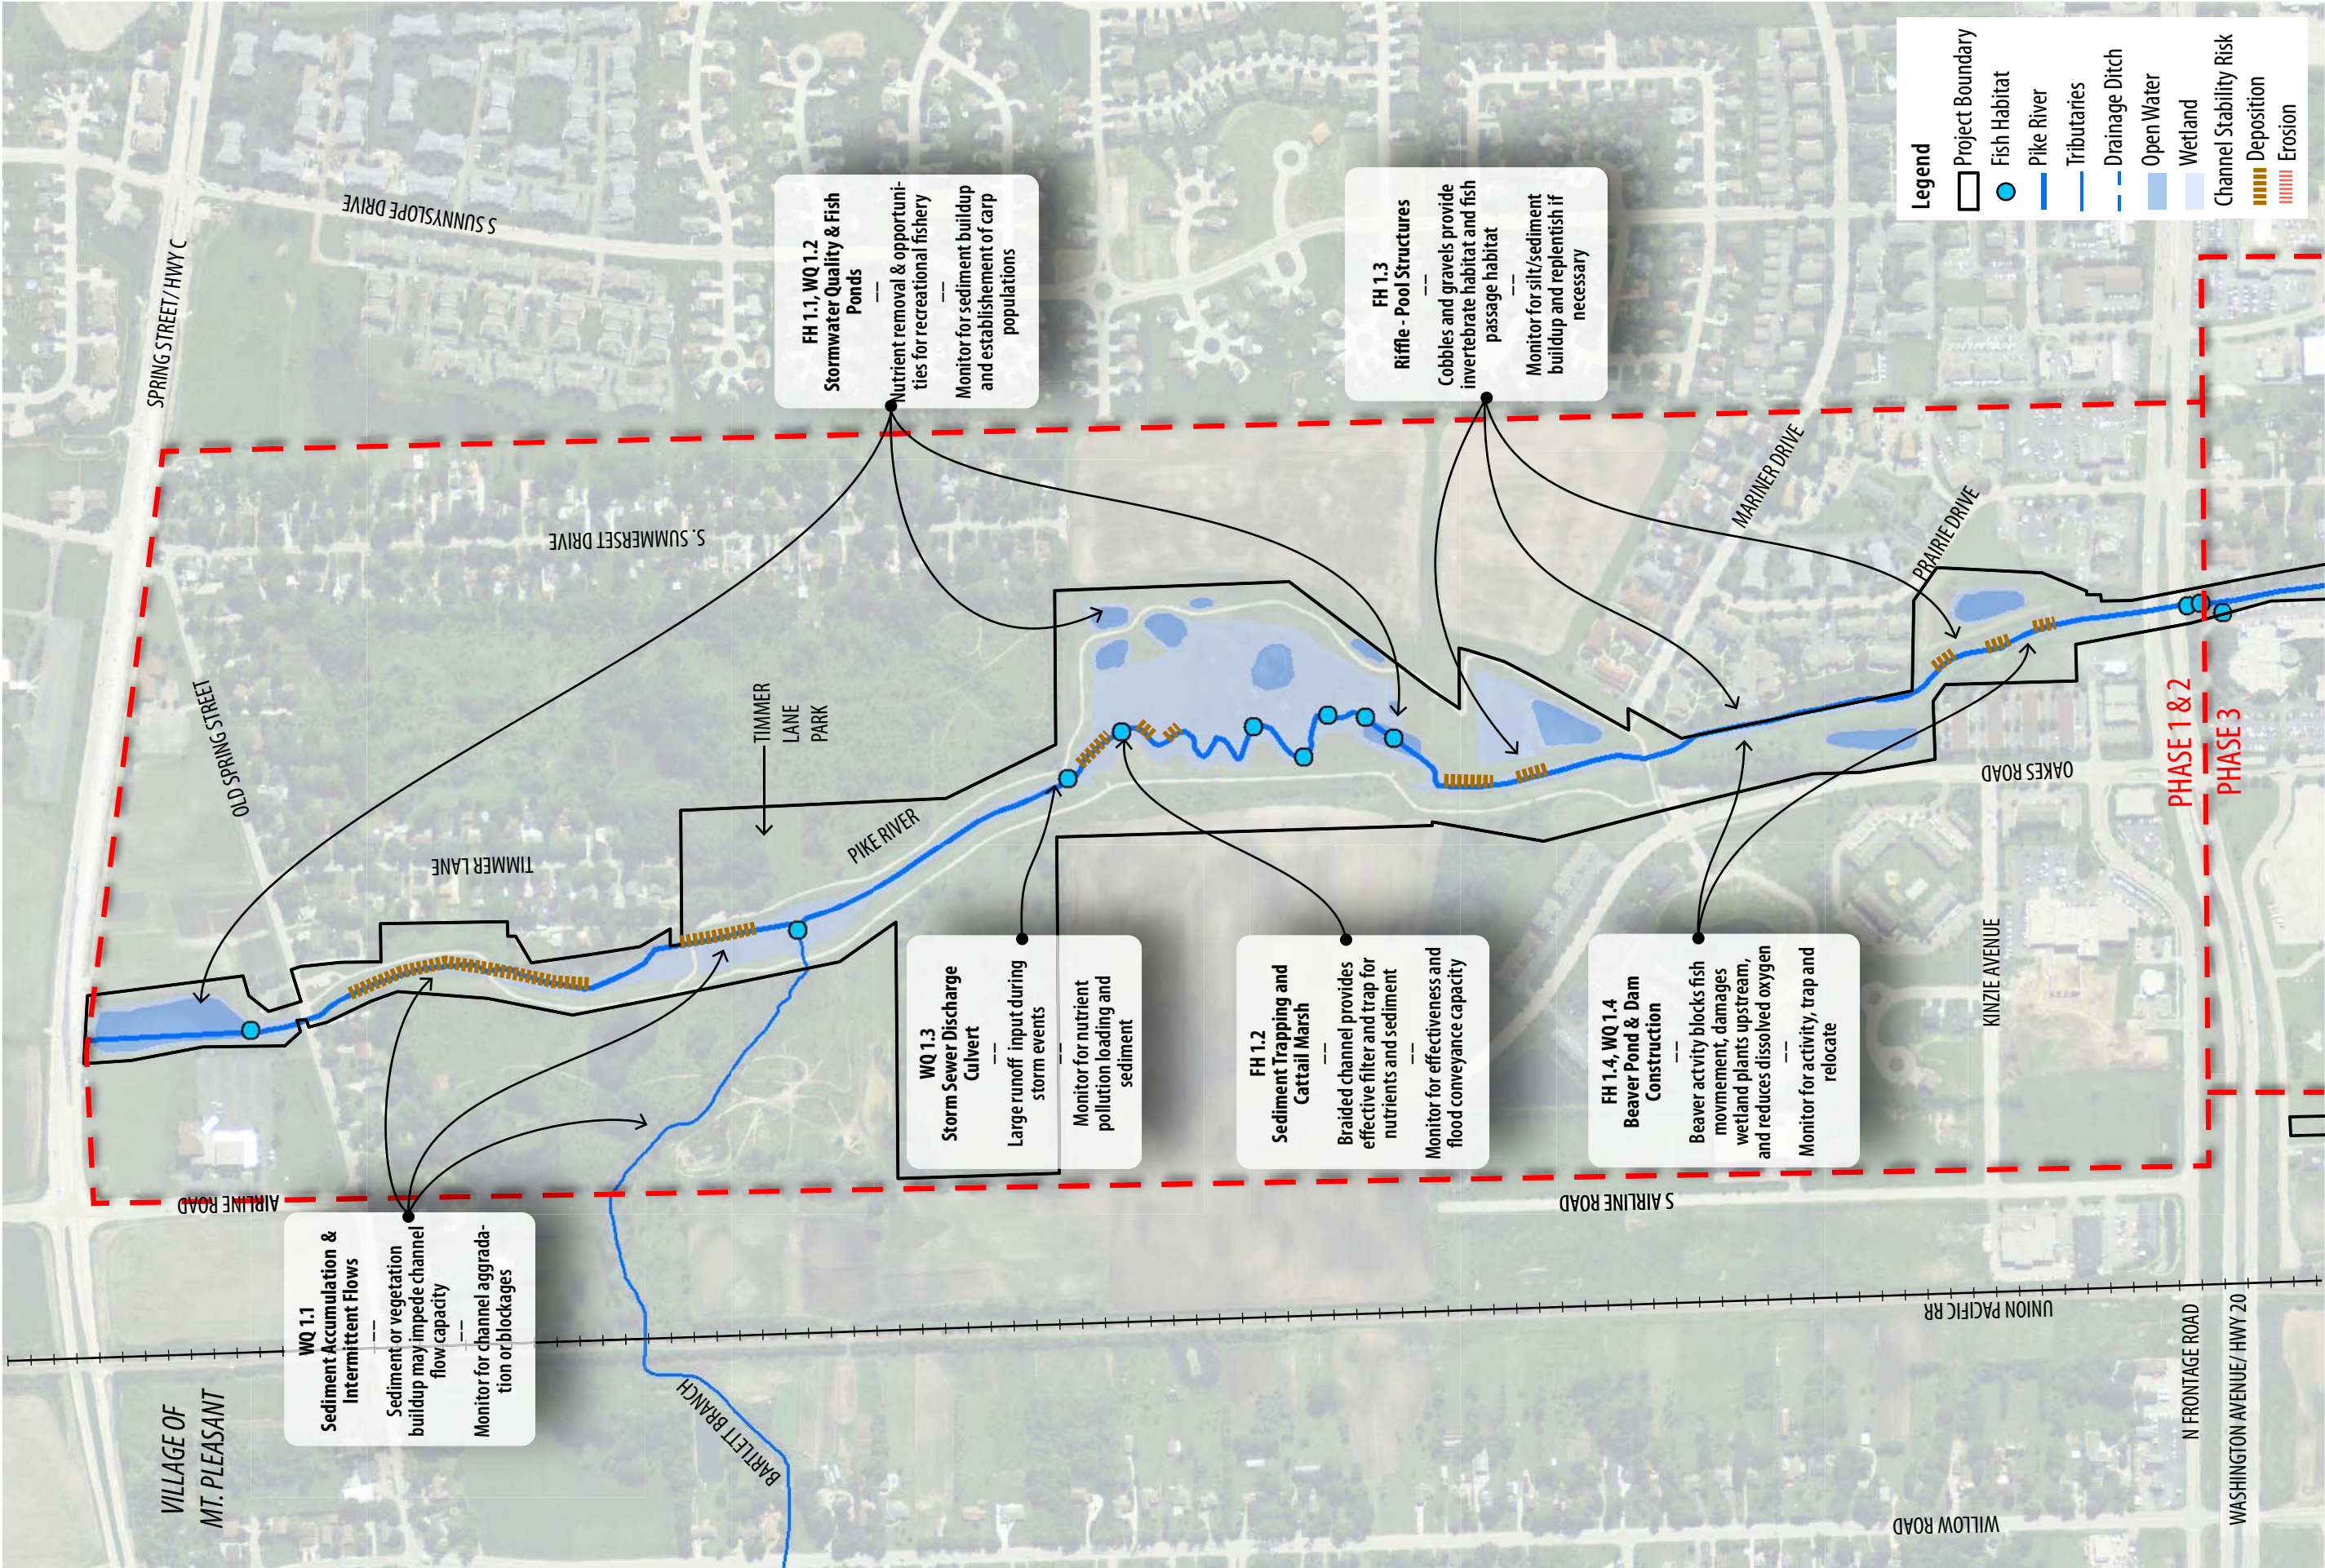
Fish Habitat Phase 1 & 2

- Oakes Road culvert blockage of bed-load sediment will result in continued bed and bank erosion problems downstream until the culverts are replaced with proper placement or by a clear-span bridge
- Oakes Road culvert blocks upstream fish passage and prevents full potential of upstream fish community

- Placement of brush bundles in the reach upstream of Oakes Road can promote channel meandering and habitat enhancement
- Periodic addition of small gravels and course sands downstream of Oakes Road can enhance habitat and bed stability
- Replacement of culverts at Oakes Road with a clear span bridge will improve fish passage and streambed stability

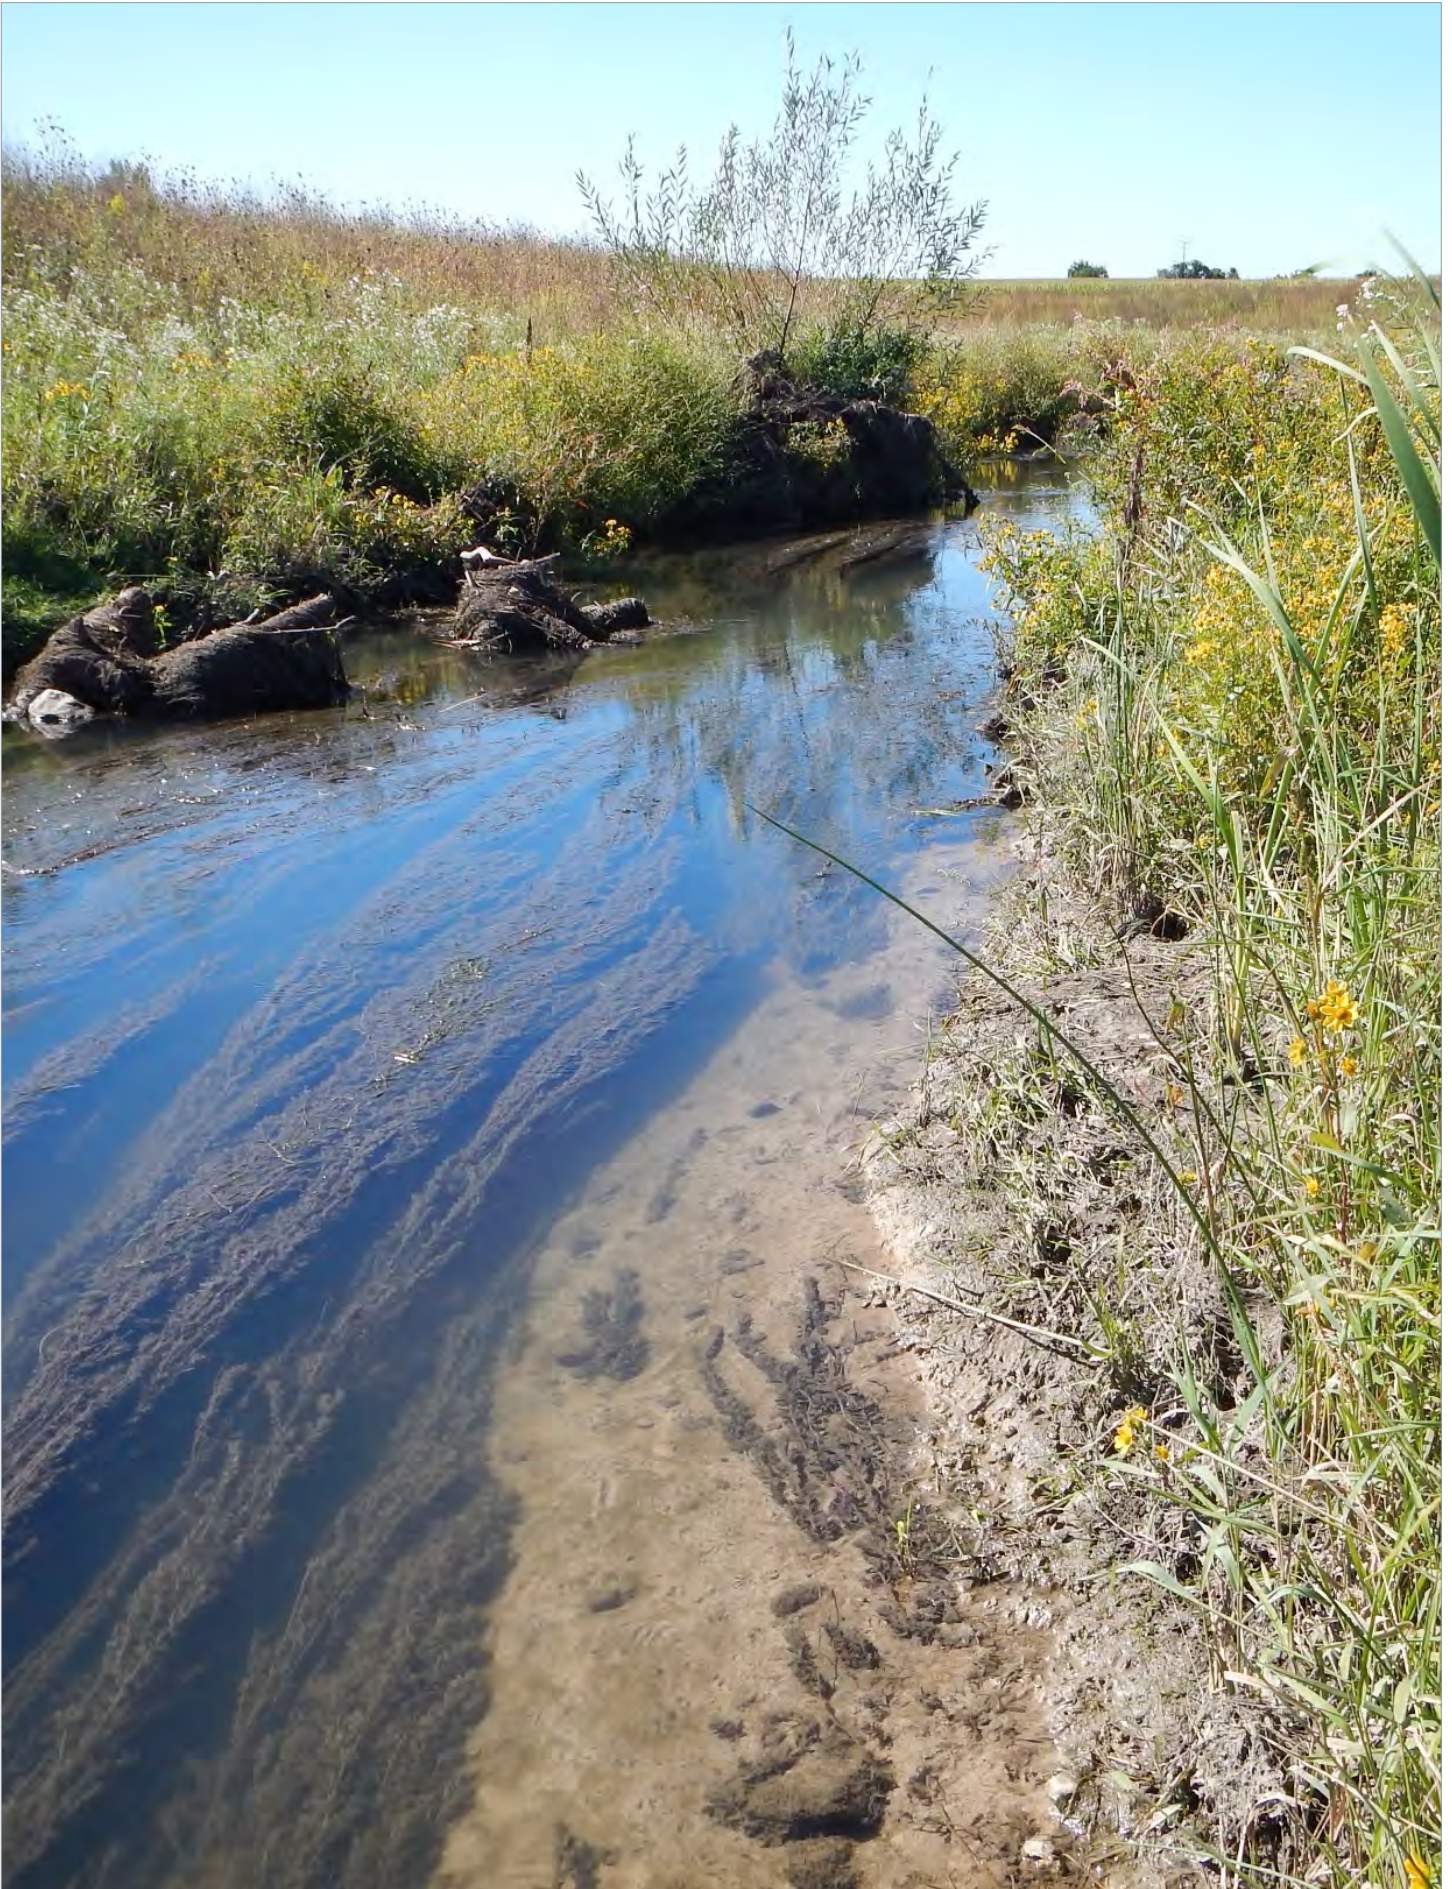
Phase 6 stream, in stream habitat structures on left of photo, bare banks on right side of photo. Photo by A. Thompson 2014
