Building Inspection Report

123 Client Address, Calgary, AB

Report Number:
12090408

Report Overview

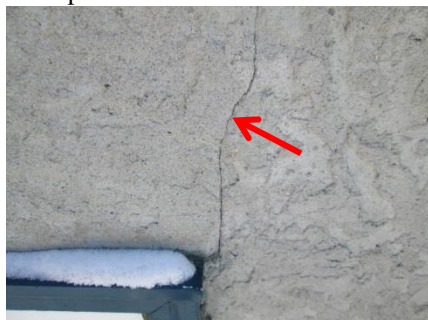
Examples of locations to monitor:

- **Monitor:** Typical foundation cracks were noted on the exterior. They appear to be stable. However, at this time it cannot be determined if future movement or leakage will occur. Recommend monitoring all cracks and repair if necessary. Please refer to the lot grading and surface water control comments in the exterior section of the report for related information. If repairs are necessary, illustrations below show different ways cracks can be sealed.

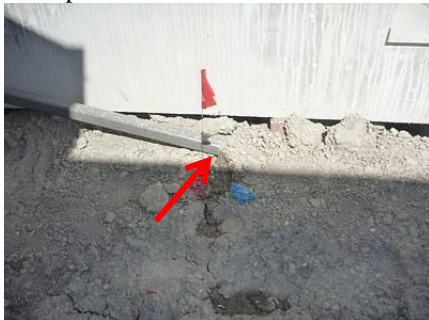
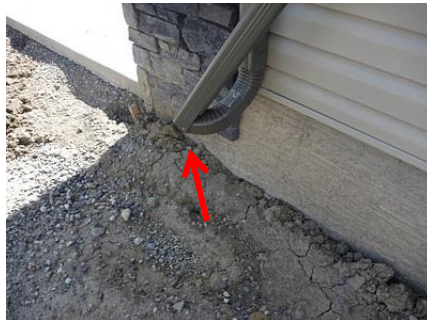
Examples of locations that need to be repaired:

- **Repair:** The downspout(s) should discharge water at least five (5) feet from the house. Storm water should be encouraged to flow away from the building at the point of discharge.

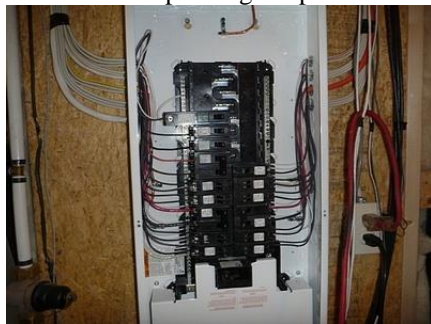
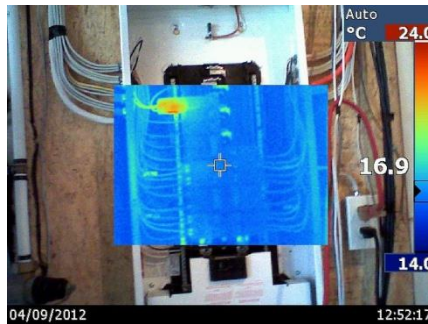
A thermal and visual inspection of the electrical panel found it to be in good order. The temperatures do not appear to be out of the normal operating temperatures.

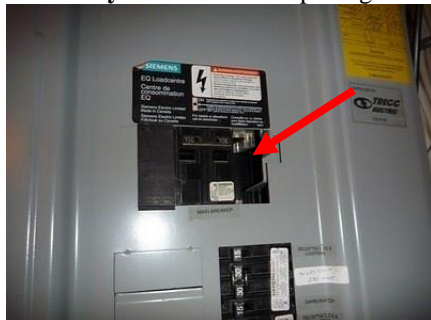
- **Safety Concern:** An opening in the panel next to the main breaker should be sealed to prevent possible electrocution.

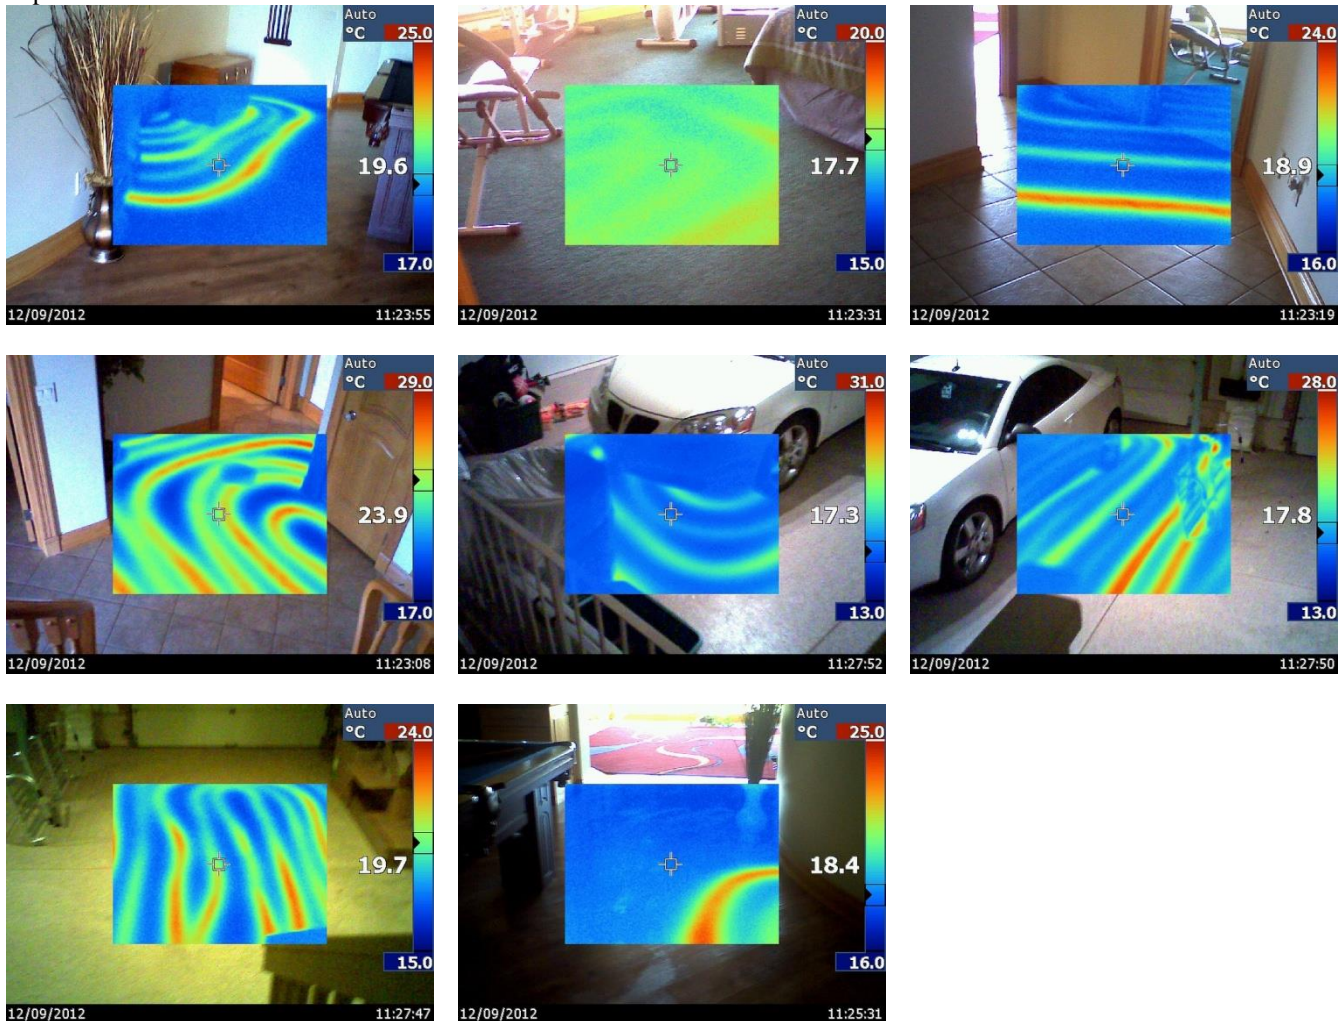
Thermal images of the in-floor heating system indicated that the system appeared to be in good order at the time of the inspection.

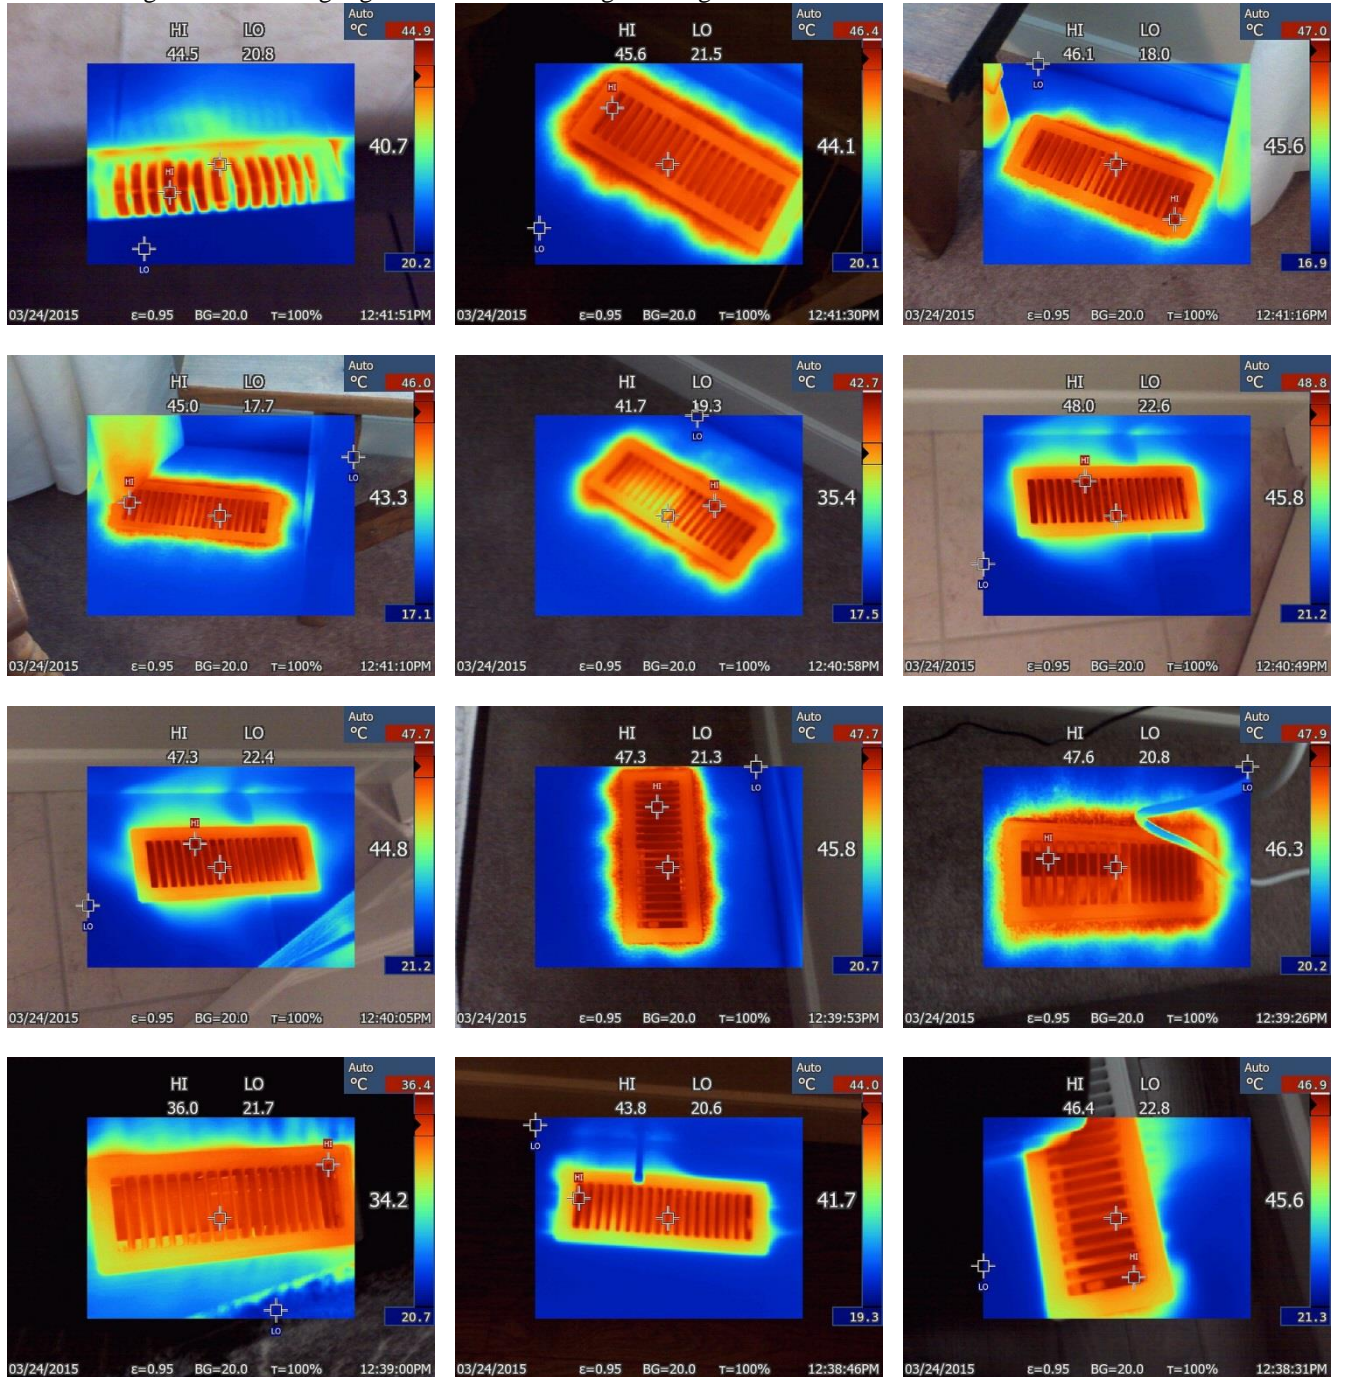
Thermal images of the heating registers found heat being discharged at these locations:

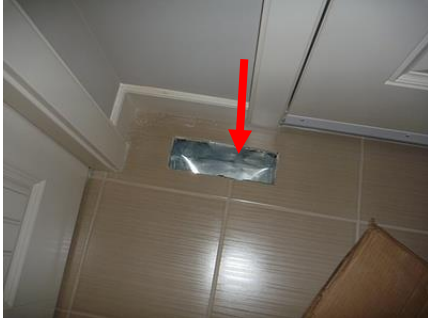
Next to garage man door

- **Repair:** Missing registers should be replaced. Registers help disperse the air in the room.

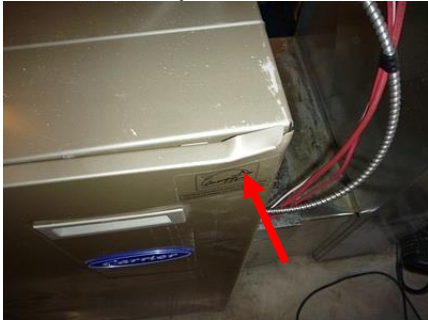
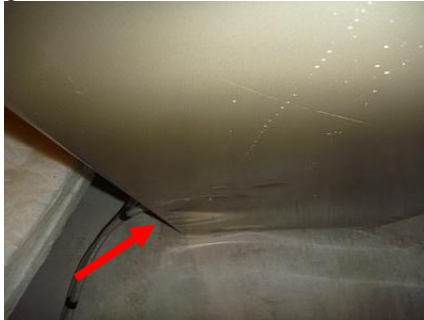
- **Repair:** The furnace cabinet and front panel is damaged in several locations. Although this does not affect the functionality of the furnace, the damage is noticeable.

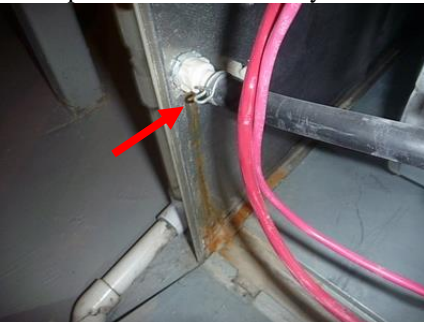
Furnace

- **Monitor:** Rust and corrosion was noted in the furnace. This situation should be checked by a heating specialist and repairs made as necessary.

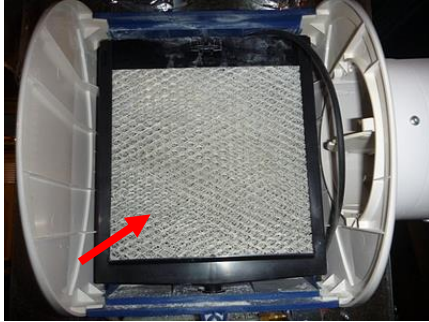
- **Repair:** The humidifier has lacked maintenance. Cleaning and repairs should be undertaken. Watch out for humidifier leaks into the furnace where costly (and hidden) damage can occur.

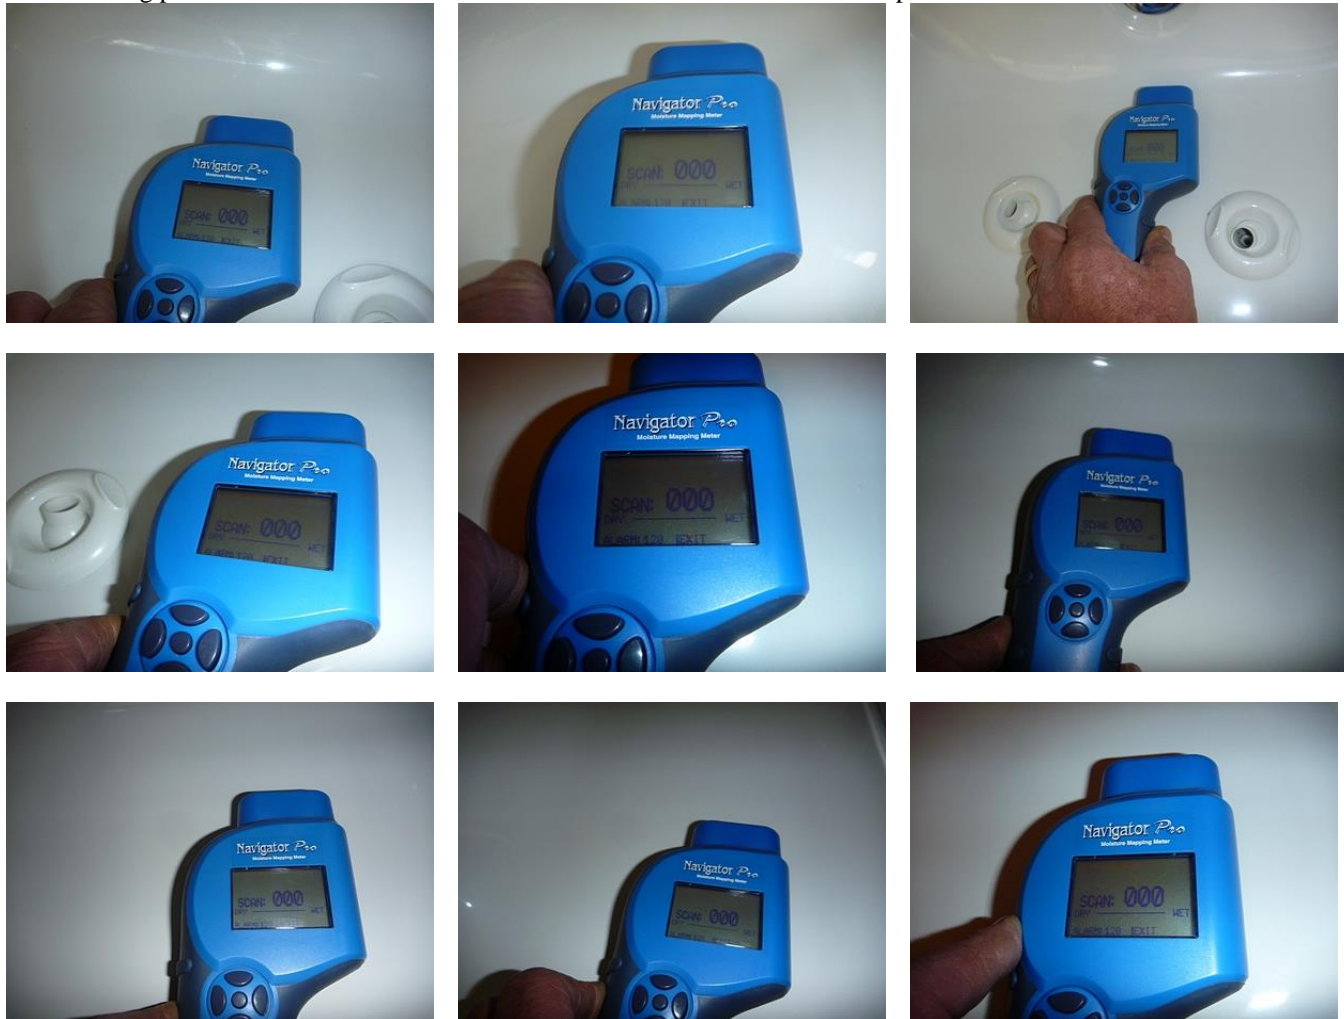
The following photos are of moisture meter tests in these areas at the time of the inspection:

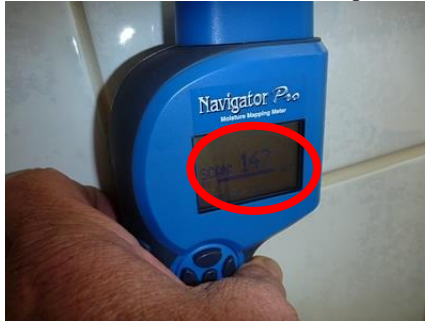
- **Monitor:** Moisture meter readings were high around the bench in the main bathroom shower stall. This may be due to the density of the material used for the base of the bench. There were no visible signs of excessive moisture or water damage at the time of the inspection. This should be monitored and repaired if necessary.

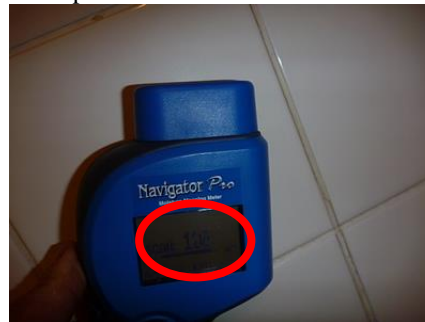
High moisture readings

- **Major Concern:** Moisture meter test of the walls around the basement shower found excessive moisture on the back wall towards the front of the stall. The inspector also found that the wall was soft to the touch. Water stains on the back side of the drywall were also noted from the furnace room. There may be hidden damage behind the tiles. This condition should be examined further and repaired.

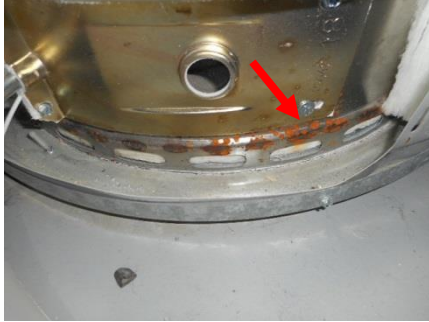
- **Monitor:** A slight amount of rust was noted on the exterior of the holding tank of the hot water heater. The rust may be from condensation on the exterior of the tank. This should be monitored and repaired if necessary.
