# PROPERTY CONDITION ASSESSMENT

1234 Main Street

January 2, 2017

RE: 1234 Main Street  
Des Plaines, IL 60000

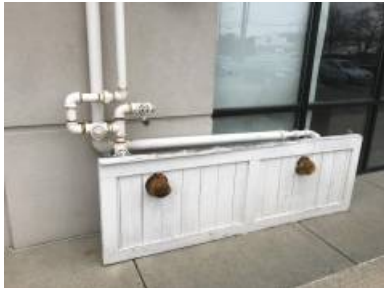
**Gas Service**

Gas meter and shutoff is located in the front of building.

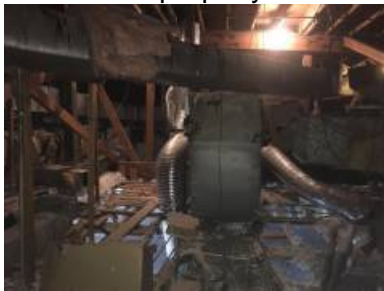
#### Attic Spaces

Attic spaces are heavily obstructed with air ducts, framing and other construction components which make it difficult to properly evaluate, however, this is normal and to be expected.

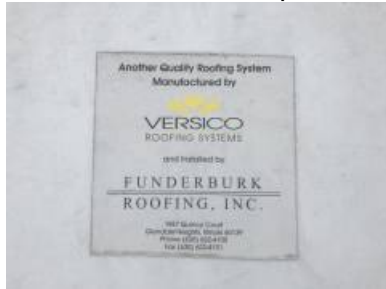
### Roofing Materials

This section of the report is concerning the roofing materials by Versico.

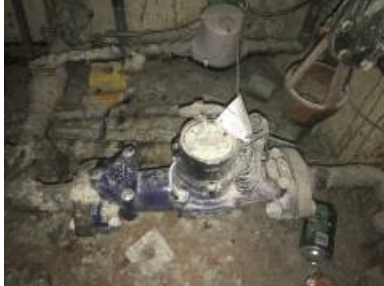
### Supply Piping System

The majority of the visible supply line piping is copper. Unable to fully evaluate the supply line plumbing system as the water was turned off on the day of inspection.

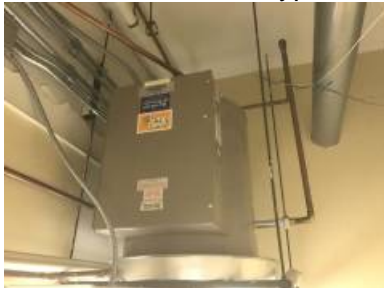
### Type of Water Heating Systems

None, in the unfinished section. Bank has Hot water for domestic use is supplied by various small, electric, on-demand type water heaters located throughout the structure(s).

Water heater was found in good working condition.

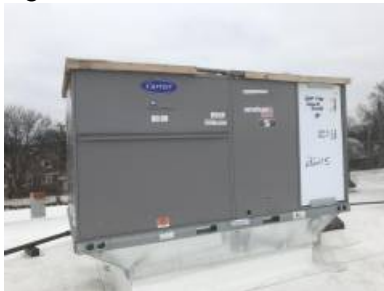
The type of system is roof top unit forced air.

Age 05/14

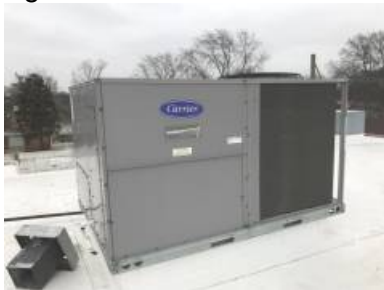
### Heating Unit #2

Located at the roof.

The type of system is roof top unit forced air.

Age 01/11.

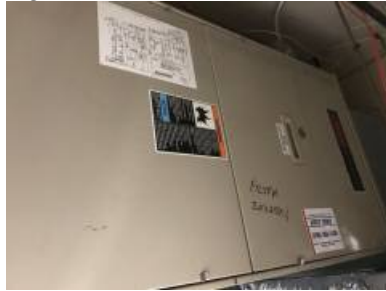
**Heating Unit #3**

Located at the bank side ceiling of lady room.

Good condition.

Age 1992.

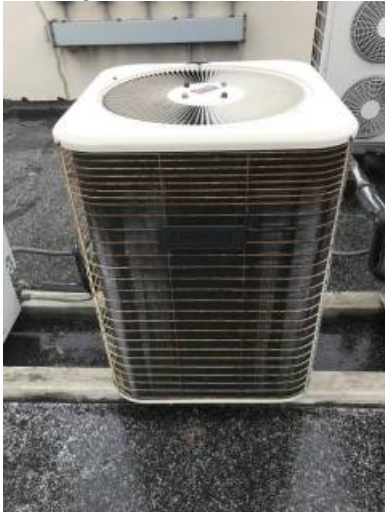
Located on the canopy over the drive up lane.  
Manufactured by LENNOX. Ton 4

The age of this unit appears to be 18-20 Years.

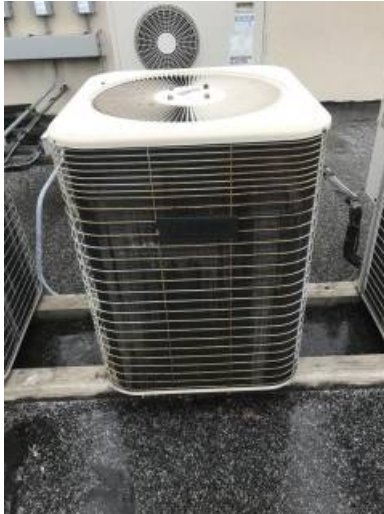
**Cooling Unit #3**

Located on the canopy over the drive up lane.  
Manufactured by LENNOX. Ton 4

The age of this unit appears to be 18-20 Years.

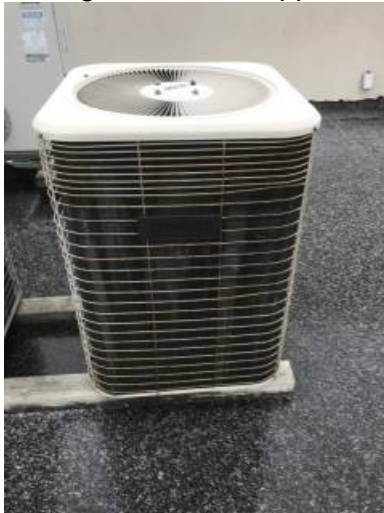
**Cooling Unit #4**

Located on the canopy over the drive up lane.  
Manufactured by LENNOX. Ton 4  
The age of this unit appears to be 18-20 Years.

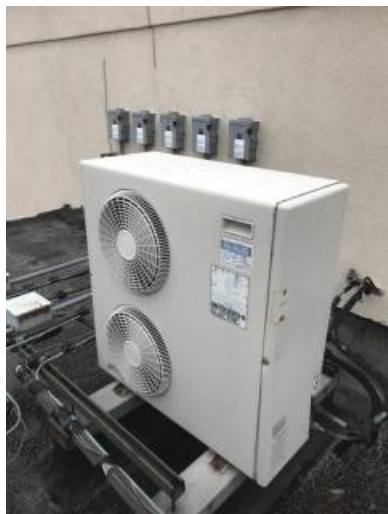
**Cooling Unit #5**

Located on the canopy over the drive up lane.  
There are two Slim PAC units installed.  
Unable to read identification plate.  
Manufactured by Mitsubishi.

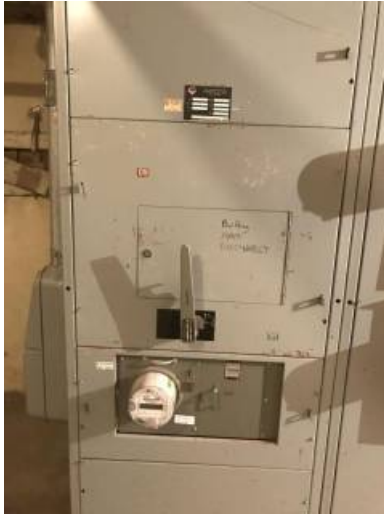
### **Service Disconnect**

The main disconnect is located at the In the electrical room in the 2nd floor on the unfinished side.

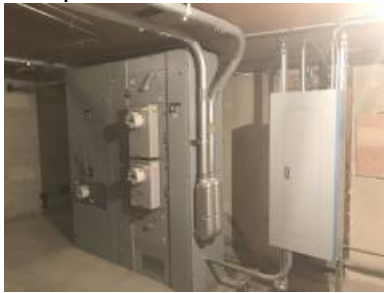
**Panel Types**

The panels and switchboards have been upgraded from the original.

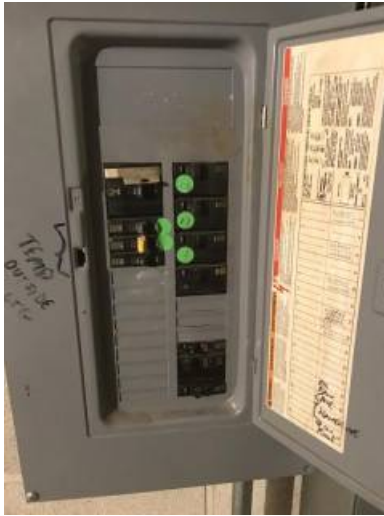
**Panel #1**

Located in electrical room.  
Good condition.

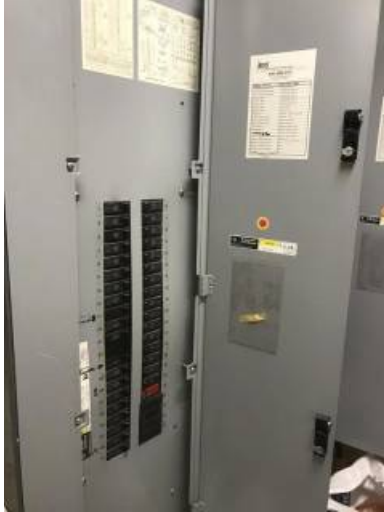
**Panel #5**

*We found the following safety concerns regarding the open electrical trough directly below panel #5*

Located in electrical room on the bank side  
Good condition.

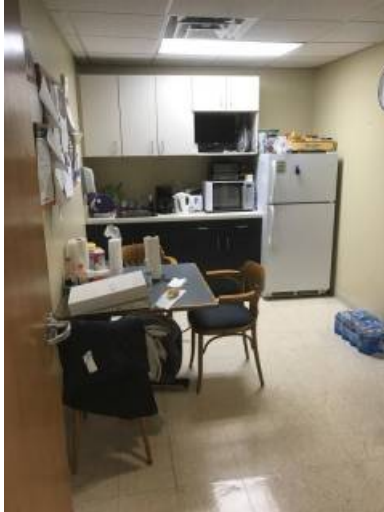
#### Kitchen Appliances

All kitchen appliances were functioning adequately in the apartments we inspected.

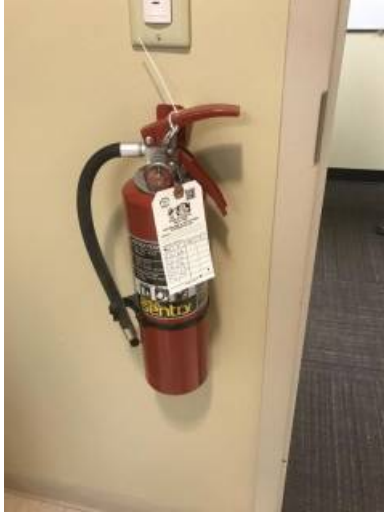
#### Fire Extinguishers

There appear to be an adequate number of fire extinguishers installed for this facility,

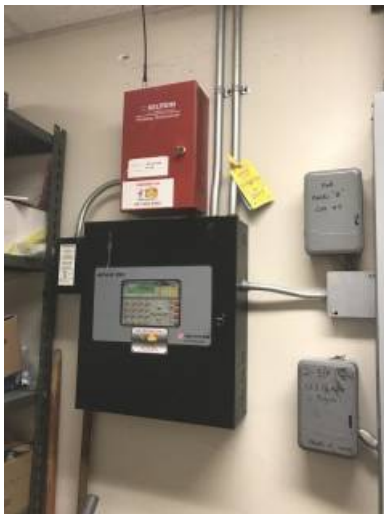
### **Fire Alarm Systems**

A fire alarm system appears to be installed for this structure, however, these are beyond the scope of this assessment.
