Inspection Report

Property Address:
11111 25th Street
Olympia WA 98513

CCS Inspection Services, LLC

Date: 1/30/2017	Time: 11:50 AM	Report ID: 29/01/17
Property: 11111 25th Street Olympia WA 98513	Customer: Client Name	Real Estate Professional:

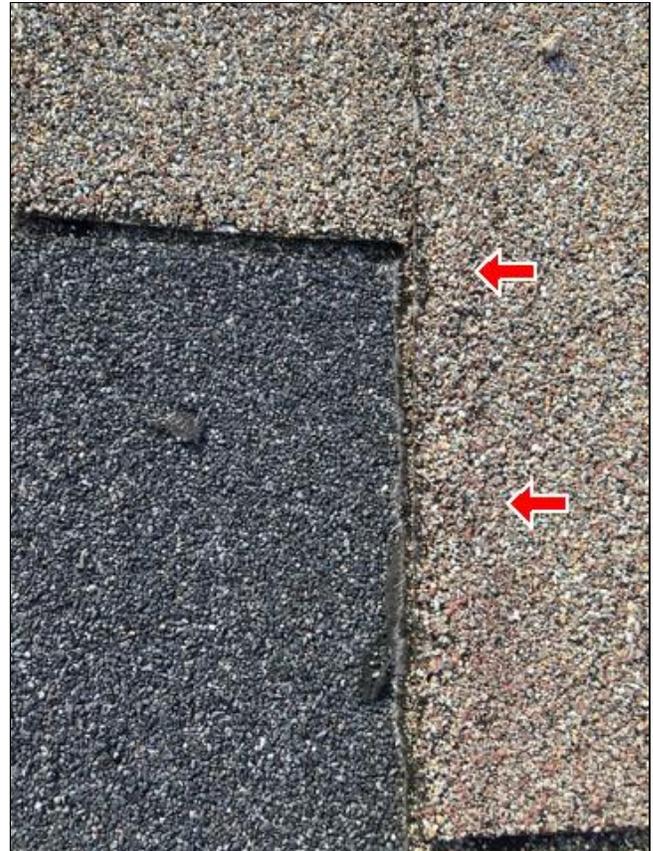
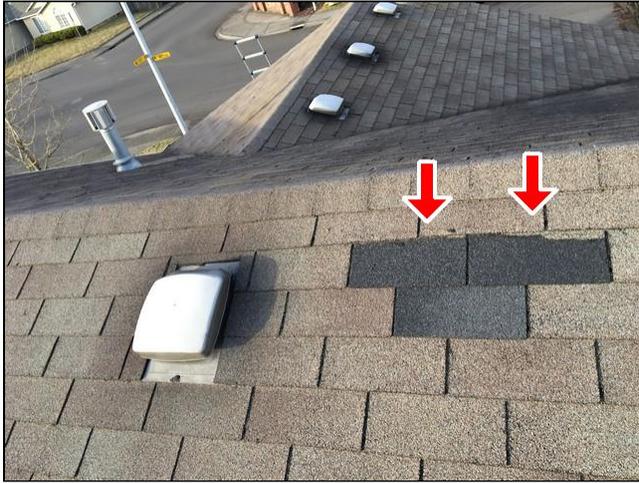
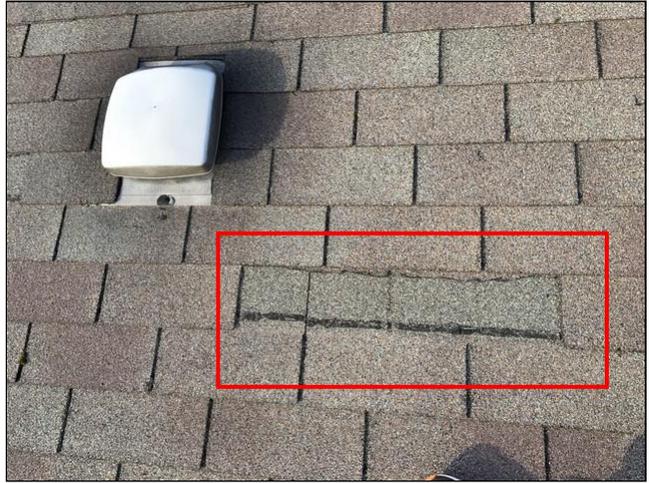
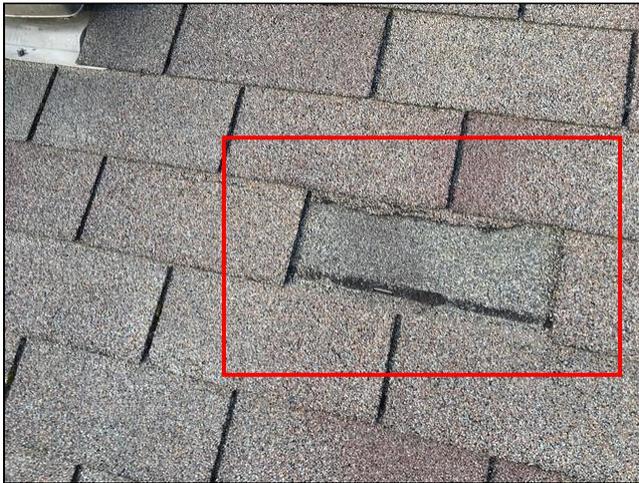
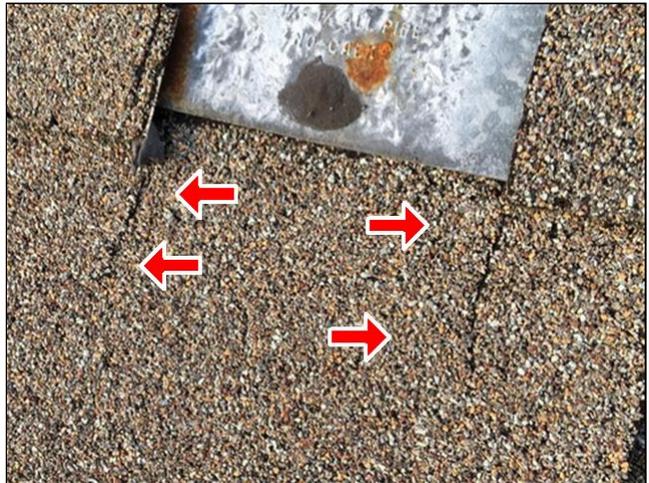
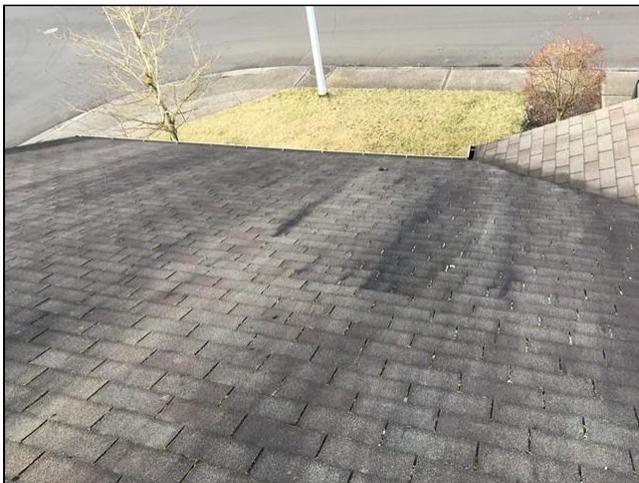
Roof covering is at end of service life . The asphalt shingle roof surface is displaying indicators that the protective roof covering is at or near the end of its service life. The average expected service life of a asphalt shingle roof that has been properly cared for is 20 years. As a result of a review of the roof covering, the overall condition is such that the roof is deemed to be at or beyond its limits of its serviceable life. Extensive indicators of age are noted. Consideration should be given to replacing the roof covering; the timing to ultimate failure of the roof covering in preventing water infiltration is unpredictable. Failing to replace the roof covering may result in damage to the structure and contents of the home.

Asphalt shingles are missing. A missing roof shingle represents a localized reduction in the ability of the roof surface to protect against moisture penetration. Progressive damage may occur to underlying and adjacent shingles. The condition may result in water infiltration to the interior. Missing shingle covering should be immediately repaired. A roofing specialist may be required to perform the repairs.

Asphalt shingle roof is patched. An area of roof covering is observed to have been patched as a result of a previous repair activity. Areas of shingle surface repair are often susceptible to future deterioration. Repairs often involve use of roofing adhesives which are exposed, and are therefore prone to deterioration from ultraviolet rays from the sun. Repaired areas should be closely monitored for indications of degradation that could affect the ability of the roof surface to protect against water infiltration. Extensive repairs may be an indication that the roof is near or past its useful life expectancy, and may be due for replacement.

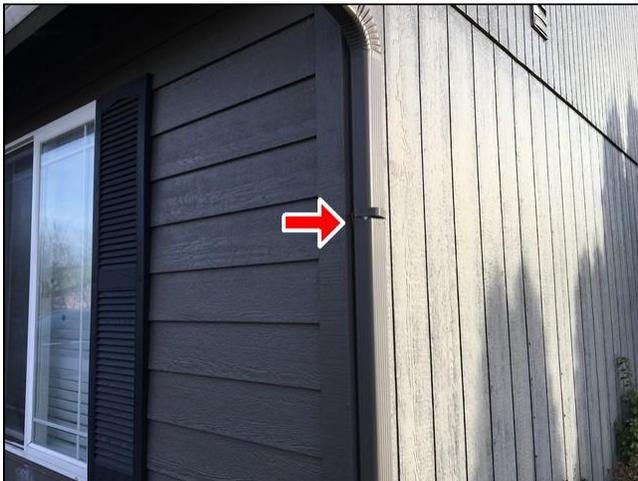
1.3 Item 1(Picture)

Gutter downspout is loose. Loose downspouts will over time become detached. Repairs should be conducted as soon as possible to prevent damage to the downspout. Repair should include properly securing the downspout to the structure and assuring that water freely flows and drains from the downspout

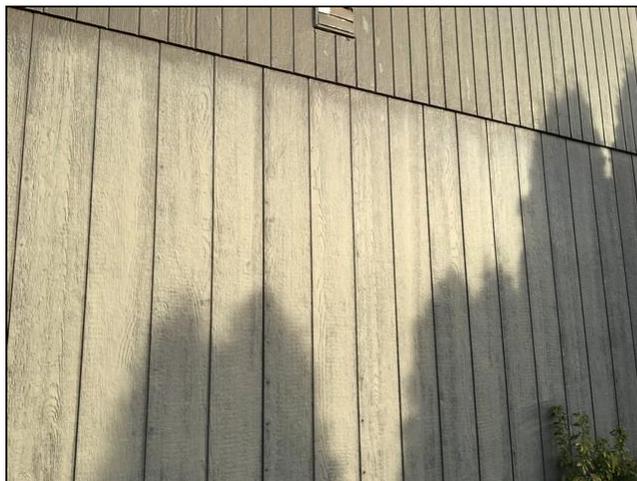
2.0 Item 2(Picture)

(2) **Exterior cladding material (OSB). This material is prone to moisture damage.** Composite wood siding, manufacture with wood chips and glue also called oriented strand board (OSB) siding is prone to swelling and deterioration if caulking and edge paint is not actively maintained .

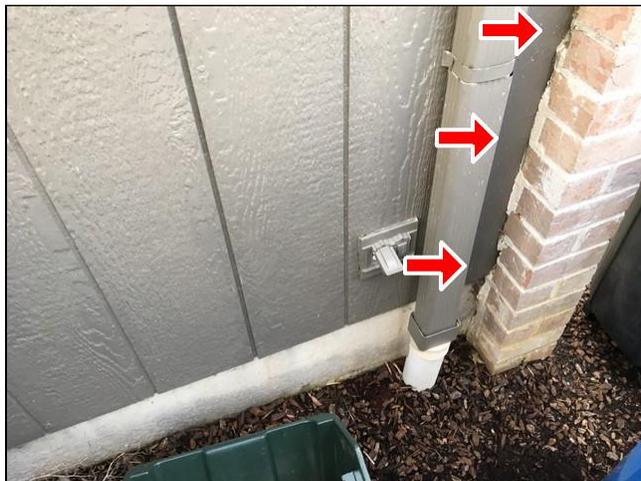
2.0 Item 3(Picture)

(3) **Joints between cladding materials are not properly sealed.** The junction areas between different cladding materials need to be sealed to prevent water, air, and pest infiltration into the home. The usual method of sealing is by caulking the gaps created at the junction areas.

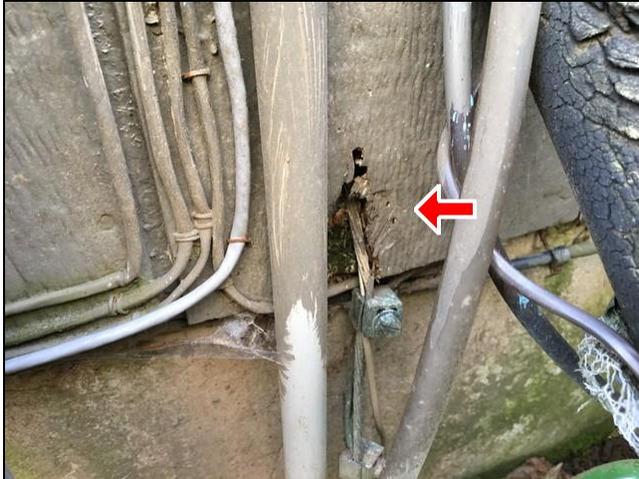
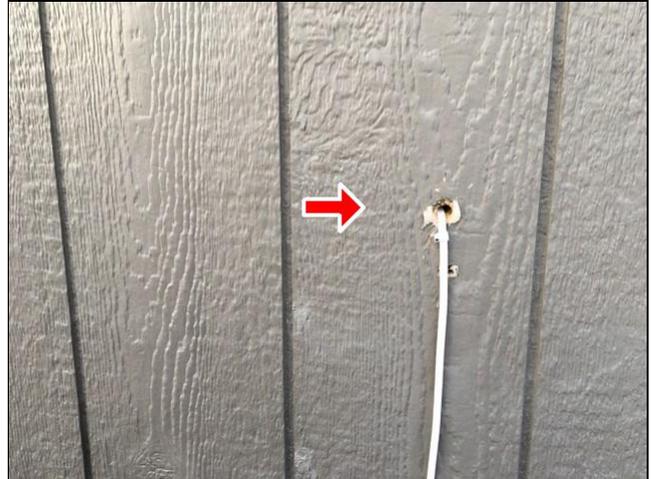
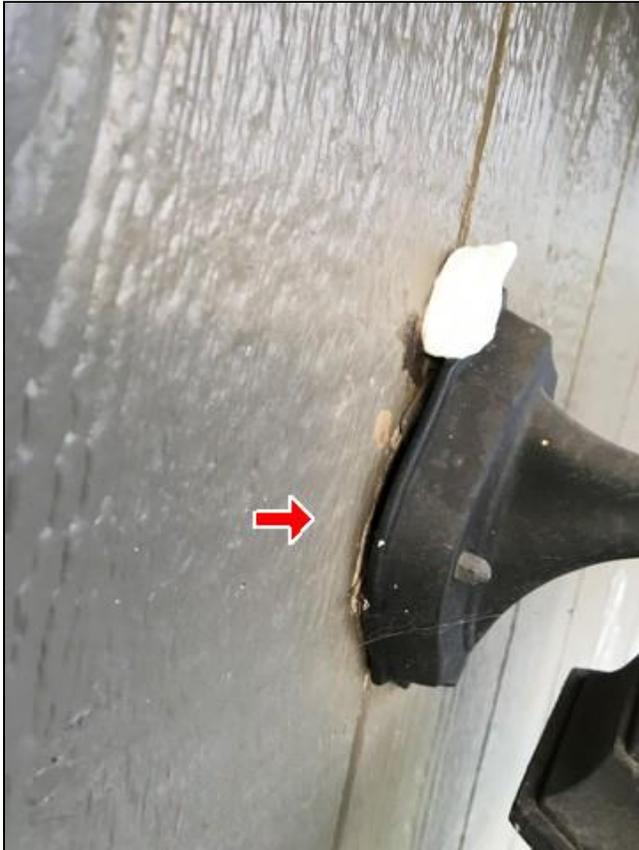
(4) **Hole in the exterior siding is observed.** Unintended water, air or pest infiltration into the house can result in significant damage to surfaces and property, and if not corrected, may lead to damage and rot to structural elements. Unintended air infiltration may affect interior air quality and conditioning. Unintended pest entry can

result in damage to interior finishes and belongings, and in some cases may present health risks. Corrective action is required to seal all openings through the exterior wall system.

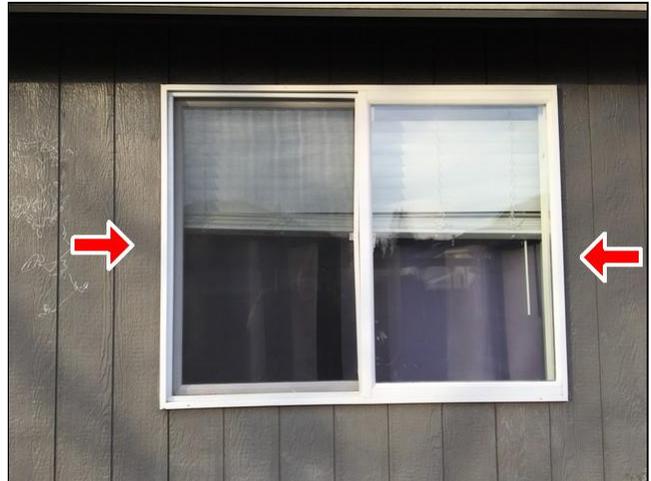
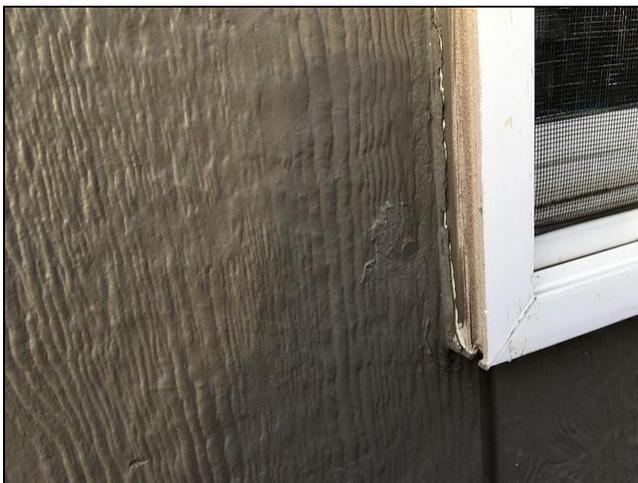
(1) **Windows need caulking at several locations.** Caulking at window frames serves several functions, including preventing air, water, and pest infiltration, and restricting heat loss or gain through the exterior wall. Moisture has the greatest potential for damage; unintended water infiltration into the house can cause significant damage to surfaces and property, and if not corrected, may lead to damage and rot to structural elements. Caulking repairs are required at the noted location(s), and should be performed at the earliest opportunity. Preventative maintenance should include reviewing and repairing exterior caulking at doors, windows, and wall penetrations at least twice a year.

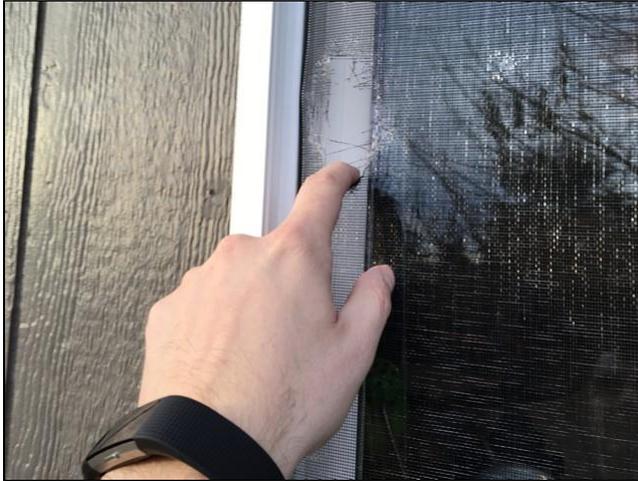
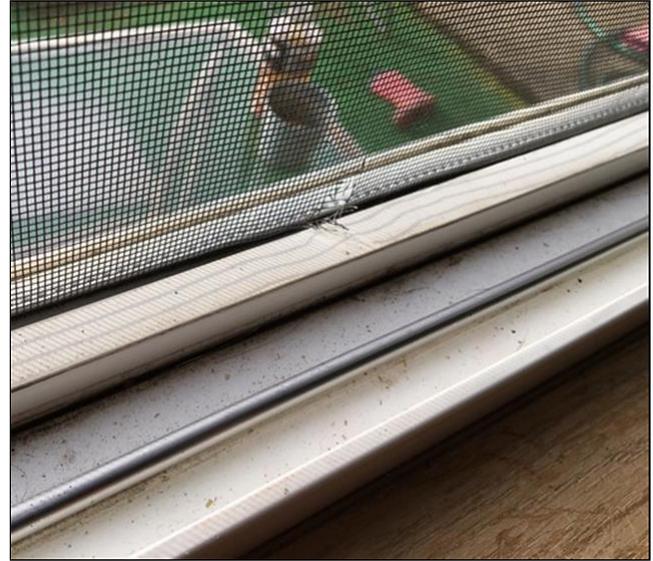
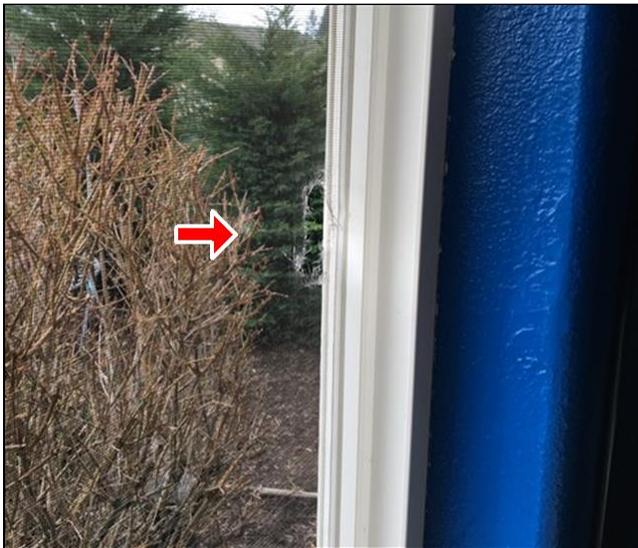
(2) **Window screen damage is observed.** The primary purpose of the screen is to prevent pest entry when the window unit is used for ventilation. A secondary function of the screen is to restrict the ability of children or pets to unintentionally leave the house. Damaged screens will often result in unintended consequences, such as pest entry (insects, birds, rodents, etc.) or unintended "escape" of small children or pets. Although screens can be breached, their presence often restricts small children from leaving the home, and becoming exposed to risks to their safety. Windows are often at sufficient height from the ground that fall hazards should be considered as a primary safety concern. Damaged screens at windows are often considered to be cosmetically detracting.

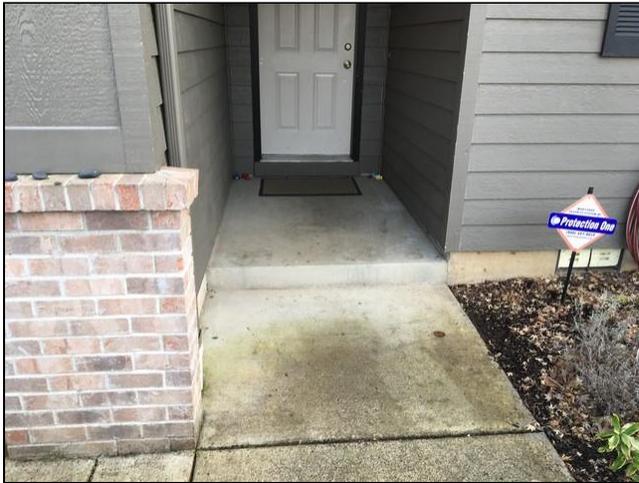
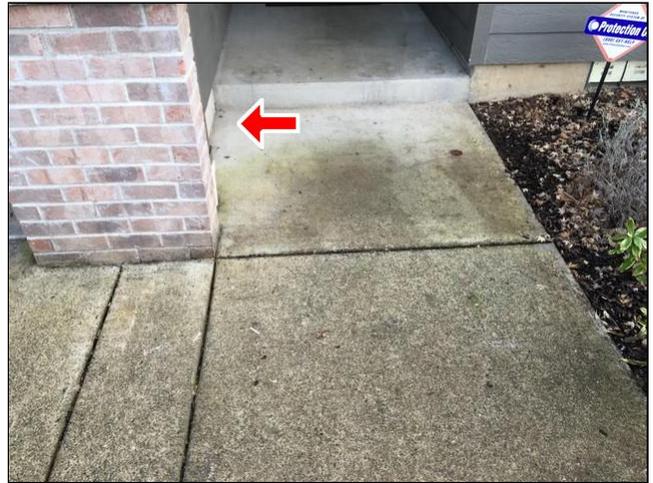
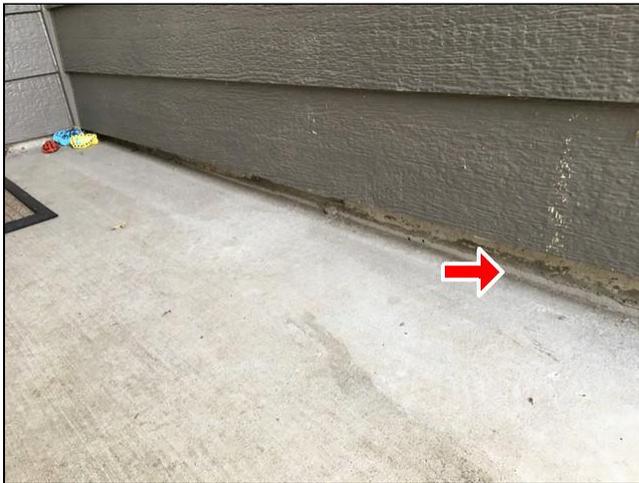
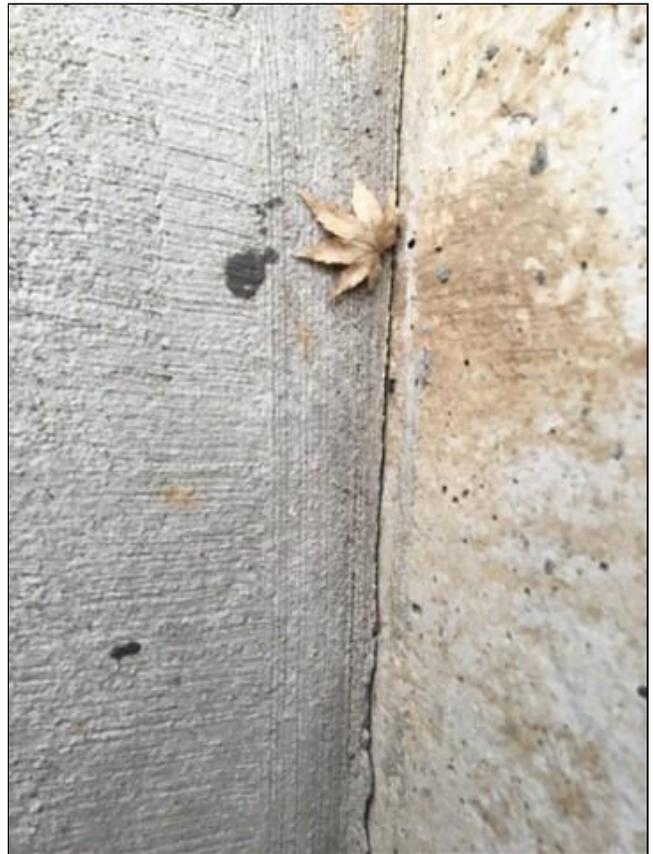
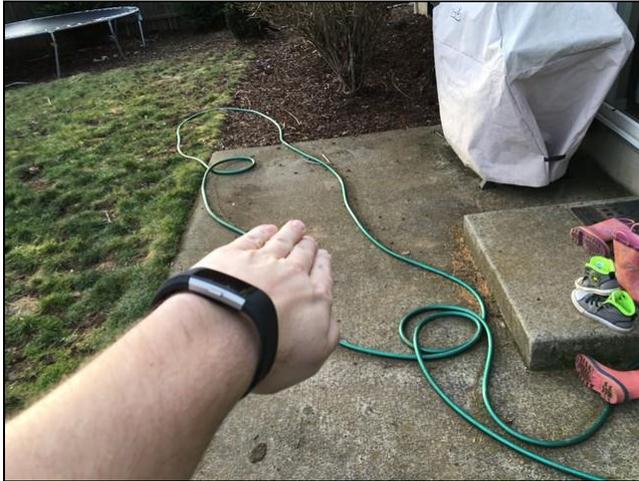
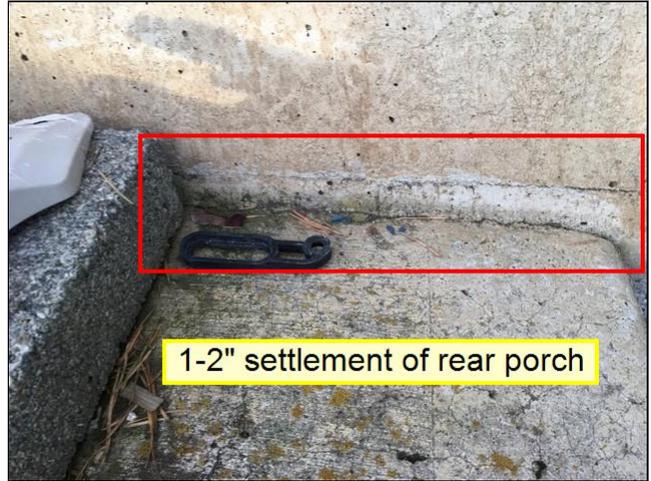
Settlement is observed at the porch. Settlement of the porch is often due to poor grading, soil or compaction issues, and ground heave. This condition may impair drainage. Settlement can result in water ponding on the porch, which will promote further deterioration of the porch over time. Low areas on the porch can result in ice patches in the winter, which pose a slip and fall hazard.

Rear porch has settled to the point that water does not completely shed away from the home.

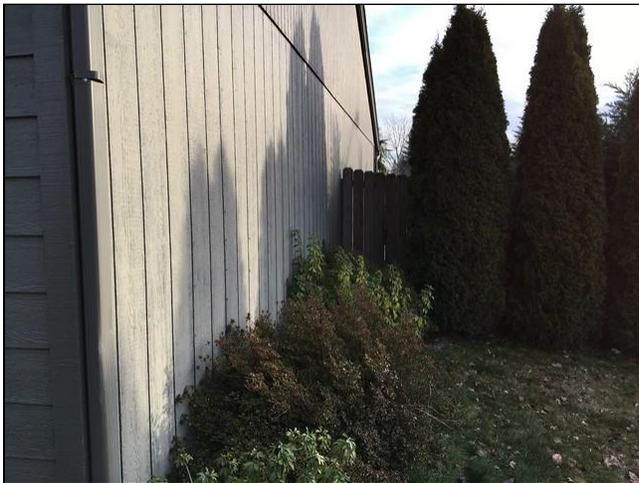
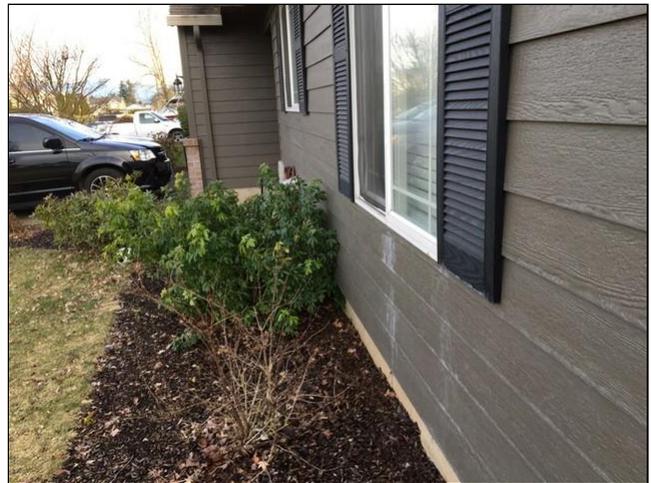
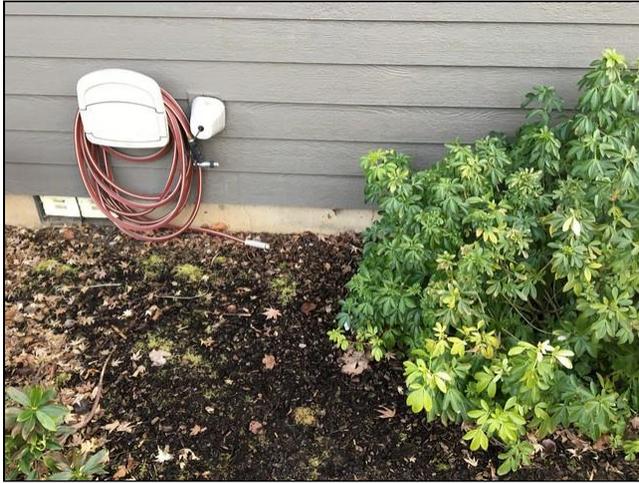
Shrubs are planted to close to house. Shrubs planted close to a house may over time cause detrimental effects to the exterior components of the home. Shrubs tend to hold moisture near the house, and can promote moisture-related problems to the home's exterior finishes, and in some cases, the structure in the areas of contact. Some shrubs have water-seeking roots, which can extend to and clog the home's foundation drainage system. As a guide, the maximum outermost branches of a mature shrub should be no closer than 2 feet from any surface of the home.

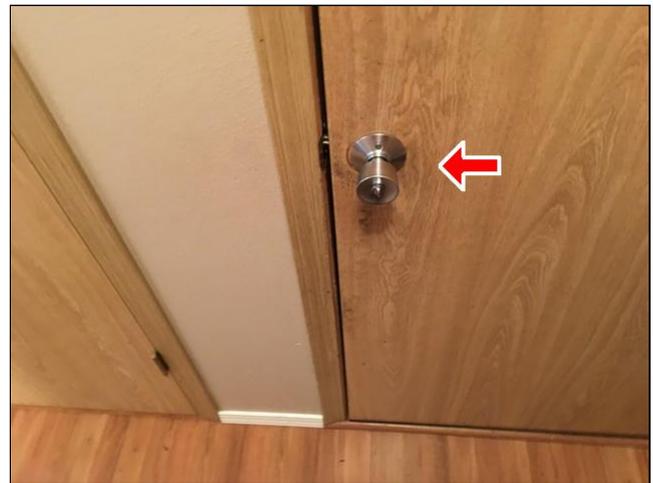
3.2 Item 2(Picture)

Garage occupant door automatic closer is defective or missing. A door closer provided for the door between the home interior and the garage shall be installed in a manner to ensure the door closes and latches in accordance with current industry standards for installation and safety. Doors between a home and an attached garage must be maintained to be gas-proof.

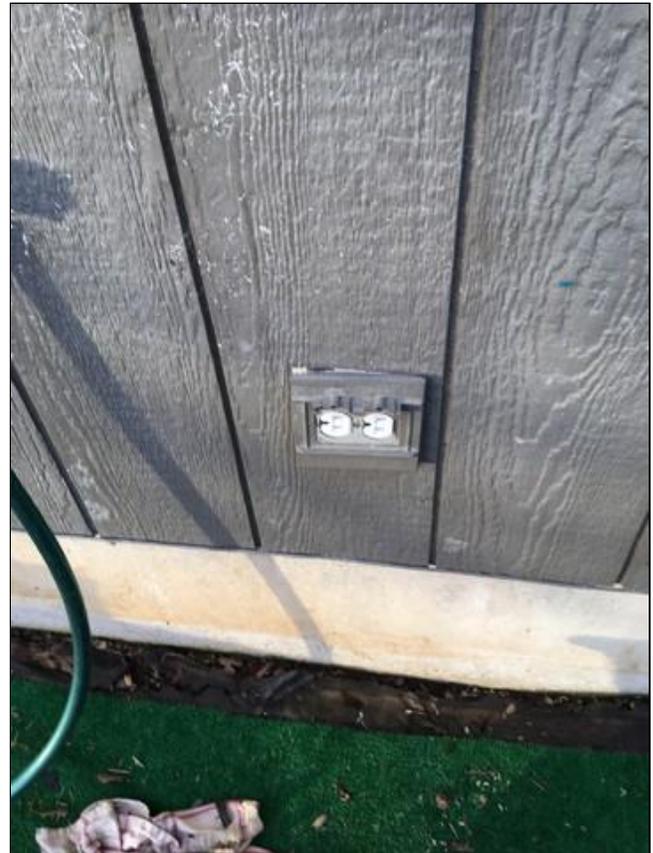
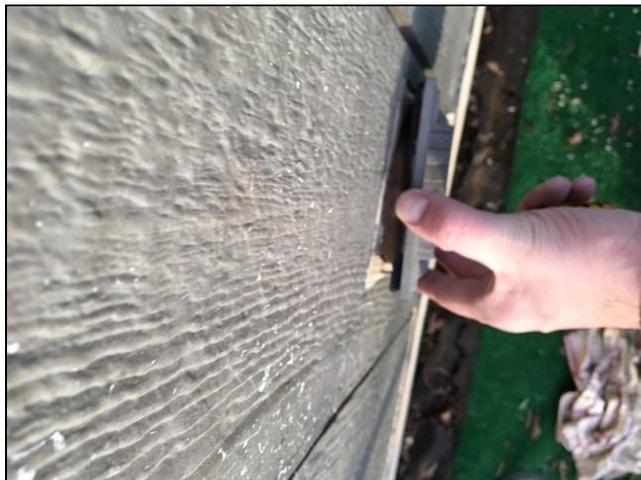
Damaged exterior outlet cover. Electrical outlets installed in outdoor locations require protection from water entry and contaminants. An outlet with a missing or damaged cover, when in an outdoor location, is subject to damage and deterioration if its weathertight protection has been compromised. Receptacles displaying damage or deterioration should be immediately replaced and a suitable cover installed.

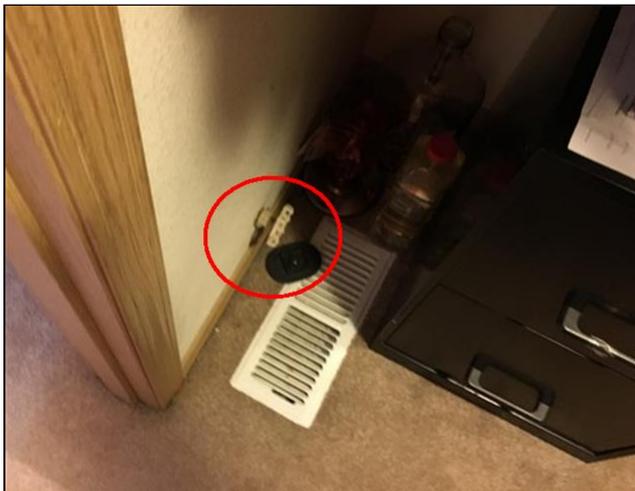
5.3 Item 1(Picture)

The main shut off is located inside the master room closet.

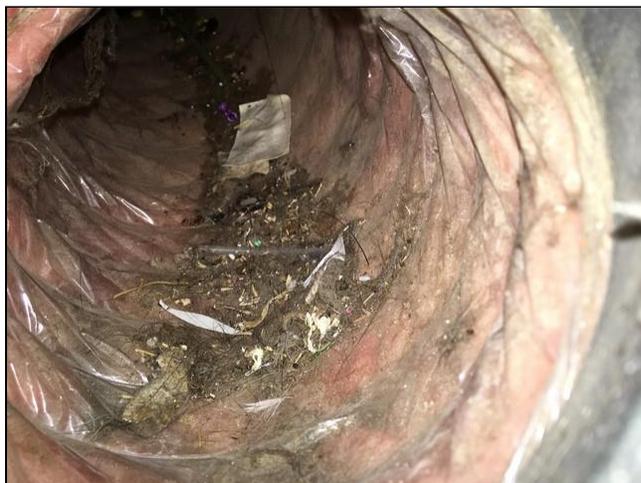
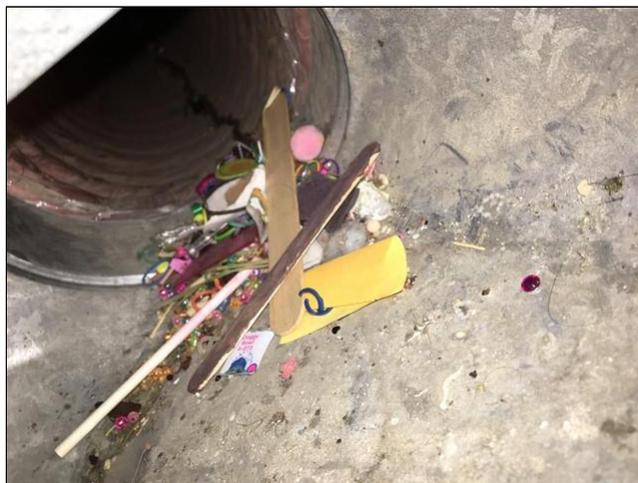
(2) **Heat register boots are full of debris and should be cleaned.** Dirt and debris in the heat registers will emit dust and contaminates in to the air supply. All supply registers should be clean to improve the air quality of the home.

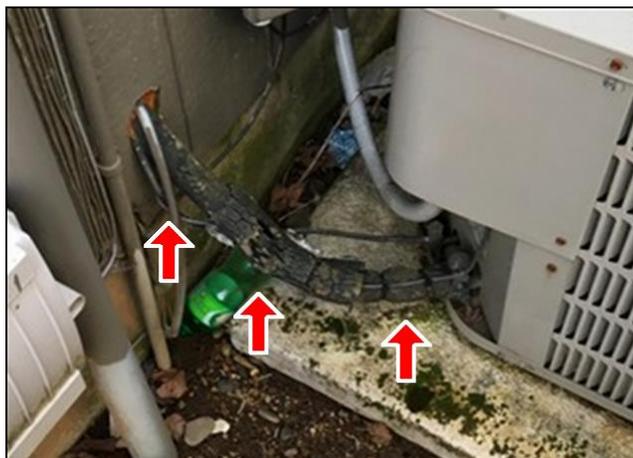
6.8 Item 3(Picture)

(2) The foam sleeve on suction line is damaged at outside unit. Damaged/ Missing foam on suction line can cause energy loss and condensation. I recommend service or repair as needed.

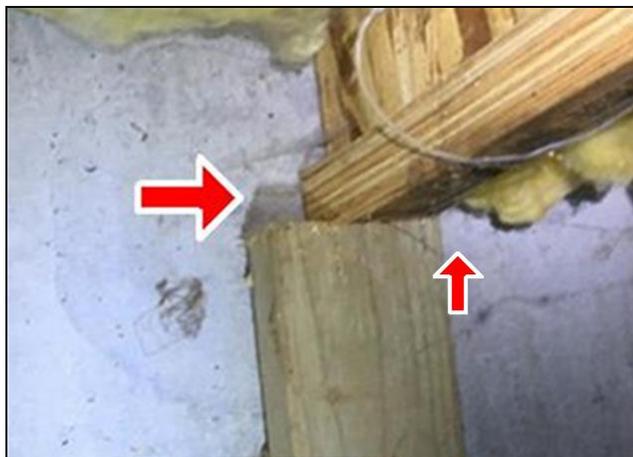
7.3 Item 1(Picture)

Insufficient end support of beams.

Structural beams are crucial to providing proper transfer of floor and wall loads to components such as the foundation, load-bearing walls, and support columns or posts. Typically, beams should have end bearing of about 3-1/2" (90 mm) over its supporting element.

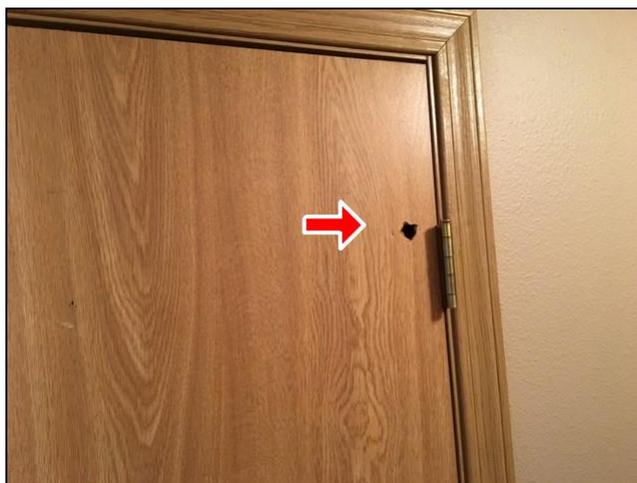
8.3 Item 1(Picture)

Interior door is damaged. A condition of physical damage impairs the appearance of the door. Certain forms of damage may affect the current or future operation of the door.

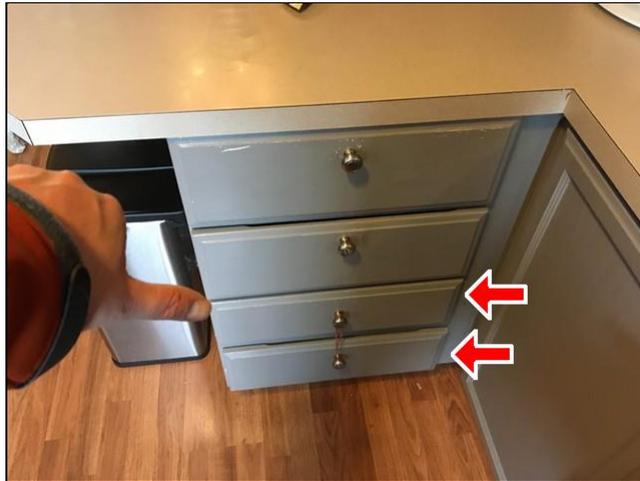
8.7 Item 1(Picture)

Damage to the cabinet is noted. A condition of physical damage impairs the appearance of the cabinet. Certain forms of damage may affect the current and future performance of cabinet doors or drawers.

Cabinet drawers are noted to bind when they are opened and closed. Cabinet drawers that bind are prone to damage. Repair or adjustment to the drawer fit is recommended.

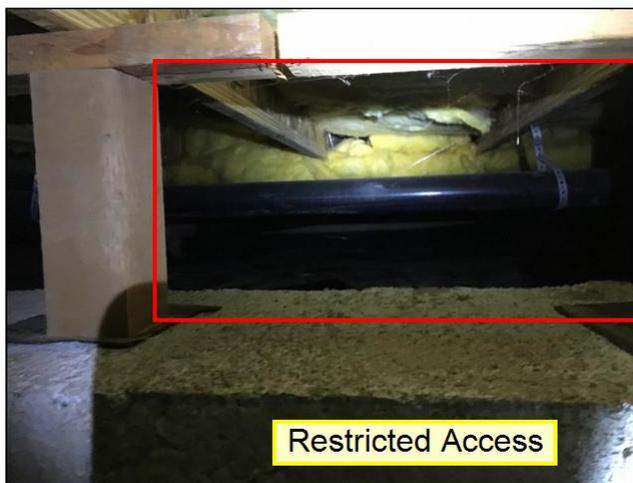
9.3 Item 1(Picture)

(2) **Due to restrictions, I could only reach 2 of the four corners of the crawlspace.**

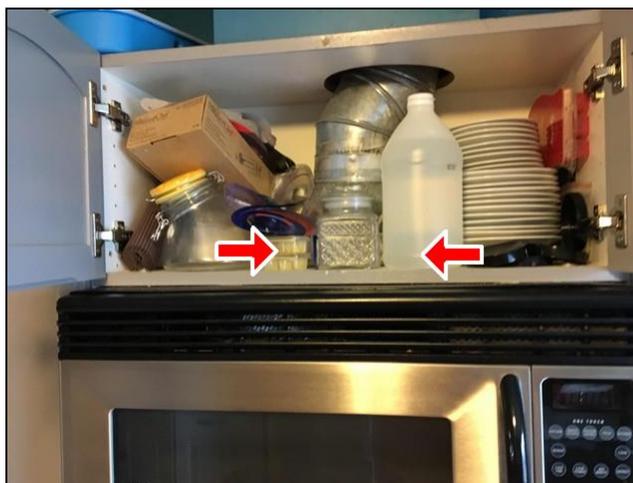
9.5 Item 1(Picture)

(1) Vent above microwave **does not appear to be connected.** When operating the fan on the microwave, air is recirculated into the kitchen instead of through the vent to the exterior of the home.

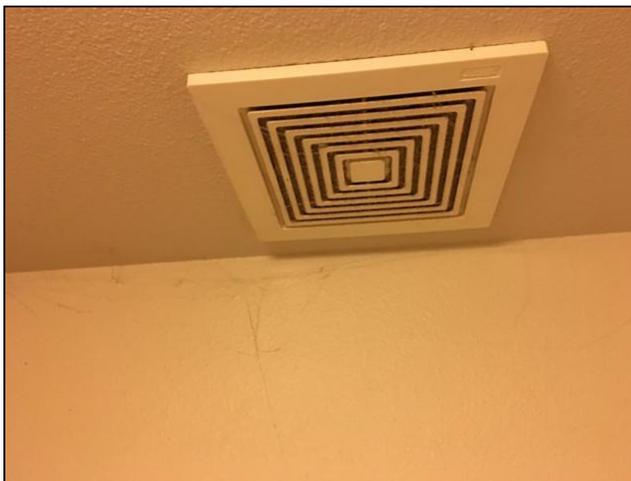
9.5 Item 2(Picture)

(2) **Exhaust fan is noisy.** An exhaust fan appears to be unusually noisy. This may be an indication that the fan is defective or has been incorrectly installed. Failure to correct may lead to premature failure of the fan, and may be an indication that the fan is not operating as intended.

Signs of bacterial growth on the shower ceiling could be caused by the lack of proper ventilation during shower use.

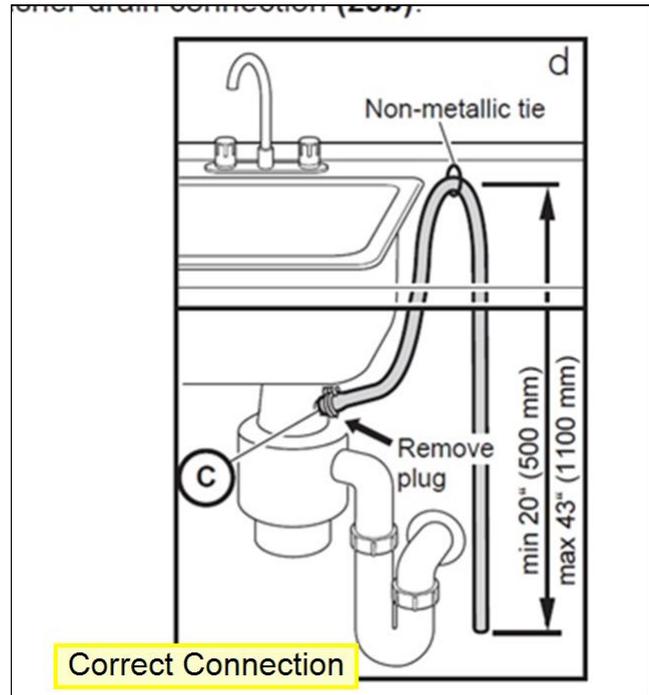
10.0 Item 2(Picture)

The dishwasher washer drain line is not looped to prevent back siphon. The dishwasher is functional but discharges without a mandated anti-siphon valve, which is contrary to the installation instructions, and which also creates a potential drainage problem and a health hazard.

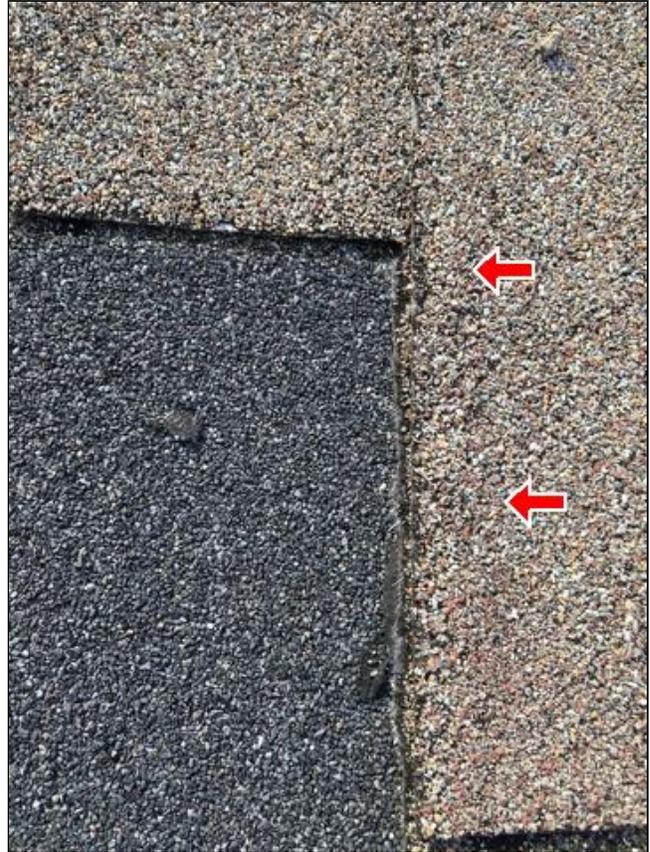
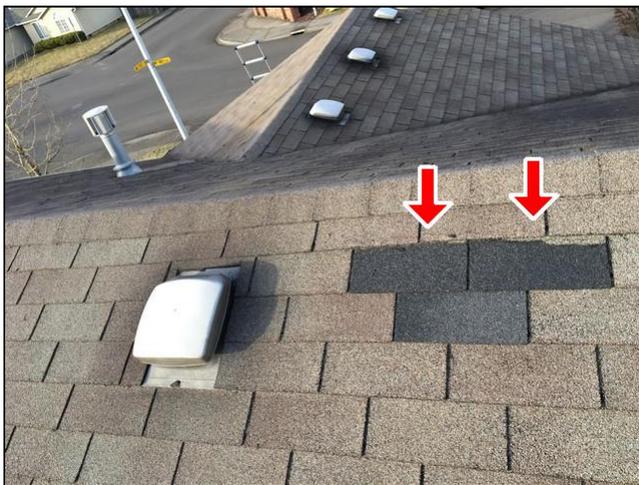
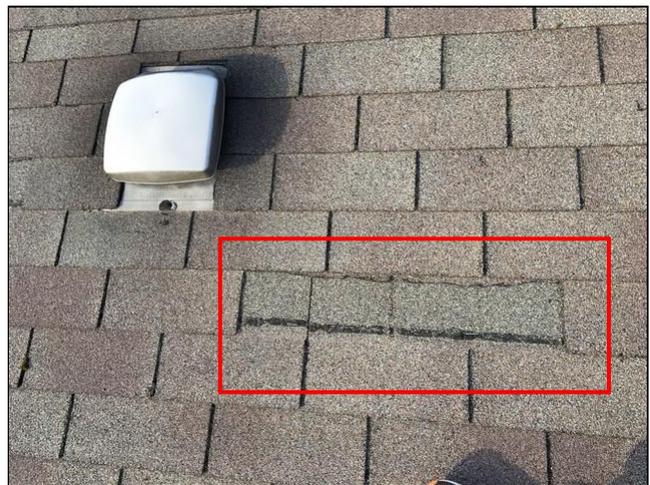
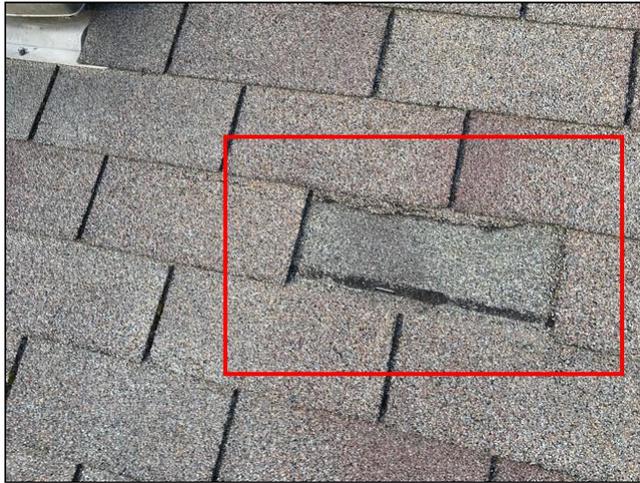
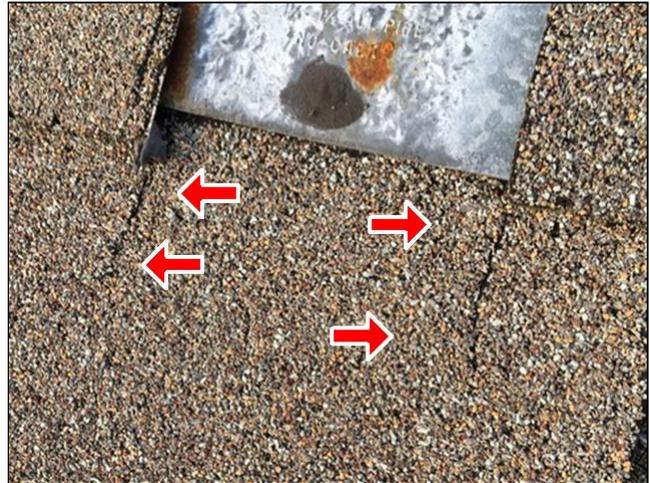
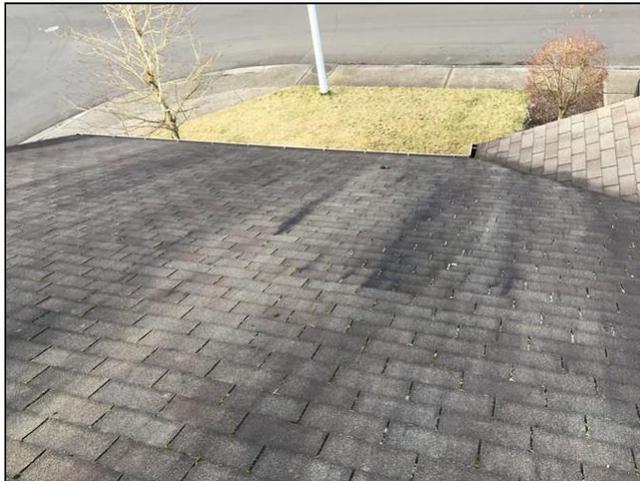
Roof covering is at end of service life. The asphalt shingle roof surface is displaying indicators that the protective roof covering is at or near the end of its service life. The average expected service life of a asphalt shingle roof that has been properly cared for is 20 years. As a result of a review of the roof covering, the overall condition is such that the roof is deemed to be at or beyond its limits of its serviceable life. Extensive indicators of age are noted. Consideration should be given to replacing the roof covering; the timing to ultimate failure of the roof covering in preventing water infiltration is unpredictable. Failing to replace the roof covering may result in damage to the structure and contents of the home.

Asphalt shingles are missing. A missing roof shingle represents a localized reduction in the ability of the roof surface to protect against moisture penetration. Progressive damage may occur to underlying and adjacent shingles.

Asphalt shingle roof is patched. An area of roof covering is observed to have been patched as a result of a previous repair activity. Areas of shingle surface repair are often susceptible to future deterioration. Repairs often involve use of roofing adhesives which are exposed, and are therefore prone to deterioration from ultraviolet rays from the sun. Repaired areas should be closely monitored for indications of degradation that could affect the ability of the roof surface to protect against water infiltration. Extensive repairs may be an indication that the roof is near or past its useful life expectancy, and may be due for replacement.

The condition may result in water infiltration to the interior. Missing shingle covering should be immediately repaired. A roofing specialist may be required to perform the repairs.

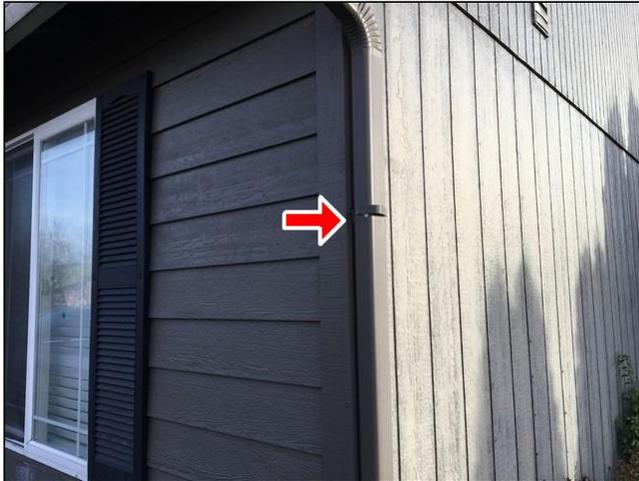
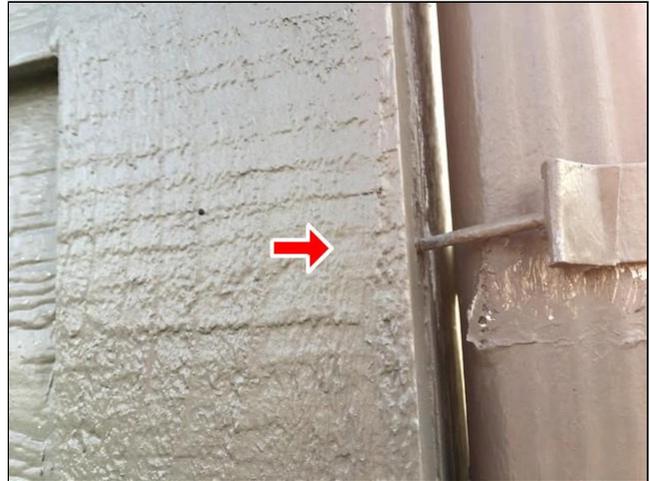
Gutter downspout is loose. Loose downspouts will over time become detached. Repairs should be conducted as soon as possible to prevent damage to the downspout. Repair should include properly securing the downspout to the structure and assuring that water freely flows and drains from the downspout

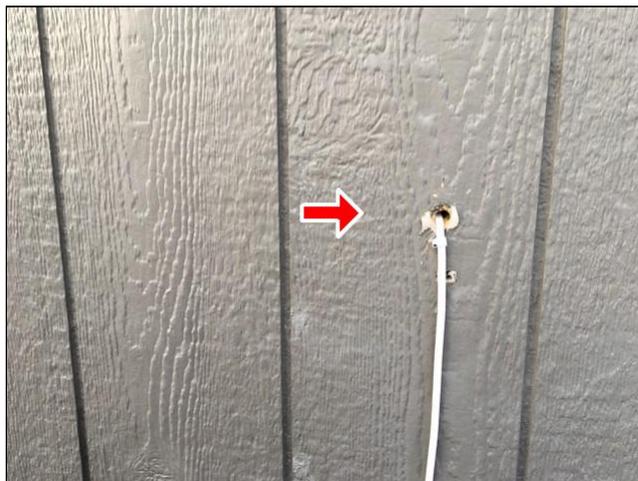
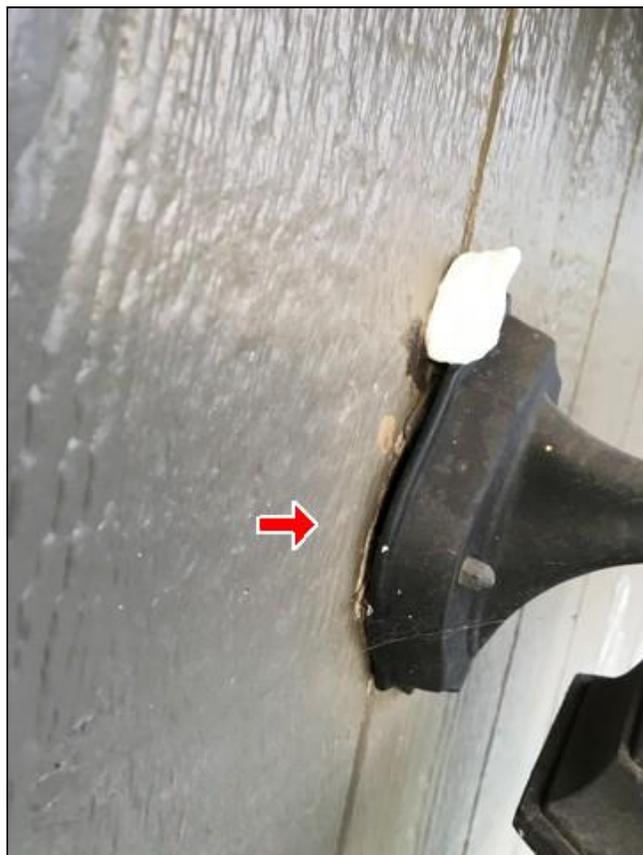
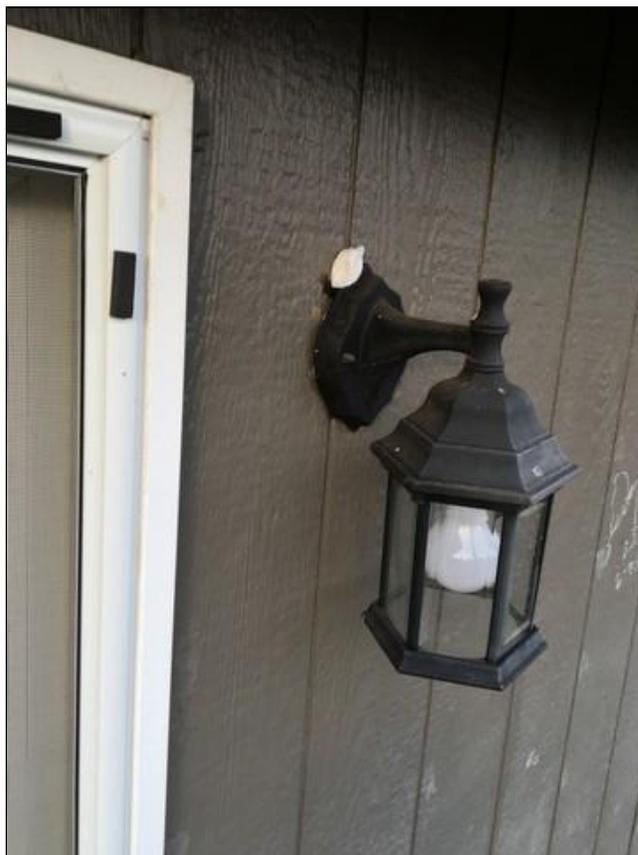
(4) **Hole in the exterior siding is observed.** Unintended water, air or pest infiltration into the house can result in significant damage to surfaces and property, and if not corrected, may lead to damage and rot to structural elements. Unintended air infiltration may affect interior air quality and conditioning. Unintended pest entry can result in damage to interior finishes and belongings, and in some cases may present health risks. Corrective action is required to seal all openings through the exterior wall system.

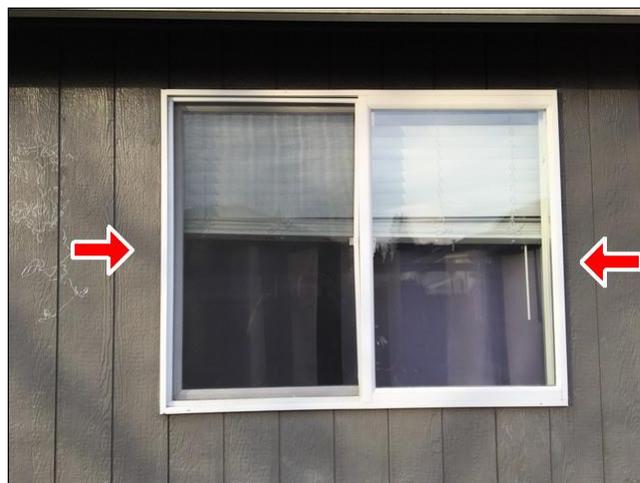
2.2 Item 2(Picture)

(1) **Windows need caulking at several locations.** Caulking at window frames serves several functions, including preventing air, water, and pest infiltration, and restricting heat loss or gain through the exterior wall. Moisture has the greatest potential for damage; unintended water infiltration into the house can cause significant damage to surfaces and property, and if not corrected, may lead to damage and rot to structural elements. Caulking repairs are required at the noted location(s), and should be performed at the earliest opportunity. Preventative maintenance should include reviewing and repairing exterior caulking at doors, windows, and wall penetrations at least twice a year.

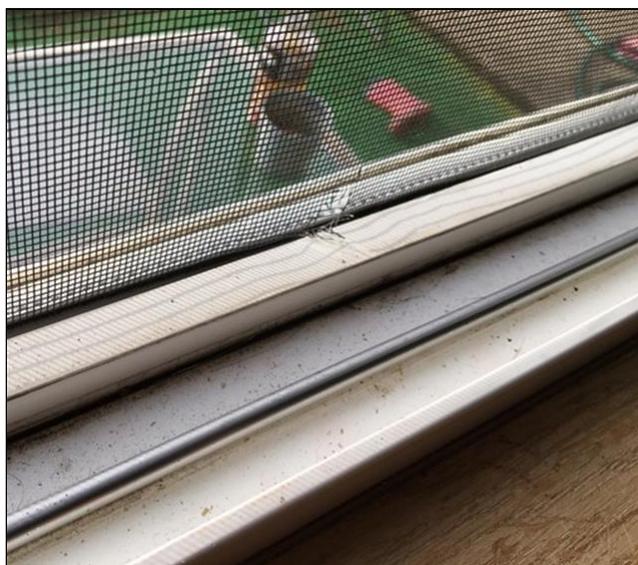
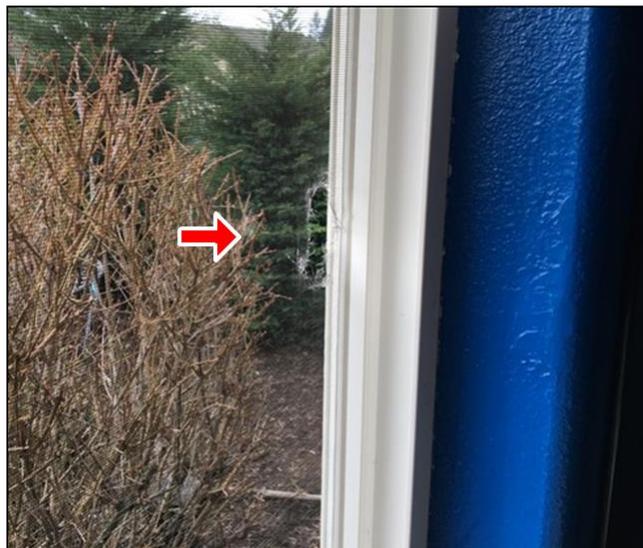
(2) **Window screen damage is observed.** The primary purpose of the screen is to prevent pest entry when the window unit is used for ventilation. A secondary function of the screen is to restrict the ability of children or pets to unintentionally leave the house. Damaged screens will often result in unintended consequences, such as pest entry (insects, birds, rodents, etc.) or unintended "escape" of small children or pets. Although screens can be breached, their presence often restricts small children from leaving the home, and becoming exposed to risks to their safety. Windows are often at sufficient height from the ground that fall hazards should be considered as a primary safety concern. Damaged screens at windows are often considered to be cosmetically detracting.
