Inspection Report

Property Address:
11111 25th Street
Olympia WA 98513

CCS Inspection Services, LLC

Date: 1/30/2017	Time: 11:50 AM	Report ID: 29/01/17
Property: 11111 25th Street Olympia WA 98513	Customer: Client Name	Real Estate Professional:

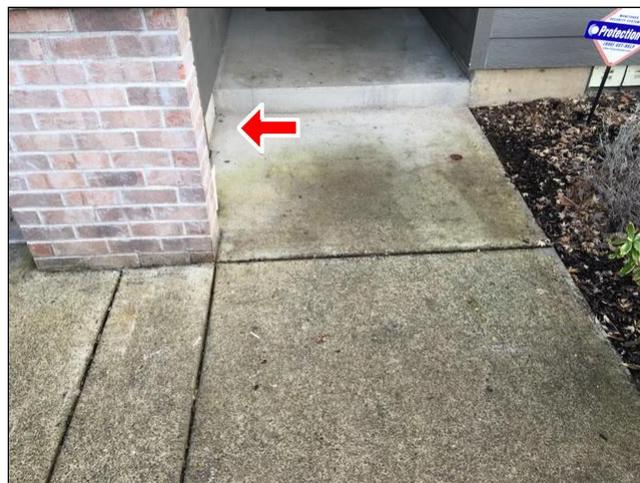
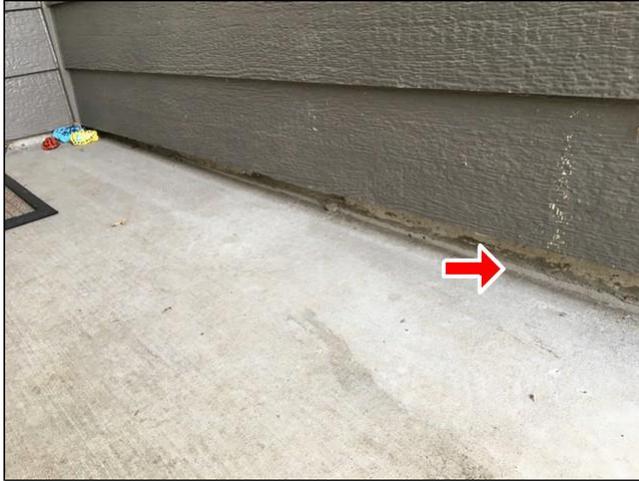
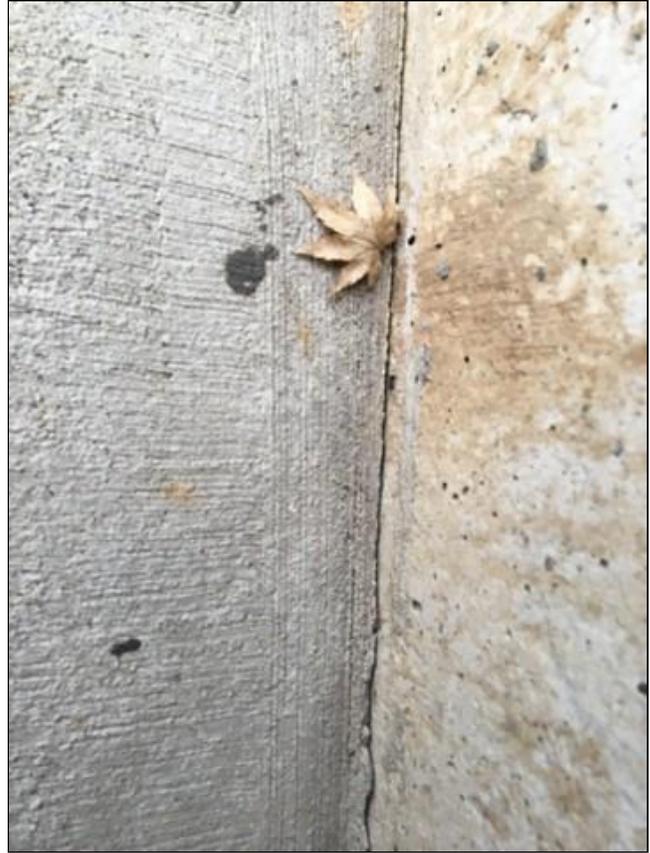
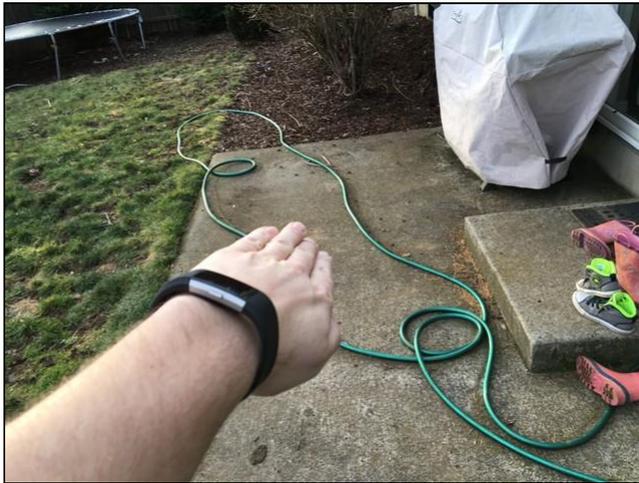
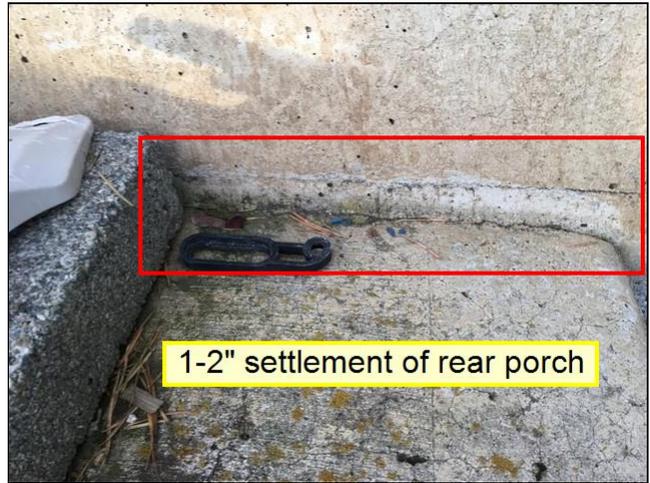
Settlement is observed at the porch. Settlement of the porch is often due to poor grading, soil or compaction issues, and ground heave. This condition may impair drainage. Settlement can result in water ponding on the porch, which will promote further deterioration of the porch over time. Low areas on the porch can result in ice patches in the winter, which pose a slip and fall hazard.

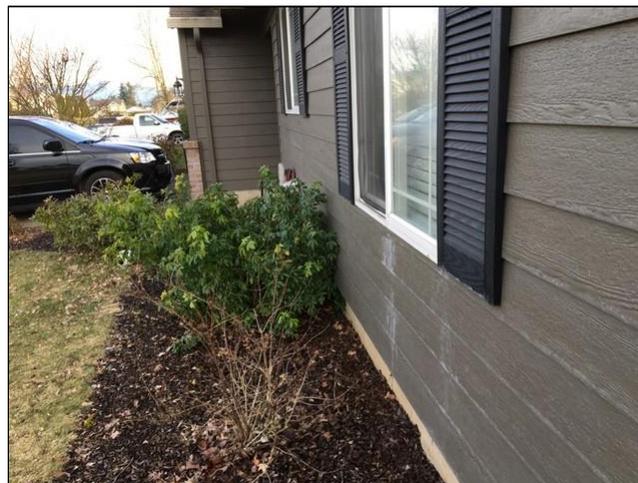
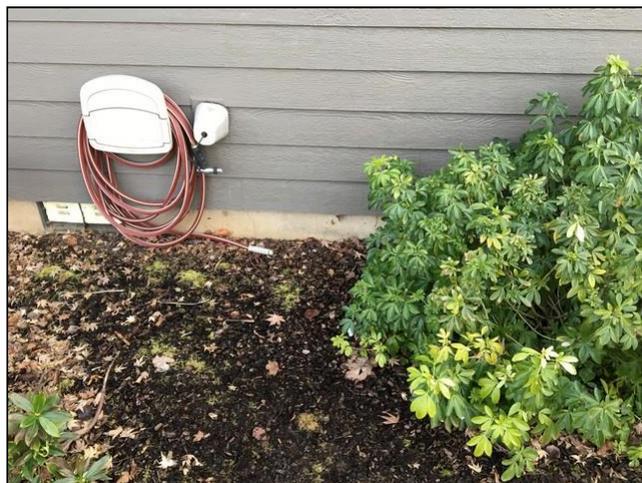
Shrubs are planted to close to house. Shrubs planted close to a house may over time cause detrimental effects to the exterior components of the home. Shrubs tend to hold moisture near the house, and can promote moisture-related problems to the home's exterior finishes, and in some cases, the structure in the areas of contact. Some shrubs have water-seeking roots, which can extend to and clog the home's foundation drainage system. As a guide, the maximum outermost branches of a mature shrub should be no closer than 2 feet from any surface of the home.

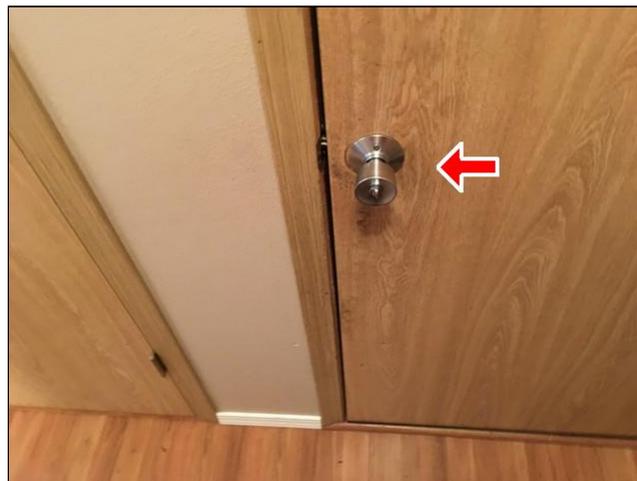
3.2 Item 2(Picture)

Garage occupant door automatic closer is defective or missing. A door closer provided for the door between the home interior and the garage shall be installed in a manner to ensure the door closes and latches in accordance with current industry standards for installation and safety. Doors between a home and an attached garage must be maintained to be gas-proof.

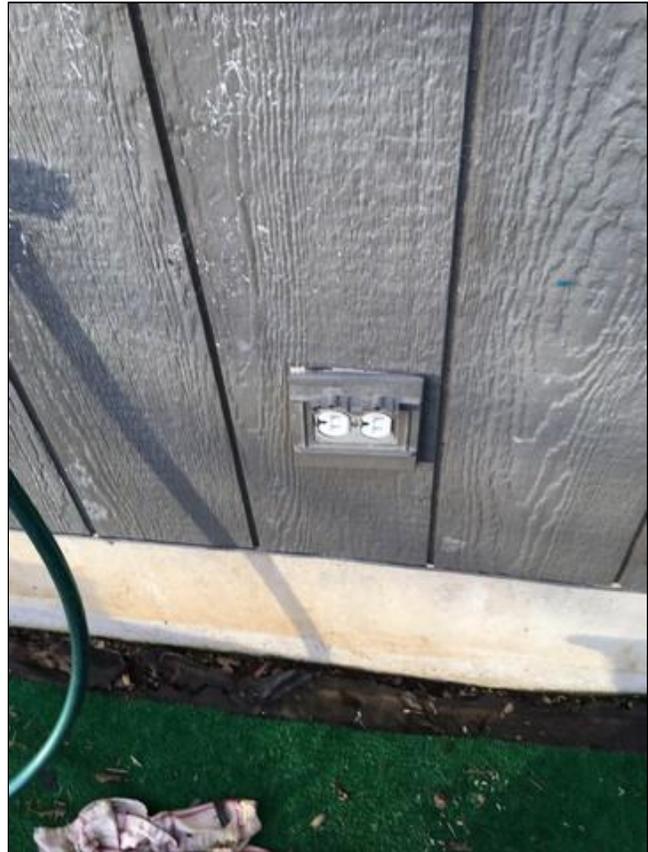
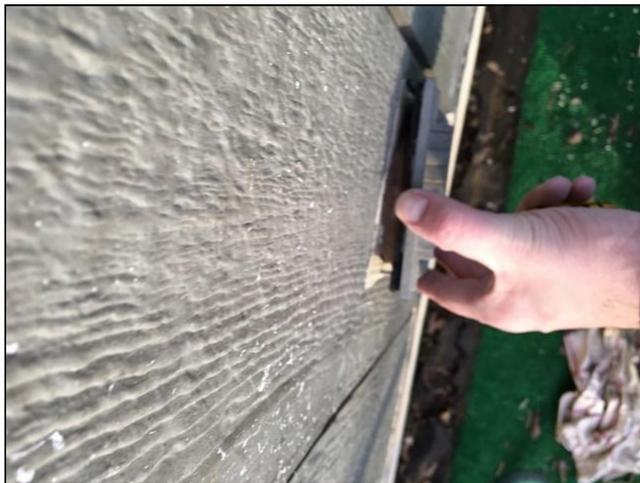
(1) **An electrical outlet is observed to be damaged.** The usual cause is due to impact or other forms of mechanical action to fracture the insulating body of the outlet. An outlet that has been damaged may result in the internal contacts not being secured as required, and the risk of short circuiting and arcing is now possible. Damaged outlets should be considered a safety hazard and should be immediately replaced.

(2) **An electrical outlet is observed to be not adequately secured to its outlet box.** A loose receptacle may in certain circumstances present a risk of fire and electrical shock should the receptacle or exposed copper on wires come in contact with the side of the metal outlet box. Loose receptacles should be repaired to ensure they are properly positioned and secured in their outlet boxes. Regular home maintenance routines should include checking for and correcting loose receptacle.

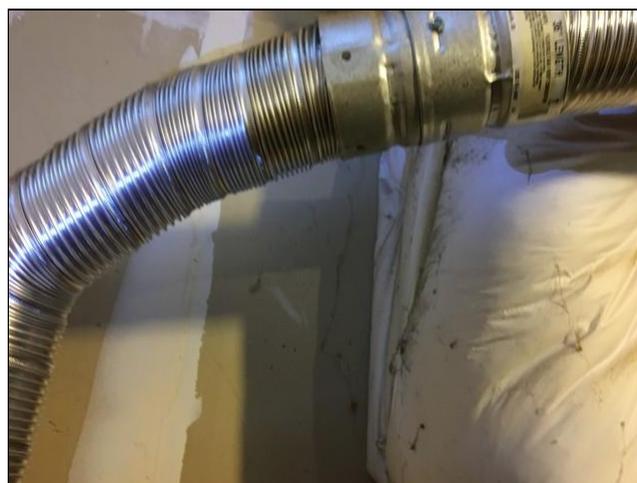
5.2 Item 2(Picture)

(1) **Water heater is past expected service life.** There are a wide variety of residential water heaters that range in capacity from fifteen to one hundred gallons. They can be expected to last at least as long as their warranty, or from five to eight years, but they will generally last longer. However, few of them last longer than fifteen or twenty years and many eventually leak. So it is always wise to have them installed over a drain pan plumbed to the exterior. Also, it is prudent to flush them annually to remove minerals that include the calcium chloride bi-product of many water softening systems. The water temperature should be set at a minimum of 110 degrees fahrenheit to kill microbes and a maximum of 140 degrees to prevent scalding. Also, water heaters can be dangerous if they are not seismically secured and equipped with either a pressure/temperature relief valve and discharge pipe plumbed to the exterior, or a Watts 210 gas shut-off valve.

The exhaust vent pipe for the hot water tank has been improperly installed. To permit safe venting of exhaust gases, where ever there is a connection made, it should be from male end to female end. Currently, the vent piping is installed reversed, causing gases to leak out into the garage.

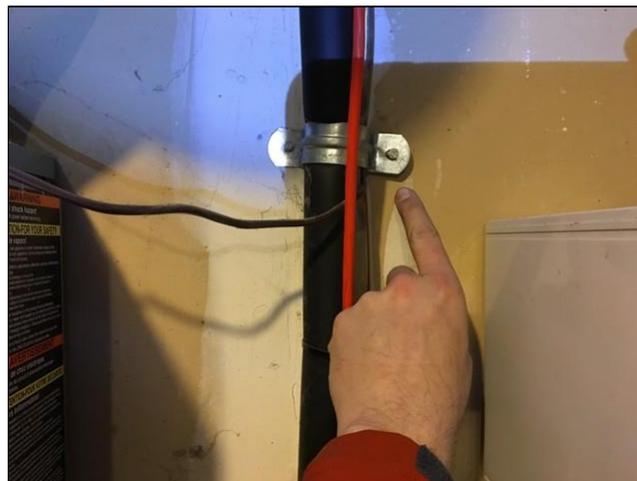
6.0 Item 2(Picture)

Mounting hardware loose or missing.

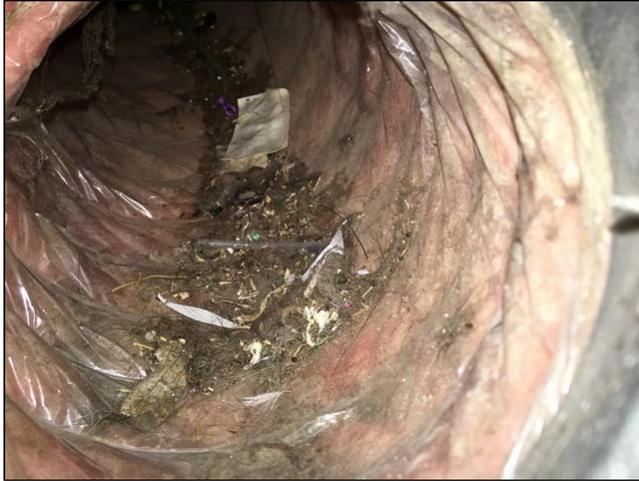
6.3 Item 2(Picture)

(2) **Heat register boots are full of debris and should be cleaned.** Dirt and debris in the heat registers will emit dust and contaminates in to the air supply. All supply registers should be clean to improve the air quality of the home.

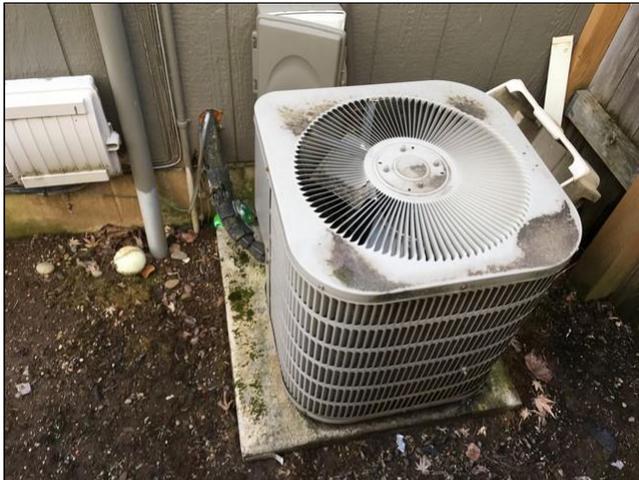
6.8 Item 1(Picture)

(1) **Air conditioner is due for annual service.** A visual inspection has revealed that the air conditioner is due for its annual cleaning and maintenance. Annual cleaning and maintenance will prolong the life of the installed components and increase energy efficiency.

Unable to evaluate air conditioning system due to outdoor ambient air temperature being below 60 degrees. Operating below this temperature can damage air conditioning compressor.

The future performance of the air conditioner is suspect. The current condition of the AC is such that the functionality of the unit to provide adequate cooling in the future is suspect. As a minimum, it is suggested that the AC be checked and tested by a HVAC specialist to better evaluate its current condition and future capability to provide cooling. Alternatively, consideration should be given to provide for future replacement should the AC fail to functionally and economically meet the cooling needs for this home.

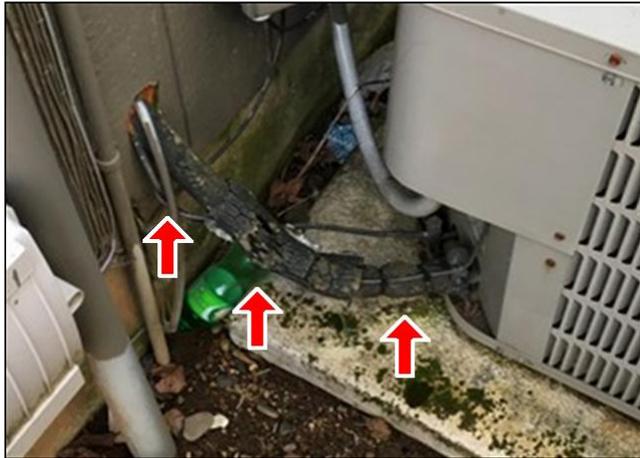
6.8 Item 3(Picture)

(2) The foam sleeve on suction line is damaged at outside unit. Damaged/Missing foam on suction line can cause energy loss and condensation. I recommend service or repair as needed.

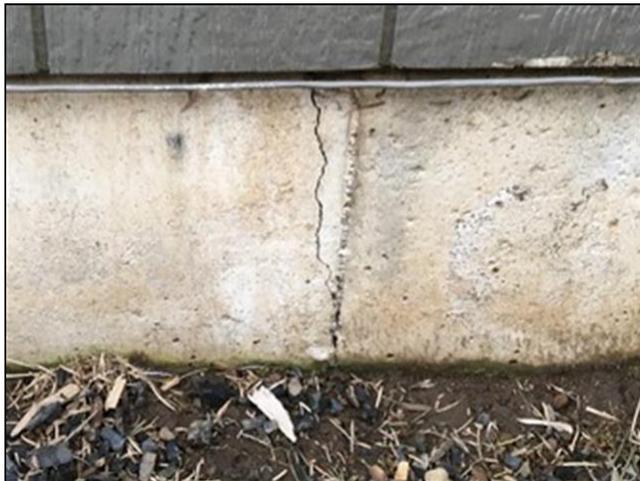
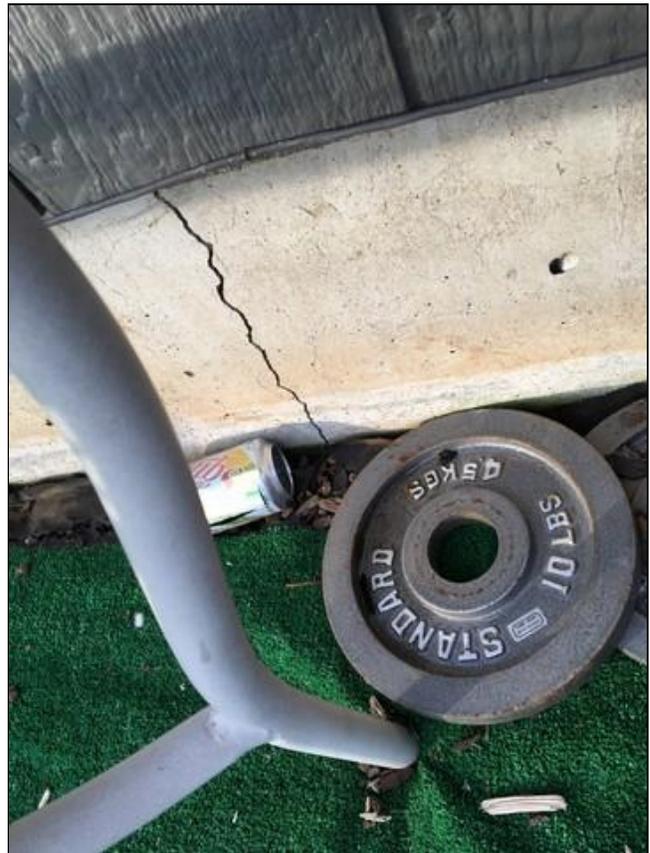
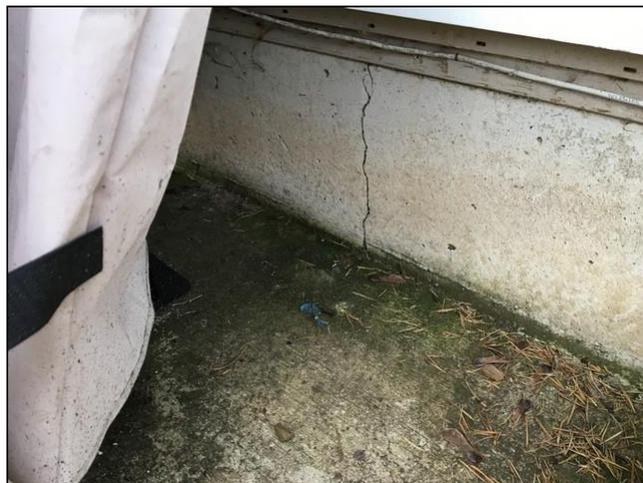
Cracks in the foundation wall are observed during examination of the exterior of the home. At the time of inspection, the crack(s) are regarded to be **minor**. Ascertaining the cause of a crack cannot be readily determined during a home inspection, but are typically due to shrinkage of the concrete during curing, settlement of soils below the footings, pressure of soils against the foundation wall, or from a physical shock, seismic or hydrological event. **At the time of inspection, adverse effects are not observed.**

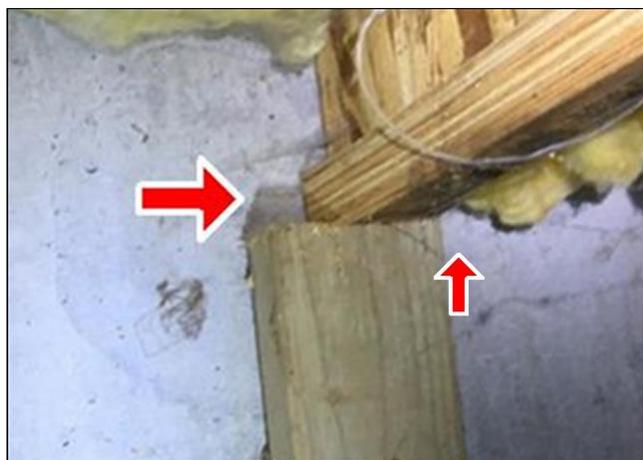
7.3 Item 1(Picture)

Insufficient end support of beams. Structural beams are crucial to providing proper transfer of floor and wall loads to components such as the foundation, load-bearing walls, and support columns or posts. Typically, beams should have end bearing of about 3-1/2" (90 mm) over its supporting element.

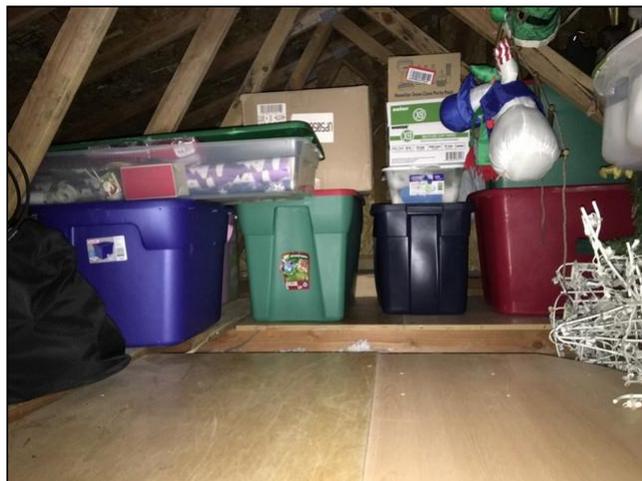
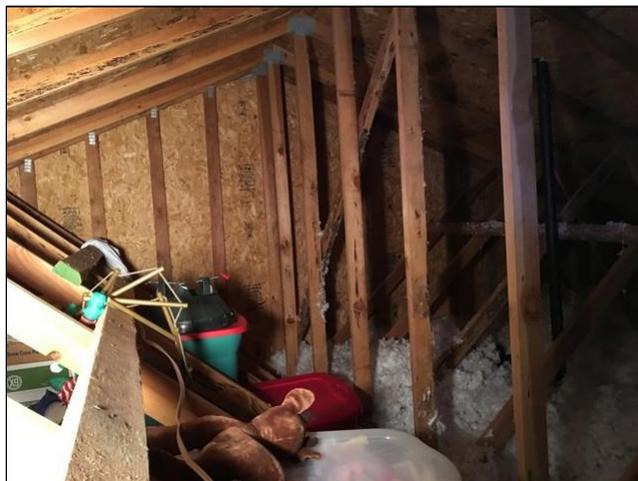
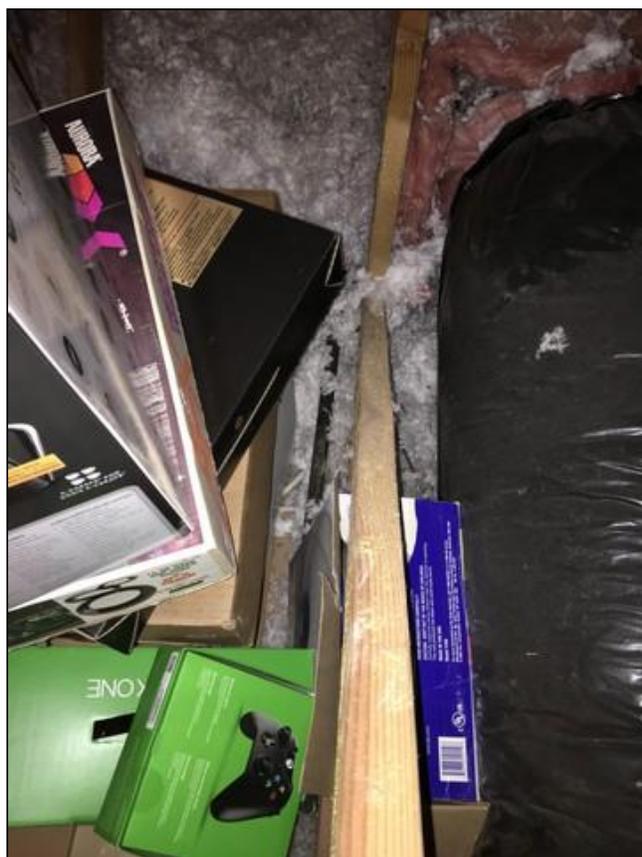
Alterations resulting in the addition of load that exceeds the design load for the truss shall not be permitted without verification that the truss is capable of supporting such additional loading. For the most part, attics were not designed as storage spaces. They are a part of the raw underbelly of structure that holds a house together and protects it from the elements. Because of this, installing a floor to an attic always involves some level of disturbance. If the roof structure of your home was designed with prefabricated trusses, your attic was definitely not designed for any storage. There are several reasons for this. First, adding weight to the top of the bottom 2x4 that makes up the truss is a big no-no. Roof trusses are specifically designed to take the weight of the roof (and the snow, wind, rain, etc.) and distribute it downward and outward to the load-bearing exterior walls through a series of interconnecting wood framing pieces known as "chords". Adding storage to any other part of this finely tuned structural marvel risks weakening the roof system.

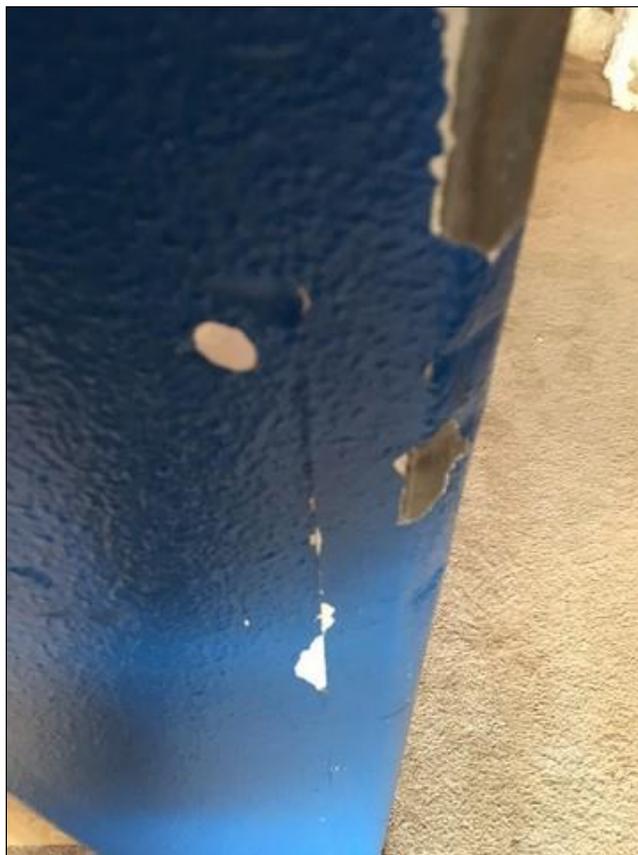
8.1 Item 2(Picture)

Drywall is cracked. Minor cracks in drywall and plaster are normally a cosmetic issue, which can be readily repaired.

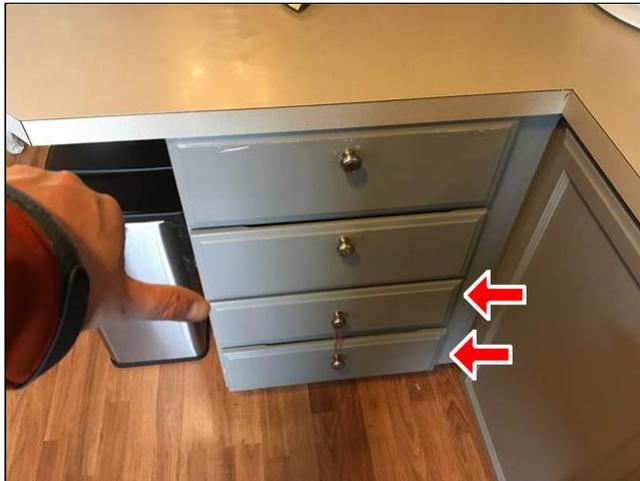
8.7 Item 1(Picture)

Damage to the cabinet is noted. A condition of physical damage impairs the appearance of the cabinet. Certain forms of damage may affect the current and future performance of cabinet doors or drawers.

Cabinet drawers are noted to bind when they are opened and closed. Cabinet drawers that bind are prone to damage. Repair or adjustment to the drawer fit is recommended.

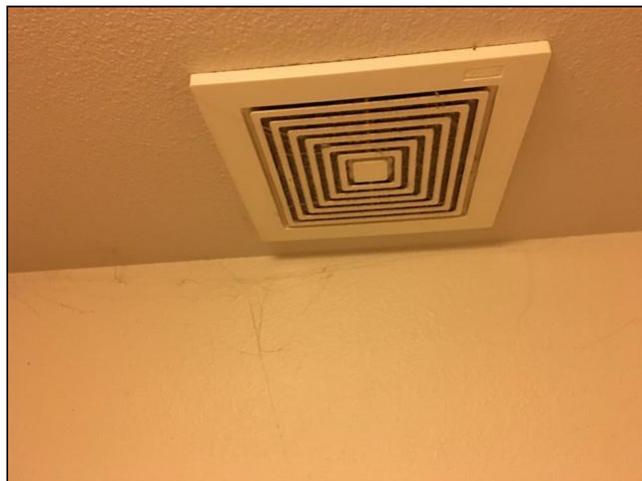
9.5 Item 2(Picture)

(2) **Exhaust fan is noisy**. An exhaust fan appears to be unusually noisy. This may be an indication that the fan is defective or has been incorrectly installed. Failure to correct may lead to premature failure of the fan, and may be an indication that the fan is not operating as intended.

Signs of bacterial growth on the shower ceiling could be caused by the lack of proper ventilation during shower use.
