# Inspection Report

**Property Address:**  
Wantamoveto MT St.  
Missoula MT 59804

**J&S HOME INSPECTIONS**

<b>Date:</b> 6/10/2012	<b>Time:</b> 08:00 AM	<b>Report ID:</b> 942
<b>Property:</b> Wantamoveto MT St. Missoula MT 59804	<b>Customer:</b> Mr. Joe Homebuyer	<b>Real Estate Professional:</b> John Thomas Montana Real Estate

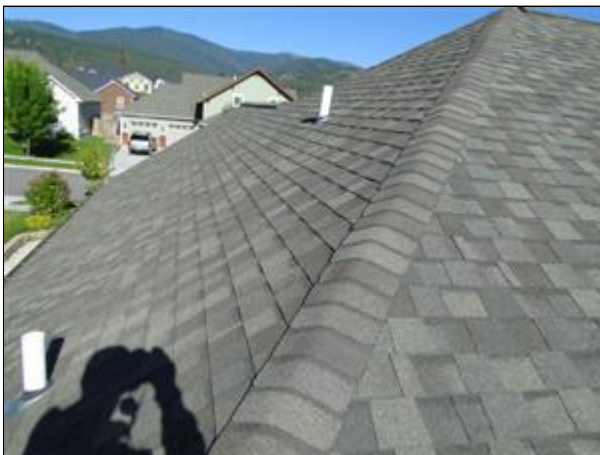
Roof was walked at the time of inspection. There were no excessive signs of curling edges, bumps, bubbles, or excessive granule loss. The roof appears serviceable.

1.0 Picture 1 Overview of roof covering.

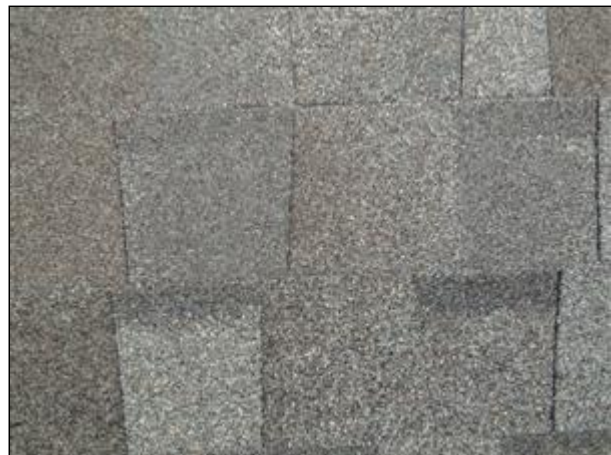
1.0 Picture 2 Close up of shingles.

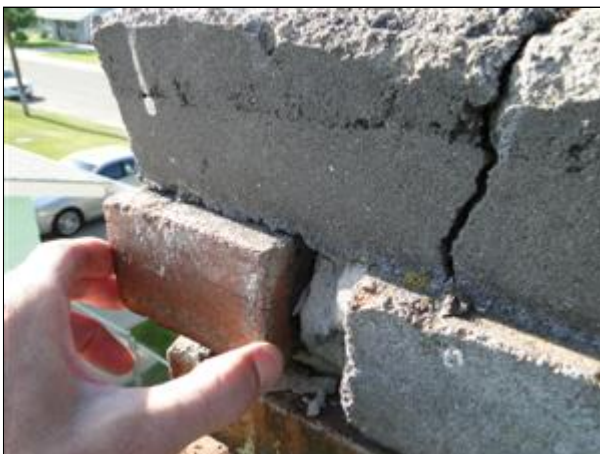
(3) Brick chimney is in need of repairs. The concrete cap is cracked in a few areas, the chimney cap does not extend over the bricks with a proper drip edge, bricks are starting to fail in a few areas due to water flowing over them from the chimney cap, loose bricks at corners, failing mortar etc. Recommend a qualified mason examine chimney and make necessary repairs.

1.2 Picture 8 Loose corner bricks, crack at cap.

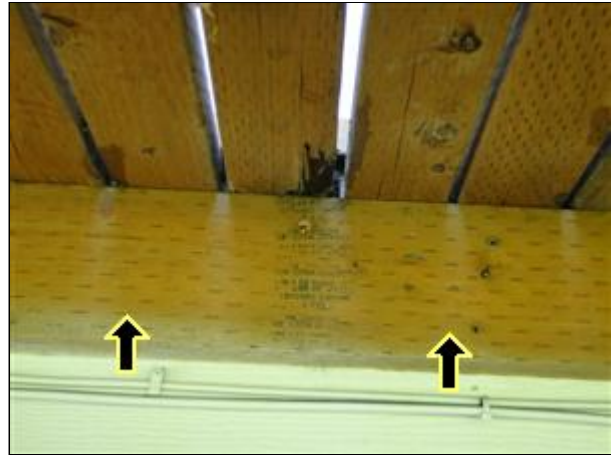
The back deck has been constructed poorly and is a safety hazard. I was able to stand at either corner of the deck and push the deck back and forth with one hand with little effort. Normally we like to see a header board attached to structure with carriage or lag bolts, then floor joist run perpendicular to the header board attached with joist hangers, 6x6 support posts set on concrete footings with post anchors, doubled up rim joist, railings post blocked in and secured with carriage bolts, floor joist 16" on center, deck boards of your choice attached to floor joist, proper drip edge installed between deck and structure, handrailing 34" to 36" tall with spindles no more than 4" apart etc. This deck has uneven deck boards (trip hazard), header attached to structure with screws, floor joists run the wrong direction, joists 24" on center, rotten support posts on old deck, above ground concrete block footings, a wood drip edge which will cause rot between it and structure, sloping walkway, handrailing way too short, spindles missing on hand rails etc. This deck may collapse under the weight of several people (10-20). This deck really needs to be removed and a properly built deck installed.

2.4 Picture 2 Header board attached to structure with screws.

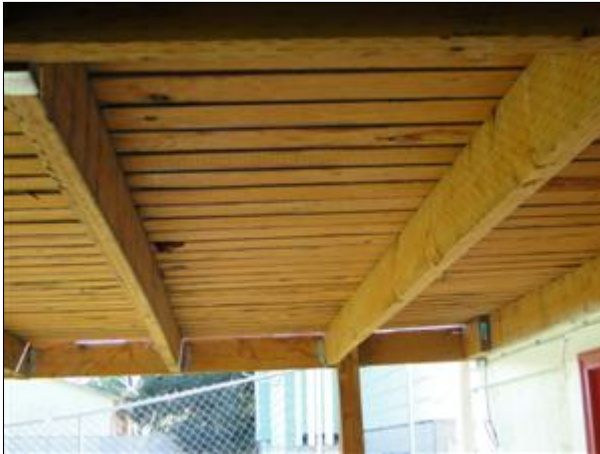
2.4 Picture 3 Floor joists spaced to far apart, run wrong direction.

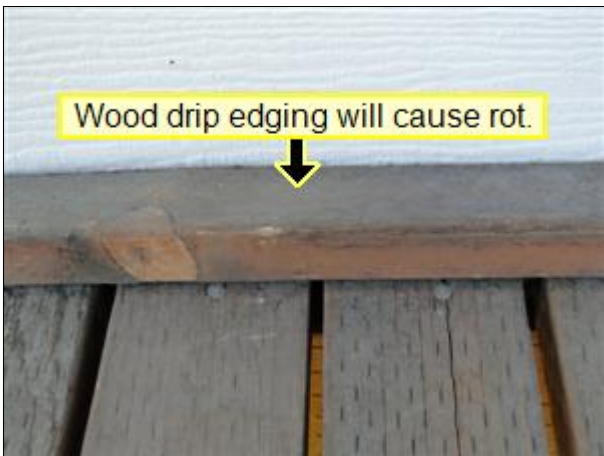
2.4 Picture 9 No metal drip edge installed.

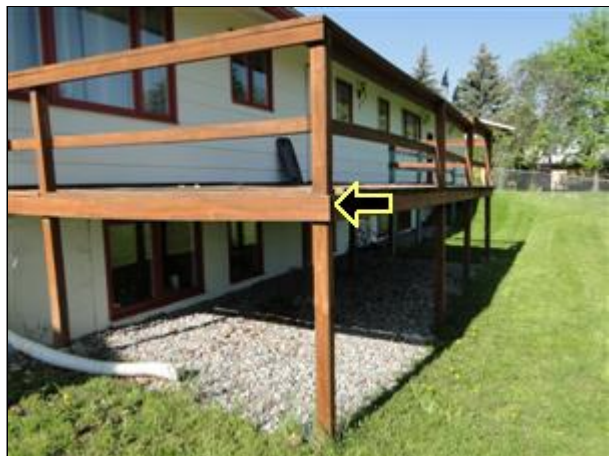
2.4 Picture 10 Push right here, whole deck sways.

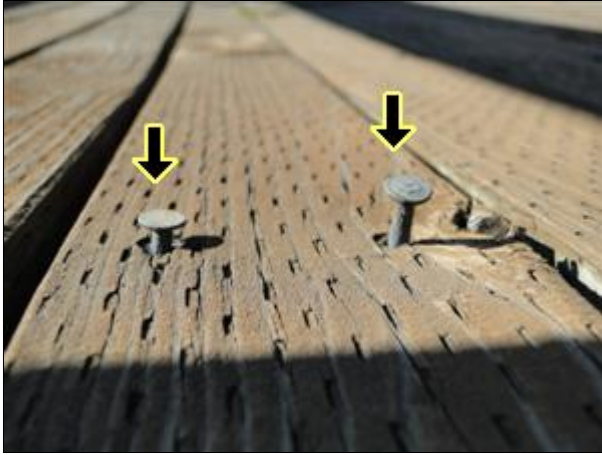
2.4 Picture 11 Smooth nails backing out, no screws.

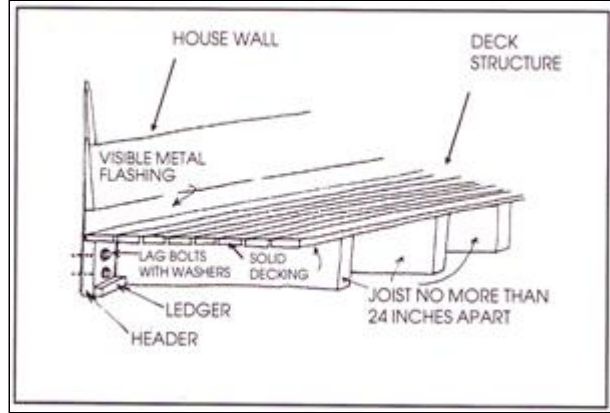
2.4 Picture 12 Proper deck building diagram.

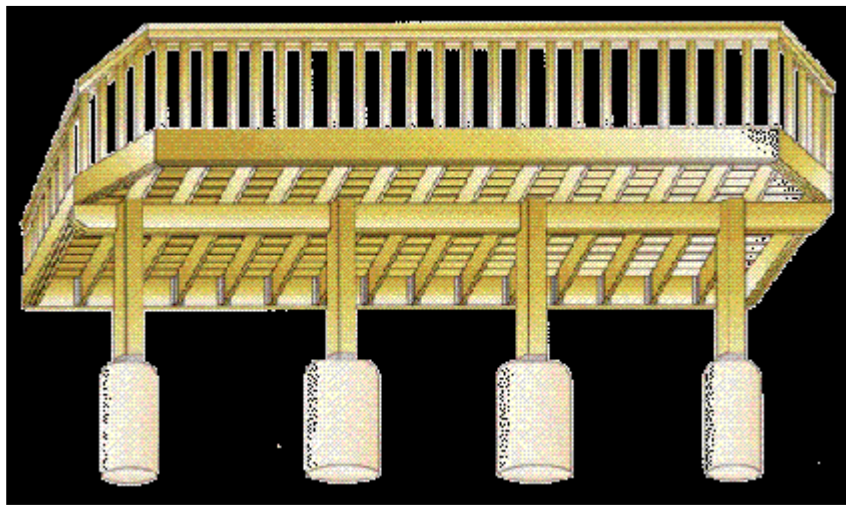
2.4 Picture 13 Sample of deck construction.

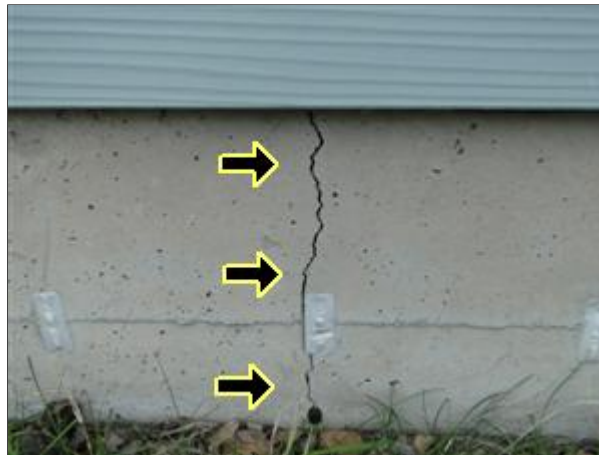
(1) There are minor settling cracks in the foundation of the home. These cracks are common with homes on concrete foundations. These types of cracks are usually not a major concern unless they present as a leak in the basement or crawlspace.

2.5 Picture 1 Foundation crack.

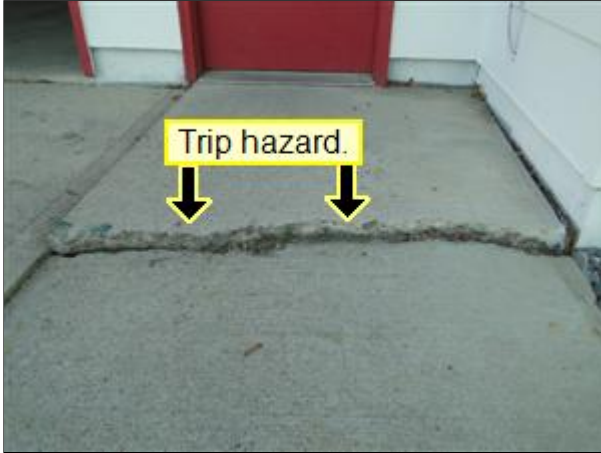
(1) The concrete walk way has some substantial cracks that may cause a trip hazard. The walk way is reaching its life expectancy in this area and should be replaced soon. Recommend consulting with a concrete contractor for recommendations for grinding trip hazard down or replacing with new concrete.

2.11 Picture 1 Entry walk way to garage.

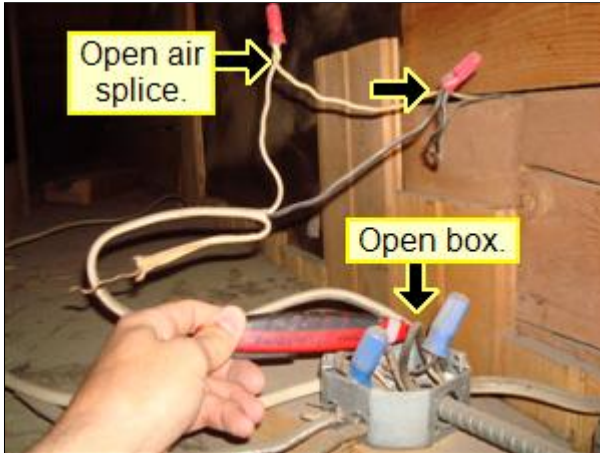
(1) There are multiple open junction boxes and exposed or open air splices at the garage ceiling area. Light fixtures have been wired with orange extension cords with exposed splices. Recommend a licensed electrician correct these wiring issues and store all splices within junction boxes, properly secure with wire collars and blank cover plates. Rewire all light fixtures properly. This will help prevent accidental shocks and contain any sparks should there be a short circuit within these junction boxes and light fixtures..

3.7 Picture 1 Wiring issues at garage ceiling.

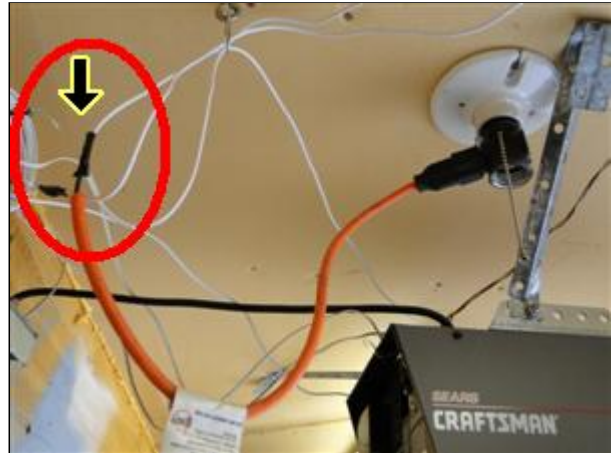
3.7 Picture 2 Orange extension cord with open air splices for light fixtures.

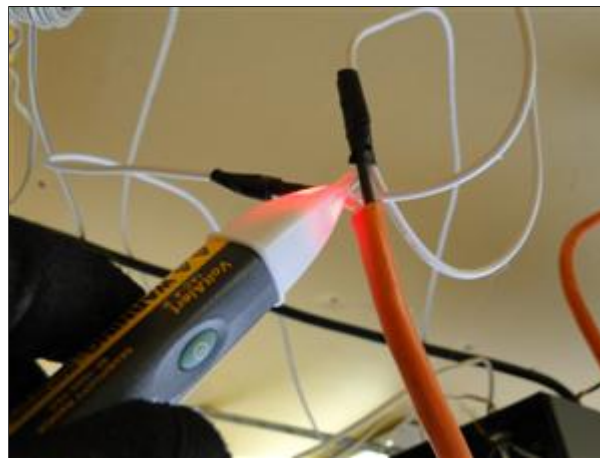
3.7 Picture 3 Close up of live open air splices.

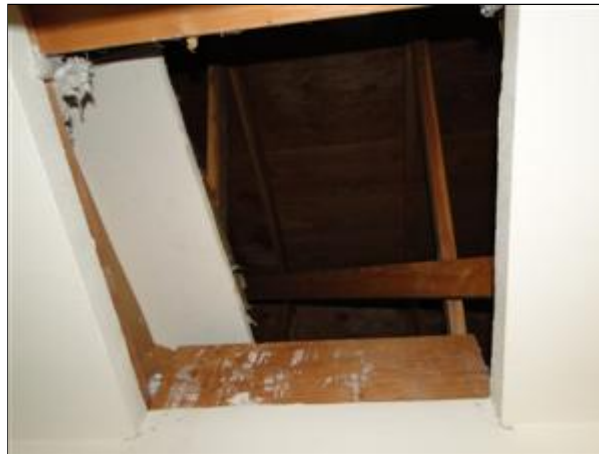
Attic access is located in the garage.

4.0 Picture 1 View of attic access.

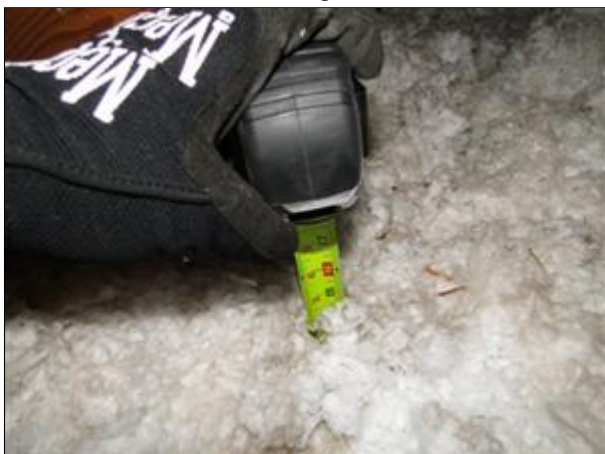
Insulation around the attic access area measures 16" inches. The average R value for blown in fiberglass is 2.8 per inch. Therefore your total estimated R value equals,  $2.8 \times 16 = R44.8$  Cardboard soffit dams are in place which will create good air flow from soffit vents to ridge vents in attic.

4.1 Picture 1 16" blown in insulation.

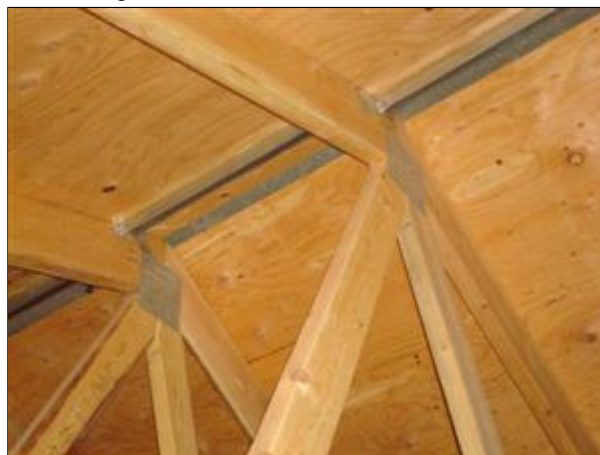
4.2 Picture 1 View of roof structure.

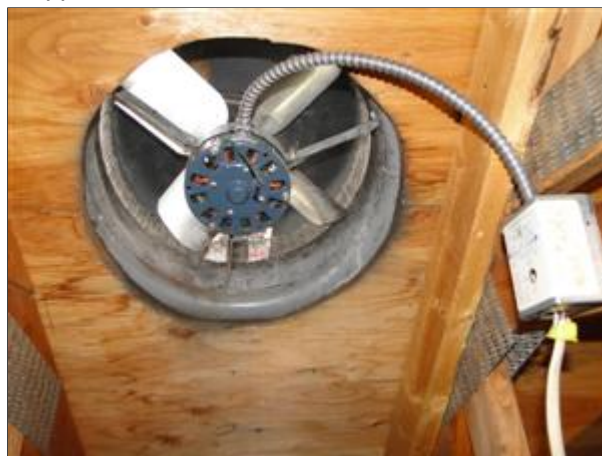
Attic fan was tested for function and appears serviceable.

4.3 Picture 1 View of attic fan.

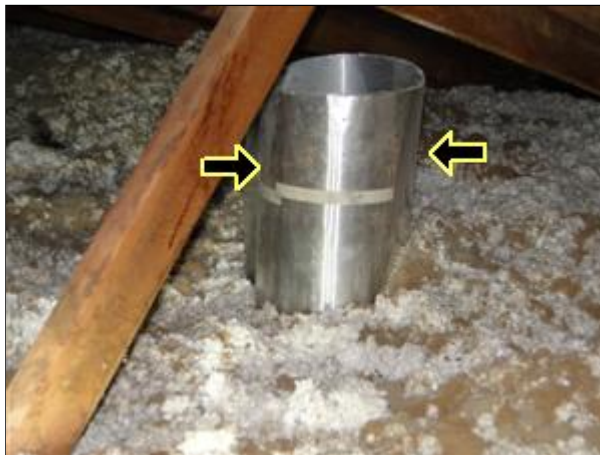
The bathroom exhaust fan terminates in the attic. This is pumping warm moist air into the attic. This will cause mildew or mold to form in this area. In the winter time it will cause frost to form in the attic. This may present as a huge leak as soon as the temperature warms up and weeks of frost melts and works its way into the home. Recommend adding insulated duct work to a vent register that exits through the roof or the north gabled end of the home. This will help remove moist warm air from the attic.

4.6 Picture 1 Duct work terminates in attic.

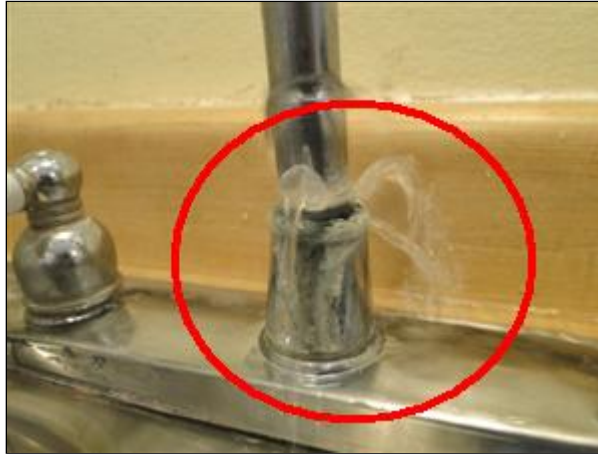
The kitchen faucet has a leak at the ball joint. This can usually be fixed with a spring and packing kit or cartridge kit. Recommend repairing or replacing faucet as needed.

5.10 Picture 1 Leak at swivel neck.

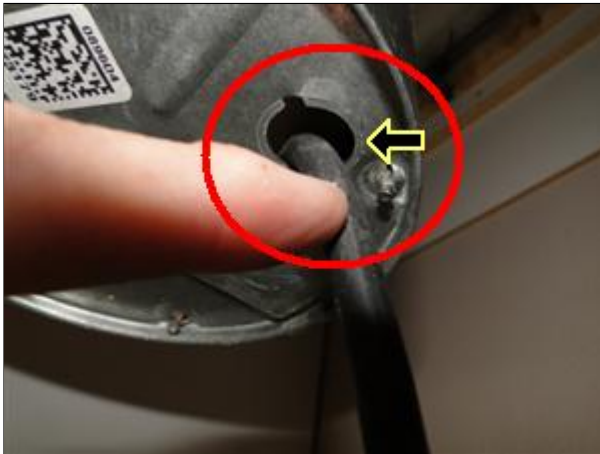
(2) The garbage disposal is missing a power cable wire collar where the power cord enters the unit. Recommend a licensed electrician remove power wire and add the proper wire collar. This will help prevent pulling the power cord loose and possibly causing a short or shock hazard.

5.12 Picture 1 Collar missing here.

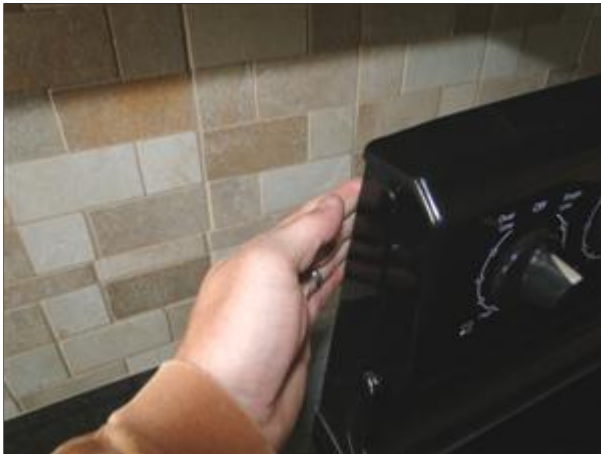
(2) Oven tip bracket has not been installed. This allows the oven to tip away from the wall. Should a child open the door and sit on it the range may tip over and seriously injure them. Recommend adding tip bracket per manufacturers instructions.

5.13 Picture 1 Oven tips away from wall easily.

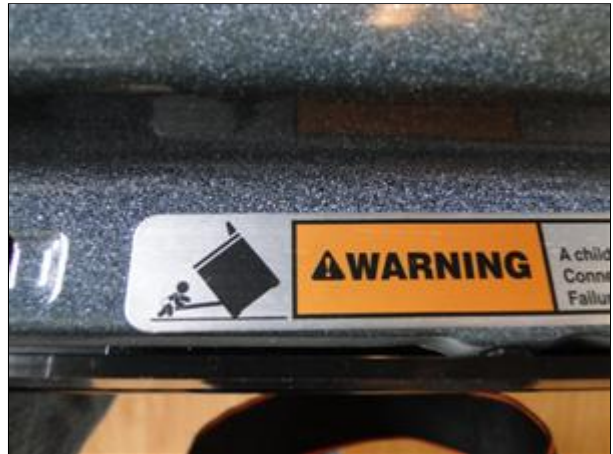
5.13 Picture 2 Read warning label at oven door.

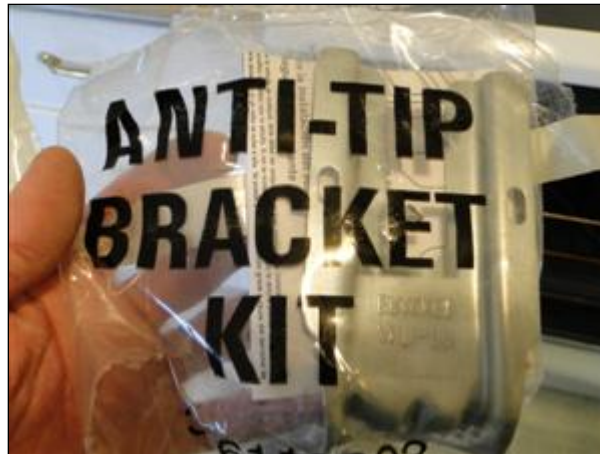
5.13 Picture 3 Tip bracket kit in cabinet above stove.

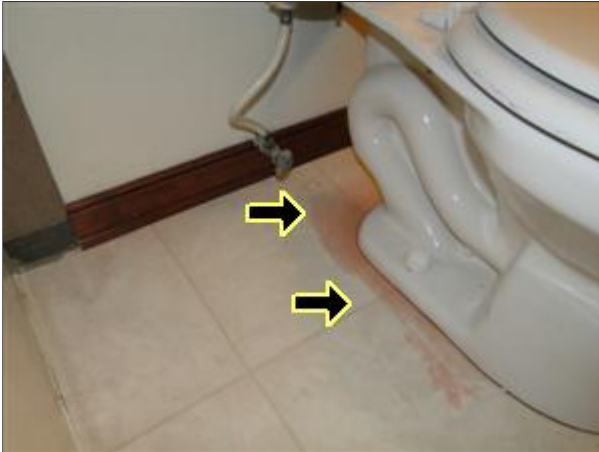
(2) Upstairs hallway toilet has a leak between the toilet tank and bowl. This is usually one of two issues, either bad bolt rubber gaskets or bad rubber gasket between the tank and bowl. As always we recommend a licensed plumber replace both when you have the unit apart for repairs as the parts are only a few dollars.

6.13 Picture 1 Standing water here.

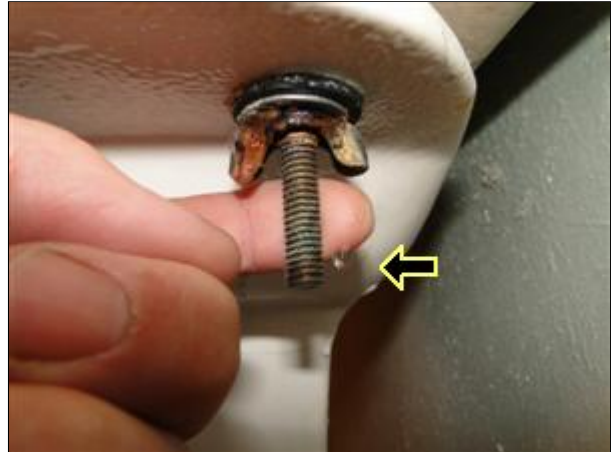
6.13 Picture 2 Water dripping off of tank bolts.

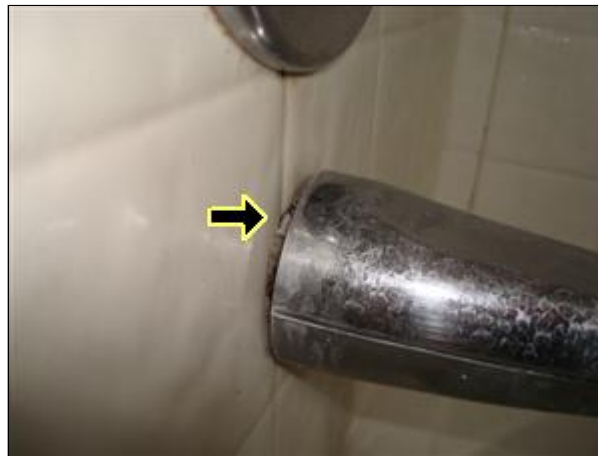
There is a small gap where the faucet nozzle meets the shower wall in the downstairs bathroom. Recommend adding clear silicone caulking where the faucet nozzle meets the shower wall. This will help prevent water penetration between the shower surround and wall.

6.15 Picture 1 Gap here needs caulking.

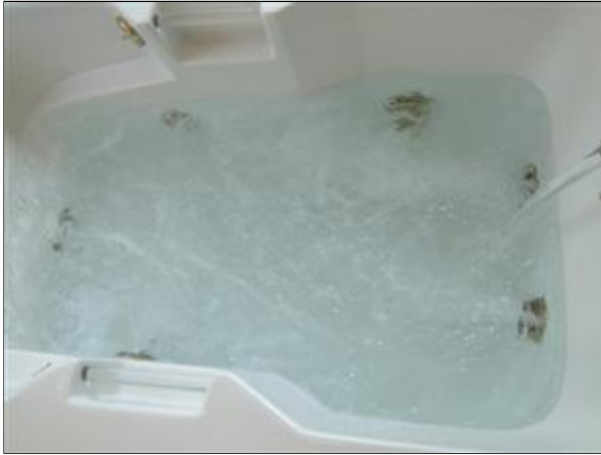
(1) Spa tubs are out of the scope of our inspections, however as a courtesy to our customer the spa tub was filled with water and run for 10 minutes. The unit was functional and appears serviceable at the time of inspection.

6.16 Picture 1 View of spa tub on and working.

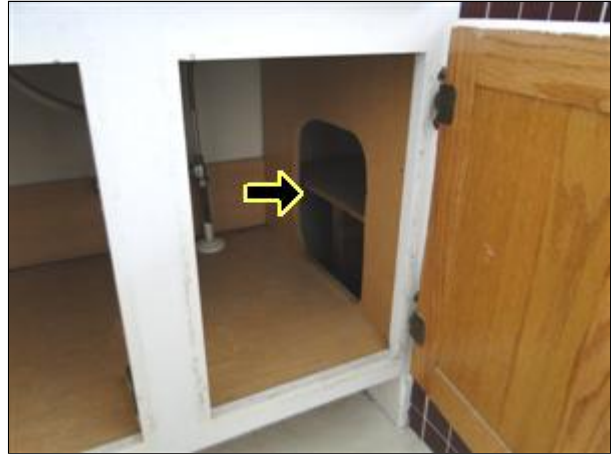
6.16 Picture 2 Spa access panel under cabinet.

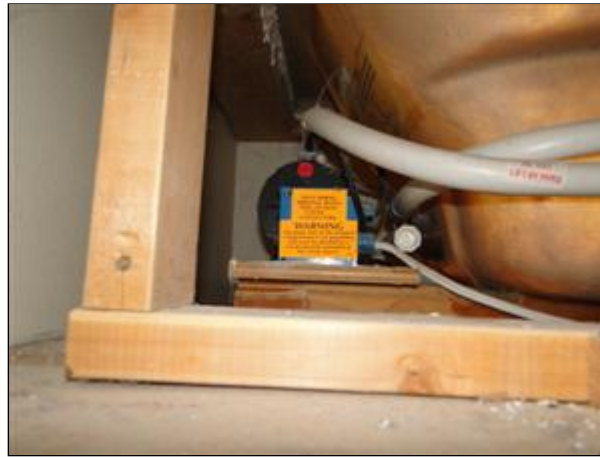
6.16 Picture 3 View inside access area and pump.

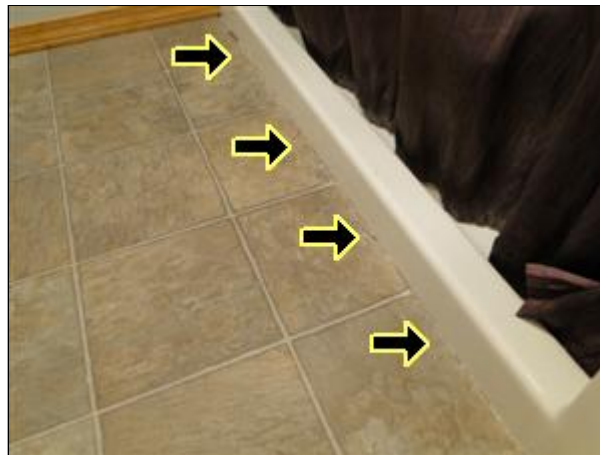
(2) The upstairs bath tub / shower stall has failing caulking where the bath tub meets linoleum floor. Recommend removing all old caulking and adding new tub and tile silicone caulking. Also recommend adding caulking to baseboards around the tube area to keep water from penetrating behind the walls and under the linoleum.

6.16 Picture 4 Caulking missing or failing here.

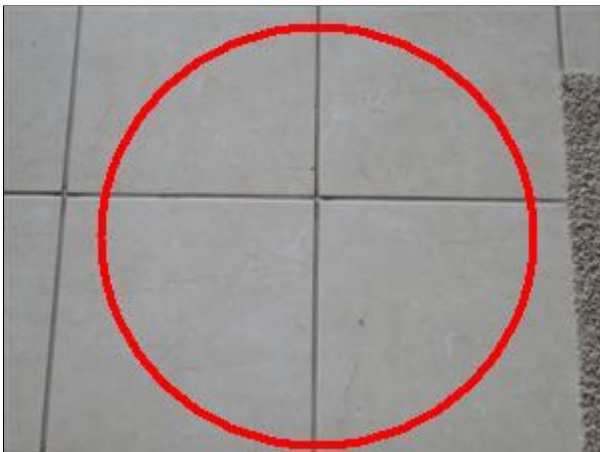
The tiles at the front entry have lost their mechanical bond in some areas. This is easily determined by knocking on the tiles and listening for a hollow sound. This means the tile has lost adhesion with the substrate below. This will cause the grout lines to crack and eventually the tiles will crack as well. Recommend removing grout around loose tiles, remove tiles from floor and clean back side, clean concrete floor, re-install tiles using the proper thinset mortar for this application with the correct bonding additives, once tiles set up over night grout and seal grout after it has cured per manufacturers recommendations.

7.2 Picture 1 Tiles sound hollow here.

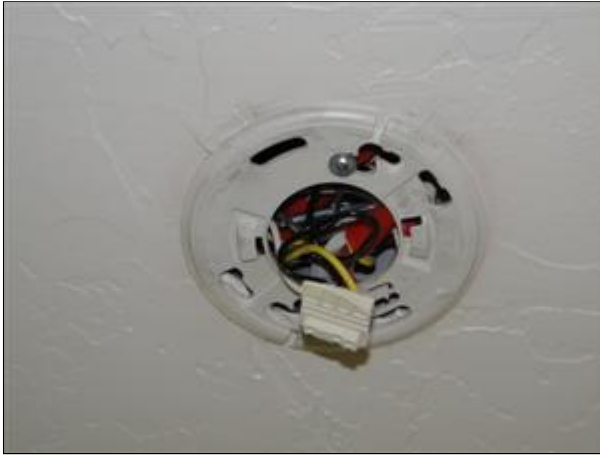
7.8 Picture 1 Missing smoke detector at master.

As always change all batteries in smoke detectors and test for function. Replace any units that are missing or do not function correctly with new. We also recommend adding at least one carbon monoxide tester at the utility/mechanical room.

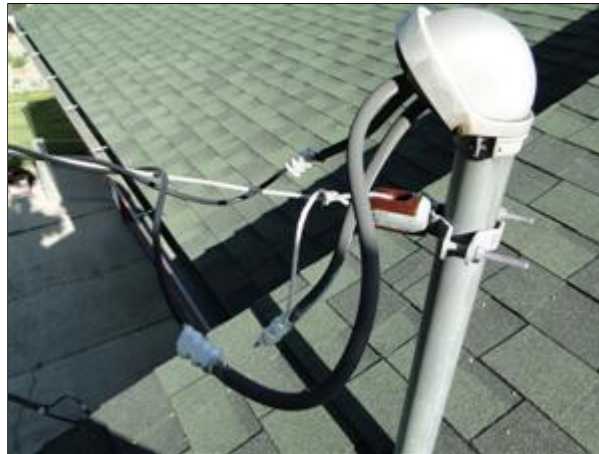
View of overhead service entrance conductors.

8.0 Picture 1 Overhead mast for entrance conductors.

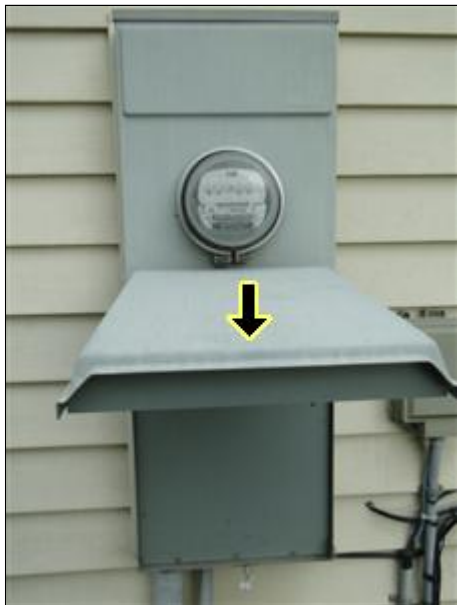
Main breaker is located under the gray panel just below the electric meter on the east exterior wall. The breaker is marked "200" and labeled "SERVICE DISCONNECT".

8.1 Picture 1 Main breaker under this panel.

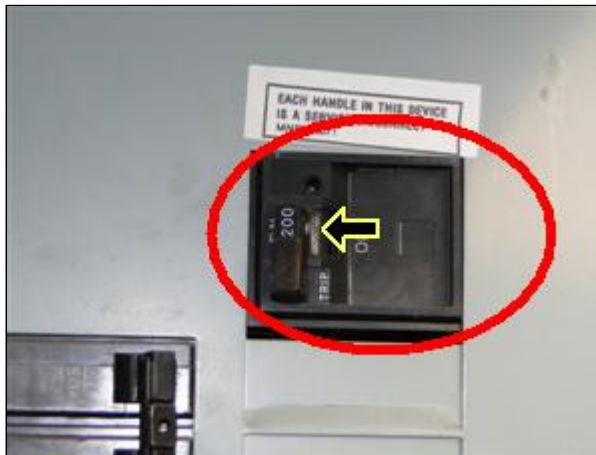
8.1 Picture 2 View of main breaker.

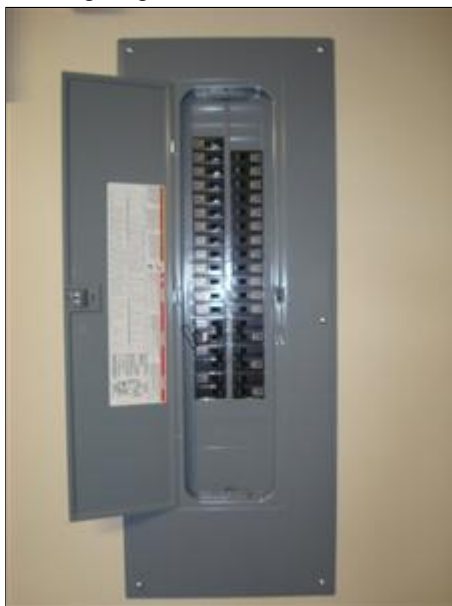
The main circuit breaker panel is located in the garage west wall.

8.2 Picture 1 Main breaker box.

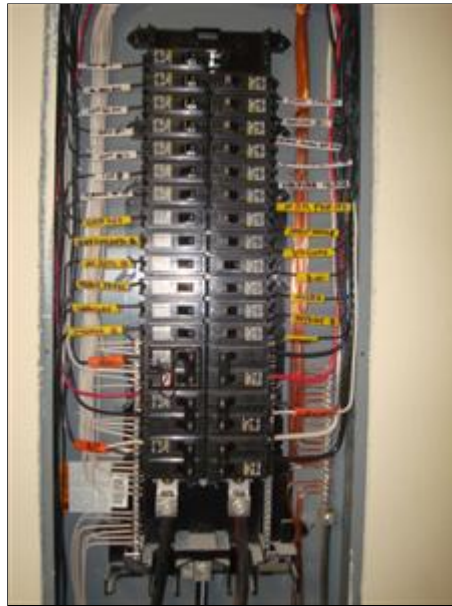
View of the interior main circuit breaker panel at time of inspection. Nice clean installation, excellent.

8.3 Picture 1 View of interior.

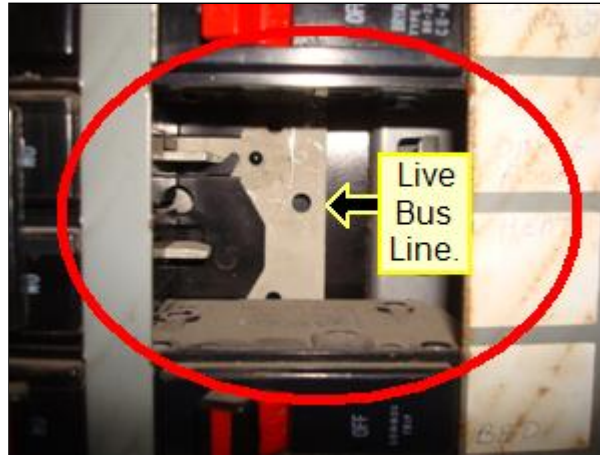
(1) Slots tabs are missing on the dead front panel at main breaker box. This may allow a finger to accidentally go inside the circuit breaker box and touch one of the live bus lines. Recommend adding plastic cover plates to these open slots. This will help prevent accidental shocks.

8.8 Picture 1 Serious shock hazard.

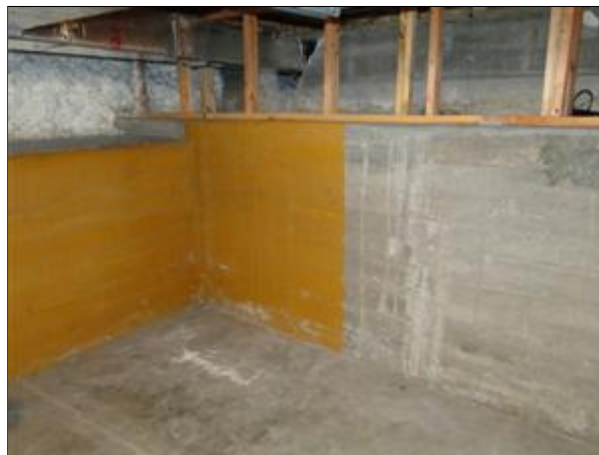
View of foundation walls in unfinished basement.

9.0 Picture 1 Masive foundation walls.

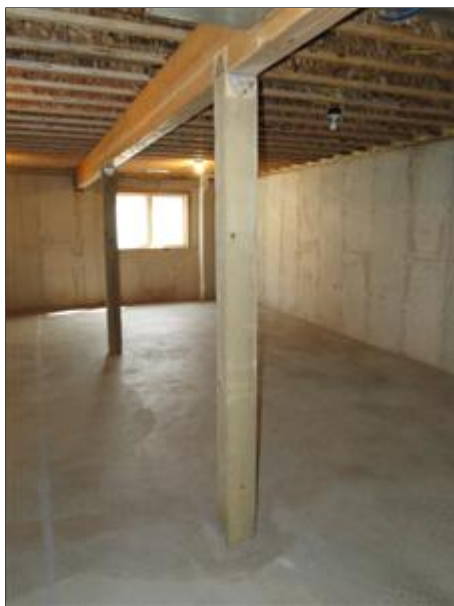
View of wood piers at time of inspection.

9.1 Picture 1 Wood piers at basement.

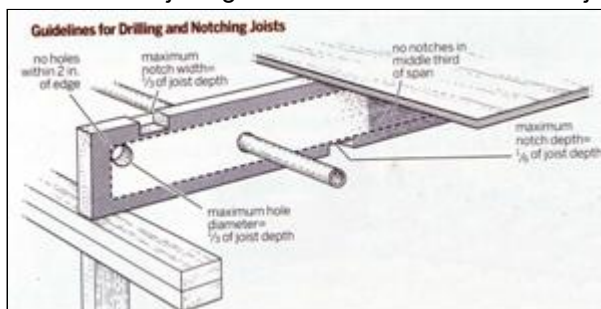
Floor joist in south west corner of crawlspace has been notched to accommodate a plumbing line. This notch appears to be almost half of the width of the floor joist and is out of tolerances for joist notching. This has compromised structure in this location. Recommend a qualified contractor examine and add a sister joist glued and screwed to notched joist.

9.2 Picture 2 Follow guide lines for notching and drilling joists.

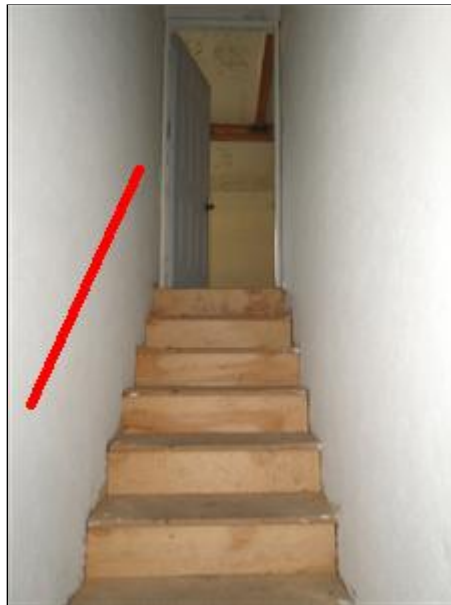
9.12 Picture 1

Handrails are missing at stairs to basement. Recommend adding handrail system to help prevent accidental falls in this location.

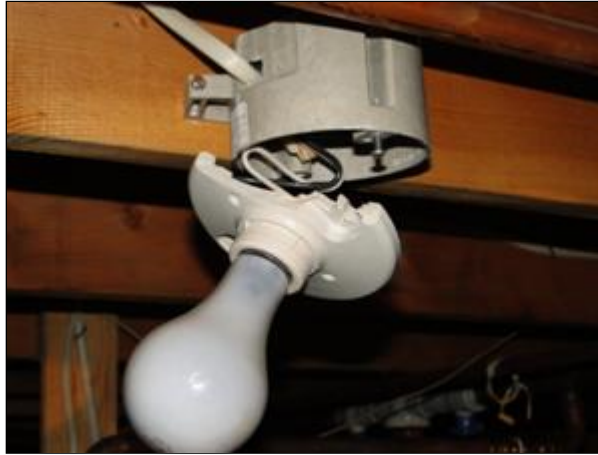
(1) Porcelain light fixture at south west basement area is damaged and not attached to junction box. Recommend a licensed electrician remove and replace with new and attach to junction box properly.

9.13 Picture 1 Porcelain light fixture damaged.

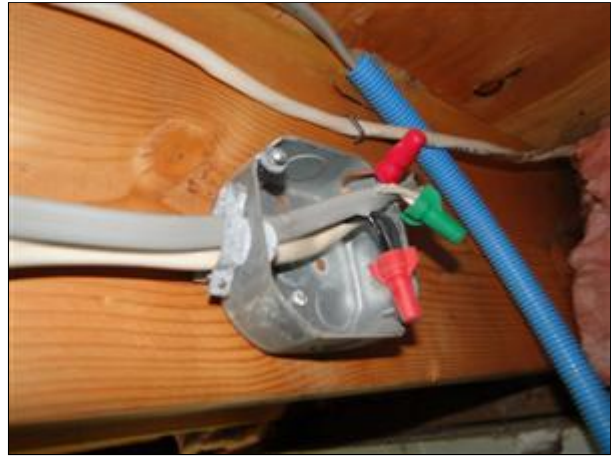
(2) There are open junction boxes located in the basement area. Recommend adding blank plate covers to these junction boxes. This will help contain any sparks should there be a short circuit in these locations.

9.13 Picture 3 Open junction box.

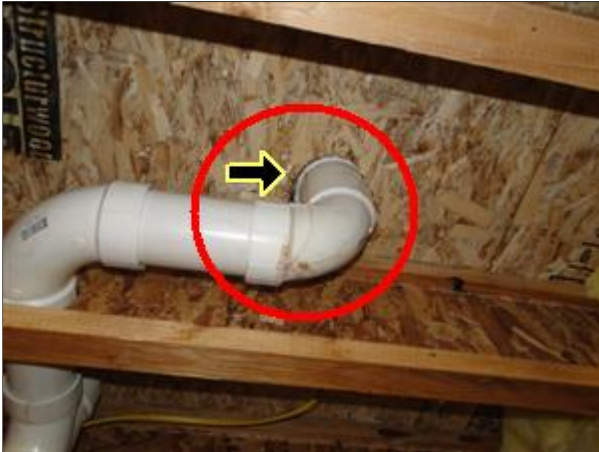
There is a drip leak at the hallway toilet pvc waste pipe in the basement. It appears the leak is coming from the closet flange area and dripping down to the elbow joint. This is either a faulty closet flange or wax ring at the toilet. Recommend a plumber remove toilet and make necessary repairs to stop this leak.

10.0 Picture 1 Leak located here.

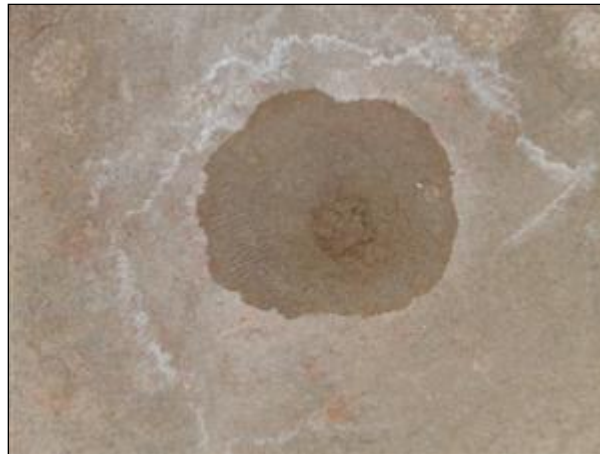
10.0 Picture 3 Wet spot at floor with previous stain marks.

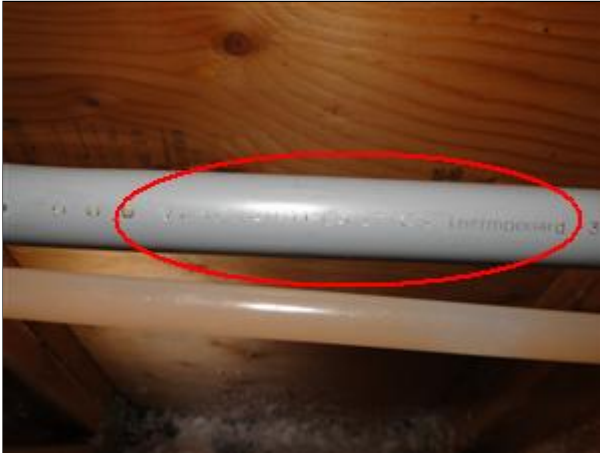
(1) The home appears to be equipped with PB or Polybutylene water supply lines which were widely used before 1996. Since then it has been replaced with Pex or crossed linked polyethylene. The PB pipe has a reputation to deteriorate from the inside out due to chlorines added to the water systems. However being on well for a water supply eliminates this specific issue. Some other problems have been related to some of the clamps used at the joints. Tools used to install clamps can over tighten and cause stress cracks on the PB pipe or on the actual clamp resulting in leaks. Most leaks are located at joints due to poor installation or faulty connection clamps. Recommend consulting a licensed plumber for confirmation of PB lines and further clarification and recommendations for replacement of PB lines.

10.1 Picture 1 PB by Vangaurd

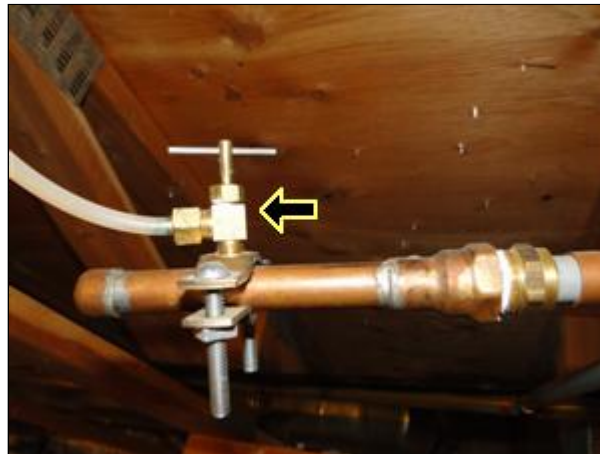
(2) Note: There is a clamp on valve (saddle valve) that pierces the copper line for its water supply located in the crawl space. These types of valves are notorious for leaking. This appears to be the water supply line for the refrigerator. Should a water supply line be needed for the refrigerator we recommend cutting this valve out and sweat in a proper shut off valve similar to the ones used for the hot and cold shut off under sinks and toilets.

10.1 Picture 3 Saddle valve, not good.

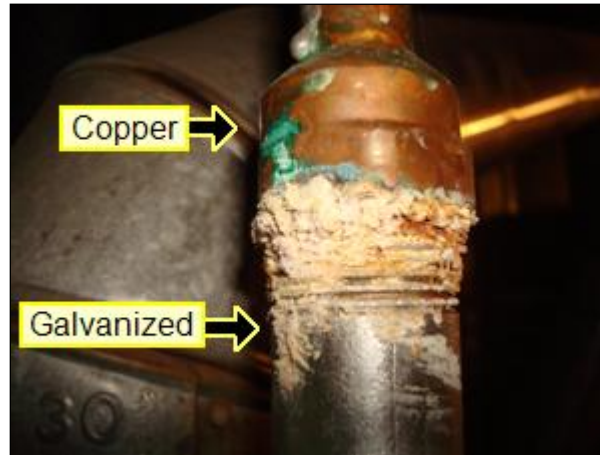
(3) Note: It was noticed that there were signs of dissimilar metal connections in some of the water supply lines in the utility room. This can lead to galvanic corrosion where one metal will wear away another. This corrosion will eventually lead to leaks in the water supply system. During any plumbing repairs in the basement take the time to replace these connections with a dielectric union. This will break the electrical current and stop the corrosion process.

10.1 Picture 4 Corrosion at dissimilar metal connection.

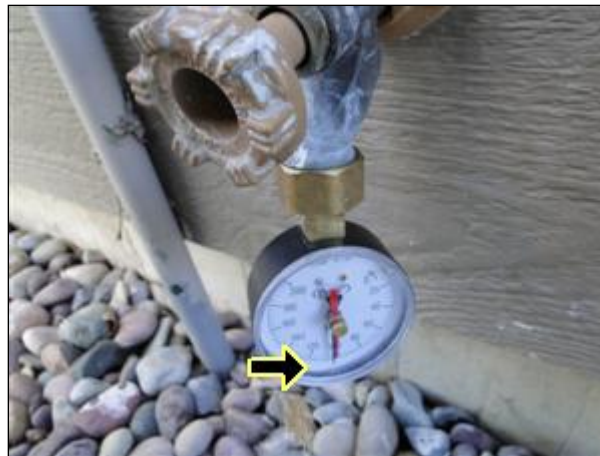
Water pressure was measured at 100 psi during the time of inspection.

10.2 Picture 1 100 psi

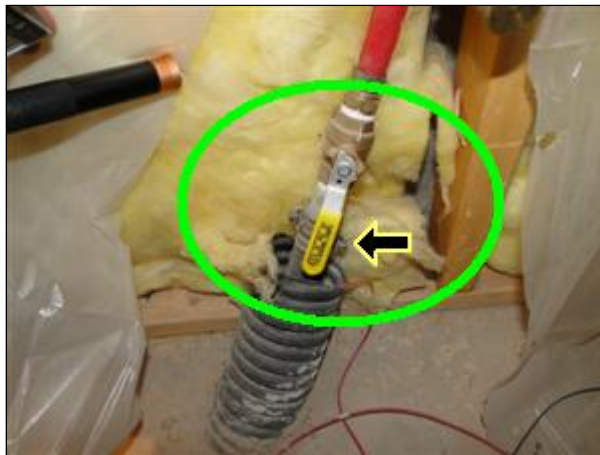
The main water shut off is located in the downstairs utility/mechanical room just to the right of the water heater. The ball valve has a yellow handle.

10.3 Picture 1 Water main shut off valve.

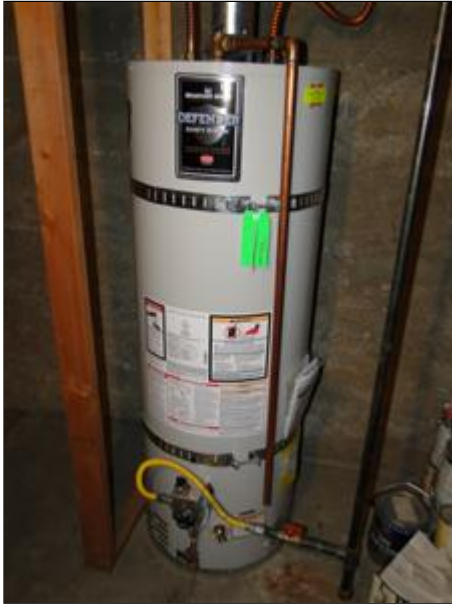
(1) The hot water heater was run for a heating cycle and completed it. The unit appears serviceable. View of combustion chamber and burner at time of inspection.

10.4 Picture 1 View of water heater.

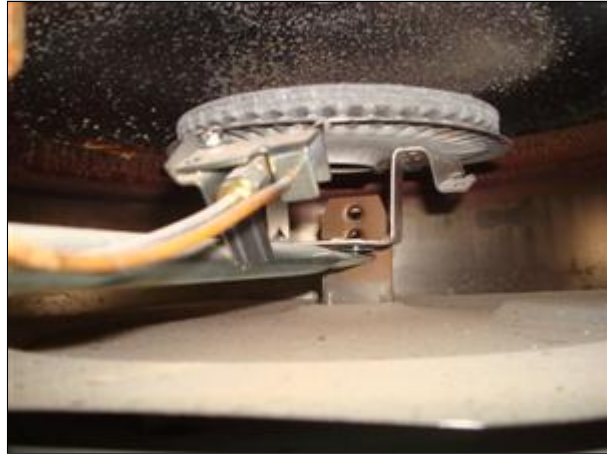
10.4 Picture 2 View of combustion chamber.

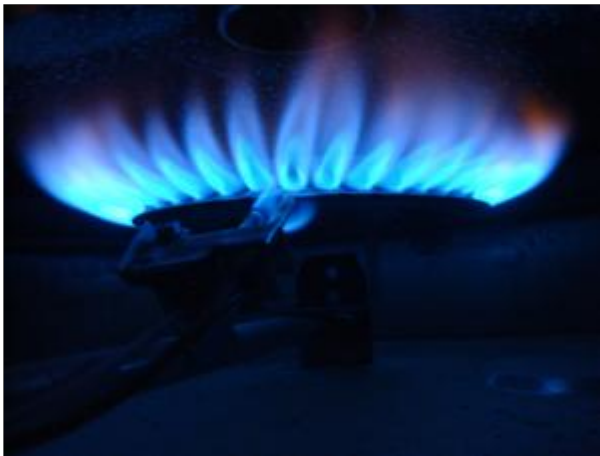
10.4 Picture 3 View of burner.

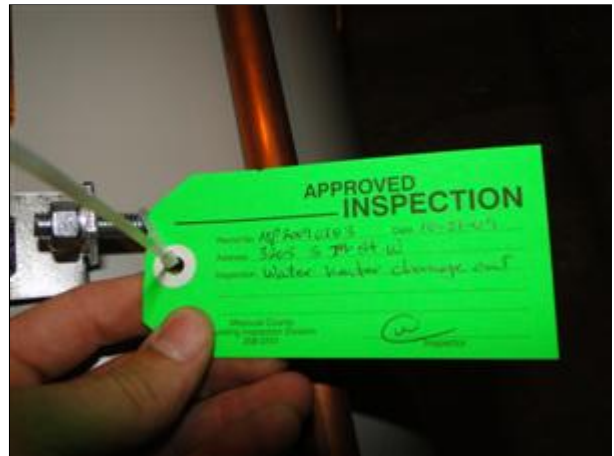
10.4 Picture 4 Inspection sticker is present.

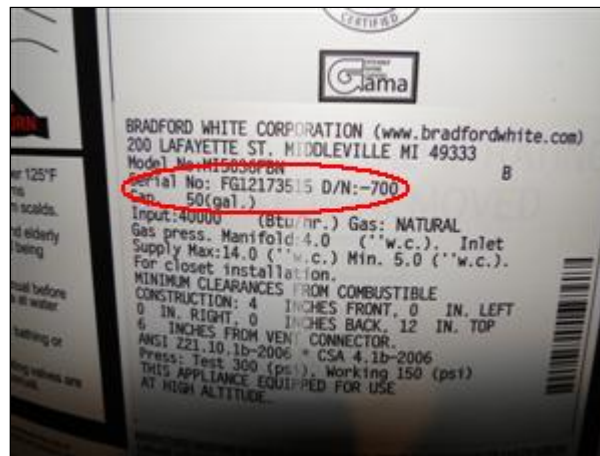
10.4 Picture 5 Serial # indicates 2005 mfg date.

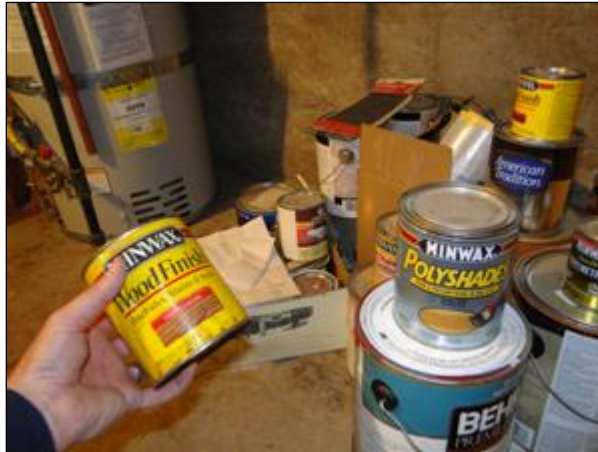
10.5 Picture 1 Paints and stains next to water heater.

Remove all flammable paints and stains from utility/mechanical room in the basement. Never store flammable items near the gas water heater or forced air furnace.

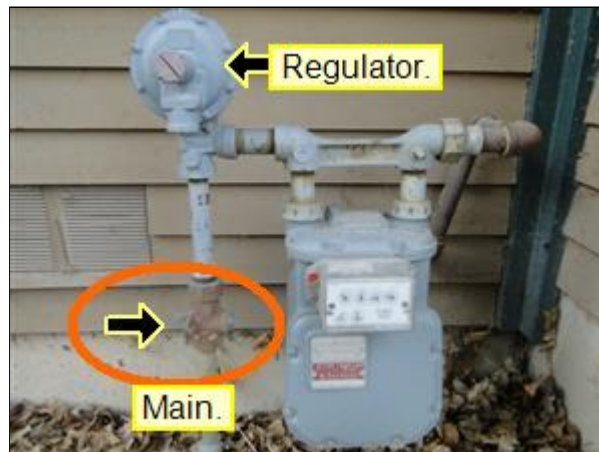
Main gas shut off is located on the south exterior of the home. The shut off valve is just below the round gas regulator.

10.10 Picture 1 Main gas shut off valve.

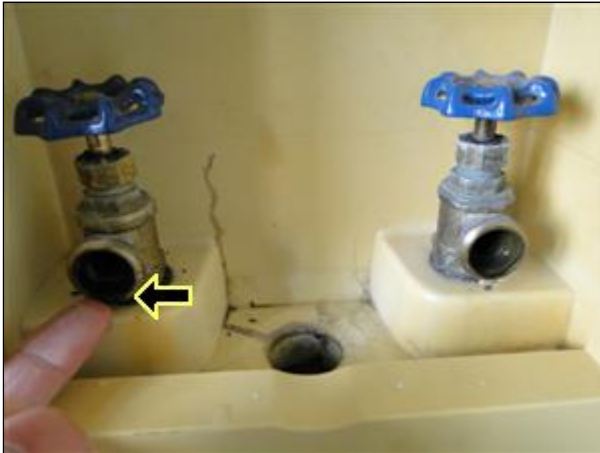
(1) Hot and cold water faucets at laundry box in laundry room have a drip leaks. Recommend a license plumber replace packing washers or replace faucets with new and test for leaks.

10.11 Picture 1 Drip leak here.

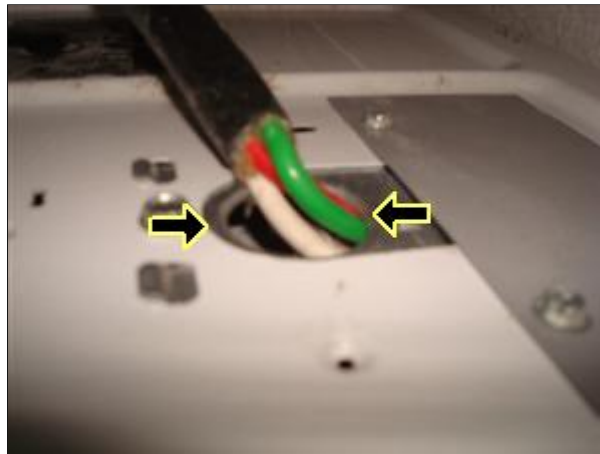
(2) The dryer power cord is missing wire collar where it enters the back of the dryer. This sharp opening may cut through the wire and pose a shock hazard. Recommend adding the proper wire collar clamp in this location.

10.11 Picture 3 Dryer missing wire collar.

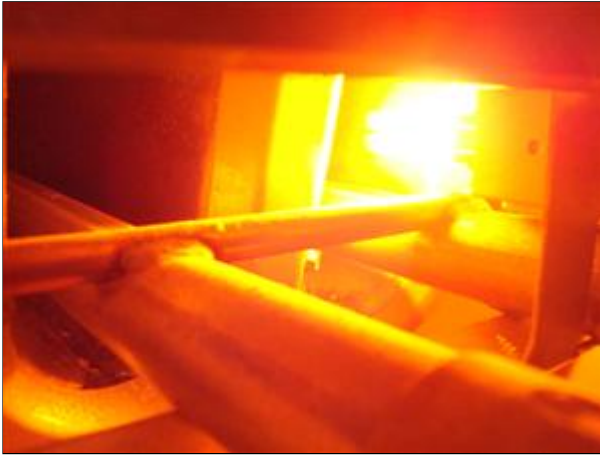
(1) Tested heating equipment for function and unit appears serviceable. Note: As always we recommend having the heating and cooling system serviced before move in and regularly there after by a professional HVAC specialist. View of ignitor and burners at time of inspection.

11.0 Picture 1 View of glow ignitor.

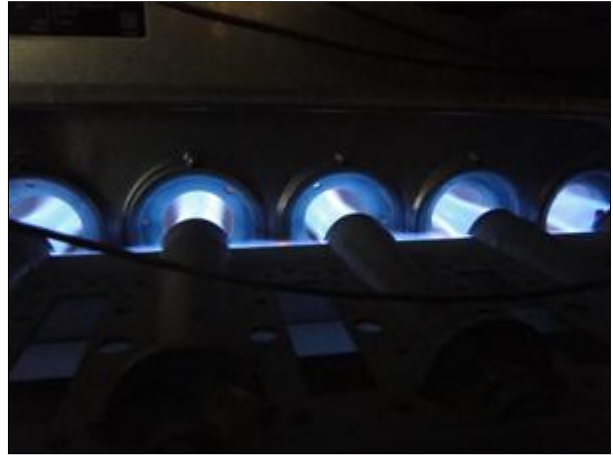
11.0 Picture 2 View of burners.

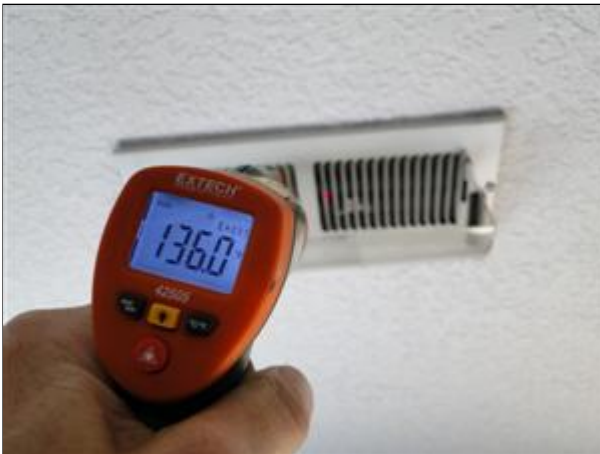
11.0 Picture 3 136 at upstairs ceiling vents.

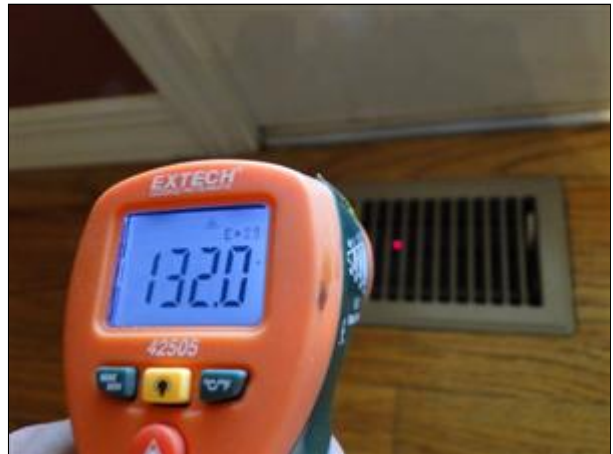
11.0 Picture 4 132 at main floor vents.

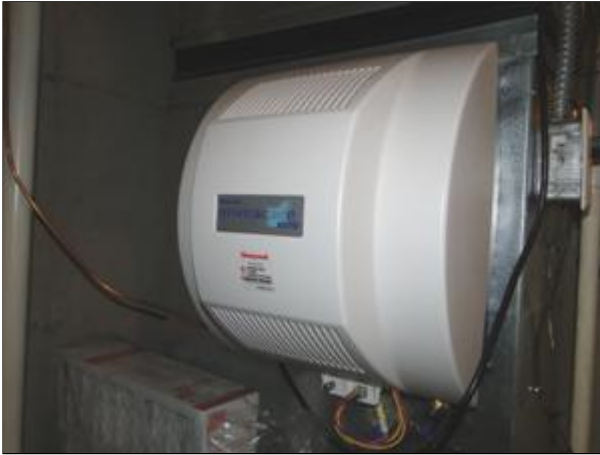
11.0 Picture 5 View of humidifier.

(2) Note: Your forced air heating system is equipped with a humidifier. Recommend reading the owners manual for the unit. Always follow cleaning and maintenance schedules to keep the humidifier pad and internal workings clean. This will help prevent the build up of mildew in the system which could possibly be spread through the forced air system.

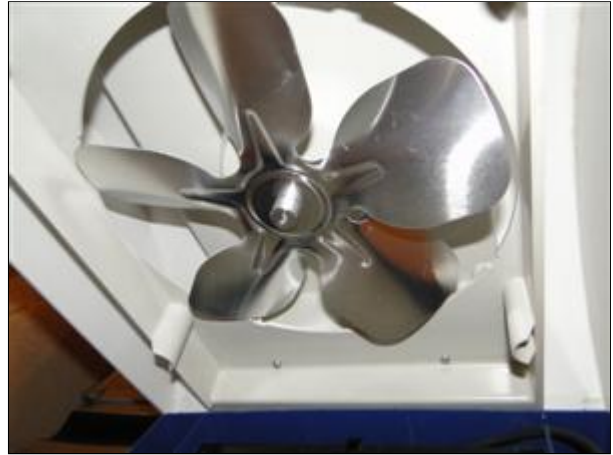
11.0 Picture 6 View of internal fan.
