# Inspection Report

**Property Address:**  
Wantamoveto MT St.  
Missoula MT 59804

**J&S HOME INSPECTIONS**

<b>Date:</b> 6/10/2012	<b>Time:</b> 08:00 AM	<b>Report ID:</b> 942
<b>Property:</b> Wantamoveto MT St. Missoula MT 59804	<b>Customer:</b> Mr. Joe Homebuyer	<b>Real Estate Professional:</b> John Thomas Montana Real Estate

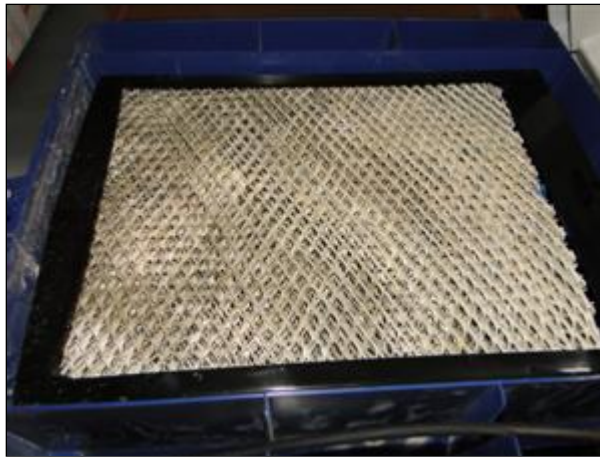
11.0 Picture 7 View of interior pad.

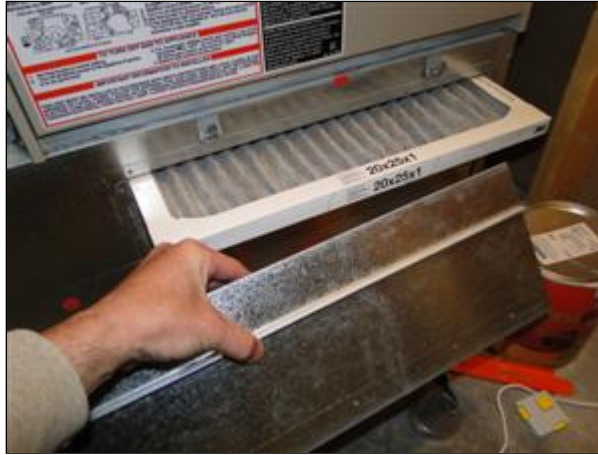
11.4 Picture 1 Filter located behind this panel.

(1) The filter for the heating unit is located between the return duct and the heating unit. Recommend changing the filter monthly when the unit is in use or per manufacturers recommendations.

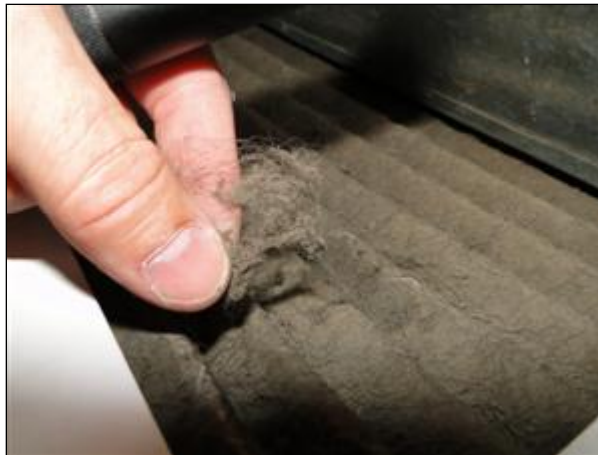
(2) The filter for the heating system is dirty and in need of replacement.

11.4 Picture 2 Filter is really dirty.

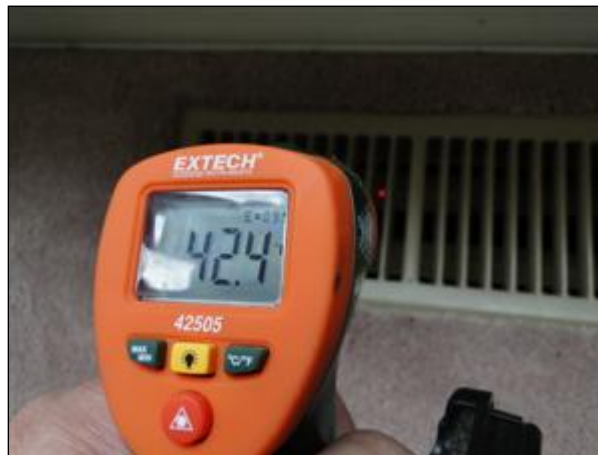
Tested air conditioning equipment for function and unit appears serviceable. Note: As always we recommend having the heating and cooling system serviced before move in and regularly there after by a professional HVAC specialist.

12.0 Picture 1 42 after 5 minute cool down.

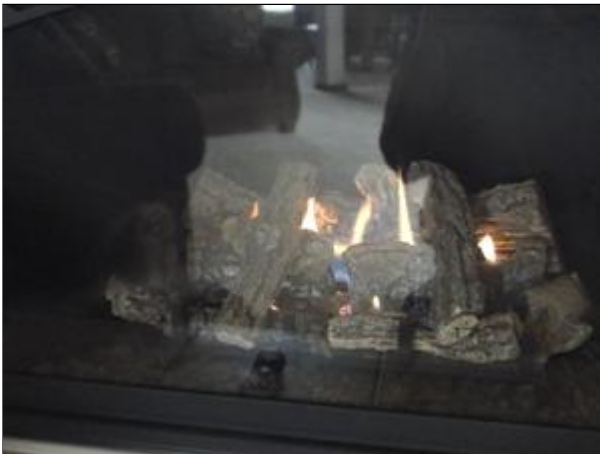
The vented gas log fireplace was tested for function and the unit appears serviceable. As always we recommend having the unit serviced by a HVAC specialist upon moving in and yearly thereafter.

13.1 Picture 1 View of unit on and functioning.

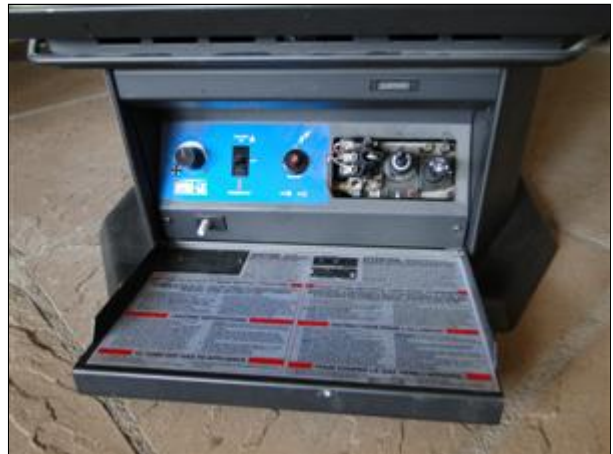
13.1 Picture 2 Controls located under bottom panel.
