LYCOMING

SERVICE INSTRUCTION

Service Instruction No. 1011L
(Supersedes Service Instruction No. 1011K
and obsoletes Service Instruction No. 1529C)
Engineering Aspects are
FAA Approved

SUBJECT: Tappets and Lifters
MODELS AFFECTED: All Lycoming engines
TIME OF COMPLIANCE: At overhaul or at owner's discretion
REASON FOR REVISION: Added new replacement part numbers

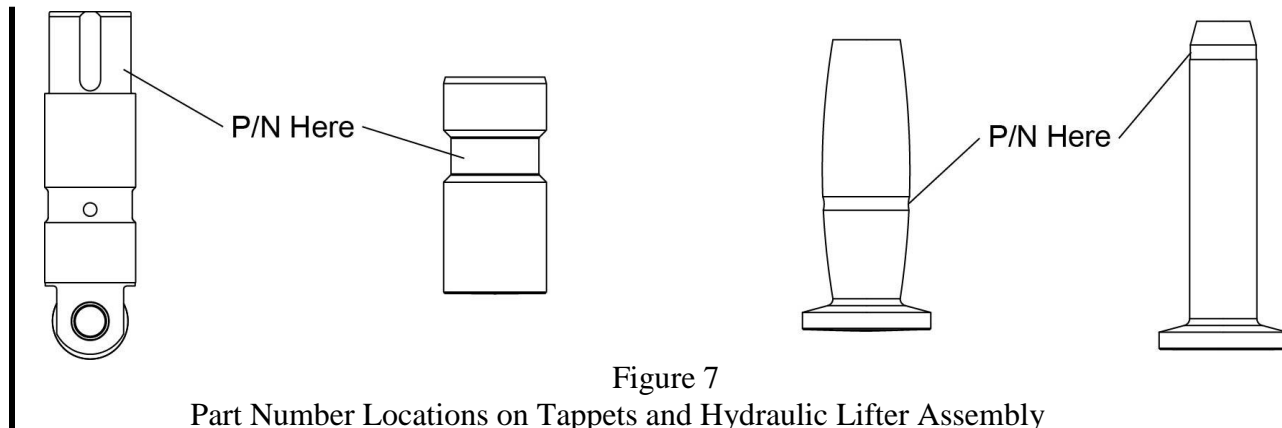
NOTICE: Figure 7 shows the location of part number stampings (the last 5 digits of the part number) of the various parts identified in Tables 3 and 4.

Part Number Locations on Tappets and Hydraulic Lifter Assembly

Task	Findings	Corrective Action
1. Examine the tappet body (and plunger on the tappet) for part number identification as shown in the illustrations in Figure 7.		If the part number cannot be identified, remove and replace the tappet body with a new tappet body.
