SWIMMING POOL DAMAGE INSPECTION REPORT

January 21, 2022

RE: Baycrest Homeowner's Association Property Tower Hill File #CLM0015504
25422 Galashields Circle
Bonita Springs, FL 34134 Omega Forensic File #20437

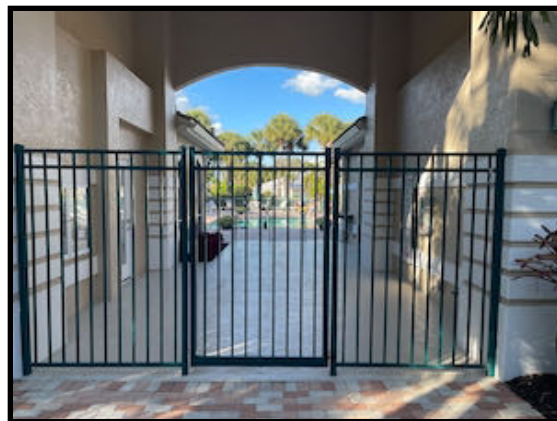
Entry Gate to Clubhouse Pool Area

- Entering the clubhouse pool area, we observed **no evidence of lightning damage to the exterior of the clubhouse building.** The stuccoed walls and windows appear to be intact and in good condition. The stuccoed ceiling over the gated entry area is intact, with no indications of cracking.

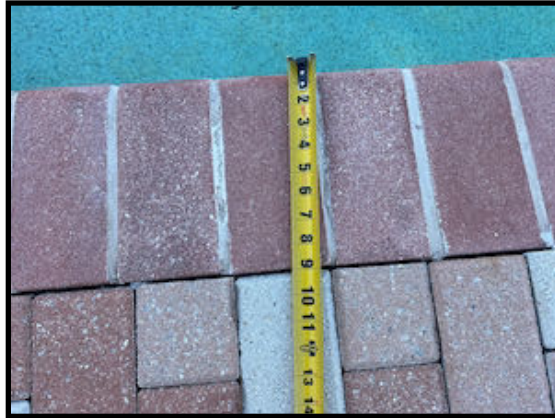
- From ground level, we could see that the **tiled roof over the clubhouse building** appears to be in good condition, with no signs of damage from a lightning strike. The gutters and downspouts around the perimeter of the roof also appear to be intact and in place.
- We could see the in-ground swimming pool is surrounded by **brick coping and a brick paver deck**. There is no evidence of lightning-related damage to the brick pavers or the coping.
- We took measurements around the edge of the pool and found that **the coping bricks are about 9 inches long**. This is an indication that the pool shell beneath the coping is likely about 7 or 8 inches thick.

Measuring Coping at Edge of Pool

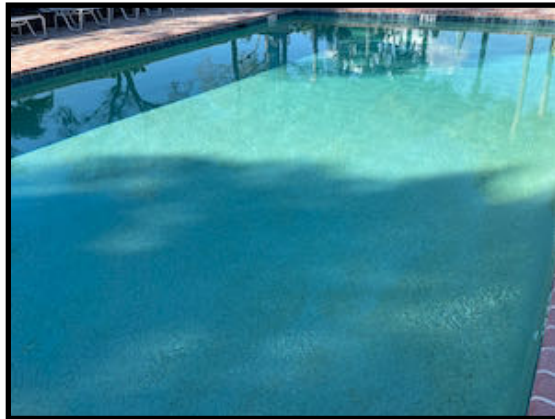
View Inside Swimming Pool

- We could see that the **rectangular swimming pool** has a shallow end on the south side that is approximately 3 feet and 6 inches deep, and a deep end on the north side that is about 6 feet deep. The shell of the swimming pool has a marcite coating with a pebble finish.

- We observed **11 bulges in the pool shell**, including 6 on the east side of the pool, 4 on the north side of the pool and 1 on the west side of the pool. There is no evidence of bulges in the pool shell at the south end of the pool that is closest to the clubhouse. We numbered the individual bulges and marked their approximate location inside the pool shell in the diagram included in page 2 of this report.

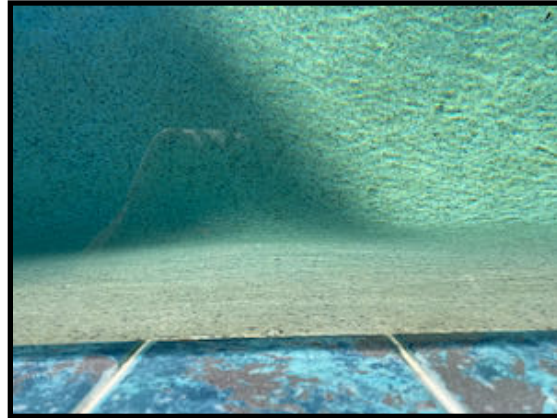
Another Bulge on East Side of Pool

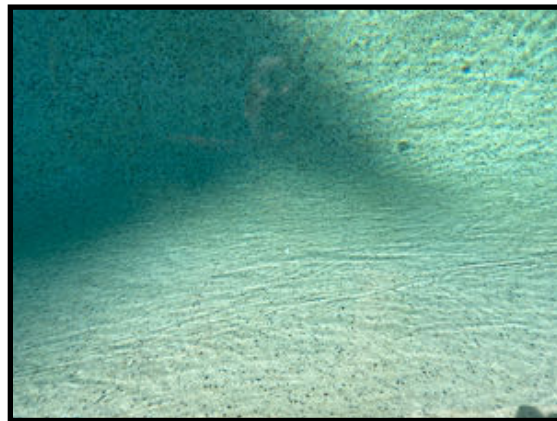
Closer View of Bulge in Pool Wall

- We noted that some of the bulges along the east side of the pool exhibit **white spots near their center that appear to be calcium deposits.**

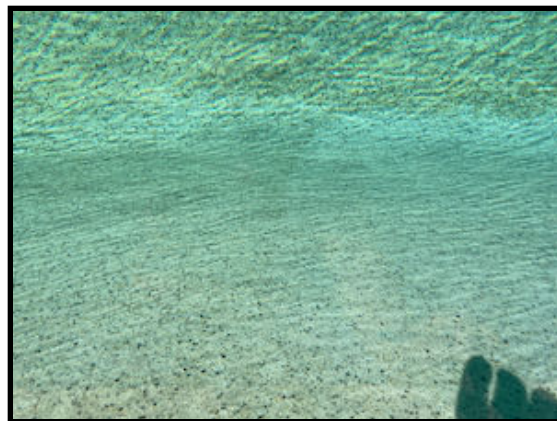
Closer View of Bulge in Pool Wall

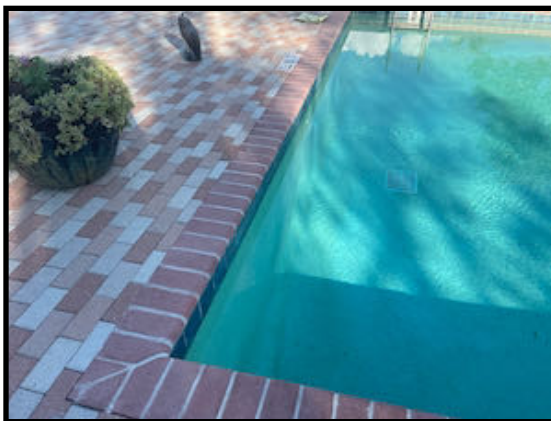
Overview of Bulges at North End of Pool

The claimed damage at the property consists of eleven bulges in the pool finish that vary in diameter and in the depth that they project out from the pool walls. These bulges are consistent with pool finish delamination that can typically develop due to improper prepping or application of the finish material that was applied to the original pool shell. We noted that some of the bulges inside the pool exhibit white spots near their center that appear to be calcium deposits. This is another common condition that is evidence of routine pool finish failure. The gentleman who accompanied us during our inspection told us that the pool is not losing water, which is an indication the underlying pool shell and piping is still intact and was not ruptured or damaged by the reported lightning strike. In our judgement, it would require destructive testing in the pool to further investigate the cause of the pool finish failure but this type of pool finish failure is not unusual for pool finishes as they age.

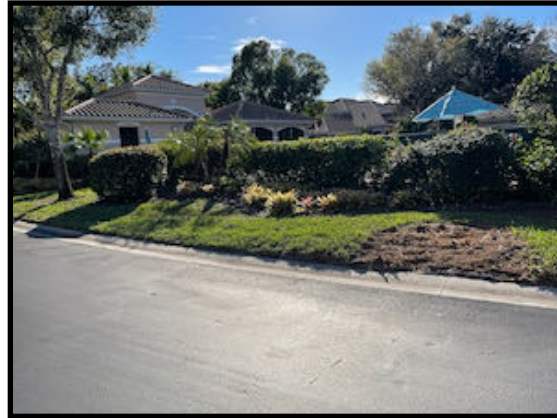
Outside Pool Area Viewing Towards Stump Area

ground in this area that is located directly next to the road. The tree stump is located outside the fence of the pool area and is approximately 30 to 35 feet away from the closest edge of the pool shell.

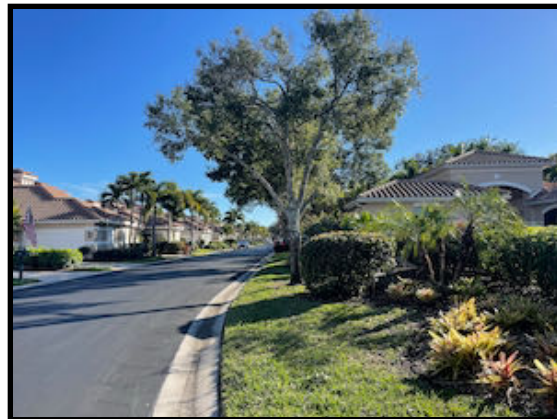
Two Trees on East Side of Pool Area

- We could see there are **two trees** next to the road that are located just south of the tree that was reportedly struck by lightning. Both of these trees have canopies that are approximately 30 feet in diameter. Typically the root system of a tree extends

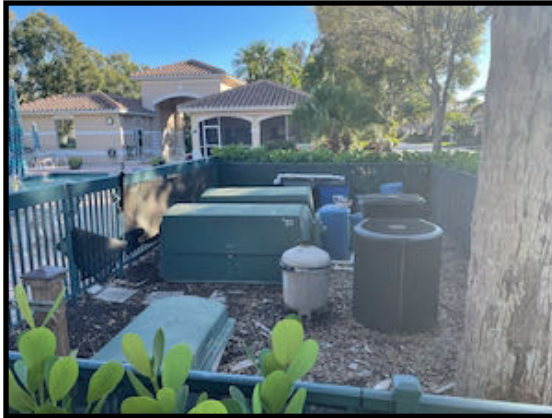
Pool Equipment on West Side of Pool Area

- The **pool equipment** is located within a fenced area on the west side of the pool deck. There is no evidence of lightning damage to the pool equipment, and none has been reported by the Association.
- The gentleman who accompanied us pointed out the property across the road from the tree that was reportedly struck by lightning and told us **the owner of the home reported that one or two palm trees in his yard died as a result of the lightning strike.** We noted there are many other palm trees in closer proximity to the tree that was reportedly struck by lightning that show no indications of damage.

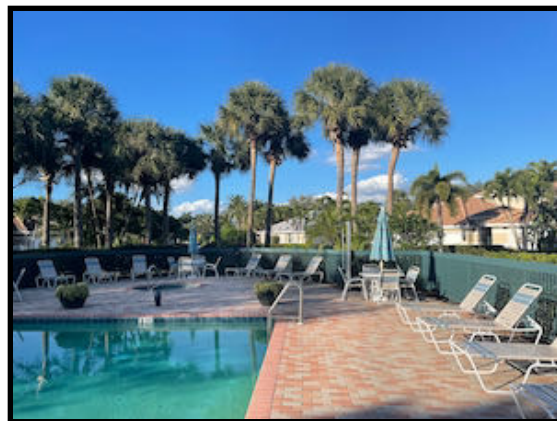
Multiple Palm Trees Near Pool Area Appear Intact
