Part IV: BARANGAY SURVEYS, PENINSULAR & NEAR ISLANDS Methodology

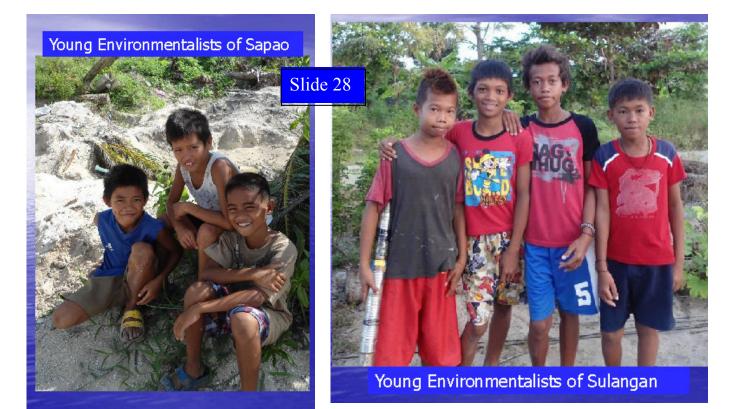
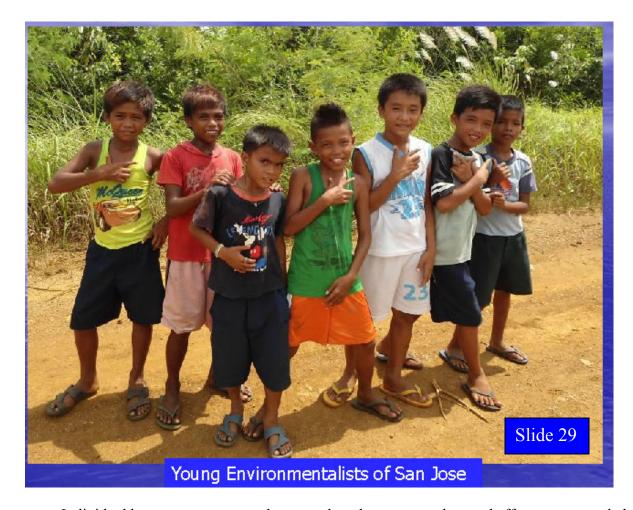
In many instances, one individual or groups of young environmentalists were eager to give the surveyor a complete tour of the barangay and a comprehensive inventory of the wells Slides 28 & 29). In Barangay San Jose on Manicani Island, the elementary school allowed a group of students to accompany and assist in the field work. The surveyor hopes the short course in environmental field methods was helpful. It was particularly beneficial to the purposes of the survey and assessment to identify an individual with extensive knowledge of local water resources and issues. Often a resident was very interested in hearing my concerns about cross-contamination between wells. The survey methodology, while concentrating on the collection of specific location and quality data, was conducted to allow time to discuss with the residents their concerns and issues related to the environment.
