# Property Inspection Report

123 Main Street

Unit T1

**Terra Home Inspections LLC**

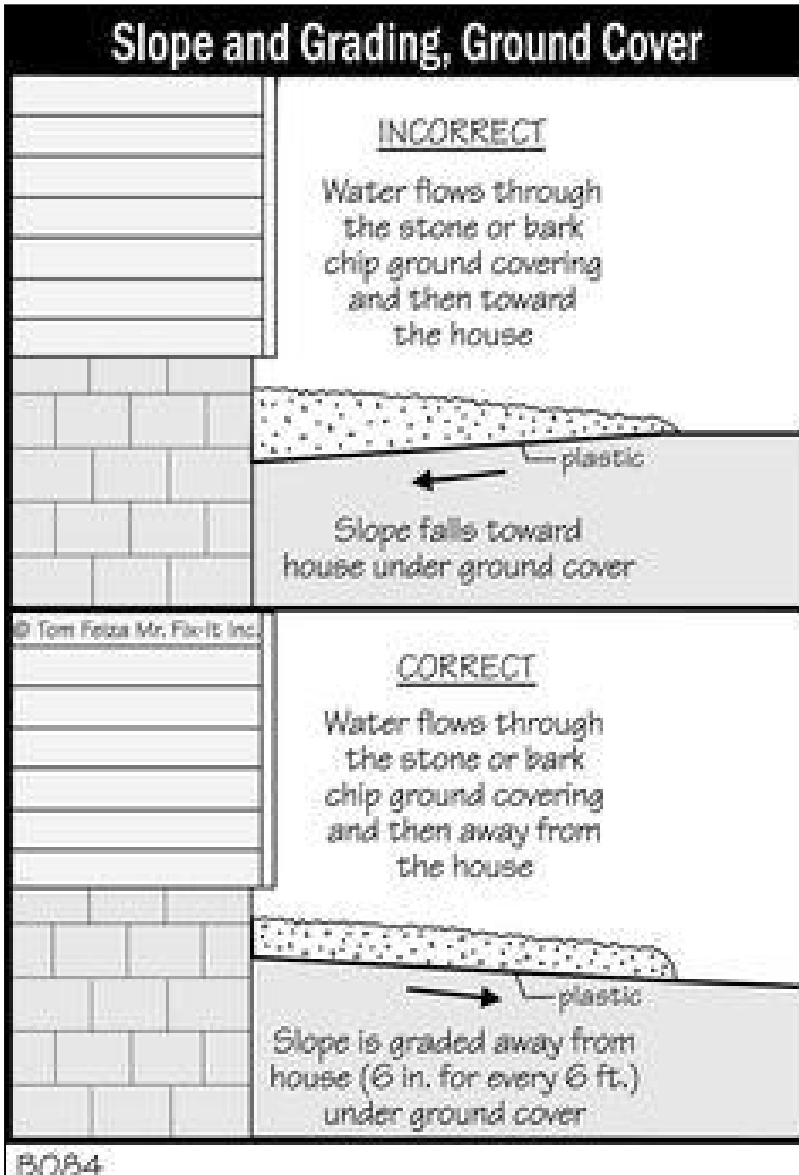
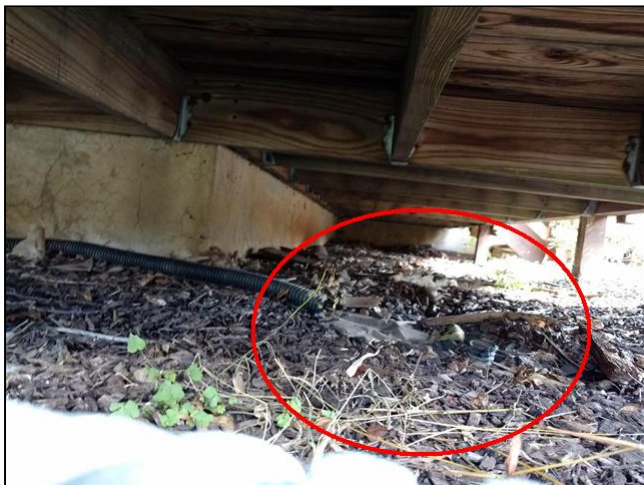
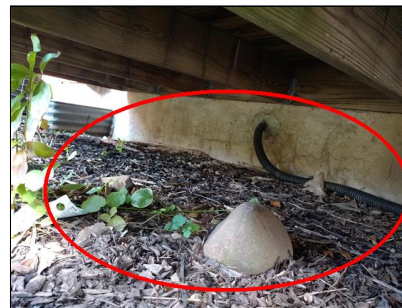
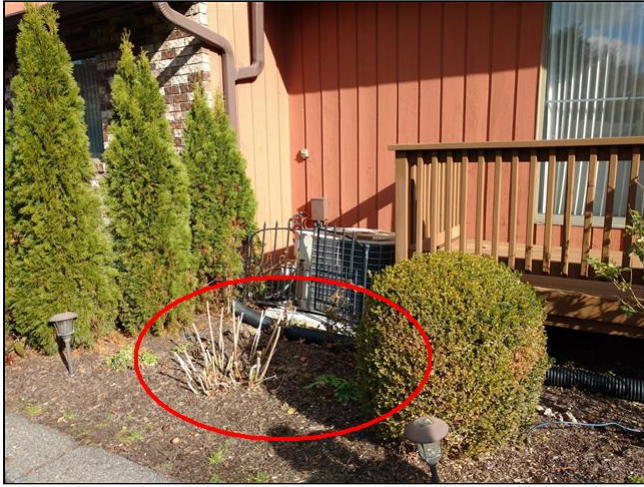
The grading (slope of ground surface) next to the foundation under the deck areas was pitched towards the foundation. The grading whenever possible should be pitched away from the foundation to prevent moisture intrusion from entering the foundation walls and basement. Recommend further evaluation of all of the exterior grading by a qualified, licensed contractor and repair as necessary.

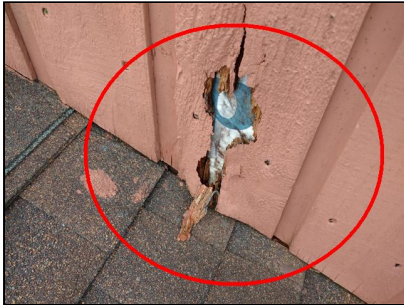
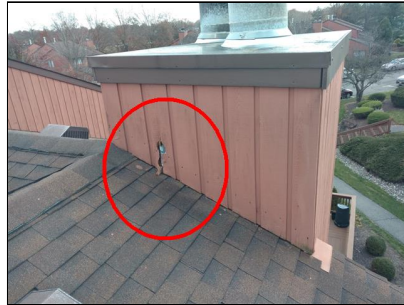
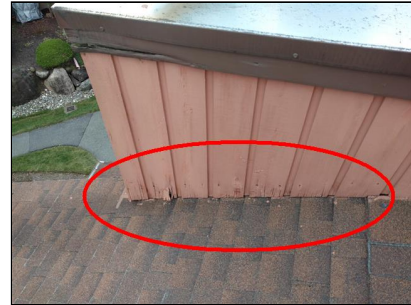
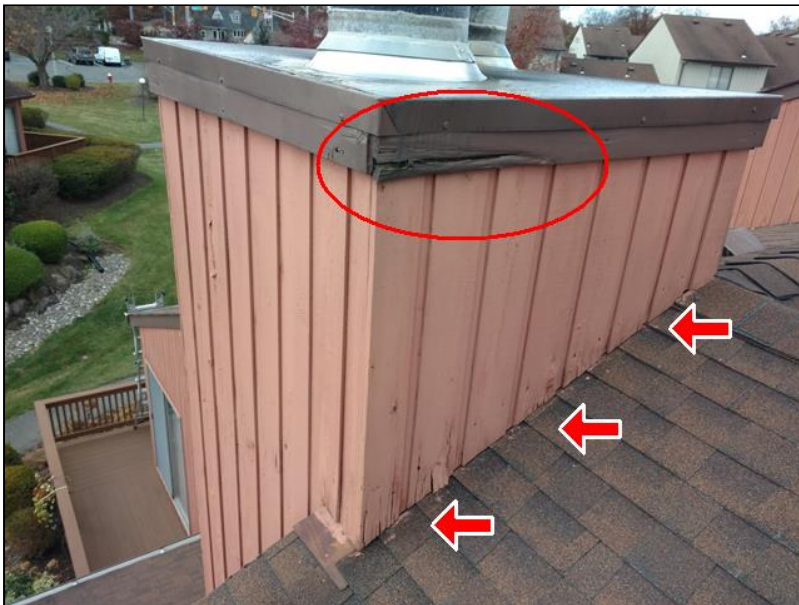
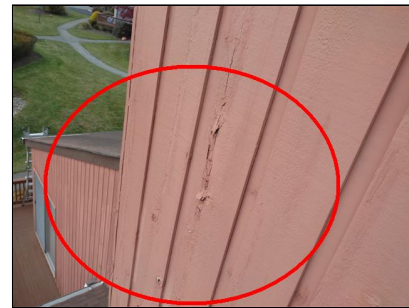
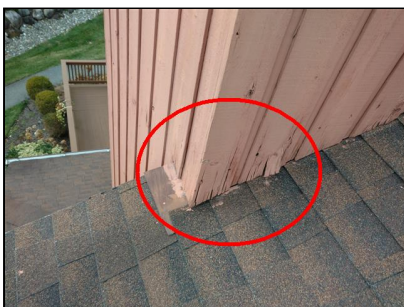
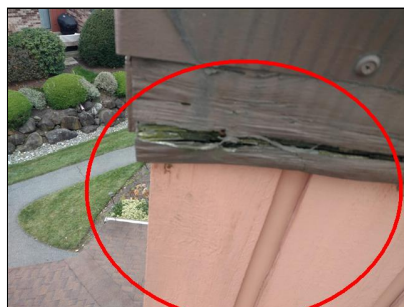
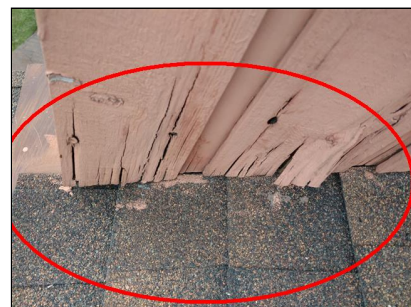
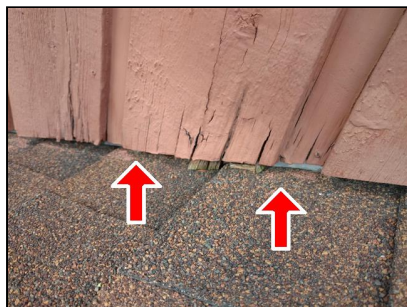
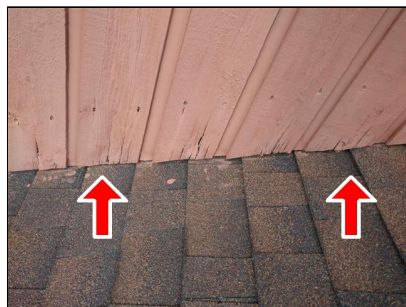
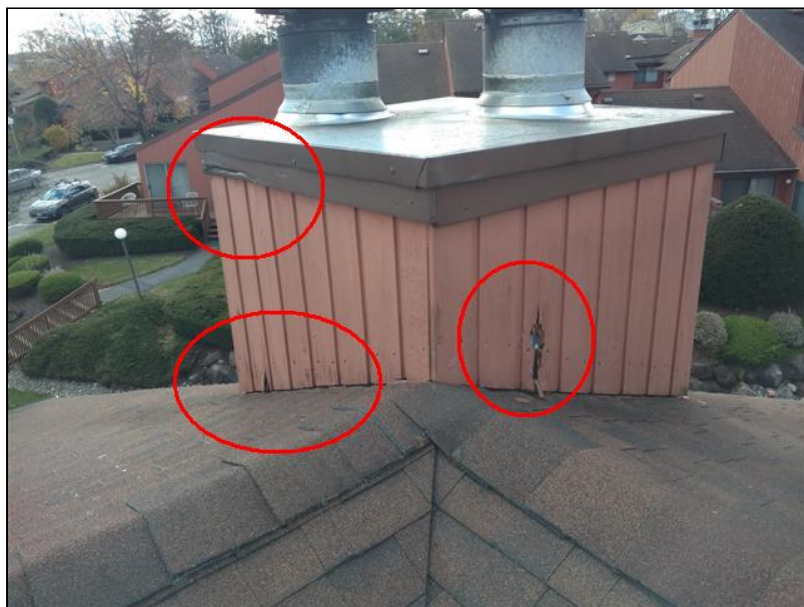
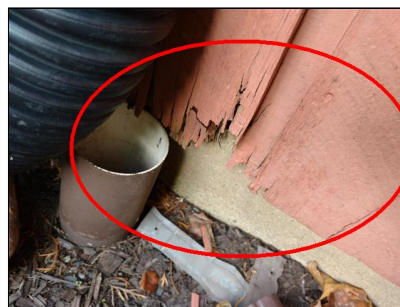
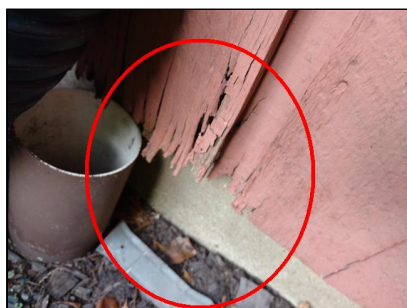
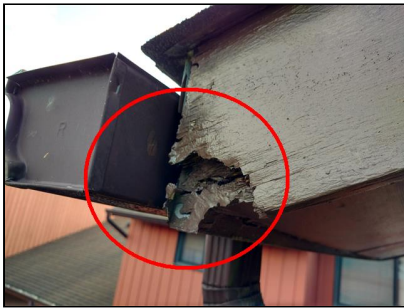
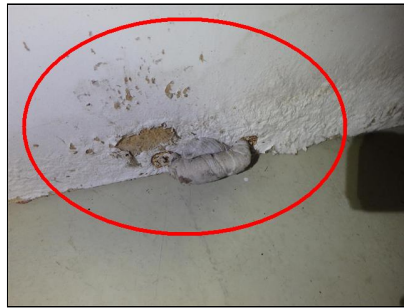
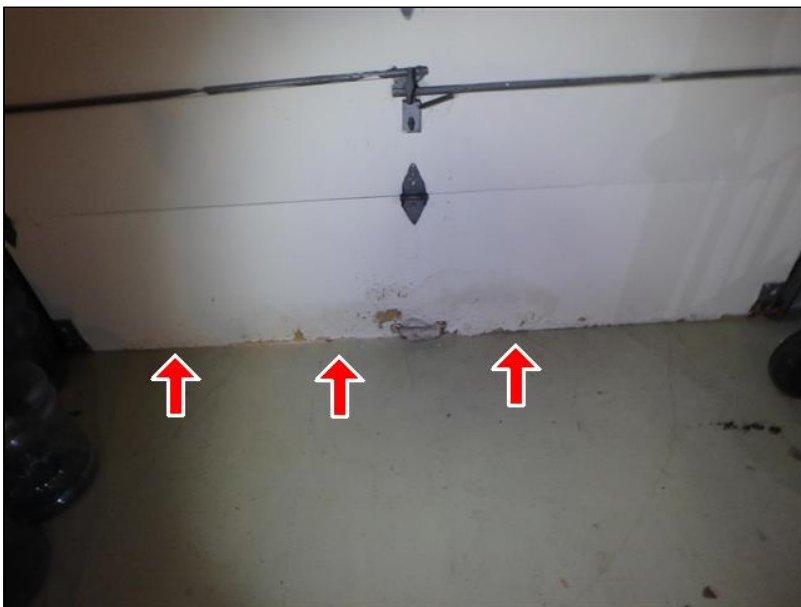
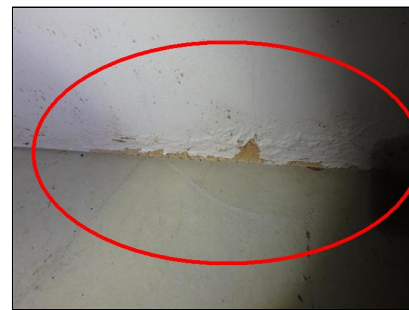
As observed on the exterior that affects the dwelling, there were portions of some of the exterior elements (windows, window frames, window flashings, doors, door frames, door flashings, siding/cladding, masonry, brick and/or stone veneer, trim, framing, flashings, eaves, fascias, soffits and/or gable ends) that were either missing, had open gaps/holes/unsealed joints, were not functioning as intended, were deteriorated/damaged and/or had a peeling paint condition. The condition of the noted elements/areas may worsen as well as possible structural/moisture damage behind/under these elements could occur if the needed repairs are not completed. Damage to the interior finishing materials may also occur. A further evaluation of the **ENTIRE exterior of the dwelling** should be completed by a qualified, licensed contractor and the necessary repairs be completed. **There may be hidden moisture damage, deterioration and/or wood destroying insect damage within the structure behind/under the effected exterior elements that was not visible at the time of the inspection.**

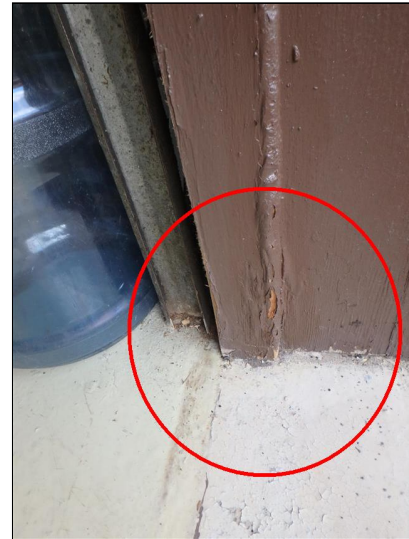
2.0 Item 14 (Picture) Basement window frame deteriorated

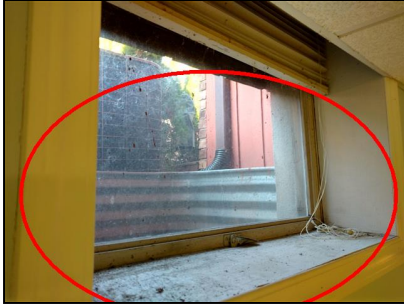
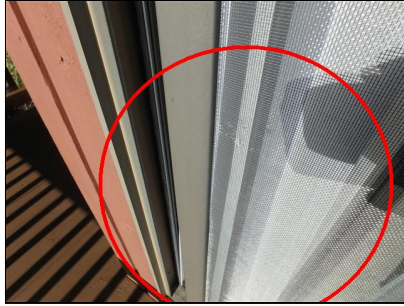
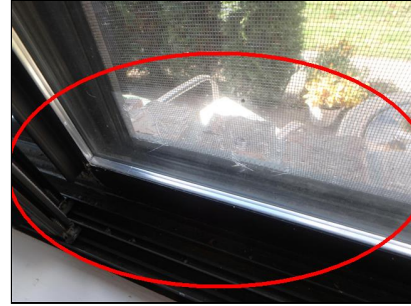
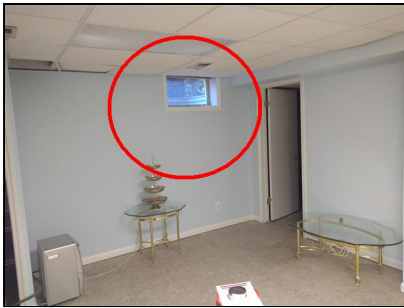
(2) Some of the window and door screens were ripped. Also the basement window would not open. Recommend further evaluation by a qualified, licensed contractor and repair as necessary.

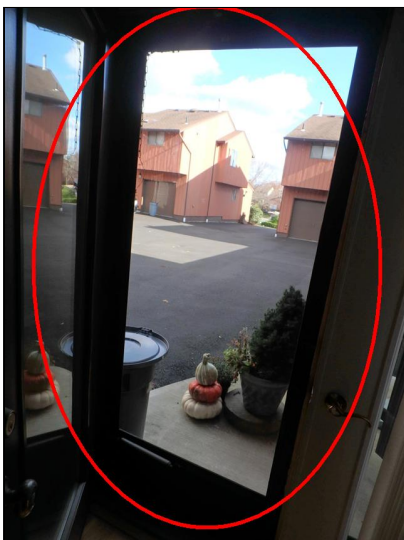
2.4 Item 1 (Picture)

(2) The self closer on the rear storm door was not functioning. The door was slamming shut when opened. This is a safety issue as someone could be injured by the door slamming shut. Recommend further evaluation for repairs by a qualified, licensed contractor.

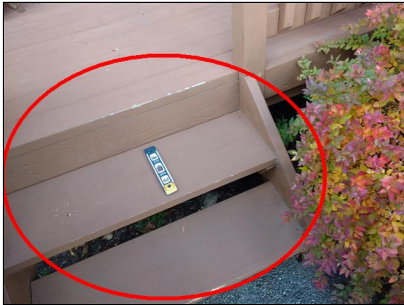
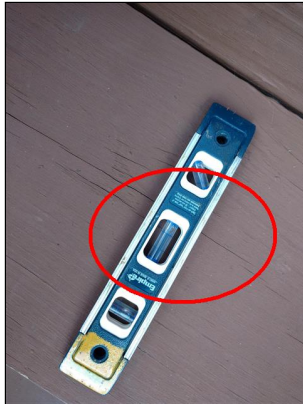
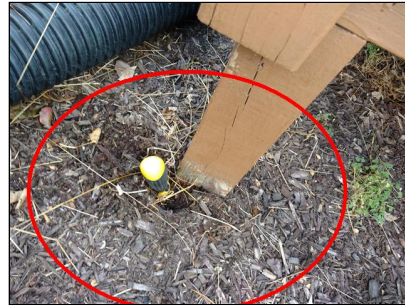
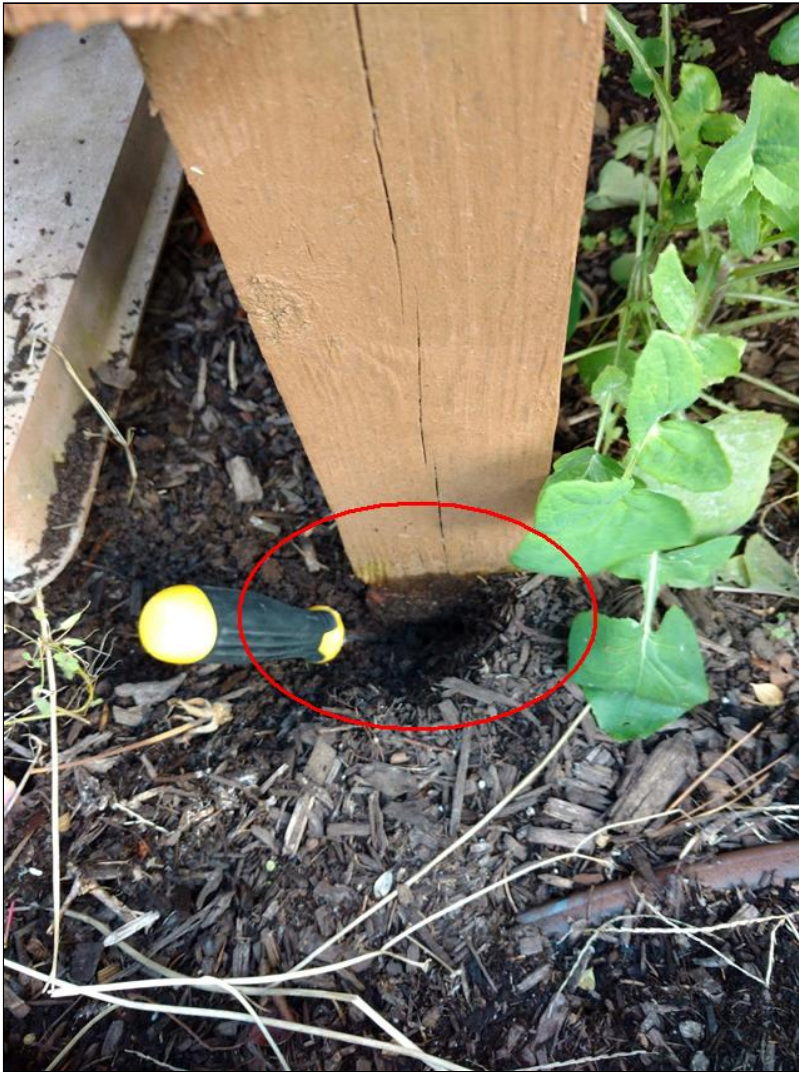
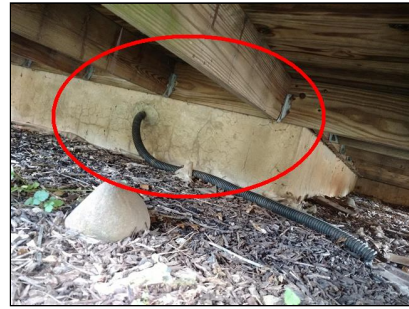
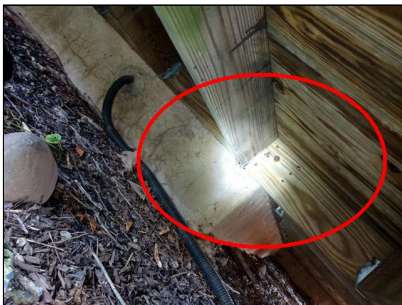
There were numerous issues were observed pertaining to the wood deck. They included:

- 1) There were no top of support post to beam and no stair stringer to the deck structure mechanical connectors present.
- 2) There were no visible footings under some of the support posts.
- 3) The stair treads were sloping downwards which is a safety concern.
- 4) Some of the joist hangers were rusted.

These are safety concerns. These conditions may also worsen if the needed repairs are not completed. The support posts may deteriorate. A further evaluation of the ENTIRE deck should be completed by a qualified, licensed deck contractor and the necessary repairs be completed.

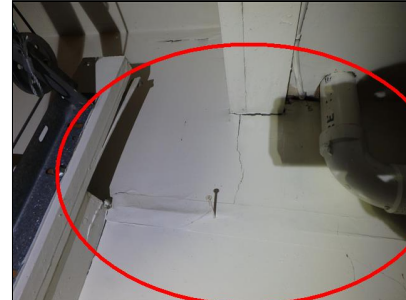
3.9 Item 2 (Picture)

Portions of the walls and/or ceiling surfaces in the garage had numerous cracks, gaps, unsealed joints, deteriorated/damaged areas, holes and/or missing sections. The garage space should be 100% sealed off to the living space to prevent possible carbon monoxide from a vehicle from entering the living space above and also from a fire block standpoint. These noted conditions may worsen if the needed repairs are not completed. Recommend further evaluation by a qualified, licensed contractor and repair as necessary..

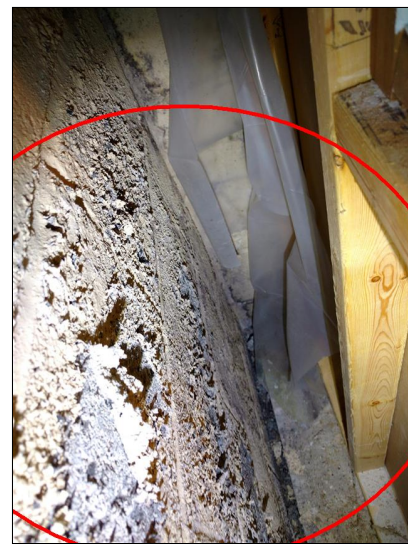
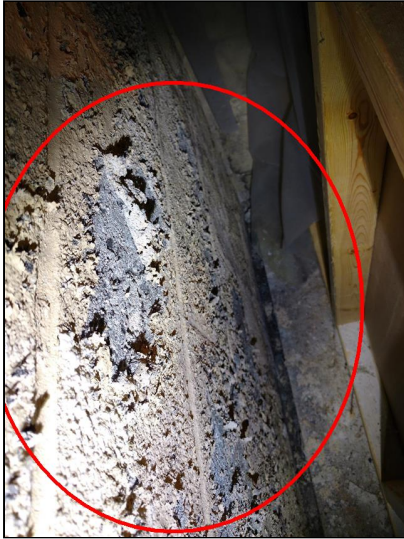
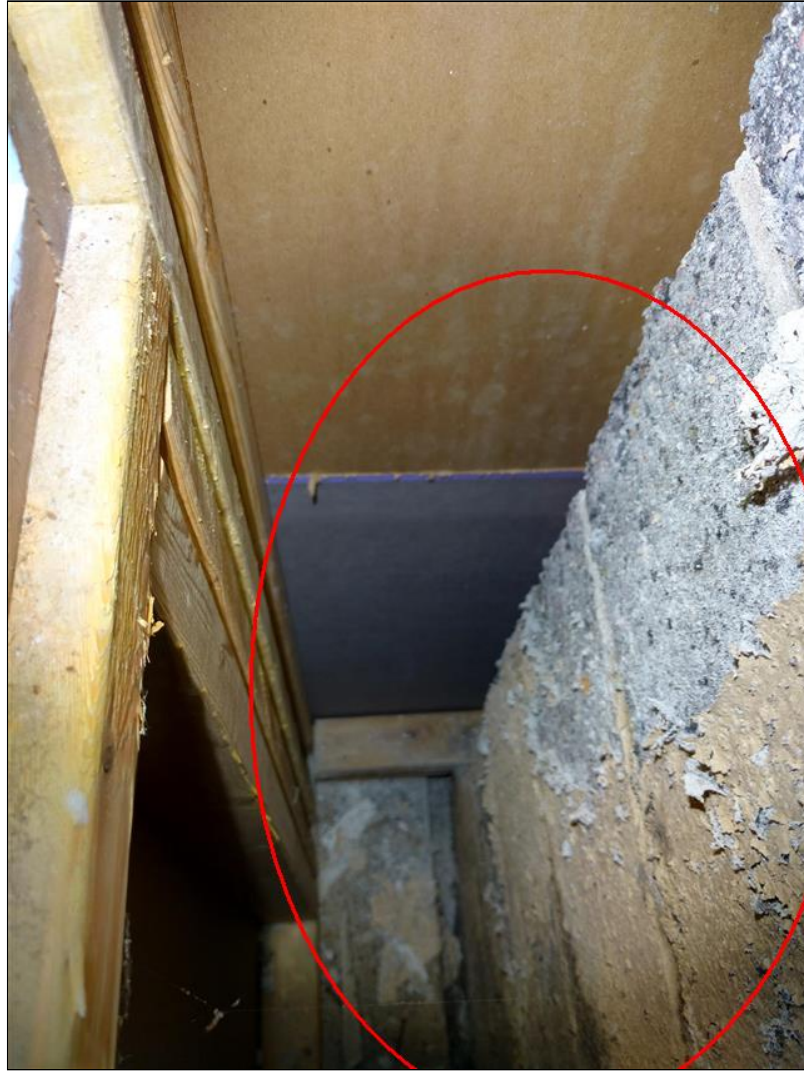
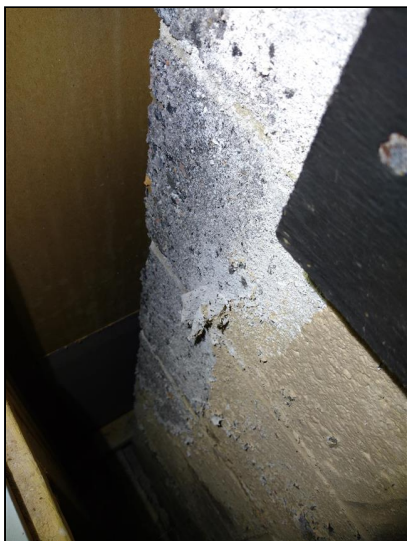
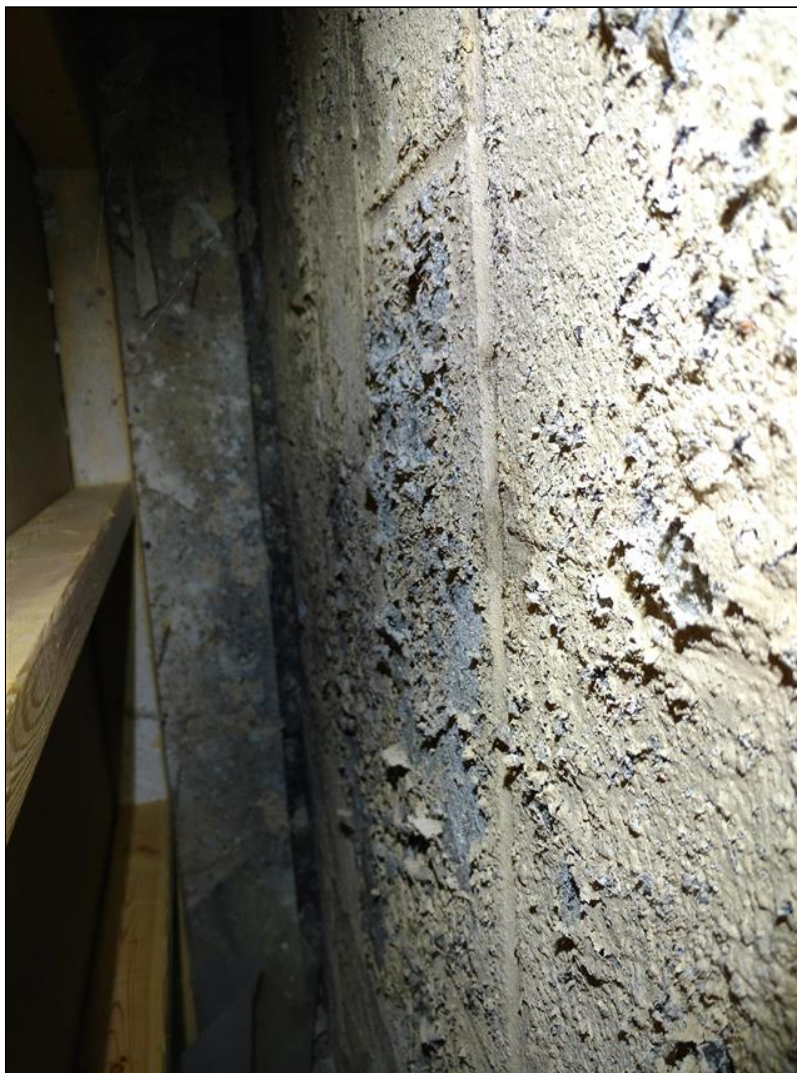
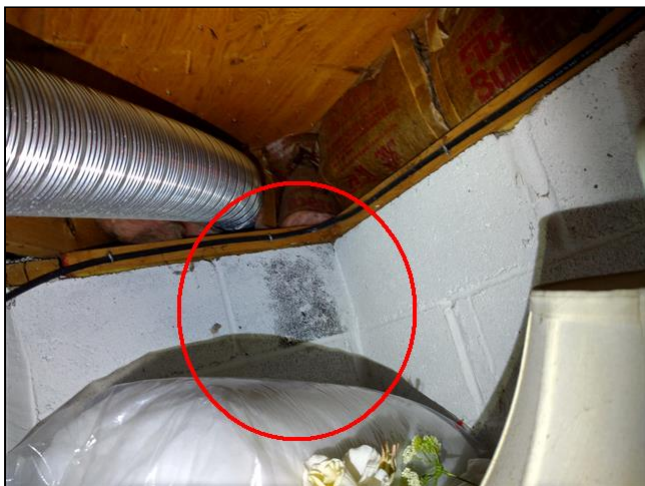
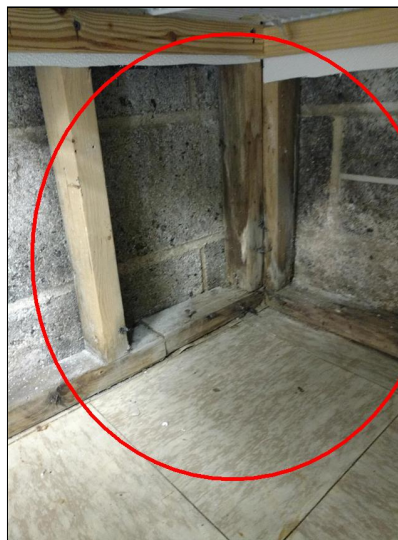
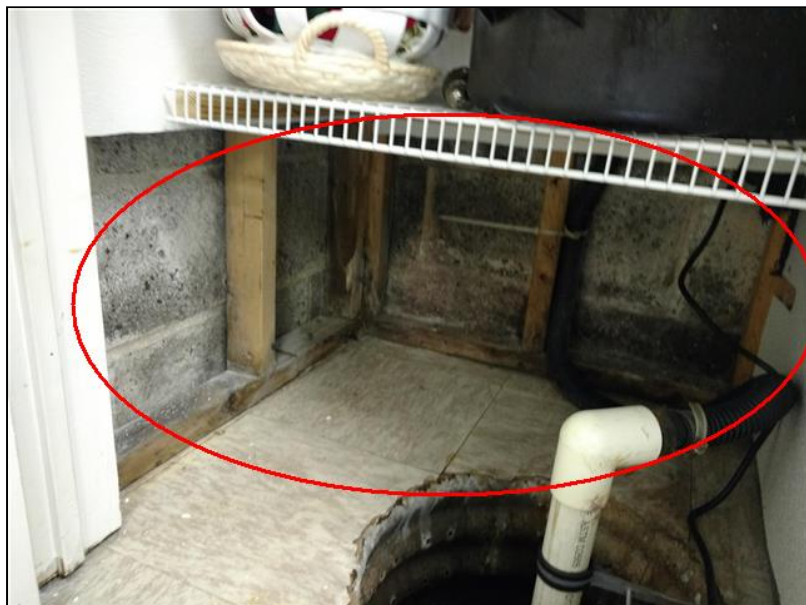
(1) As observed in some of the visible portions of the foundation in the basement, there was evidence of moisture intrusion (efflorescence, staining, peeling paint and/or mortar decay) observed on the foundation walls. Moisture can create high humidity, mold & can damage stored items & finishing materials. There may be some drainage and/or grading issues on the exterior that are contributing to these condition(s). The noted conditions may worsen any needed repairs are not completed. A further evaluation of the entire foundation (both interior and exterior) should be completed by a qualified, licensed masonry contractor and the necessary repairs be completed. **This condition may also exist behind finished basement walls/floor coverings. It may be less severe or worse than what was visible.**

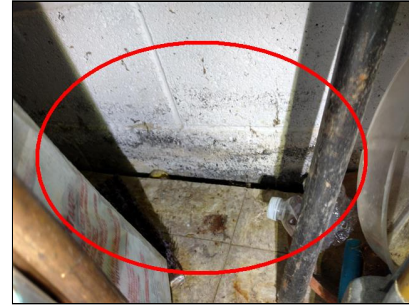
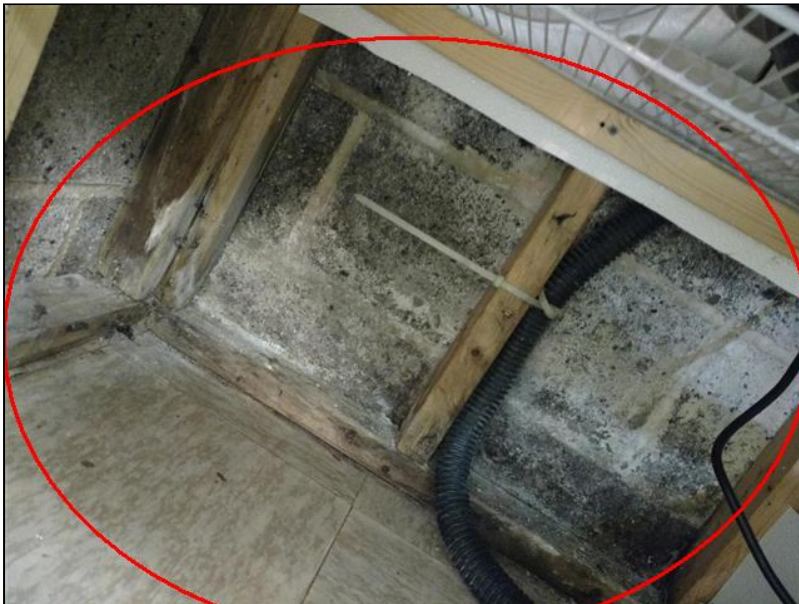
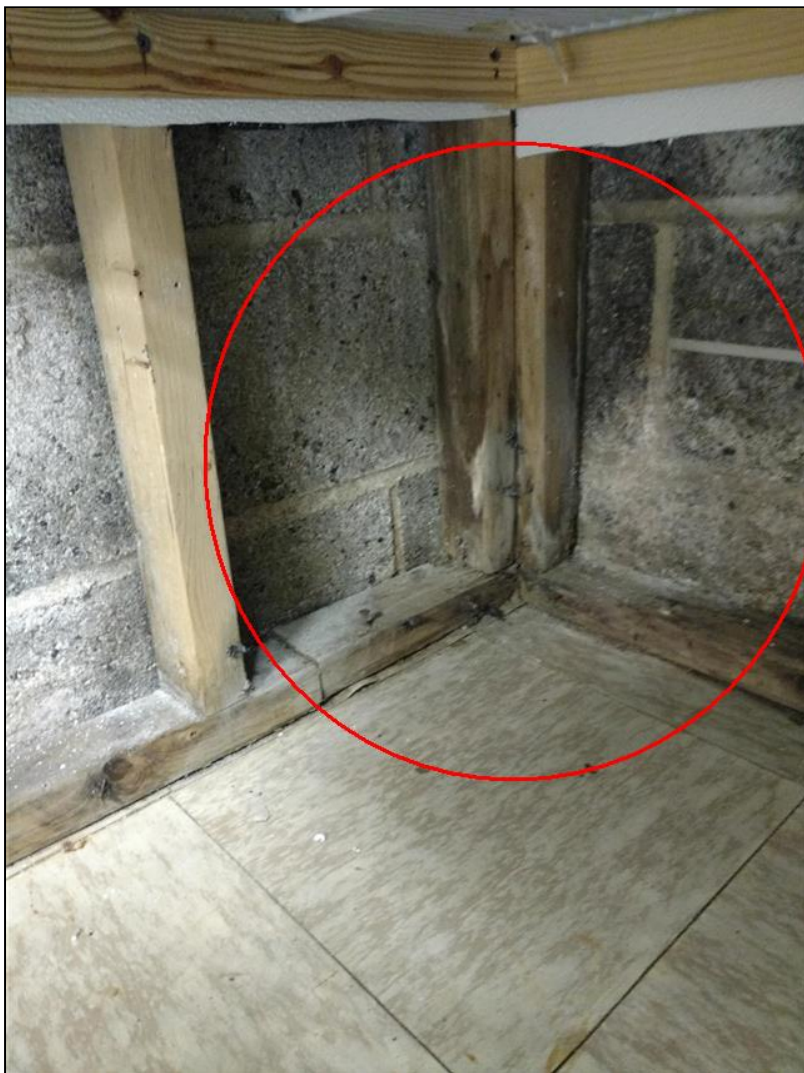
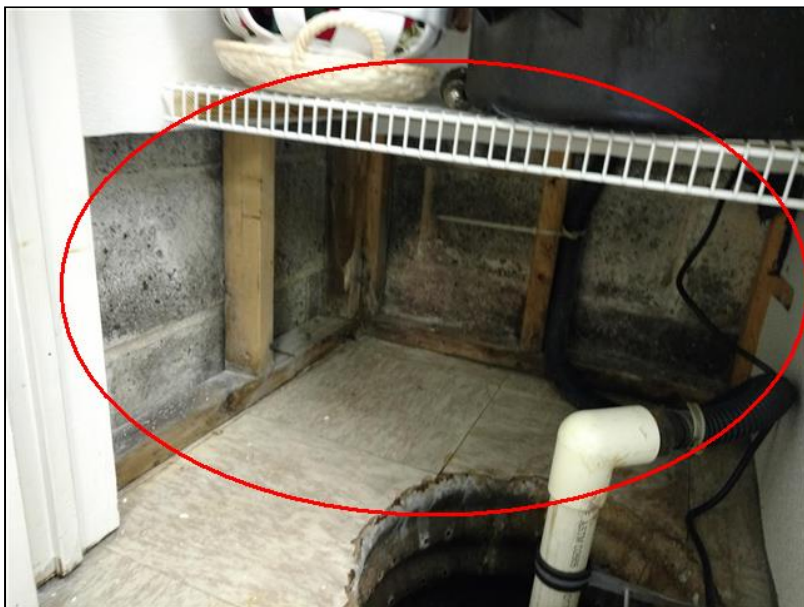
(2) There was what appeared to be a black organic growth condition (possibly mold) on the visible portions of the foundation walls and finished wall structure in the basement. This is a potential health concern as molds have the potential to cause numerous health problems. Molds produce allergens (substances that can cause allergic reactions), irritants, and in some cases, potentially toxic substances (mycotoxins). Inhaling or touching mold or molds spores may

cause allergic reactions in sensitive individuals. These conditions may also worsen if any needed repairs are not completed. **A further evaluation/testing of the ENTIRE basement should be completed by a qualified, licensed environmental contractor and any necessary repairs/remediations be completed.** Additional information from the US EPA pertaining to mold in the home can be review at <http://www.epa.gov/mold/moldbasics.html> **This condition may also exist behind finished basement walls/floor coverings. There may be hidden damage. It may be less severe or worse than what was visible.** Also to note, the walls inside the closet that houses the sump pump were covered with fiberglass reinforced plastic (FRP) panels. This is not typical as finished wall are usually covered with drywall. They may have done this because the drywall may have been getting mold on it because of the high moisture within this closet.

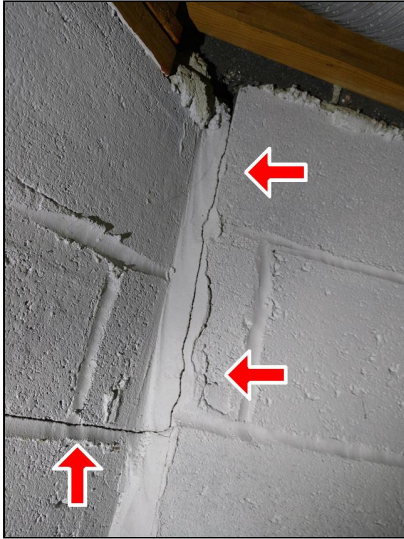
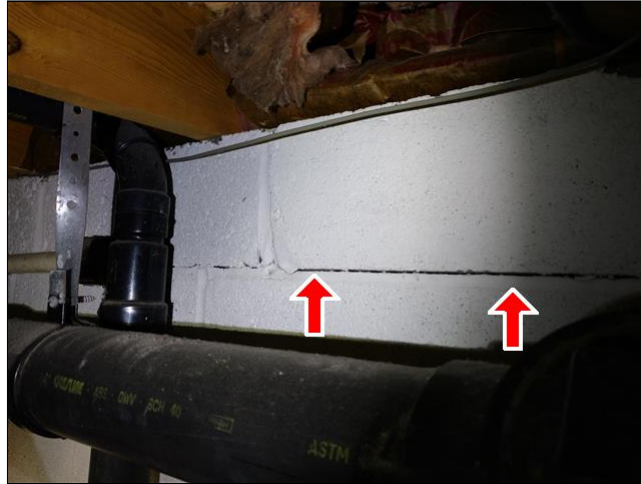
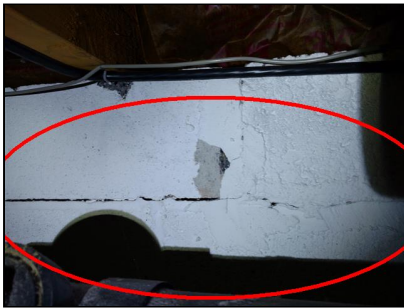
(3) There were numerous cracks and/or deteriorated areas present on some of the visible portions of the interior and/or exterior foundation wall surfaces. These conditions if not repaired may lead to possible moisture intrusion into the foundation walls and the basement along with possible deterioration of the foundation walls and the interior finishes of the house. These conditions may also worsen if the needed repairs are not completed. A further evaluation of the ENTIRE foundation (both interior and exterior) should be completed by a qualified, licensed structural contractor and the necessary repairs be completed. **These conditions may also exist behind finished basement walls/floors. They may be less severe or worse than what was visible.**

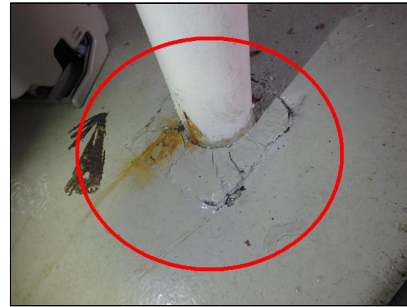
4.1 Item 3 (Picture)

As observed in the garage, one of the steel lally support columns appeared to have numerous rust stains/scabs/cracks towards the bottom of it. This condition is usually caused by moisture that is moving up from the garage floor and through the cement that inside the steel lally column due to capillary action. The inside of the column then rusts out and holes develop. These little scabs then start to allow moisture to weep out and run down the sides of the column. Over time a few things couple happen as a result of this condition. First the column may rust more at the base. The metal can rust out so much the column compresses on itself and may drop a little. This in turn may cause the structure above to drop a little. This may cause minor hairline cracks in the walls, ceiling and/or floor surfaces above. Sometimes the steel column may also split apart. Further deterioration of this column as well as structural damage and/or damage to the finishing materials could occur if the needed repairs are not completed. Recommend further evaluation by a qualified, licensed structural contractor and repair/replace as necessary.

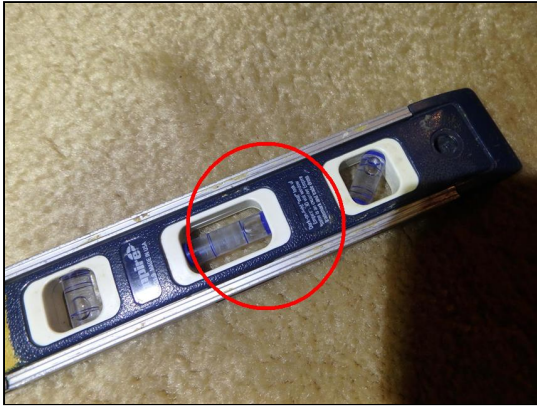
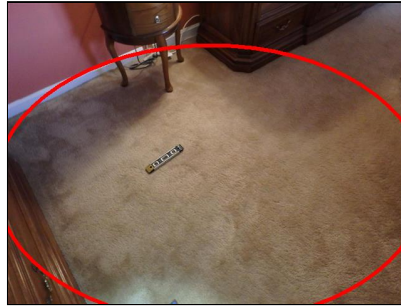
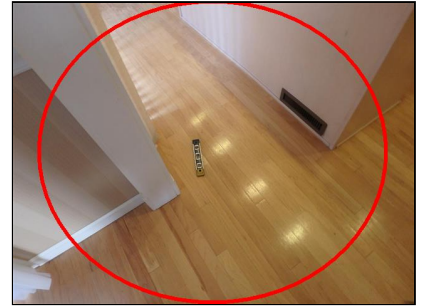
As observed in a small area in the kitchen and in the master bedroom, there were numerous floors surfaces that had a noticeable sloping condition present. The condition of the sloping floors in question could worsen in the future if any needed structural repairs are not completed. Future structural damage as well as damage to the interior finishes (walls, ceilings, flooring) could also occur. The area of concern in the bedroom may be a result of the carpet padding under the carpet being worn or there may be a structural issue causing the sloping condition. Sometimes carpet padding in high traffic areas becomes worn over other portions of the carpeted flooring. A further evaluation of the ENTIRE structure/ dwelling should be completed by a qualified, licensed structural contractor and any necessary repairs completed.

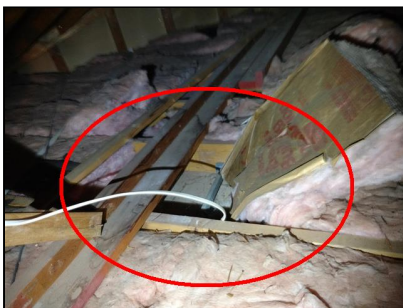
6.2 Item 1 (Picture)

As observed in the attic space, there were a few floor joist bays that had either missing, damaged and/or deteriorated insulation. Recommend further evaluation of all of the attic insulation by a qualified, licensed contractor and repair/replace/install the insulation in these joist bays to reduce energy expenses and prevent condensation/mold in the attic space by reducing the heat loss from the living space to the attic space.

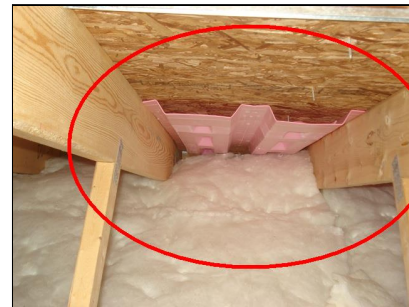
6.3 Item 2 (Picture) Example of venting

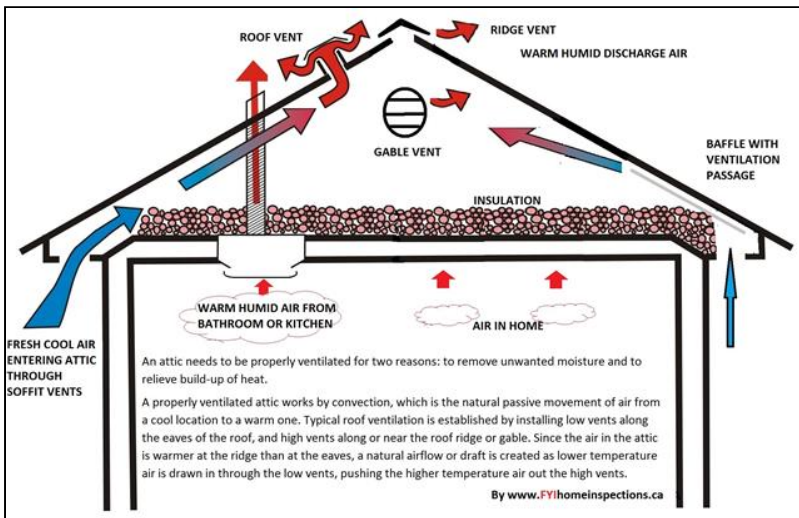
6.3 Item 3 (Picture) Example of venting

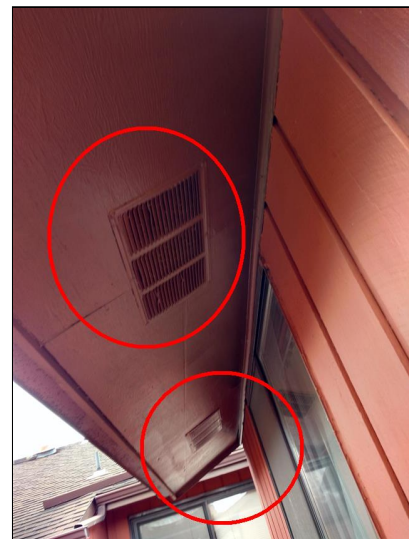
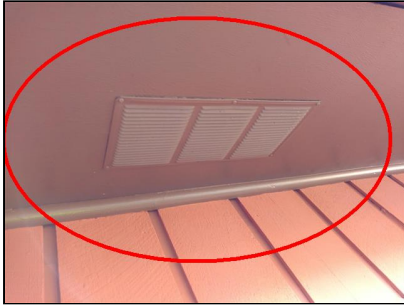
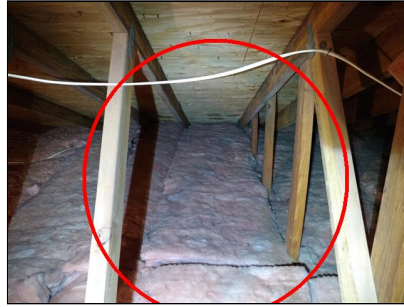
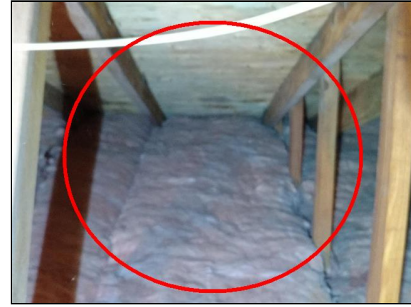
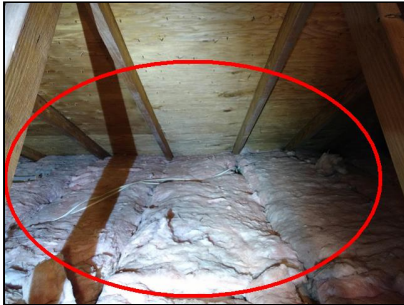
As observed in the attic space, the soffit vents appeared to be blocked with insulation. Recommend adding soffit vent baffles in the attic to avoid premature aging of roof decking/covering and help to maintain proper humidity and temperature control within the attic space. The venting in the attic space currently may not be adequate without the soffit vents being cleared and open for air flow.

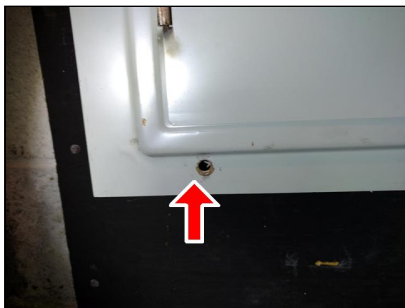
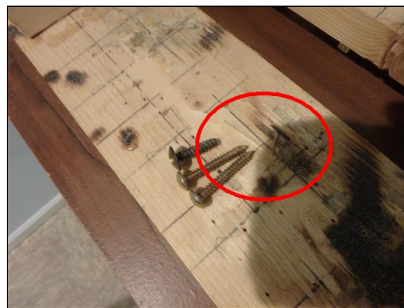
(2) Two of the hold down screws for the front cover on the sub panel in the unit had pointed tips. These screws should have blunt (dull) tips to prevent the tip of the screw from piercing the insulation on the wires inside the panel if they came in contact with them. One of the necessary screws was also missing. Recommend having a qualified, licensed electrician install the required OEM (original equipment manufacturer) screws.

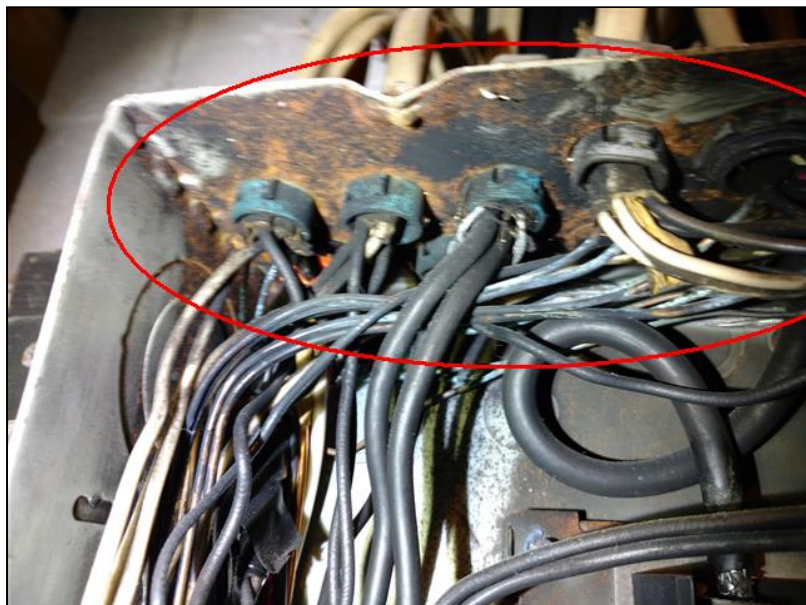
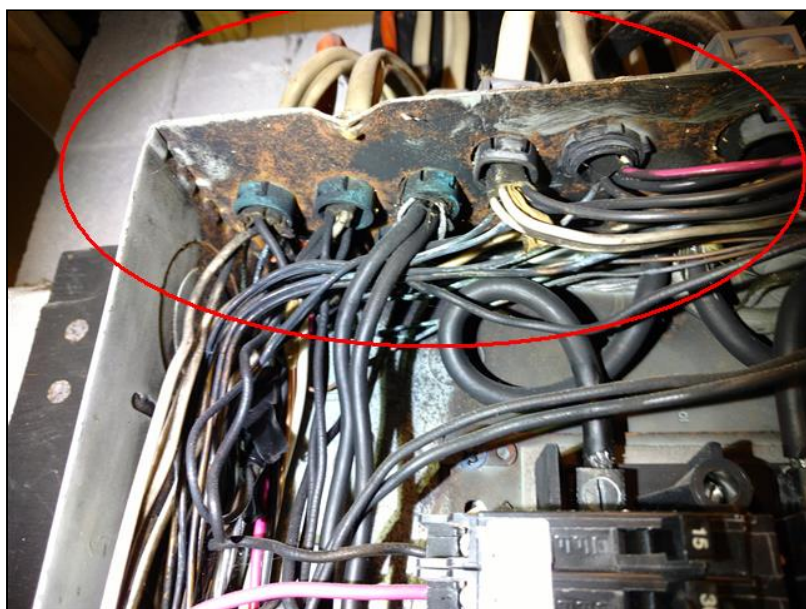
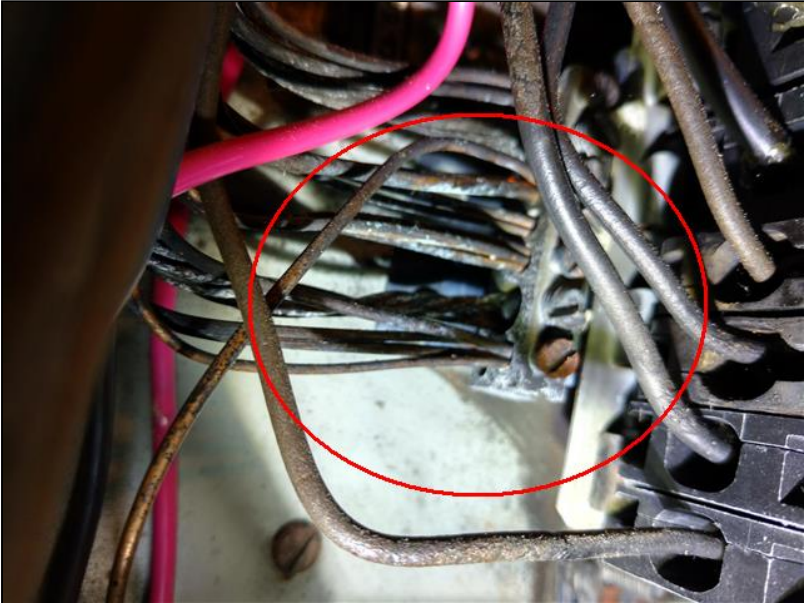
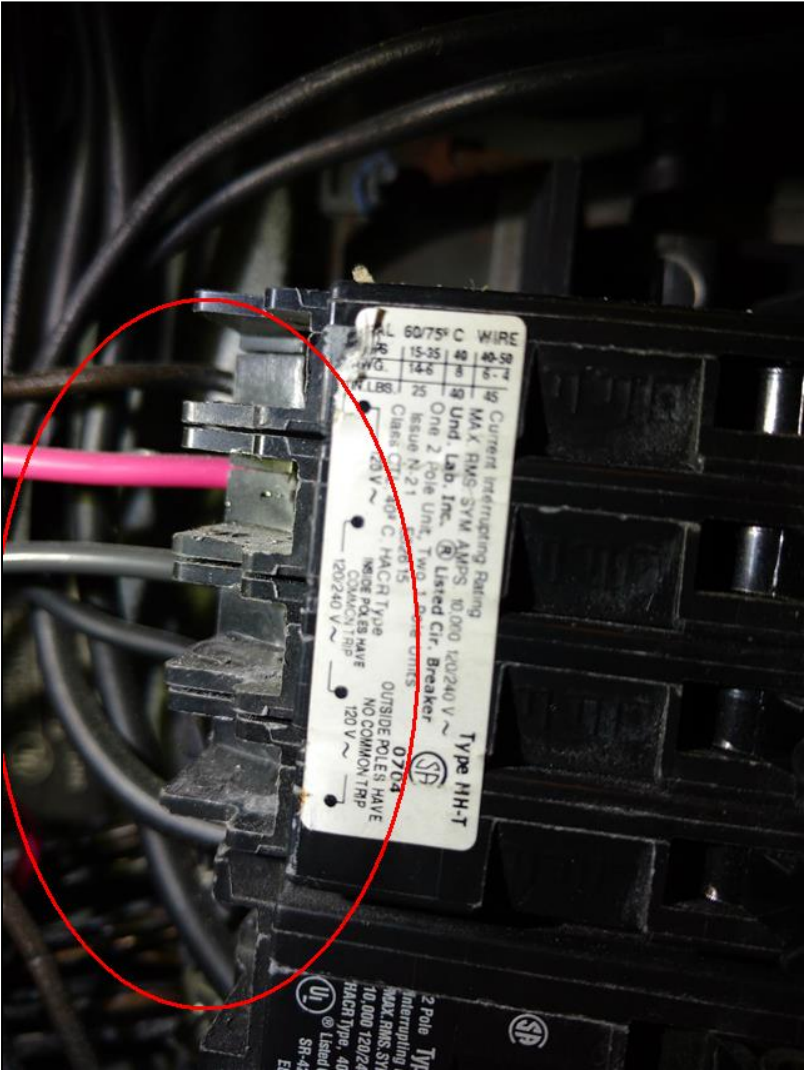
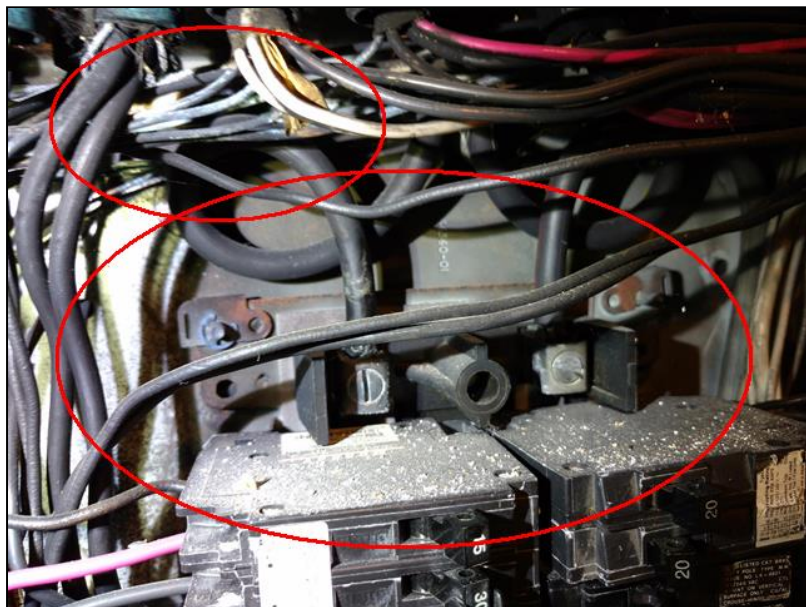
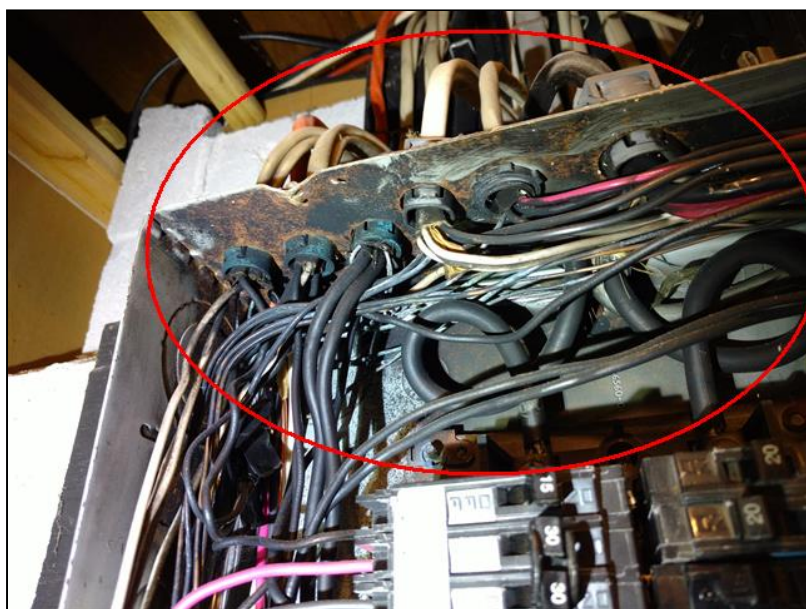
(3) As observed in the sub panel in the basement, there appeared to have been a small fire inside the panel as the internal components were burnt and scorched. **This is a MAJOR SAFTY CONCERN and MAJOR FIRE HAZARD and should be repaired/replaced IMMEDIATELY.** The internal components may have been damaged as a result and there may be future fires within this panel. **Based on these and all of the electric related defects present, a further evaluation of the ENTIRE electric sub panel in the basement and the main electric service panel, main disconnect circuit breaker and the electric meter (which are on the exterior) should be completed IMMEDIATELY by a qualified, licensed electrician and the necessary repairs/replacements completed. The homeowner should be notified of this condition and the need for repairs/replacement immediately.**
