# Property Inspection Report

123 Main Street

Unit T1

**Terra Home Inspections LLC**

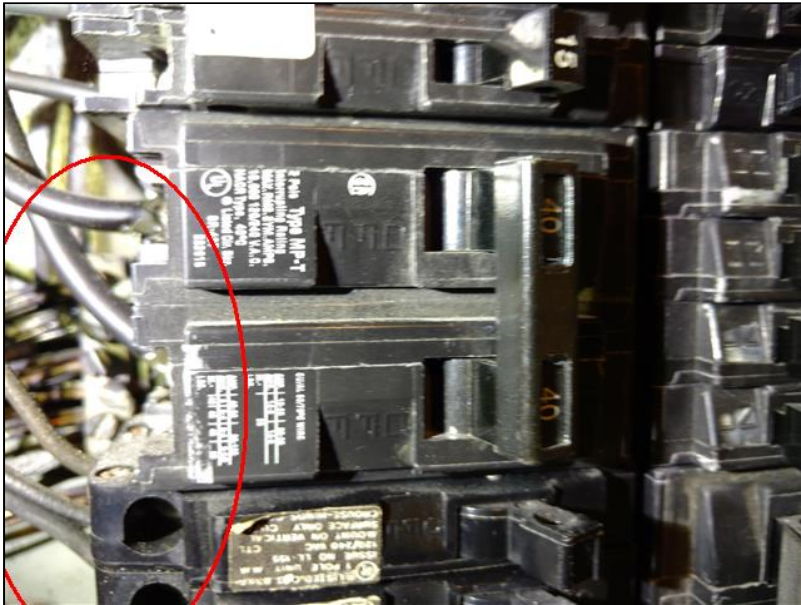
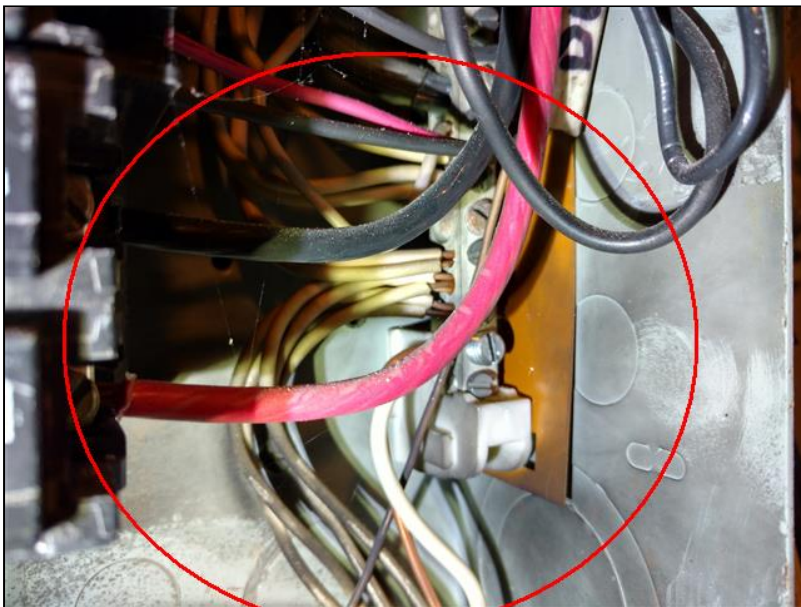
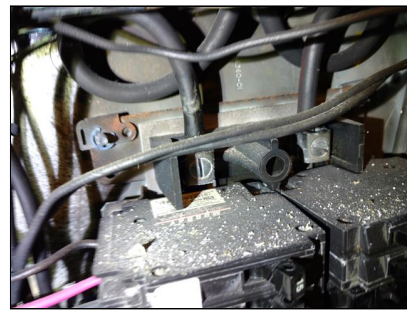
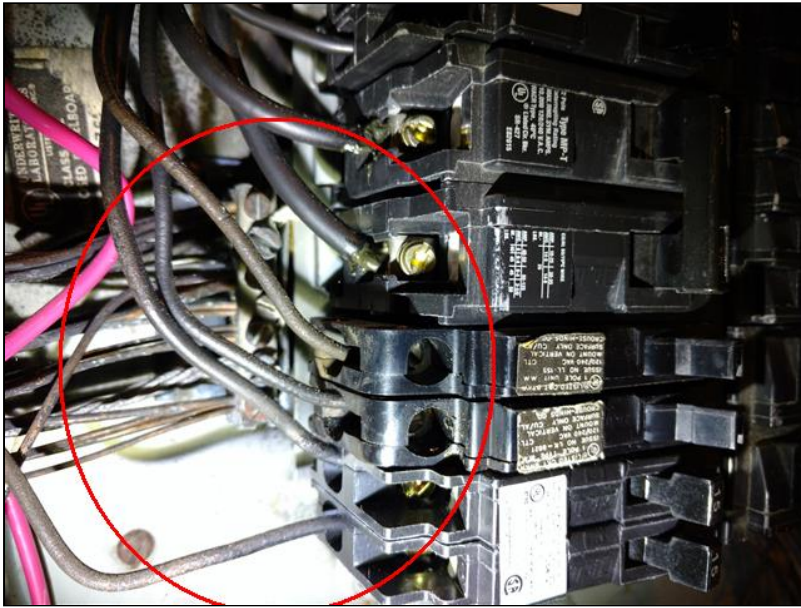
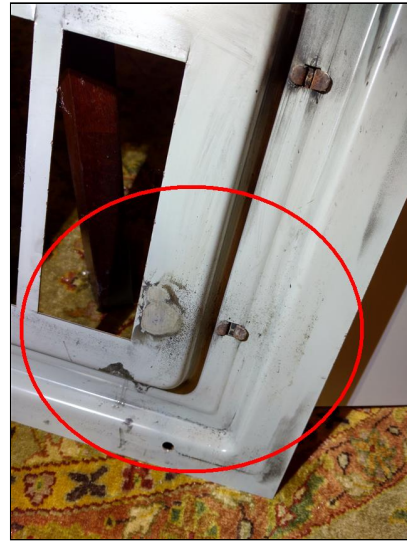
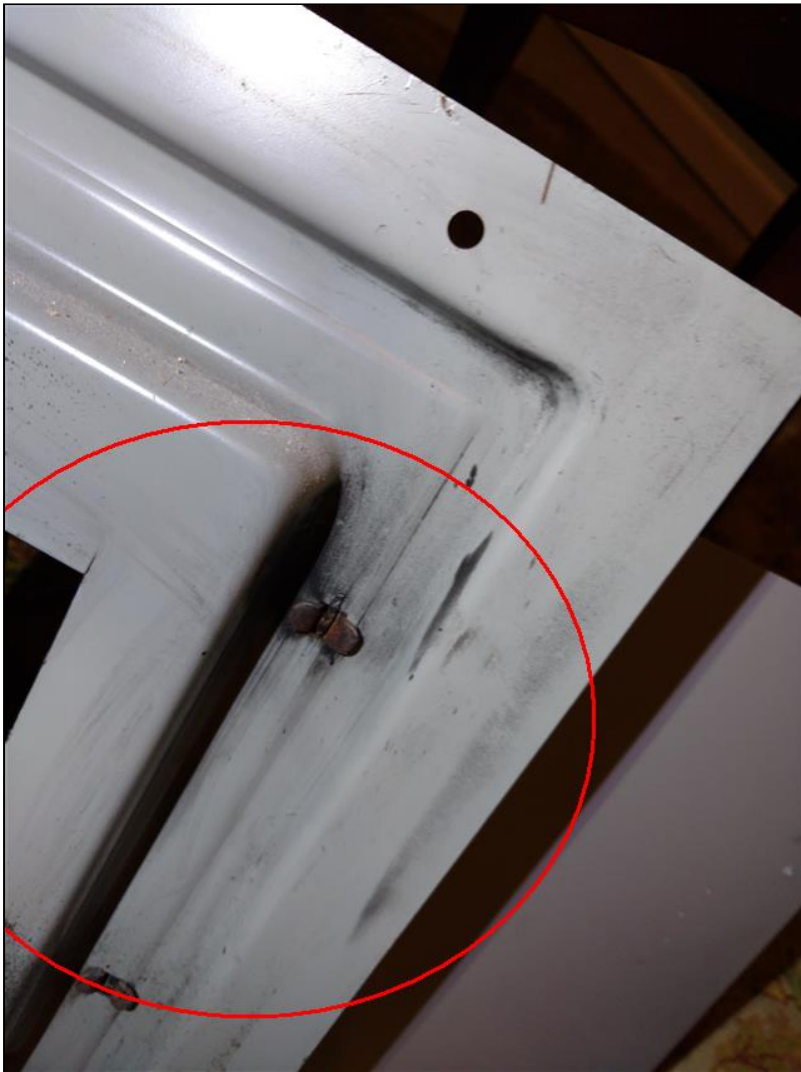
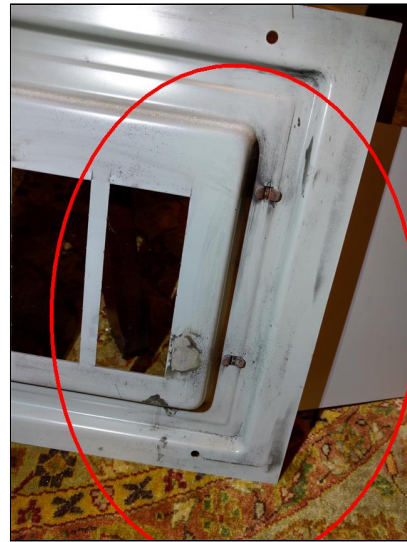
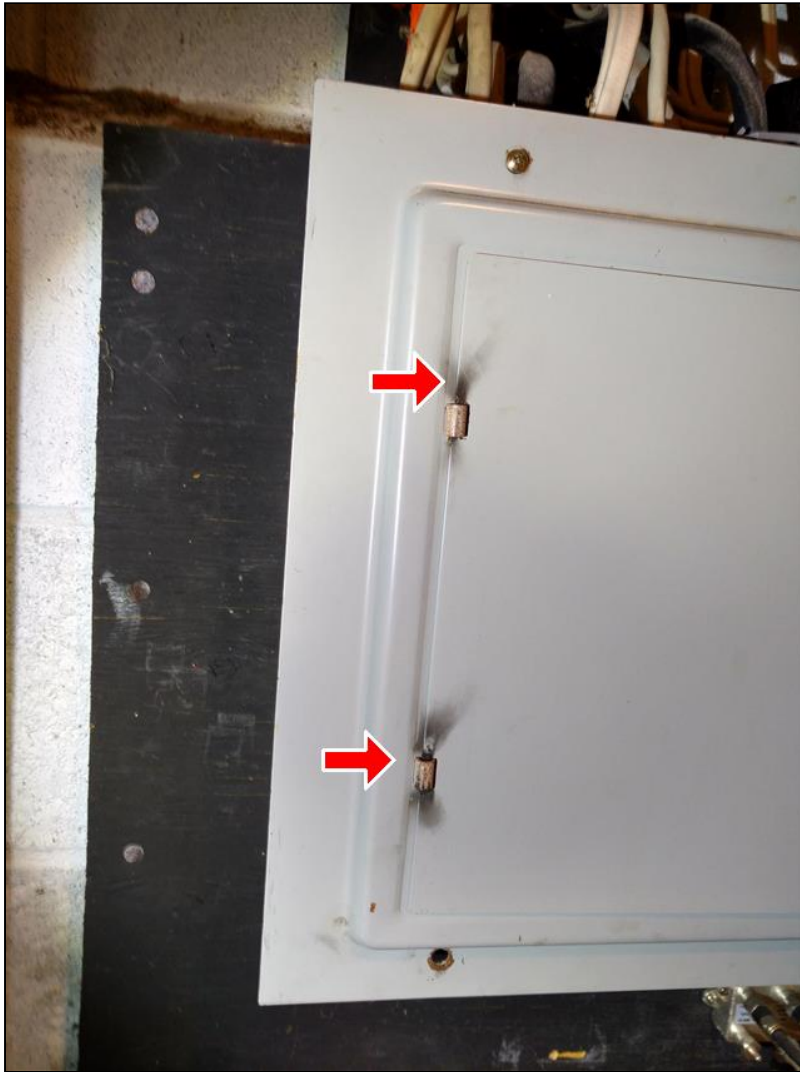
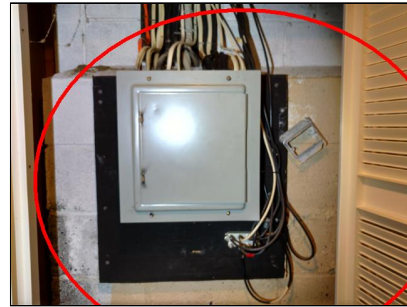
(3) As observed in the sub panel in the basement, there appeared to have been a small fire inside the panel as the internal components were burnt and scorched. **This is a MAJOR SAFTY CONCERN and MAJOR FIRE HAZARD and should be repaired/replaced IMMEDIATELY.** The internal components may have been damaged as a result and there may be future fires within this panel. **Based on these and all of the electric related defects present, a further evaluation of the ENTIRE electric sub panel in the basement and the main electric service panel, main disconnect circuit breaker and the electric meter (which are on the exterior) should be completed IMMEDIATELY by a qualified, licensed electrician and the necessary repairs/replacements completed. The homeowner should be notified of this condition and the need for repairs/replacement immediately.**

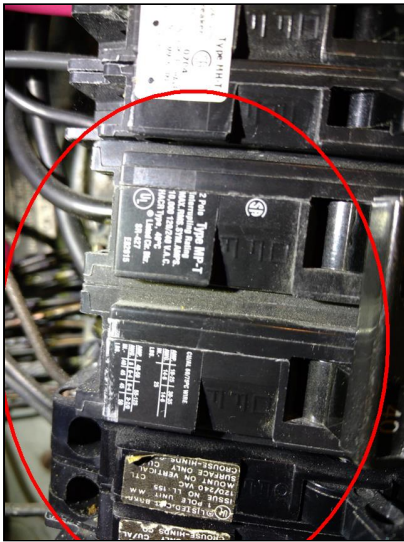
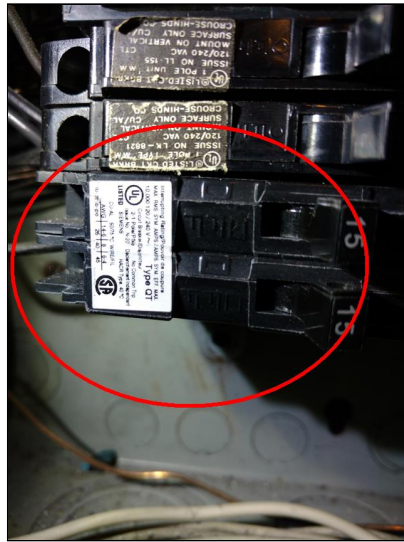
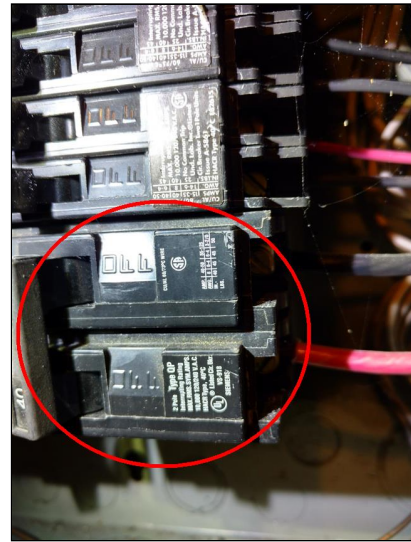
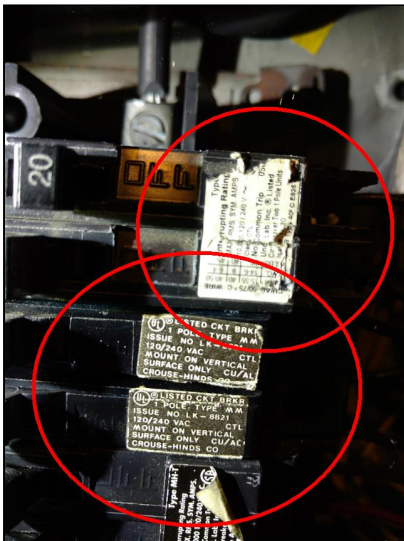
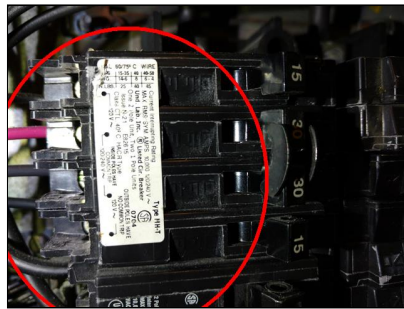
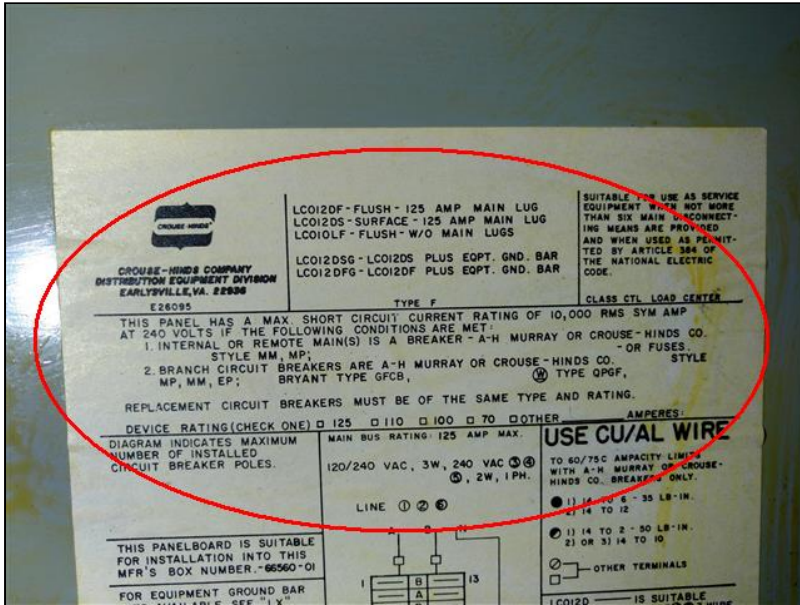
(1) As observed in the electric sub panel, there were numerous different manufacturer brands of circuit breakers installed in the panel. Per the manufacturer's wiring specifications, there are only certain types and brands of circuit breakers that are allowed to be safely utilized in this panel. This is a potential safety concern and fire hazard as this panel may not be designed for use with these circuit breakers. **Based on these and all of the electric related defects present, a further evaluation of the ENTIRE electric sub panel in the basement and the main electric service panel, main disconnect circuit breaker and the electric meter (which are on the exterior) should be completed by a qualified, licensed electrician and the necessary repairs/replacements completed.**

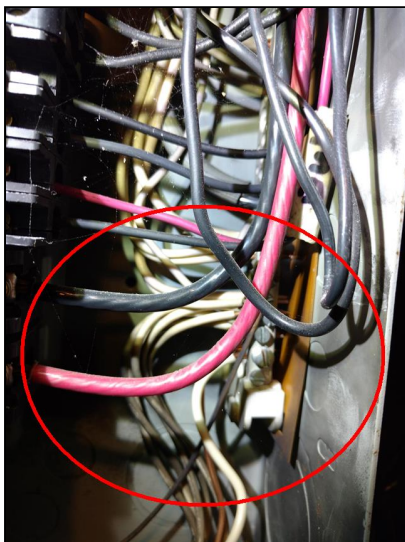
7.7 Item 1 (Picture)

(1) There were grounded (neutrals) wires that were doubled up under the same terminals (lugs) on the neutral bus bar in the main electric service panel. The connection of grounded and grounding wires in this situation creates a significant problem. One of the objectives of a correct arrangement of bonding jumpers, neutrals and grounding wires is to allow for circuit isolation if the electrical system needs to be worked on. Also most panels are only designed for one grounded wire per lug. The wires could come loose and heat up if they are double lugged. This requirement has been generally enforced in the past by a close review of the manufacturer markings and by NEC 110.3 (b). Clause 12.3.10 of UL 67 (panelboards) states, "Each neutral conductor shall terminate within the panel board in an individual terminal that is not also used for another conductor". Recommend having a qualified, licensed electrician make all the corrections necessary to ensure the safe and proper operation of the service panel.

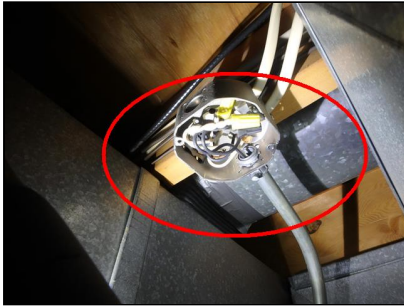
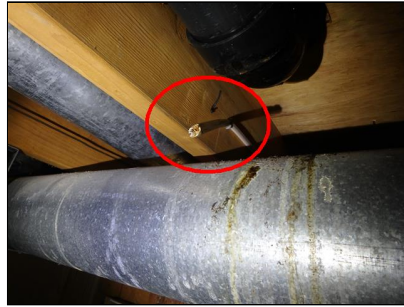
(3) There was a cut wire observed in the basement that was not safely terminated in a junction box. The wire was not live at the time of the inspection. This is a safety issue and a potential fire hazard. Recommend further evaluation by a qualified, licensed electrician and repair as necessary. There was also a junction box that was missing a cover.

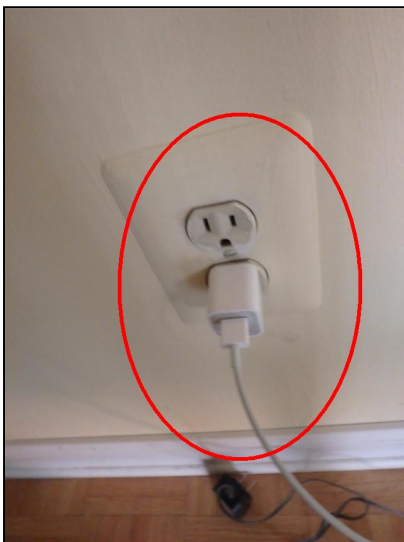
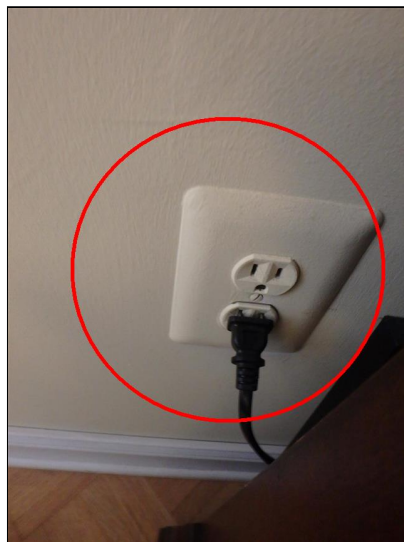
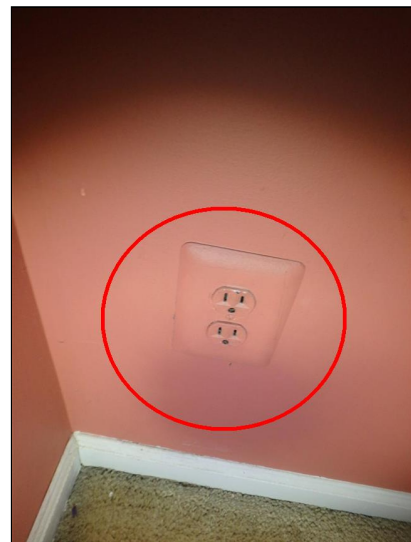
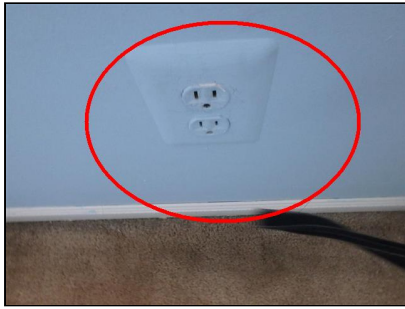
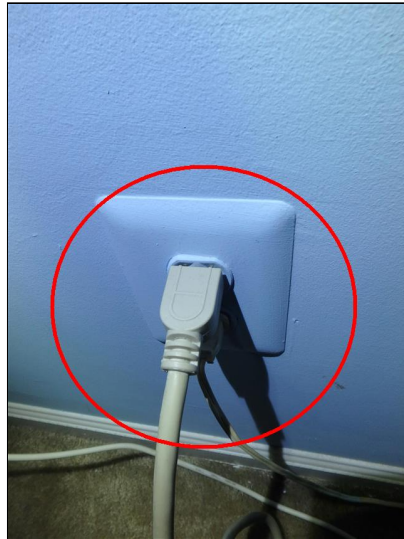
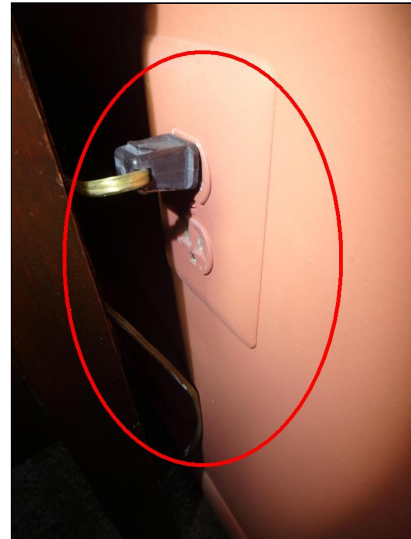
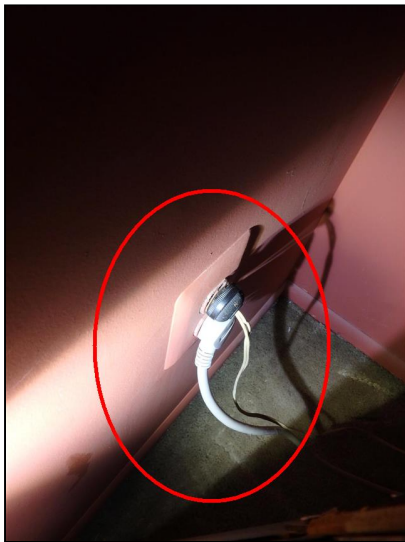
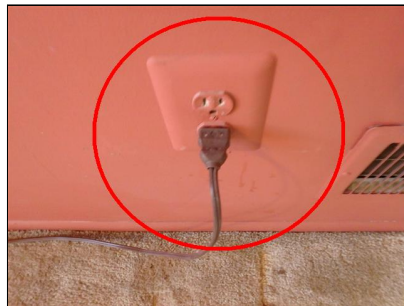
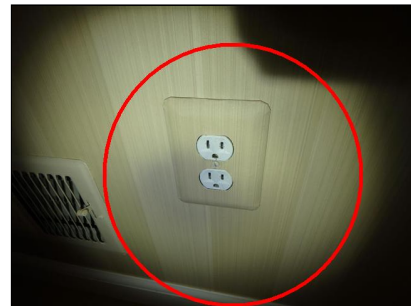
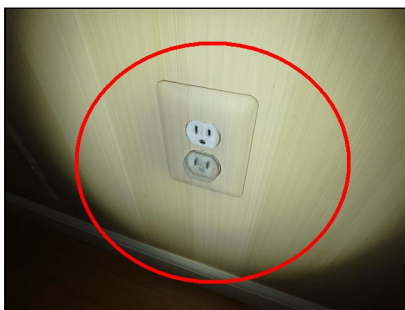
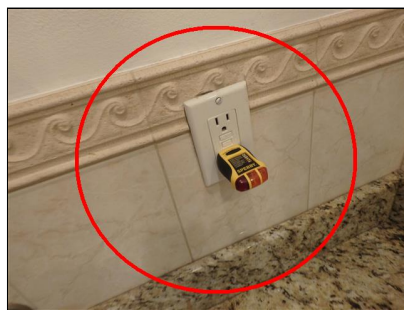
(1) As observed throughout the dwelling, there were numerous electric receptacles that were painted. This may hinder the functionality of the receptacles as it may be hard to plug any power cords into these receptacles due to the buildup on paint in the holes. It may also cause them to heat up. These are safety concerns and a potential fire hazards. Electrical receptacles should not be painted. **A further evaluation of ALL of the receptacles/outlets should be completed by a qualified, licensed electrician and the necessary repairs/replacements be completed. There was also some outlets that were loose as well.**

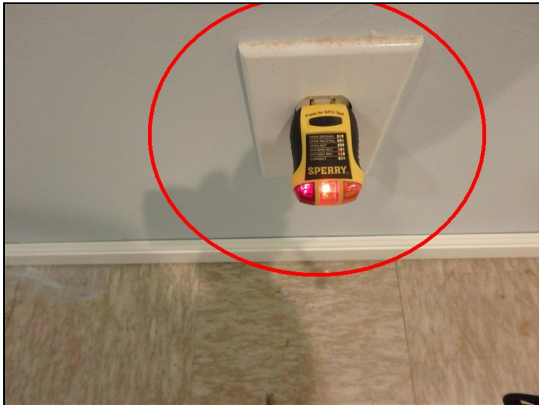
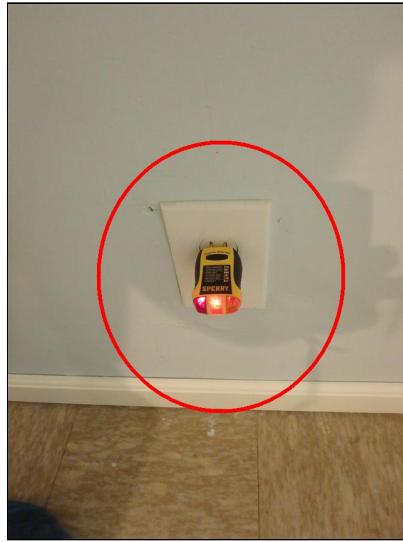
(2) There were electrical receptacles located in the basement that had a reversed polarity condition. Reversed polarity is when the hot and neutral connections at a receptacle are wired "backwards". It is also possible, all these effected outlets could be wired on the same circuit and the wire feeding this circuit was wired backwards somewhere downstream from the outlets. Reversed polarity creates a potential shock hazard and should be repaired. Recommend further by a qualified, licensed electrician and repair as necessary.

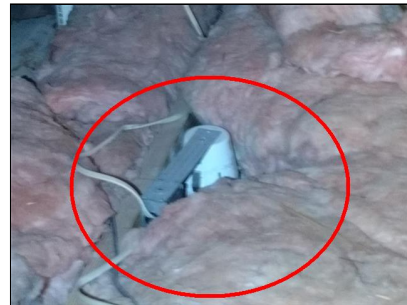
7.8 Item 15 (Picture)

(3) As observed in the attic space, there was at least one of the 2nd floor recessed light housings were covered and/or touching the insulation that was in the floor joist bays. These lights should not be installed with insulation within 3 inches of fixture sides or wiring compartment nor above fixture in such manner to entrap heat. This is a major fire and safety issue. Recommend moving all of the insulation away from the housings as required. **There may be additional light fixtures that were not visible and covered with insulation. ALL of the recessed light housings in the attic should be checked.**

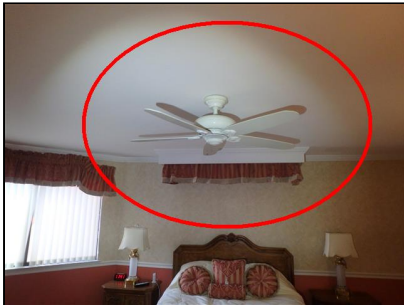
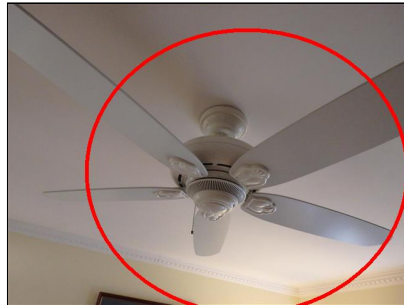
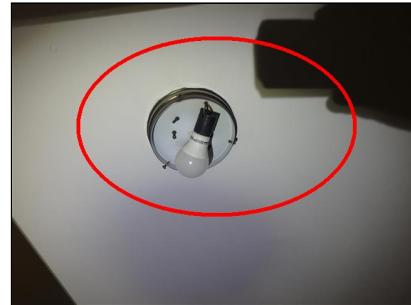
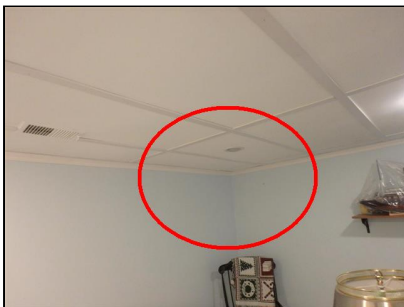
(4) There were numerous light fixtures that were missing light bulbs and/or appeared to have burned out bulbs present. As a result, these light fixtures could not be tested for proper operation. There were also light fixtures that appeared to be damaged and in need of repairs. All of these are potential safety concerns. Also to note, the ceiling fans on the lower level and the master bedroom were not functioning. A further evaluation of ALL of the interior and exterior light fixtures and ceiling fans should be completed by a qualified, licensed electrician and replace/install bulbs and/or repair/replace light fixtures as necessary.

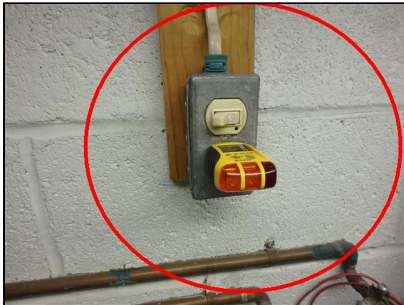
7.8 Item 21 (Picture)

(6) The electric receptacle located in the basement laundry/wash sink area was not GFCI protected. Receptacles located on the exterior, in garages, kitchen sink area, bathrooms and laundry areas should be GFCI protected. A ground fault circuit interrupter (GFCI) is a device (outlet or circuit breaker) that shuts off an electric power circuit when it detects that current is flowing along an unintended path, such as through water or a person. It is used to reduce the risk of electric shock. They can also prevent fires, like when a live wire touches a metal conduit. For safety purposes, would recommend upgrading this receptacle.. This should be done by a qualified, licensed electrician.

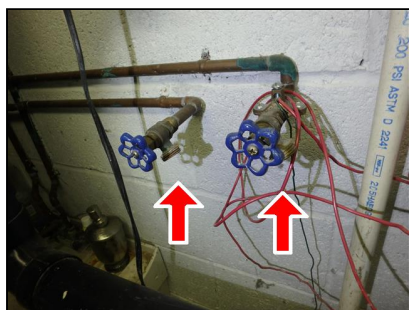
8.1 Item 1 (Picture) These should be capped.

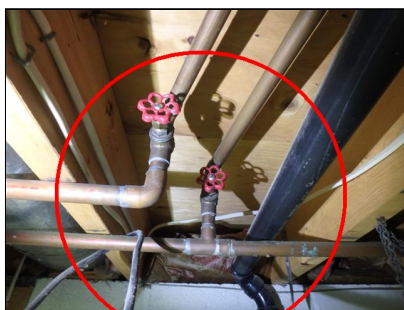
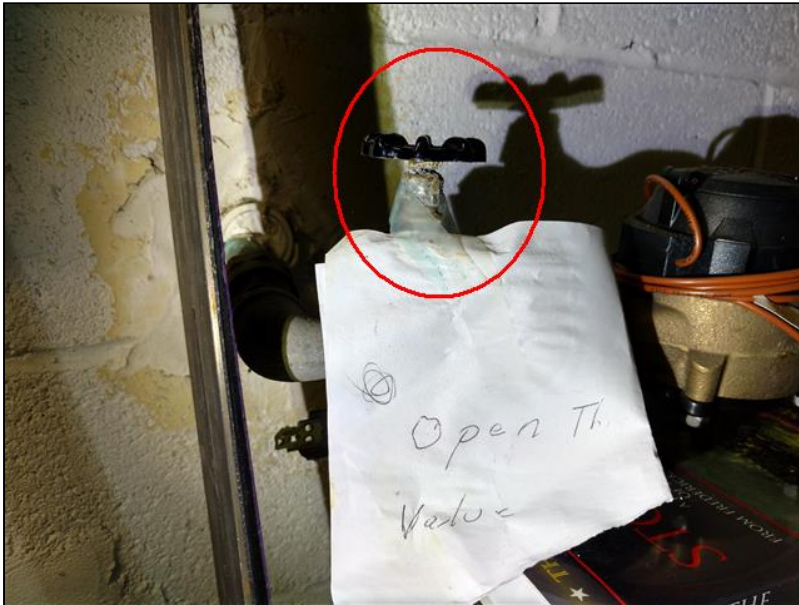
Testing of the water shut off valves located throughout the dwelling (especially the ones located in basements, crawlspaces, under sinks, behind toilets, etc.) and on the exterior for functionality is beyond the scope of the home inspection. Sometimes if the valves are turned/tested even just slightly, they may start to leak due to mineral buildup on the packings/seals. Also, due to age, corrosion and/or mineral buildup that may be on them, they may or may not function properly in the future in the event of an emergency or a need to service part of the plumbing system.

**Therefore, a further evaluation of ALL of the water shut off valves in the dwelling (basement, under sinks, behind toilets, etc.) and any on the exterior should be completed by a qualified, licensed plumber and any necessary repairs/valve replacements should be completed. This includes the main water supply shut off valve on the street side of the water meter that appeared to be seized up (wouldn't turn). This is the most important water shut off valve in the entire house and it should be 100% functional. This should be repaired by a qualified, licensed plumber.**

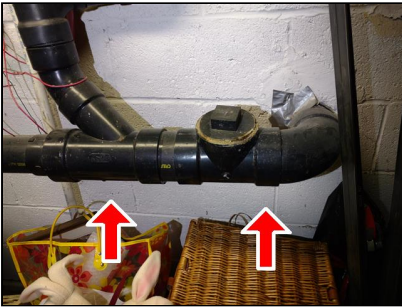
8.2 Item 1 (Picture)

(1) As observed in the dwelling, there were numerous sections of the DWV (drain, waste, vent) piping that were ABS. While the interior visible portions appeared to be in a serviceable condition, the underground portions may be compromised. The main concern is the portions that run from the house to the sewer main. To insure the main DWV system is 100% functional, it is recommended the DWV piping be scoped by a qualified, licensed plumber/professional to ascertain the integrity of such piping.

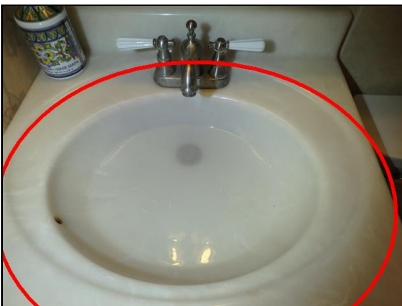
8.2 Item 3 (Picture)

(3) The drain in the bathroom sink was draining very slowly. The drain could be clogged slightly which could be fixed by using a common drain opener solution available at most home centers. There also may be an issue with the connected drain piping. Recommend further evaluation by a qualified, licensed plumber and repair as necessary.

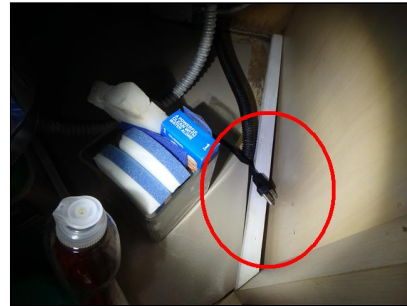
8.3 Item 2 (Picture)

Present at the kitchen sink is an Insinkerator instant hot water dispenser. This unit was unplugged and therefore could not be tested to see if it makes hot water. Also to note, this dispenser is a potential safety concern as the hot water coming out of this dispenser could be as hot as 185 degrees Fahrenheit. This is a safety concern as the water coming out of this dispenser may instantly cause scalding if someone were to attempt to wash their hands with this water or come into contact with this water for any reason. This dispenser should be plugged in and tested.

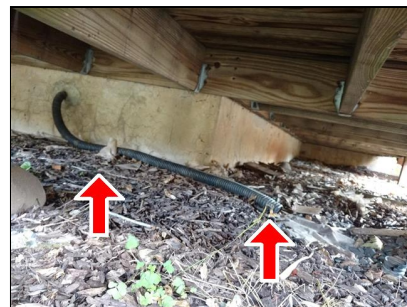
8.5 Item 2 (Picture)

The sump pump drain for the sump pump located in the basement should be extended out at least 6ft from the foundation wall (or as far out as possible). Currently, the discharge piping is discharging the water onto the ground next to the foundation wall. Thus, the water could be seeping down and going into the foundation wall and possibly migrate back into the basement. Recommend further evaluation by a qualified, licensed plumber and repair as necessary.

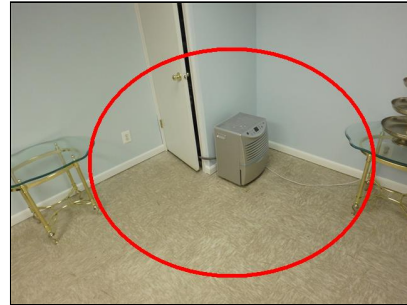
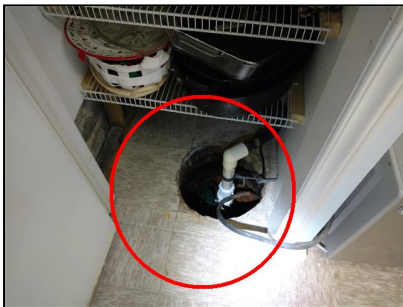
(1) As observed in basement, the sump pump pit/metal basket was severely deteriorated and was in need of replacement by a qualified, licensed plumber. This condition may worsen if the needed repairs are not completed. The current condition of the basket may let dirt/stone debris into the pit which may damage the sump pump.

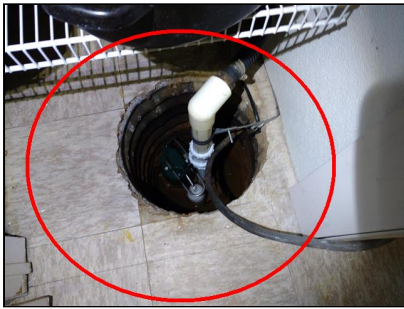
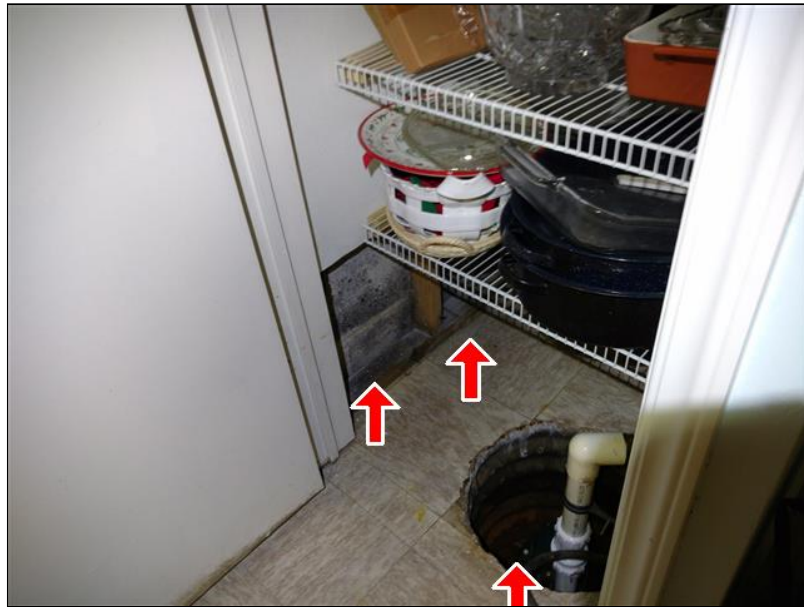
(2) The sump pump pit had no cover present. Sump pump pits should have a proper cover to prevent a high humidity condition in the surrounding area. Mold may form on the basement finishes as a result. It may also prevent radon from seeping into the living spaces. Recommend a further evaluation by a qualified, licensed plumber and repair as necessary.

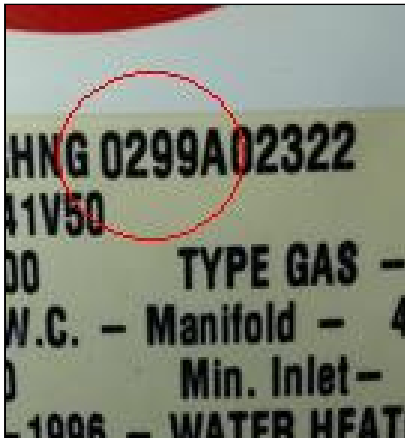
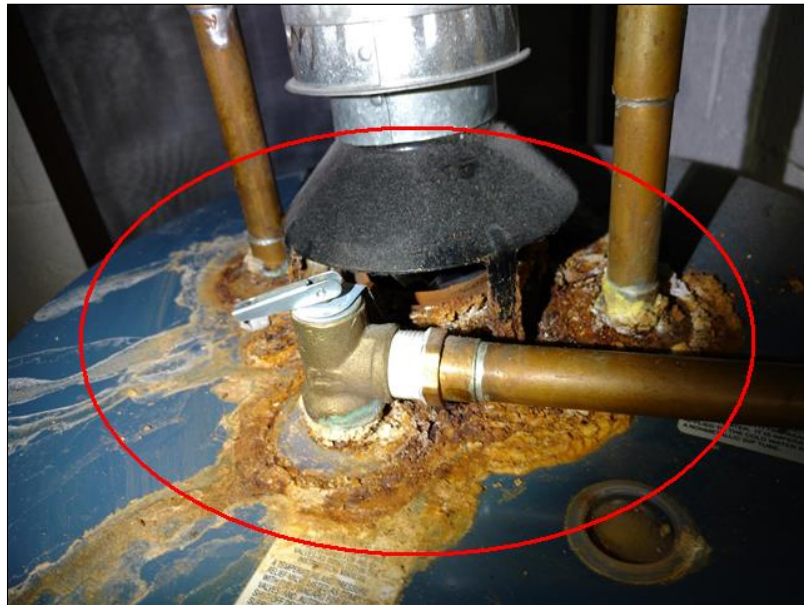
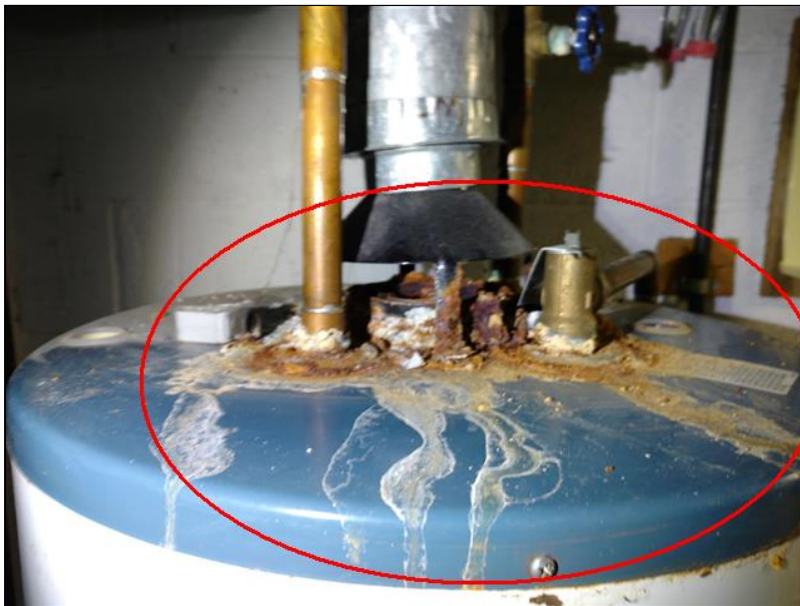
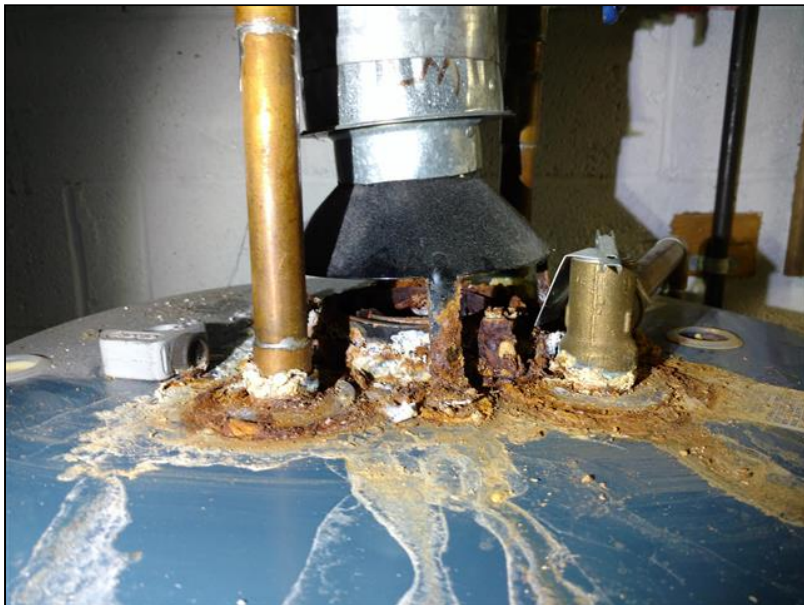
Information taken from the data tag places the age of the water heater at around 21 years old. It is considered to be at the end of its expected lifespan. **Based on the observations of the water heater, the water heater should be replaced IMMEDIATELY as it is a MAJOR SAFETY CONCERN by a qualified, licensed plumber. The homeowner should be notified of this condition and the need for a replacement.**

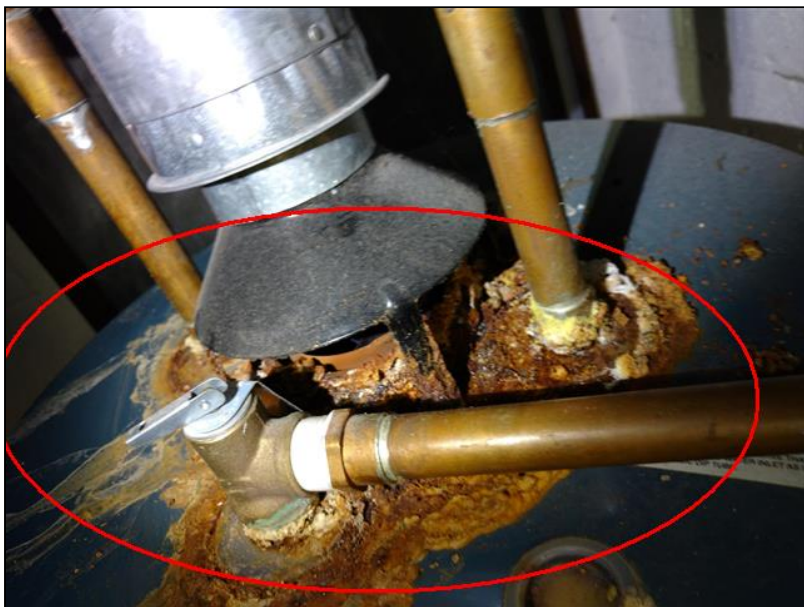
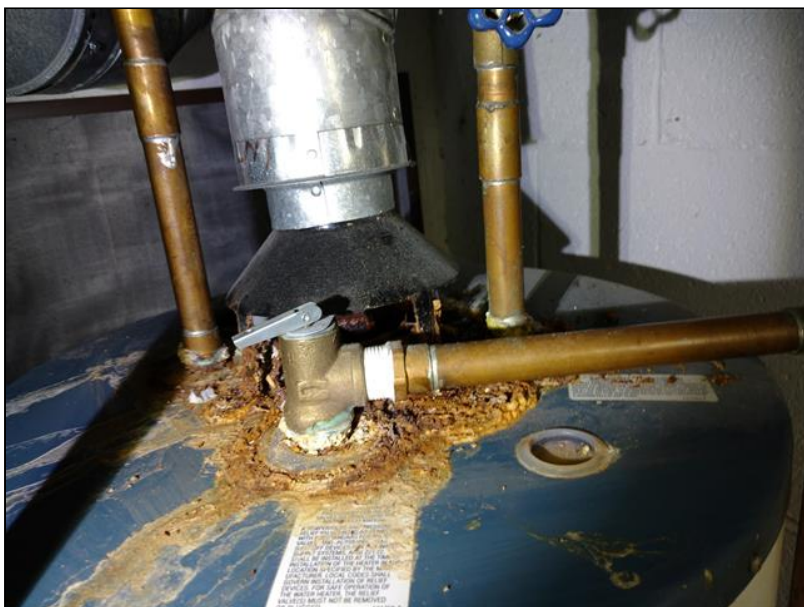
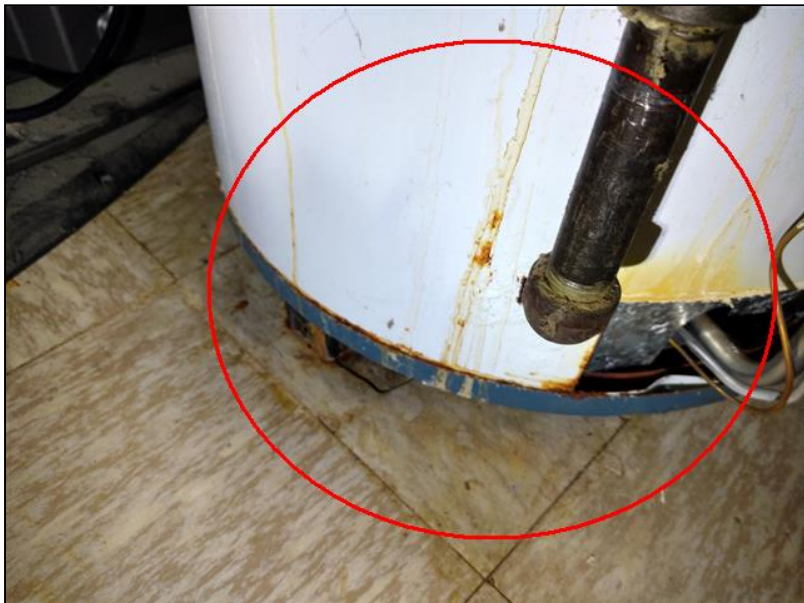
The top of the water heater was severely deteriorated as it appears to be a MAJOR venting issue resulting in the water heater back drafting. **Based on the severity of the deterioration, this is a MAJOR SAFETY CONCERN as combustion by products (carbon dioxide, carbon monoxide and nitrogen oxide) may be entering the dwelling instead of being properly vented out of the dwelling. The bottom of the water heater was also rusted/deteriorated. These conditions may worsen as well as possible flooding of the basement if the necessary replacement is not completed. The water heater should be replaced IMMEDIATELY by a qualified, licensed plumber. The homeowner should be notified of this condition and the need for a replacement.**

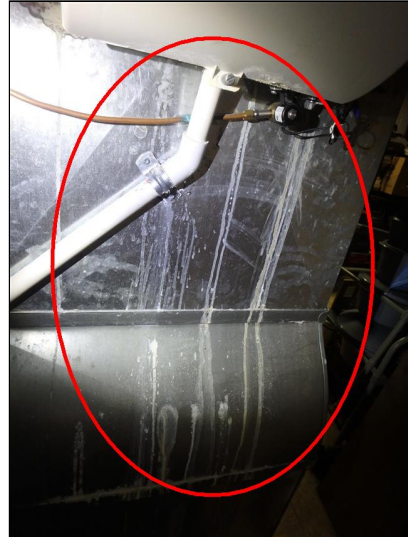
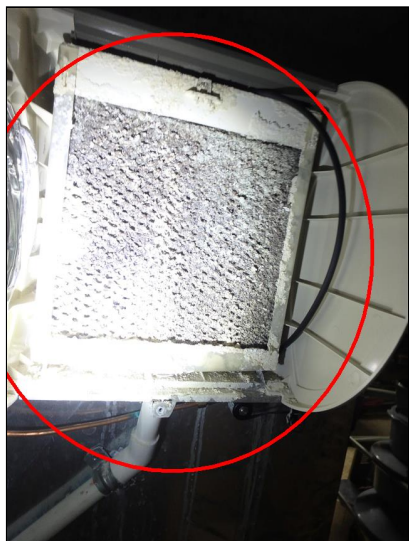
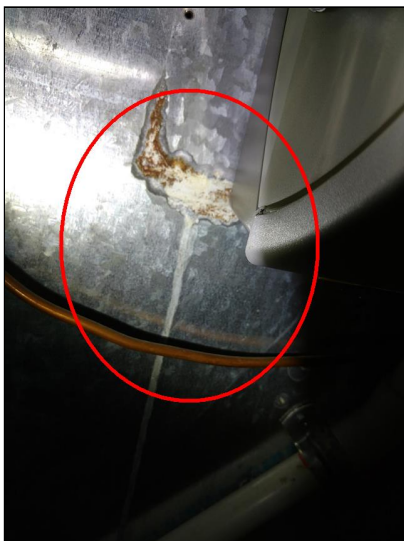
(1) The humidifier pad/filter in the built in humidifier on the side of the furnace was severely deteriorated and is in need of replacement. There was a heavy mineral buildup on the pad/filter. This may effect the performance of the humidifier is the pad/filter is not changed. Also to note, there was a large amount of staining present on the ducting below the unit. The humidifier should not be used until the necessary repairs are completed by a qualified, licensed HVAC professional.

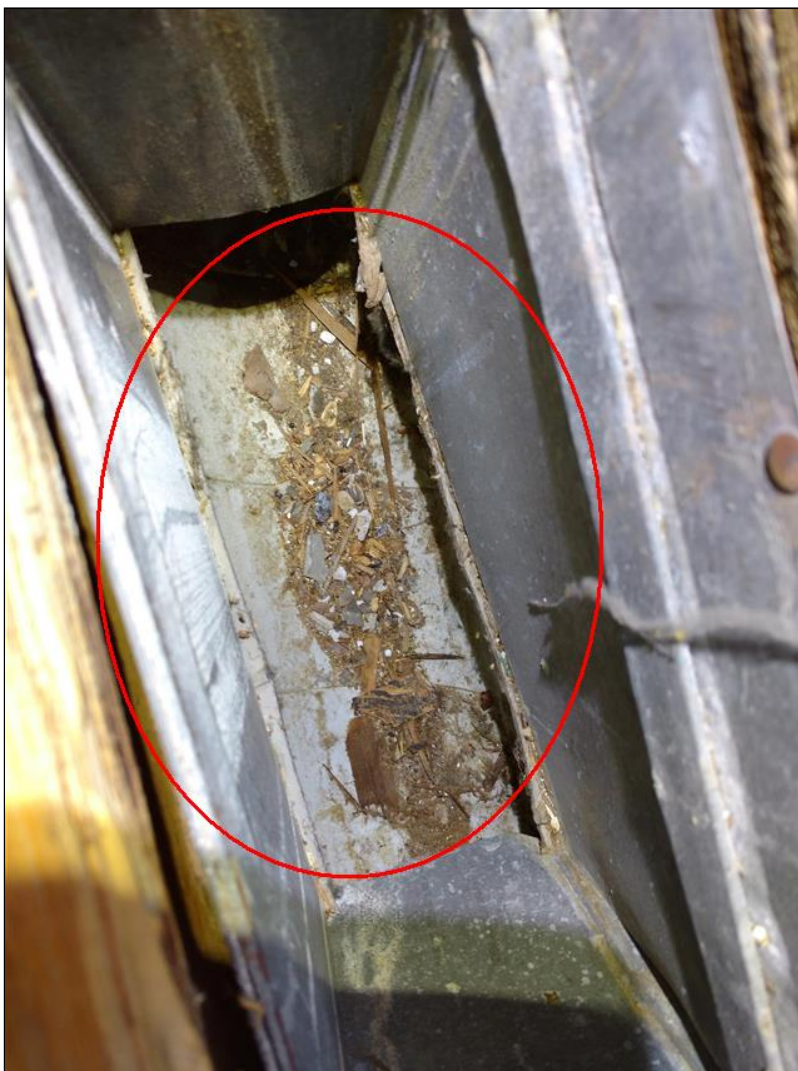
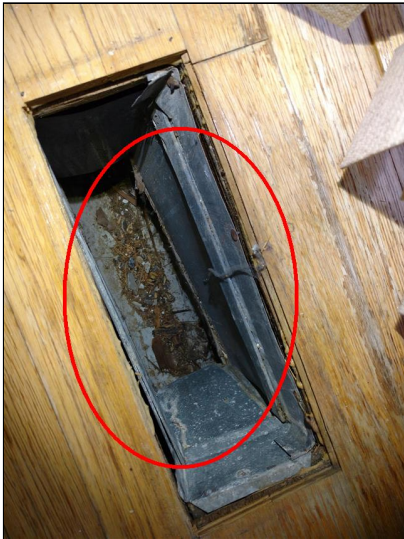
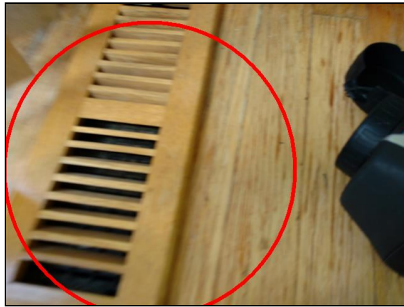
(2) As observed in the basement utility room, there was an HVAC supply air duct that was semi-disconnected. This condition if not repaired, will have an affect on the air flow in the room where this duct is running to. Also, there were debris in the duct in the kitchen in front of the refrigerator. This should be cleaned out. Recommend further evaluation by a qualified, licensed contractor and repair as necessary.

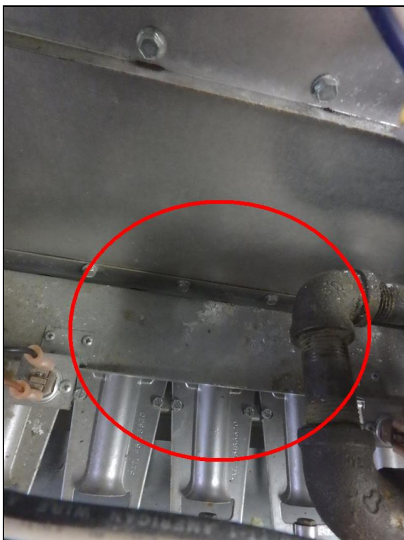
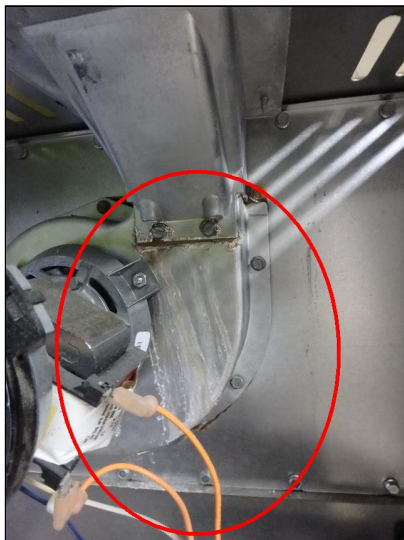
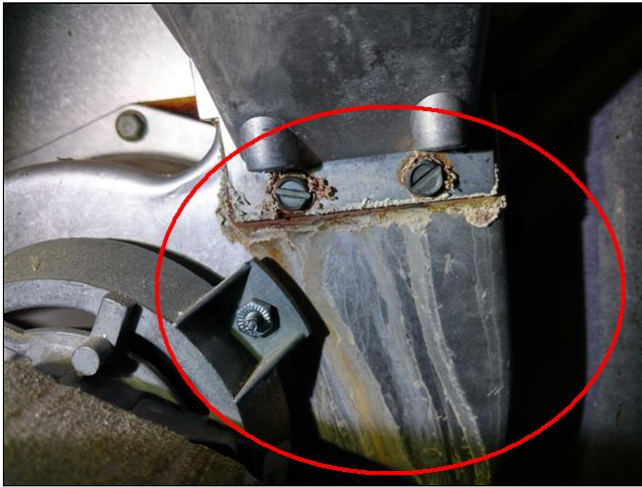
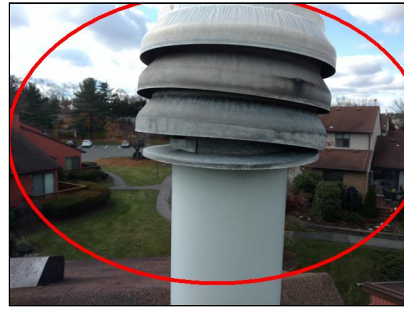
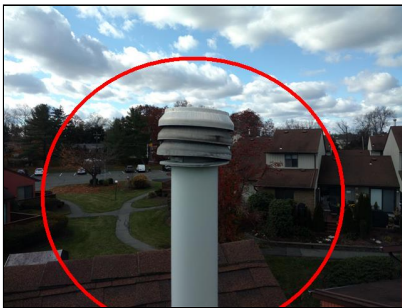
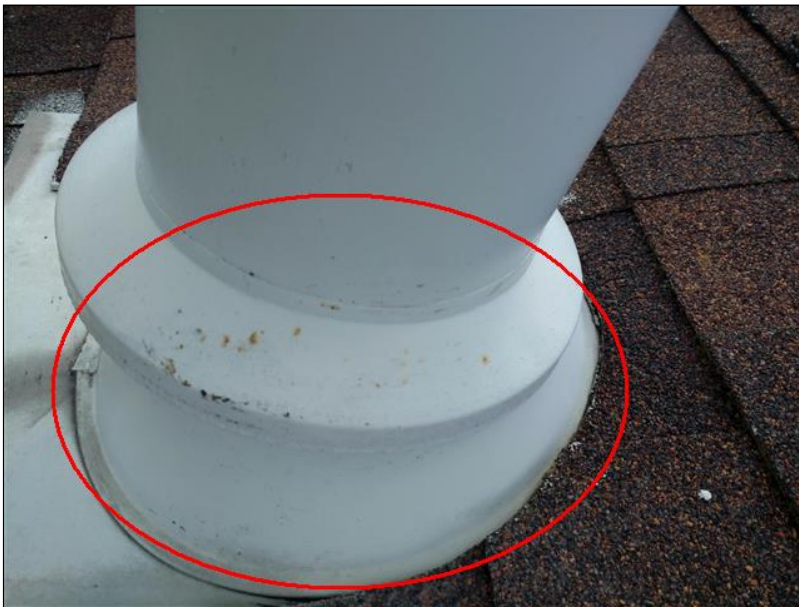
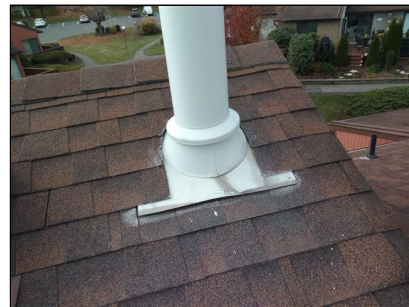
(1) There was white "condensate" observed on the outside of the vent connector and on the inside of the top furnace compartment. The combustion by-products of a gas furnace are made up of slightly acidic moisture. Under normal furnace operation this particulate is vented to the exterior of the home through the chimney. For various reasons it can condensate inside the vent connectors or chimney and drip out the vent connectors and/or back into the furnace. This condition could lead to corrosion of the furnace components and/or the venting system itself if not repaired. There may be an issue with the venting. Also to note, the chimney cap was loose/damaged. The exterior portion of the metal chimney also appeared to have been recently painted for an unknown reason. It may have been rusted or it may have just been painted to make it look better. Recommend further evaluation of the furnace of the ENTIRE length of the metal chimney/venting by a qualified, licensed HVAC professional and repair as necessary.

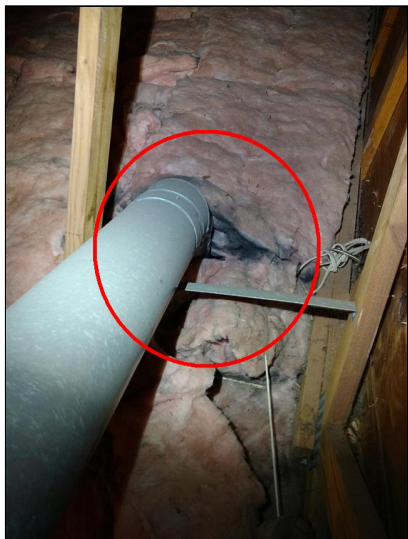
10.2 Item 8 (Picture)

(2) The minimum clearance for the B vent exhaust ducting serving the gas fired water heater and furnace from combustibles is 1 inch. As observed in the attic space, there was kraft faced batts insulation touching a portion of the B vent ducting. This is a safety concern and a potential fire hazard. Recommend moving the insulation away from the B vent ducting to comply with the clearance requirements.

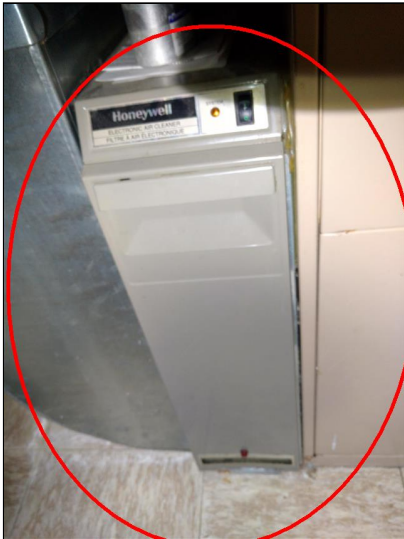
10.5 Item 1 (Picture)

There was an electronic air filter present that was filtering the air in the HVAC unit. These types of filters have their pros and cons and may not be as effective as a high quality HEPA or other disposable type filters. They often tend to fail as they get older as well. In some instances, people would disconnect the power going to this unit and buy disposable type filters that are designed to fit into the existing electronic air filter housing. Also to note, the power switch for this filter was in the off position. Therefore it was not functioning. There was also a large amount of not normal noise coming from the area of this filter when the heating system was tested/operated.

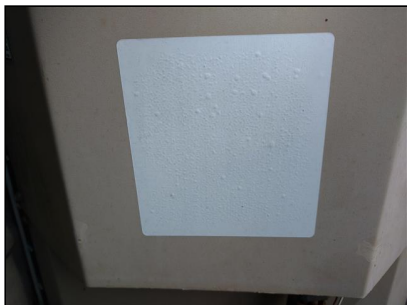
11.0 Item 1 (Picture)

(1) Information taken from the data tag, places the age of the A/C evaporator at around 20 years old. It is considered to be at end of its expected lifespan. Recommend budgeting for a replacement in the near future. The A/C condenser may be the same age (20 years old-the data tag was unreadable)

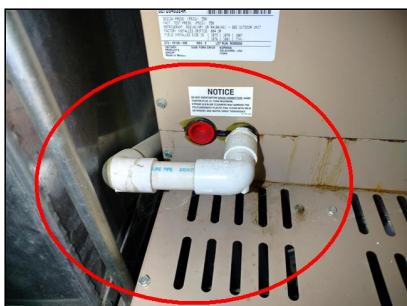
11.0 Item 2 (Picture)

(2) The primary condensate drain pipe for the central air conditioning system was missing the required p-trap where it exits the evaporator coil housing. The primary purpose of a condensate trap (p-trap) is to prevent air from moving in or out of the coil box or air handler during operation. This condition may cause condensate drainage issues. Recommend further evaluation by a qualified, licensed HVAC professional and repair as necessary.
