# Property Inspection Report

123 Main Street

Unit T1

**Terra Home Inspections LLC**

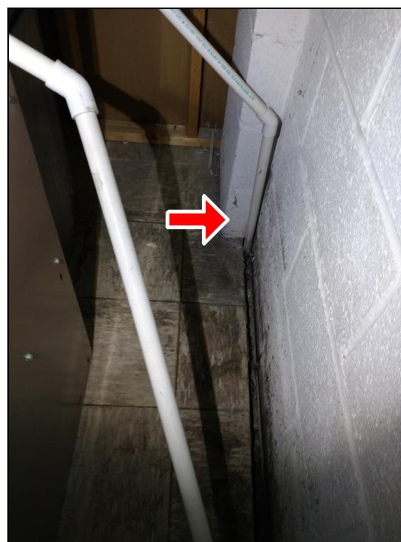
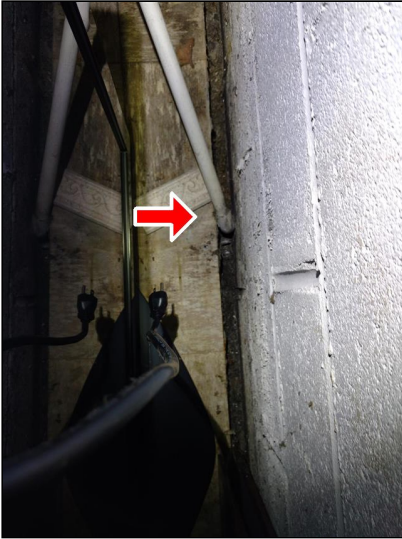
(3) The main condensate drain pipe for the central air conditioning system was draining the condensate (water) it produces into the gap in between the basement floor slab and the masonry foundation wall. The humidifier was also draining into this gap. These are not good arrangements as the condensate may cause the earth under the basement concrete floor to undermine which may cause damage to the basement floor. **It may also cause an excessive amount of unwanted moisture in the basement and possible moisture damage to the foundation walls.** There was a suspect mold condition on the foundation walls in this area. A condensate pump should be installed next to the HVAC unit and the condensate will then be pumped by the condensate pump into the DWV system or to the exterior. Recommend further evaluation by a qualified, licensed HVAC professional and repair as necessary.

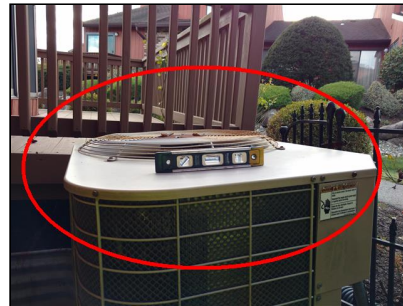
11.0 Item 7 (Picture)

(4) The central air conditioning system exterior condenser unit was out of level. Being out of level may cause the components inside to fail prematurely and may also prohibit the air conditioning system from functioning properly. Recommend further evaluation by a qualified, licensed plumber and repair as necessary.

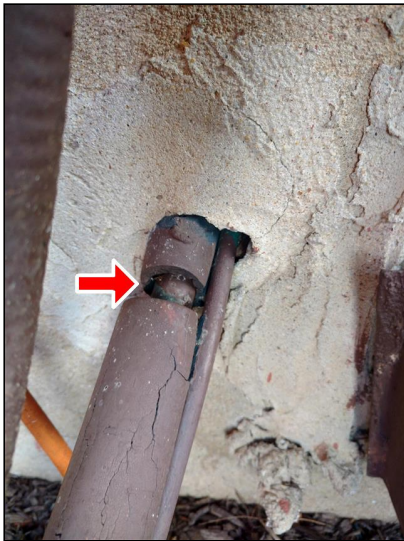
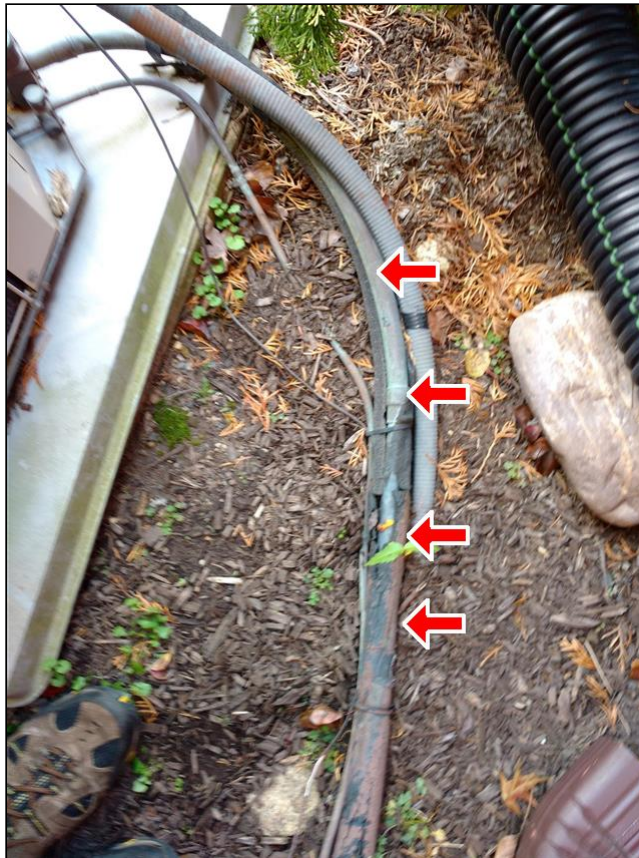
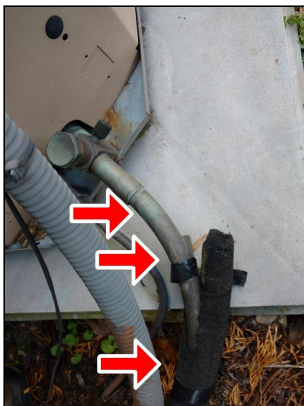
The insulation wrap on the central air conditioning system refrigerant line was deteriorated and/or missing in area(s). These condition(s) may worsen if the needed repairs are not completed. This condition may also affect the performance of the air conditioning system if not repaired. Recommend further evaluation by a qualified, licensed HVAC contractor and repair as necessary.

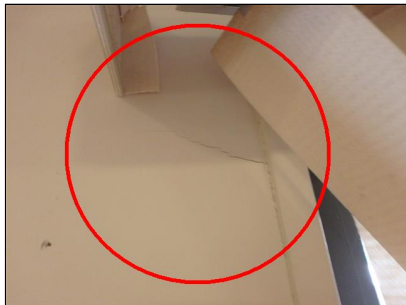
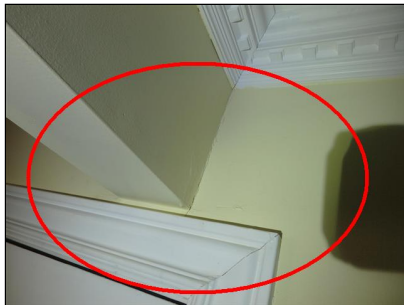
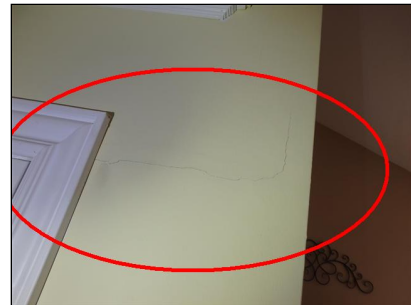
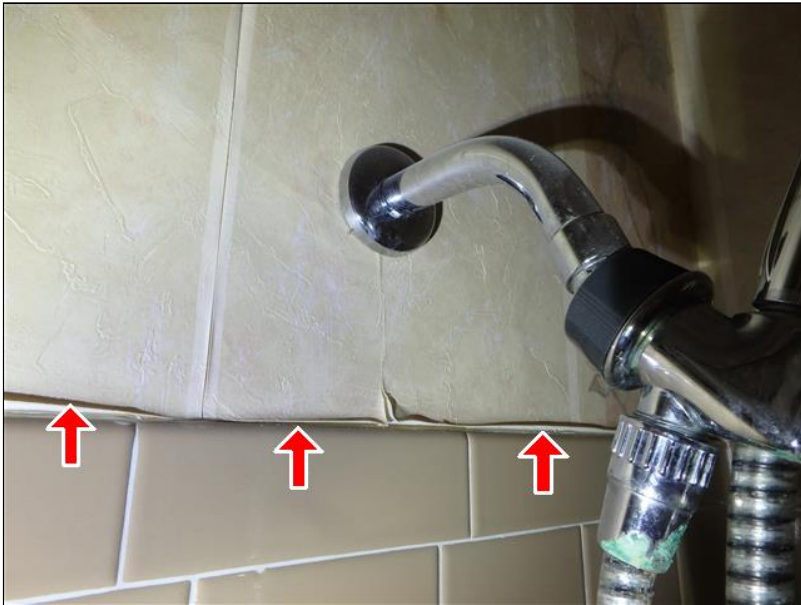
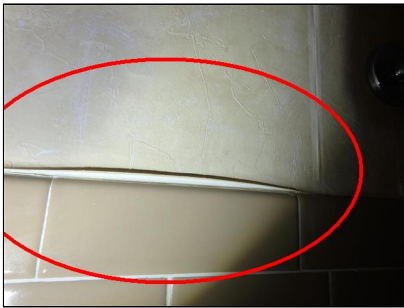
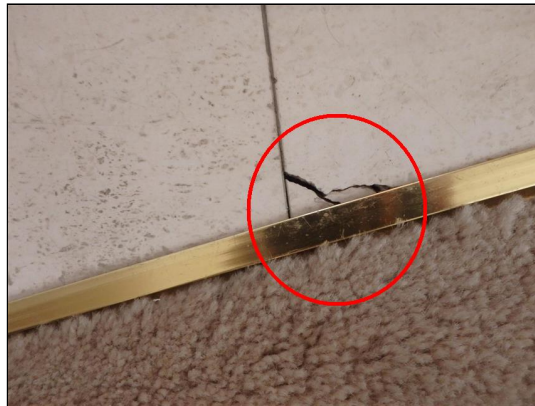
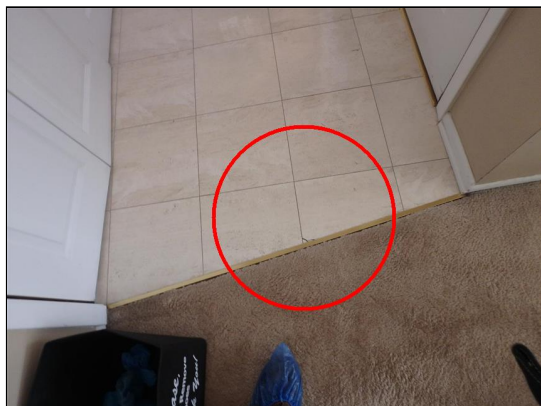
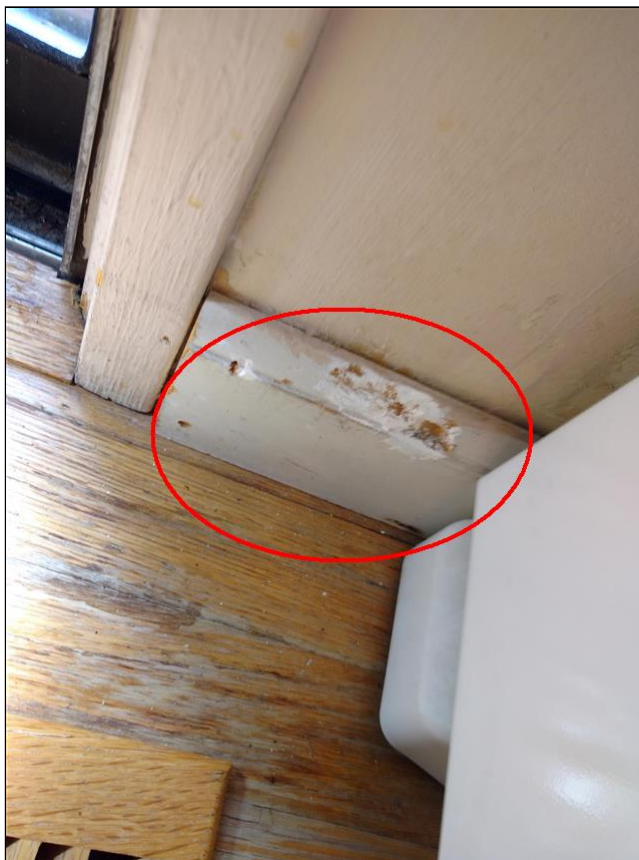
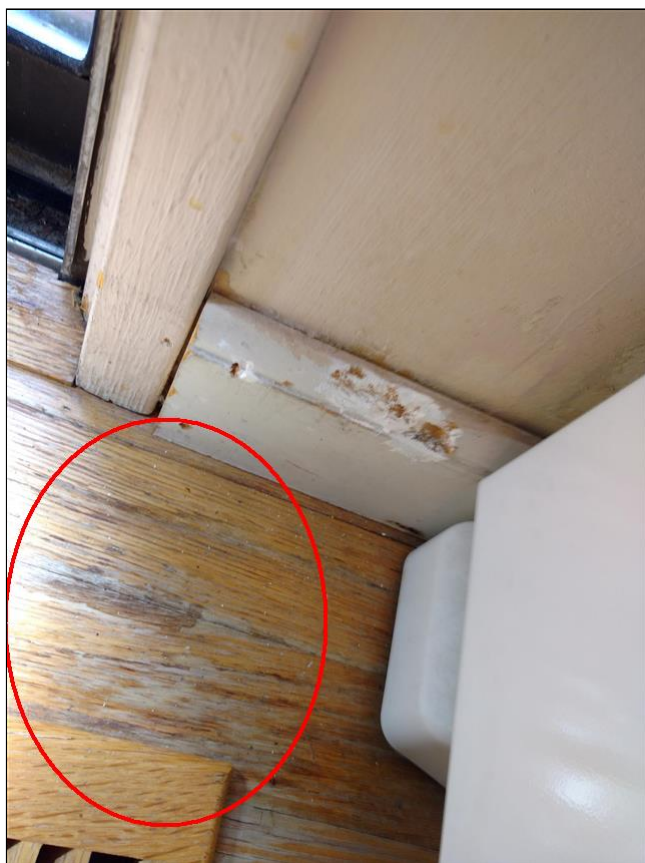
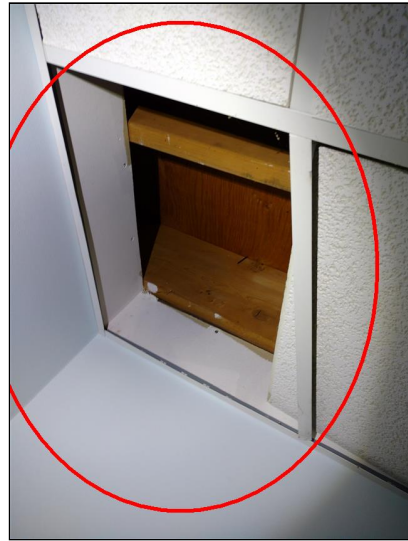
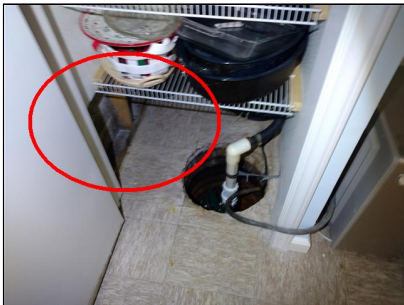
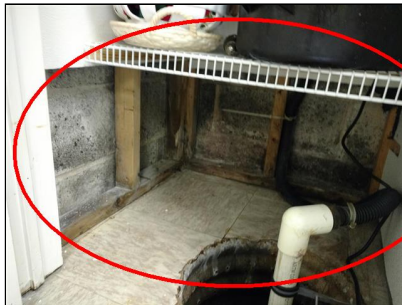
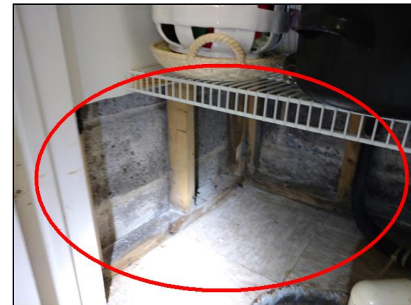
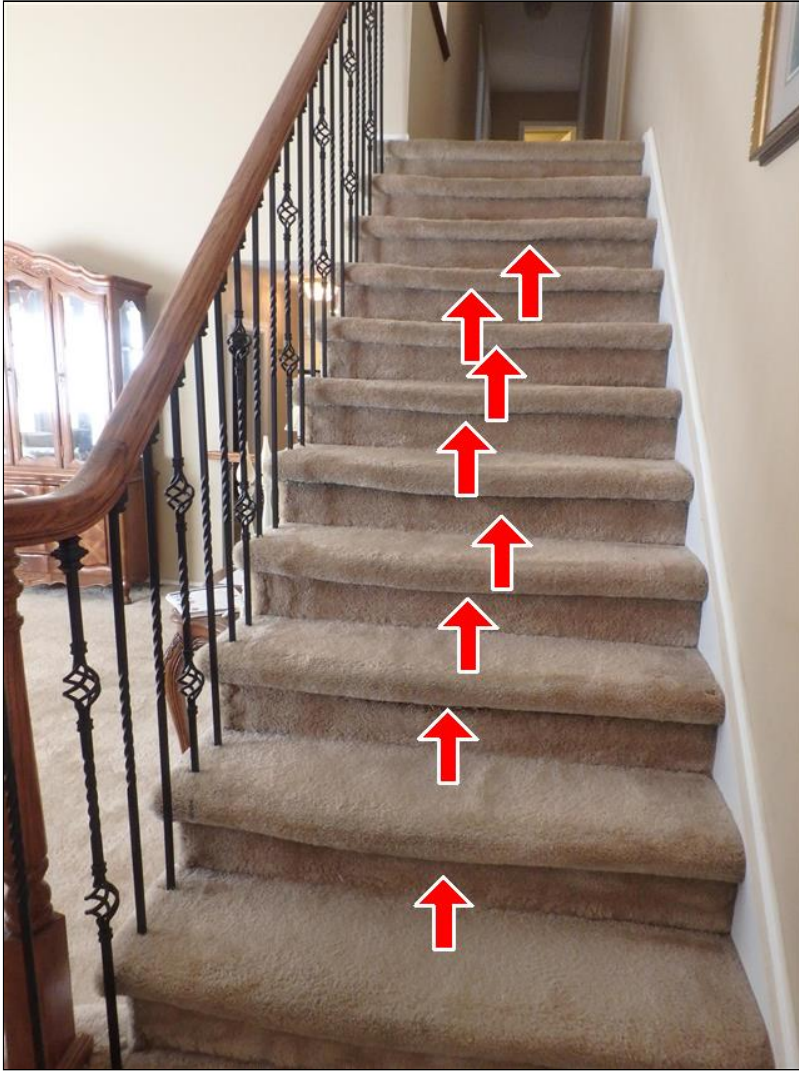
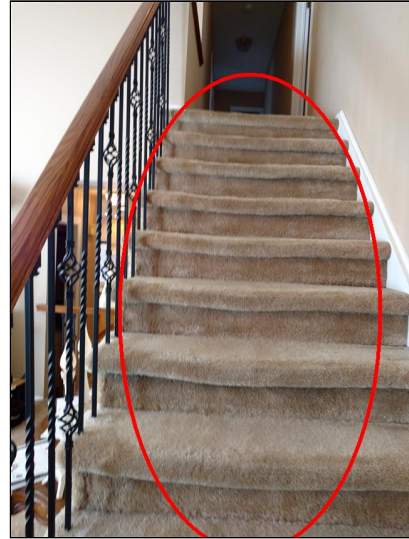
As observed in various areas of the dwelling, there were numerous portions of some of the wall, ceiling and/or floor surfaces that were either cracked, loose, damaged, deteriorated, not functioning as intended and/or had a peeling paint condition. These conditions may worsen if the necessary repairs are not completed. Further/other damage to the finishes may also occur. A further evaluation of ALL of the interior wall, floor and ceiling surfaces should be completed by a qualified, licensed contractor and the necessary repairs be completed. These conditions may also possibly exist on any surfaces that are covered with wall paper. Also to note, there were numerous portions of the carpeting where the padding/carpet appeared to be worn/compressed. This included the areas that appeared to be sloping.

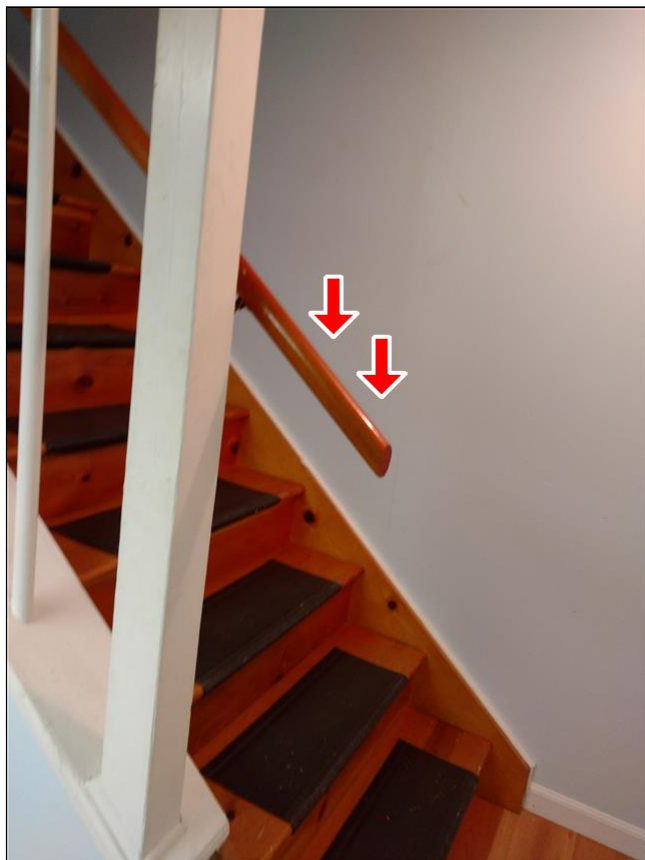
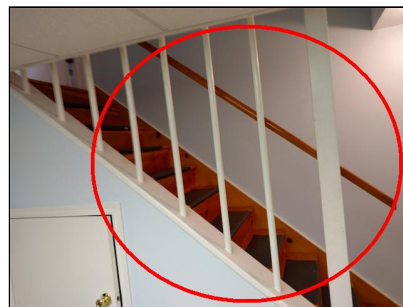
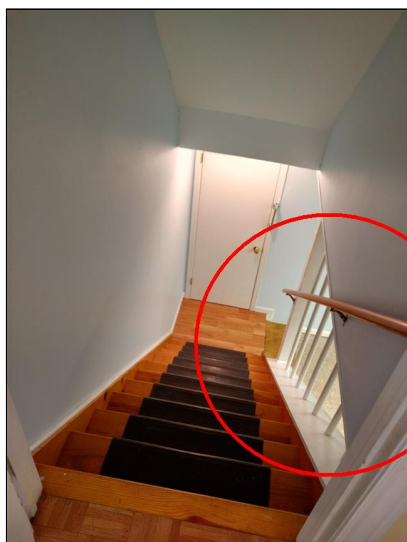
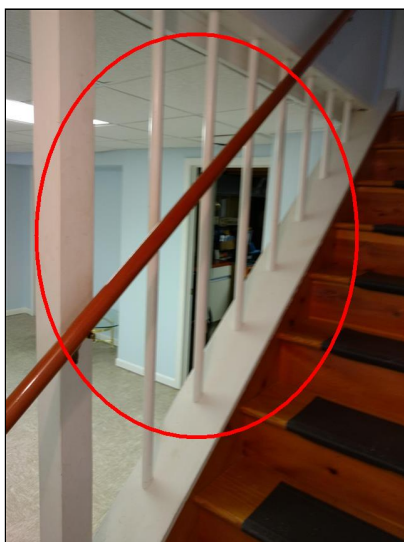
(1) The handrail(s) did not have the required returns at the ends to the wall which is a safety concern. The ends of the handrail may catch on loose fitting clothing, purses, bags, jewelery, etc. and could contribute to personal injury. Recommend further evaluation by a qualified, licensed contractor and repair as necessary. Also to note, the baluster spacing was greater than the 4" that is permitted. This is another safety concern.

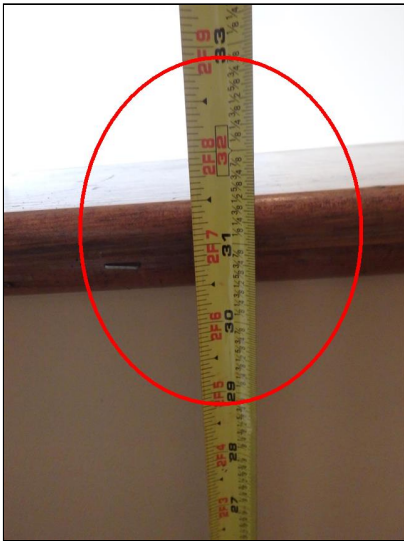
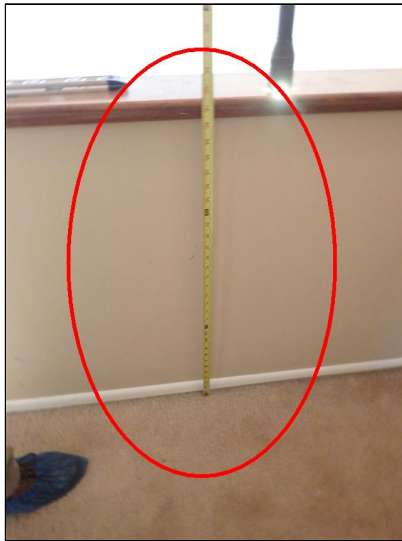
(2) The guardrail assembly on the 2nd stairwell only measured around 31-32 inches in height. Guardrails serving this application should be a minimum of 36 inches in height. This is a safety concern as someone could fall over the guardrails and possibly be injured. Recommend further evaluation by a qualified, licensed contractor and repair as necessary.

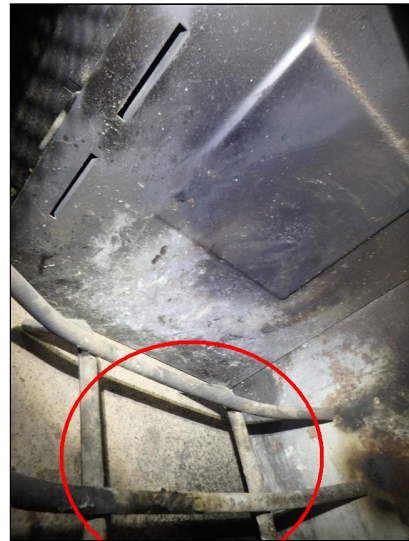
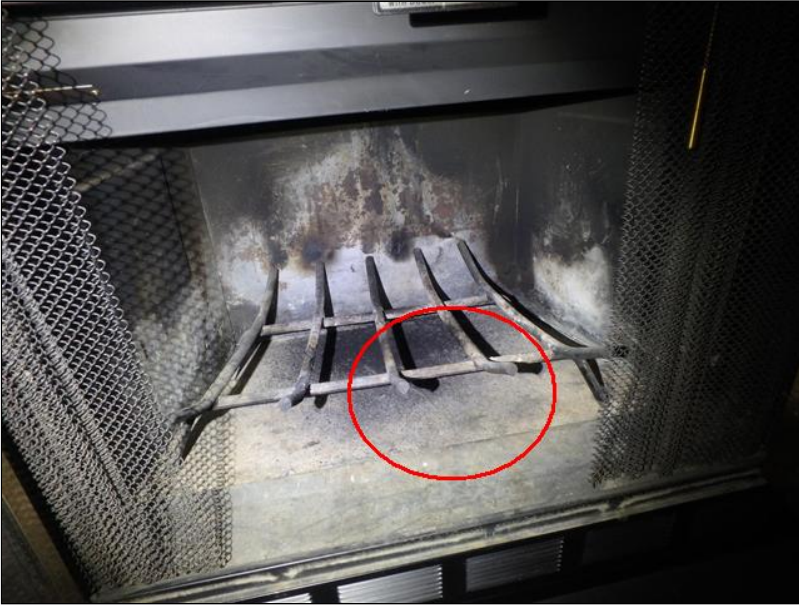
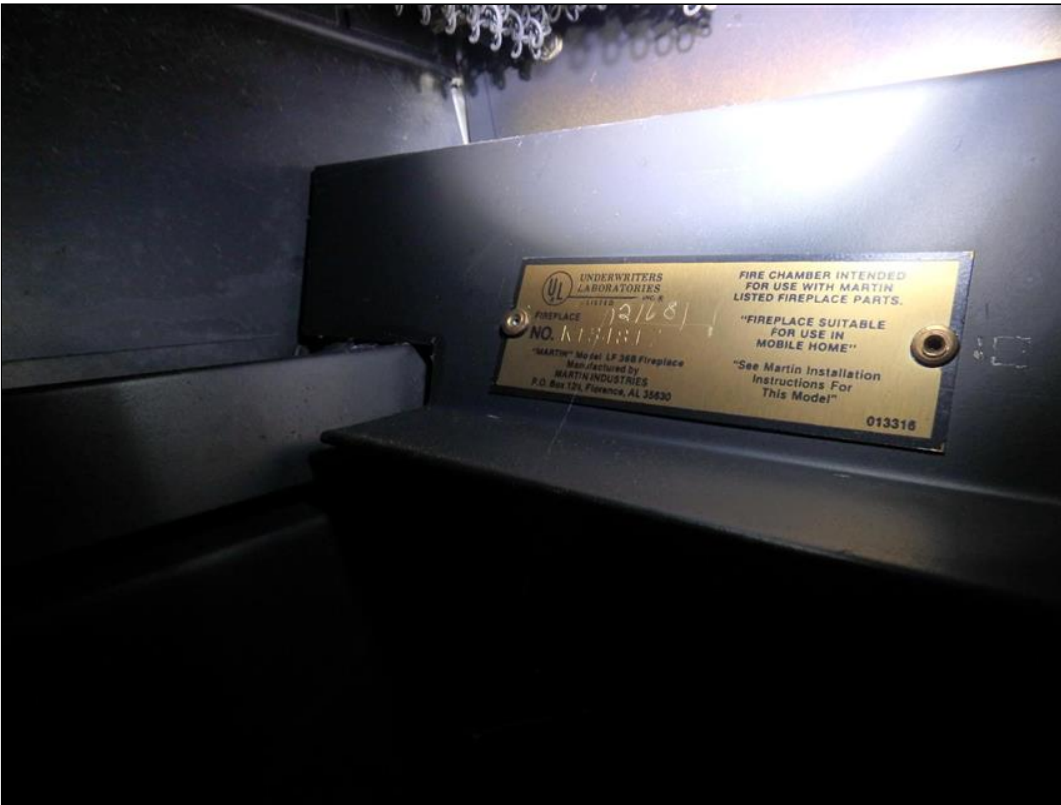
(2) As observed in the wood burning fireplace, the bottom insert refractory panel had a crack in it. This is a safety concern as this panel keeps the fire inside the firebox. Recommend further evaluation by a qualified, licensed fireplace professional and repair as necessary. As a precaution, the fireplace should not be used until the necessary repairs are completed and a level 2 chimney inspection is completed.

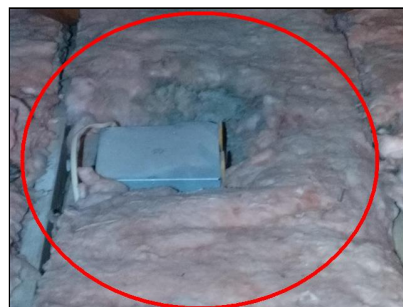
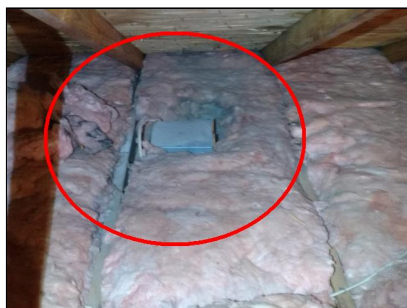
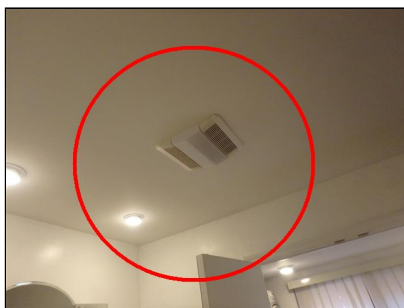
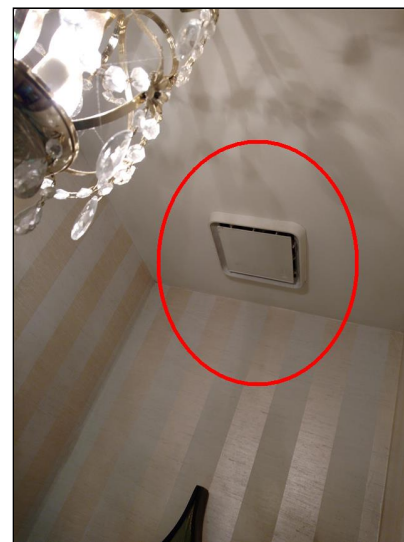
The exhaust fan for the master bathroom was venting into the attic space. This condition may cause a buildup of moisture and mold in the attic. This exhaust fan should be venting to the exterior. Recommend directing the vent towards the exterior to allow for proper ventilation to be performed by a qualified, licensed contractor. Also to note, the venting of the main level bathroom exhaust fan is suspect. There was no visible termination point on the exterior for this exhaust fan. So, it is suspected that the exhaust fan may be venting into the ceiling space above the bathroom. This venting should be terminated outdoors and may cause moisture damage/a mold condition to the surrounding structure if the needed repairs are not completed. This fan should also be further evaluation by a qualified, licensed contractor and repaired if necessary.

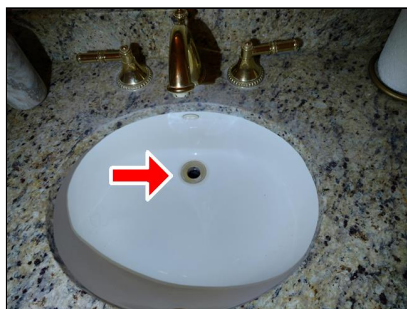
13.2 Item 1 (Picture)

The sink stopper in the bathroom sink was missing. This will prevent you from filling up the sink if you wanted to do so. Recommend further evaluation by a licensed plumber and repair as necessary.

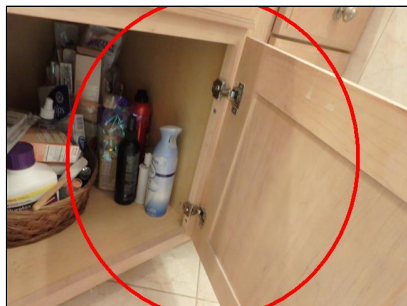
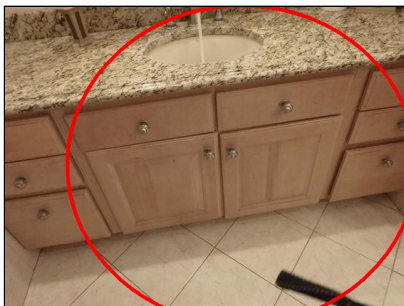
Portions of the bathroom vanity was damaged, had worn out hardware and/or not functioning as intended and in need of repairs. These conditions may worsen as well as possible damage to the cabinetry could occur if the needed repairs are not completed. Recommend further evaluation by a qualified, licensed contractor and repair as necessary.

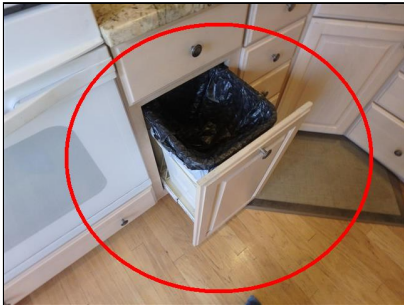
14.1 Item 1 (Picture)

Portions of the cabinetry were damaged, had worn out hardware and/or not functioning as intended and in need of repairs. These conditions may worsen as well as possible damage to the cabinetry could occur if the needed repairs are not completed. Recommend further evaluation of all of the kitchen cabinetry by a qualified, licensed contractor and repair as necessary.

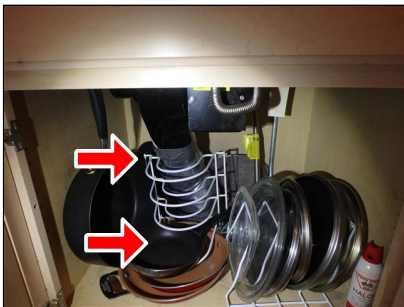
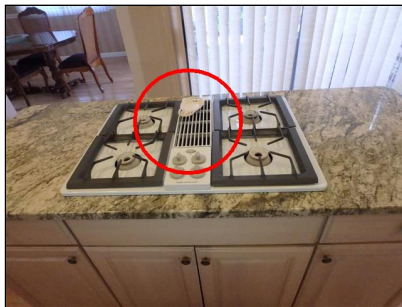
The venting of the down draft exhaust fan is suspect. It should be ascertained as to where this is venting and if it venting properly.

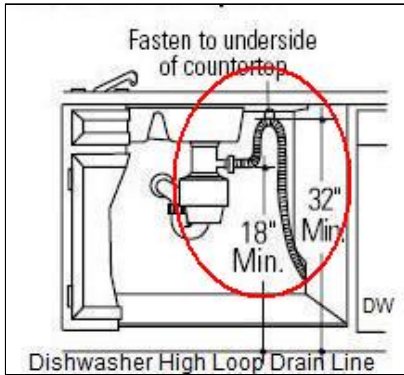
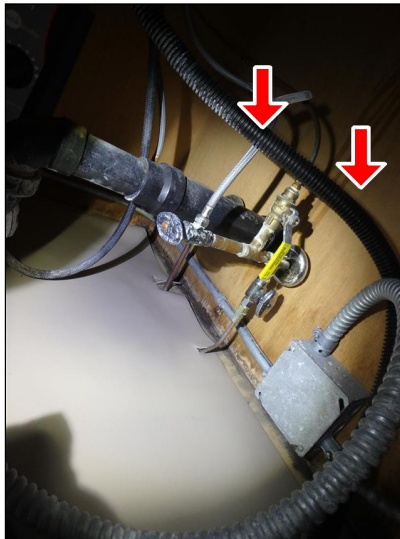
(1) The drain line on the dishwasher is not high looped under the countertop. The dishwasher drain line under the kitchen sink should be looped up as high as possible in the cabinet and up under the countertop. This prevents dirty/contaminated water from the sink from back flowing into the dishwasher. Recommend further evaluation by a qualified, licensed plumber and repair as necessary.

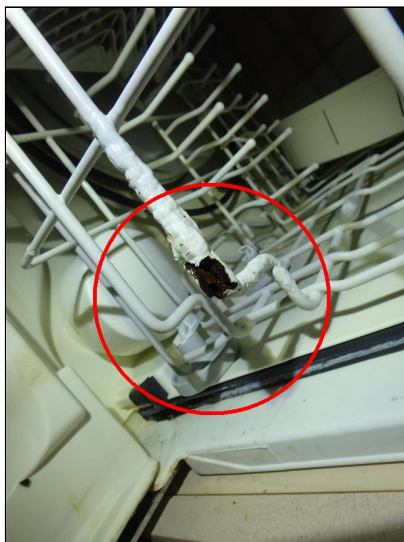
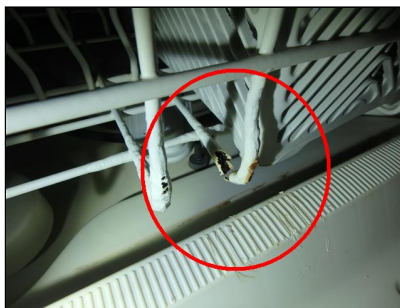
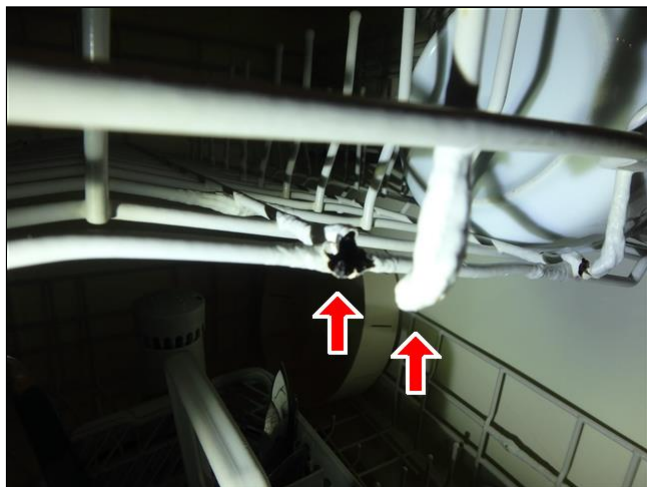
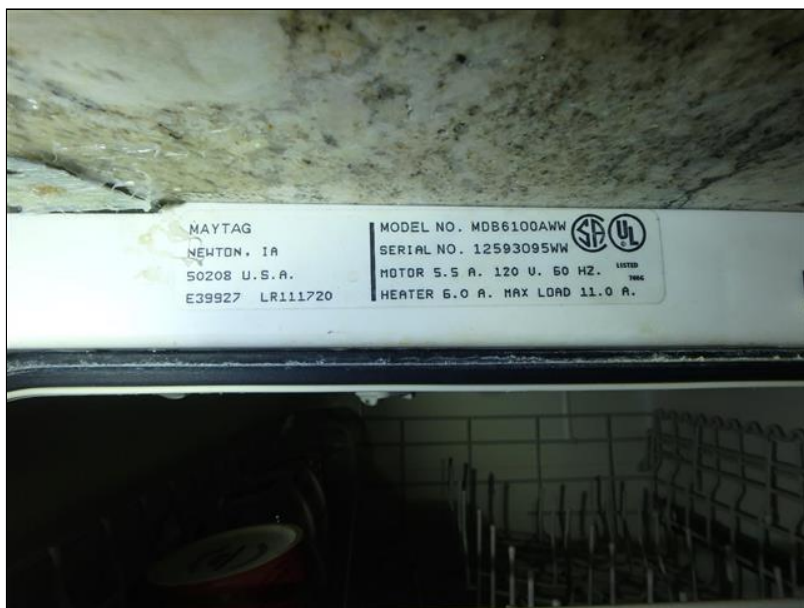
(2) Portions of the pull out drawers in the dishwasher appeared to be deteriorated and/or rusted. This is a potential health concern. Recommend further evaluation by a qualified, licensed appliance repair professional and repair/replace as necessary.

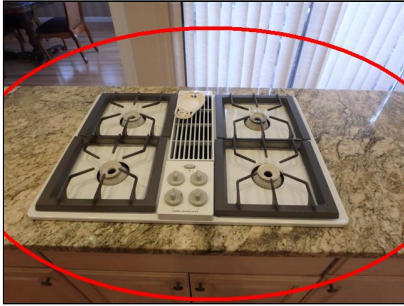
14.9 Item 1 (Picture)

Two of the burners did not light when tested. Recommend further evaluation by a qualified, licensed appliance professional and repair/replace as necessary.

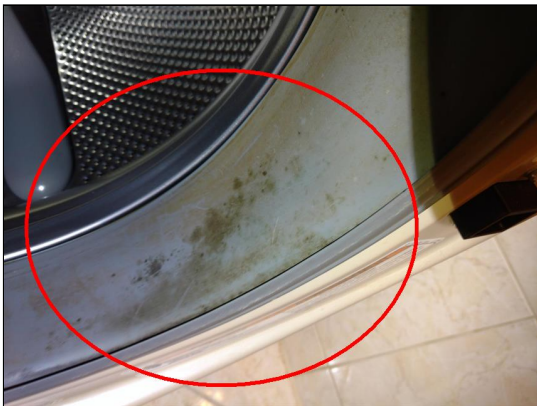
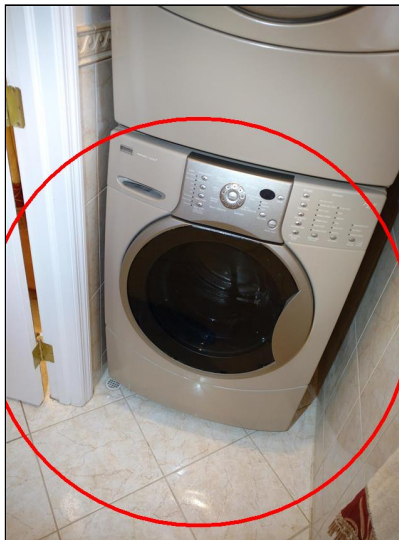
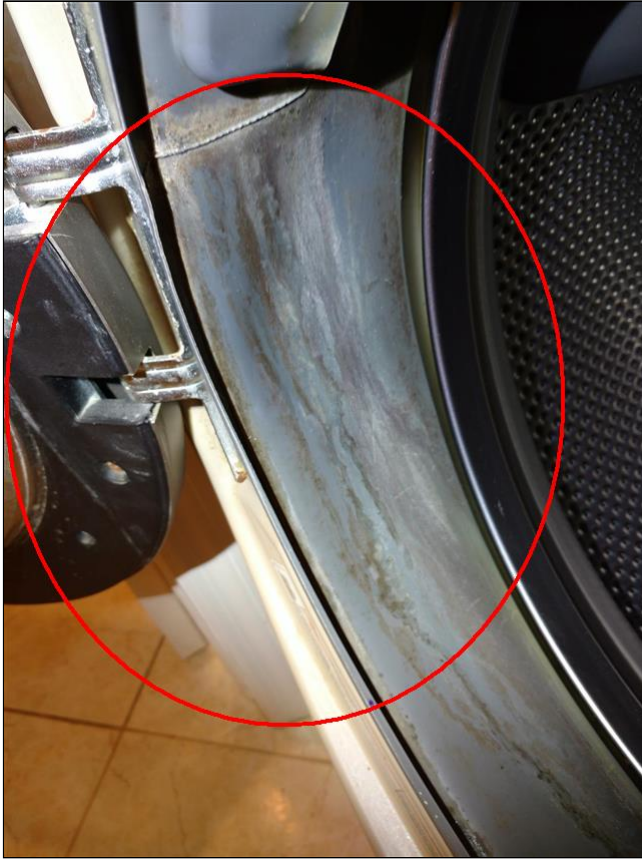
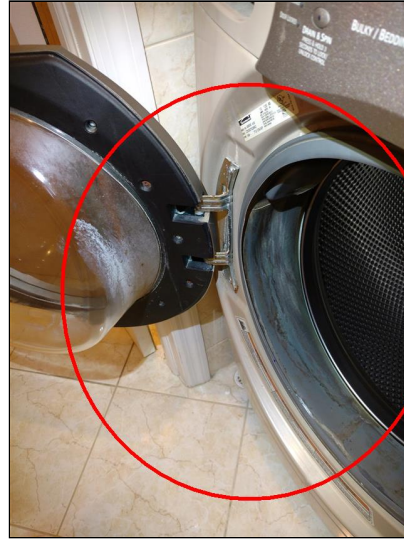
As observed inside the clothes washing machine, there was some minor mildew on the rubber portions of the drum. This should be cleaned and ideally the front door should be left open when the machine is not in use to let the inside of the washing machine dry out and not leave any mildew.

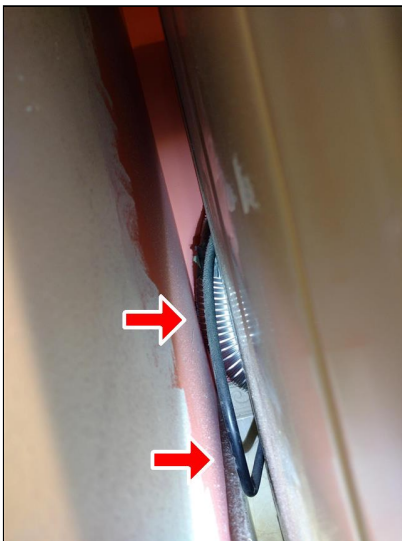
15.1 Item 1 (Picture)

(1) Rubber water supply fill hoses for the clothes washing machine were observed in the laundry area. Rubber fill hoses have a limited life span and are prone to bursting. A burst hose can result in flooding and serious water damage. It is recommended to replace rubber washing machine hoses with braided stainless steel mesh, burst resistant hoses. This should be the buyer's responsibility as the rubber fill hoses that were present appeared to be in a serviceable condition. These hoses are available at the Home Depot, Lowes or any other home center and usually cost around \$20-\$30.

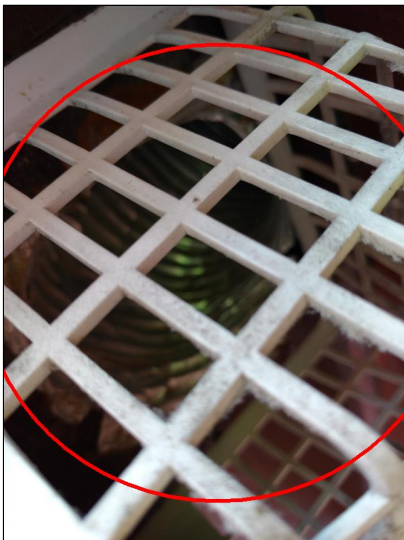
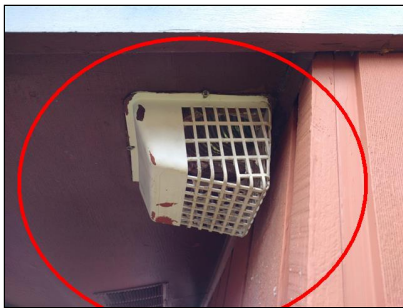
The back portions of the laundry equipment could not be viewed. This includes the water supply lines, natural gas supply line, dryer ducting, the water supply shut off valves and the clothes washer drain. Therefore, the inspection of all of the items/components is limited. They may not be functioning as intended and may have issues/defects present. Also to note, the exterior portion of the dryer venting was missing a backdraft damper door. This condition could allow wildlife/bugs to enter the dryer vent ducting and possibly clog it. Cold/hot air can also migrate into the dryer as a result. Recommend further evaluation by qualified, licensed contractor and repair as necessary.

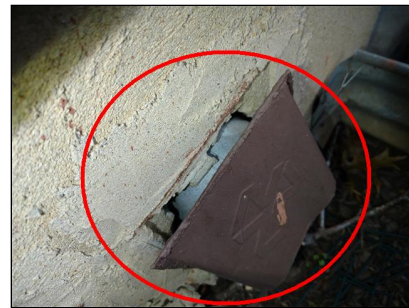
15.4 Item 3 (Picture) Old dryer vent under deck appears to be not in use. The foundation penetration should be sealed

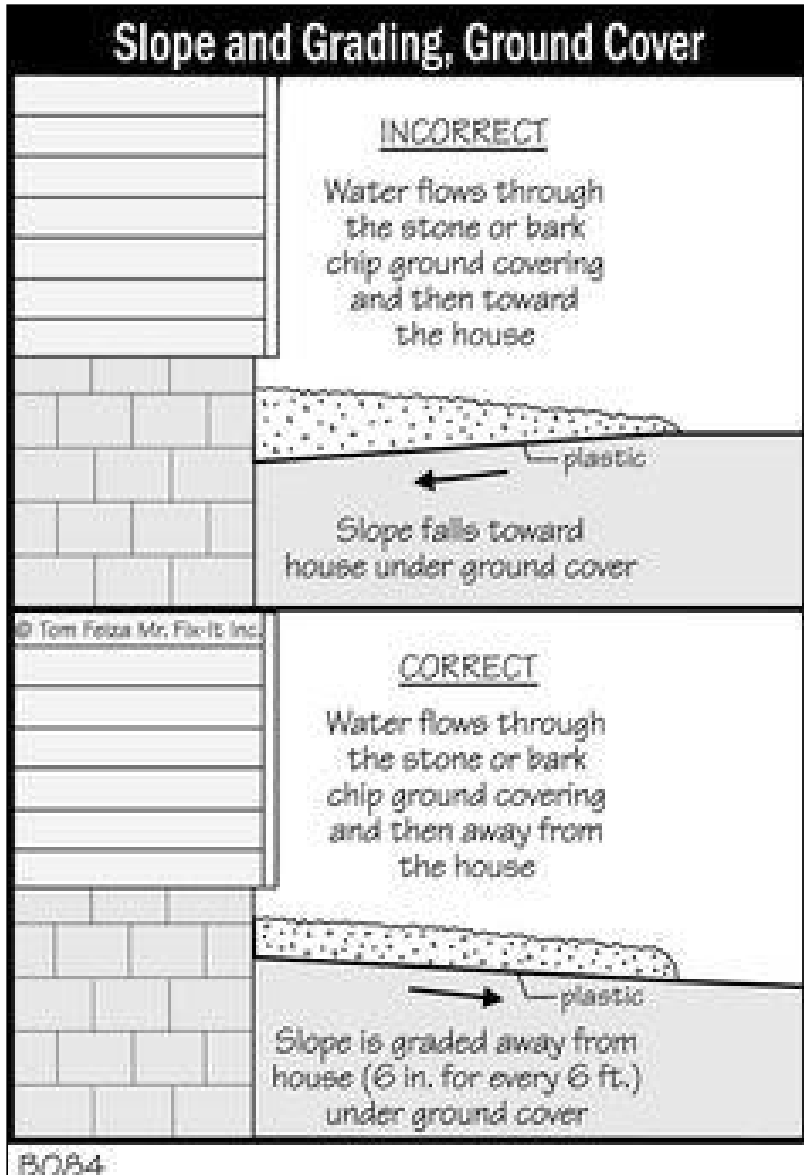
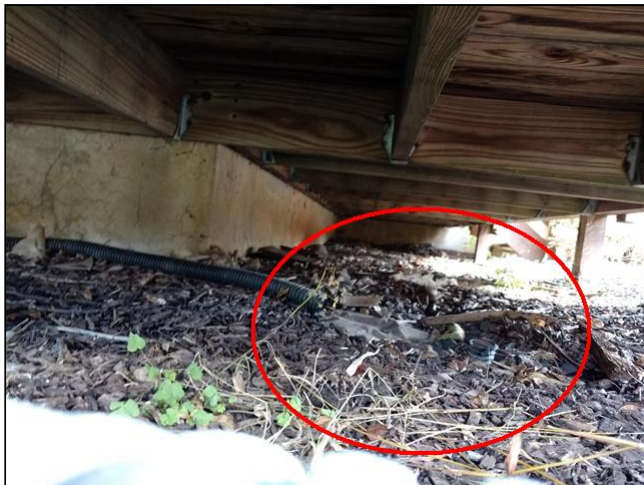
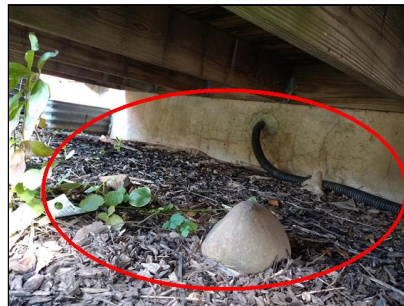
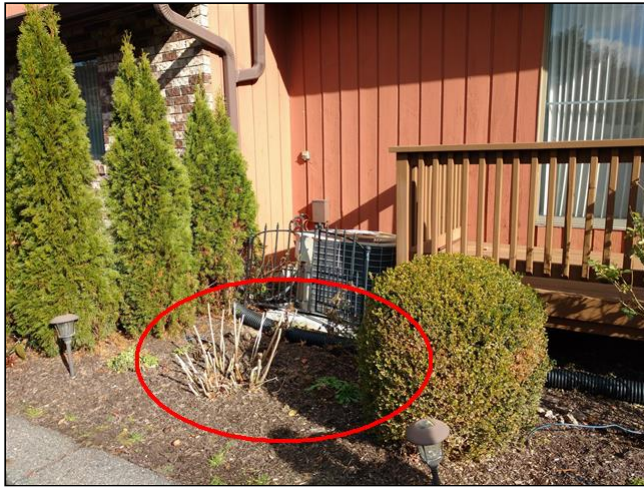
The grading (slope of ground surface) next to the foundation under the deck areas was pitched towards the foundation. The grading whenever possible should be pitched away from the foundation to prevent moisture

intrusion from entering the foundation walls and basement. Recommend further evaluation of all of the exterior grading by a qualified, licensed contractor and repair as necessary.

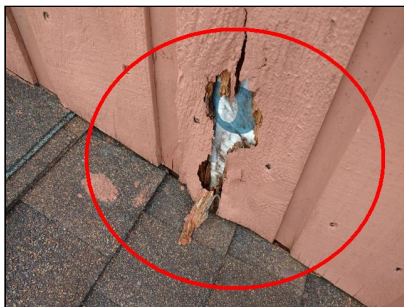
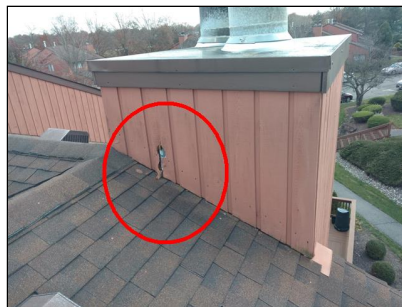
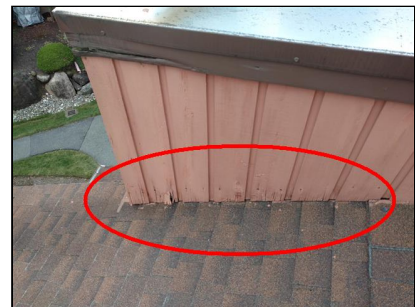
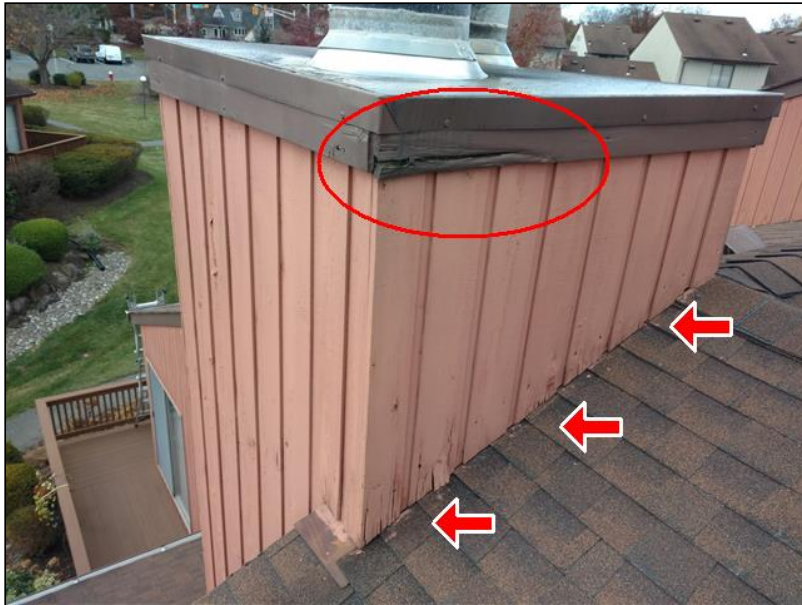
As observed on the exterior that affects the dwelling, there were portions of some of the exterior elements (windows, window frames, window flashings, doors, door frames, door flashings, siding/cladding, masonry, brick and/or stone veneer, trim, framing, flashings, eaves, fascias, soffits and/or gable ends) that were either missing, had open gaps/holes/unsealed joints, were not functioning as intended, were deteriorated/damaged and/or had a peeling paint condition. The condition of the noted elements/areas may worsen as well as possible structural/moisture damage behind/under these elements could occur if the needed repairs are not completed. Damage to the interior finishing materials may also occur. A further evaluation of the **ENTIRE exterior of the dwelling** should be completed by a qualified, licensed contractor and the necessary repairs be completed. **There may be hidden moisture damage, deterioration and/or wood destroying insect damage within the structure behind/under the effected exterior elements that was not visible at the time of the inspection.**

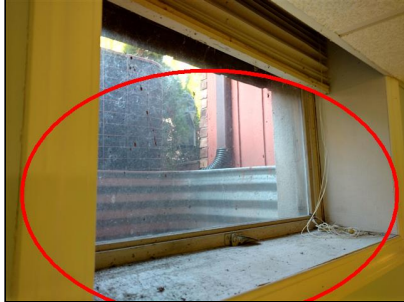
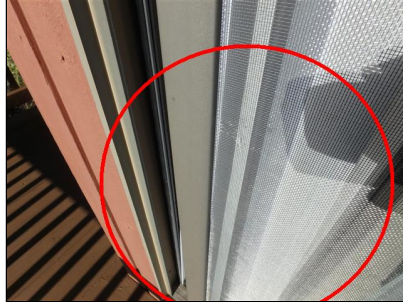
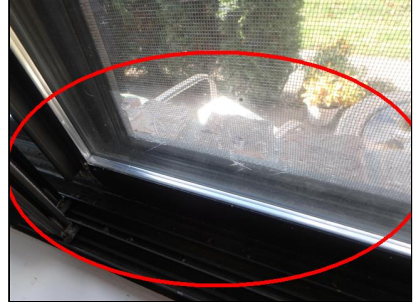
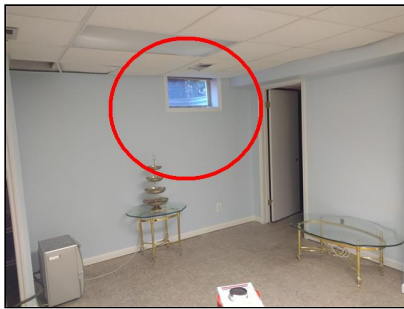
(2) Some of the window and door screens were ripped. Also the basement window would not open. Recommend further evaluation by a qualified, licensed contractor and repair as necessary.

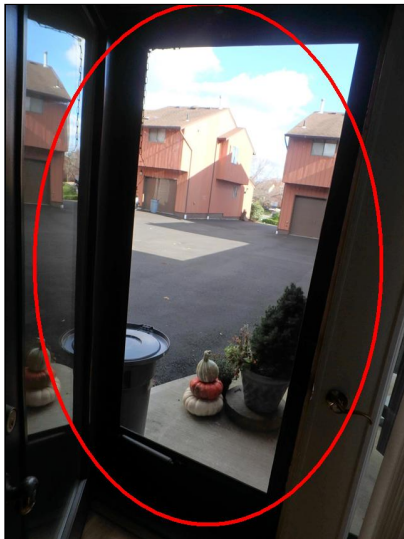
2.4 Item 1 (Picture)

(2) The self closer on the rear storm door was not functioning. The door was slamming shut when opened. This is a safety issue as someone could be injured by the door slamming shut. Recommend further evaluation for repairs by a qualified, licensed contractor.

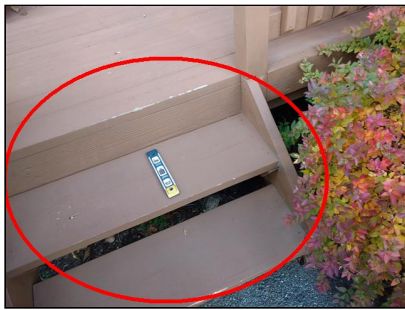
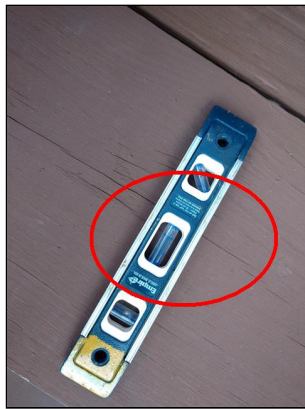
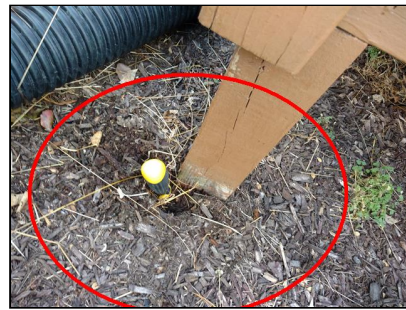
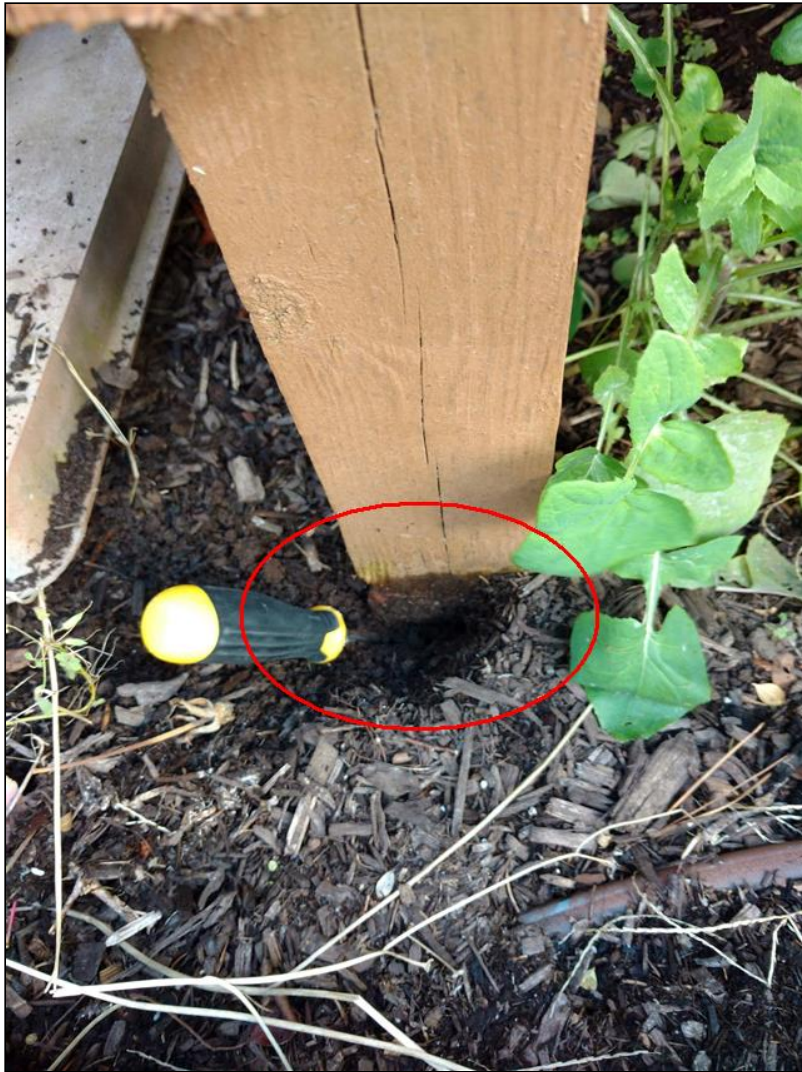
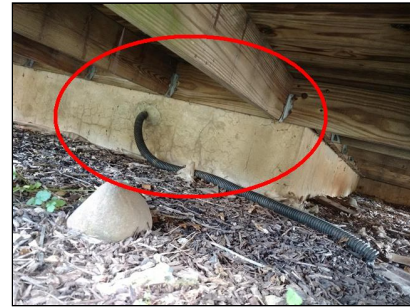
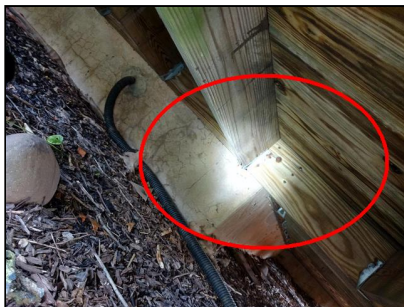
There were numerous issues were observed pertaining to the wood deck. They included:

- 1) There were no top of support post to beam and no stair stringer to the deck structure mechanical connectors present.
- 2) There were no visible footings under some of the support posts.
- 3) The stair treads were sloping downwards which is a safety concern.
- 4) Some of the joist hangers were rusted.

These are safety concerns. These conditions may also worsen if the needed repairs are not completed. The support posts may deteriorate. A further evaluation of the ENTIRE deck should be completed by a qualified, licensed deck contractor and the necessary repairs be completed.

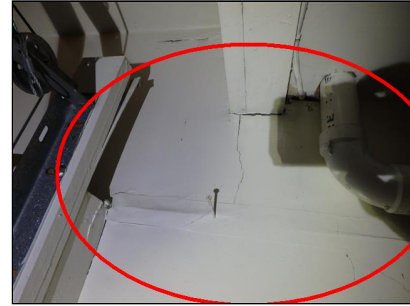
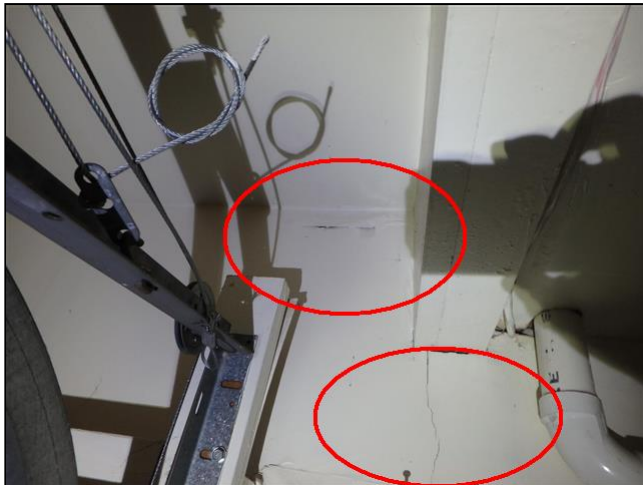
Portions of the walls and/or ceiling surfaces in the garage had numerous cracks, gaps, unsealed joints, deteriorated/damaged areas, holes and/or missing sections. The garage space should be 100% sealed off to the living space to prevent possible carbon monoxide from a vehicle from entering the living space above and also from a fire block

standpoint. These noted conditions may worsen if the needed repairs are not completed. Recommend further evaluation by a qualified, licensed contractor and repair as necessary..
