# Property Inspection Report

123 Main Street

Unit T1

**Terra Home Inspections LLC**

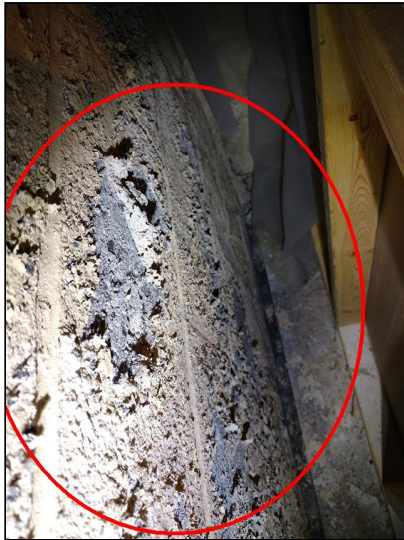
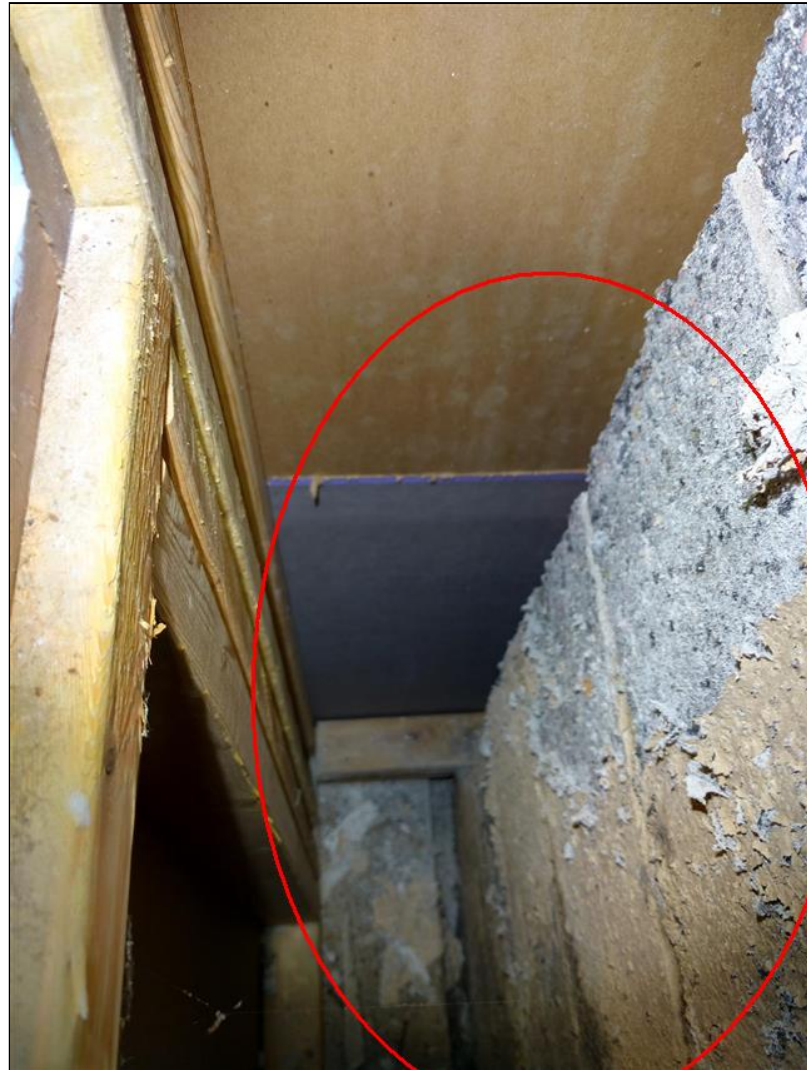
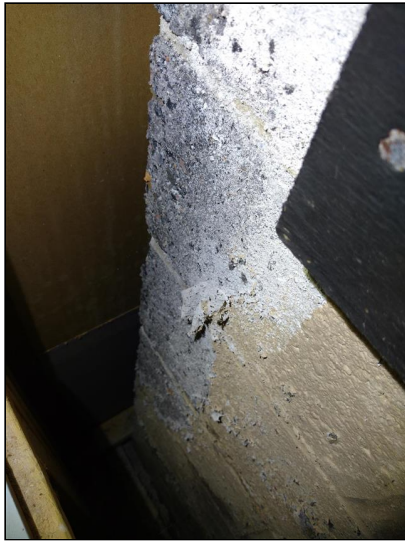
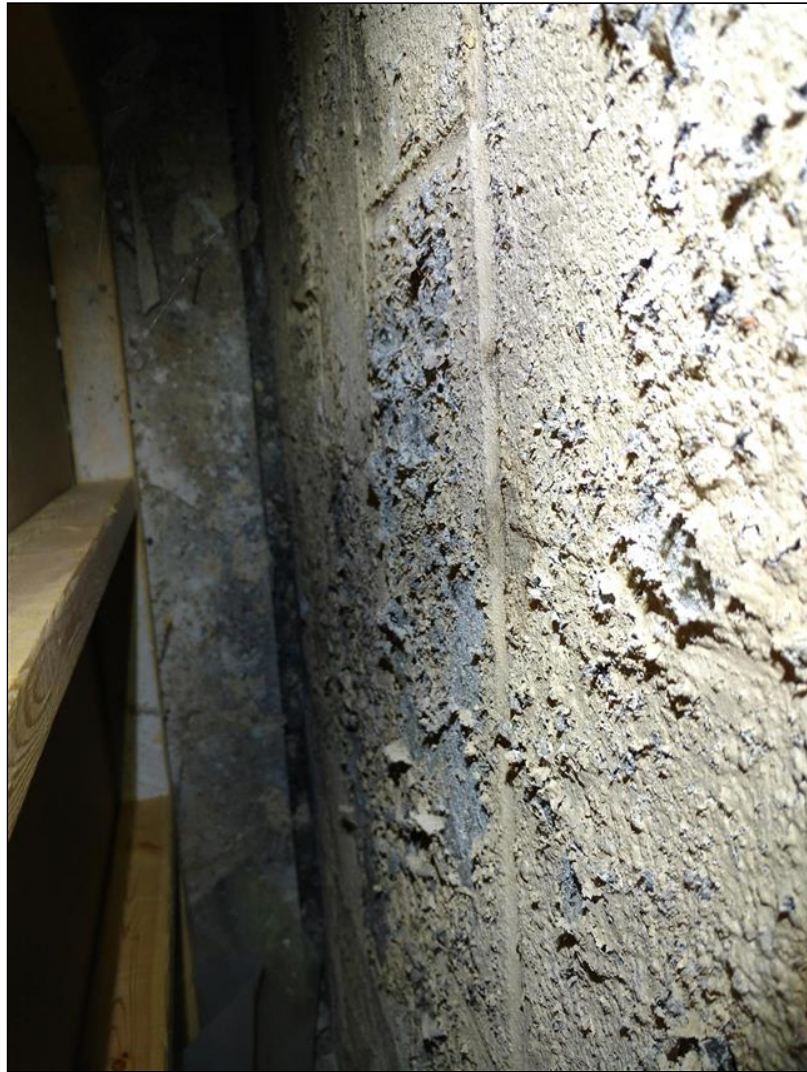
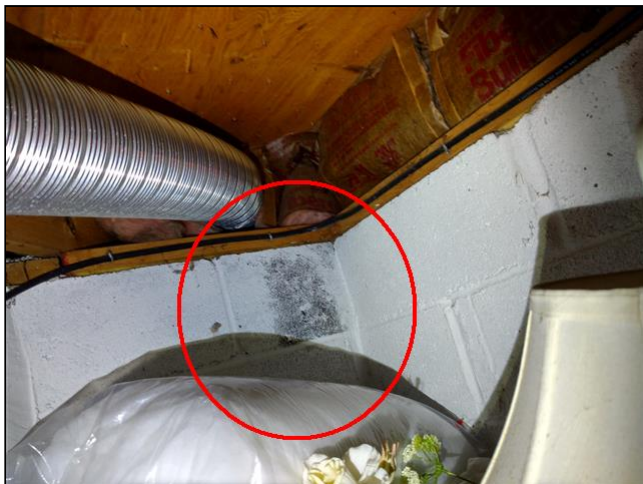
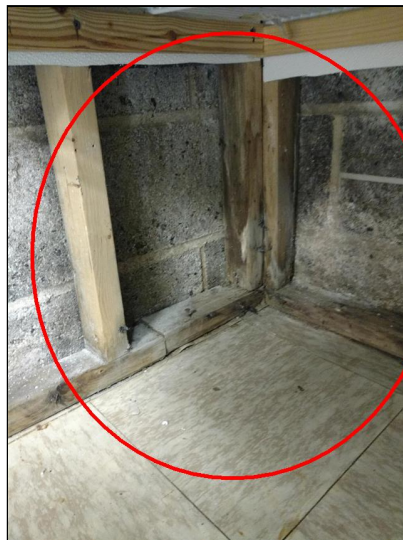
(1) As observed in some of the visible portions of the foundation in the basement, there was evidence of moisture intrusion (efflorescence, staining, peeling paint and/or mortar decay) observed on the foundation walls. Moisture can create high humidity, mold & can damage stored items & finishing materials. There may be some drainage and/or grading issues on the exterior that are contributing to these condition(s). The noted conditions may worsen any needed repairs are not completed. A further evaluation of the entire foundation (both interior and exterior) should be completed by a qualified, licensed masonry contractor and the necessary repairs be completed. **This condition may also exist behind finished basement walls/floor coverings. It may be less severe or worse than what was visible.**

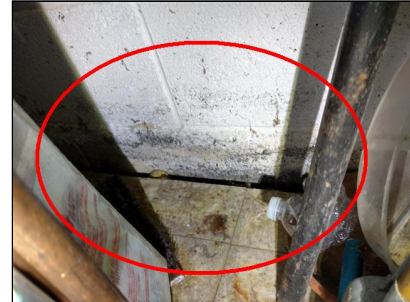
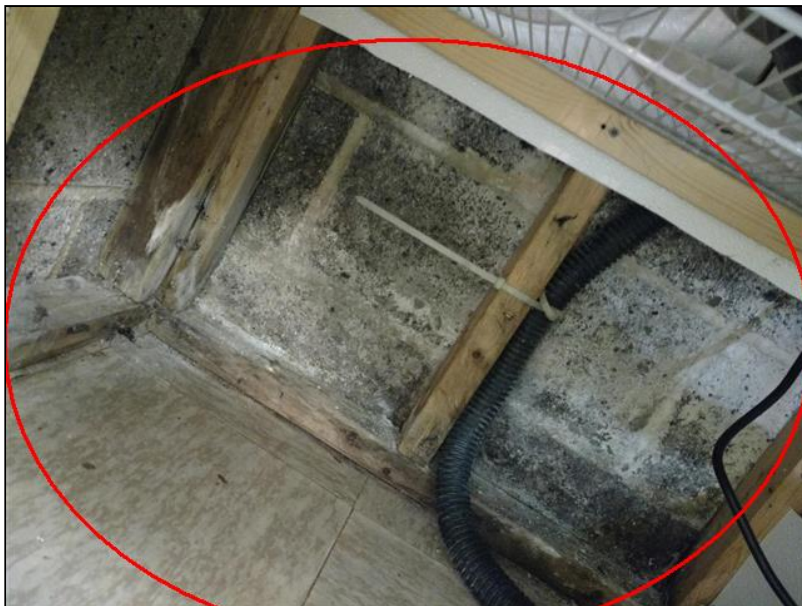
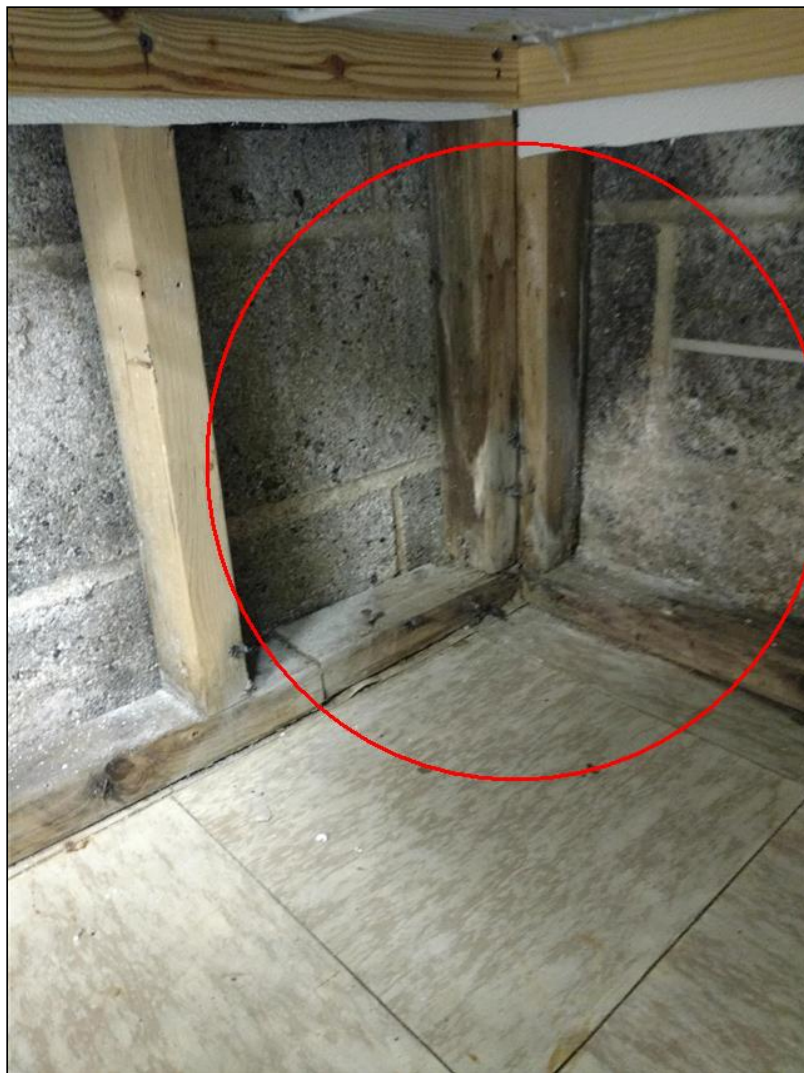
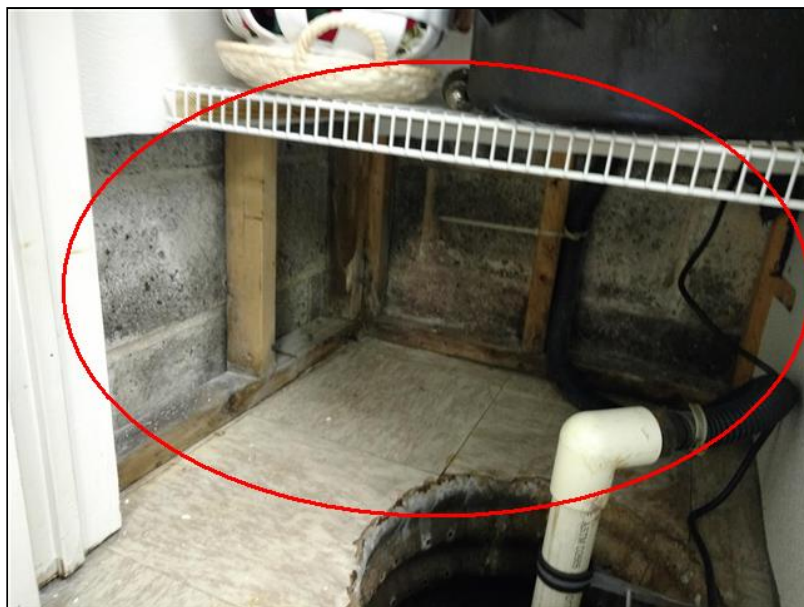
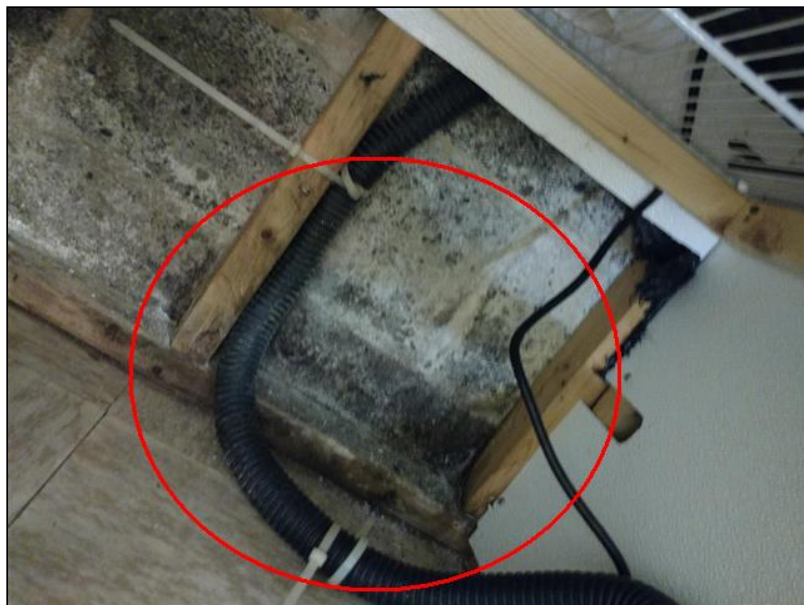
(2) There was what appeared to be a black organic growth condition (possibly mold) on the visible portions of the foundation walls and finished wall structure in the basement. This is a potential health concern as molds have the potential to cause numerous health problems. Molds produce allergens (substances that can cause allergic reactions), irritants, and in some cases, potentially toxic substances (mycotoxins). Inhaling or touching mold or molds spores may cause allergic reactions in sensitive individuals. These conditions may also worsen if any needed

repairs are not completed. **A further evaluation/testing of the ENTIRE basement should be completed by a qualified, licensed environmental contractor and any necessary repairs/remediations be completed.** Additional information from the US EPA pertaining to mold in the home can be review at <http://www.epa.gov/mold/moldbasics.html> **This condition may also exist behind finished basement walls/floor coverings. There may be hidden damage. It may be less severe or worse than what was visible.** Also to note, the walls inside the closet that houses the sump pump were covered with fiberglass reinforced plastic (FRP) panels. This is not typical as finished wall are usually covered with drywall. They may have done this because the drywall may have been getting mold on it because of the high moisture within this closet.

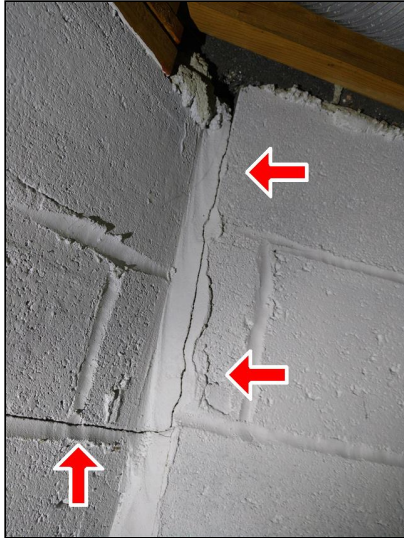
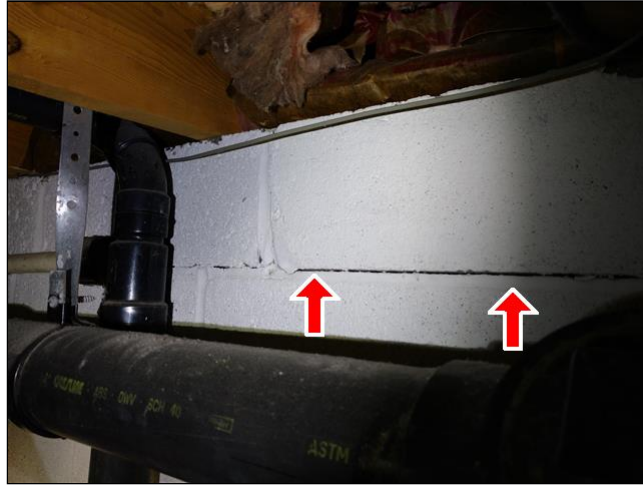
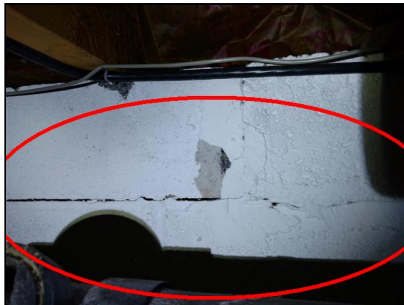
(3) There were numerous cracks and/or deteriorated areas present on some of the visible portions of the interior and/or exterior foundation wall surfaces. These conditions if not repaired may lead to possible moisture intrusion into the foundation walls and the basement along with possible deterioration of the foundation walls and the interior finishes of the house. These conditions may also worsen if the needed repairs are not completed. A further evaluation of the ENTIRE foundation (both interior and exterior) should be completed by a qualified, licensed structural contractor and the necessary repairs be completed. **These conditions may also exist behind finished basement walls/floors. They may be less severe or worse than what was visible.**

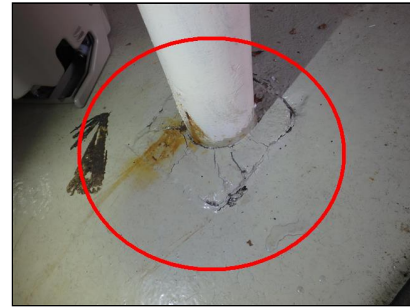
4.1 Item 3 (Picture)

As observed in the garage, one of the steel lally support columns appeared to have numerous rust stains/scabs/cracks towards the bottom of it. This condition is usually caused by moisture that is moving up from the garage floor and through the cement that inside the steel lally column due to capillary action. The inside of the column then rusts out and holes develop. These little scabs then start to allow moisture to weep out and run down the sides of the column. Over time a few things couple happen as a result of this condition. First the column may rust more at the base. The metal can rust out so much the column compresses on itself and may drop a little. This in turn may cause the structure above to drop a little. This may cause minor hairline cracks in the walls, ceiling and/or floor surfaces above. Sometimes the steel column may also split apart. Further deterioration of this column as well as structural damage and/or damage to the finishing materials could occur if the needed repairs are not completed.

Recommend further evaluation by a qualified, licensed structural contractor and repair/replace as necessary.

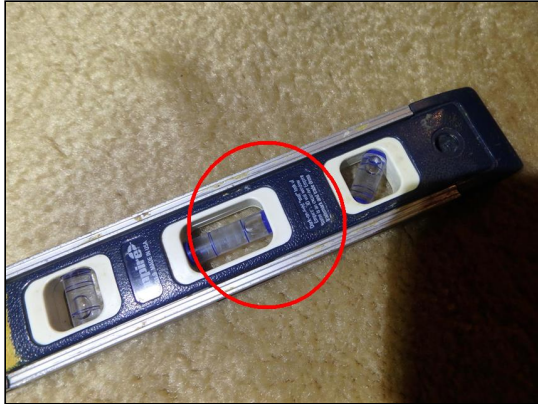
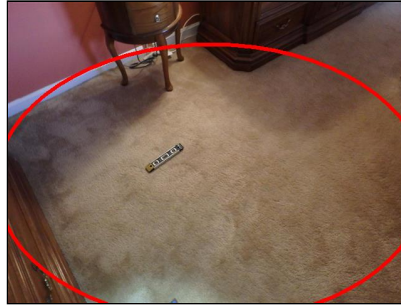
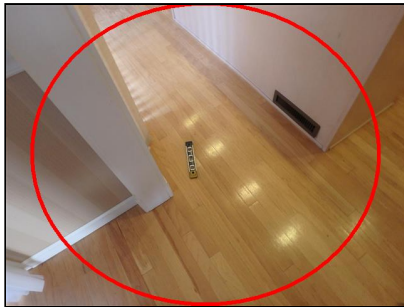
As observed in a small area in the kitchen and in the master bedroom, there were numerous floors surfaces that had a noticeable sloping condition present. The condition of the sloping floors in question could worsen in the future if any needed structural repairs are not completed. Future structural damage as well as damage to the interior finishes (walls, ceilings, flooring) could also occur. The area of concern in the bedroom may be a result of the carpet padding under the carpet being worn or there may be a structural issue causing the sloping condition. Sometimes carpet padding in high traffic areas becomes worn over other portions of the carpeted flooring. A further evaluation

of the ENTIRE structure/dwelling should be completed by a qualified, licensed structural contractor and any necessary repairs completed.

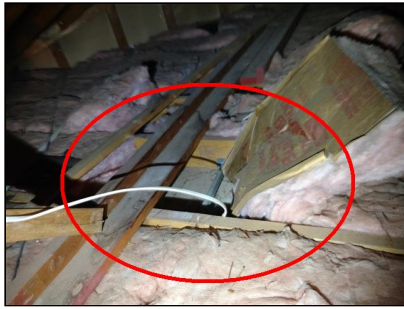
6.2 Item 1 (Picture)

As observed in the attic space, there were a few floor joist bays that had either missing, damaged and/or deteriorated insulation. Recommend further evaluation of all of the attic insulation by a qualified, licensed contractor and repair/replace/install the insulation in these joist bays to reduce energy expenses and prevent condensation/mold in the attic space by reducing the heat loss from the living space to the attic space.

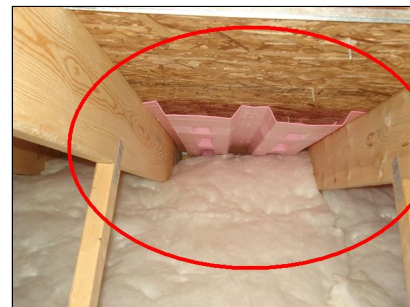
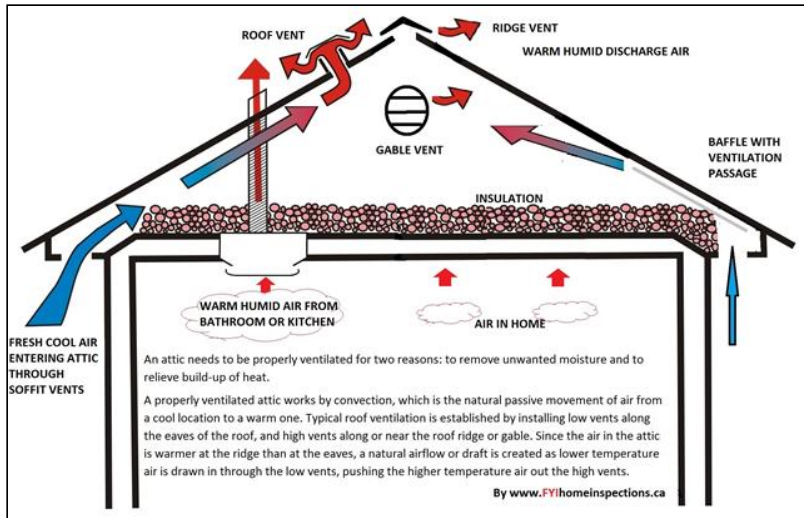
As observed in the attic space, the soffit vents appeared to be blocked with insulation. Recommend adding soffit vent baffles in the attic to avoid premature aging of roof decking/covering and help to maintain proper humidity and temperature control within the attic space. The venting in the attic space currently may not be adequate without the soffit vents being cleared and open for air flow.

6.3 Item 2 (Picture) Example of venting

6.3 Item 3 (Picture) Example of venting

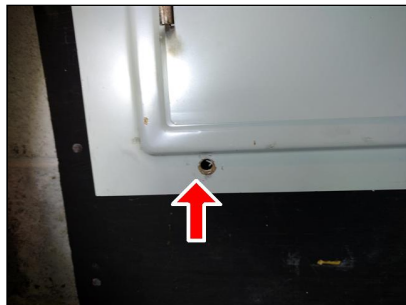
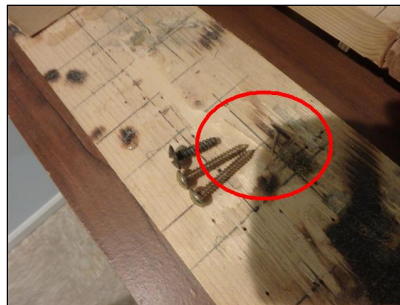
(2) Two of the hold down screws for the front cover on the sub panel in the unit had pointed tips. These screws should have blunt (dull) tips to prevent the tip of the screw from piercing the insulation on the wires inside the panel if they came in contact with them. One of the necessary screws was also missing. Recommend having a qualified, licensed electrician install the required OEM (original equipment manufacturer) screws.

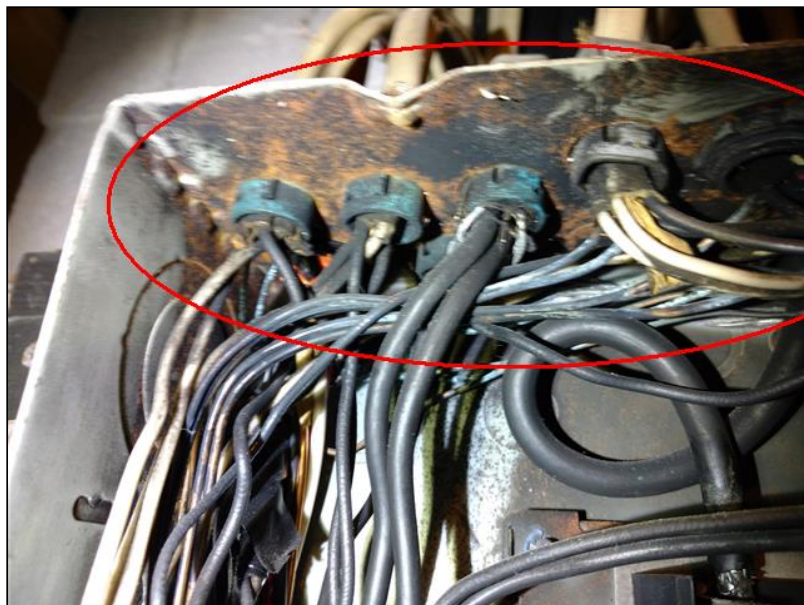
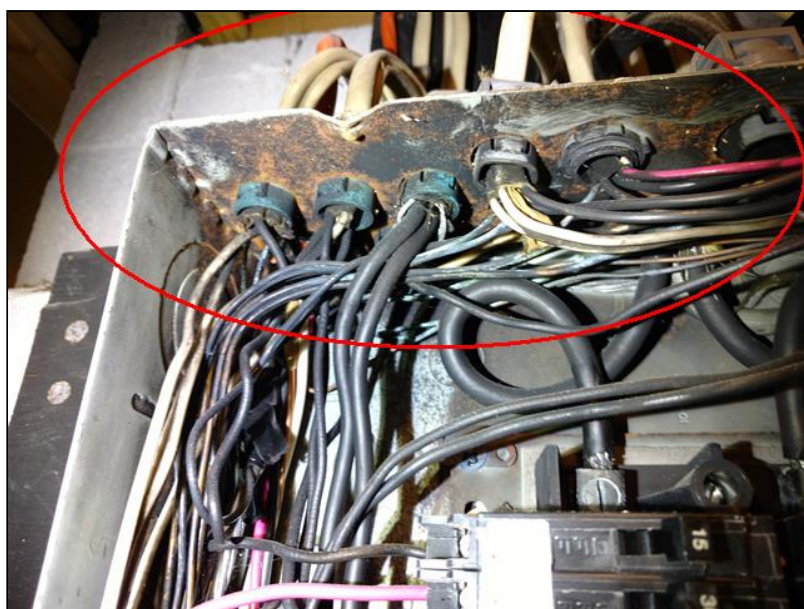
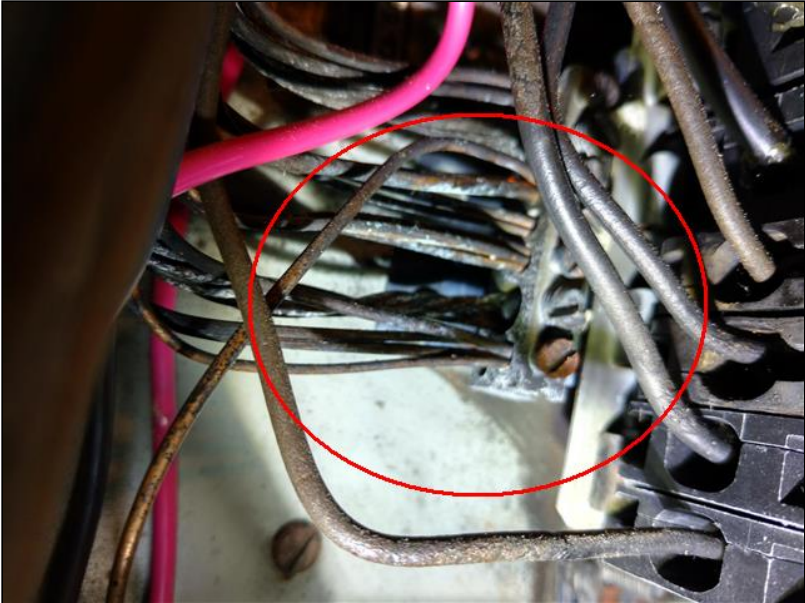
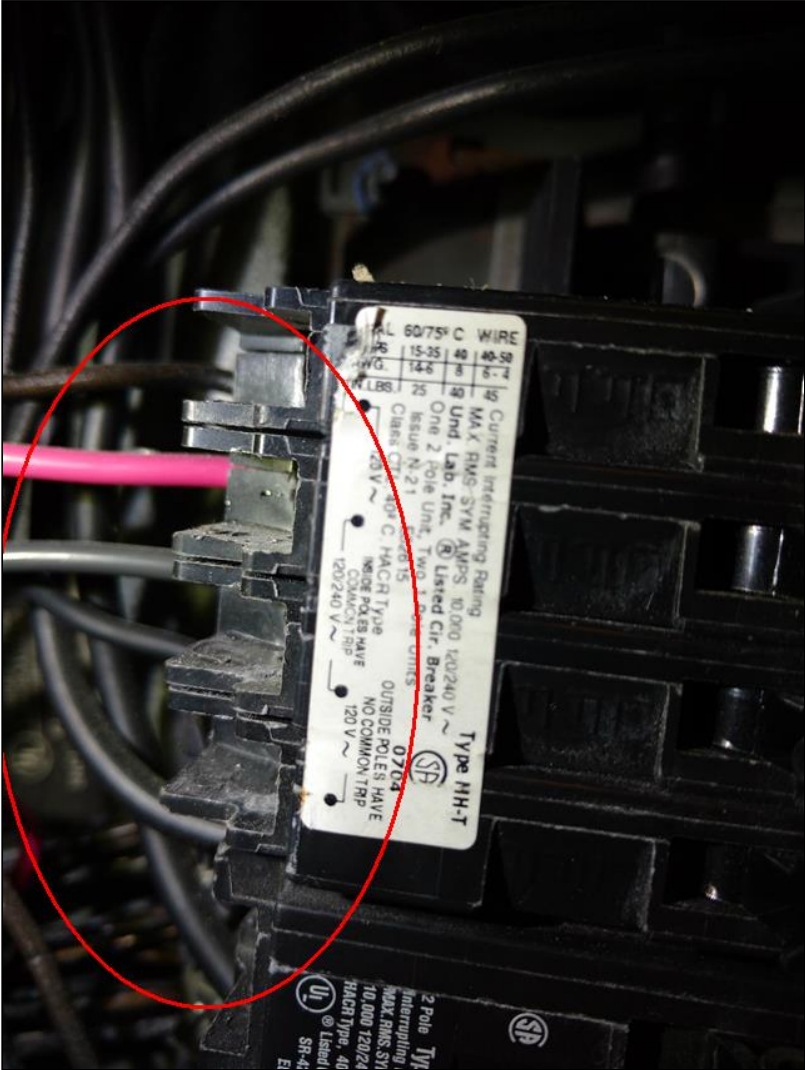
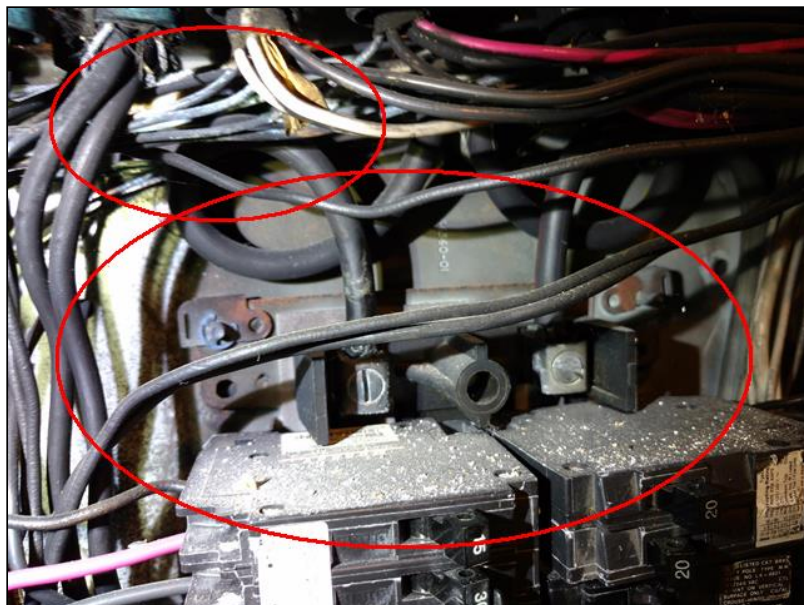
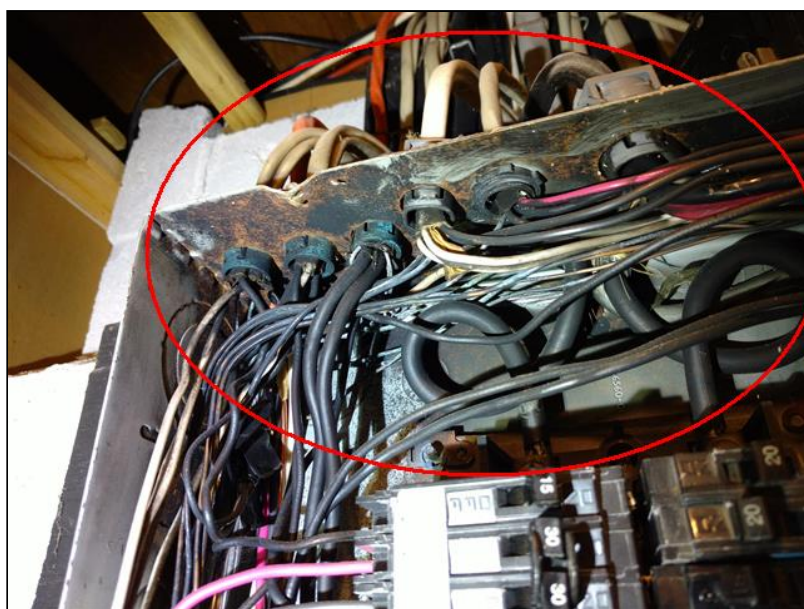
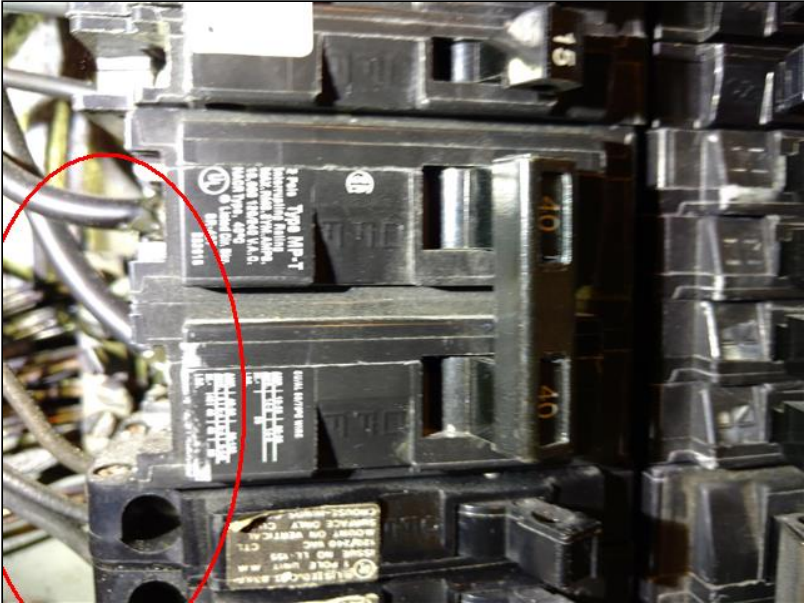
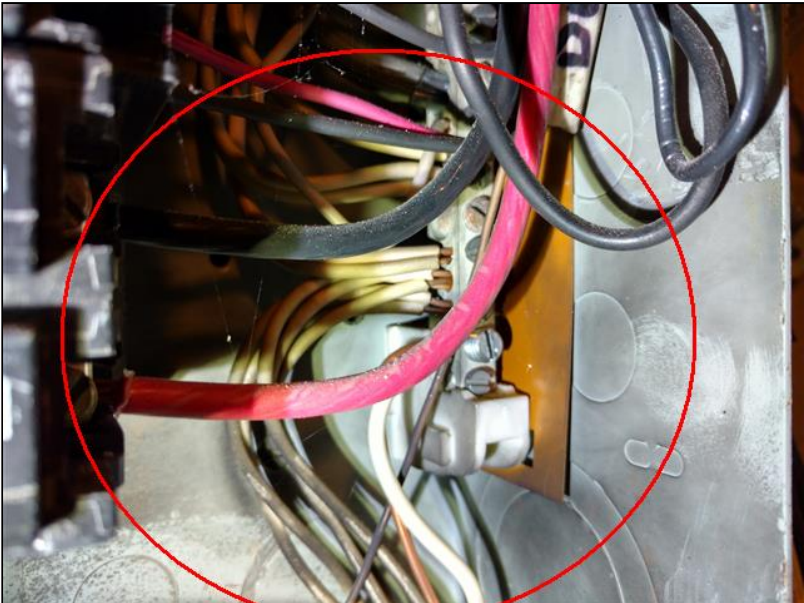
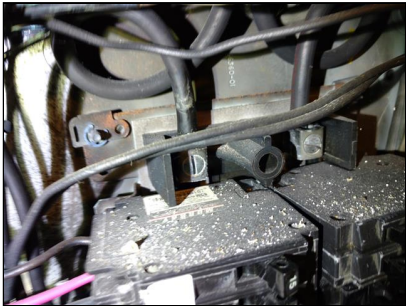
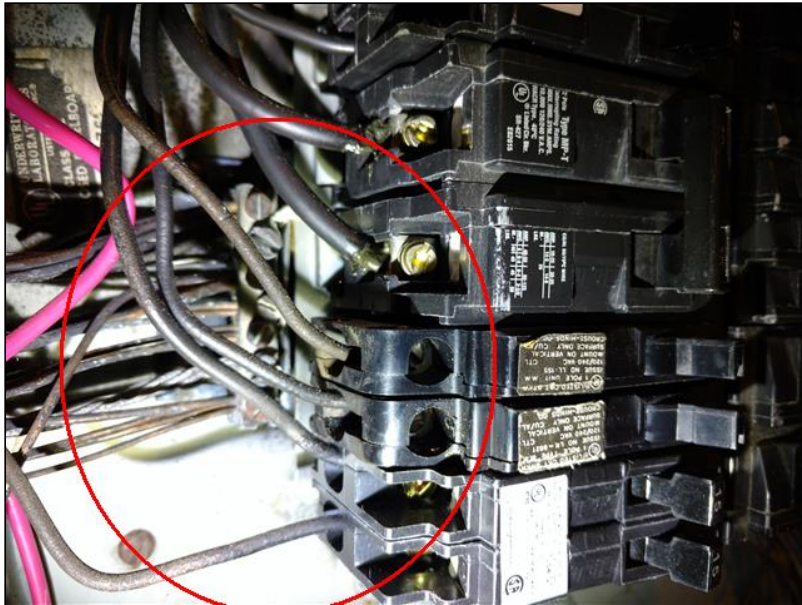
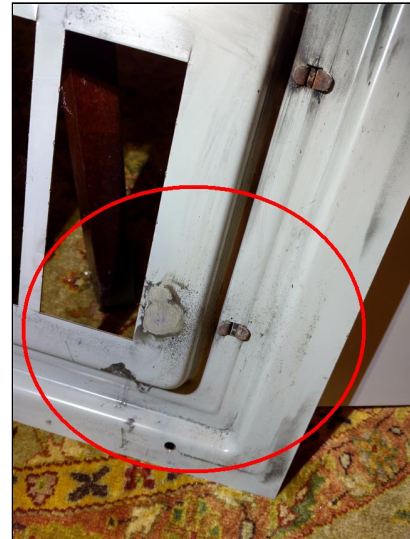
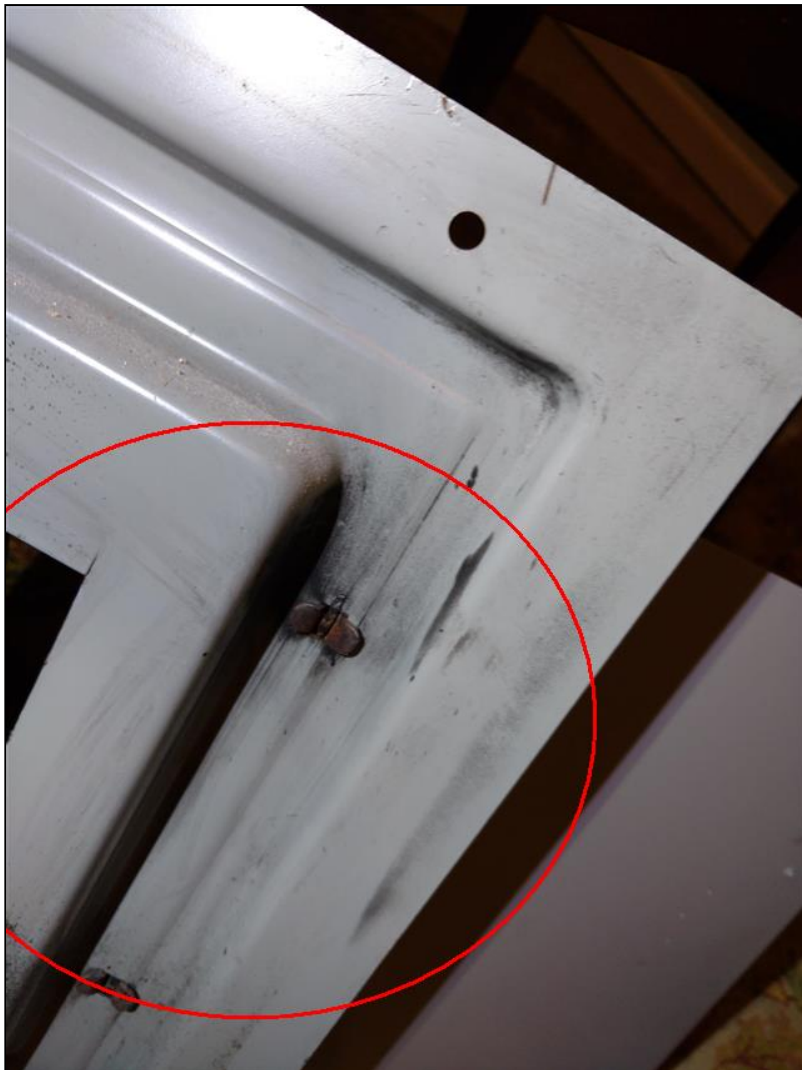
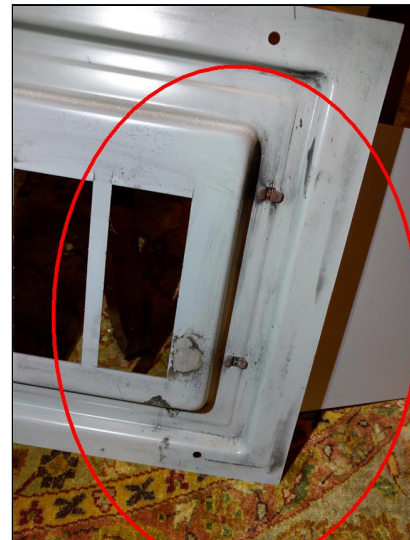
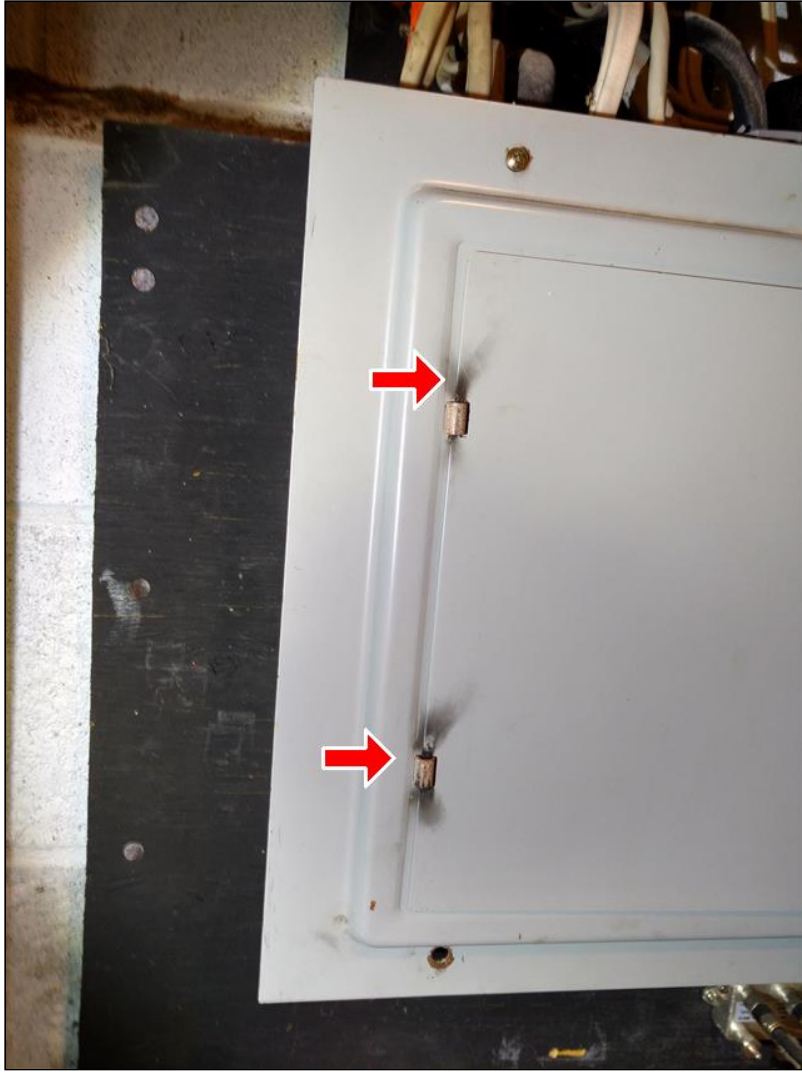
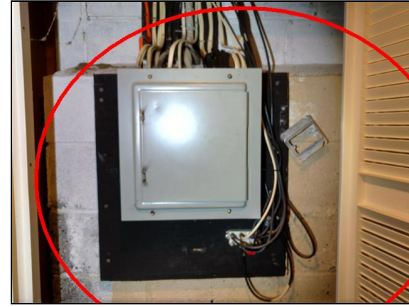
(3) As observed in the sub panel in the basement, there appeared to have been a small fire inside the panel as the internal components were burnt and scorched. **This is a MAJOR SAFETY CONCERN and MAJOR FIRE HAZARD and should be repaired/replaced IMMEDIATELY.** The internal components may have been damaged as a result and there may be future fires within this panel. **Based on these and all of the electric related defects present, a further evaluation of the ENTIRE electric sub panel in the basement and the main electric service panel, main disconnect circuit breaker and the electric meter (which are on the exterior) should be completed IMMEDIATELY by a qualified, licensed electrician and the necessary repairs/replacements completed. The homeowner should be notified of this condition and the need for repairs/replacement immediately.**

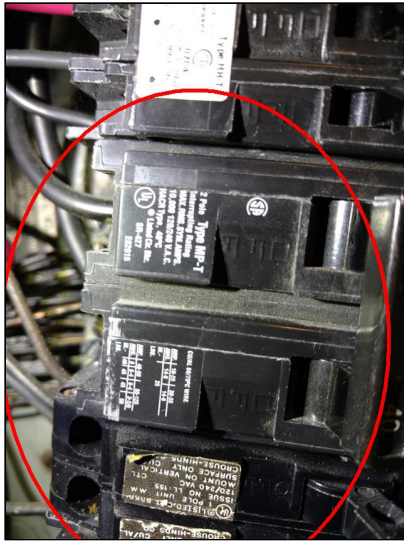
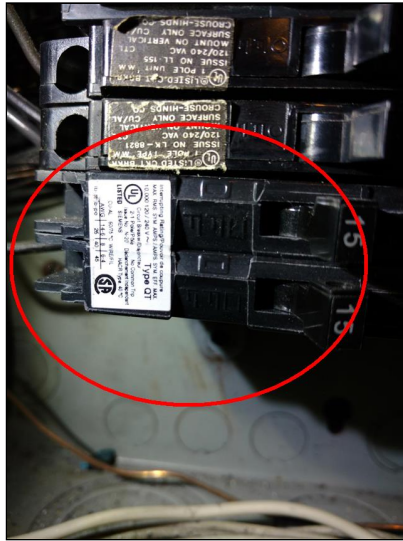
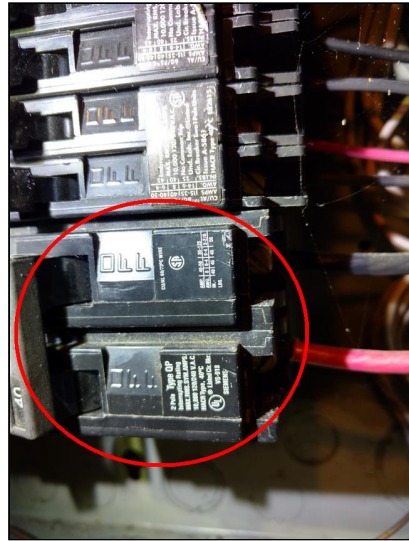
(1) As observed in the electric sub panel, there were numerous different manufacturer brands of circuit breakers installed in the panel. Per the manufacturer's wiring specifications, there are only certain types and brands of circuit breakers that are allowed to be safely utilized in this panel. This is a potential safety concern and fire hazard as this panel may not be designed for use with these circuit breakers. **Based on these and all of the electric related defects present, a further evaluation of the ENTIRE electric sub panel in the basement and the main electric service panel, main disconnect circuit breaker and the electric meter (which are on the exterior) should be completed by a qualified, licensed electrician and the necessary repairs/replacements completed.**

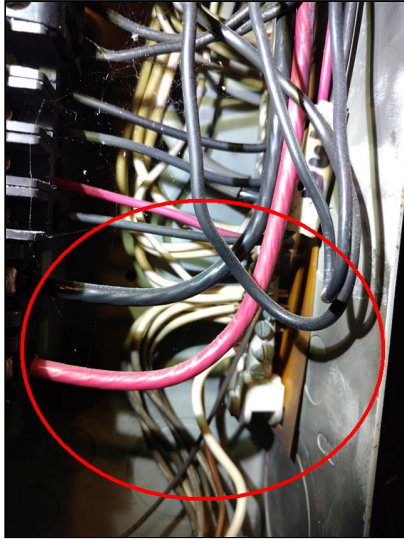
7.7 Item 1 (Picture)

(1) There were grounded (neutrals) wires that were doubled up under the same terminals (lugs) on the neutral bus bar in the main electric service panel. The connection of grounded and grounding wires in this situation creates a significant problem. One of the objectives of a correct arrangement of bonding jumpers, neutrals and grounding wires is to allow for circuit isolation if the electrical system needs to be worked on. Also most panels are only designed for one grounded wire per lug. The wires could come loose and heat up if they are double lugged. This requirement has been generally been enforced in the past by a close review of the manufacturer markings and by NEC 110.3 (b). Clause 12.3.10 of UL 67 (panelboards) states, "Each neutral conductor shall terminate within the panel board in an individual terminal that is not also used for another conductor". Recommend having a qualified, licensed electrician make all the corrections necessary to ensure the safe and proper operation of the service panel.

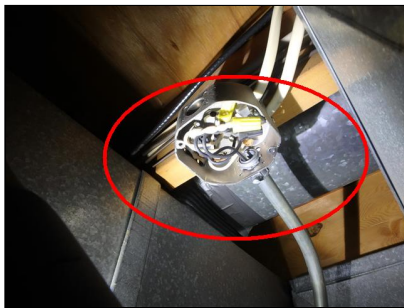
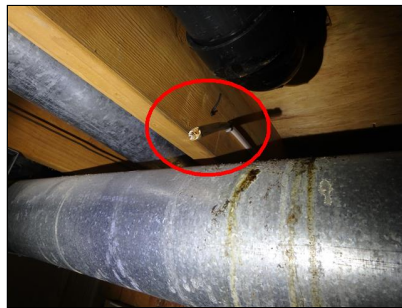
(3) There was a cut wire observed in the basement that was not safely terminated in a junction box. The wire was not live at the time of the inspection. This is a safety issue and a potential fire hazard. Recommend further evaluation by a qualified, licensed electrician and repair as necessary. There was also a junction box that was missing a cover.

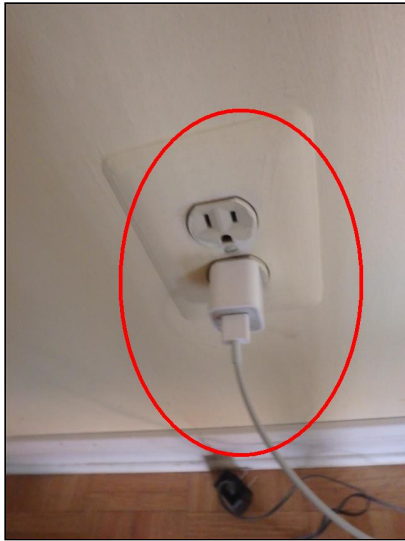
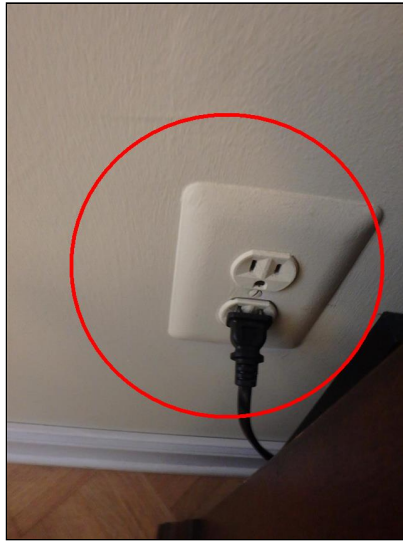
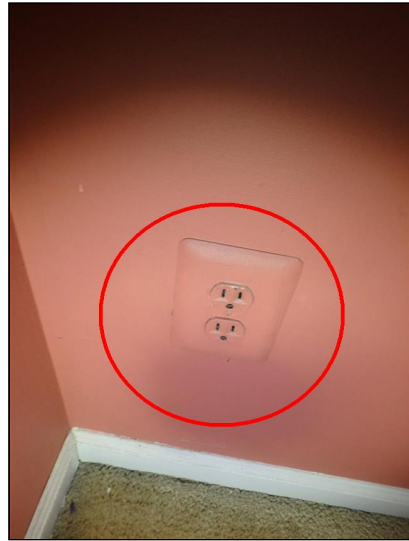
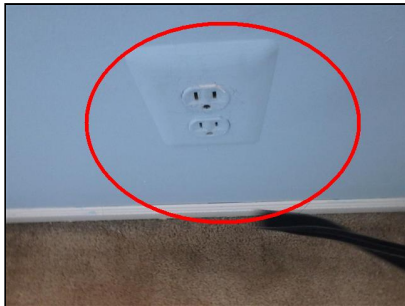
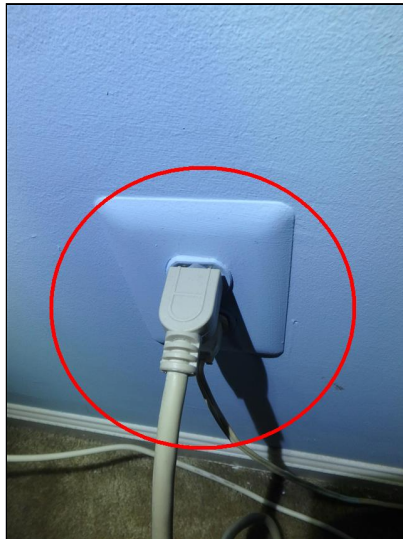
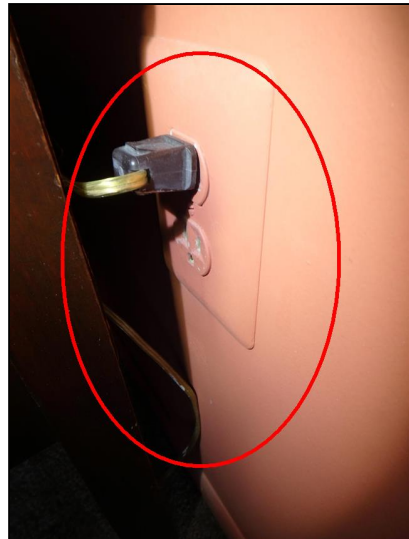
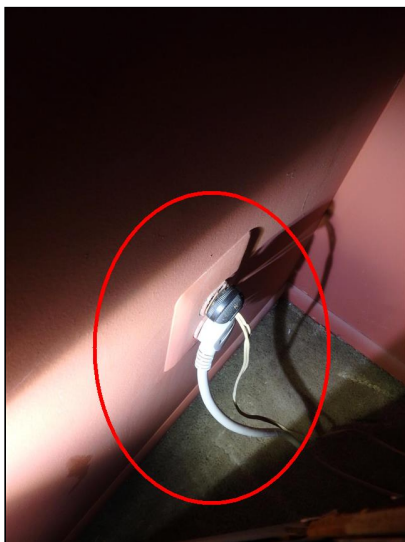
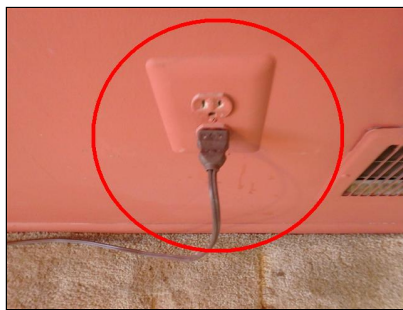
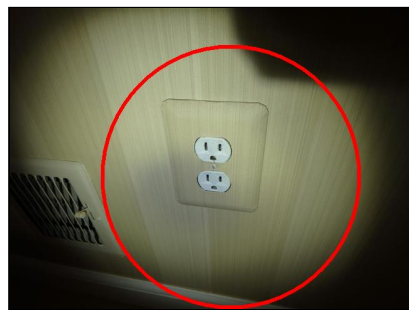
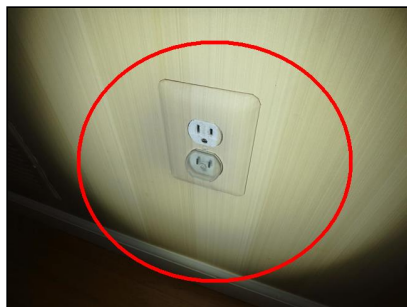
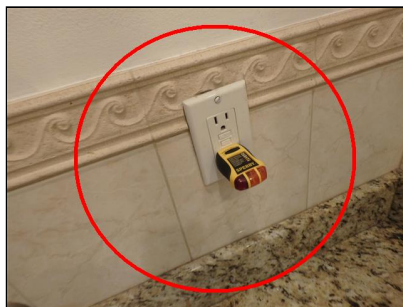
(1) As observed throughout the dwelling, there were numerous electric receptacles that were painted. This may hinder the functionality of the receptacles as it may be hard to plug any power cords into these receptacles due to the buildup on paint in the holes. It may also cause them to heat up. These are safety concerns and a potential fire hazards. Electrical receptacles should not be painted. **A further evaluation of ALL of the receptacles/outlets should be completed by a qualified, licensed electrician and the necessary repairs/replacements be completed. There was also some outlets that were loose as well.**

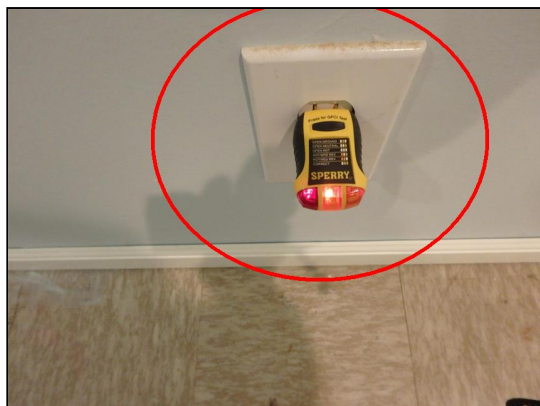
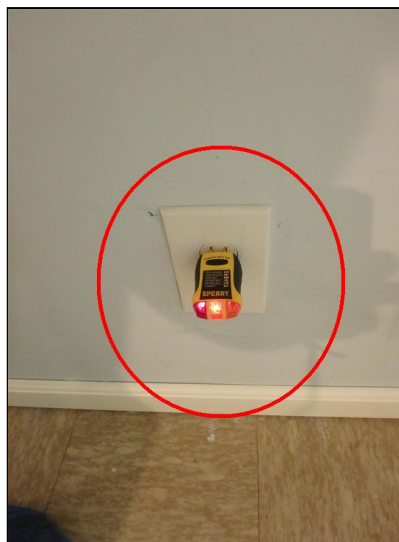
(2) There were electrical receptacles located in the basement that had a reversed polarity condition. Reversed polarity is when the hot and neutral connections at a receptacle are wired "backwards". It is also possible, all these effected outlets could be wired on the same circuit and the wire feeding this circuit was wired backwards somewhere downstream from the outlets. Reversed polarity creates a potential shock hazard and should be repaired. Recommend further by a qualified, licensed electrician and repair as necessary.

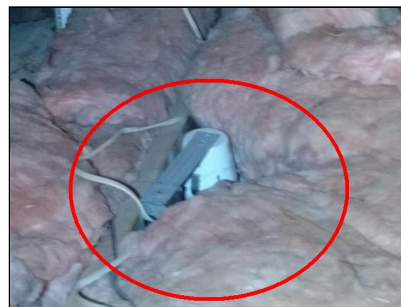
7.8 Item 15 (Picture)

(3) As observed in the attic space, there was at least one of the 2nd floor recessed light housings were covered and/or touching the insulation that was in the floor joist bays. These lights should not be installed with insulation within 3 inches of fixture sides or wiring compartment nor above fixture in such manner to entrap heat. This is a major fire and safety issue. Recommend moving all of the insulation away from the housings as required. **There may be additional light fixtures that were not visible and covered with insulation. ALL of the recessed light housings in the attic should be checked.**

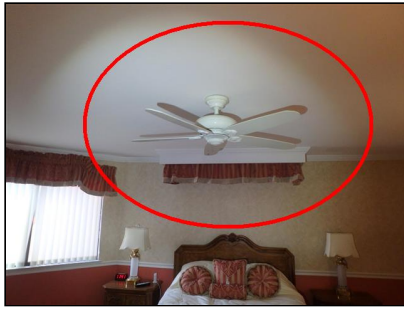
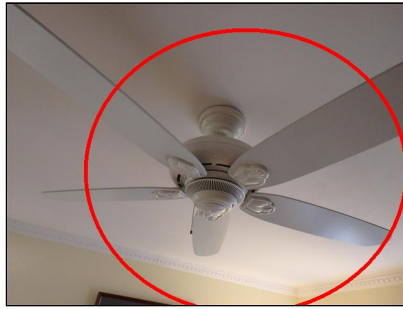
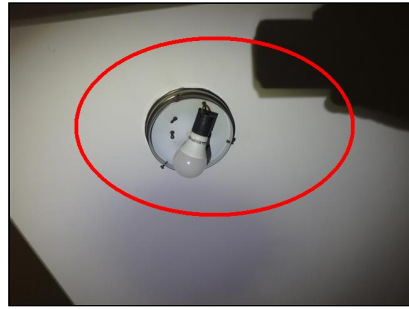
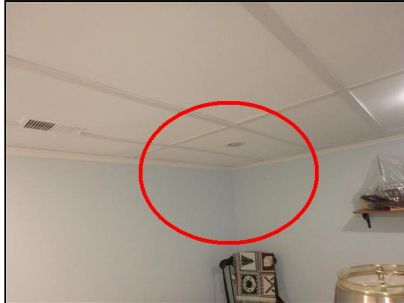
(4) There were numerous light fixtures that were missing light bulbs and/or appeared to have burned out bulbs present. As a result, these light fixtures could not be tested for proper operation. There were also light fixtures that appeared to be damaged and in need of repairs. All of these are potential safety concerns. Also to note, the ceiling fans on the lower level and the master bedroom were not functioning. A further evaluation of ALL of the interior and exterior light fixtures and ceiling fans should be completed by a qualified, licensed electrician and replace/install bulbs and/or repair/replace light fixtures as necessary.

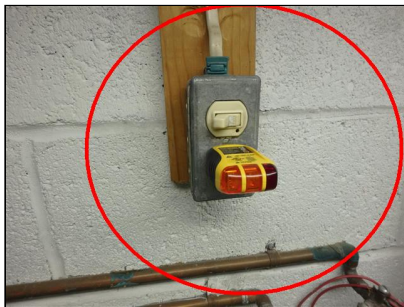
7.8 Item 21 (Picture)

(6) The electric receptacle located in the basement laundry/wash sink area was not GFCI protected. Receptacles located on the exterior, in garages, kitchen sink area, bathrooms and laundry areas should be GFCI protected. A ground fault circuit interrupter (GFCI) is a device (outlet or circuit breaker) that shuts off an electric power circuit when it detects that current is flowing along an unintended path, such as through water or a person. It is used to reduce the risk of electric shock. They can also prevent fires, like when a live wire touches a metal conduit. For safety purposes, would recommend upgrading this receptacle.. This should be done by a qualified, licensed electrician.

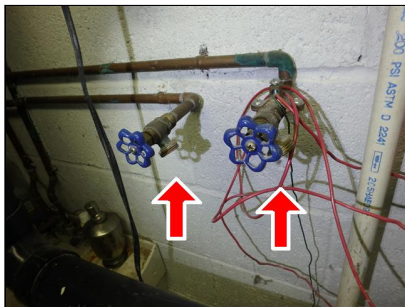
Testing of the water shut off valves located throughout the dwelling (especially the ones located in basements, crawlspaces, under sinks, behind toilets, etc.) and on the exterior for functionality is beyond the scope of the home inspection. Sometimes if the valves are turned/tested even just slightly, they may start to leak due to mineral buildup on the packings/seals. Also, due to age, corrosion and/or mineral buildup that may be on them, they may or may not function properly in the future in the event of an emergency or a need to service part of the plumbing system. **Therefore, a further evaluation of ALL of the water shut off valves in the dwelling (basement, under sinks, behind toilets, etc.) and any on the exterior should be completed by a qualified, licensed plumber and any necessary repairs/valve replacements should be completed. This includes the main water supply shut off valve on the street side of the water meter that appeared to be seized up (wouldn't turn). This is the most important water shut off valve in the entire house and it should be 100% functional. This should be repaired by a qualified, licensed plumber.**

8.1 Item 1 (Picture) These should be capped.

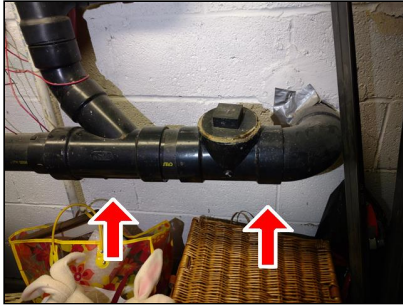
8.2 Item 1 (Picture)

(1) As observed in the dwelling, there were numerous sections of the DWV (drain, waste, vent) piping that were ABS. While the interior visible portions appeared to be in a serviceable condition, the underground portions may be compromised. The main concern is the portions that run from the house to the sewer main. To insure the main DWV system is 100% functional, it is recommended the DWV piping be scoped by a qualified, licensed plumber/professional to ascertain the integrity of such piping.
