# Property Inspection Report

123 Main Street

Unit T1

**Terra Home Inspections LLC**

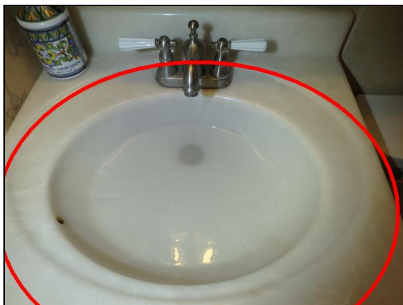
8.2 Item 3 (Picture)

(3) The drain in the bathroom sink was draining very slowly. The drain could be clogged slightly which could be fixed by using a common drain opener solution available at most home centers. There also may be an issue with the connected drain piping. Recommend further evaluation by a qualified, licensed plumber and repair as necessary.

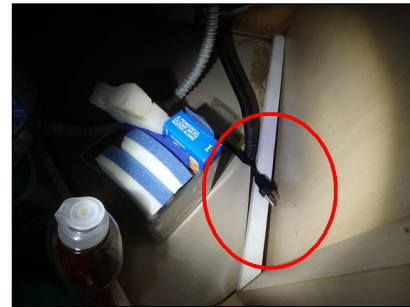
8.3 Item 2 (Picture)

water coming out of this dispenser may instantly cause scalding if someone were to attempt to wash their hands with this water or come into contact with this water for any reason. This dispenser should be plugged in and tested.

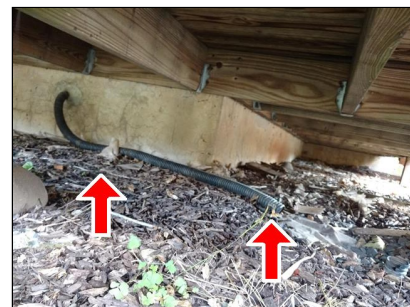
8.5 Item 2 (Picture)

The sump pump drain for the sump pump located in the basement should be extended out at least 6ft from the foundation wall (or as far out as possible). Currently, the discharge piping is discharging the water onto the ground next to the foundation wall. Thus, the water could be seeping down and going into the foundation wall and possibly migrate back into the basement. Recommend further evaluation by a qualified, licensed plumber and repair as necessary.

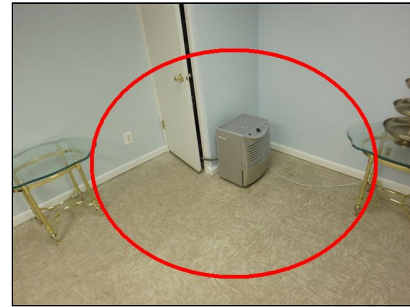
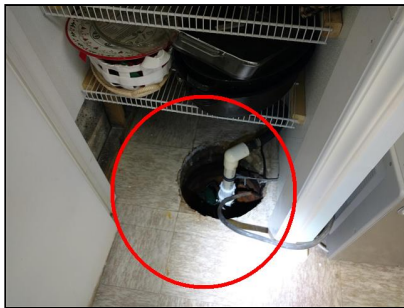
(1) As observed in basement, the sump pump pit/metal basket was severely deteriorated and was in need of replacement by a qualified, licensed plumber. This condition may worsen if the needed repairs are not completed. The current condition of the basket may let dirt/stone debris into the pit which may damage the sump pump.

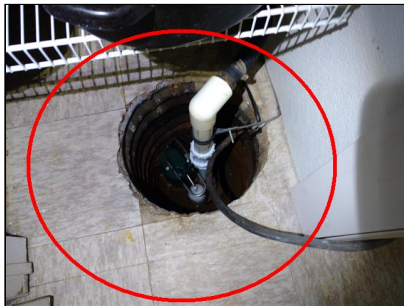
8.6 Item 4 (Picture)

(2) The sump pump pit had no cover present. Sump pump pits should have a proper cover to prevent a high humidity condition in the surrounding area. Mold may form on the basement finishes as a result. It may also prevent radon from seeping into the living spaces. Recommend a further evaluation by a qualified, licensed plumber and repair as necessary.

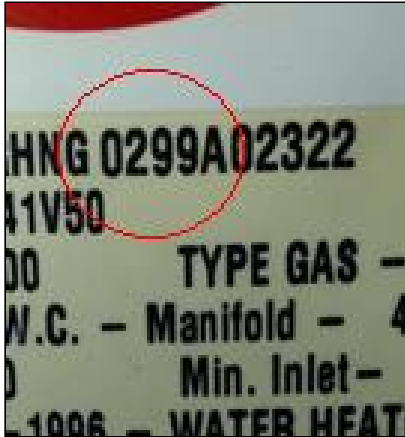
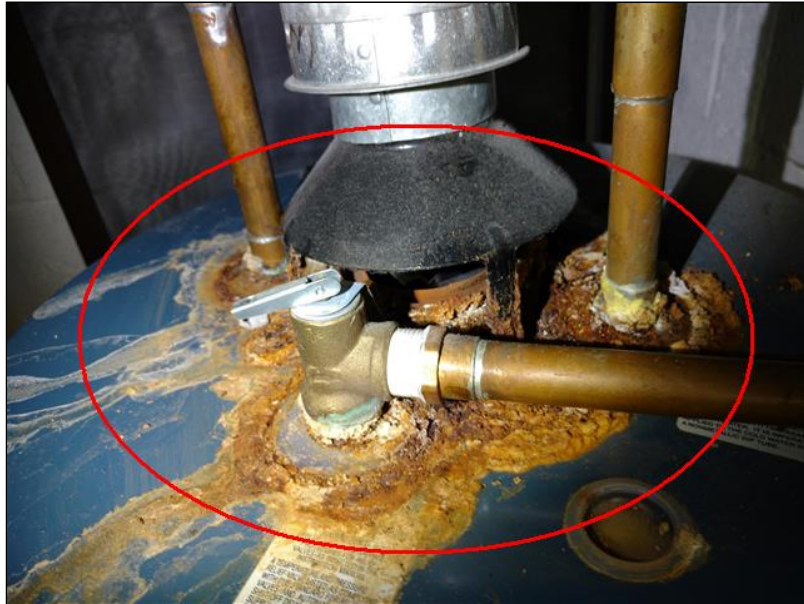
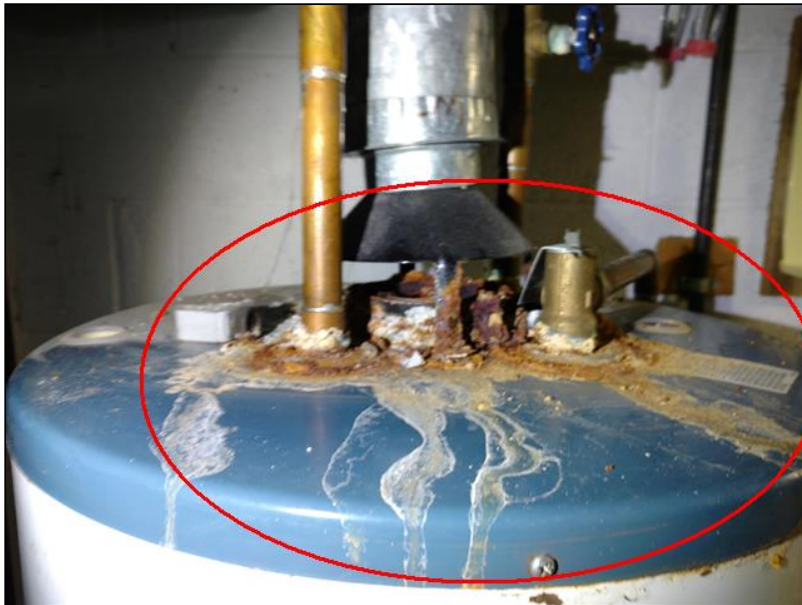
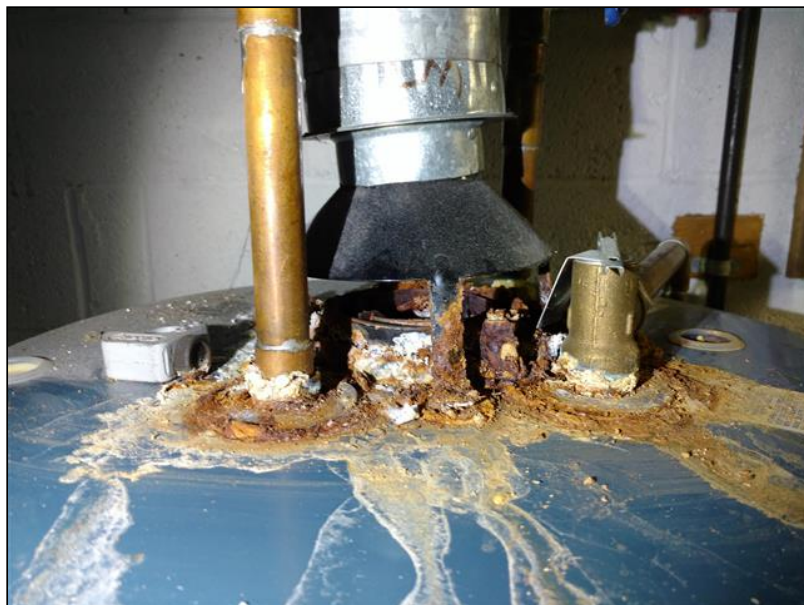
Information taken from the data tag places the age of the water heater at around 21 years old. It is considered to be at the end of its expected lifespan. **Based on the observations of the water heater, the water heater should be replaced IMMEDIATELY as it is a MAJOR SAFETY CONCERN by a qualified, licensed plumber. The homeowner should be notified of this condition and the need for a replacement.**

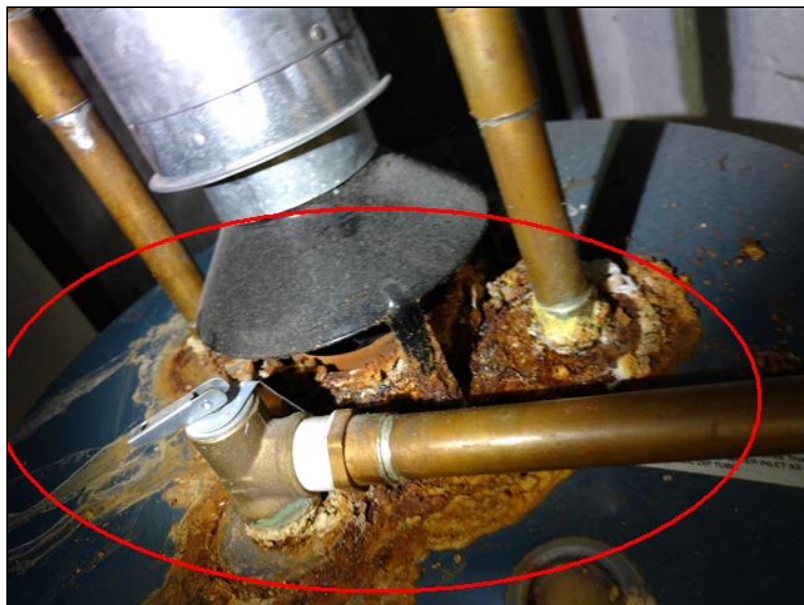
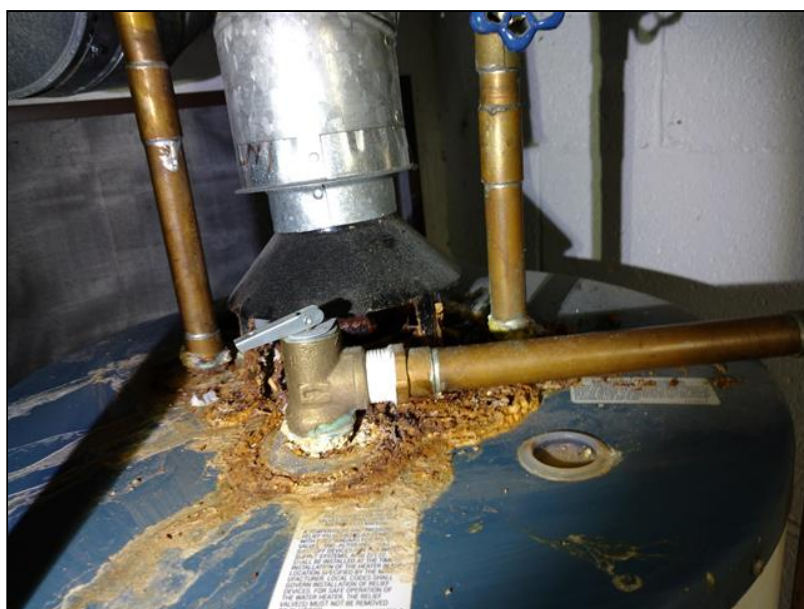
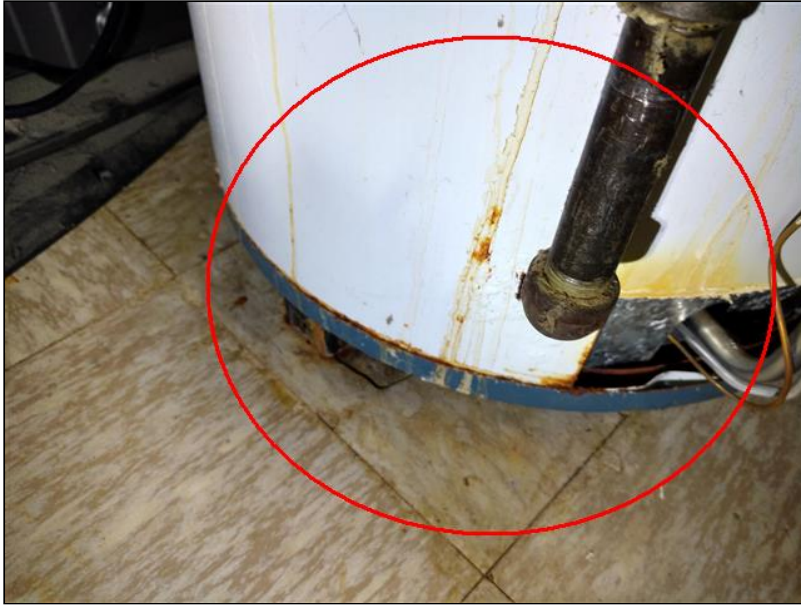
The top of the water heater was severely deteriorated as it appears to be a MAJOR venting issue resulting in the water heater back drafting. **Based on the severity of the deterioration, this is a MAJOR SAFETY CONCERN as combustion by products (carbon dioxide, carbon monoxide and nitrogen oxide) may be entering the dwelling instead of being properly vented out of the dwelling.** The bottom of the water heater was also rusted/deteriorated. These conditions may worsen as well as possible flooding of the basement if the necessary replacement is not completed. **The water heater should be replaced IMMEDIATELY by a qualified, licensed plumber. The homeowner should be notified of this condition and the need for a replacement.**

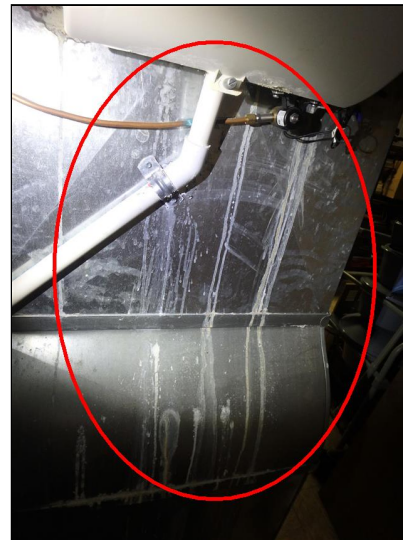
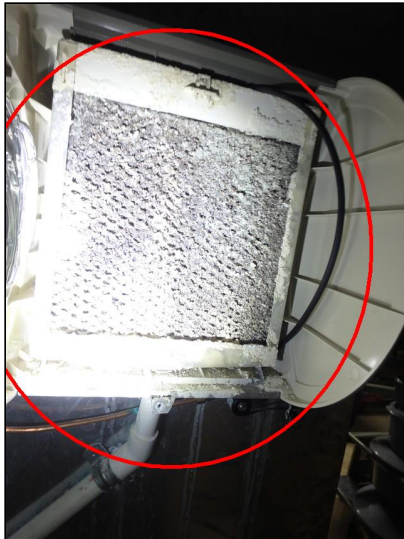
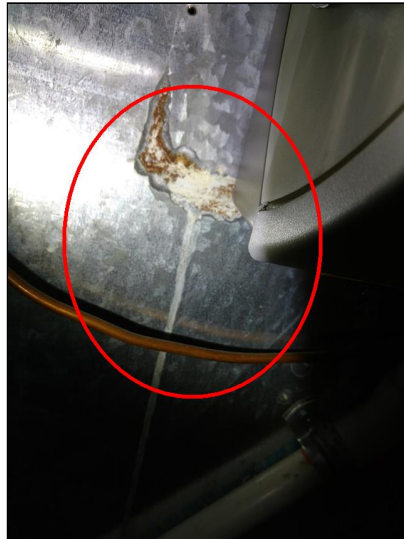
(1) The humidifier pad/filter in the built in humidifier on the side of the furnace was severely deteriorated and is in need of replacement. There was a heavy mineral buildup on the pad/filter. This may effect the performance of the humidifier is the pad/filter is not changed. Also to note, there was a large amount of staining present on the ducting below the unit. The humidifier should not be used until the necessary repairs are completed by a qualified, licensed HVAC professional.

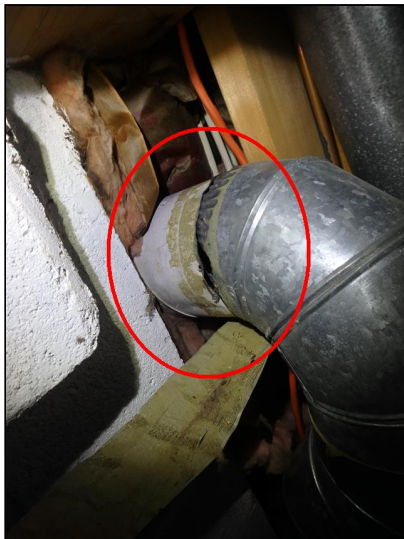
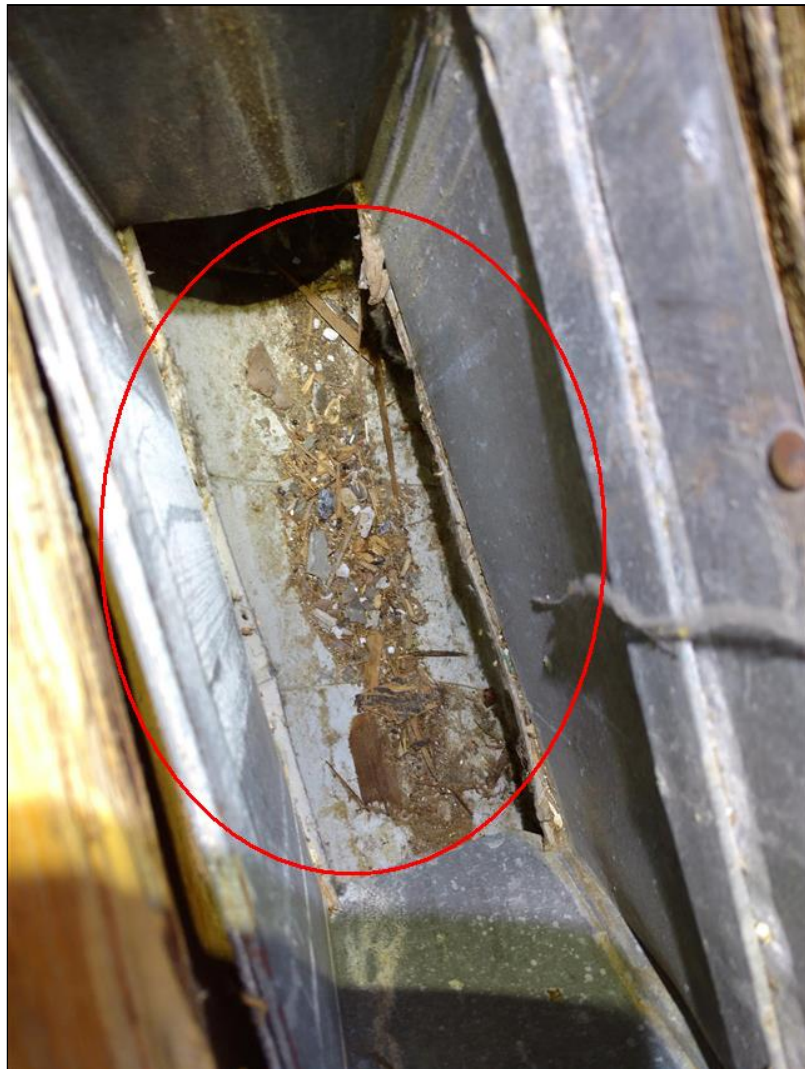
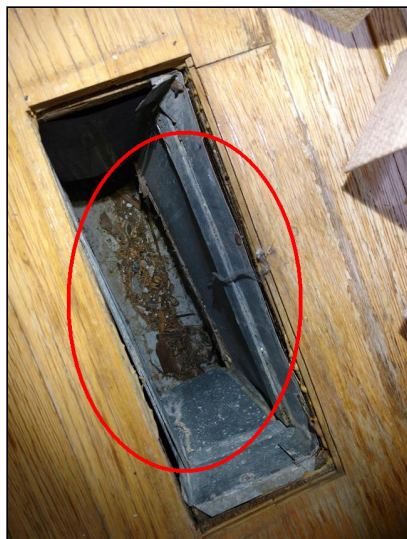
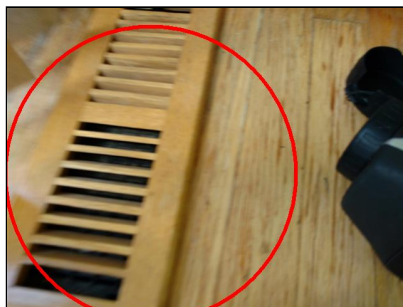
(2) As observed in the basement utility room, there was an HVAC supply air duct that was semi-disconnected. This condition if not repaired, will have an affect on the air flow in the room where this duct is running to. Also, there were debris in the duct in the kitchen in front of the refrigerator. This should be cleaned out. Recommend further evaluation by a qualified, licensed contractor and repair as necessary.

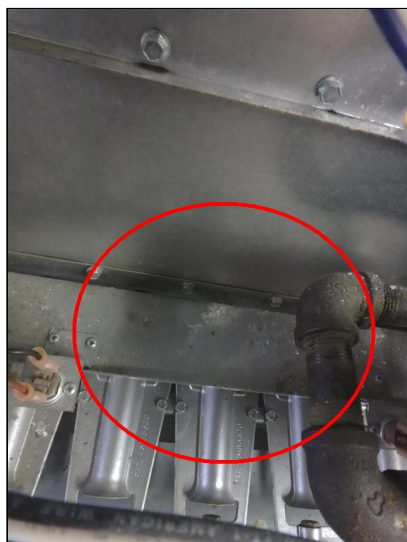
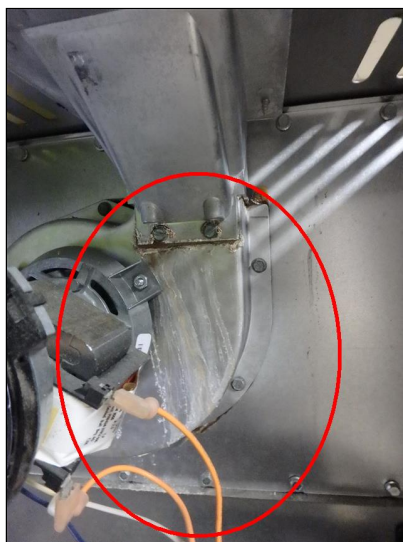
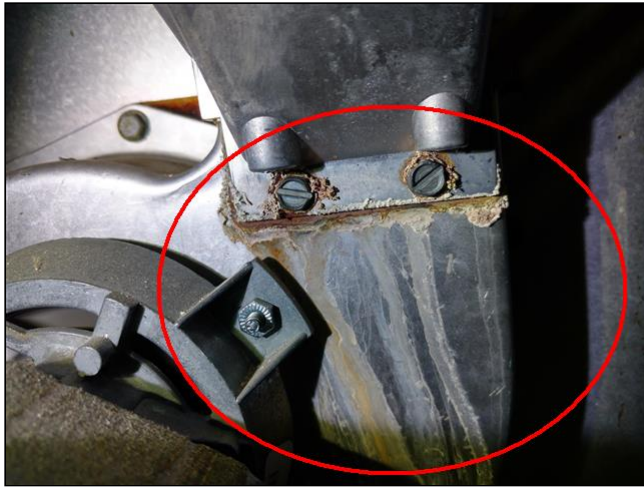
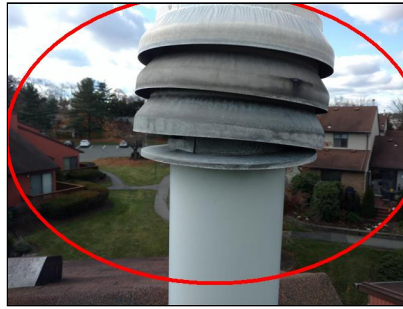
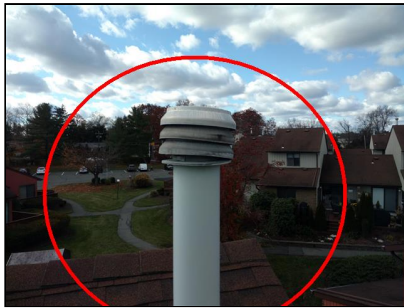
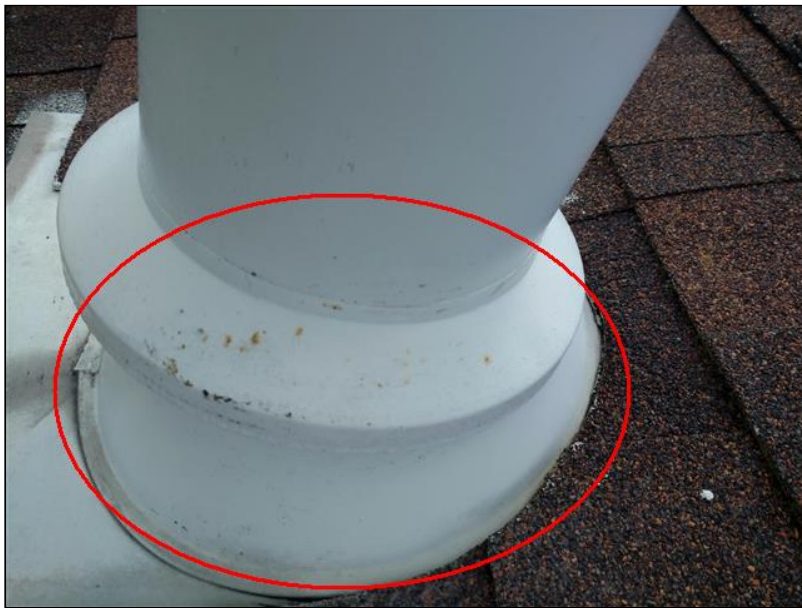
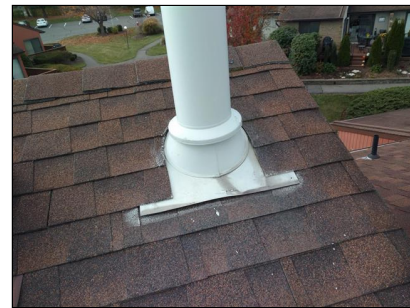
(1) There was white "condensate" observed on the outside of the vent connector and on the inside of the top furnace compartment. The combustion by-products of a gas furnace are made up of slightly acidic moisture. Under normal furnace operation this particulate is vented to the exterior of the home through the chimney. For various reasons it can condensate inside the vent connectors or chimney and drip out the vent connectors and/or back into the furnace. This condition could lead to corrosion of the furnace components and/or the venting system itself if not repaired. There may be an issue with the venting. Also to note, the chimney cap was loose/damaged. The exterior portion of the metal chimney also appeared to have been recently painted for an unknown reason. It may have been rusted or it may have just been painted to make it look better. Recommend further evaluation of the furnace of the ENTIRE length of the metal chimney/venting by a qualified, licensed HVAC professional and repair as necessary.

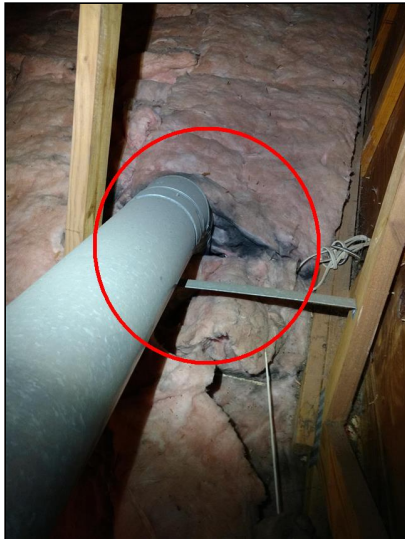
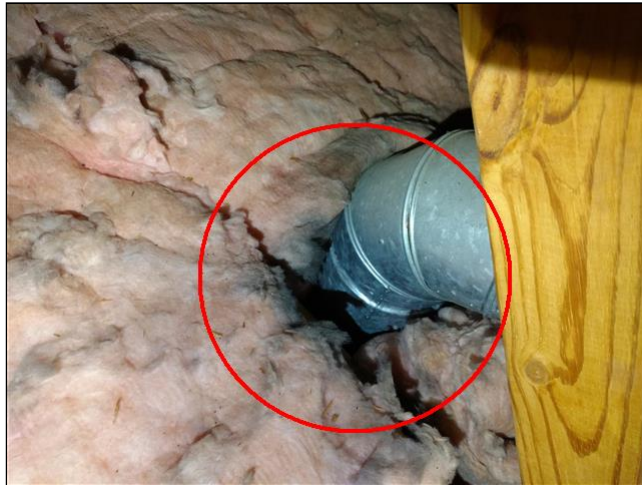
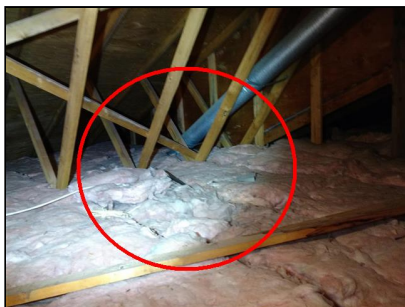
(2) The minimum clearance for the B vent exhaust ducting serving the gas fired water heater and furnace from combustibles is 1 inch. As observed in the attic space, there was kraft faced batts insulation touching a portion of the B vent ducting. This is a safety concern and a potential fire hazard. Recommend moving the insulation away from the B vent ducting to comply with the clearance requirements.

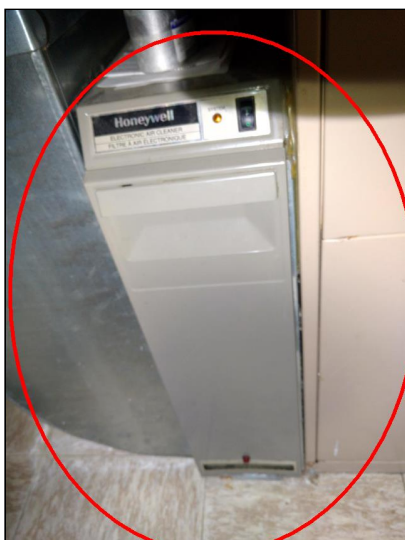
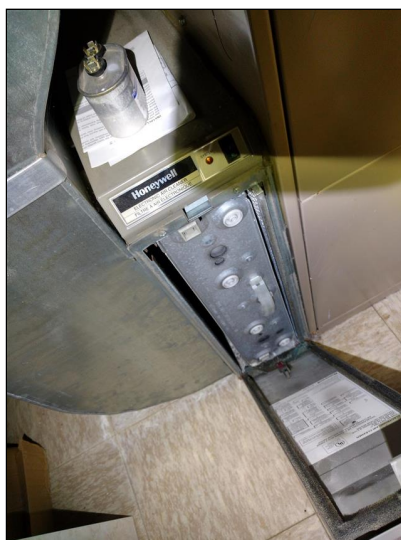
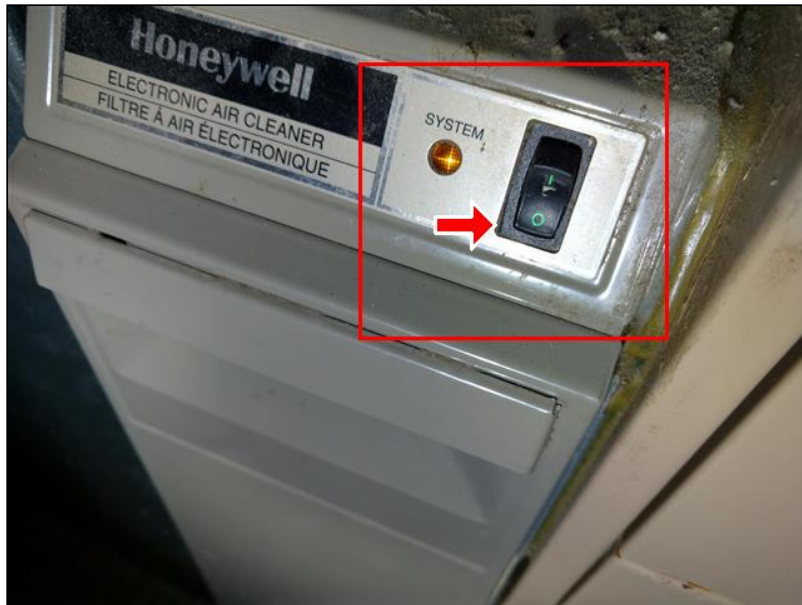
There was an electronic air filter present that was filtering the air in the HVAC unit. These types of filters have their pros and cons and may not be as effective as a high quality HEPA or other disposable type filters. They often tend to fail as they get older as well. In some instances, people would disconnect the power going to this unit and buy disposable type filters that are designed to fit into the existing electronic air filter housing. Also to note, the power switch for this filter was in the off position. Therefore it was not functioning. There was also a large amount of not normal noise coming from the area of this filter when the heating system was tested/operated.

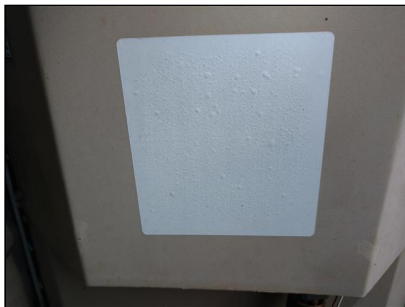
11.0 Item 1 (Picture)

(1) Information taken from the data tag, places the age of the A/C evaporator at around 20 years old. It is considered to be at end of its expected lifespan. Recommend budgeting for a replacement in the near future. The A/C condenser may be the same age (20 years old-the data tag was unreadable)

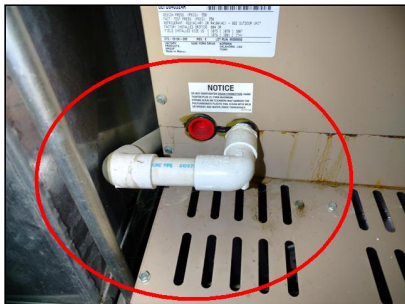
11.0 Item 2 (Picture)

(2) The primary condensate drain pipe for the central air conditioning system was missing the required p-trap where it exits the evaporator coil housing. The primary purpose of a condensate trap (p-trap) is to prevent air from moving in or out of the coil box or air handler during operation. This condition may cause condensate drainage issues. Recommend further evaluation by a qualified, licensed HVAC professional and repair as necessary.

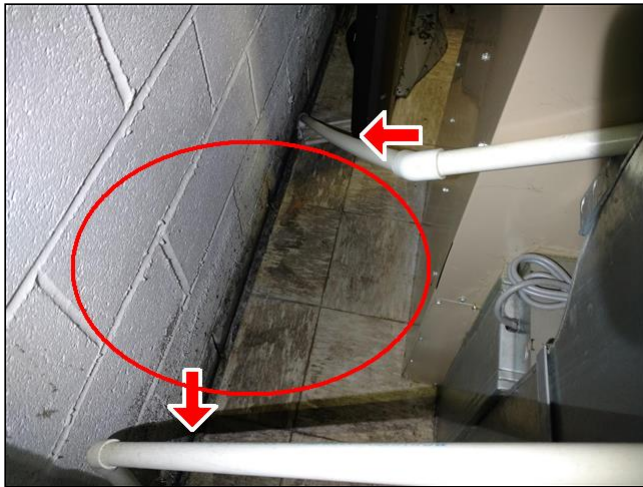
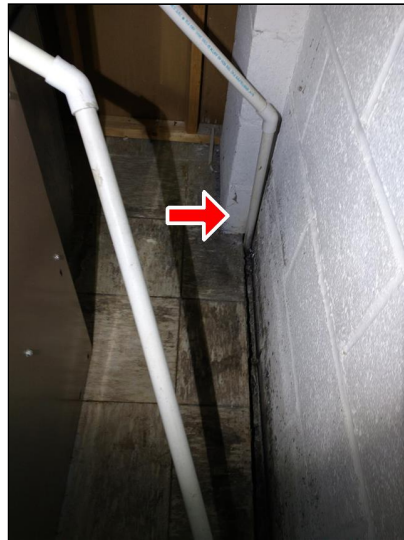
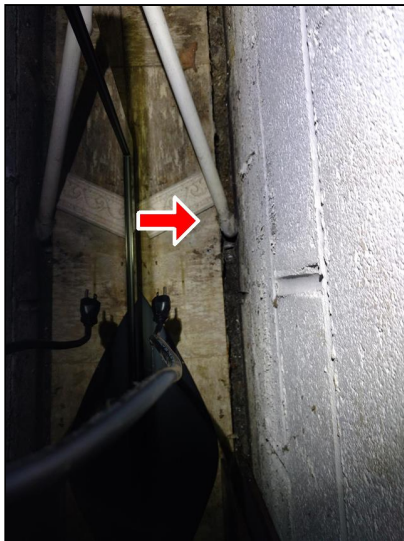
(3) The main condensate drain pipe for the central air conditioning system was draining the condensate (water) it produces into the gap in between the basement floor slab and the masonry foundation wall. The humidifier was also draining into this gap. These are not good arrangements as the condensate may cause the earth under the basement concrete floor to undermine which may cause damage to the basement floor. **It may also cause an excessive amount of unwanted moisture in the basement and possible moisture damage to the foundation walls.** There was a suspect mold condition on the foundation walls in this area. A condensate pump should be installed next to the HVAC unit and the condensate will then be pumped by the condensate pump into the DWV system or to the exterior. Recommend further evaluation by a qualified, licensed HVAC professional and repair as necessary.

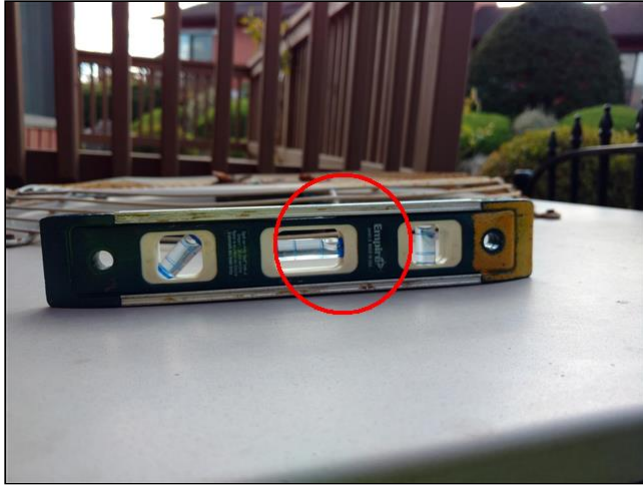
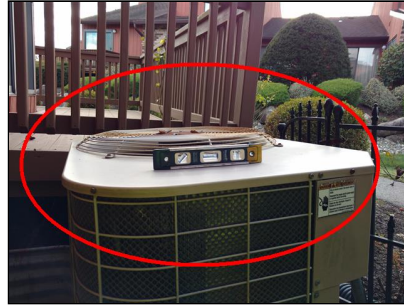
(4) The central air conditioning system exterior condenser unit was out of level. Being out of level may cause the components inside to fail prematurely and may also prohibit the air conditioning system from functioning properly. Recommend further evaluation by a qualified, licensed plumber and repair as necessary.

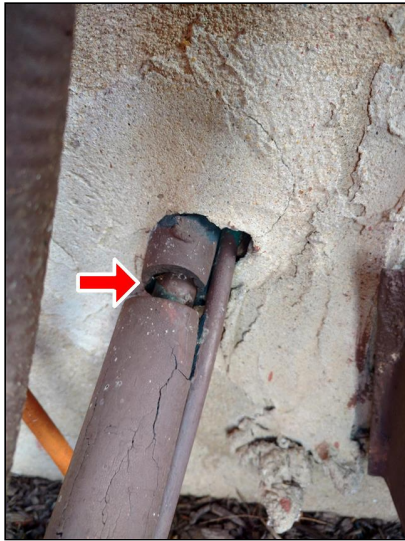
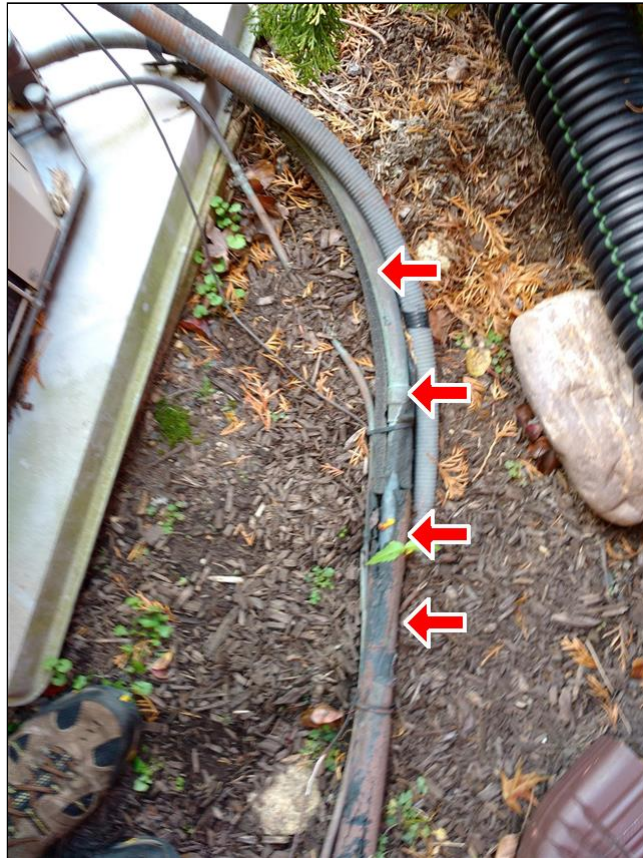
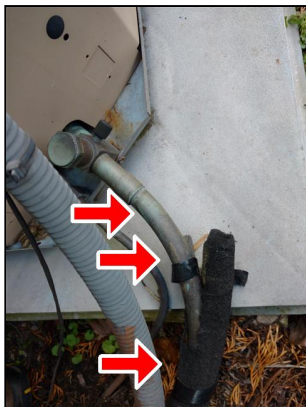
The insulation wrap on the central air conditioning system refrigerant line was deteriorated and/or missing in area(s). These condition(s) may worsen if the needed repairs are not completed. This condition may also affect the performance of the air conditioning system if not repaired. Recommend further evaluation by a qualified, licensed HVAC contractor and repair as necessary.

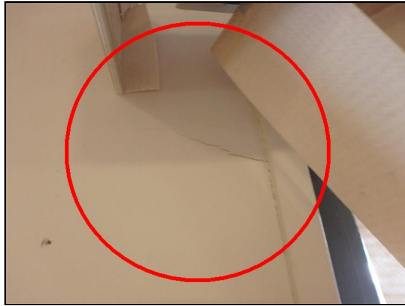
12.2 Item 1 (Picture)

As observed in various areas of the dwelling, there were numerous portions of some of the wall, ceiling and/or floor surfaces that were either cracked, loose, damaged, deteriorated, not functioning as intended and/or had a peeling paint condition. These conditions may worsen if the necessary repairs are not completed. Further/other damage to the finishes may also occur. **A further evaluation of ALL of the interior wall, floor and ceiling surfaces should be completed by a qualified, licensed contractor and the necessary repairs be completed.** These conditions may also possibly exist on any surfaces that are covered with wall paper. **Also to note, there were numerous portions of the carpeting where the padding/carpet appeared to be worn/compressed. This included the areas that appeared to be sloping.**

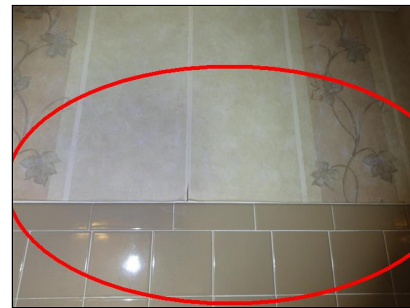
12.2 Item 4 (Picture) Wallpaper should not be in a shower area

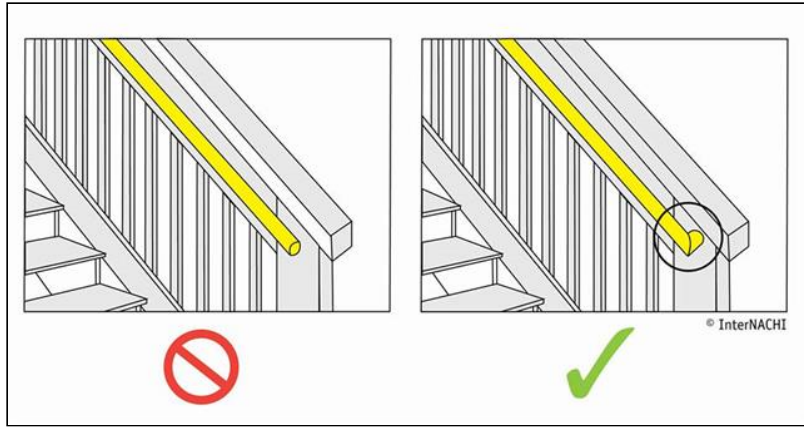
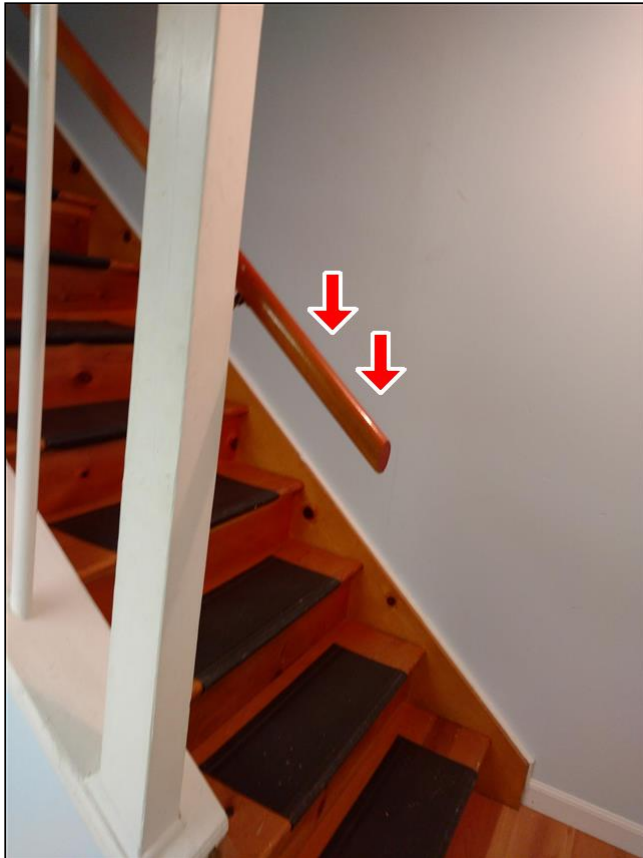
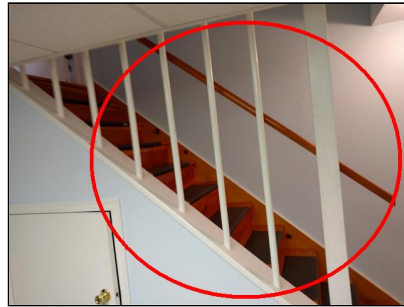
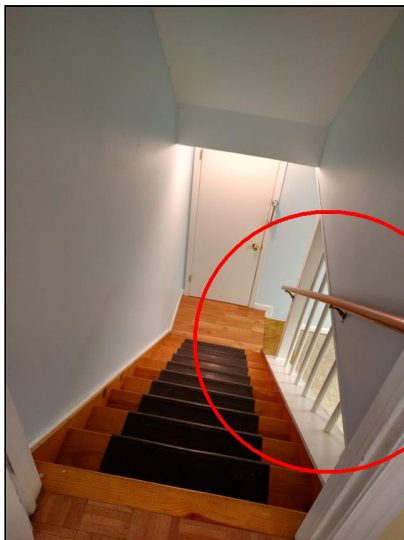
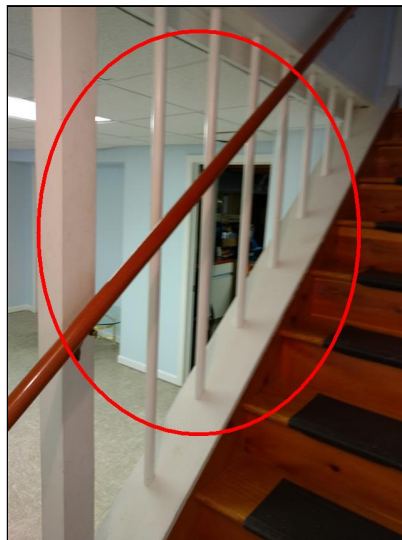
(1) The handrail(s) did not have the required returns at the ends to the wall which is a safety concern. The ends of the handrail may catch on loose fitting clothing, purses, bags, jewelry, etc. and could contribute to personal injury. Recommend further evaluation by a qualified, licensed contractor and repair as necessary. Also to note, the baluster spacing was greater than the 4" that is permitted. This is another safety concern.

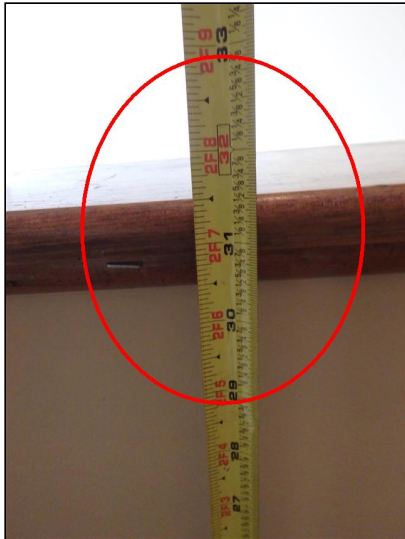
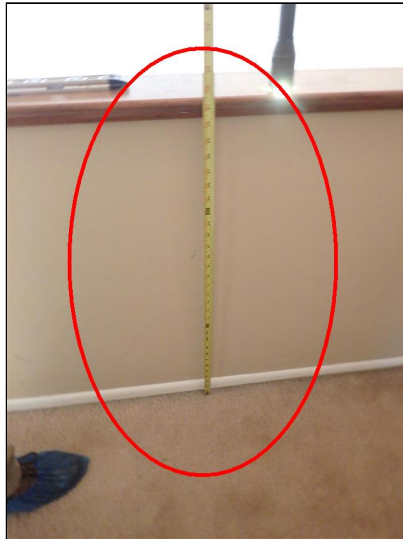
(2) The guardrail assembly on the 2nd stairwell only measured around 31-32 inches in height. Guardrails serving this application should be a minimum of 36 inches in height. This is a safety concern as someone could fall over the guardrails and possibly be injured. Recommend further evaluation by a qualified, licensed contractor and repair as necessary.

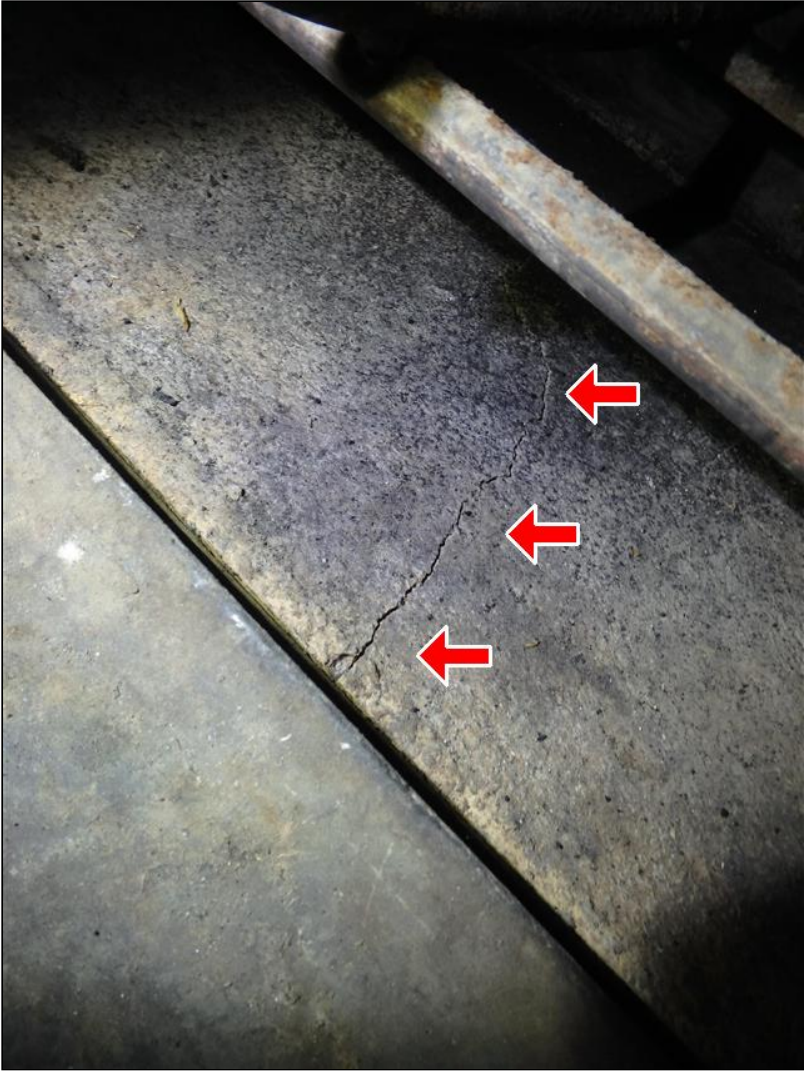
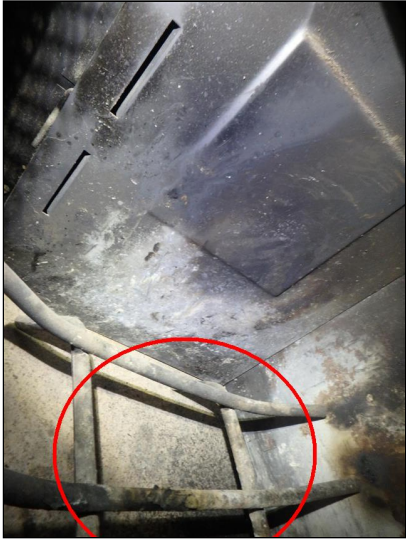
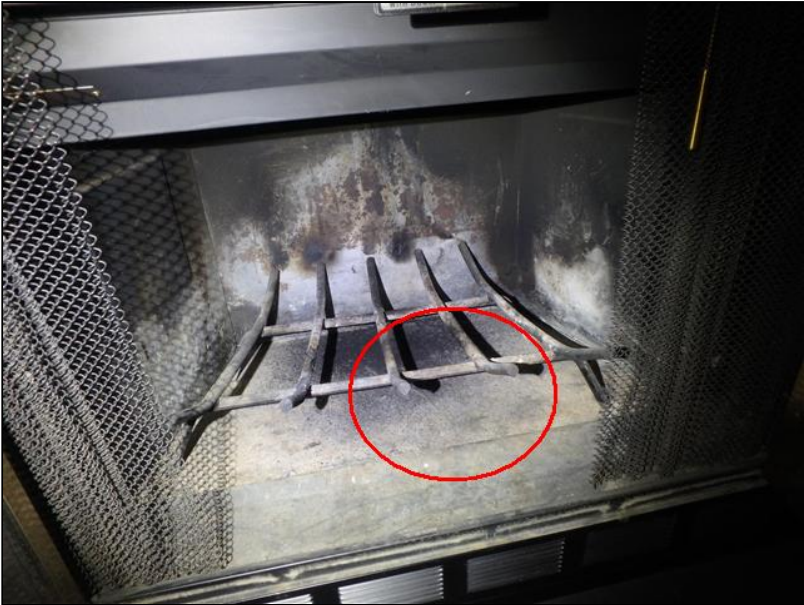
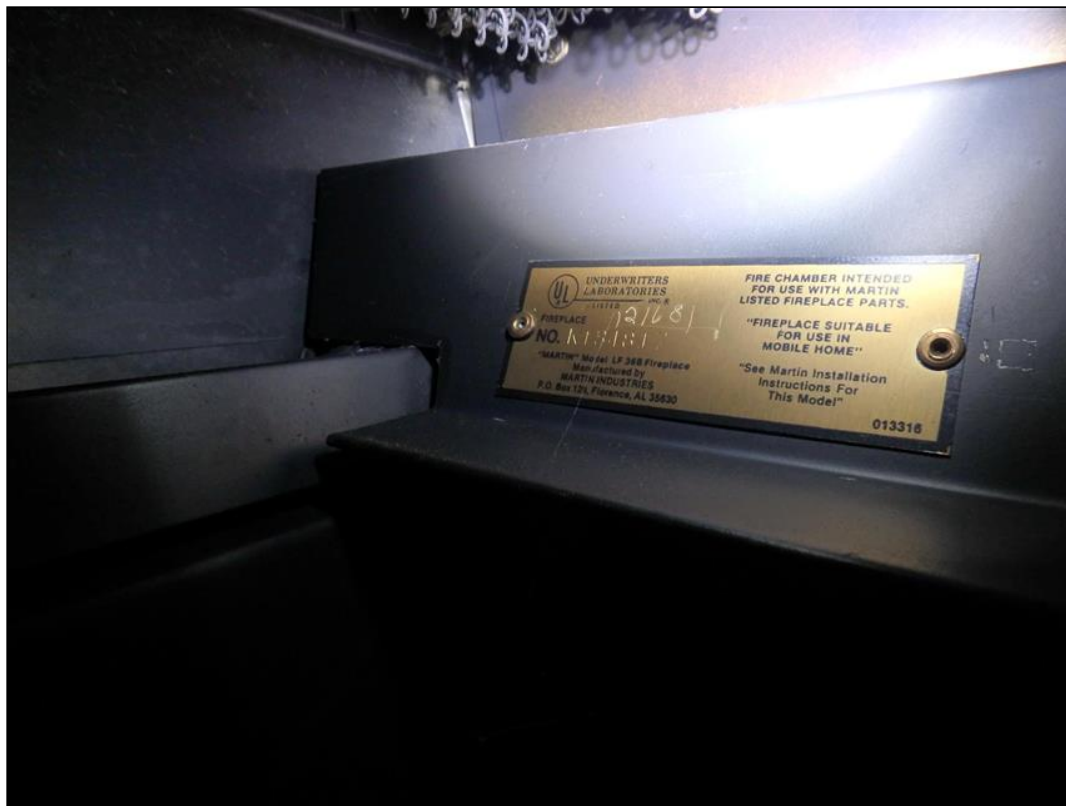
(2) As observed in the wood burning fireplace, the bottom insert refractory panel had a crack in it. This is a safety concern as this panel keeps the fire inside the firebox. Recommend further evaluation by a qualified, licensed fireplace professional and repair as necessary. As a precaution, the fireplace should not be used until the necessary repairs are completed and a level 2 chimney inspection is completed.

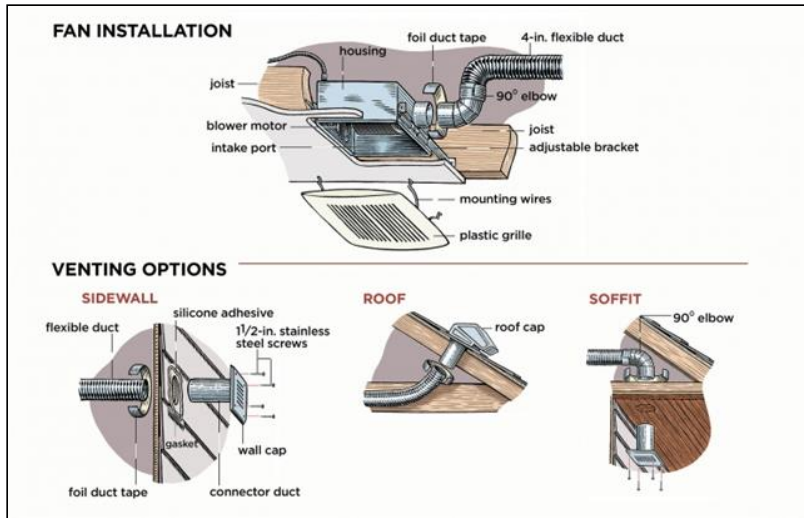
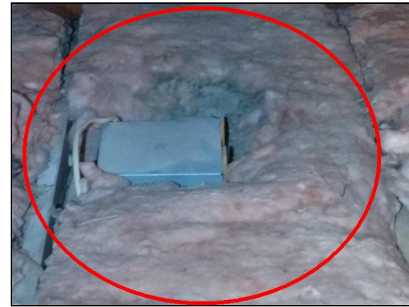
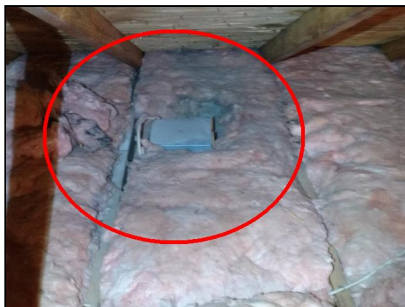
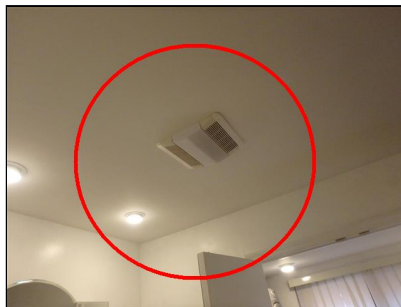
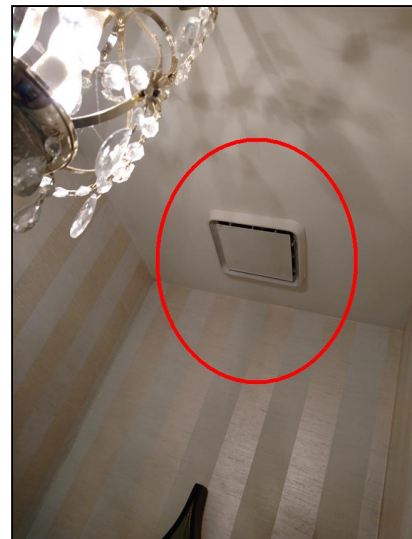
The exhaust fan for the master bathroom was venting into the attic space. This condition may cause a buildup of moisture and mold in the attic. This exhaust fan should be venting to the exterior. Recommend directing the vent towards the exterior to allow for proper ventilation to be performed by a qualified, licensed contractor. Also to note, the venting of the main level bathroom exhaust fan is suspect. There was no visible termination point on the exterior for this exhaust fan. So, it is suspected that the exhaust fan may be venting into the ceiling space above the bathroom. This venting should be terminated outdoors and may cause moisture damage/a mold condition to the surrounding structure if the needed repairs are not completed. This fan should also be further evaluation by a qualified, licensed contractor and repaired if necessary.

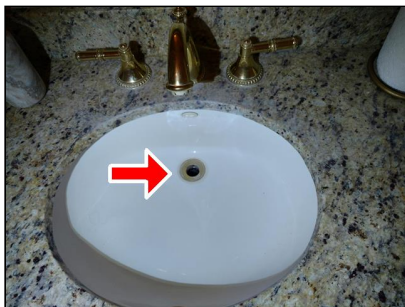
13.2 Item 1 (Picture)

The sink stopper in the bathroom sink was missing. This will prevent you from filling up the sink if you wanted to do so. Recommend further evaluation by a licensed plumber and repair as necessary.

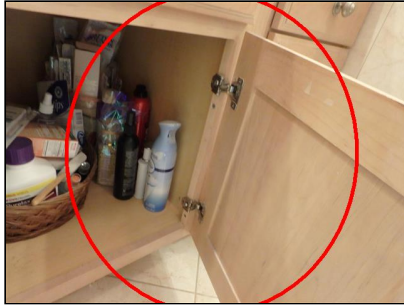
13.6 Item 1 (Picture)

Portions of the bathroom vanity was damaged, had worn out hardware and/or not functioning as intended and in need of repairs. These conditions may worsen as well as possible damage to the cabinetry could occur if the

needed repairs are not completed. Recommend further evaluation by a qualified, licensed contractor and repair as necessary.

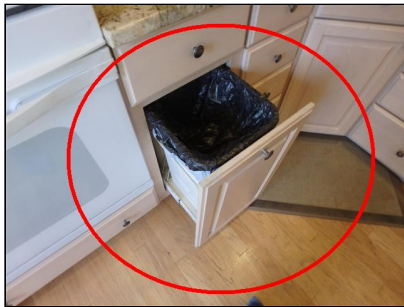
14.1 Item 1 (Picture)

Portions of the cabinetry were damaged, had worn out hardware and/or not functioning as intended and in need of repairs. These conditions may worsen as well as possible damage to the cabinetry could occur if the needed repairs are not completed. Recommend further evaluation of all of the kitchen cabinetry by a qualified, licensed contractor and repair as necessary.

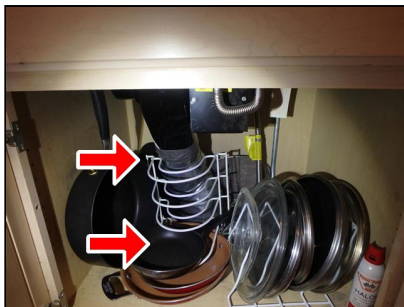
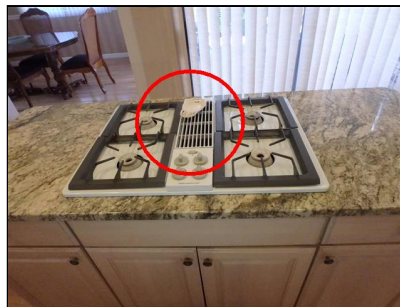
The venting of the down draft exhaust fan is suspect. It should be ascertained as to where this is venting and if it venting properly.

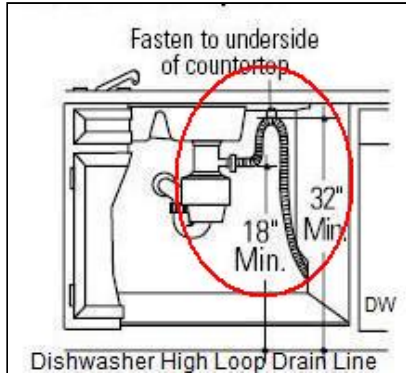
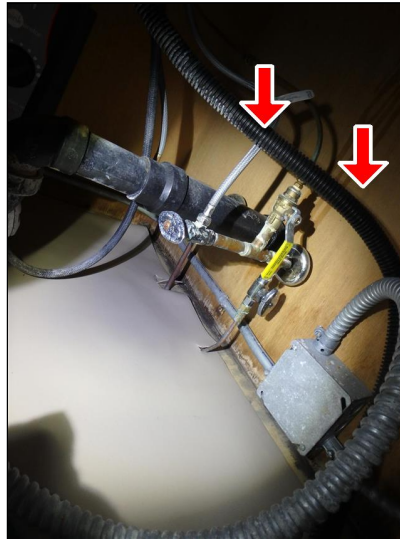
(1) The drain line on the dishwasher is not high looped under the countertop. The dishwasher drain line under the kitchen sink should be looped up as high as possible in the cabinet and up under the countertop. This prevents dirty/contaminated water from the sink from back flowing into the dishwasher. Recommend further evaluation by a qualified, licensed plumber and repair as necessary.

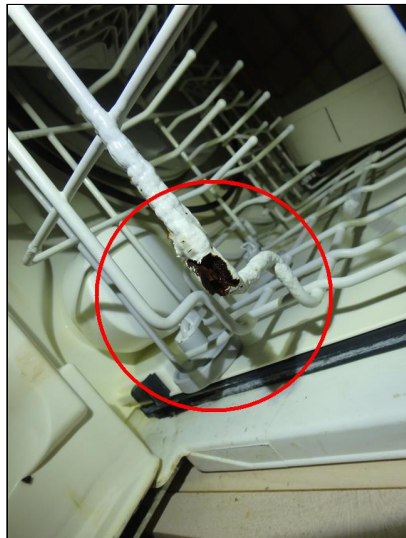
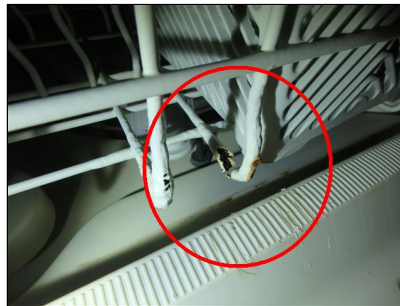
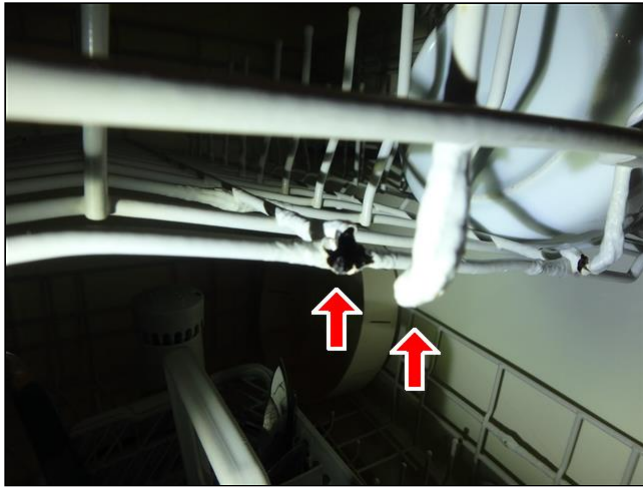
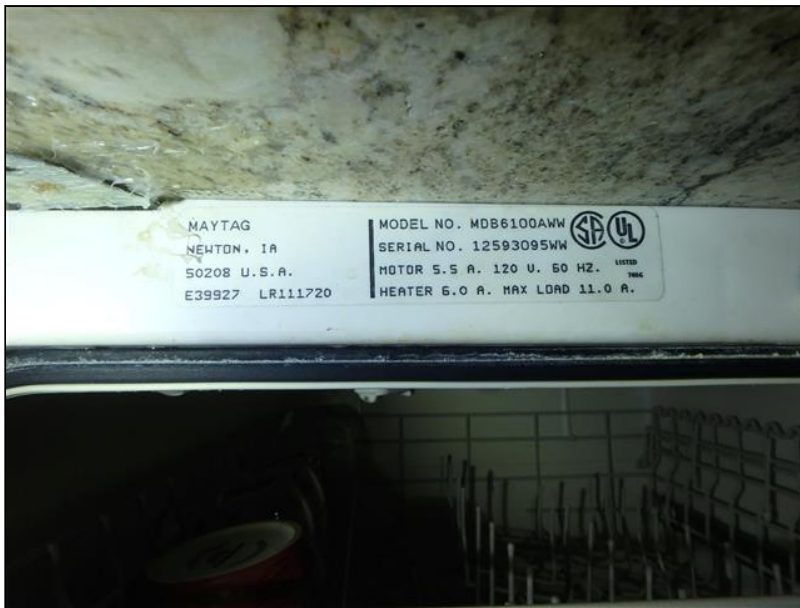
(2) Portions of the pull out drawers in the dishwasher appeared to be deteriorated and/or rusted. This is a potential health concern. Recommend further evaluation by a qualified, licensed appliance repair professional and repair/replace as necessary.

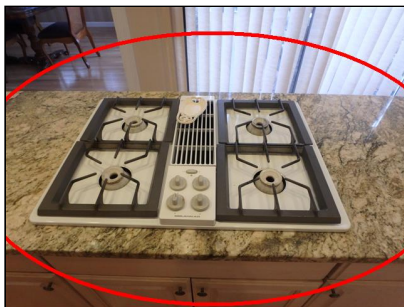
14.9 Item 1 (Picture)

Two of the burners did not light when tested. Recommend further evaluation by a qualified, licensed appliance professional and repair/replace as necessary.
