# Property Inspection Report

123 Main Street

Unit T1

**Terra Home Inspections LLC**

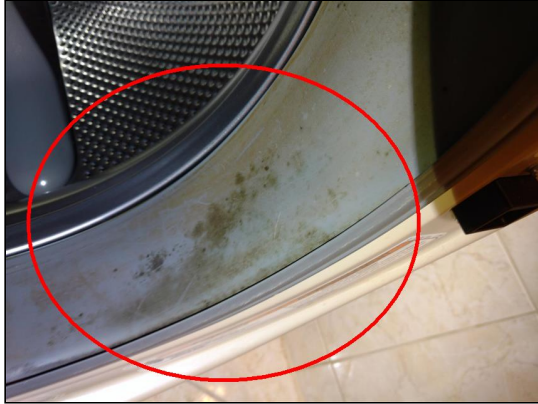
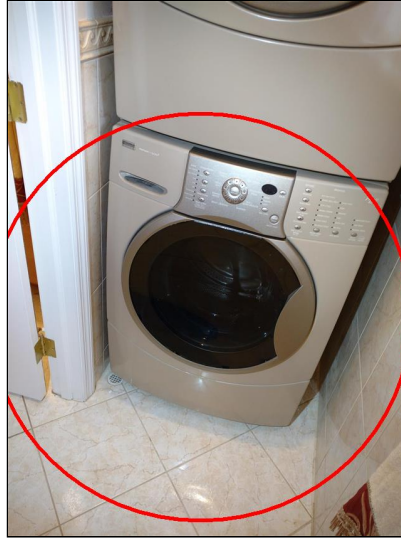
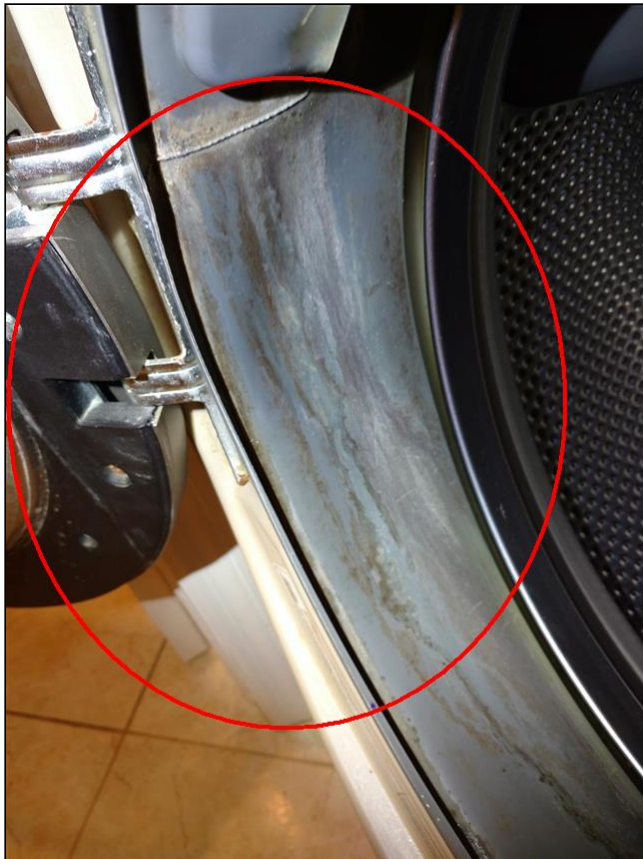
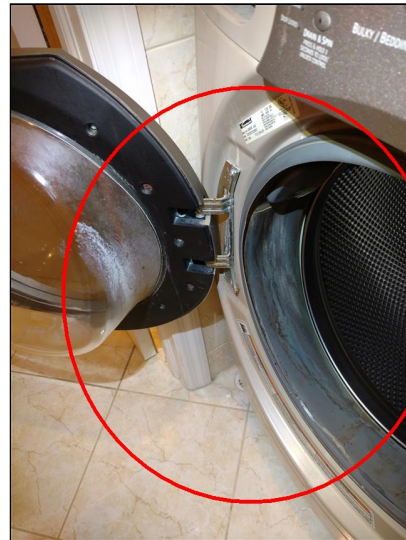
As observed inside the clothes washing machine, there was some minor mildew on the rubber portions of the drum. This should be cleaned and ideally the front door should be left open when the machine is not in use to let the inside of the washing machine dry out and not leave any mildew.

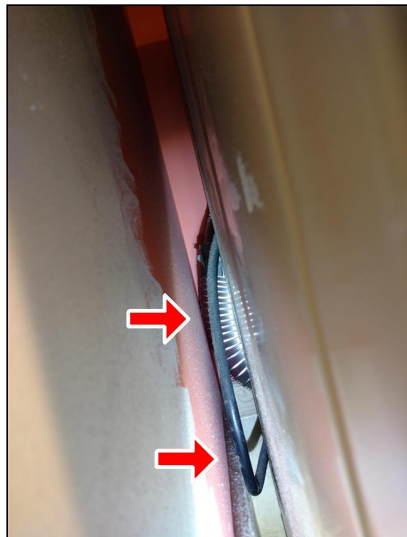
15.1 Item 1 (Picture)

(1) Rubber water supply fill hoses for the clothes washing machine were observed in the laundry area. Rubber fill hoses have a limited life span and are prone to bursting. A burst hose can result in flooding and serious water damage. It is recommended to replace rubber washing machine hoses with braided stainless steel mesh, burst resistant hoses. This should be the buyer's responsibility as the rubber fill hoses that were present appeared to be in a serviceable condition. These hoses are available at the Home Depot, Lowes or any other home center and usually cost around \$20-\$30.

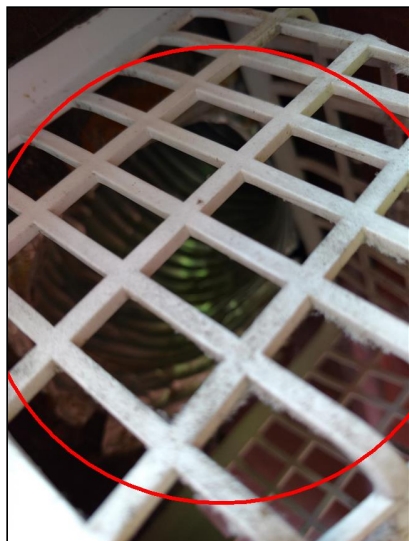
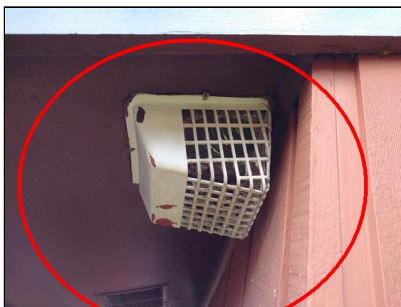
The back portions of the laundry equipment could not be viewed. This includes the water supply lines, natural gas supply line, dryer ducting, the water supply shut off valves and the clothes washer drain. Therefore, the inspection of all of the items/components is limited. They may not be functioning as intended and may have issues/defects present. Also to note, the exterior portion of the dryer venting was missing a backdraft damper door. This condition could allow wildlife/bugs to enter the dryer vent ducting and possibly clog it. Cold/hot air can also migrate into the dryer as a result. Recommend further evaluation by qualified, licensed contractor and repair as necessary.

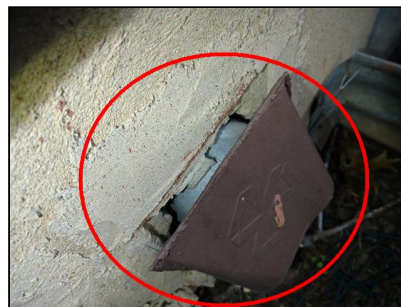
15.4 Item 3 (Picture) Old dryer vent under deck appears to be not in use. The foundation penetration should be sealed
