Property Inspection Report

Property Address:
1000 Springfield Avenue
Samletown NJ 05555

Terra Home Inspections LLC

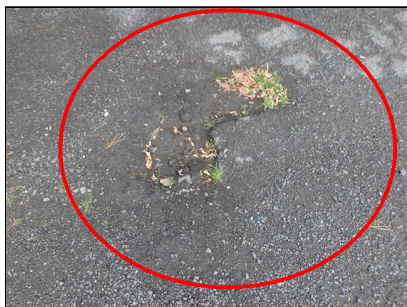
1.0 Item 2(Picture)

The asphalt driveway has numerous areas that were cracked and deteriorated. Further deterioration could occur if the needed repairs are not completed. Recommend further evaluation for repairs by a qualified, licensed driveway contractor.

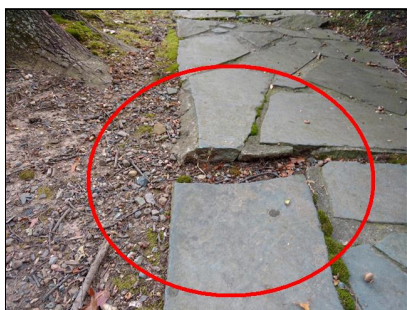
1.1 Item 2(Picture)

The front walkway had one large section that is raised which is causing a trip hazard (which is a safety issue). It appears the tree roots from the large tree are pushing this section of the walkway up. Recommend further evaluation for repairs by a qualified, licensed contractor.

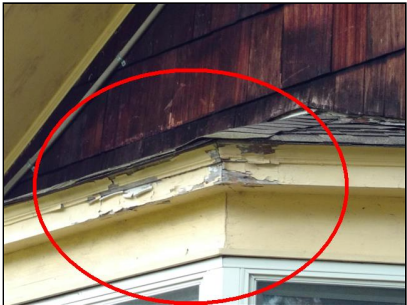
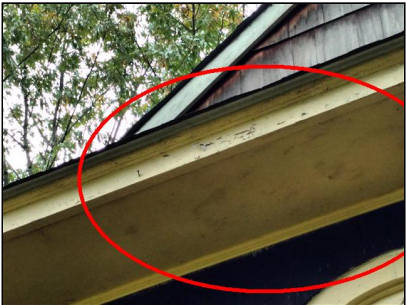
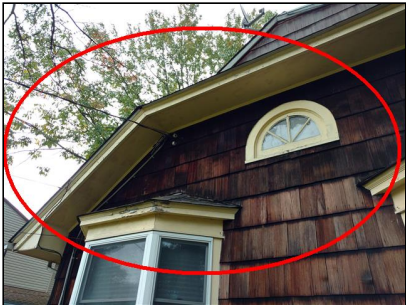
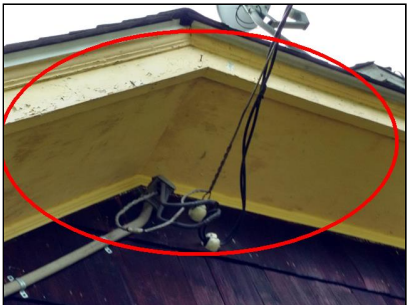
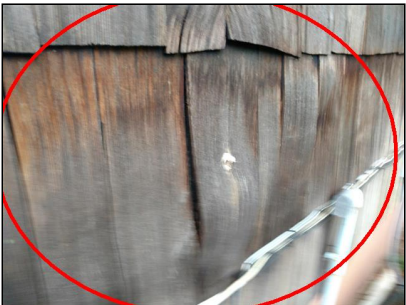
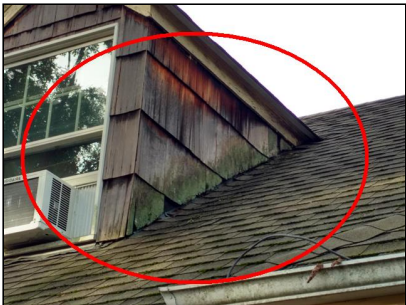
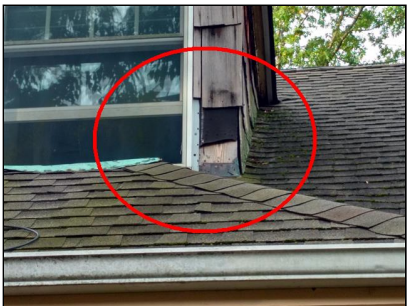
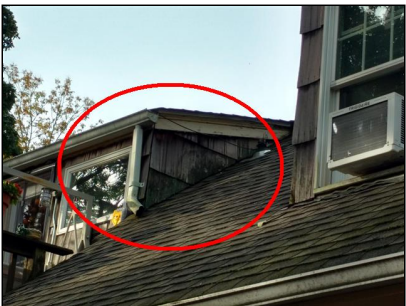
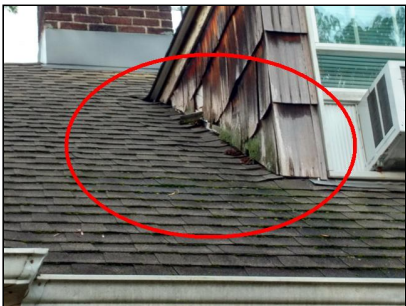
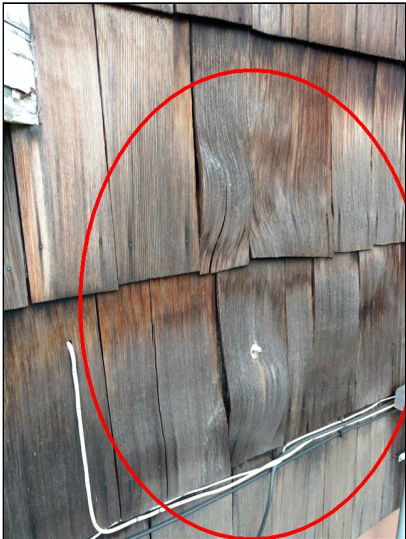
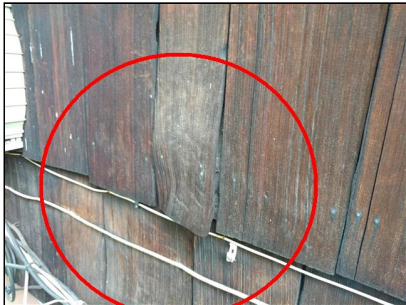
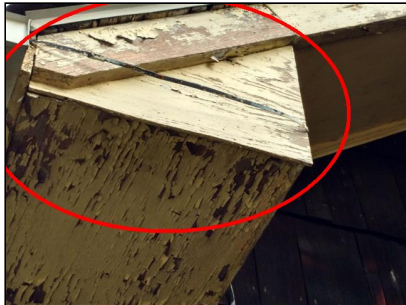
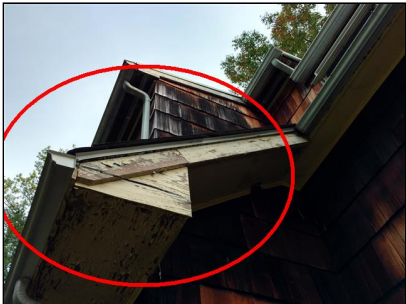
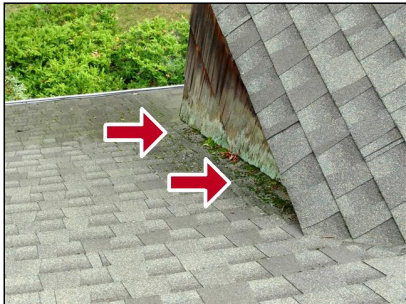
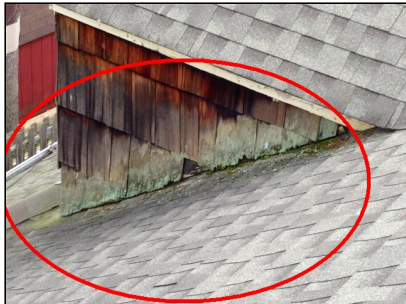
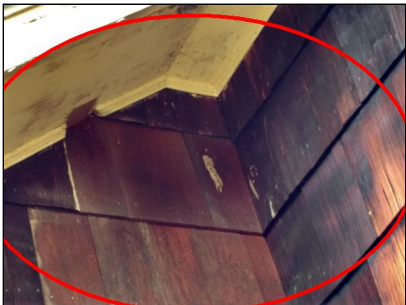
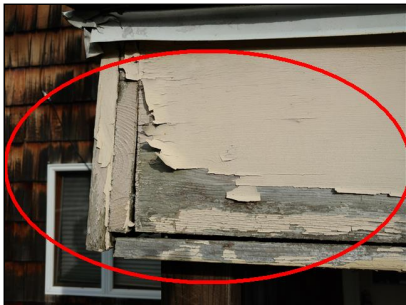
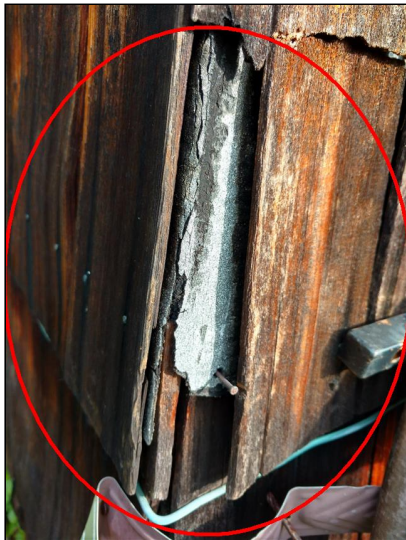
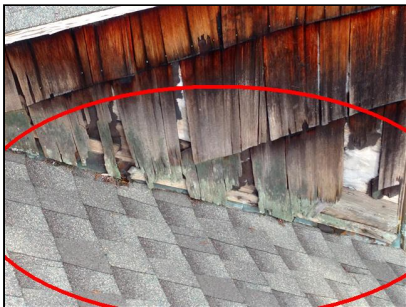
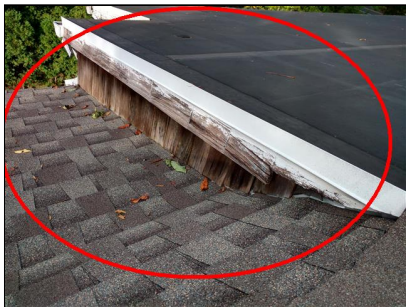
Portions of the paint on some of the exterior wood elements (wood window frames, door frames, trim, framing, wood cladding, eaves, soffits and gable ends, etc.) was peeling leaving the wood exposed to the elements. In addition, portions of some of these elements were also damaged/deteriorated. Also numerous portions of the wood shake siding were damaged, deteriorated and or missing leaving the structure open to possible moisture intrusion and/or further damage. Further deterioration of these elements as well as possible structural damage behind/under these elements could occur if the needed repairs are not completed. Lastly, just to note, due to the age of the dwelling, caution should be used on any areas where the paint is peeling as some of the peeling paint may contain lead. Recommend further evaluation of the entire exterior of the dwelling by a qualified, licensed contractor and repair as necessary.

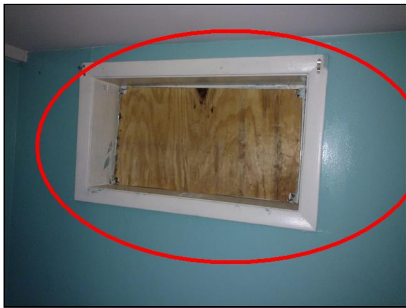
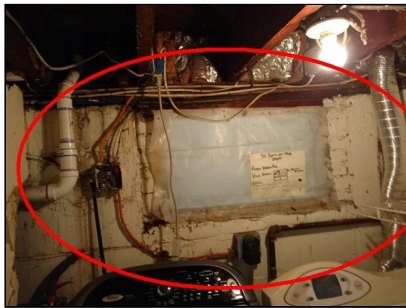
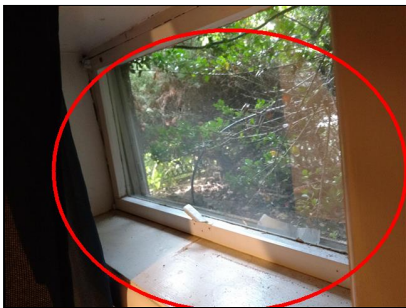
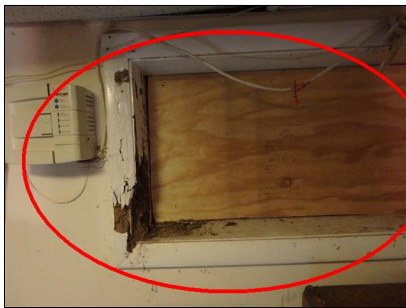
Comments: Repair/Replace
(1) As observed in the basement, there were several windows that would not open, were missing or boarded up. Boarded up windows are an issue because water could possibly migrate into the basement if the wood used to board up the window opening is not properly sealed up and coated against the elements. If water is getting in behind the wood, it could potentially rot out the window sill and/or window frame. Missing windows are also an issue because this could let unwanted wildlife, insect and the weather into the dwelling. Recommend further evaluation of all of the basement windows by a qualified, licensed contractor and repair as necessary.

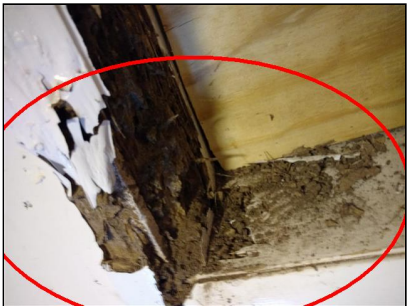
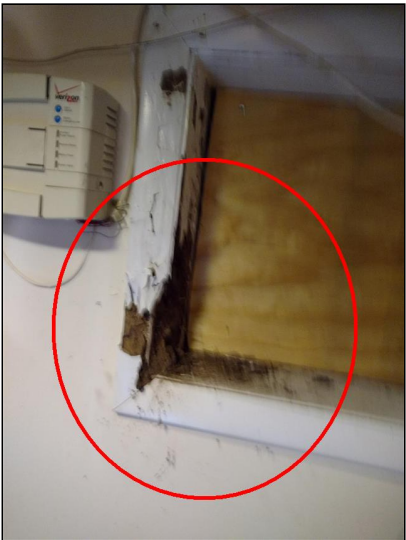
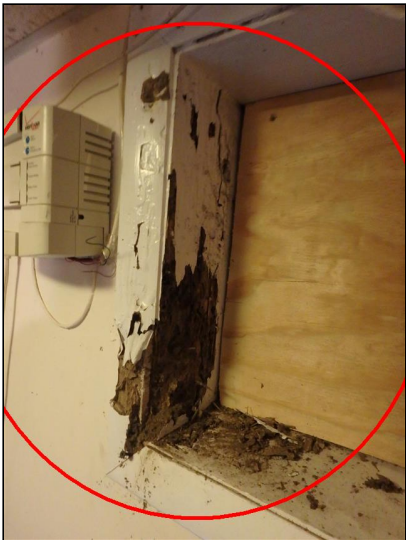
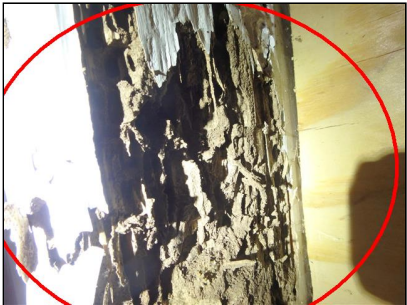
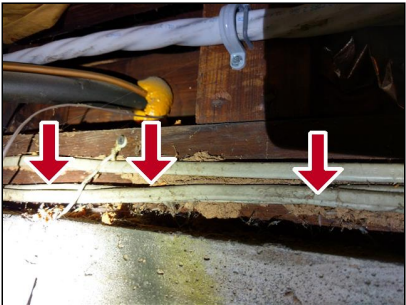
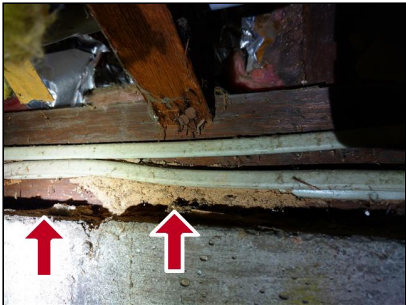
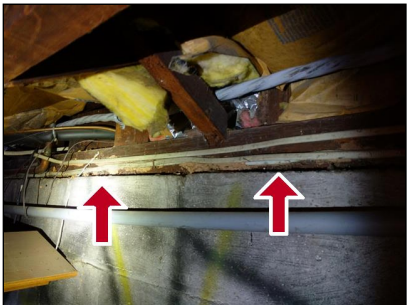
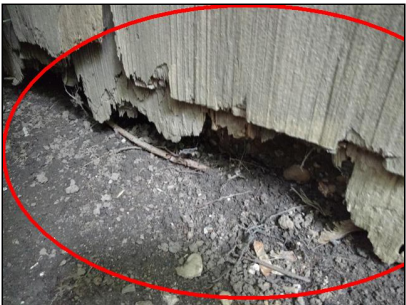
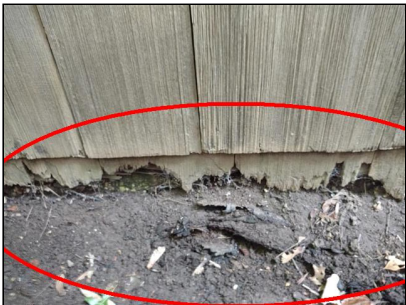
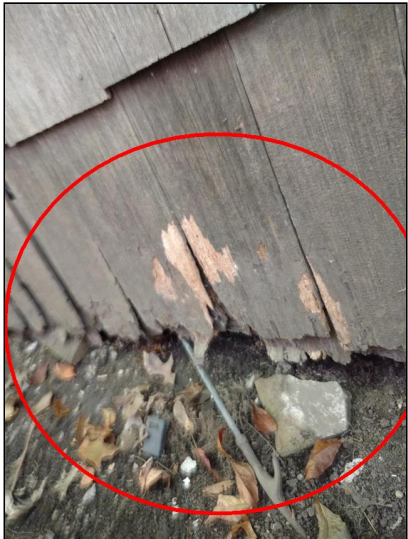
(2) Evidence of what appears to be previous termite damage was observed on the right front basement window frame and on various portions of the garage structure. There was also what appeared to be termite shelter tubes present on the front foundation wall structure. There was no active wood destroying insects observed at the time of the inspection. Further damage/deterioration to the garage and house structure/elements structure could occur if the necessary further evaluation and/or treatment option(s) are not completed. There may be hidden WDI damage that was not visible. Recommend further evaluation of the house and garage structures for treatment of WDI by a qualified, licensed pest control professional and also for repairs of the effects areas by a qualified, licensed contractor.

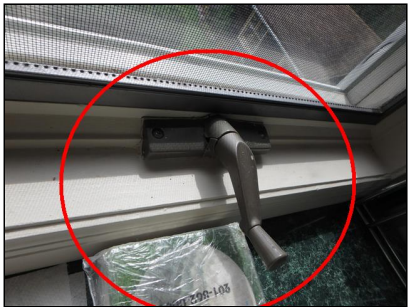
2.3 Item 17(Picture)

(3) As observed in the 2nd floor kitchen, some of the hardware on the casement windows was missing and/or damaged. Therefore, these windows will not function as intended as a result. The window lock on the 2nd floor front bedroom was also damaged. Recommend further evaluation by a qualified, licensed contactor and repair as necessary.

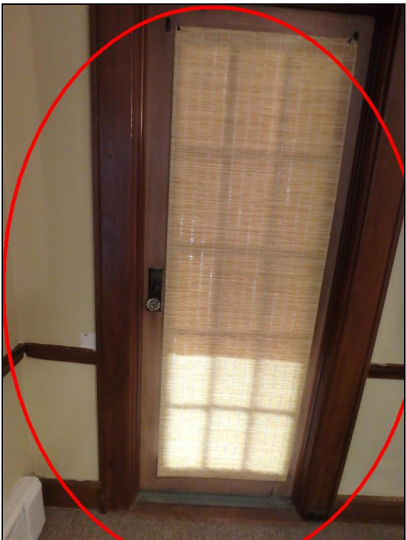
2.4 Item 2(Picture)

The self closer's on the left side entry door were missing. This is a safety issue. Also, the exterior door on the 1st floor to the deck was not functioning. It would not open. Recommend further evaluation by a qualified, licensed contractor and repair as necessary.

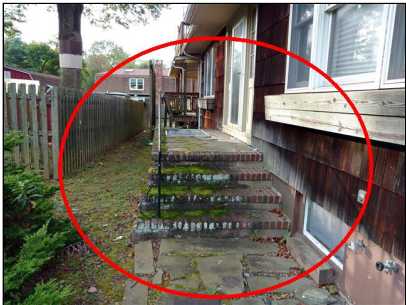
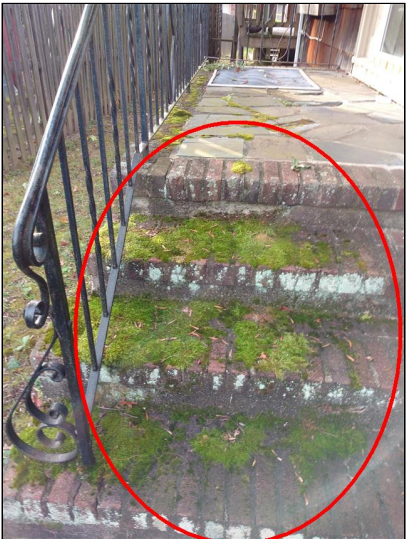
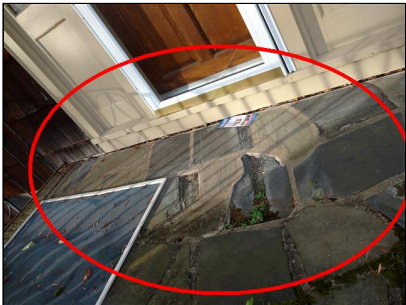
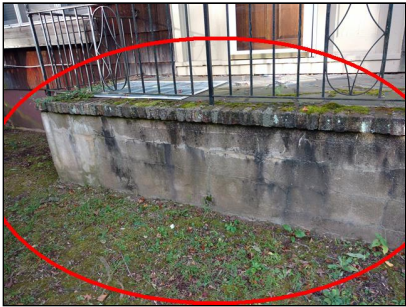
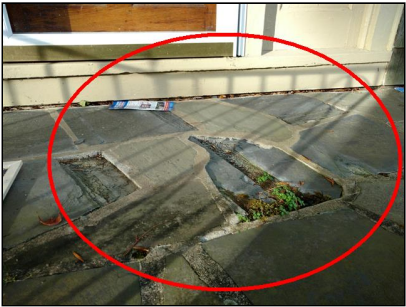
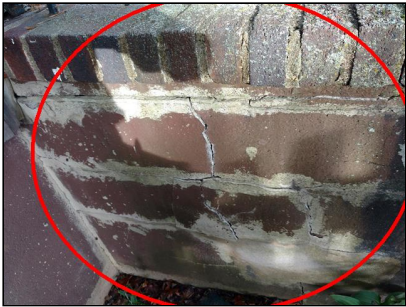
(1) The left side masonry staircase had numerous cracks and deterioration present throughout the structure. Further deterioration of the staircase could occur if the needed repairs are not completed. Recommend further evaluation by a qualified, licensed masonry contractor and repair as necessary.

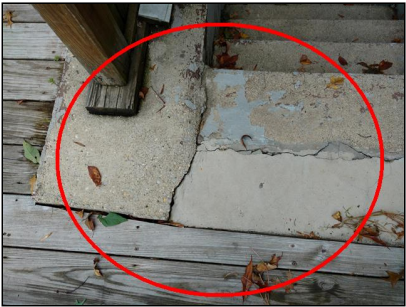
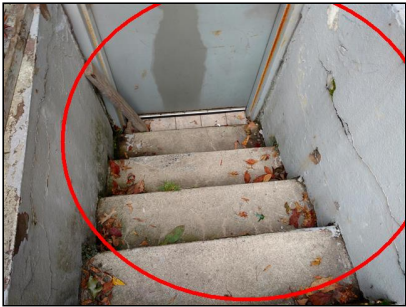
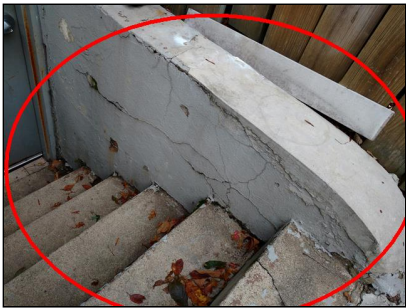
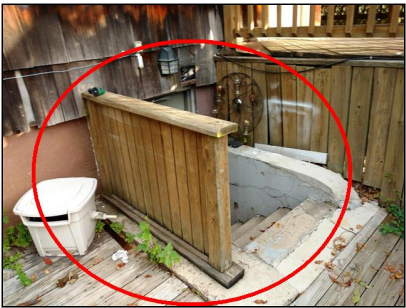
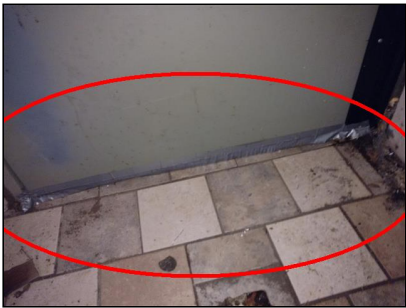
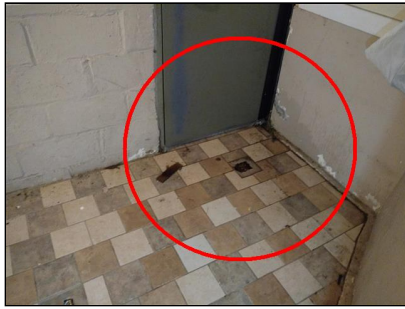
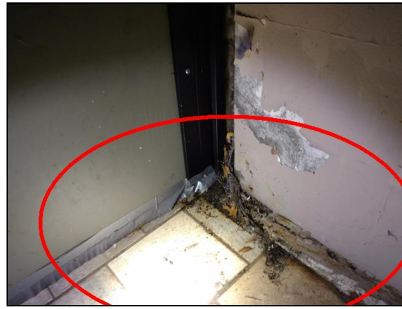
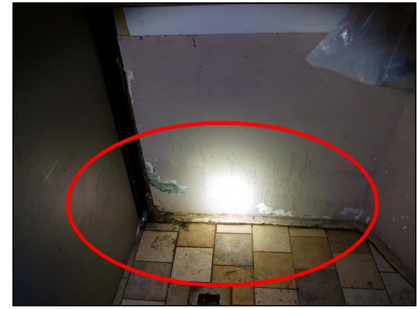
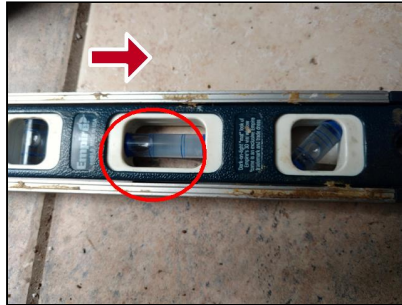
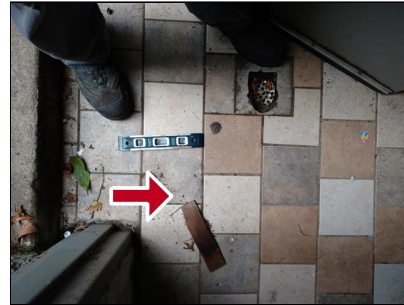
(2) The rear masonry staircase leading to the basement door had numerous cracks and deterioration present throughout the structure. Further deterioration of the staircase could occur if the needed repairs are not completed. Also, it appears water is running down the stairway and under the basement door and into the basement. The basement floor in the area under the basement door was sloped towards the basement. This could be a future concern. There was evidence of moisture damage inside the basement in the area of the basement door. The guardrail assembly surrounding this stairwell was extremely loose which is a safety concern. The stairwell also did not have a handrail. Recommend further evaluation by a qualified, licensed masonry contractor and repair as necessary.

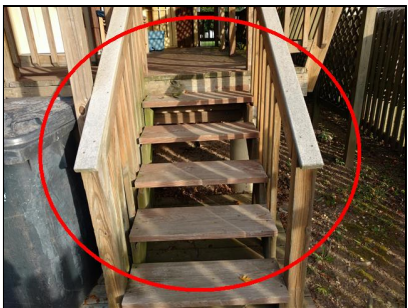
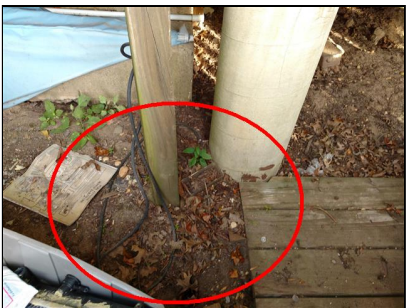
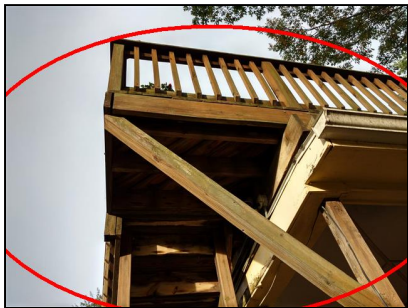
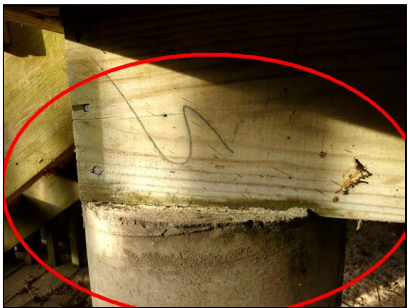
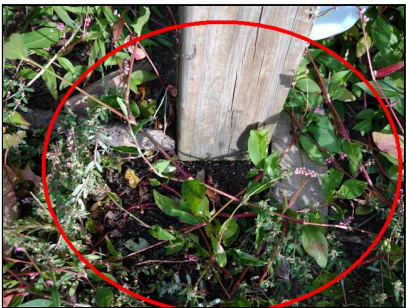
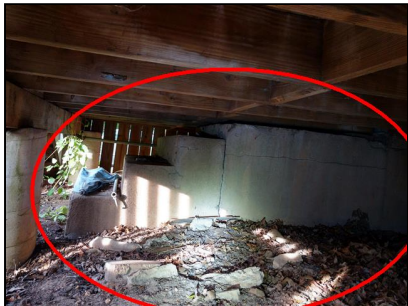
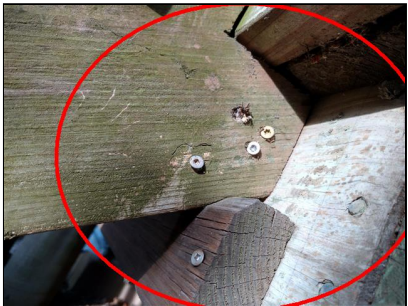
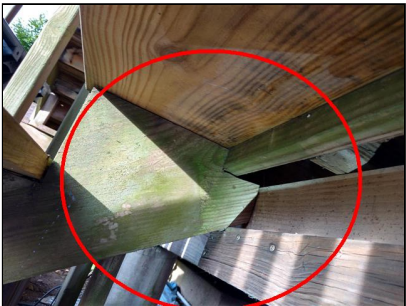
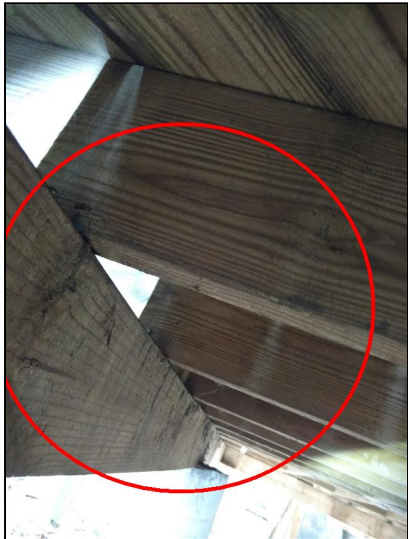
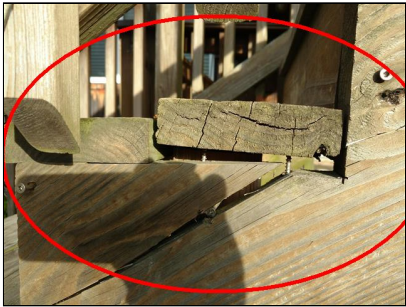
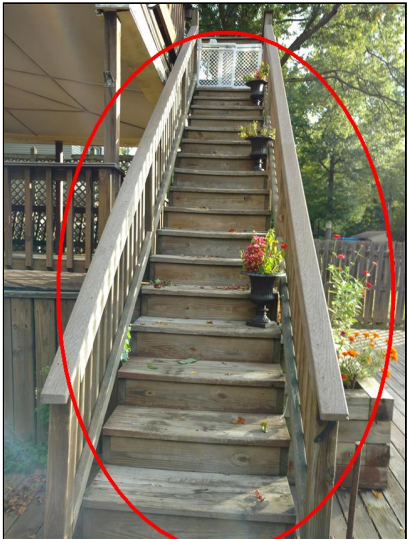
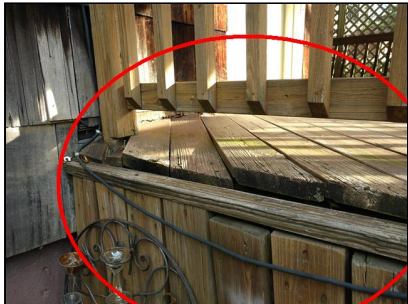
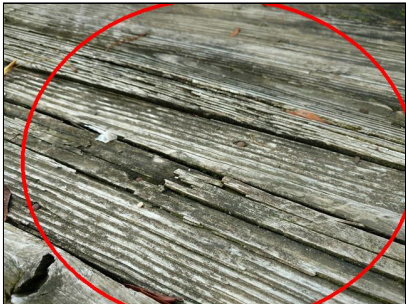
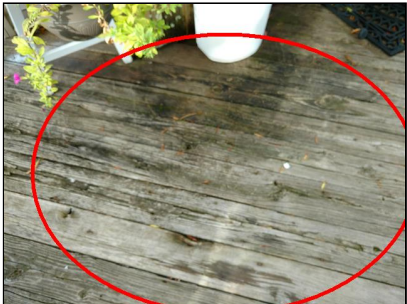
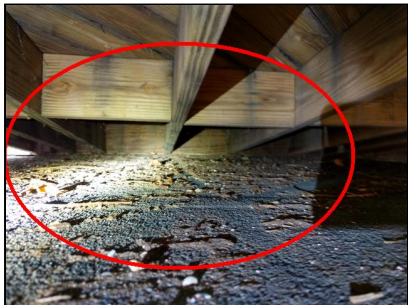
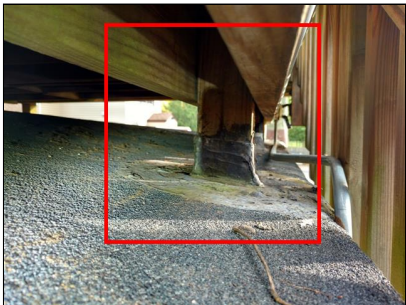
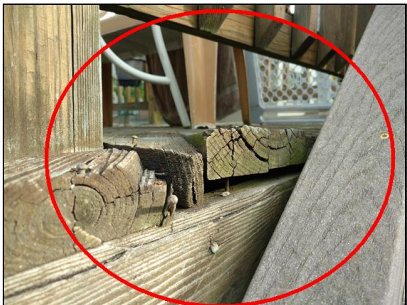
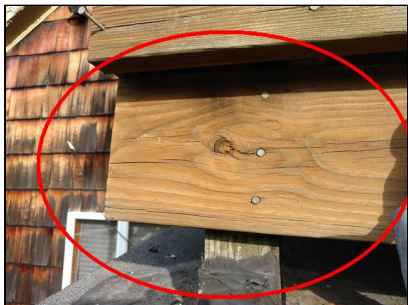
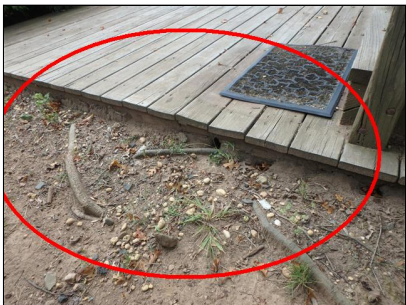
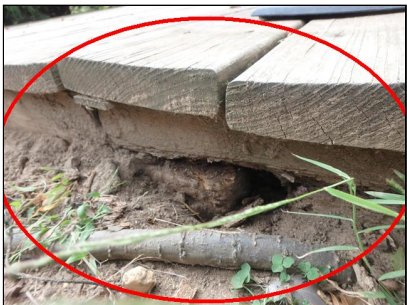
Numerous issues were observed pertaining to the rear wood deck structure(all levels);

- 3) The stair stringers/staircases appeared to be loose and moved excessively when the staircases were walked on. The stair stringers should have the required mechanical connectors connecting it to the main deck structure.

- 4) The lower ground level deck area appears to have been built in the fashion that the wood is lying on the ground. This could promote WDI damage as well as dry rot. There was numerous areas that appeared to be damaged/deteriorated. Wood should not be in contact with the ground soil.

- 5) Some of the handrail and guardrail assemblies were loose.
- 6) The handrails were not graspable. All handrails should be equivalently graspable to the 2-inch circular handgrip. The hand grip shape should provide a vertical graspable surface. It should allow the user to maintain a consistently secure natural grasp on the handrail without twisting the fingers or requiring release.

- 7) The top portion of the deck was built over an existing structure with a flat roof membrane roof covering. The top portion of the deck may have to be removed to replace the roof covering in the future.

- 13) The lower deck was built over an existing masonry staircase that was still present. This staircase appeared to have numerous cracked areas present. This is a concern as the staircase may divert water into the foundation/basement.

These are all safety concerns and the needed repairs should be completed ASAP to insure the structure is safe for the occupants. Especially, since this deck structure is the only means of egress for the 2nd floor tenants. Recommend further evaluation of the entire deck structure (all levels) by a qualified, licensed deck contractor and repair as necessary. Additional information pertaining to deck construction and safety can be found at <http://www.safestronghome.com/deck/index.asp>

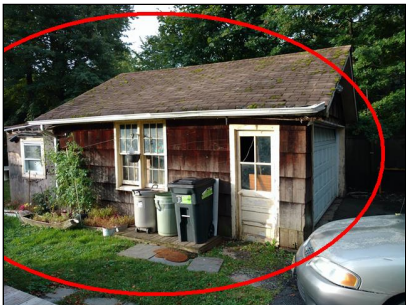
3.0 Item 1(Picture)

- 3.0 Garage
- Comments: Repair/Replace
- (1) Numerous issues were observed on the interior and exterior of the garage:
 - 1) The concrete floor had numerous small cracks present.

- 2) There were numerous sections of the exterior wood cladding/siding, garage structure, windows, doors, roof covering and trim that was damaged, deteriorated or missing.

- 3) The garage vehicle door was not closing properly due to the garage structure being damaged/deteriorated.
 - 4) Some of the gutter assemblies were damaged.

- 5) The paint was peeling in numerous sections of the garage exterior.
 - 6) A portion of the right side wall structure was damaged from what appears to be a tree stump.

- 7) The concrete apron in the front of the garage was cracked in numerous areas.
- The garage interior and exterior was cluttered with storage in sections. Numerous parts of the garage structure could not be viewed. Further deterioration of the noted garage elements could occur of the needed repairs are not completed. Recommend further evaluation of the entire garage (both interior and exterior) by qualified, licensed roofing, general and masonry contractors as well as a structural engineer and repair as necessary.

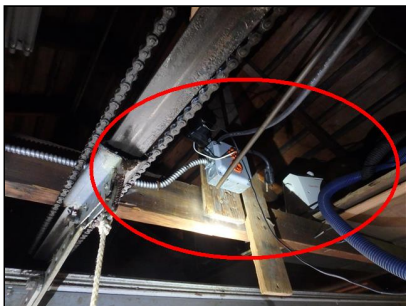
3.2 Item 1(Picture)

Comments: Repair/Replace
The automatic garage door opener was unplugged at the time of the inspection. In addition, the garage door was disconnected from the automatic garage door opener trolley. Therefore, the automatic garage door opener could not be operated and tested. Recommend further evaluation by a qualified, licensed garage door professional and repair as necessary.

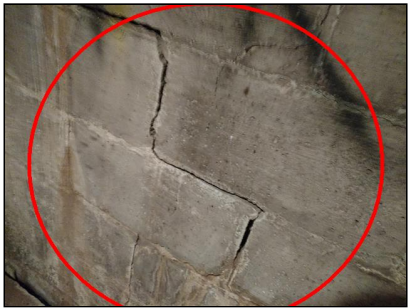
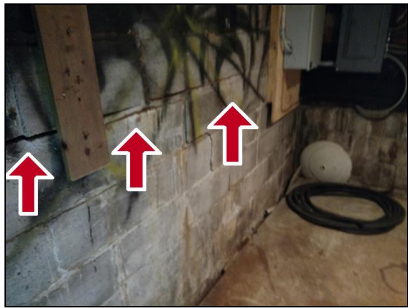
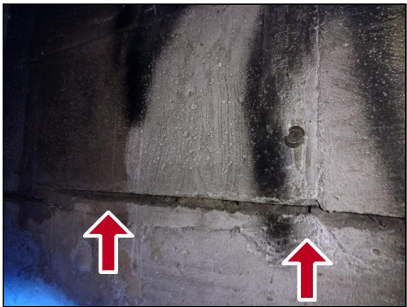
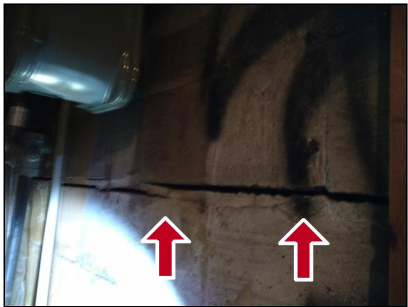
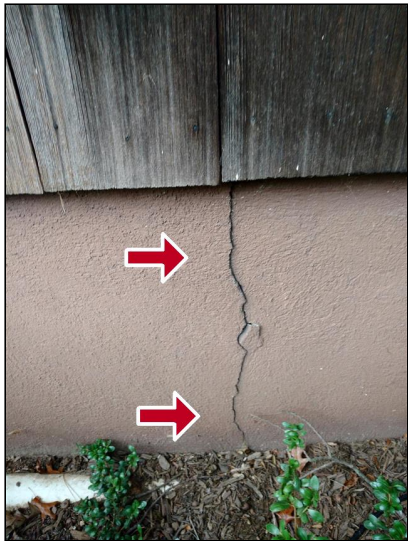
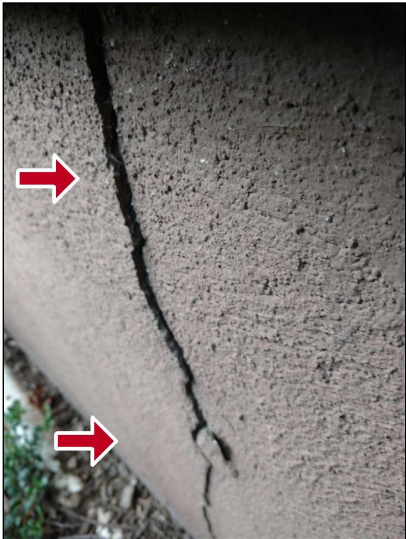
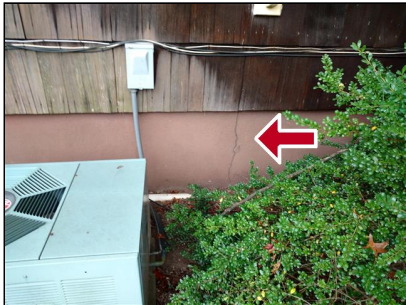
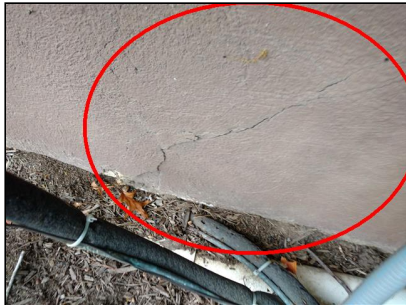
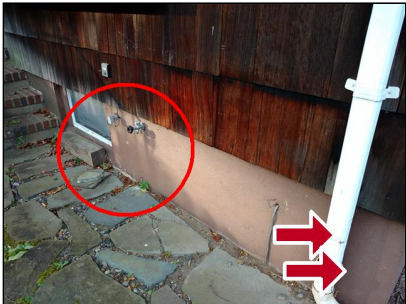
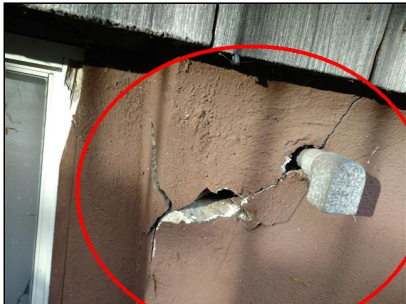
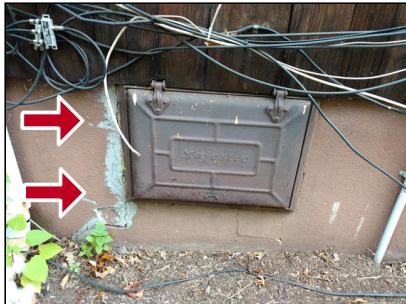
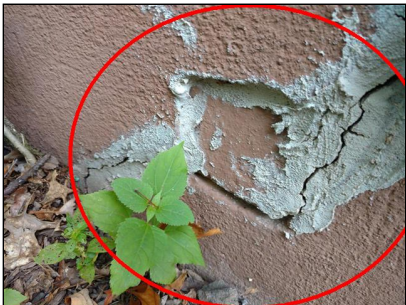
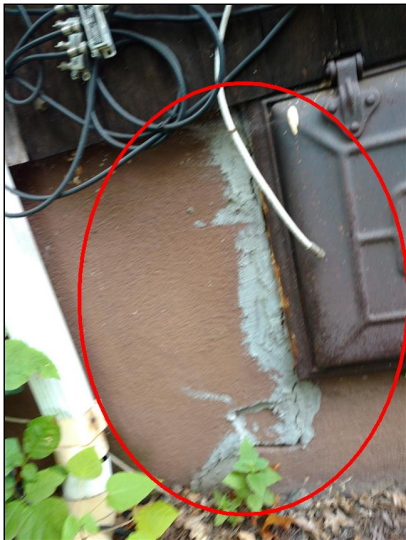
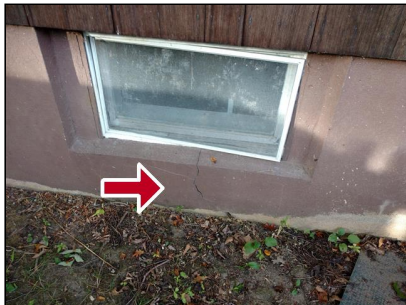
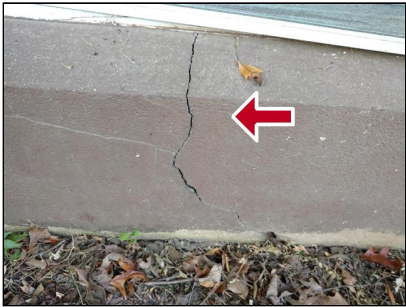
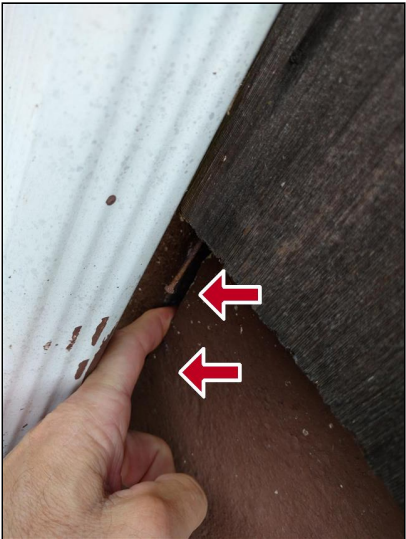
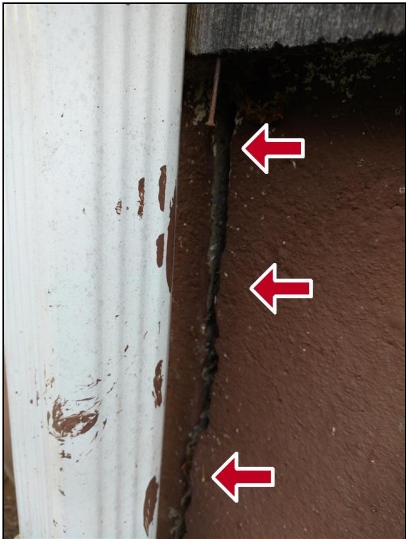
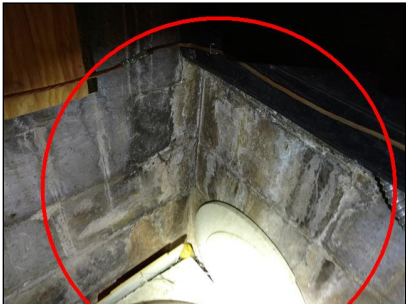
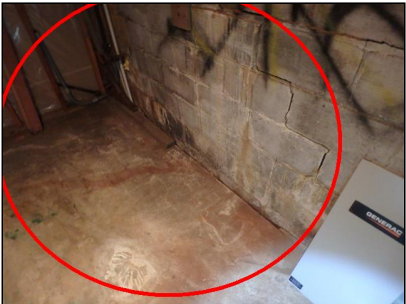
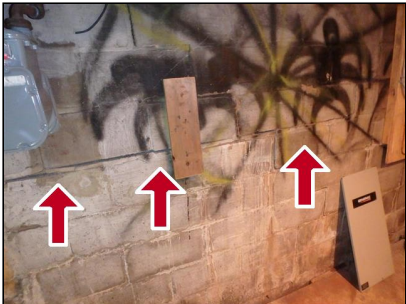
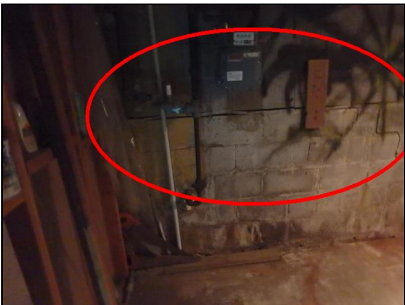
There were numerous vertical and horizontal cracks observed in the interior and exterior foundation wall surfaces. The front foundation wall as viewed in the basement, appeared to be heaving inwards as there was a large horizontal crack present. Also in the unfinished basement areas, there was evidence of previous moisture intrusion (efflorescence/ staining/peeling paint/mortar decay) observed on the foundation walls. Moisture can create high humidity, mold & can damage stored items & finishing materials. These areas appeared to be dry at the time of the inspection. Further deterioration of the foundation and possible structural damage to the rest of the dwelling could occur if the needed repairs are not completed. Recommend further evaluation of the entire foundation and house structure by a qualified, licensed structural engineer and repair as necessary.

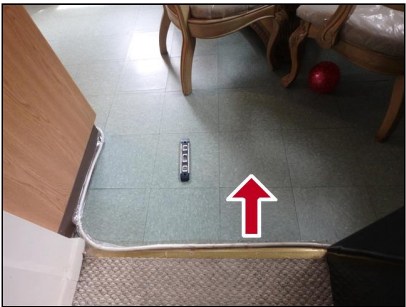
4.5 Item 2(Picture) 2nd floor

As observed throughout the house, there were numerous floors that had a noticeable sloping condition present. The condition of the sloping floors in question could worsen in the future if the needed structural repairs are not completed. Based on this and other structural observations, it is recommended a further evaluation of the entire house structure by a qualified, licensed structural engineer be performed and repaired per their recommendations.

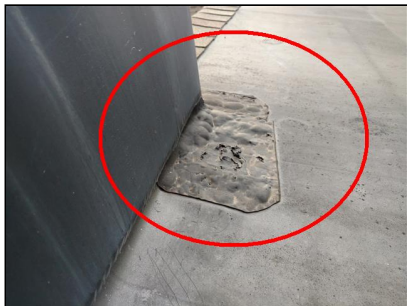
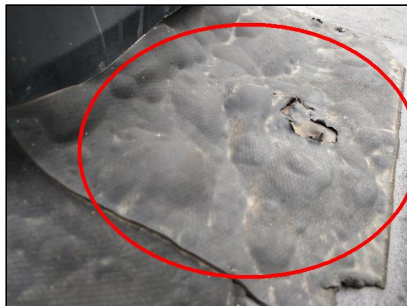
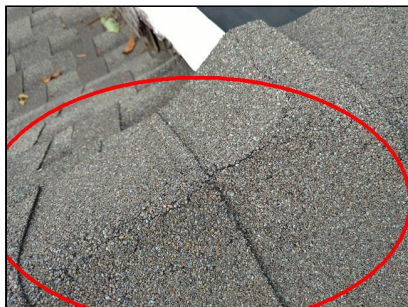
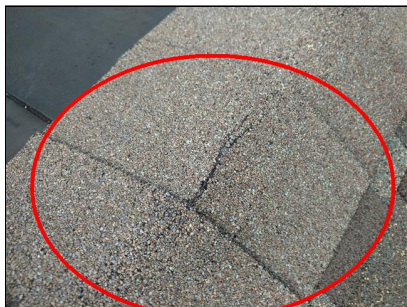
Observed on the flat roof in the area below the chimney flashings, two small sections of the flat roof membrane had several blisters/bubbles present. Blisters/bubbles are typically created by voids between the roofing membrane and the roof decking. If these blisters or the seams open up, water could enter the structure below. There were also a few roof peak shingles that had some minor cracking present. Recommend further evaluation of all of the roof covering materials by a qualified, licensed roofing contractor and repair as necessary.

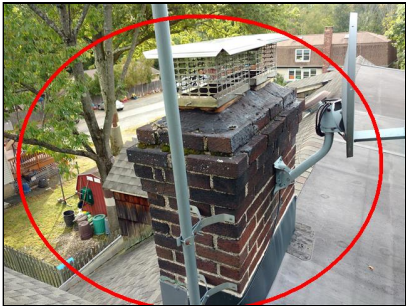
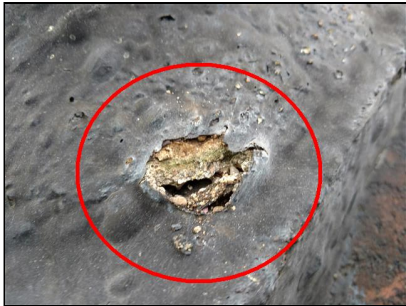
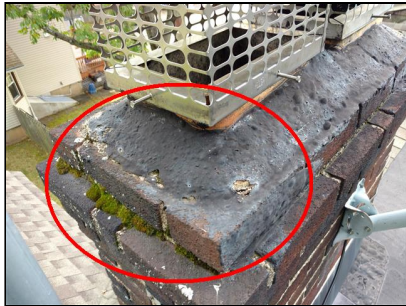
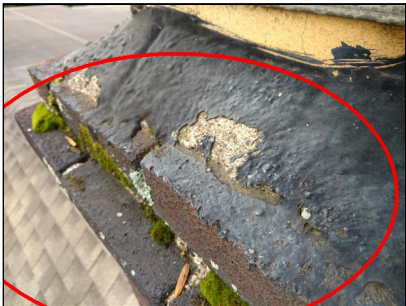
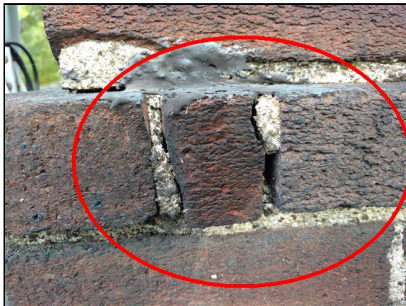
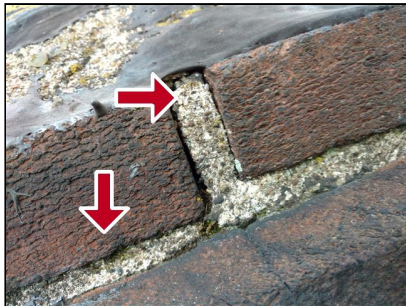
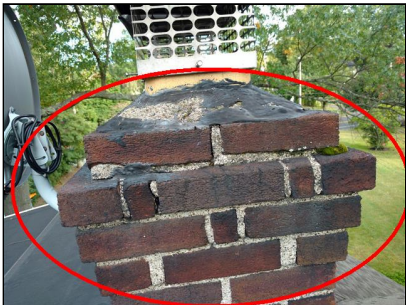
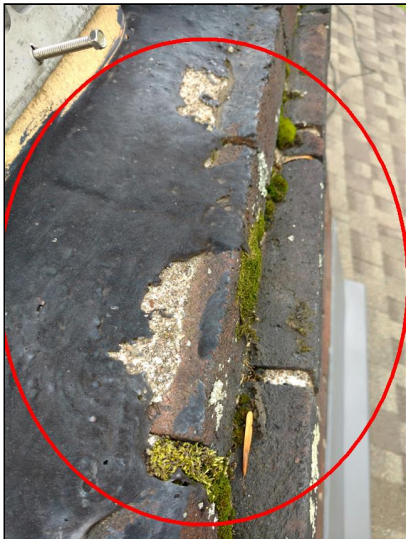
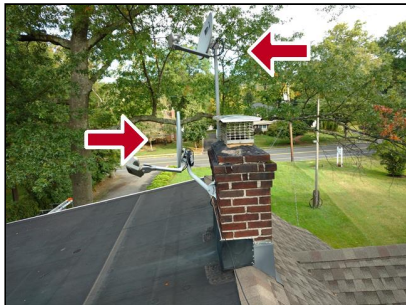
(2) Numerous issues were observed on the exterior masonry chimney:

- 1) There were numerous deteriorated areas present in the masonry chimney crown (top flat portion of chimney around the flue).
- 2) There was minor deterioration present in some of the mortar joints mainly towards the top of the chimney.
- 3) There were two satellite dishes mounted to the exterior chimney structure. This may be a future concern as it might put unwanted stress on the chimney structure in windy conditions.

Further deterioration of the chimney as well as possible moisture intrusion into the structure below could occur if the necessary repairs are not completed. Recommend further evaluation of the entire chimney (both interior and exterior portions) by a qualified, licensed chimney professional and repair as necessary.

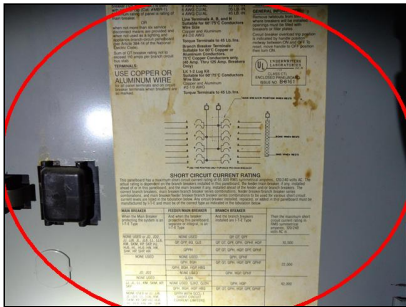
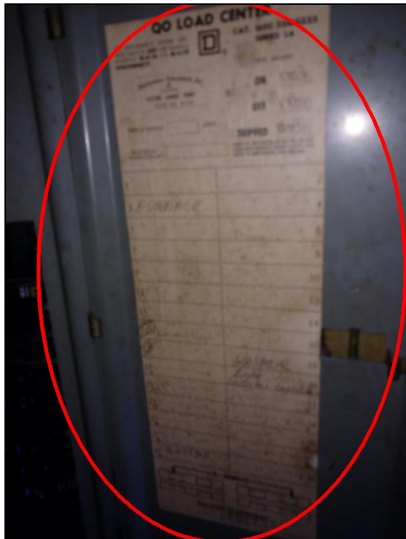
(1) As observed in all 3 electric panels, the circuit breaker wiring legends were in-complete and/or appeared to be inaccurate. These legends should be clearly marked identifying which circuit breaker shuts off which particular wiring circuit running throughout the house. This information is needed in case of emergency's or anytime individual circuits need to be turned off. It is recommend a qualified, licensed electrician verify each circuit and label accordingly.

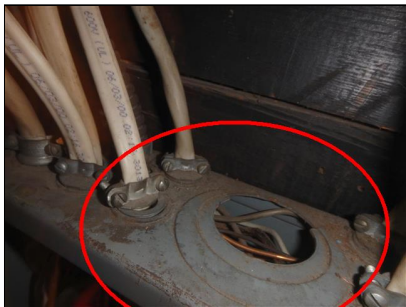
7.4 Item 2(Picture)

(2) There were knockout plugs missing from the electric sub panel located in the basement. Current electric safety standards state that unused openings in such equipment need to be closed. Covering these openings helps prevent accidental shocks, helps prevent hot sparks from escaping if something goes wrong inside the enclosure and helps to prevent pests from entering. Recommend further evaluation for repairs by a qualified, licensed electrician.

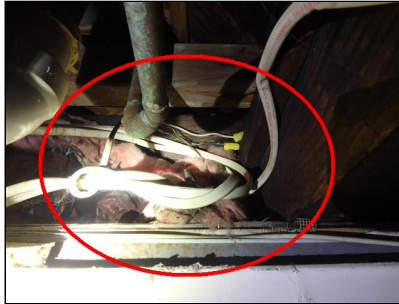
7.7 Item 1(Picture)

As observed in the basement, there was a live wire in the ceiling area that was not safely terminated in a junction box or light fixture. There were also some exterior wires for the exterior lighting that were not protected. These are safety concerns and potential fire hazards. Recommend further evaluation for repairs by a qualified, licensed electrician.

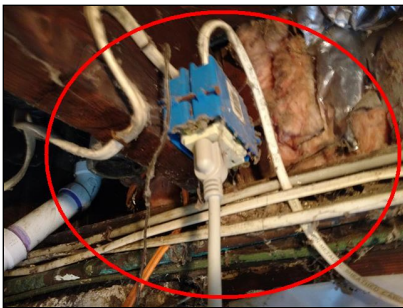
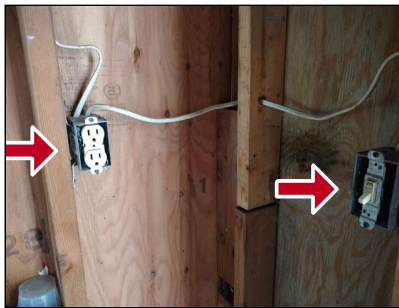
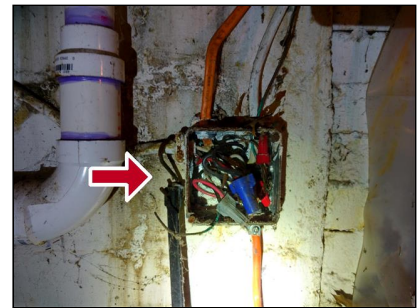
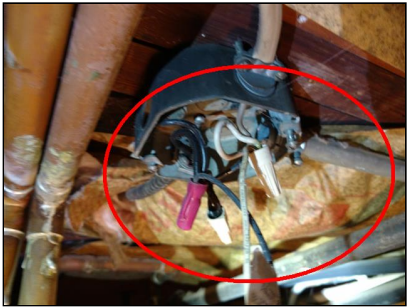
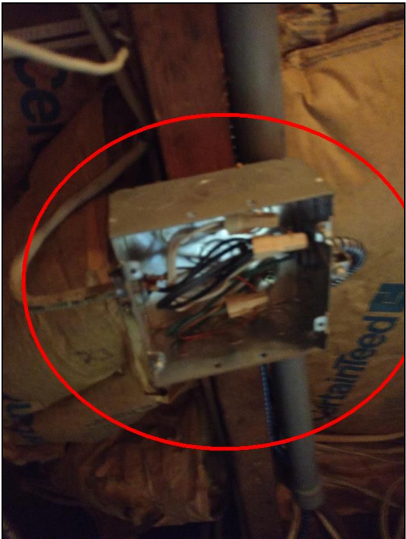
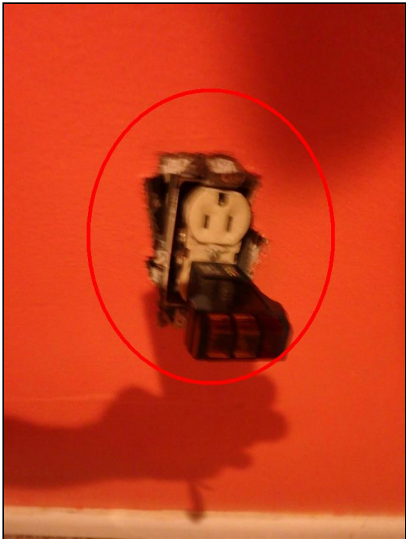
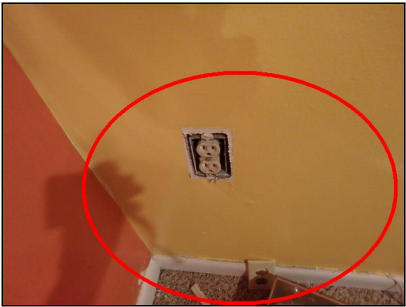
(1) As observed mainly in the basement, exterior and in the garage, there were numerous electrical junction boxes, light switches and outlets that didn't have the required cover plates on them. The cover plates are required in order to contain any arcing which would potentially cause a fire. If a wire is loose, the amperage will go up, which causes heat. This excessive heat is also capable of causing a fire. The idea is to keep all splices enclosed to reduce the risk of fire and to prevent damage to the wires due to accidental contact. Recommend further evaluation by a qualified, licensed electrician and install the needed covers.

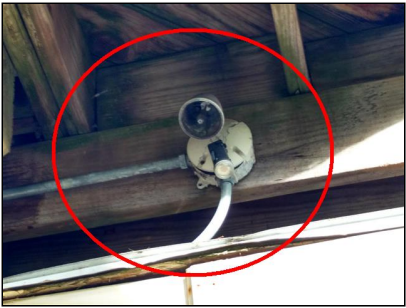
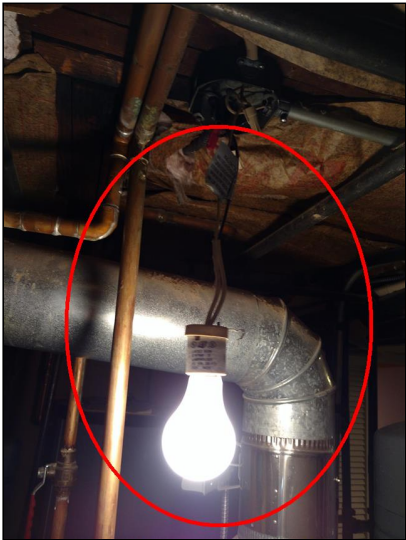
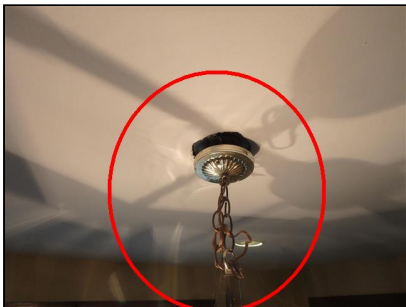
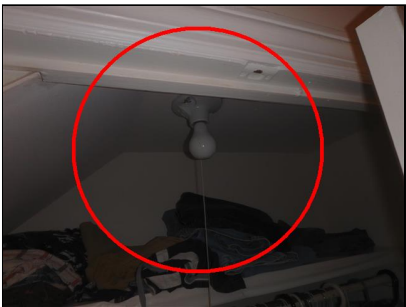
(2) Observed throughout the dwelling and on the exterior, there were numerous light fixtures that were either damaged, not functioning, not installed properly and/or missing light bulbs. This are potential safety concerns. Recommend further of all of the light fixtures by a qualified, licensed electrician and repair as necessary.

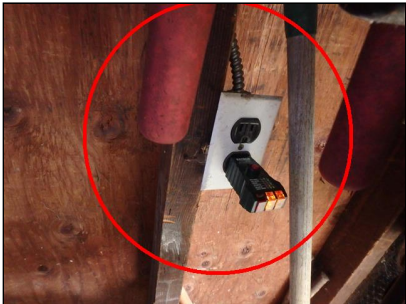
7.8 Item 13(Picture)

(3) There were numerous electrical receptacles that were not GFCI protected. These were located in the basement kitchen countertop area, basement bathroom, inside the garage and on the exterior. Receptacles located on the exterior, in garages, kitchen sink area, bathrooms and laundry areas should be GFCI protected. A ground fault circuit interrupter (GFCI) is a device (outlet or circuit breaker) that shuts off an electric power circuit when it detects that current is flowing along an unintended path, such as through water or a person. It is used to reduce the risk of electric shock. They can also prevent fires, like when a live wire touches a metal conduit. While the existing receptacles appeared to be in serviceable condition, for safety purposes, it is recommended that these existing receptacles be upgraded to GFCI type receptacles. This should be done by a qualified, licensed electrician.

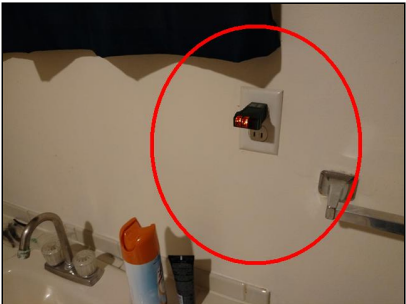
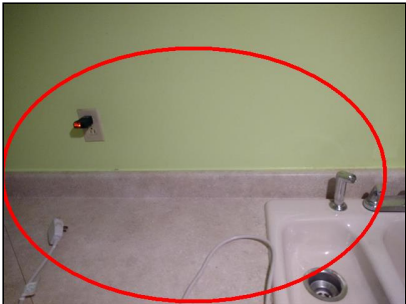
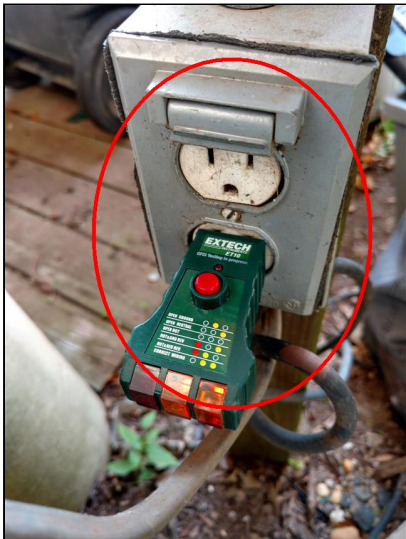
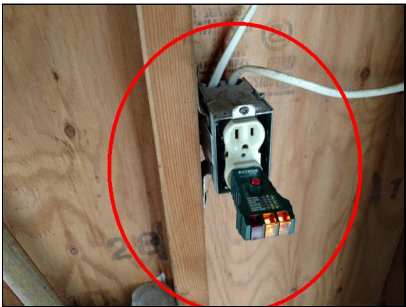
(4) There were numerous damaged electrical receptacles present in the basement. These are all safety issues. Recommend further evaluation for repairs by a licensed electrician.

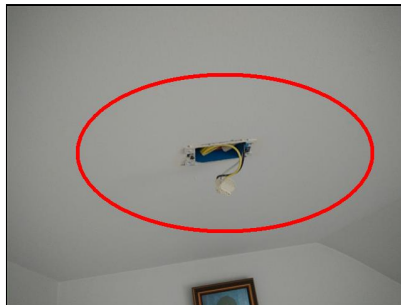
7.10 Item 1(Picture)

There was a hard wired smoke detector missing in the 2nd floor bedroom. Recommend further evaluation for repairs by a qualified, licensed electrician.

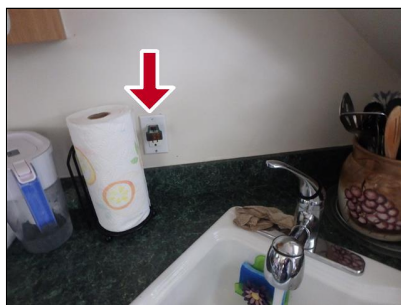
7.12 Item 1(Picture)

The GFCI electrical receptacle in the 2nd floor kitchen was damaged. This is a safety issue and it also creates a potential shock hazard. Recommend further evaluation by a qualified, licensed electrician and repair as necessary.
