Property Inspection Report

Property Address:
1000 Springfield Avenue
Samletown NJ 05555

Terra Home Inspections LLC

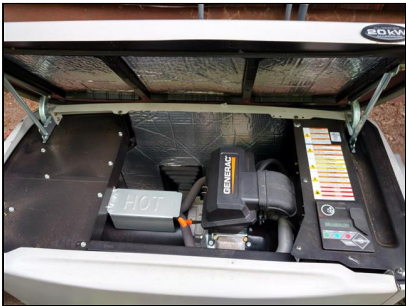
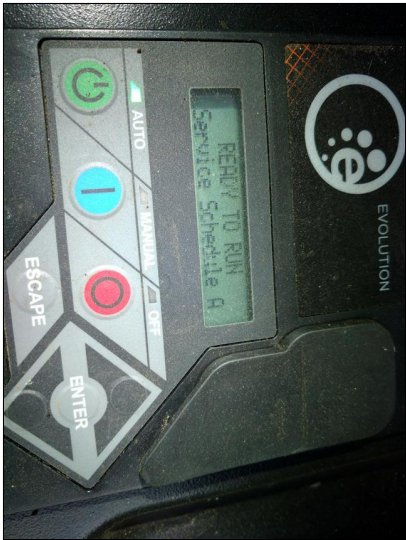
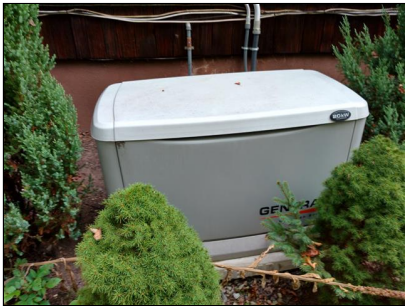
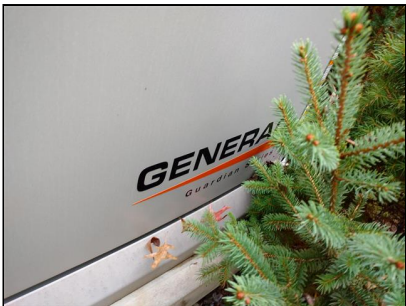
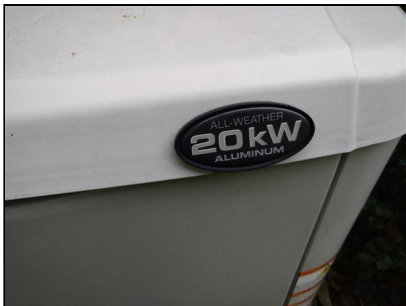
There was a Generac natural gas powered backup generator present. While the generator and the connected electrical equipment (automatic transfer switch and emergency load center panel) appeared to be in serviceable condition, it was not tested. The inspector does not operate any system (especially electrical) that is shut down. Recommend verifying the proper operation of the generator and connected electrical equipment by the homeowner or a qualified, licensed electrician prior to closing or any other contractual deadlines.

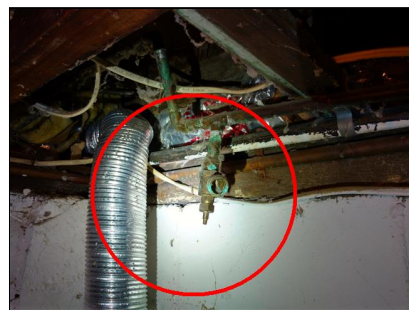
8.1 Item 2(Picture)

Testing of the water shut off valves located throughout the house (especially the ones located in the basement, under sinks, behind toilets, etc.) for functionality is beyond the scope of the home inspection. Due to age, corrosion and/or mineral buildup that may be on them, they may or may not function properly in the future in the event of an emergency or a need to service part of the plumbing system. Several of the water shut off valves that were observed appeared to be frozen when they were turned slightly and would not turn. There were also numerous shutoff valves that were missing their required handles. Recommend further evaluation of all of the water shut off valves in the dwelling (basement, under sinks, behind toilets, etc.) by a qualified, licensed plumber and repair as necessary.

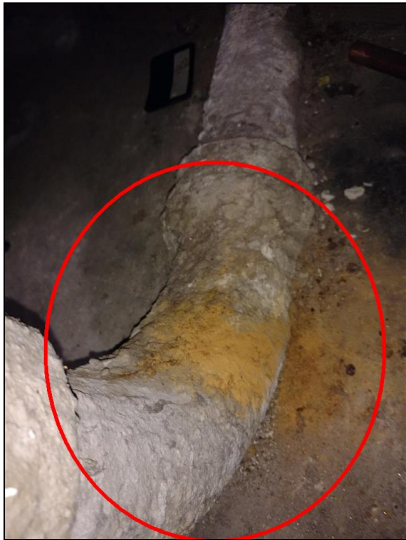
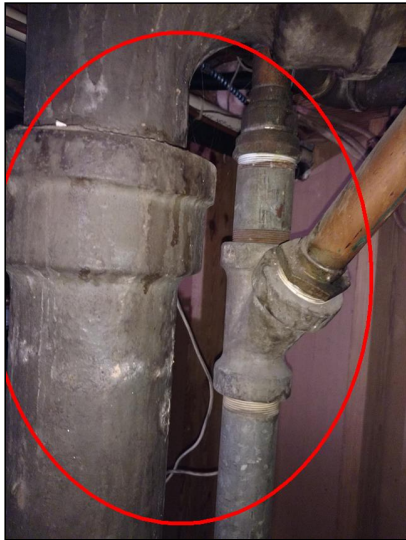
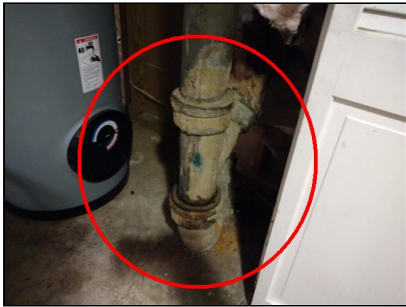
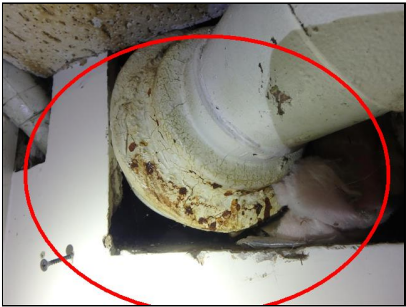
There were numerous rust stains/blisters observed on numerous sections of the cast iron DWV (drain, waste, vent) piping in the basement. These rust marks/blisters are usually caused by tiny pin holes that are in the pipe. As the water leaks out of these tiny pin holes it rusts and forms the blisters. These blisters are usually caused by pitting and corrosion inside the pipe. Also, to note, portions of the DWV piping was galvanized pipe. This has similar characteristics to cast iron as far as the deterioration is concerned. Recommend further evaluation of all of the DWV piping by a qualified, licensed plumber and repair as necessary. In addition, due to the age of the house and since cast iron piping deteriorates from the inside out, it is recommended the main cast iron DWV piping (especially the portion that goes out to the main sewer connection in the street) be scoped by a qualified, licensed plumber to ascertain the integrity of the piping. But, on old cast iron DWV piping systems this sometimes cannot be done without compromising the existing DWV piping system and should not be done if it will compromise the existing DWV piping system. Sometimes the clean out plugs that are needed to be removed to inspect the inside of the piping are frozen or severely deteriorated and will not come off to access the piping.

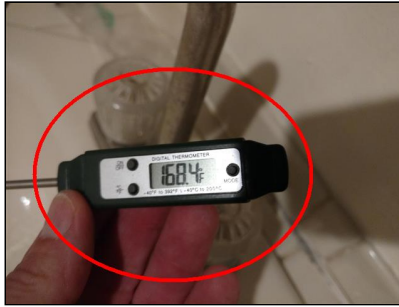
8.3 Item 1(Picture)

The hot water temperature at the basement bathroom sink faucet was 168 degrees. From a safety standpoint, the hot water temperature should not be over 120 degrees. This is a major safety concern (especially if children are present) as scalding could occur with the hot water being so hot. It is recommended turning down the temperature setting on the hot water storage tank.

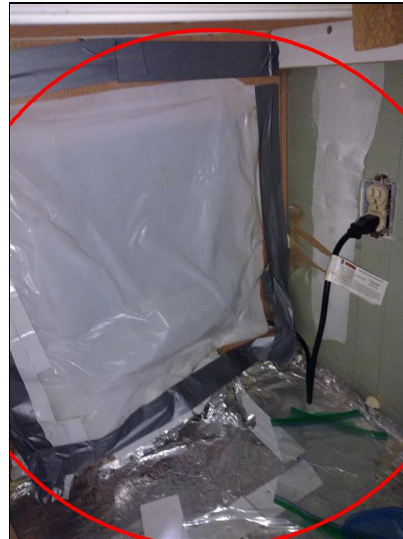
8.5 Item 2(Picture)

As observed in the basement, there was what appeared to be a sump pump present under the kitchen cabinets. It is suspected the water discharge piping for the sump pump was directed into the sanitary sewer piping running out to the sanitary sewer main. The water discharged from the sump pump is not permitted to be connected to the sanitary sewer system. It can be connected to a storm sewer system (which is not present in this dwelling) or directed to the exterior. It is recommended this sump pump discharge piping be directed to the exterior with the discharge point as far away from the foundation as possible. There was no visible discharge piping to the exterior. Also, this sump pump was sealed and therefore, it could not be tested. The inspection was limited. Recommend further evaluation by a qualified, licensed plumber and repair as necessary.

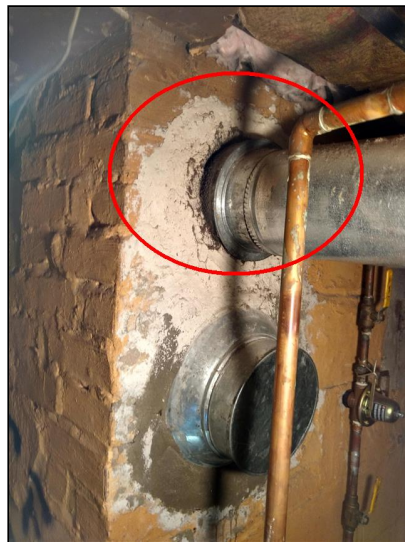
10.2 Item 2(Picture)

The exhaust venting/vent connector for the boiler was not sealed up at all the chimney thimble connection. The vent pipe was just stuck into the chimney opening with large gaps between the vent connector and the chimney thimble opening. There was no sealing material present. This is a **major safety concern** as combustion by products (carbon dioxide, carbon monoxide and nitrogen oxide) may be entering the dwelling instead of being properly vented into the chimney and out of the dwelling. This should be repaired **immediately**. Recommend further evaluation by a qualified, licensed plumber and repair as necessary.

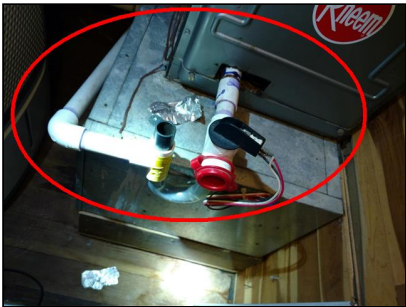
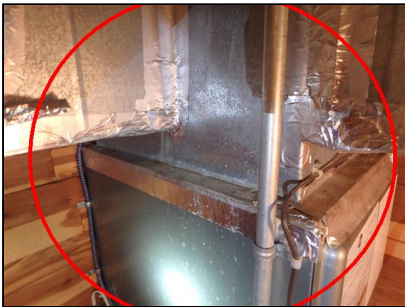
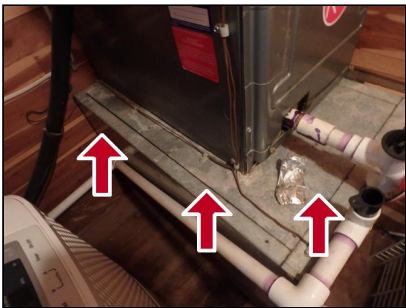
As observed in the attic area on the 2nd floor, portions of the HVAC supply ducting appeared to be sweating when operated. Portions of the ducting were wet and there was dry water staining on the ducting and the A/C air handler cabinet. This could be a future concern as the condensation could damage the building materials in this area. Recommend further evaluation by a qualified, licensed plumber and repair if necessary.

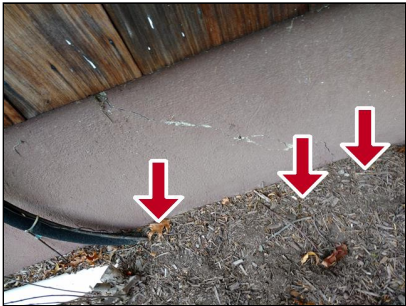
11.2 Item 2(Picture)

The insulation wrap on one of the exterior condenser refrigerant lines was deteriorated/missing in spots. Also, both of the refrigerant lines were buried in the mulch next to the condensers. The refrigerant lines should not be in contact with the ground. This may cause the insulation wrap to deteriorate. In addition, this condition may affect the performance of the air conditioning system if not repaired. Recommend further evaluation by a qualified, licensed HVAC professional and repair as necessary.

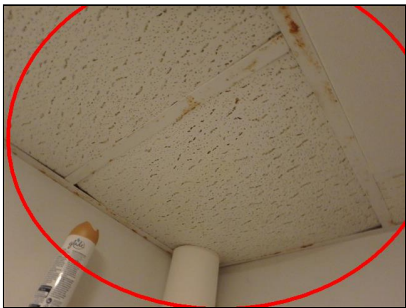
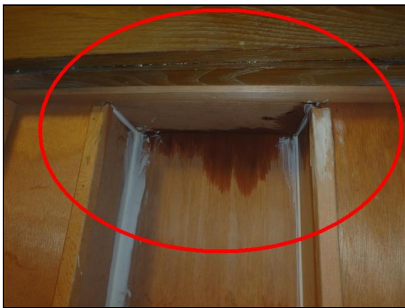
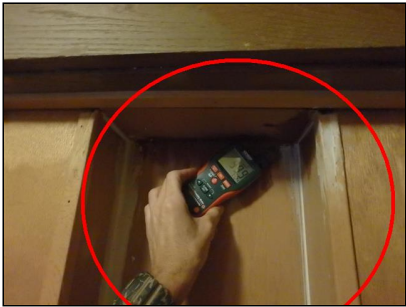
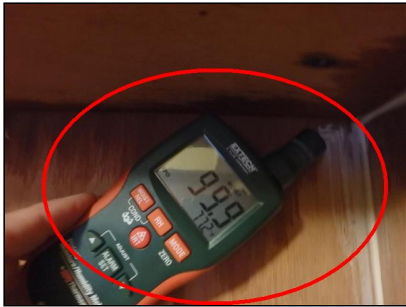
(2) There was a drop ceiling present in the 1st floor bathroom which covered the entire ceiling. This is an issue as the metal framing could rusted due to the moisture while taking a shower and also moisture could get trapped in the space above the drop ceiling and the 2nd floor subfloor. Mold could possibly form on the ceiling tiles as well as the space above the drop ceiling. In addition to this drop ceiling being present, it also appears the toilet in the 2nd floor bathroom was or is leaking down into the 1st floor bathroom and hallway closet. The ceiling and wall was wet in these areas. Please keep in mind there may be hidden moisture damage (possible mold) in these effected areas. Recommend further evaluation by a qualified, licensed contractor and repair as necessary. The toilet in the 2nd floor bathroom should also be evaluated.

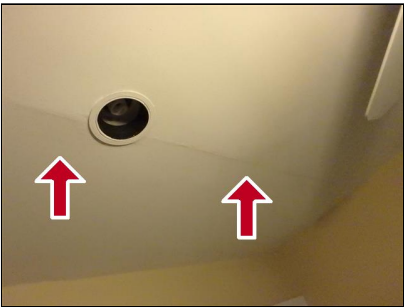
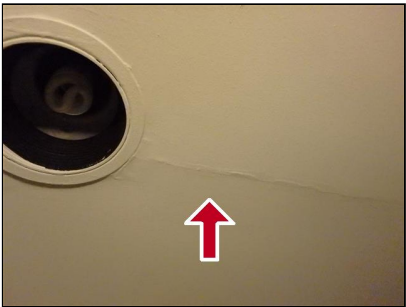
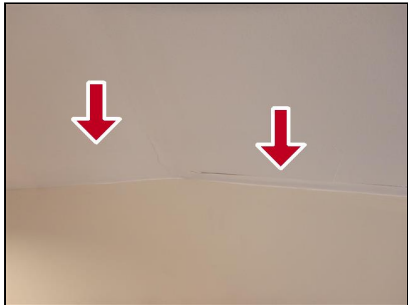
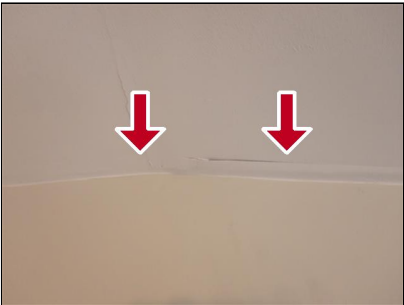
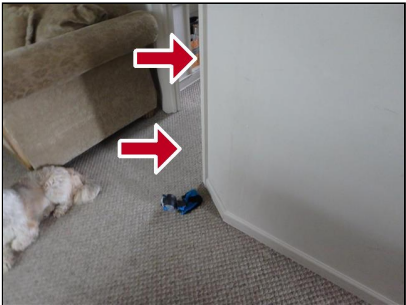
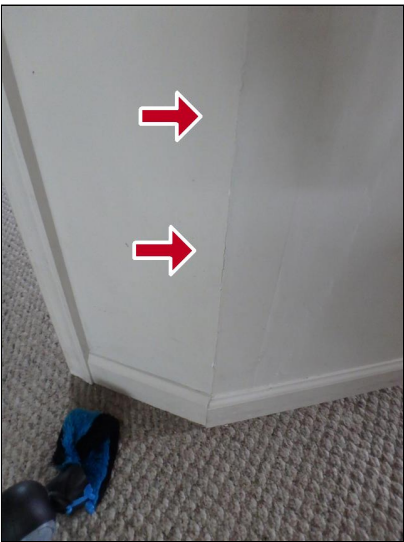
As observed throughout the dwelling, there were small cracks observed in the some of the ceiling and wall surfaces. These types of cracks are common in a house of this age. The condition of these cracks may worsen if the necessary repairs are not completed. There was also a portion of the drywall that was damaged in the basement. Recommend further evaluation of all of the wall/ceiling surfaces by a qualified, licensed contractor and repair as necessary.

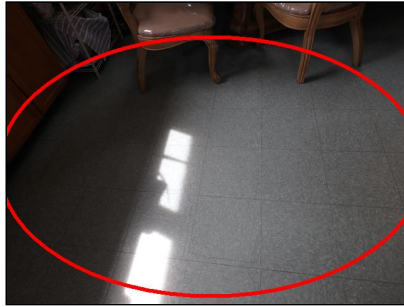
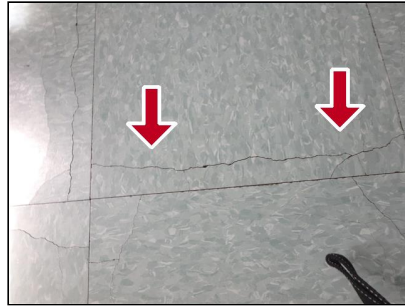
A observed in the 2nd floor kitchen, there were several loose and damaged vinyl floor tiles. This condition may worsen and/or damage to the flooring may occur if the needed repairs are not completed. Recommend further evaluation by a qualified, licensed contractor and repair as necessary.

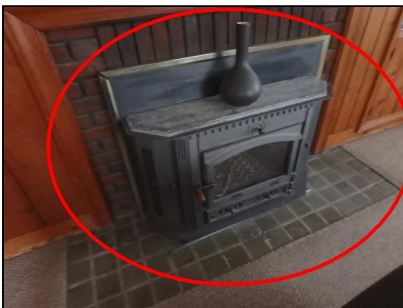
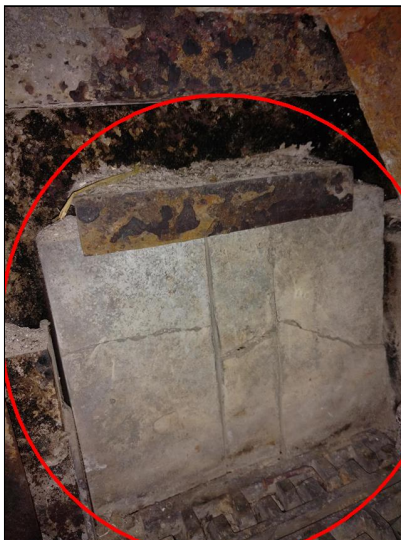
(2) As observed in the wood burning fireplace, the rear and side refractory panels were cracked in numerous areas. This is a concern as these panels keep the fire inside the firebox. The gasket material on the front door also appeared to be damaged. Recommend further evaluation by a qualified, licensed fireplace professional and repair as necessary.

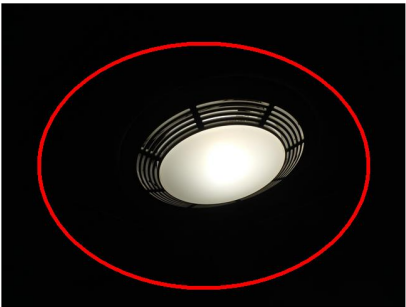
13.1 Item 1(Picture)

(1) The exhaust fans located in the basement and 1st floor bathrooms did not appear to be functioning. A working exhaust fan ensures ventilation of moisture from the bathroom in the event the bathroom window is not open (winter time). This is especially important where bathtubs or showers are present. Recommend further evaluation for repairs by a qualified, licensed electrician.

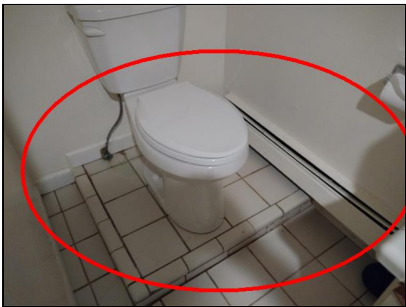
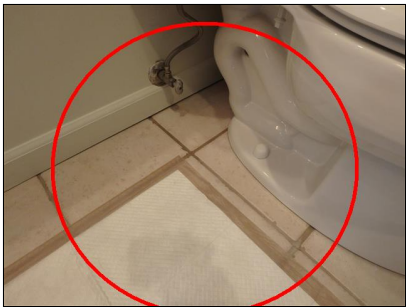
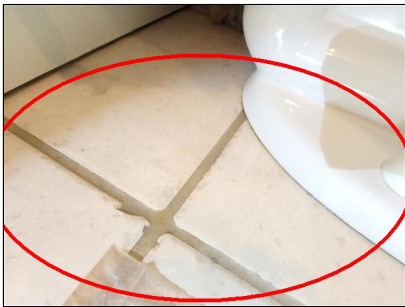
The toilets in the 2nd floor and basement bathrooms were not functioning properly. There appeared to loose and leaking water from underneath them. The area below the 2nd floor bathroom in the 1st floor unit had water damage present on the bathroom ceiling. Recommend further evaluation for repairs by a qualified, licensed plumber.

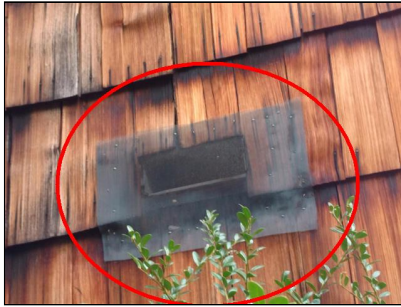
14.4 Item 1(Picture)

(1) The exterior damper assembly was missing from the 1st floor kitchen exhaust fan. This is a concern as the weather, insects and wildlife could possibly get into the dwelling. Recommend further evaluation by a qualified, licensed contractor and repair as necessary.

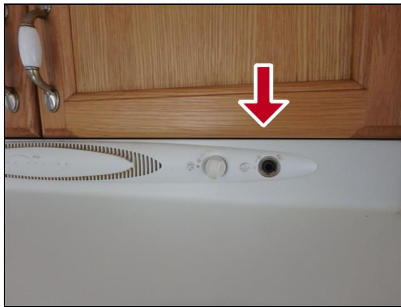
14.4 Item 2(Picture)

(2) The 2nd floor exhaust fan/hood was missing a control knob. Recommend repairing as necessary.

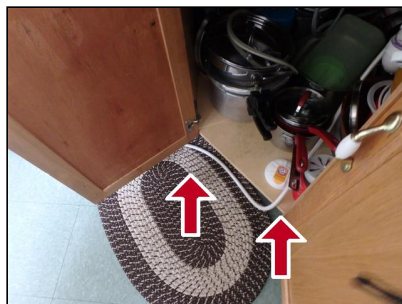
14.10 Item 1(Picture)

The routing of the water supply line for the 2nd refrigerator in the 2nd floor kitchen was suspect. It was routed out the front of a cabinet and across the kitchen floor. This is a concern as someone could trip on this supply line and potentially damage it and causing it to leak. Recommend repairing/re-routing this supply line as needed.

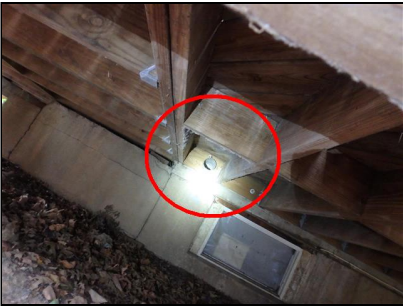
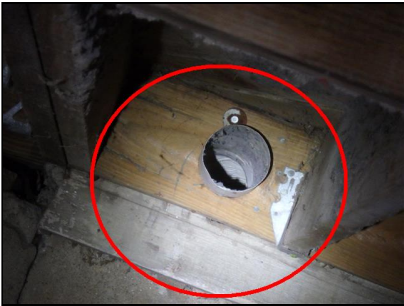
The exterior portion of the dryer vent was missing. This condition could allow wildlife to enter the dryer vent ducting and possibly clog it. Recommend further evaluation by a qualified, licensed contractor and repair as necessary.

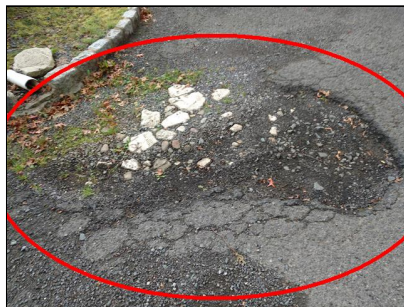
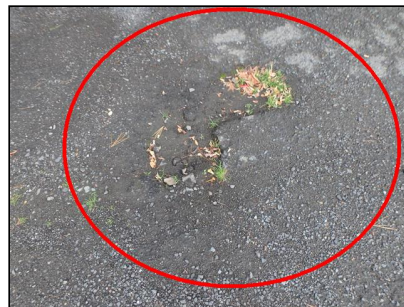
The asphalt driveway has numerous areas that were cracked and deteriorated. Further deterioration could occur if the needed repairs are not completed. Recommend further evaluation for repairs by a qualified, licensed driveway contractor.

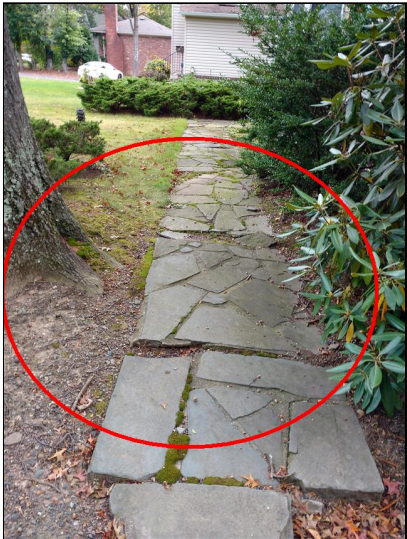
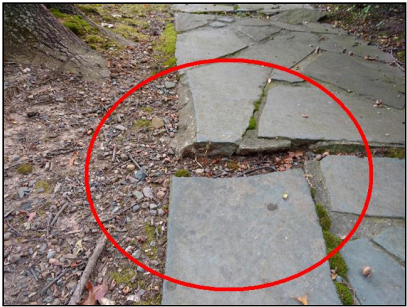
The front walkway had one large section that is raised which is causing a trip hazard (which is a safety issue). It appears the tree roots from the large tree are pushing this section of the walkway up. Recommend further evaluation for repairs by a qualified, licensed contractor.

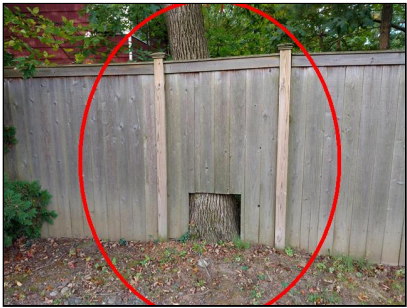
1.3 Item 1(Picture)

There was a large tree on the front side of the house with tree limbs within 10ft of the house, some were hanging over the roof slightly. This tree also appeared to be damaging the front walkway. Trees in contact or proximity to house can provide pathways for wood destroying insects, as well as abrade and damage the exterior cladding, windows, screens and roofs. They will also fill the gutters up with tree debris. Also, the roots from trees close to the foundation of the house could possibly damage the foundation of the house, side walkways and underground sewer piping. There was also a tree along the right side property line that appeared to be growing through the fence. This may damage the fence in the future. Recommend removing/trimming back these trees as necessary.

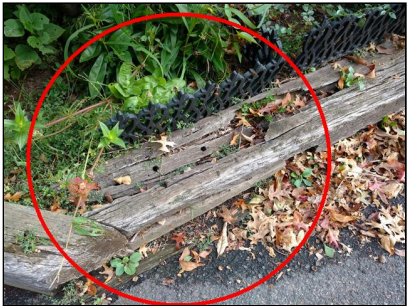
1.4 Item 1(Picture)

Portions of the small wood tie retaining wall in the rear was deteriorated. If not repaired, further deterioration of the retaining wall could occur. Recommend further evaluation for repairs by a qualified, licensed contractor.

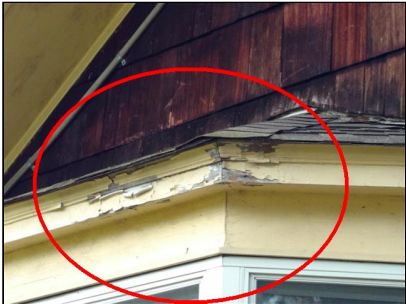
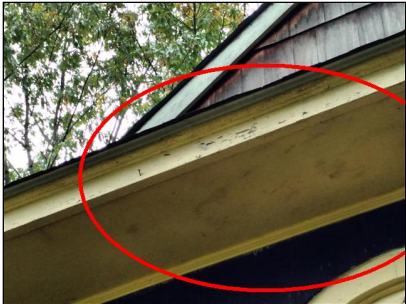
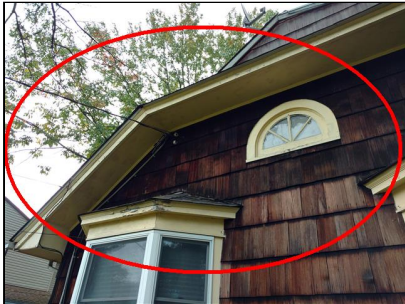
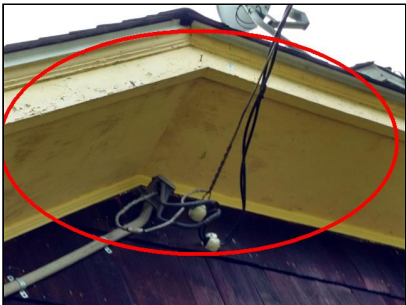
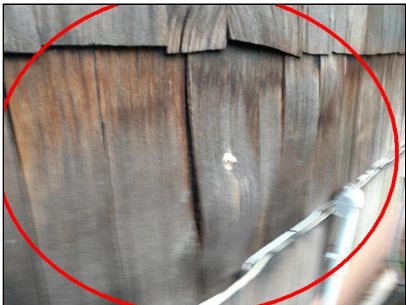
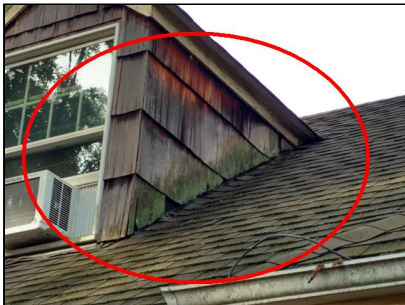
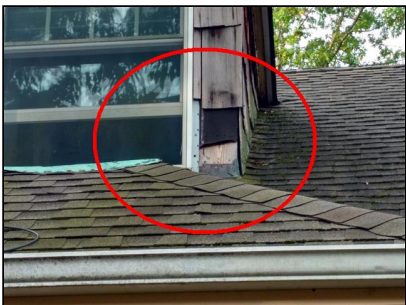
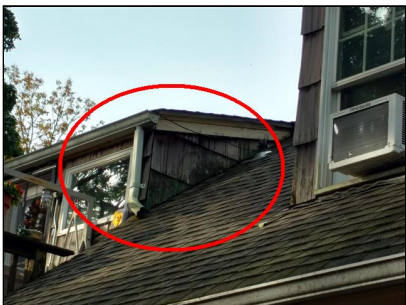
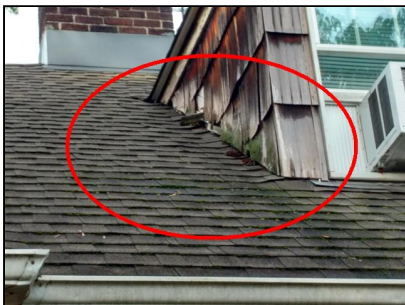
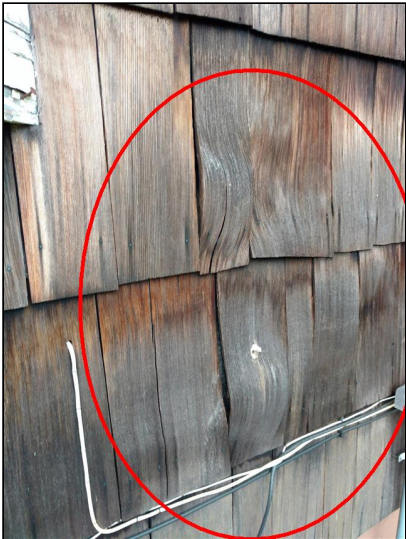
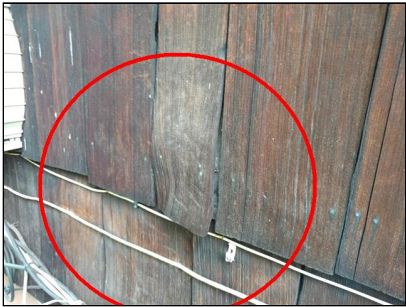
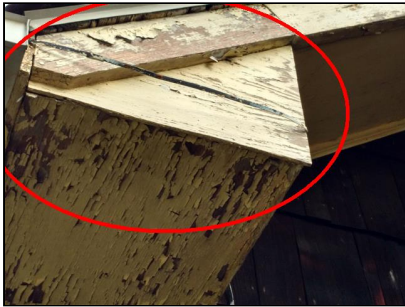
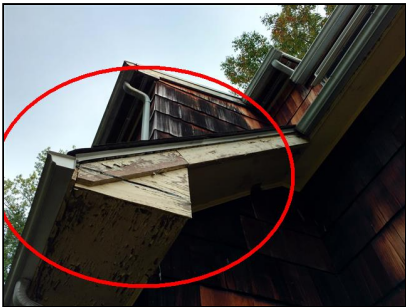
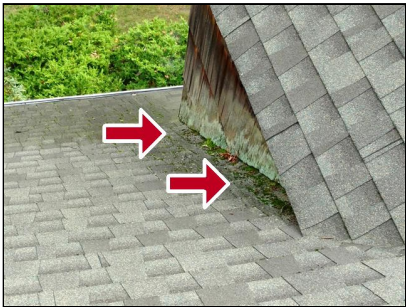
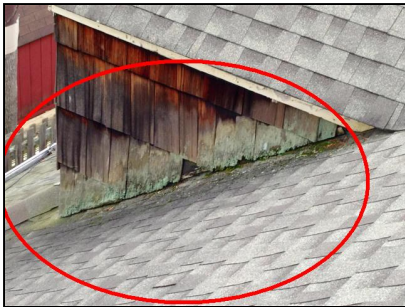
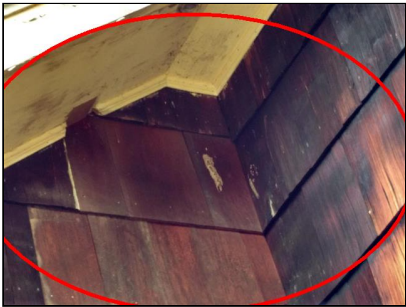
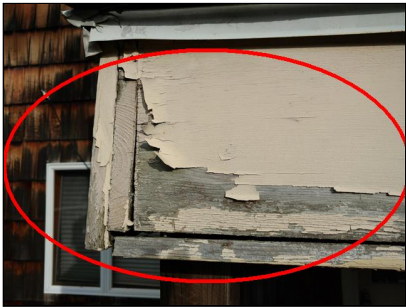
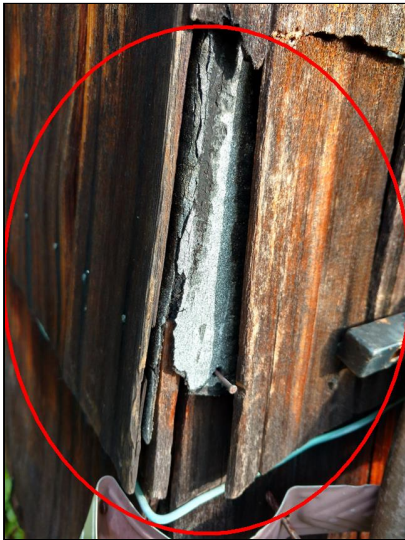
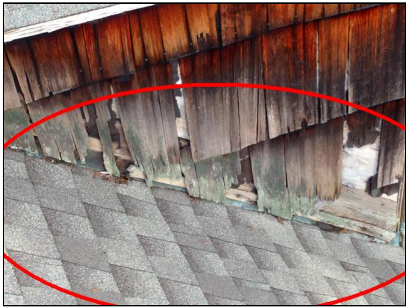
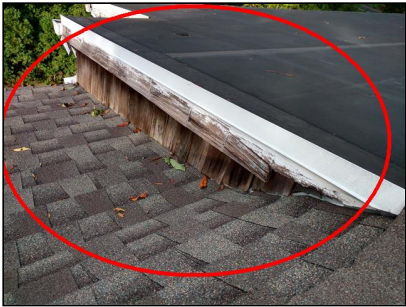
Portions of the paint on some of the exterior wood elements (wood window frames, door frames, trim, framing, wood cladding, eaves, soffits and gable ends, etc.) was peeling leaving the wood exposed to the elements. In addition, portions of some of these elements were also damaged/deteriorated. Also numerous portions of the wood shake siding were damaged, deteriorated and or missing leaving the structure open to possible moisture intrusion and/or further damage. Further deterioration of these elements as well as possible structural damage behind/under these elements could occur if the needed repairs are not completed. Lastly, just to note, due to the age of the dwelling, caution should be used on any areas where the paint is peeling as some of the peeling paint may contain lead. Recommend further evaluation of the entire exterior of the dwelling by a qualified, licensed contractor and repair as necessary.

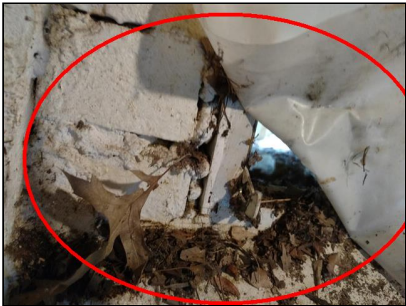
2.3 Item 1(Picture)

(1) As observed in the basement, there were several windows that would not open, we missing or boarded up. Boarded up windows are an issue because water could possibly migrate into the basement if the wood used to board up the window opening is not properly sealed up and coated against the elements. If water is getting in behind the wood, it could potentially rot out the window sill and/or window frame. Missing windows are also an issue because this could let unwanted wildlife, insect and the weather into the dwelling. Recommend further evaluation of all of the basement windows by a qualified, licensed contractor and repair as necessary.

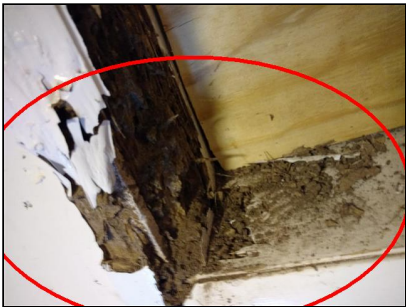
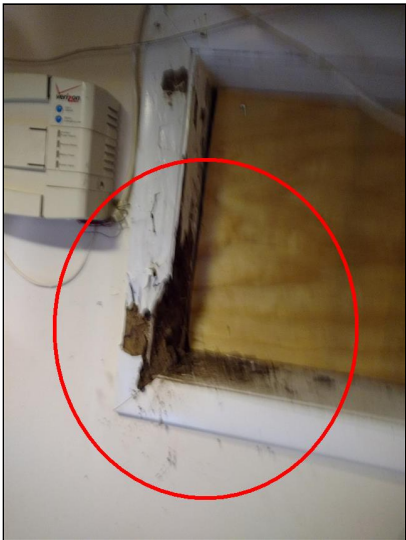
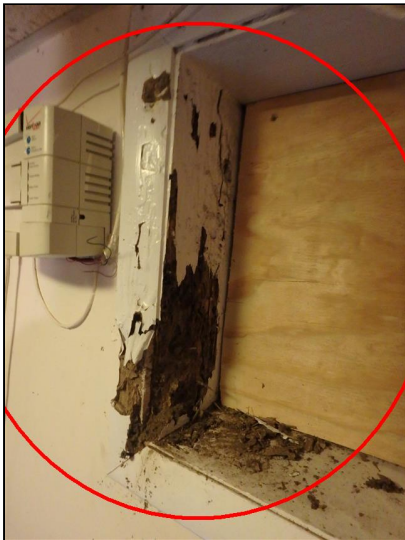
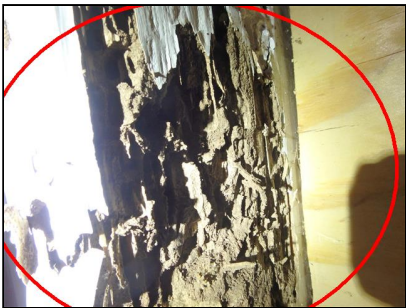
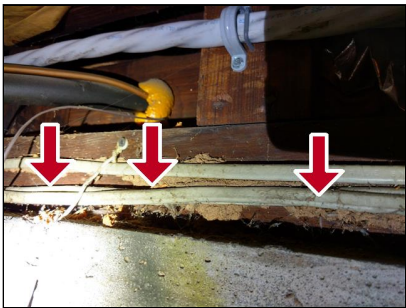
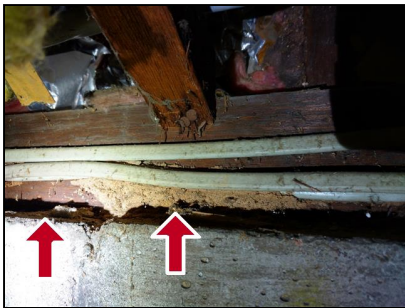
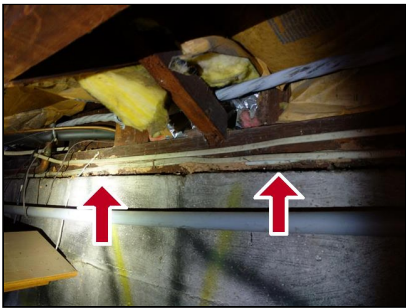
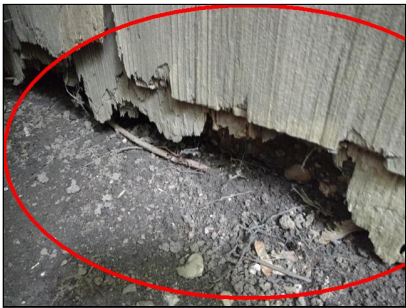
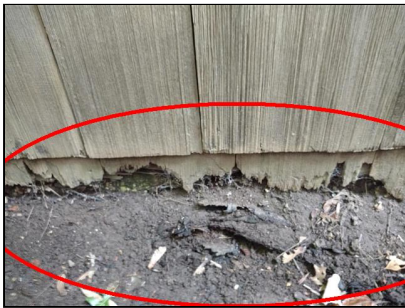
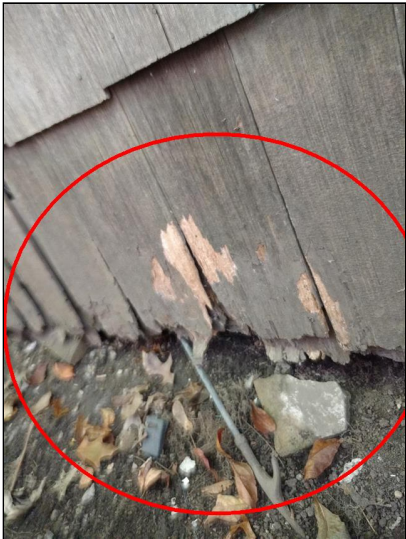
(2) Evidence of what appears to be previous termite damage was observed on the right front basement window frame and on various portions of the garage structure. There was also what appeared to be termite shelter tubes present on the front foundation wall structure. There was no active wood destroying insects observed at the time of the inspection. Further damage/deterioration to the garage and house structure/elements structure could occur if the necessary further evaluation and/or treatment option(s) are not completed. There may be hidden WDI damage that was not visible. Recommend further evaluation of the house and garage structures for treatment of WDI by a

qualified, licensed pest control professional and also for repairs of the effects areas by a qualified, licensed contractor.

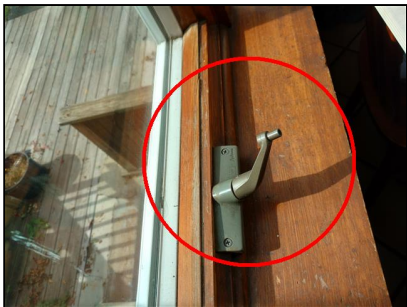
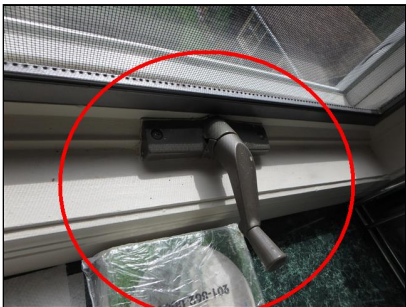
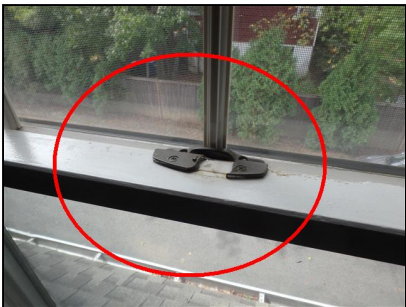
(3) As observed in the 2nd floor kitchen, some of the hardware on the casement windows was missing and/or damaged. Therefore, these windows will not function as intended as a result. The window lock on the 2nd floor front bedroom was also damaged. Recommend further evaluation by a qualified, licensed contractor and repair as necessary.

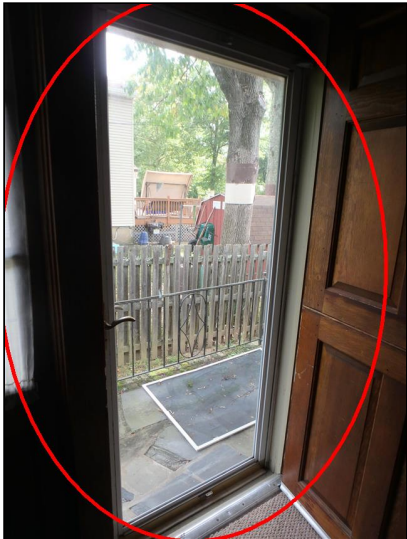
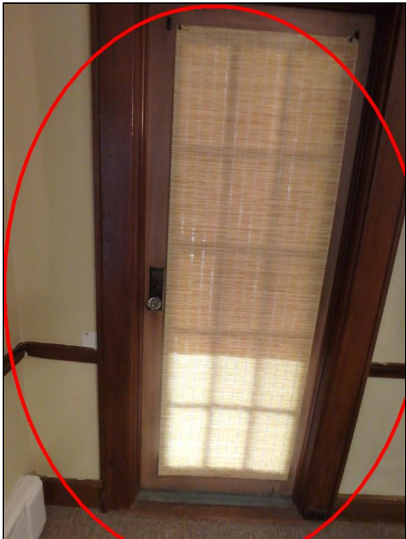
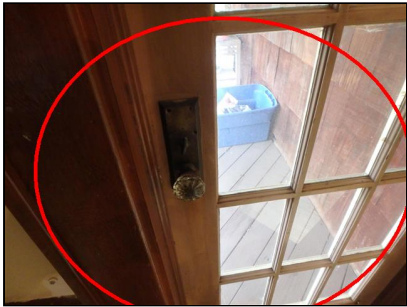
The self closer's on the left side entry door were missing. This is a safety issue. Also, the exterior door on the 1st floor to the deck was not functioning. It would not open. Recommend further evaluation by a qualified, licensed contractor and repair as necessary.

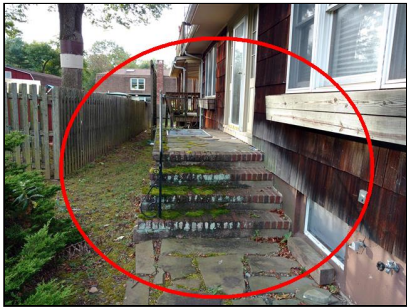
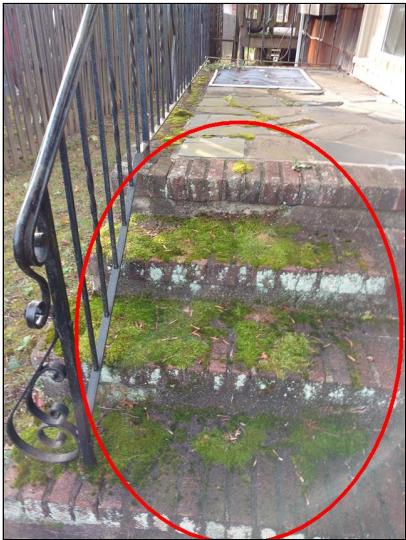
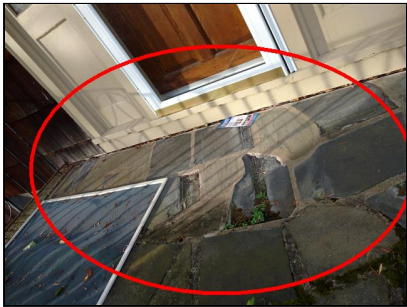
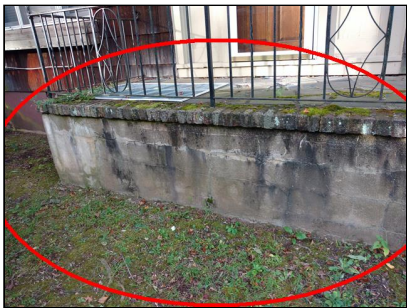
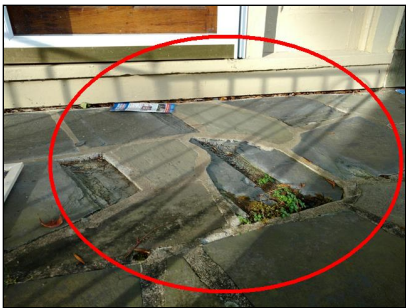
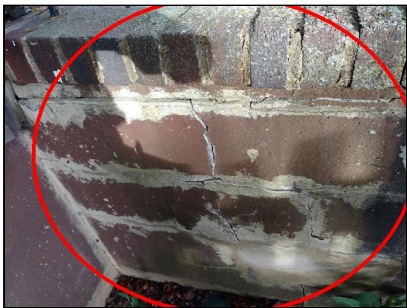
(1) The left side masonry staircase had numerous cracks and deterioration present throughout the structure. Further deterioration of the staircase could occur if the needed repairs are not completed. Recommend further evaluation by a qualified, licensed masonry contractor and repair as necessary.

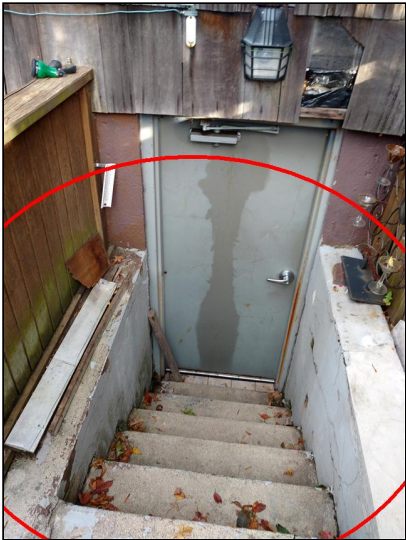
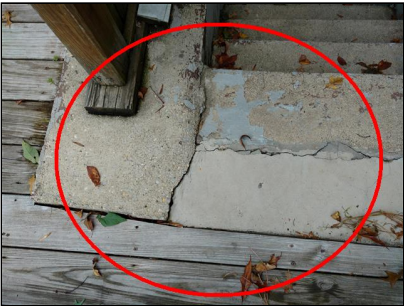
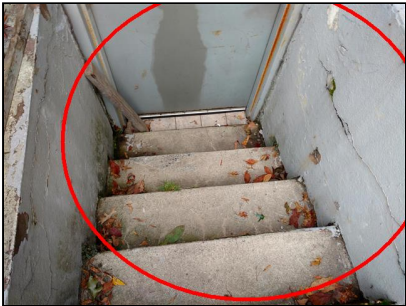
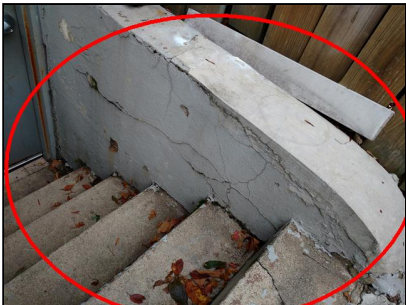
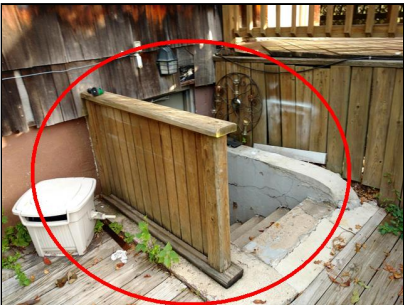
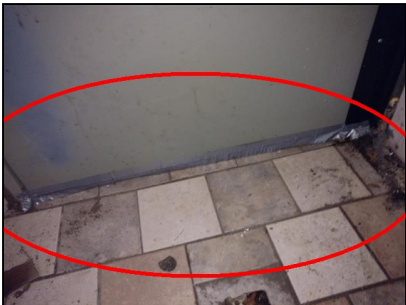
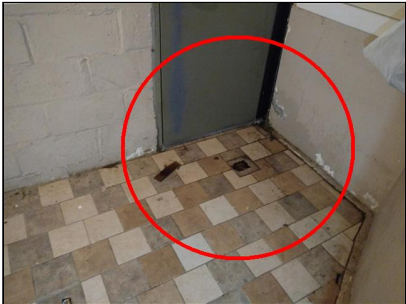
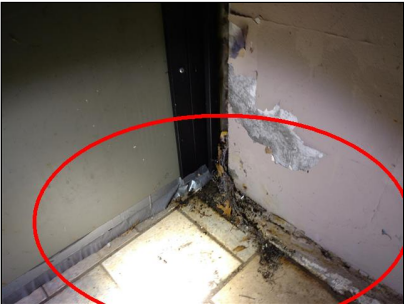
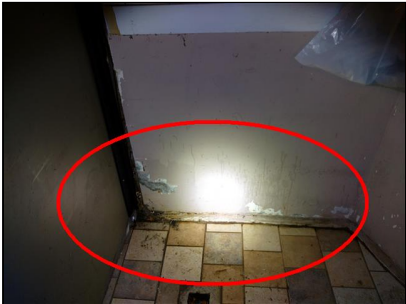
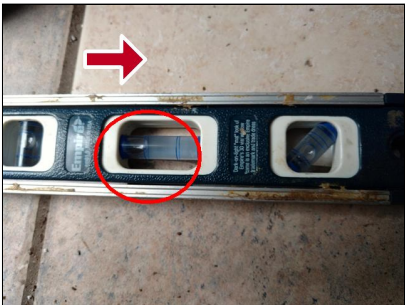
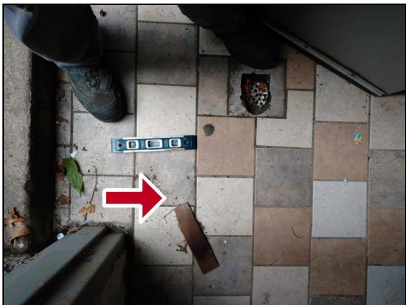
(2) The rear masonry staircase leading to the basement door had numerous cracks and deterioration present throughout the structure. Further deterioration of the staircase could occur if the needed repairs are not completed. Also, it appears water is running down the stairway and under the basement door and into the basement. The

basement floor in the area under the basement door was sloped towards the basement. This could be a future concern. There was evidence of moisture damage inside the basement in the area of the basement door. The guardrail assembly surrounding this stairwell was extremely loose which is a safety concern. The stairwell also did not have a handrail. Recommend further evaluation by a qualified, licensed masonry contractor and repair as necessary.

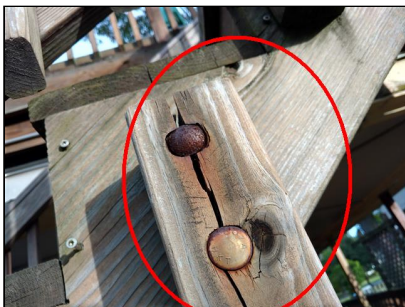
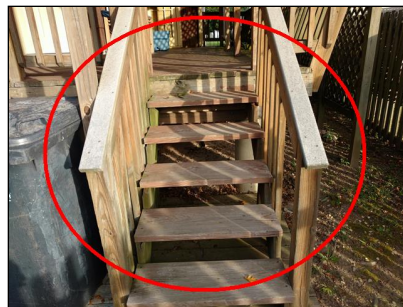
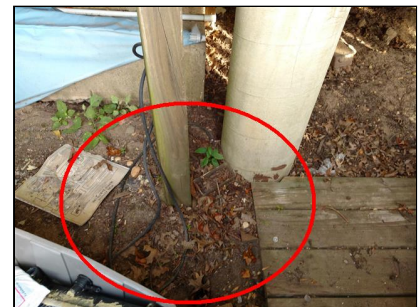
Numerous issues were observed pertaining to the rear wood deck structure(all levels);

- 3) The stair stringers/staircases appeared to be loose and moved excessively when the staircases were walked on. The stair stringers should have the required mechanical connectors connecting it to the main deck structure.

- 4) The lower ground level deck area appears to have been built in the fashion that the wood is lying on the ground. This could promote WDI damage as well as dry rot. There was numerous areas that appeared to be damaged/deteriorated. Wood should not be in contact with the ground soil.

- 5) Some of the handrail and guardrail assemblies were loose.
- 6) The handrails were not graspable. All handrails should be equivalently graspable to the 2-inch circular handgrip. The hand grip shape should provide a vertical graspable surface. It should allow the user to maintain a consistently secure natural grasp on the handrail without twisting the fingers or requiring release.

- 7) The top portion of the deck was built over an existing structure with a flat roof membrane roof covering. The top portion of the deck may have to be removed to replace the roof covering in the future.

- 13) The lower deck was built over an existing masonry staircase that was still present. This staircase appeared to have numerous cracked areas present. This is a concern as the staircase may divert water into the foundation/basement.

These are all safety concerns and the needed repairs should be completed ASAP to insure the structure is safe for the occupants. Especially, since this deck structure is the only means of egress for the 2nd floor tenants.

Recommend further evaluation of the entire deck structure (all levels) by a qualified, licensed deck contractor and repair as necessary. Additional information pertaining to deck construction and safety can be found at <http://www.safestronghome.com/deck/index.asp>

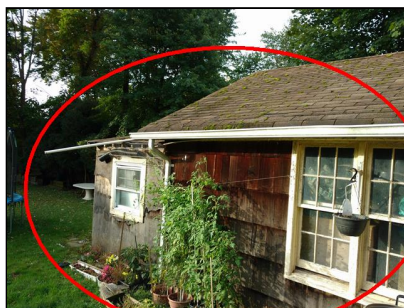
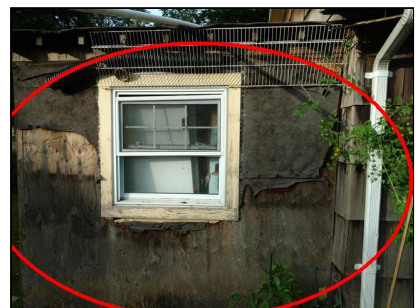
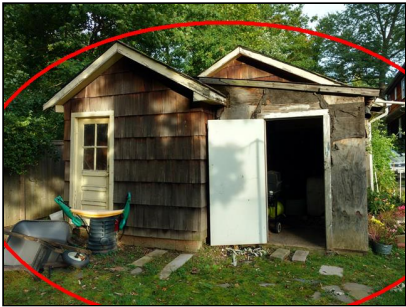
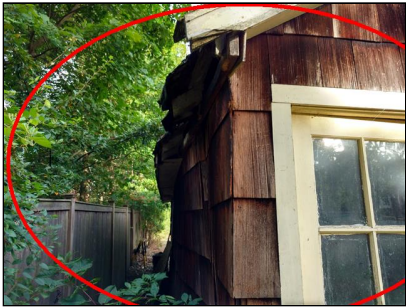
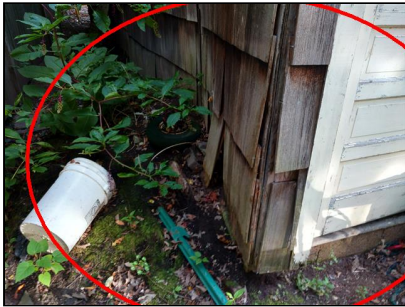
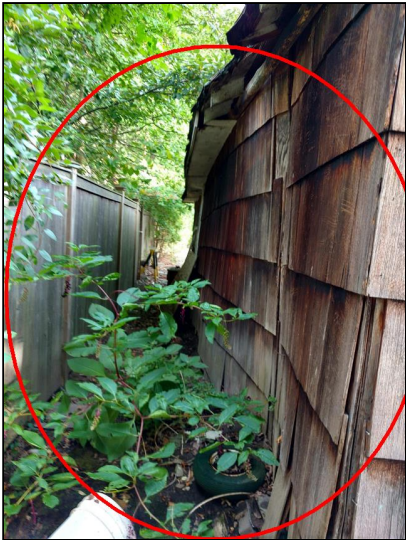
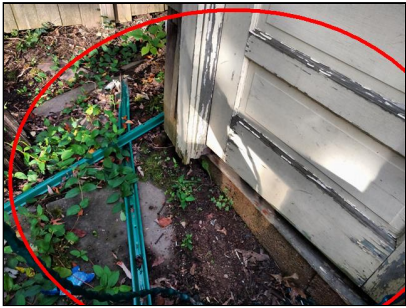
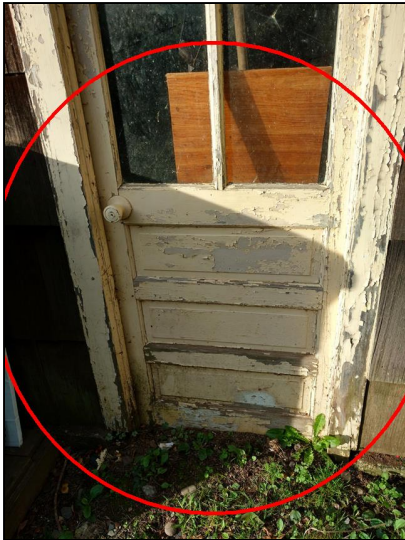
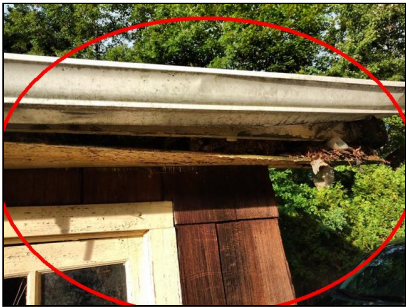
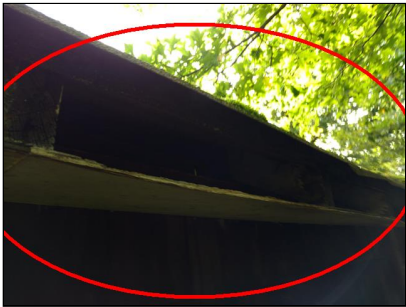
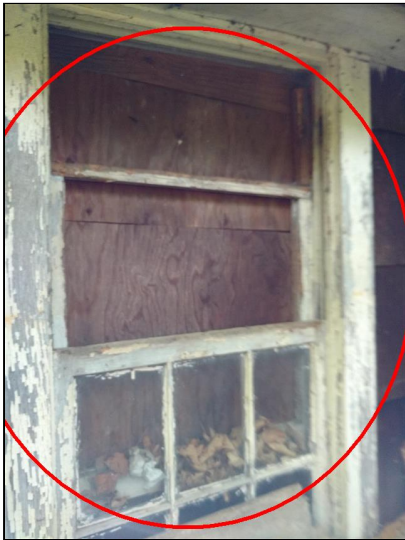
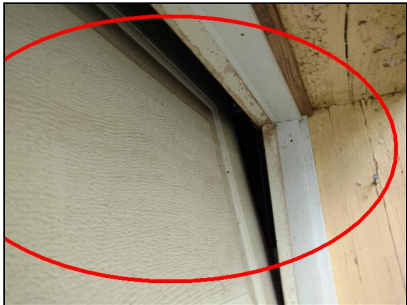
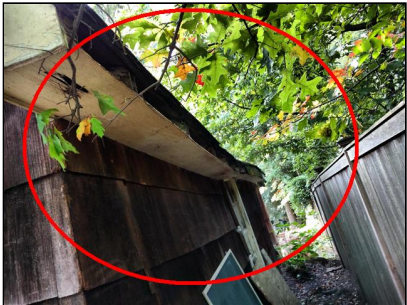
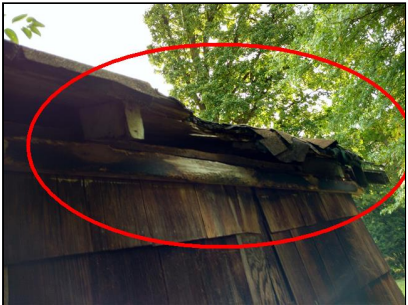
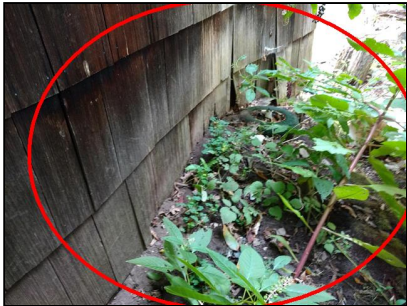
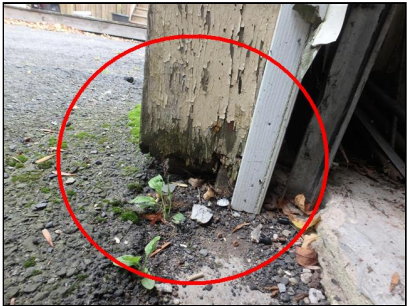
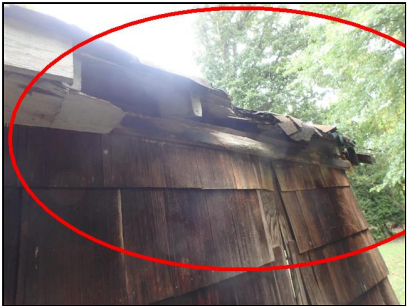
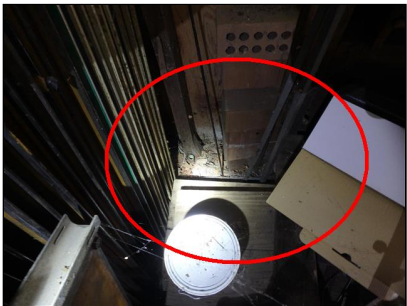
(1) Numerous issues were observed on the interior and exterior of the garage:

- 1) The concrete floor had numerous small cracks present.
- 2) There were numerous sections of the exterior wood cladding/siding, garage structure, windows, doors, roof covering and trim that was damaged, deteriorated or missing.
- 3) The garage vehicle door was not closing properly due to the garage structure being damaged/deteriorated.
- 4) Some of the gutter assemblies were damaged.
- 5) The paint was peeling in numerous sections of the garage exterior.
- 6) A portion of the right side wall structure was damaged from what appears to be a tree stump.
- 7) The concrete apron in the front of the garage was cracked in numerous areas.

The garage interior and exterior was cluttered with storage in sections. Numerous parts of the garage structure could not be viewed. Further deterioration of the noted garage elements could occur if the needed repairs are not completed. Recommend further evaluation of the entire garage (both interior and exterior) by qualified, licensed roofing, general and masonry contractors as well as a structural engineer and repair as necessary.

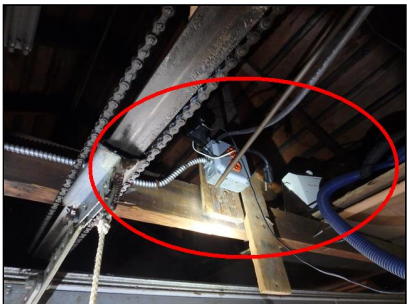
3.2 Item 1(Picture)

The automatic garage door opener was unplugged at the time of the inspection. In addition, the garage door was disconnected from the automatic garage door opener trolley. Therefore, the automatic garage door opener could not be operated and tested. Recommend further evaluation by a qualified, licensed garage door professional and repair as necessary.

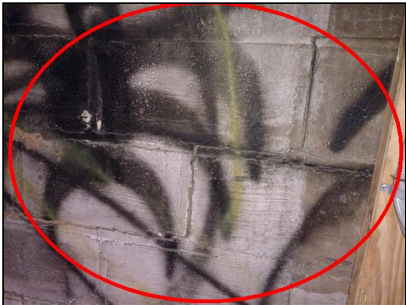
4.0 Item 1(Picture)

There were numerous vertical and horizontal cracks observed in the interior and exterior foundation wall surfaces. The front foundation wall as viewed in the basement, appeared to be heaving inwards as there was a large horizontal crack present. Also in the unfinished basement areas, there was evidence of previous moisture intrusion (efflorescence/staining/peeling paint/mortar decay) observed on the foundation walls. Moisture can create high humidity, mold & can damage stored items & finishing materials. These areas appeared to be dry at the time of the inspection. Further deterioration of the foundation and possible structural damage to the rest of the dwelling could occur if the needed repairs are not completed. Recommend further evaluation of the entire foundation and house structure by a qualified, licensed structural engineer and repair as necessary.
