Property Inspection Report

Property Address:
1000 Springfield Avenue
Samletown NJ 05555

Terra Home Inspections LLC

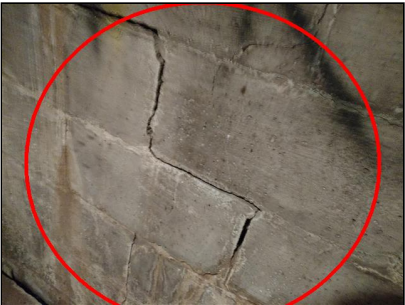
4.0 Item 2(Picture)

There were numerous vertical and horizontal cracks observed in the interior and exterior foundation wall surfaces. The front foundation wall as viewed in the basement, appeared to be heaving inwards as there was a large horizontal crack present. Also in the unfinished basement areas, there was evidence of previous moisture intrusion (efflorescence/staining/peeling paint/mortar decay) observed on the foundation walls. Moisture can create high humidity, mold & can damage stored items & finishing materials. These areas appeared to be dry at the time of the inspection. Further deterioration of the foundation and possible structural damage to the rest of the dwelling could occur if the needed repairs are not completed. Recommend further evaluation of the entire foundation and house structure by a qualified, licensed structural engineer and repair as necessary.

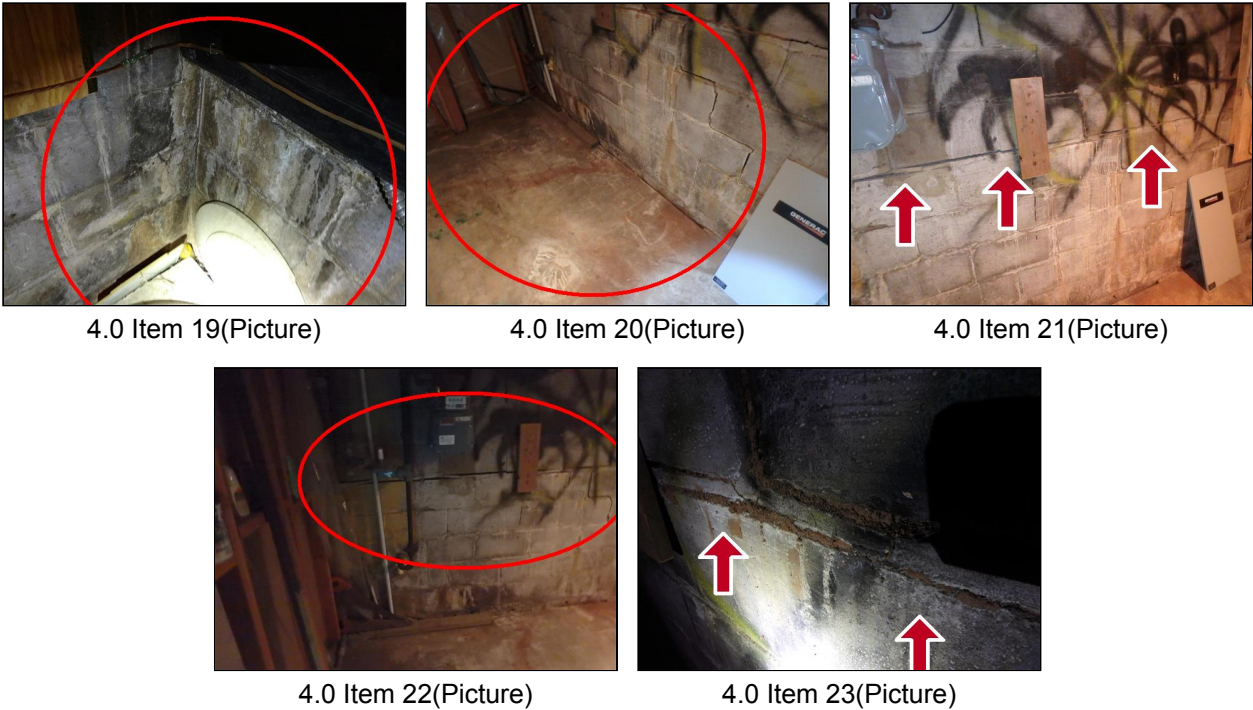
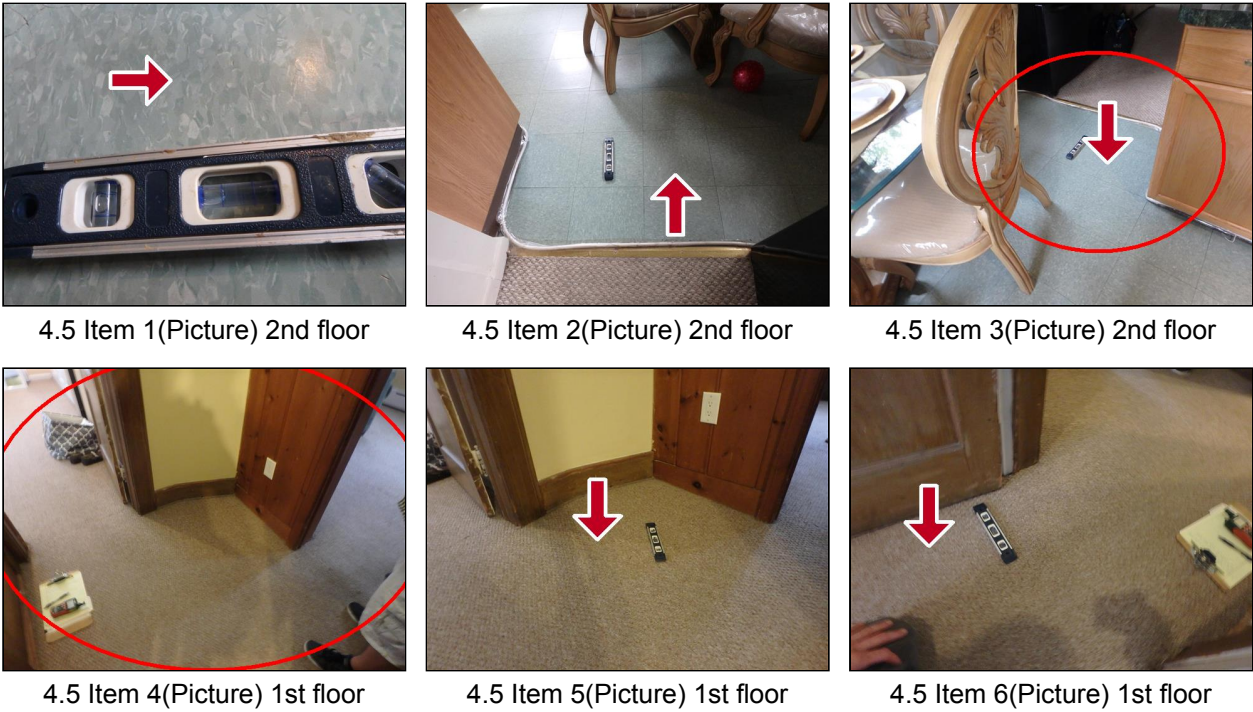
As observed throughout the house, there were numerous floors that had a noticeable sloping condition present. The condition of the sloping floors in question could worsen in the future if the needed structural repairs are not completed. Based on this and other structural observations, it is recommended a further evaluation of the entire house structure by a qualified, licensed structural engineer be performed and repaired per their recommendations.

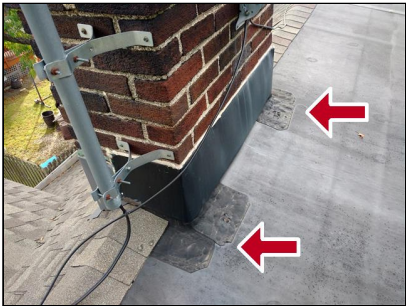
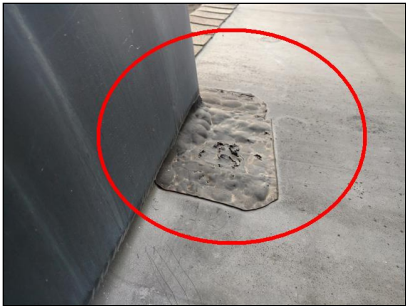
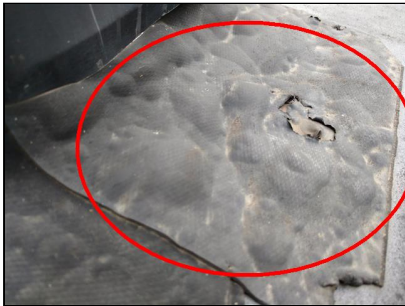
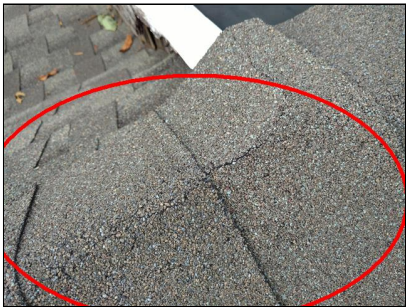
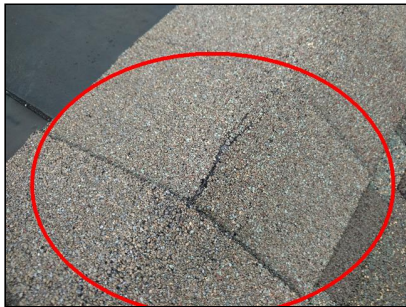
Observed on the flat roof in the area below the chimney flashings, two small sections of the flat roof membrane had several blisters/bubbles present. Blisters/bubbles are typically created by voids between the roofing membrane and the roof decking. If these blisters or the seams open up, water could enter the structure below. There were also a few roof peak shingles that had some minor cracking present. Recommend further evaluation of all of the roof covering materials by a qualified, licensed roofing contractor and repair as necessary.

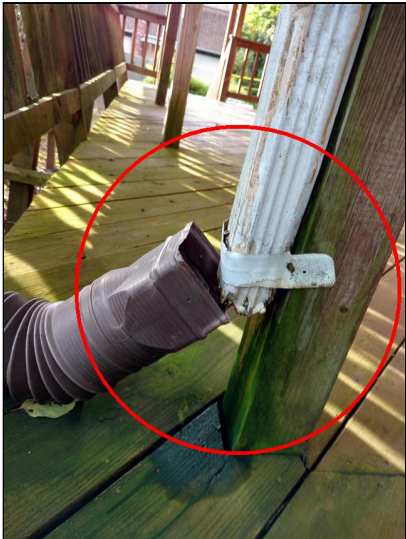
5.2 Item 1(Picture)

The exterior downspouts should be extended at least 6 feet from the foundation of the house. Extending the downspouts helps shed water away from the foundation. Water can weaken and deteriorate the foundation and can possibly migrate into the basement. Recommend extending the downspouts as necessary.

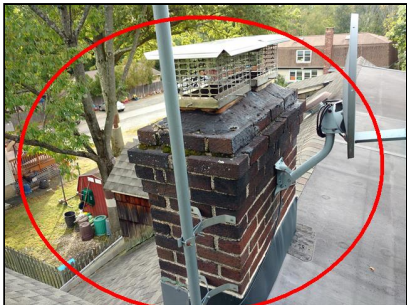
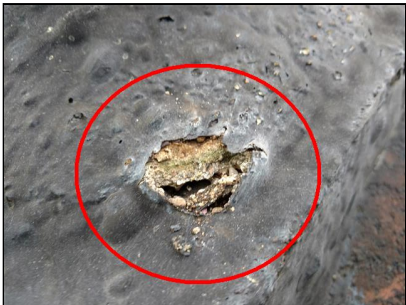
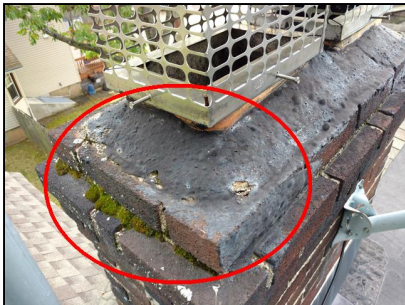
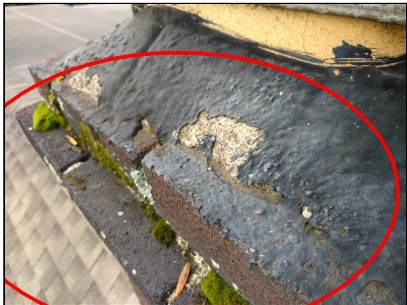
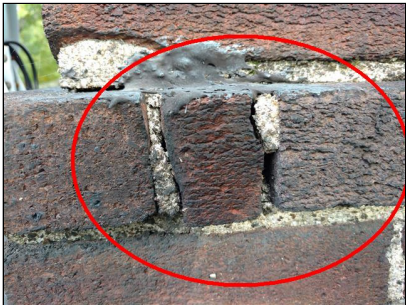
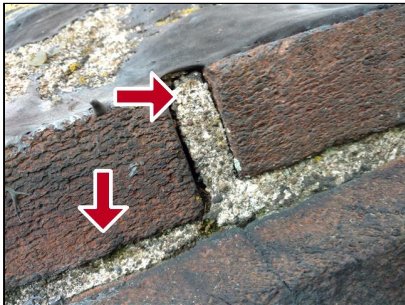
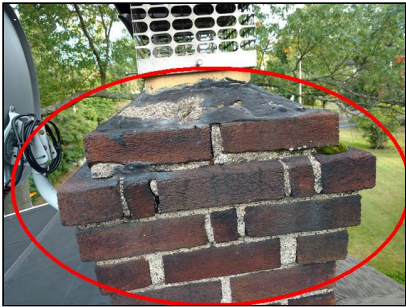
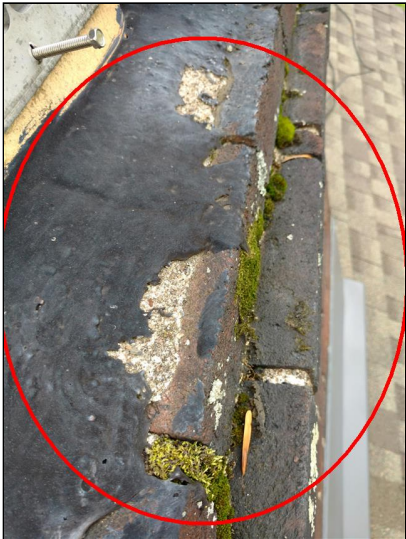
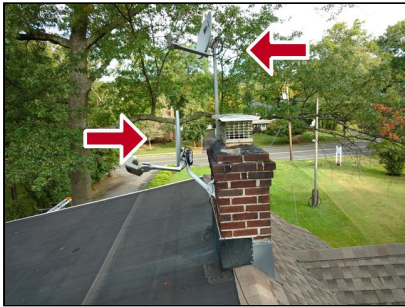
- (2) Numerous issues were observed on the exterior masonry chimney:
- 1) There were numerous deteriorated areas present in the masonry chimney crown (top flat portion of chimney around the flue).

- 2) There was minor deterioration present in some of the mortar joints mainly towards the top of the chimney.
 - 3) There were two satellite dishes mounted to the exterior chimney structure. This may be a future concern as it might put unwanted stress on the chimney structure in windy conditions.

Further deterioration of the chimney as well as possible moisture intrusion into the structure below could occur if the necessary repairs are not completed. Recommend further evaluation of the entire chimney (both interior and exterior portions) by a qualified, licensed chimney professional and repair as necessary.

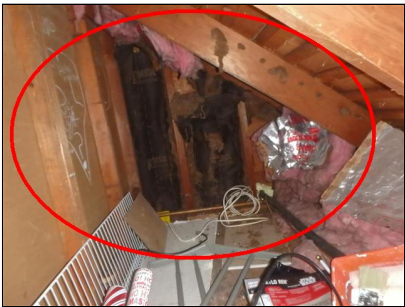
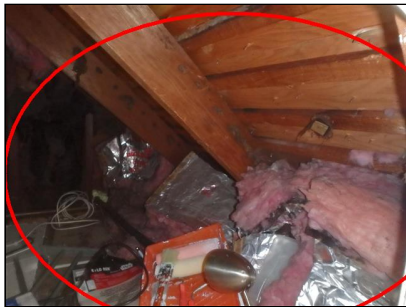
Several of the fiberglass insulation batts fell out of the rafter bays in the 2nd floor attic space and are laying on the attic floor. Recommend further evaluation for repairs by a qualified, licensed contractor.

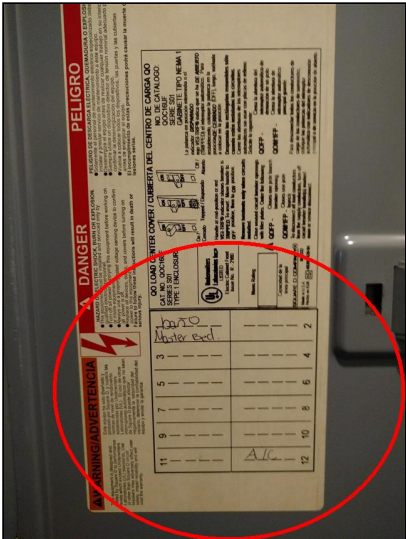
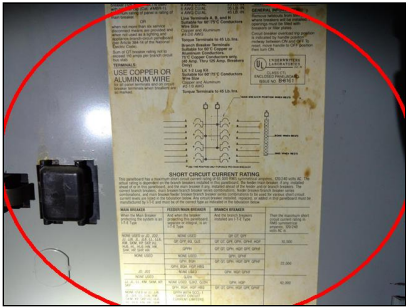
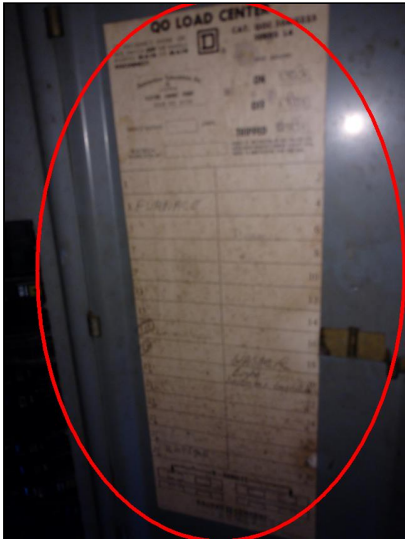
(1) As observed in all 3 electric panels, the circuit breaker wiring legends were in-complete and/or appeared to be inaccurate. These legends should be clearly marked identifying which circuit breaker shuts off which particular wiring circuit running throughout the house. This information is needed in case of emergency's or anytime individual circuits need to be turned off. It is recommend a qualified, licensed electrician verify each circuit and label accordingly.

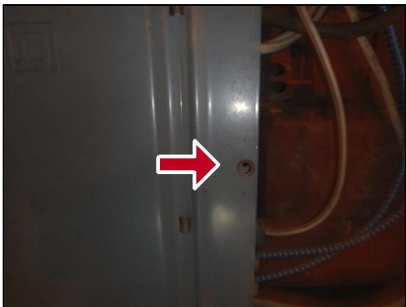
7.3 Item 4(Picture)

(2) There were 2 hold down screws missing from the dead front (front cover) on the main service panel located in the basement. All the required home down screws should be in place to insure all the electrical equipment is held in place. Recommend having a qualified, licensed electrician install the proper manufacturer approved hold down screws.

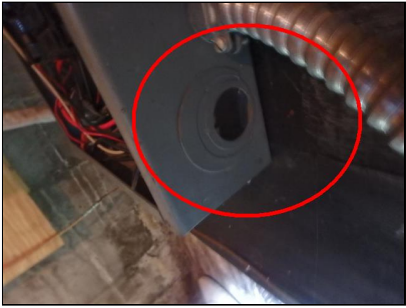
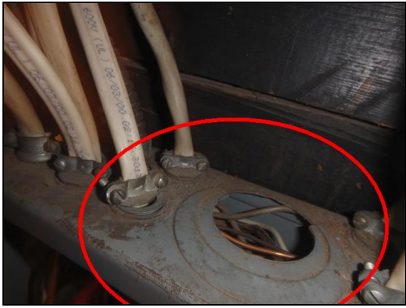
(2) There were knockout plugs missing from the electric sub panel located in the basement. Current electric safety standards state that unused openings in such equipment need to be closed. Covering these openings helps prevent accidental shocks, helps prevent hot sparks from escaping if something goes wrong inside the enclosure and helps to prevent pests from entering. Recommend further evaluation for repairs by a qualified, licensed electrician.

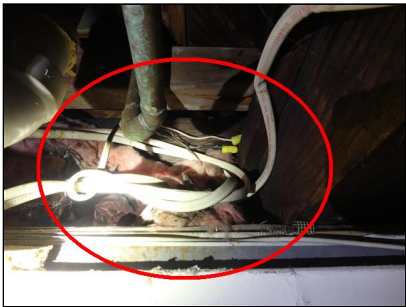
7.7 Item 1(Picture)

As observed in the basement, there was a live wire in the ceiling area that was not safely terminated in a junction box or light fixture. There were also some exterior wires for the exterior lighting that were not protected. These are safety concerns and potential fire hazards. Recommend further evaluation for repairs by a qualified, licensed electrician.

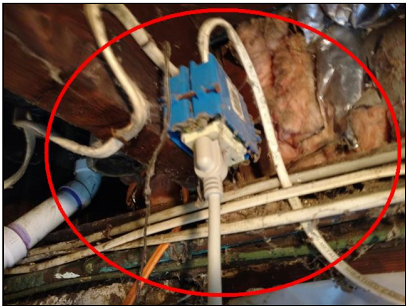
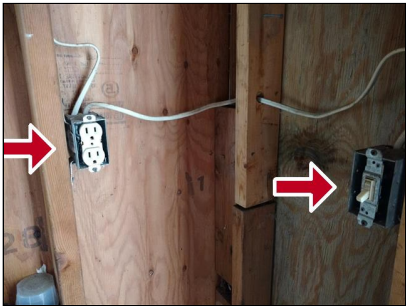
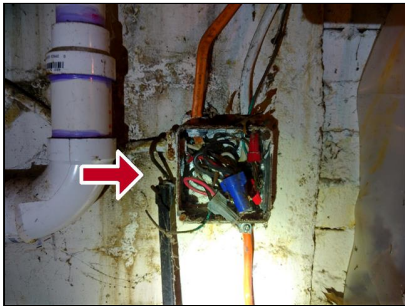
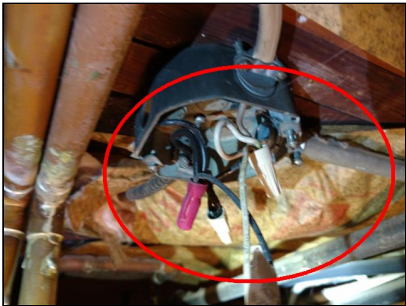
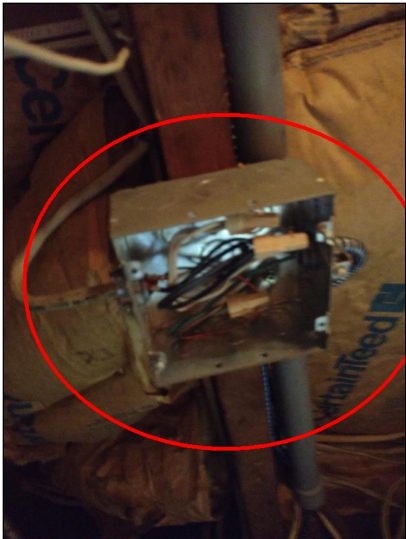
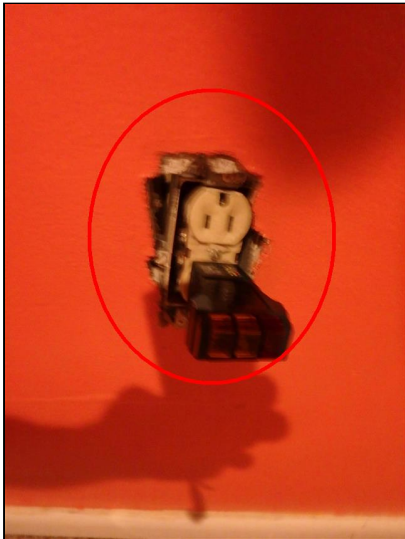
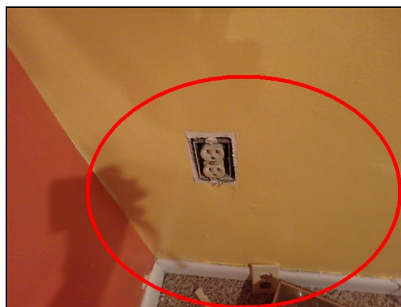
(1) As observed mainly in the basement, exterior and in the garage, there were numerous electrical junction boxes, light switches and outlets that didn't have the required cover plates on them. The cover plates are required in order to contain any arcing which would potentially cause a fire. If a wire is loose, the amperage will go up, which causes heat. This excessive heat is also capable of causing a fire. The idea is to keep all splices enclosed to reduce the risk of fire and to prevent damage to the wires due to accidental contract. Recommend further evaluation by a qualified, licensed electrician and install the needed covers.

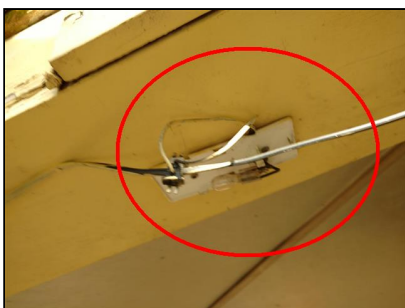
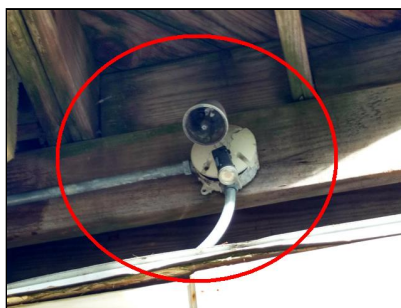
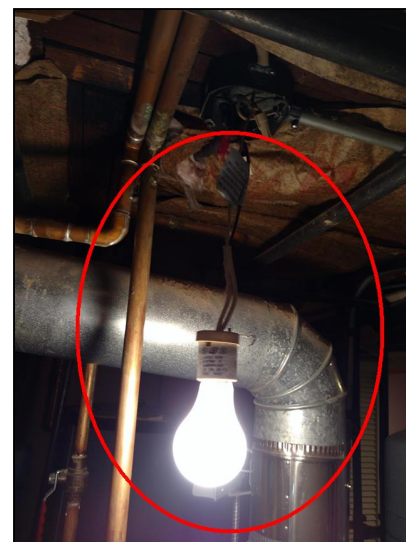
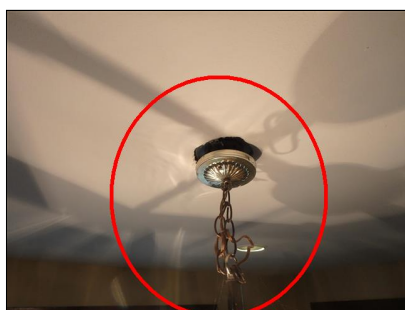
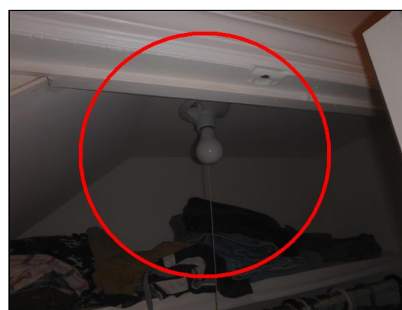
(2) Observed throughout the dwelling and on the exterior, there were numerous light fixtures that were either damaged, not functioning, not installed properly and/or missing light bulbs. This are potential safety concerns. Recommend further of all of the light fixtures by a qualified, licensed electrician and repair as necessary.

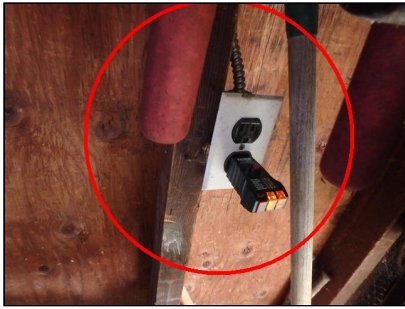
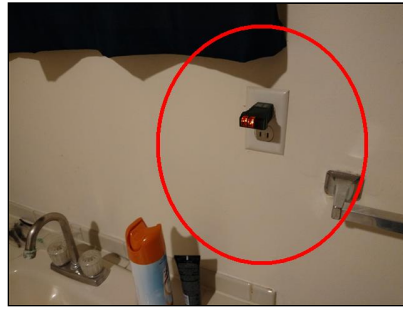
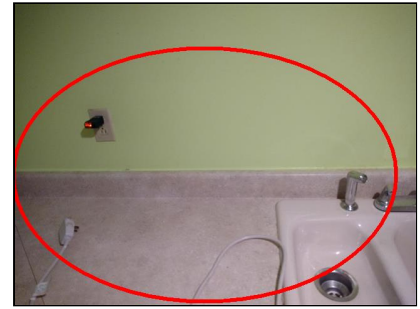
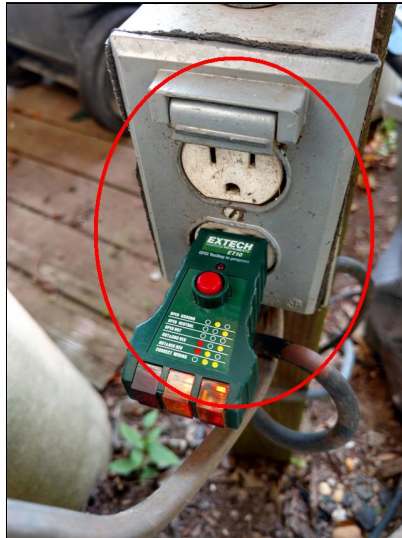
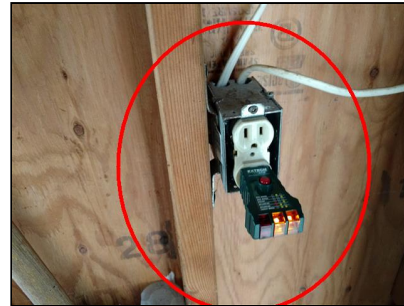
(3) There were numerous electrical receptacles that were not GFCI protected. These were located in the basement kitchen countertop area, basement bathroom, inside the garage and on the exterior. Receptacles located on the exterior, in garages, kitchen sink area, bathrooms and laundry areas should be GFCI protected. A ground fault circuit interrupter (GFCI) is a device (outlet or circuit breaker) that shuts off an electric power circuit when it detects that current is flowing along an unintended path, such as through water or a person. It is used to reduce the risk of electric shock. They can also prevent fires, like when a live wire touches a metal conduit. While the existing receptacles appeared to be in serviceable condition, for safety purposes, it is recommended that these existing receptacles be upgraded to GFCI type receptacles. This should be done by a qualified, licensed electrician.

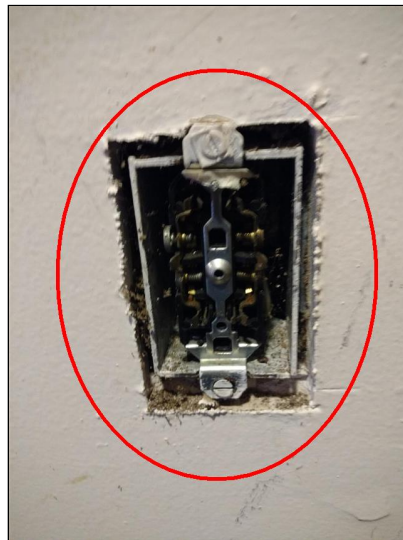
7.8 Item 18(Picture)

(4) There were numerous damaged electrical receptacles present in the basement. These are all safety issues. Recommend further evaluation for repairs by a licensed electrician.

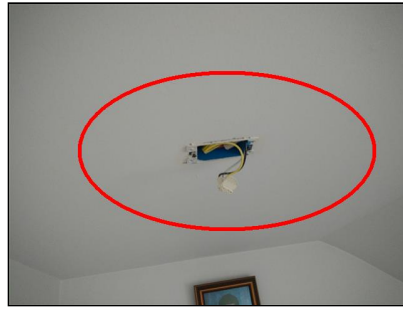
7.10 Item 1(Picture)

There was a hard wired smoke detector missing in the 2nd floor bedroom. Recommend further evaluation for repairs by a qualified, licensed electrician.

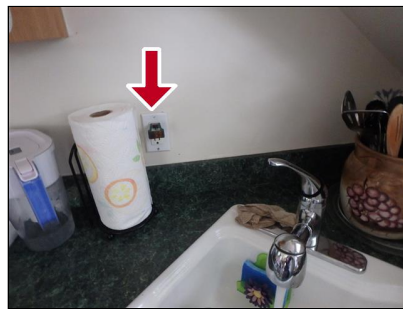
7.12 Item 1(Picture)

The GFCI electrical receptacle in the 2nd floor kitchen was damaged. This is a safety issue and it also creates a potential shock hazard. Recommend further evaluation by a qualified, licensed electrician and repair as necessary.

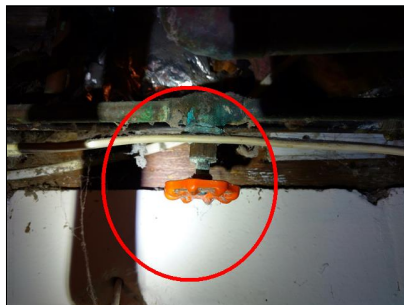
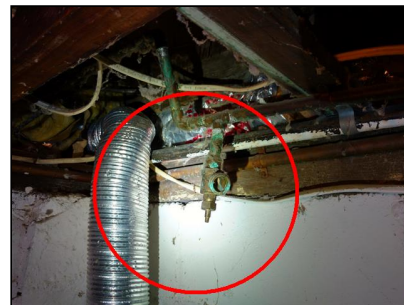
Testing of the water shut off valves located throughout the house (especially the ones located in the basement, under sinks, behind toilets, etc.) for functionality is beyond the scope of the home inspection. Due to age, corrosion and/or mineral buildup that may be on them, they may or may not function properly in the future in the event of an emergency or a need to service part of the plumbing system. Several of the water shut off valves that were observed appeared to be frozen when they were turned slightly and would not turn. There were also numerous shutoff valves that were missing their required handles. Recommend further evaluation of all of the water shut off valves in the dwelling (basement, under sinks, behind toilets, etc.) by a qualified, licensed plumber and repair as necessary.

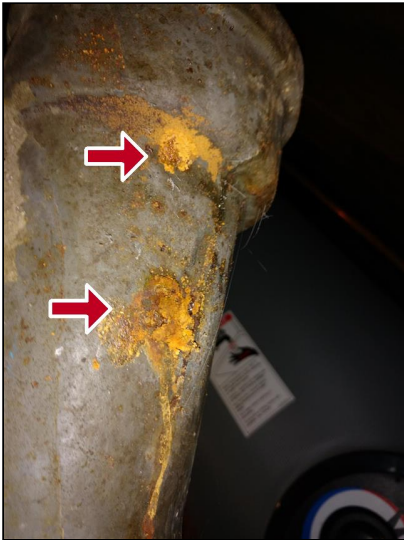
There were numerous rust stains/blisters observed on numerous sections of the cast iron DWV (drain, waste, vent) piping in the basement. These rust marks/blisters are usually caused by tiny pin holes that are in the pipe. As the water leaks out of these tiny pin holes it rusts and forms the blisters. These blisters are usually caused by pitting and corrosion inside the pipe. Also, to note, portions of the DWV piping was galvanized pipe. This has similar characteristics to cast iron as far as the deterioration is concerned. Recommend further evaluation of all of the DWV piping by a qualified, licensed plumber and repair as necessary. In addition, due to the age of the house and since cast iron piping deteriorates from the inside out, it is recommended the main cast iron DWV piping (especially the portion that goes out to the main sewer connection in the street) be scoped by a qualified, licensed plumber to ascertain the integrity of the piping. But, on old cast iron DWV piping systems this sometimes cannot be done without compromising the existing DWV piping system and should not be done if it will compromise the existing DWV piping system. Sometimes the clean out plugs that are needed to be removed to inspect the inside of the piping are frozen or severely deteriorated and will not come off to access the piping.

8.2 Item 1(Picture) Suspected blisters

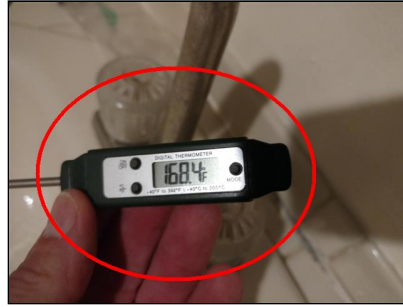
8.3 Item 1(Picture)

The hot water temperature at the basement bathroom sink faucet was 168 degrees. From a safety standpoint, the hot water temperature should not be over 120 degrees. This is a major safety concern (especially if children are present) as scalding could occur with the hot water being so hot. It is recommended turning down the temperature setting on the hot water storage tank.

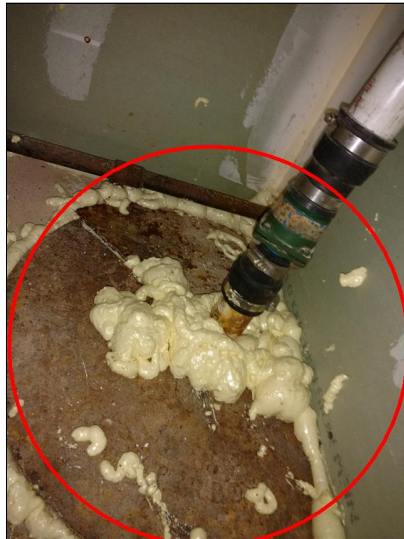
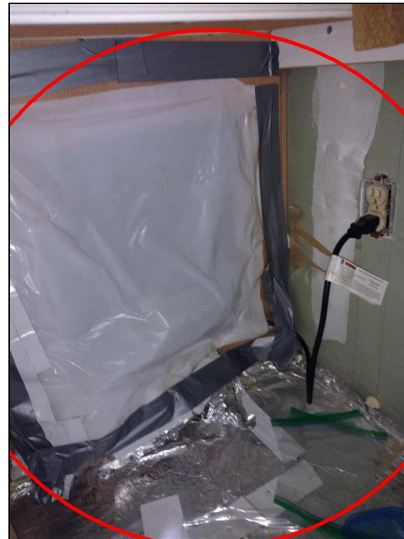
As observed in the basement, there was what appeared to be a sump pump present under the kitchen cabinets. It is suspected the water discharge piping for the sump pump was directed into the sanitary sewer piping running out to the sanitary sewer main. The water discharged from the sump pump is not permitted to be connected to the sanitary sewer system. It can be connected to a storm sewer system (which is not present in this dwelling) or directed to the exterior. It is recommend this sump pump discharge piping be directed to the exterior with the discharge point as far away from the foundation as possible. There was no visible discharge piping to the exterior. Also, this sump pump was sealed and therefore, it could not be tested. The inspection was limited. Recommend further evaluation by a qualified, licensed plumber and repair as necessary.

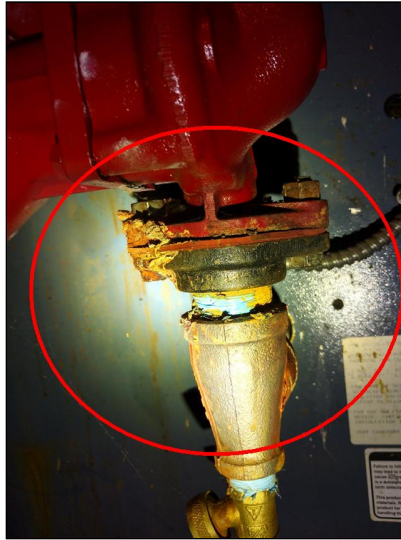
10.1 Item 1(Picture)

As observed in the basement on the side of the boiler, it appears the heating distribution system piping may be leaking in the area of the circulating pump and other pipes. There was no active leaks visible at the time of the inspection. Recommend further evaluation for repairs by a qualified, licensed plumber.

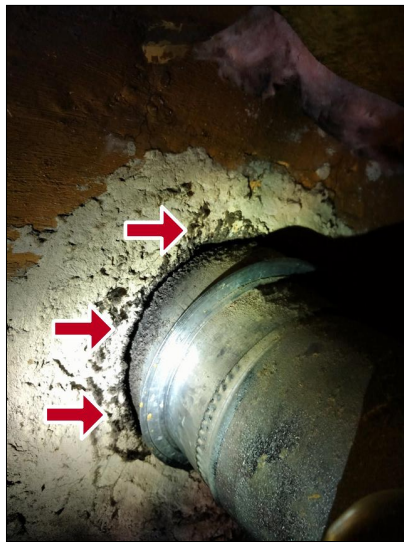
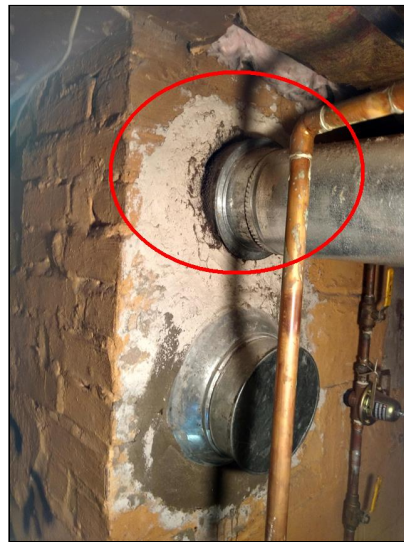
The exhaust venting/vent connector for the boiler was not sealed up at all the chimney thimble connection. The vent pipe was just stuck into the chimney opening with large gaps between the vent connector and the chimney thimble opening. There was no sealing material present. This is a **major safety concern** as combustion by products (carbon dioxide, carbon monoxide and nitrogen oxide) may be entering the dwelling instead of being properly vented into the chimney and out of the dwelling. This should be repaired **immediately**. Recommend further evaluation by a qualified, licensed plumber and repair as necessary.

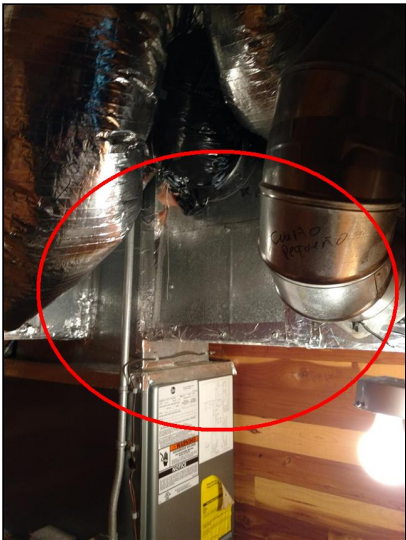
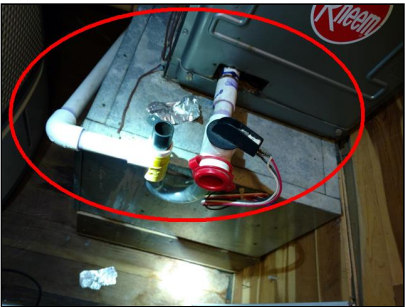
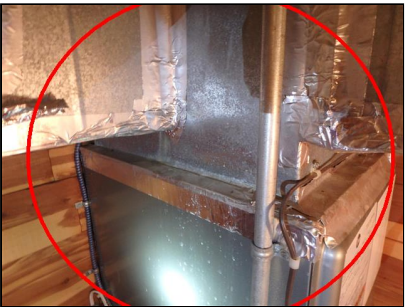
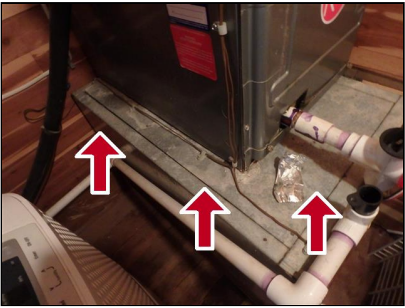
As observed in the attic area on the 2nd floor, portions of the HVAC supply ducting appeared to be sweating when operated. Portions of the ducting were wet and there was dry water staining on the ducting and the A/C air handler

cabinet. This could be a future concern as the condensation could damage the building materials in this area. Recommend further evaluation by a qualified, licensed plumber and repair if necessary.

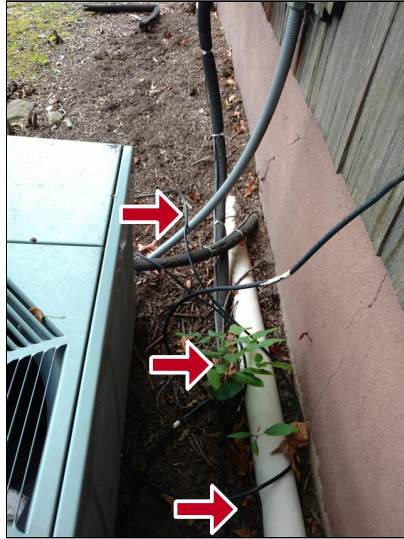
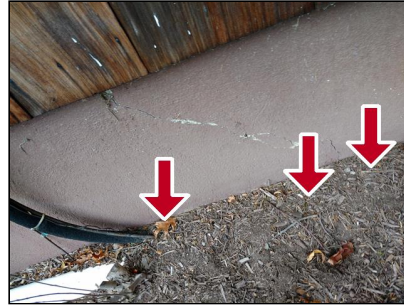
The insulation wrap on one of the exterior condenser refrigerant lines was deteriorated/missing in spots. Also, both of the refrigerant lines were buried in the mulch next to the condensers. The refrigerant lines should not be in contact with the ground. This may cause the insulation wrap to deteriorate. In addition, this condition may affect the performance of the air conditioning system if not repaired. Recommend further evaluation by a qualified, licensed HVAC professional and repair as necessary.

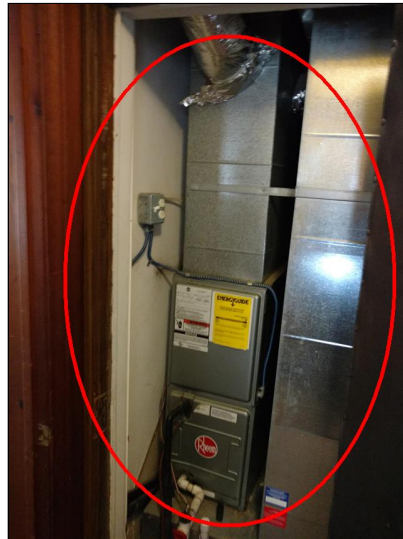
11.3 Item 1(Picture)

The air handler for the air conditioning system for the 1st floor did not appear to have a return air filter. This is an issue as the return air filter keeps the internal parts of the air handler free of dust and debris, it filters the air being circulated within the living spaces and not having one in place will also effect the performance of the air conditioning system. Recommend further evaluation by a qualified, licensed plumber and repair as necessary.

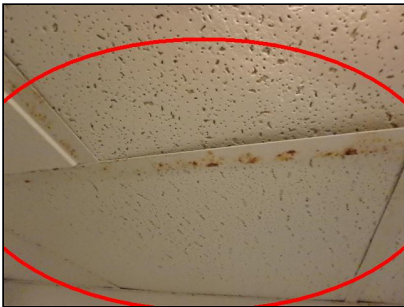
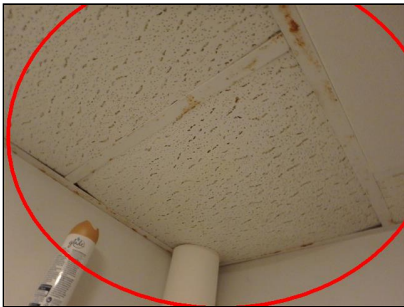
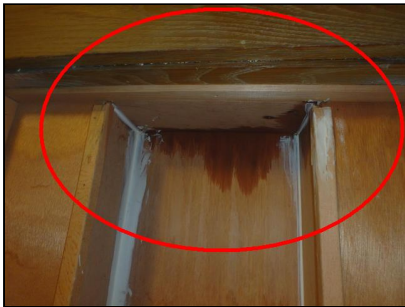
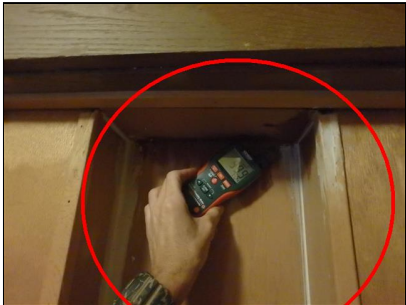
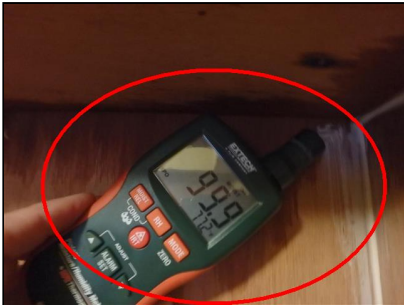
(2) There was a drop ceiling present in the 1st floor bathroom which covered the entire ceiling. This is an issue as the metal framing could rusted due to the moisture while taking a shower and also moisture could get trapped in the space above the drop ceiling and the 2nd floor subfloor. Mold could possibly form on the ceiling tiles as well as the space above the drop ceiling. In addition to this drop ceiling being present, it also appears the toilet in the 2nd floor bathroom was or is leaking down into the 1st floor bathroom and hallway closet. The ceiling and wall was wet in these areas. Please keep in mind there may be hidden moisture damage (possible mold) in these effected areas.

Recommend further evaluation by a qualified, licensed contractor and repair as necessary. The toilet in the 2nd floor bathroom should also be evaluated.

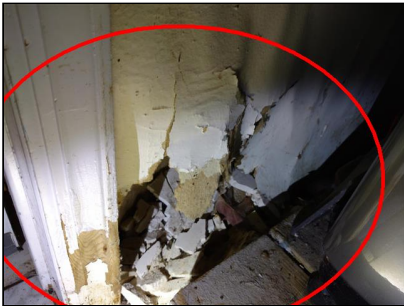
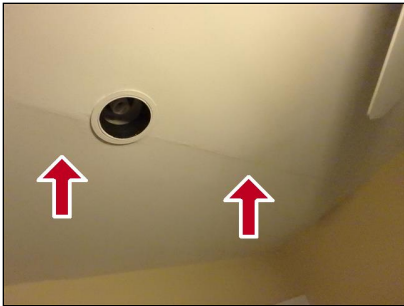
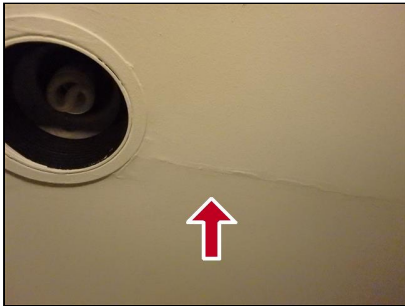
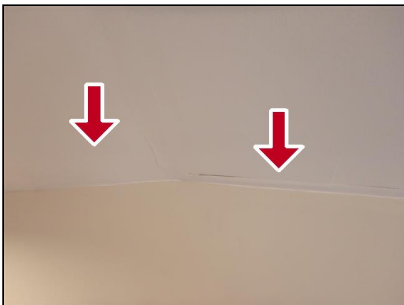
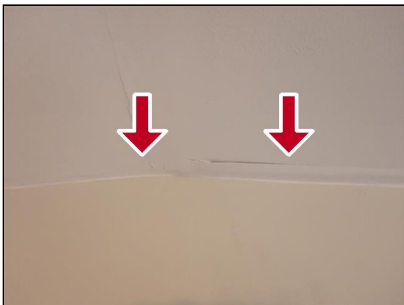
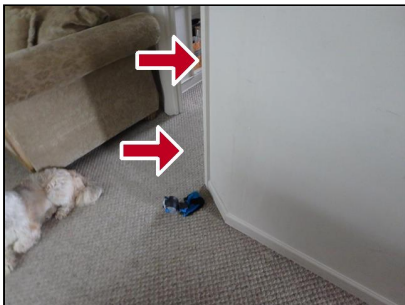
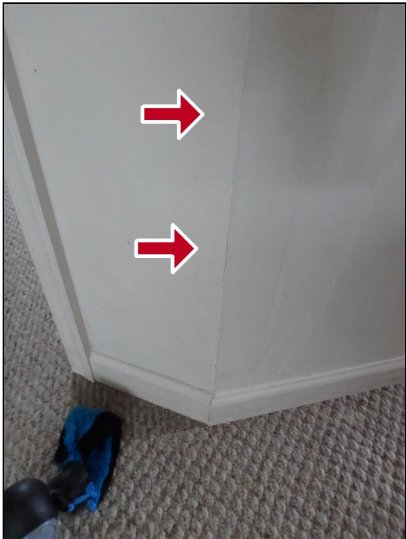
As observed throughout the dwelling, there were small cracks observed in the some of the ceiling and wall surfaces. These types of cracks are common in a house of this age. The condition of these cracks may worsen if the necessary repairs are not completed. There was also a portion of the drywall that was damaged in the basement. Recommend further evaluation of all of the wall/ceiling surfaces by a qualified, licensed contractor and repair as necessary.

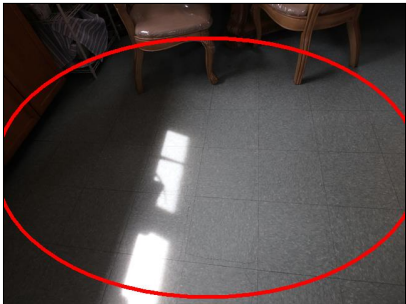
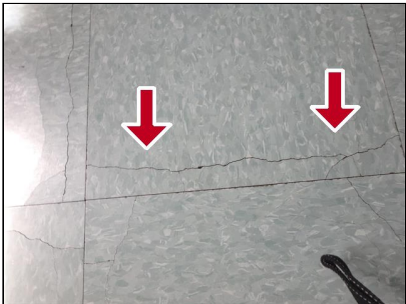
A observed in the 2nd floor kitchen, there were several loose and damaged vinyl floor tiles. This condition may worsen and/or damage to the flooring may occur if the needed repairs are not completed. Recommend further evaluation by a qualified, licensed contractor and repair as necessary.

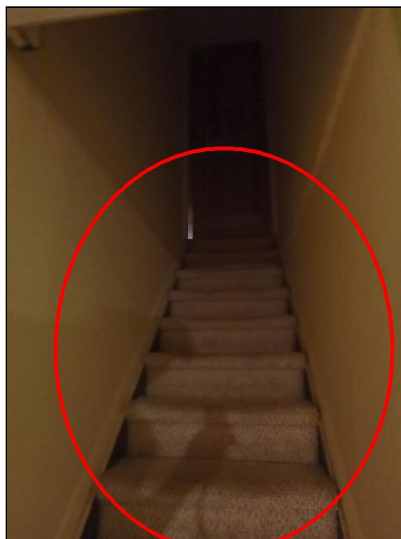
12.5 Item 1(Picture)

As observed in the basement stairwell, there was no handrail present. All stairwells should have handrails which should be continuous from the bottom to the top. The missing handrail is a safety concern. Recommend further evaluation for repairs by a qualified, licensed contractor.

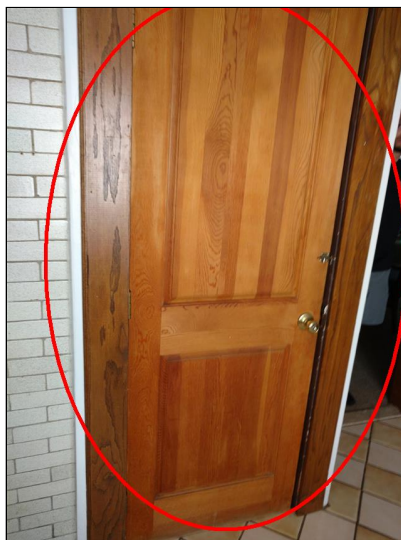
12.7 Item 1(Picture)

The bottom of the interior door leading to the basement was rubbing on the floor. Damage to the door and/or the floor could occur if not repaired. Recommend further evaluation for repairs by a licensed contractor.

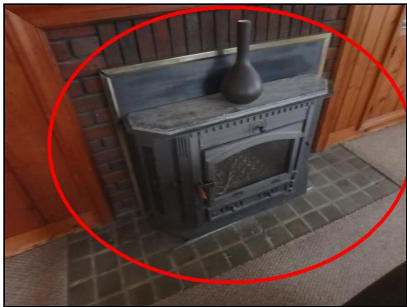
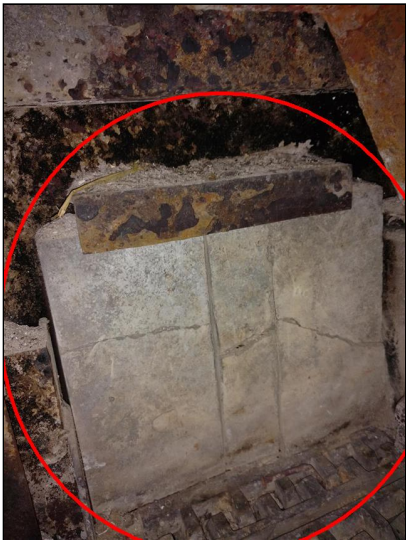
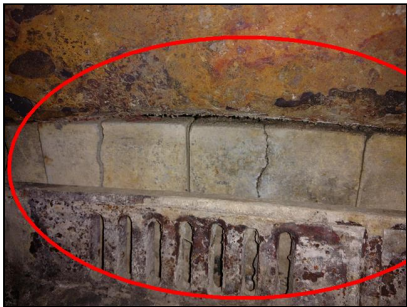
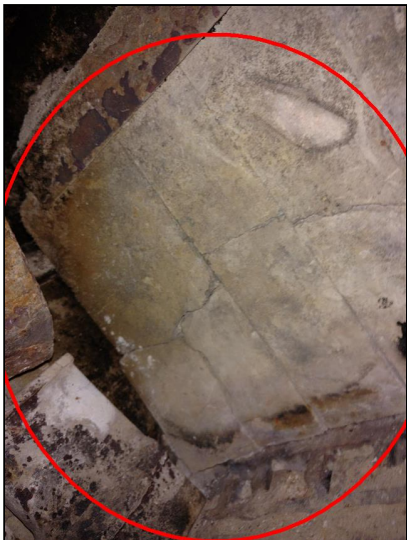
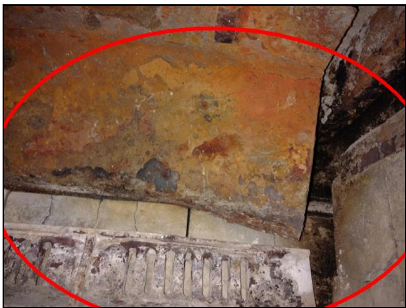
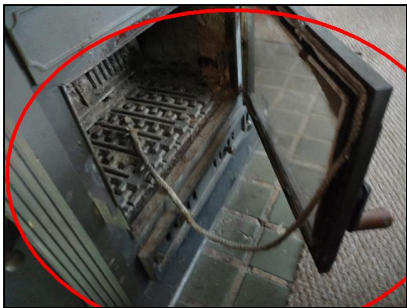
(2) As observed in the wood burning fireplace, the rear and side refractory panels were cracked in numerous areas. This is a concern as these panels keep the fire inside the firebox. The gasket material on the front door also

appeared to be damaged. Recommend further evaluation by a qualified, licensed fireplace professional and repair as necessary.

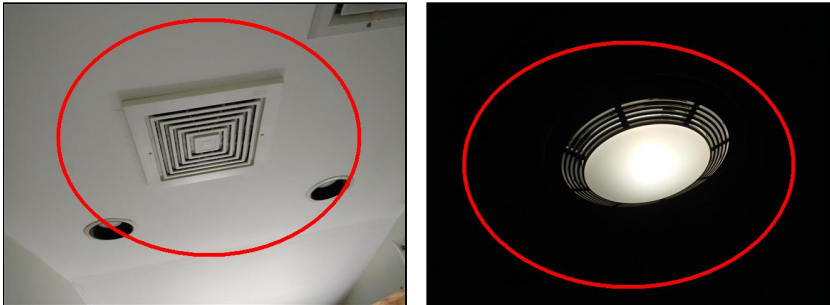
(1) The exhaust fans located in the basement and 1st floor bathrooms did not appear to be functioning. A working exhaust fan ensures ventilation of moisture from the bathroom in the event the bathroom window is not open (winter time). This is especially important where bathtubs or showers are present. Recommend further evaluation for repairs by a qualified, licensed electrician.

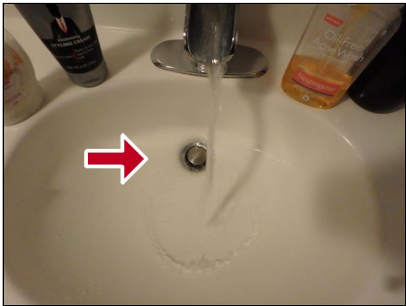
13.2 Item 1(Picture)

The sink stopper in the 1st floor bathroom sink was not functioning properly. It appears it may just need to be adjusted as it was sealing properly. This will prevent you from filling up the sink if you wanted to do so. Recommend further evaluation by a qualified, licensed plumber and repair as necessary.

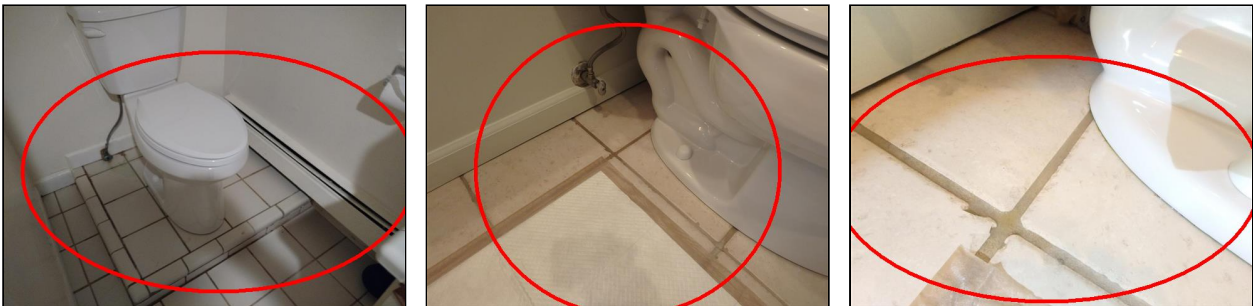
The toilets in the 2nd floor and basement bathrooms were not functioning properly. There appeared to loose and leaking water from underneath them. The area below the 2nd floor bathroom in the 1st floor unit had water damage present on the bathroom ceiling. Recommend further evaluation for repairs by a qualified, licensed plumber.

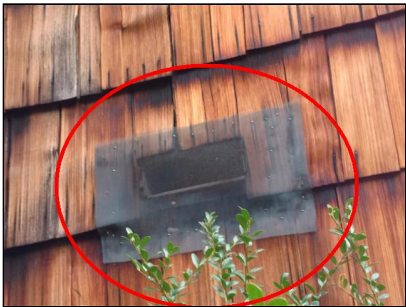
14.4 Item 1(Picture)

(1) The exterior damper assembly was missing from the 1st floor kitchen exhaust fan. This is a concern as the weather, insects and wildlife could possibly get into the dwelling. Recommend further evaluation by a qualified, licensed contractor and repair as necessary.

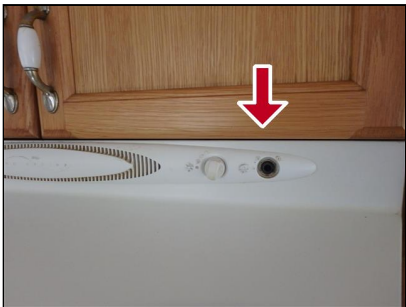
14.4 Item 2(Picture)

(2) The 2nd floor exhaust fan/hood was missing a control knob. Recommend repairing as necessary.

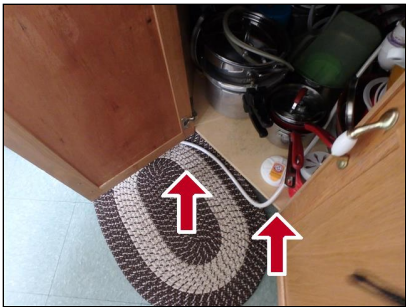
14.10 Item 1(Picture)

The routing of the water supply line for the 2nd refrigerator in the 2nd floor kitchen was suspect. It was routed out the front of a cabinet and across the kitchen floor. This is a concern as someone could trip on this supply line and potentially damage it and causing it to leak. Recommend repairing/re-routing this supply line as needed.

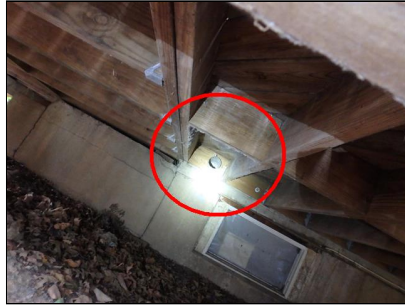
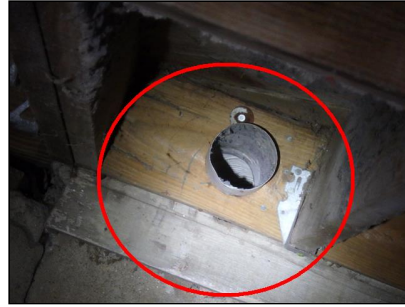
The exterior portion of the dryer vent was missing. This condition could allow wildlife to enter the dryer vent ducting and possibly clog it. Recommend further evaluation by a qualified, licensed contractor and repair as necessary.
