Home Inspection Report

1234 New Street
Better City, North Carolina 27215

Date of Inspection: Saturday, February 28, 2015

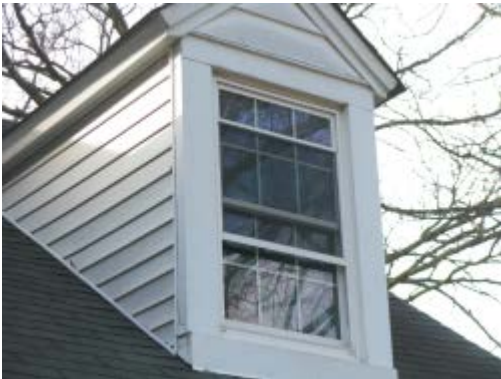
(B1 - 1.3) Main House Front

Additional Photograph: This a photograph of decayed boxing at the left front corner of the main home. All corner trims areas were noted to have some level of decay.
