Property Inspection Report

Property Address:
503 First Street
Inspectionville NJ 07000

Terra Home Inspections LLC

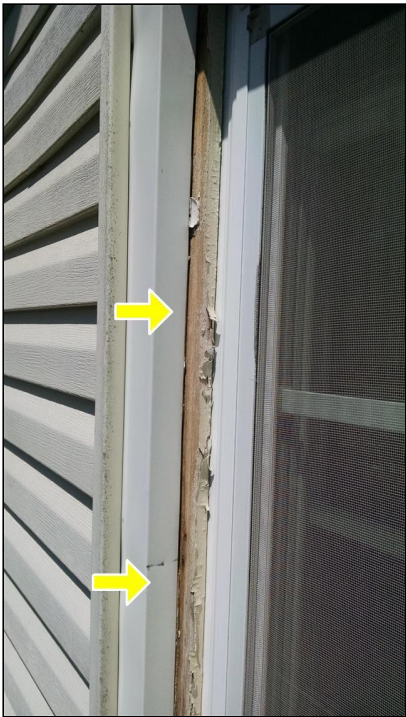
2.3 Item 2(Picture) Rear bedroom window

2.3 (1) The paint is peeling off of the wood trim around the old attic wood windows. If the trim is not caulked and painted, the trim could deteriorate. Also it appears there were new vinyl windows installed in the rear bedroom and they were not flashed properly on the exterior. There are some flashing pieces missing. Recommend further evaluation for repairs by a qualified, licensed contractor.

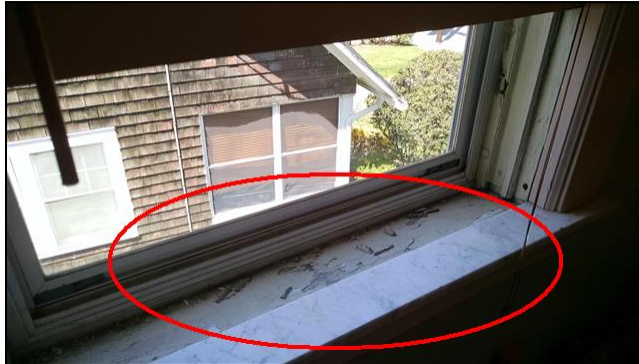
2.3 Item 5(Picture)

2.3 (3) The glazing is chipping off of the old wood framed window in the 2nd floor bathroom. Recommend further evaluation for repairs by a qualified, licensed contractor.

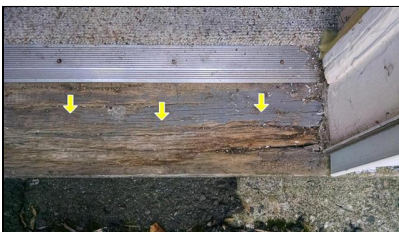
2.4 Item 1(Picture)

2.4 (1) The door threshold on the side exterior door is deteriorating. It is worn from the elements and the paint is peeling. Recommend further evaluation for repairs by a qualified, licensed contractor.

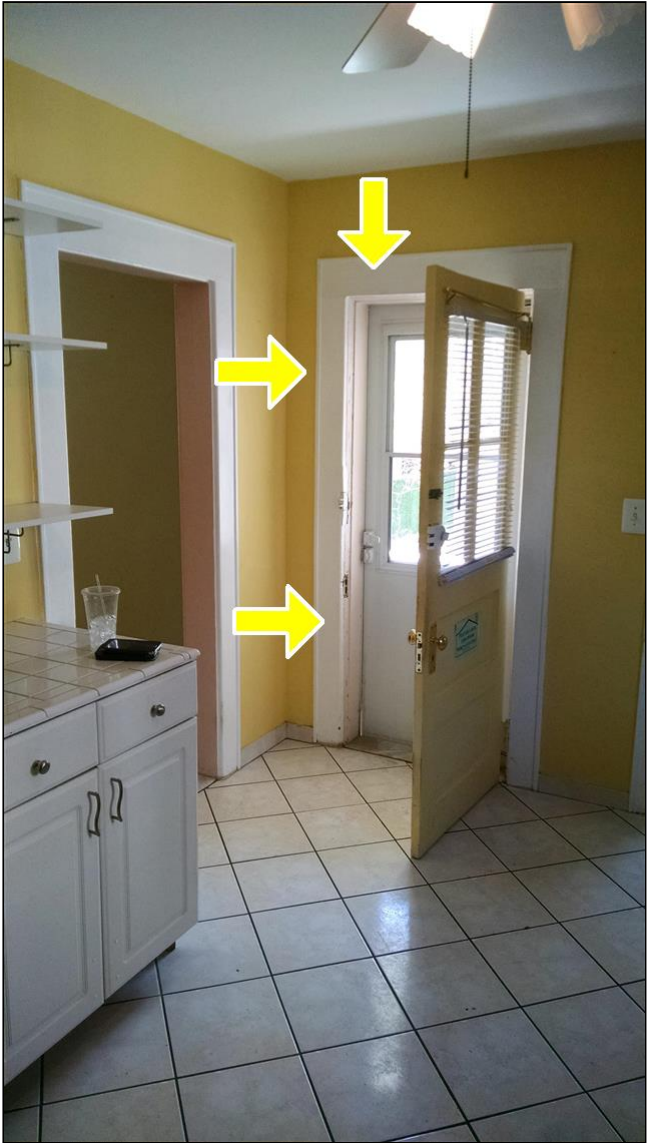
2.4 Item 3(Picture)

2.4 (2) The rear exterior wood door is not closing properly. There is a big gap on the top and the door is not fitting properly in the door frame. Recommend further evaluation for repairs by a qualified, licensed contractor.

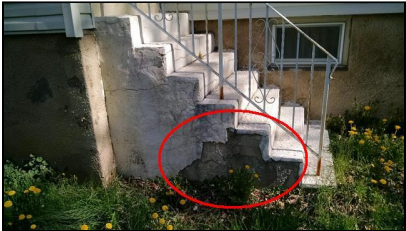
2.6 Item 1(Picture)

2.6 (1) There appears to be 3 layers of masonry parging on the rear set of masonry steps that is cracking and peeling off. If not repaired the structure of the steps could be compromised. Recommend further evaluation for repairs by a qualified, licensed contractor.

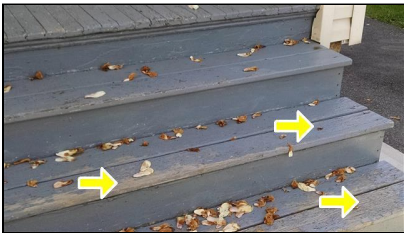
2.6 Item 2(Picture)

2.6 (2) The boards on the front set of steps are loose and the paint is peeling off them. This is a safety hazard as someone could trip or fall if the board came off. Also the wood could deteriorate if not covered with an appropriate paint coating. Recommend further evaluation for repairs by a qualified, licensed contractor.

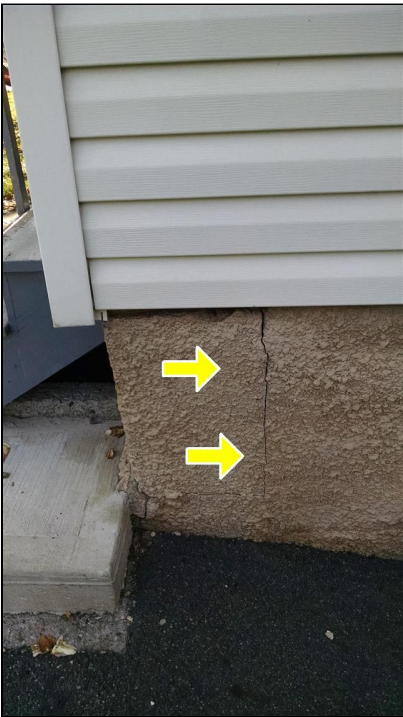
5.0 (1) There were numerous vertical cracks visible in the exterior wall surface of the foundation. These cracks could let water into the foundation walls and which may deteriorate the walls and the interior of the dwelling. The locations are noted on the corresponding pictures. Recommend further evaluation for repairs by a qualified, licensed contractor.

5.0 Item 2(Picture) Right side near driveway

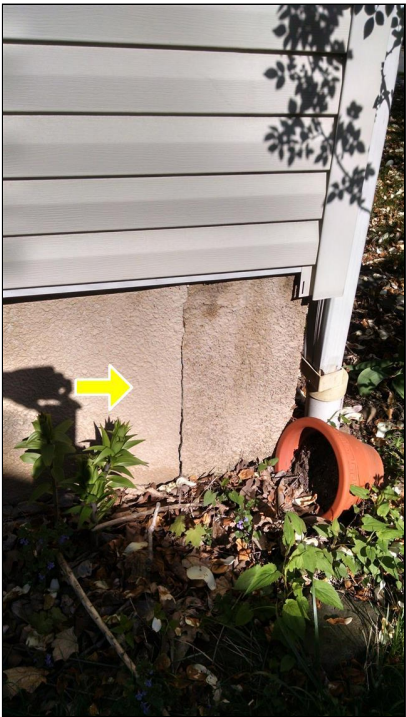
5.0 Item 3(Picture) Left front side

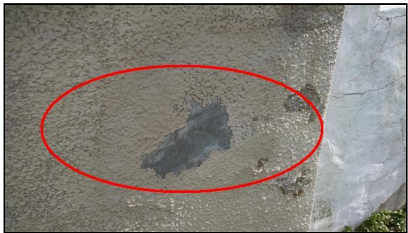
5.0 (2) The parging on the rear exterior foundation wall in several areas is flaking off. If not repaired, this could lead to deterioration of the foundation walls. Recommend further evaluation for repairs by a qualified, licensed contractor.

5.0 Item 5(Picture) Rear foundation wall

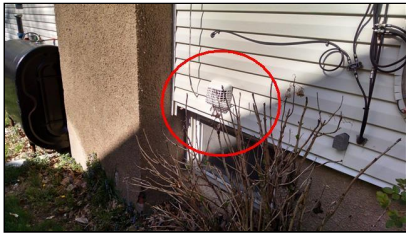
5.2 (2) There was a bathroom type exhaust fan present in the basement ceiling in the area at the bottom of the basement stairs. The fan was vented out the left side of the house. But, in the vent piping leading to the side of the house, there was a in-line duct fan installed to pull air into the home and apparently out of the exhaust fan in the ceiling. The duct fan was hooked up to a wall switch on the wall. When tested, the duct fan operated but no air was coming out of the grate nor was the squirrel cage fan in the ceiling exhaust fan spinning. Recommend further evaluation for repairs by a qualified, licensed electrician.

5.2 Item 3(Picture) Outside vent opening

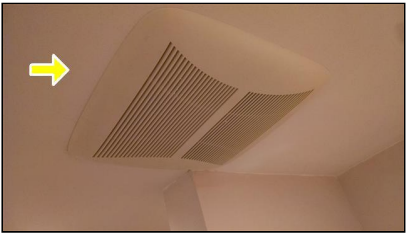
5.2 Item 4(Picture) Exhaust fan

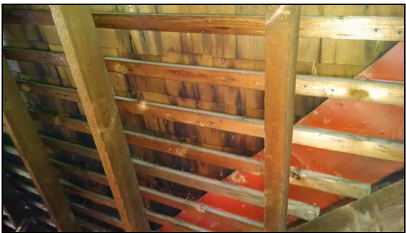
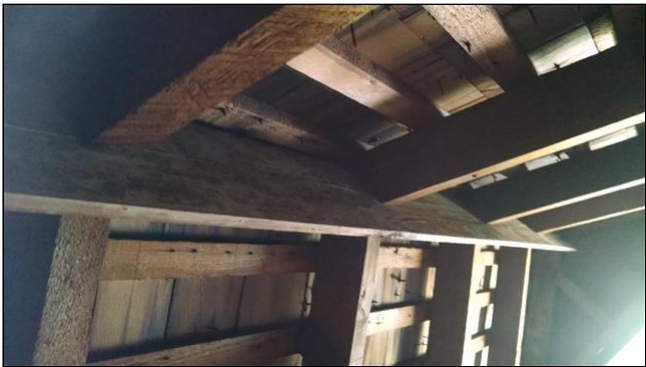
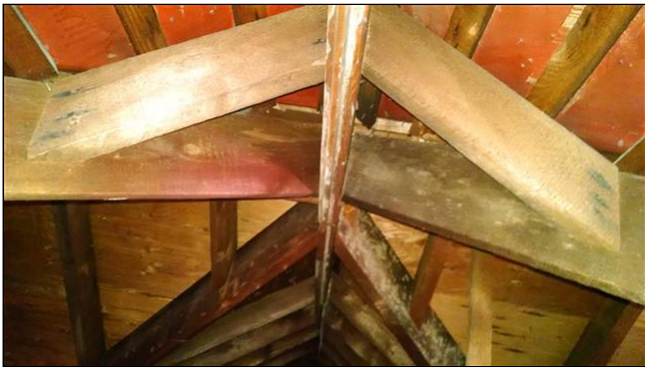
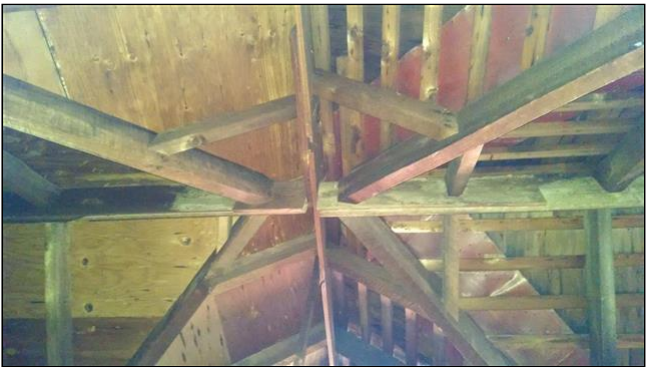
5.6 The roof structure was constructed with 1 3/4"x4" (actual measurement) wood rafters that varied from 19" to 24" on center. The wood ridge board measured 3/4"x7" (actual measurement). The ridge board was doubled up where all of the roof planes meet. There was plywood decking on the front portion of the main roof and what appeared to be the original wood shake roof (used as decking) on the rear portion of the main roof. By today's standards the roof structure framing is undersized. The roof structure could be compromised by the weight of the numerous roof layers present and a heavy snow/ice load during the winter months. I recommend consulting a qualified, licensed contractor with structural experience for their evaluation and opinion.

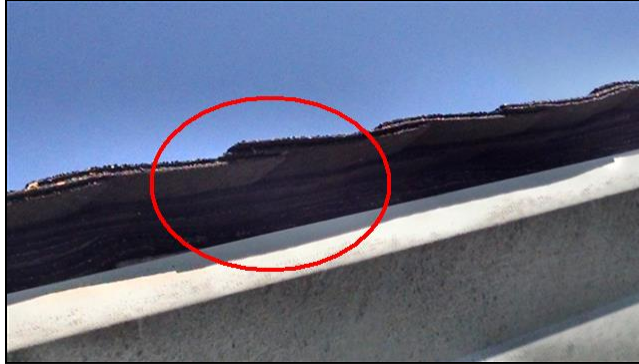
6.0 (2) It appears there are 4-5 layers of roof shingles on the rear half of the main roof including the original wood shake roof covering. The total measurement of these coverings together was close to 1 1/2". This portion of the roof didn't appear to be leaking but the weight of these coverings along with a deep snow/ice load could compromise the roof structure which is undersized by today's standards. Recommend further evaluation by a qualified, licensed roofing contractor.

6.0 Item 3(Picture) 3-4 layers of shingles

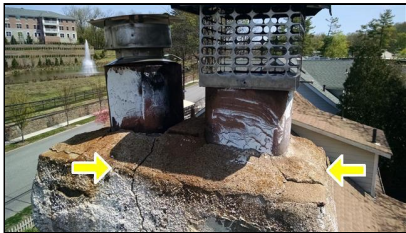
6.5 (1) The chimney above the roofline is severely deteriorated. The parging is cracked and peeling, there are several cracked bricks visible, the crown has numerous cracks and there are several bricks that are spalling. This condition could lead to moisture intrusion into the interior walls, ceilings, fireplace and the hot water heater and heating system boiler vent pipes. Recommend further evaluation for repairs by a qualified, licensed chimney professional.

6.5 Item 4(Picture) Crown cracked

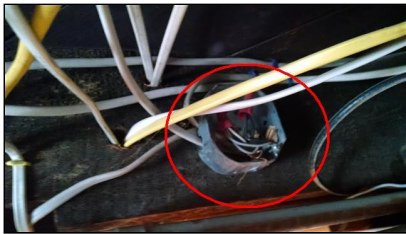
8.7 (1) There are two junction boxes located above the boiler in the basement that are missing covers. Also, the light fixture box in the same area is missing a side knockout. These are all safety issues. Recommend further evaluation for repairs by a qualified, licensed electrician

8.7 Item 1(Picture) Missing cover

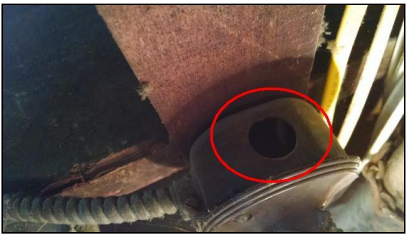
8.7 Item 2(Picture) Light fixture
missing knockout

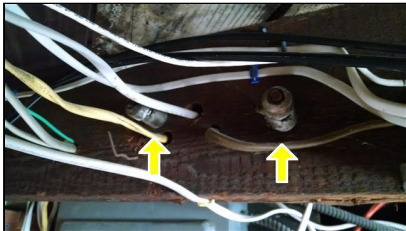
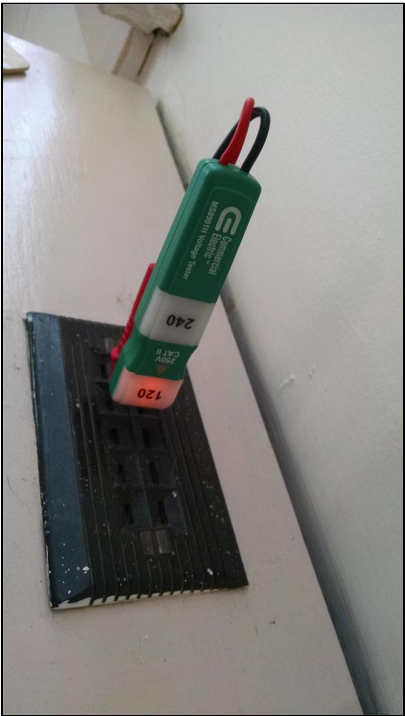
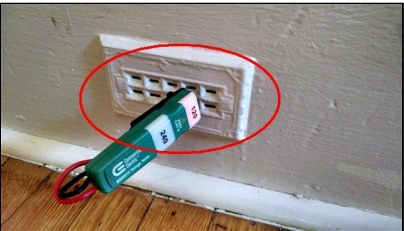
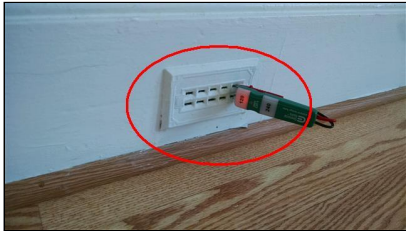
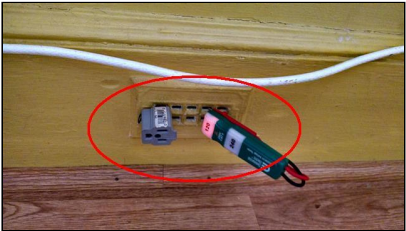
8.7 (2) There was a few old porcelain insulators that were used for the original knob and tube wiring visible in the basement above the electric service panel. While there was no knob and tube wiring visible in the unfinished area of the basement or elsewhere in the house, it still may be in the walls feeding the what appears to be the original 2 prong electric outlets located in the living room and the front and middle bedrooms. These outlets were still live. Knob and tube wiring is inadequate for today's electrical needs and is a fire risk. In addition to recommending these outlets be upgraded, a qualified, licensed electrician should be consulted to ascertain what type of wiring is feeding these outlets just to be on the safe side.

8.7 Item 3(Picture) Knob and tube wiring porcelain insulators

8.7 Item 4(Picture) Live outlet above fireplace

8.7 Item 5(Picture) Live outlet in living room wall

8.7 Item 6(Picture) Live outlet in middle bedroom wall

8.7 Item 7(Picture) Live outlet in front bedroom wall

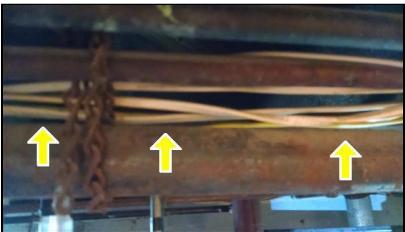
8.7 Item 8(Picture)

8.7 (3) The electric wires above the boiler in the basement should be fastened so they are not touching the hot heating distribution pipes. Recommend further evaluation for repairs by a qualified, licensed electrician

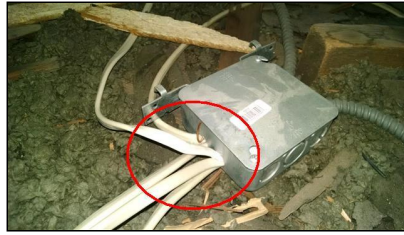
8.7 (4) There was an electrical junction box located in the attic that had 7 wires entering it, 5 of which are not fastened with the required connectors. In addition, you shouldn't have numerous wires entering the box in a single hole. This is a safety issue and a fire hazard. Recommend further evaluation for repairs by a qualified, licensed electrician.

8.7 Item 9(Picture) Wires entering the box

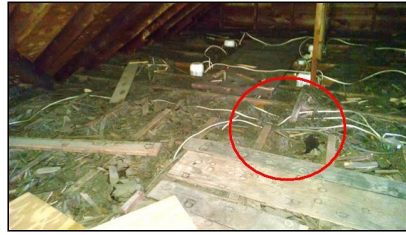
8.7 Item 10(Picture) Electric box location in attic

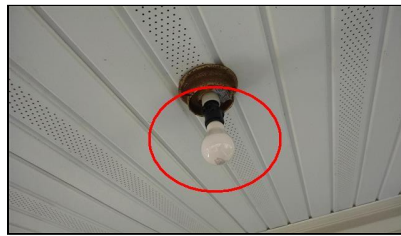
8.8 Item 1(Picture)

8.8 (1) The front and rear porch exterior light fixtures are missing the glass light globes that protect the light bulb and the fixture from the elements. This is a safety hazard. Recommend further evaluation for repairs by a qualified, licensed electrician.

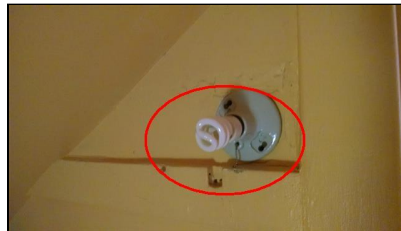
8.8 Item 2(Picture)

8.8 (2) The pull chain on the light fixture in the front bedroom closet is not functioning. Recommend further evaluation for repairs by a qualified, licensed electrician

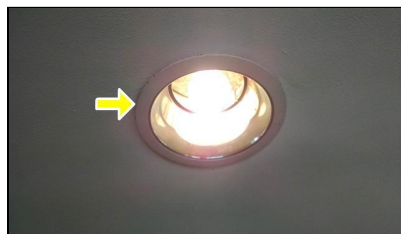
8.8 Item 3(Picture)

8.8 (3) The recessed lights in the front bedroom has different types of light bulbs in them which do not appear to be the required light bulbs for these types of fixtures. The required bulbs should be installed for safety reasons. Recommend further evaluation for repairs by a qualified, licensed electrician

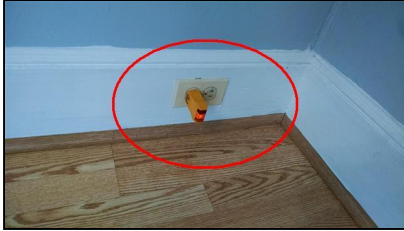
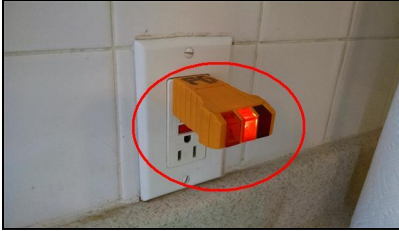
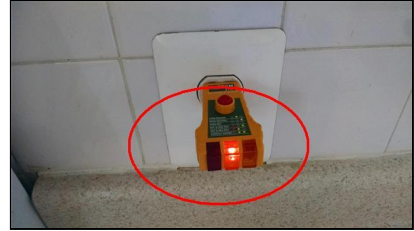
8.8 (4) There were numerous electrical outlets located in the kitchen countertop area in addition to all of the 3 prong outlets in all 3 of the bedrooms that had an open ground condition. This happens when the ground wire is not connected properly to the outlet or is broken upstream from an outlet. This condition creates a potential shock and safety hazard. Recommend further evaluation of the entire electrical system for repairs by a qualified, licensed electrician.

8.8 Item 4(Picture) Rear bedroom

8.8 Item 5(Picture) Kitchen GFCI outlet

8.8 Item 6(Picture) Kitchen outlet

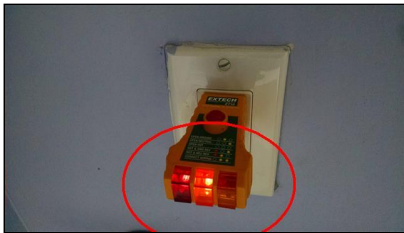
8.8 (5) There were numerous electrical outlets located in the dining room and 1st floor bathroom that had a reversed polarity condition. This happens when the hot and neutral wires get flipped around at an outlet or upstream from an outlet. Reversed polarity creates a potential shock hazard. Locations are marked on the corresponding pictures. Recommend further evaluation of the entire electrical system for repairs by a qualified, licensed electrician.

8.8 Item 7(Picture) Bathroom GFCI outlet

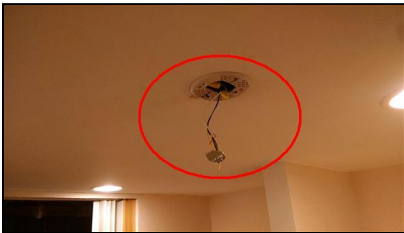
8.10 Item 1(Picture)

8.10 There was a hard wired smoke detector missing in the basement. Recommend further evaluation for repairs by a qualified, licensed electrician.

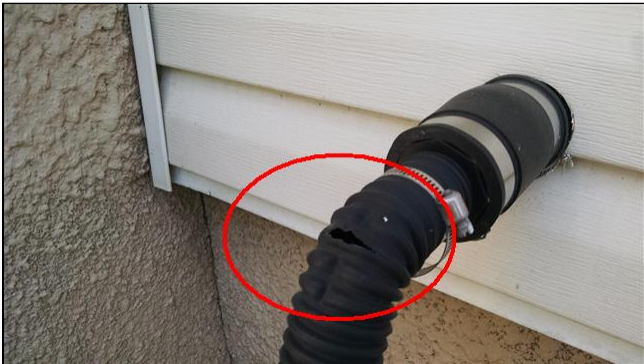
9.5 Item 1(Picture)

9.5 The discharge hose for the sump pump is cracked and is spraying water on the side of the hose when the water is discharged by the sump pump. The water should be getting discharged at least 6 feet away from the house. Recommend further evaluation for repairs by a qualified, licensed contractor.

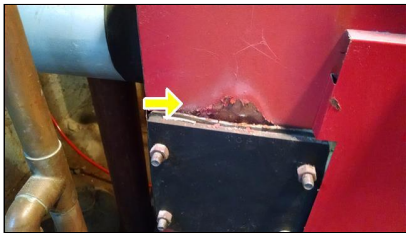
11.0 There was some scorching visible on the front of the boiler above the burner and also above the left side cover plate. Also, the boiler would not operate under normal controls and therefore could not be tested. The burner would not light off. It appeared to be out of fuel. The fuel oil storage tank was empty. The client stated they observed the boiler functioning when they looked at the house. Recommend further evaluation of the entire boiler by a qualified, licensed HVAC professional.

11.0 Item 1(Picture) Left side cover plate

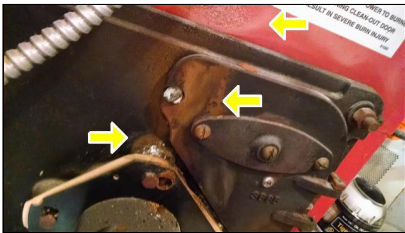
11.0 Item 2(Picture) Above burner in front

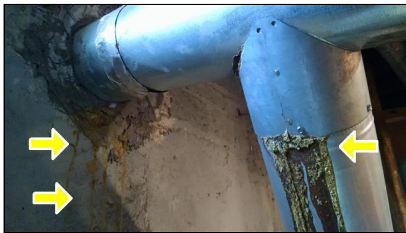
11.2 Item 1(Picture)

11.2 There was what appears to be moisture leaking out of the boiler vent pipes and also down the interior basement wall under the vent pipe where it enters into the chimney flue. This could either be condensation forming inside the vent pipe and/or chimney flue or water leaking into the chimney flue somewhere on the exterior. Recommend further evaluation for repairs by a qualified, licensed HVAC professional.

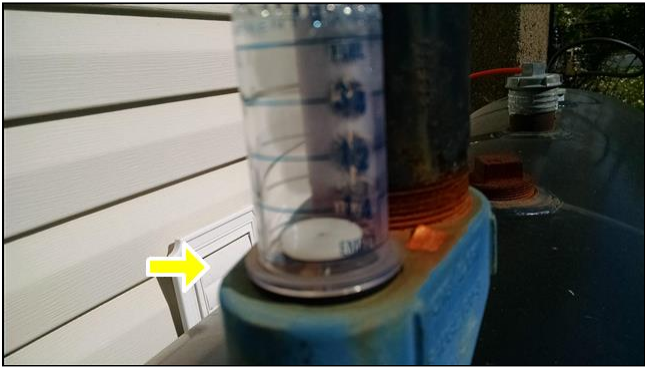
11.6 For informational purposes only-The exterior fuel oil storage tank appeared to be empty at the time of the inspection.

11.6 Item 1(Picture) Tank is empty

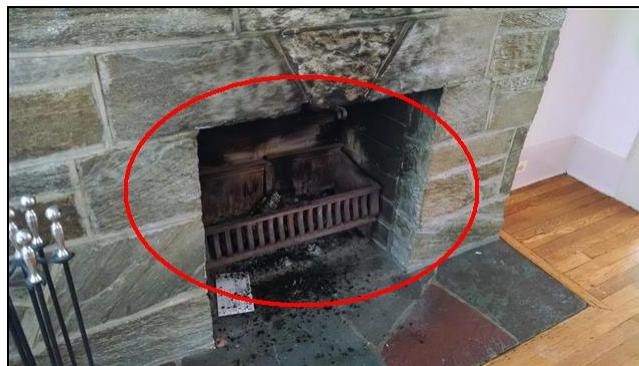
13.8 (1) The NFPA (National Fire Protection Agency- www.nfpa.org) highly recommends an annual inspection of all fireplaces and chimneys. They also recommend that an inspection take place upon the transfer of a property, the replacement of a solid fuel burning appliance, or following an external event likely to have caused damage. Our inspection of the fireplace and chimney pipe is limited to the readily visible areas and components. This visual inspection is not adequate to discover hidden deficiencies or damage should they exist. A NFPA 211 Standard, Level II inspection, which includes cleaning the interior of the chimney pipe and the use of specialized tools and testing procedures, such as video cameras, etc., is needed to thoroughly evaluate the fireplace system. If one has not been performed over the past 12 months, such an inspection is recommended at this time for your safety. Additional information pertaining to fireplace/chimney inspections can be found in Chapter 14 of the NFPA 211 standard. <http://www.nfpa.org/codes-and-standards/document-information-pages?mode=code&code=211>

13.8 Item 1(Picture) Fireplace should be cleaned and inspected

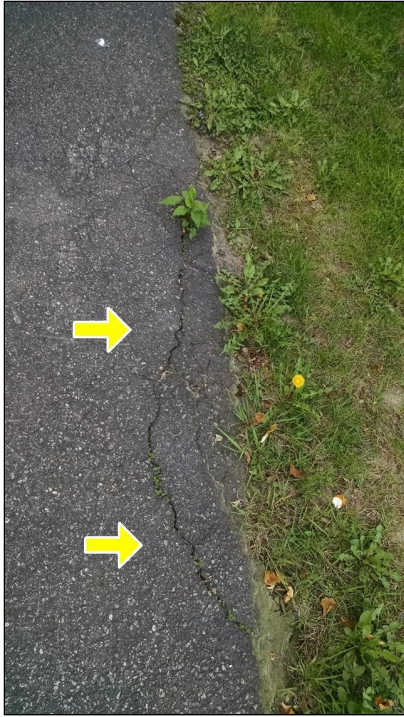
(1) The driveway has numerous areas that are cracked and depressed. Deterioration could occurred if not repaired. Recommend further evaluation for repairs by a qualified, licensed contractor.

1.0 Item 1(Picture) Cracks

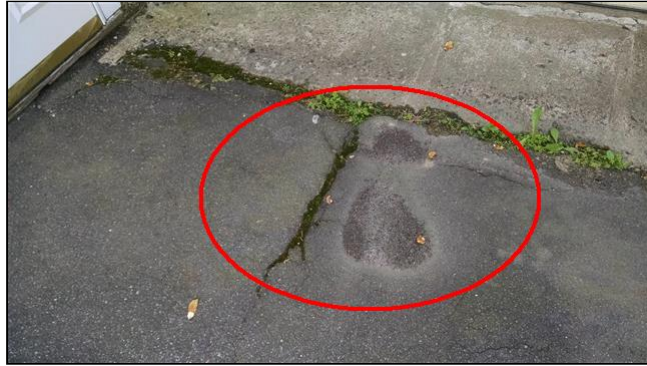
1.0 Item 2(Picture) Depression

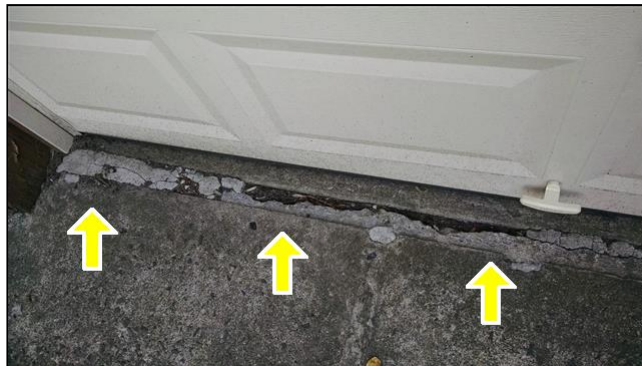
1.0 Item 3(Picture)

(2) The gap between the concrete garage floor and the concrete driveway apron needs to be sealed up. The masonry is cracked and missing. Recommend further evaluation for repairs by a qualified, licensed contractor.

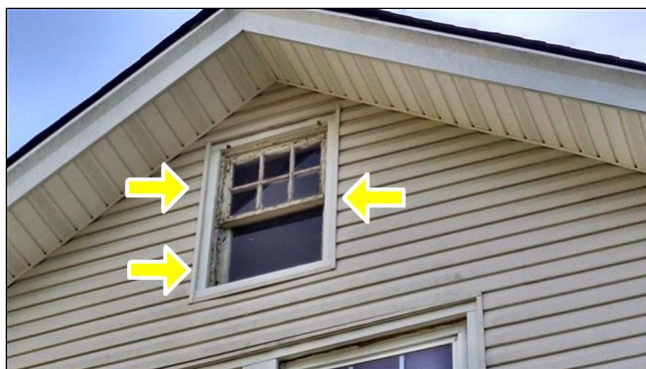
(1) The paint is peeling off of the wood trim around the old attic wood windows. If the trim is not caulked and painted, the trim could deteriorate. Also it appears there were new vinyl windows installed in the rear bedroom and they were not flashed properly on the exterior. There are some flashing pieces missing. Recommend further evaluation for repairs by a qualified, licensed contractor.

2.3 Item 1(Picture) Attic windows

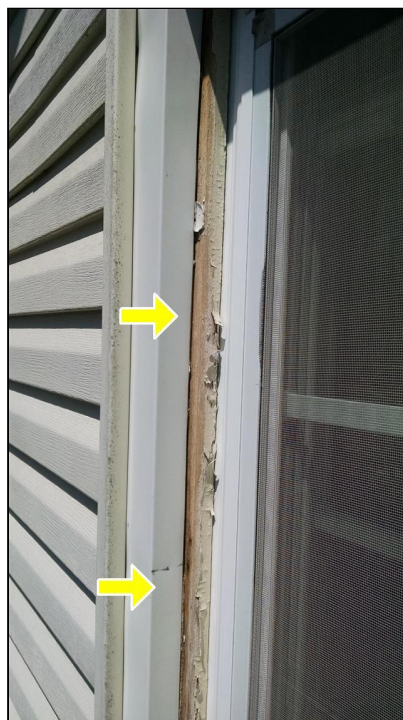
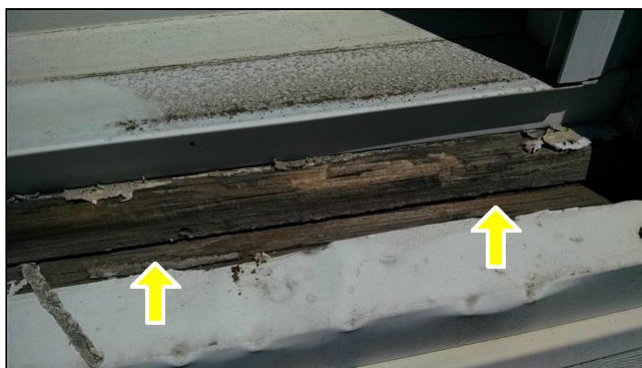
2.3 Item 2(Picture) Rear bedroom window

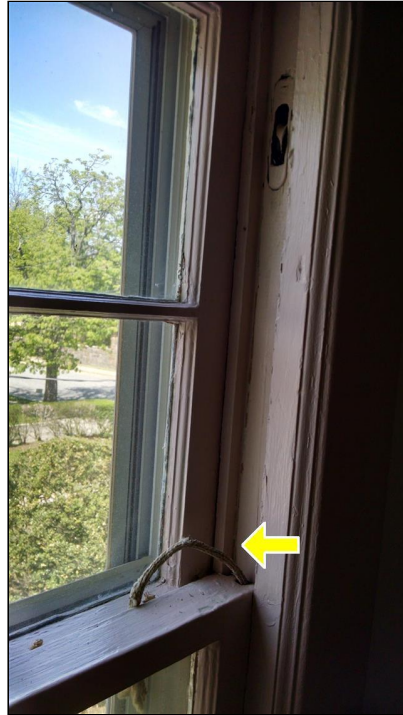
2.3 Item 4(Picture)

(2) The exterior window in the staircase leading to the 2nd floor has a broken window sash pulley cord. The window would not open. Recommend further evaluation for repairs by a qualified, licensed contractor.

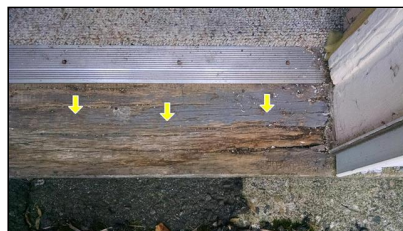
2.4 Item 1(Picture)

(1) The door threshold on the side exterior door is deteriorating. It is worn from the elements and the paint is peeling. Recommend further evaluation for repairs by a qualified, licensed contractor.

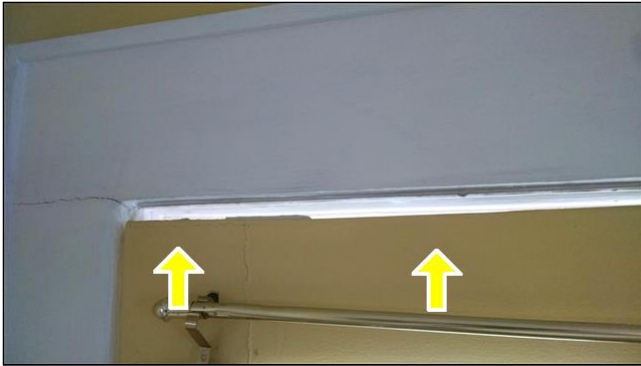
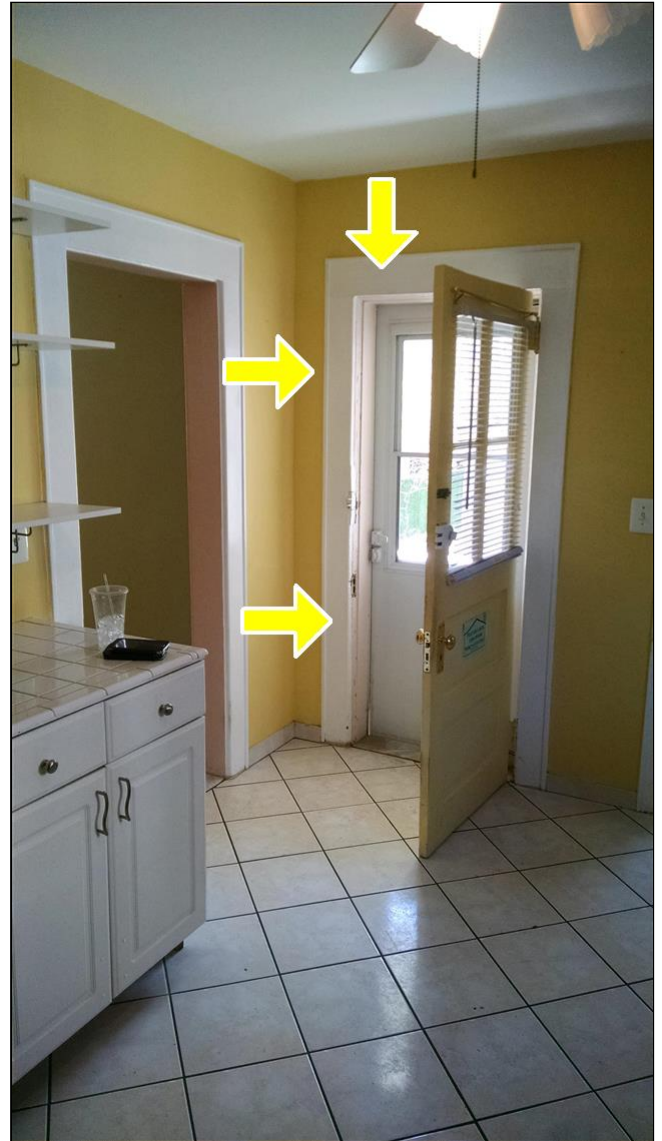
(2) The rear exterior wood door is not closing properly. There is a big gap on the top and the door is not fitting properly in the door frame. Recommend further evaluation for repairs by a qualified, licensed contractor.

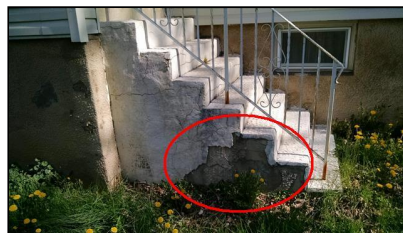
2.6 Item 1(Picture)

(1) There appears to be 3 layers of masonry parging on the rear set of masonry steps that is cracking and peeling off. If not repaired the structure of the steps could be compromised. Recommend further evaluation for repairs by a qualified, licensed contractor.

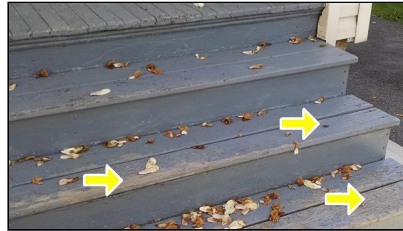
2.6 Item 2(Picture)

(2) The boards on the front set of steps are loose and the paint is peeling off them. This is a safety hazard as someone could trip or fall if the board came off. Also the wood could deteriorate if not covered with an appropriate paint coating. Recommend further evaluation for repairs by a qualified, licensed contractor.

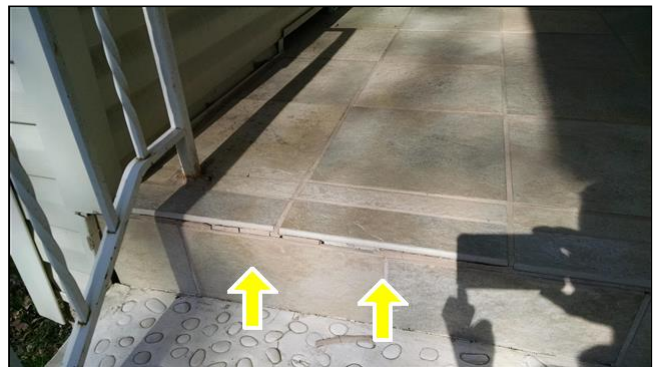
The rear porch is covered with what appears to be ceramic tile with large grout joints. The grout at the riser joint (at the top of the steps) is cracking and coming apart. There are also several loose tiles in this area. It appears whomever installed these tiles just installed them over what might have been the original wood porch boards. Also the client stated there was water damage to the ceiling in the shower area of the basement bathroom that is located below this porch. Grout joints are porous and this configuration (tile with grout joints installed outdoors exposed to the weather) without an appropriate water proofing membrane underneath may lead to moisture intrusion into the interior. The water damage to the ceiling was repaired and there was no visible water damage at the time of the inspection. Recommend further evaluation for repairs by a qualified, licensed contractor.

2.9 Item 2(Picture) Grout joints cracked and tiles loose

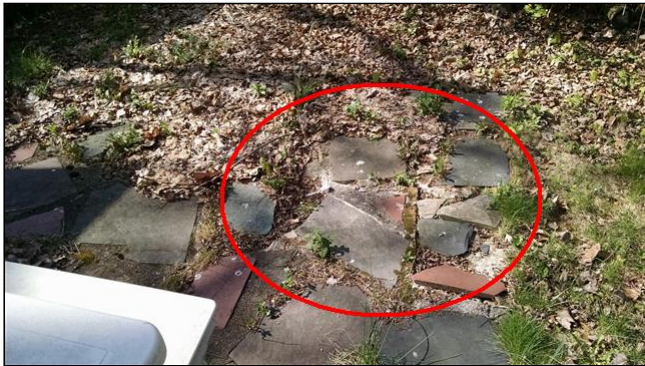
2.10 Item 1(Picture)

The masonry portion of patio located in the rear yard is deteriorated and cracked in several areas. This could be a trip hazard. Recommend further evaluation for repairs by a qualified, licensed masonry contractor.

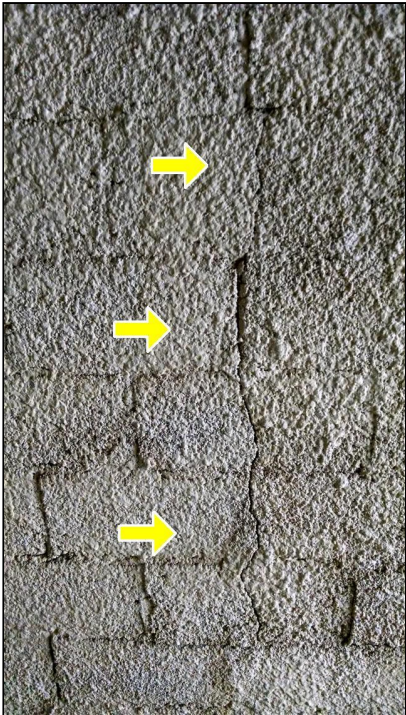
3.8 Item 1(Picture)

The right side masonry block interior wall of the garage has a vertical crack visible. This crack should be sealed up and monitored. Recommend further evaluation for repairs by a qualified, licensed contractor.

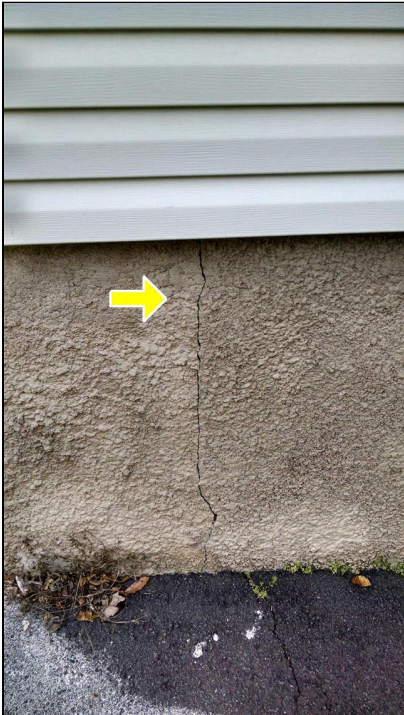
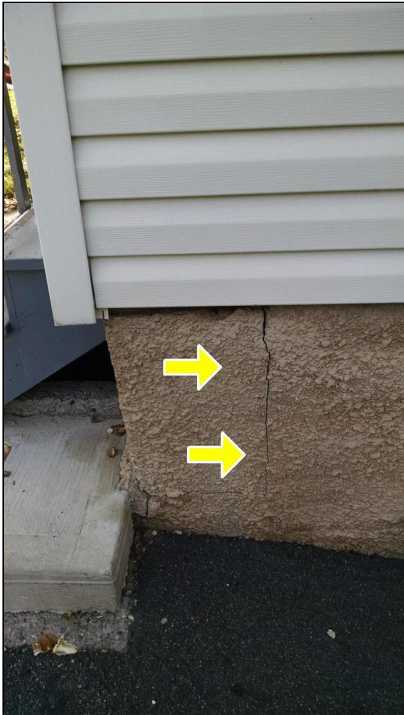
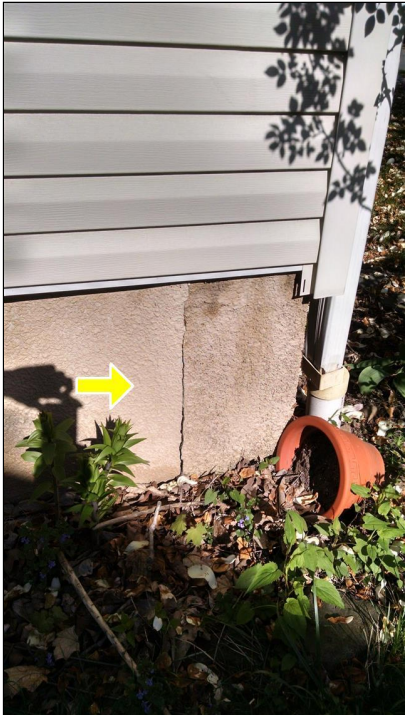
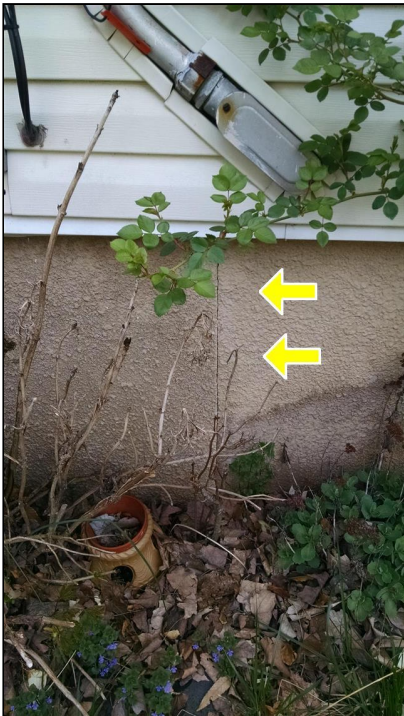
(1) There were numerous vertical cracks visible in the exterior wall surface of the foundation. These cracks could let water into the foundation walls and which may deteriorate the walls and the interior of the dwelling. The

locations are noted on the corresponding pictures. Recommend further evaluation for repairs by a qualified, licensed contractor.

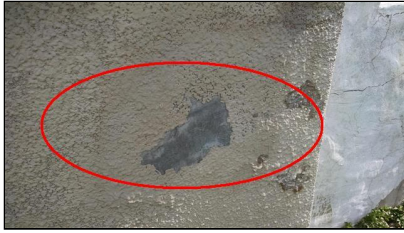
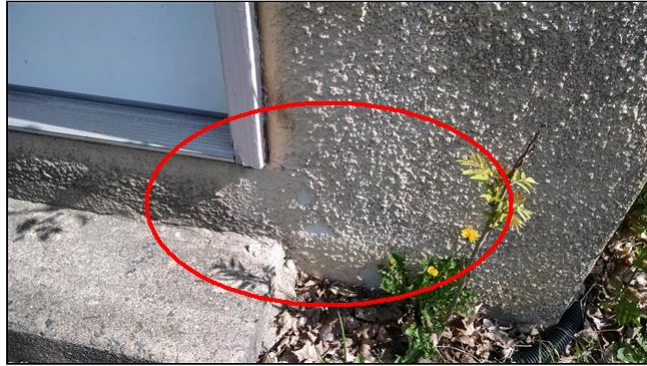
(2) The parging on the rear exterior foundation wall in several areas is flaking off. If not repaired, this could lead to deterioration of the foundation walls. Recommend further evaluation for repairs by a qualified, licensed contractor.

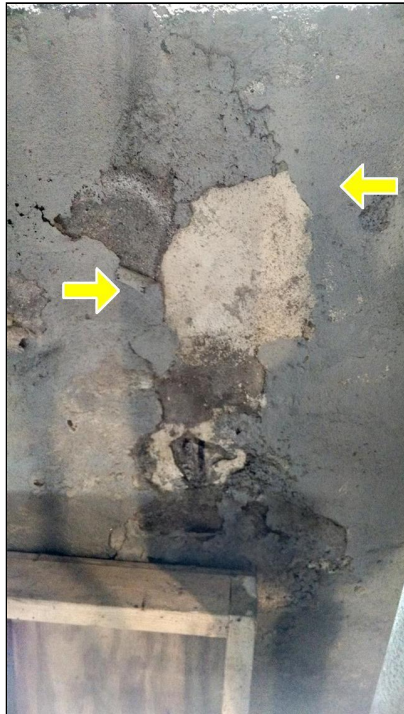
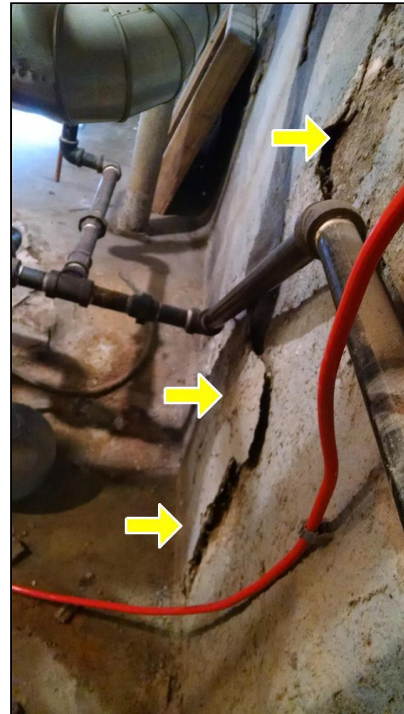
(1) The paint and parging on the interior foundation wall in the boiler area in the basement is flaking off in some areas along with small fragments of the masonry block. This is usually caused by water/moisture coming through the masonry block walls. Further deterioration of the block could occur if this isn't addressed. Recommend further evaluation for repairs by a qualified, licensed contractor.

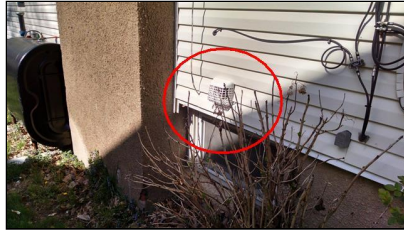
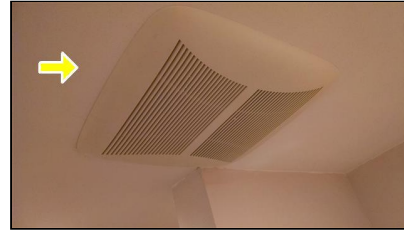
(2) There was a bathroom type exhaust fan present in the basement ceiling in the area at the bottom of the basement stairs. The fan was vented out the left side of the house. But, in the vent piping leading to the side of the house, there was a in-line duct fan installed to pull air into the home and apparently out of the exhaust fan in the ceiling. The duct fan was hooked up to a wall switch on the wall. When tested, the duct fan operated but no air was coming out of the grate nor was the squirrel cage fan in the ceiling exhaust fan spinning. Recommend further evaluation for repairs by a qualified, licensed electrician.

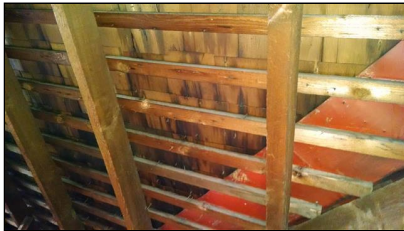
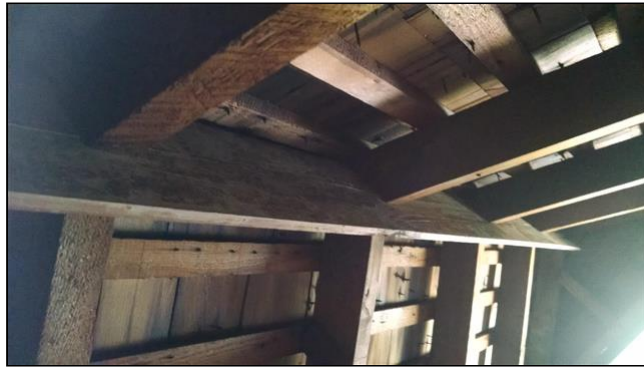
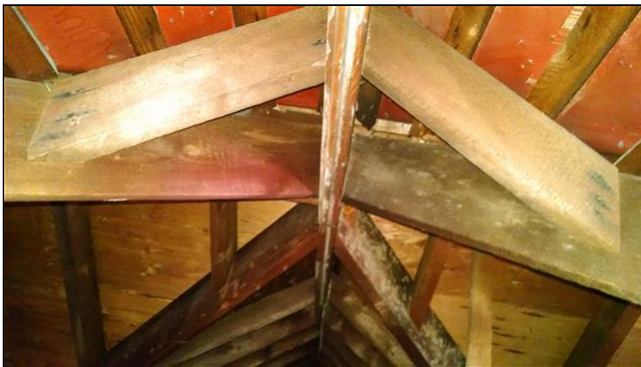
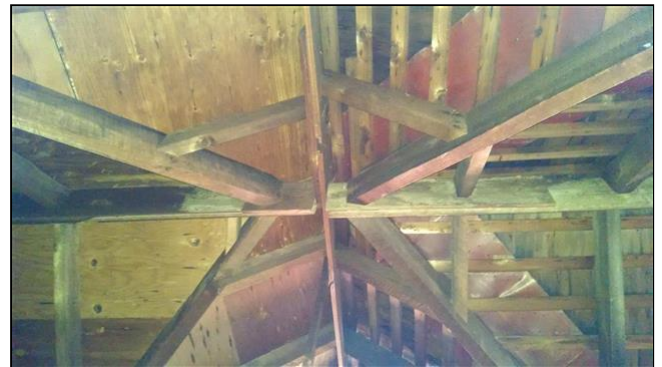
The roof structure was constructed with 1 3/4"x4" (actual measurement) wood rafters that varied from 19" to 24" on center. The wood ridge board measured 3/4"x7" (actual measurement). The ridge board was doubled up where all of the roof planes meet. There was plywood decking on the front portion of the main roof and what appeared to be the original wood shake roof (used as decking) on the rear portion of the main roof. By today's standards the roof structure framing is undersized. The roof structure could be compromised by the weight of the numerous roof layers present and a heavy snow/ice load during the winter months. I recommend consulting a qualified, licensed contractor with structural experience for their evaluation and opinion.

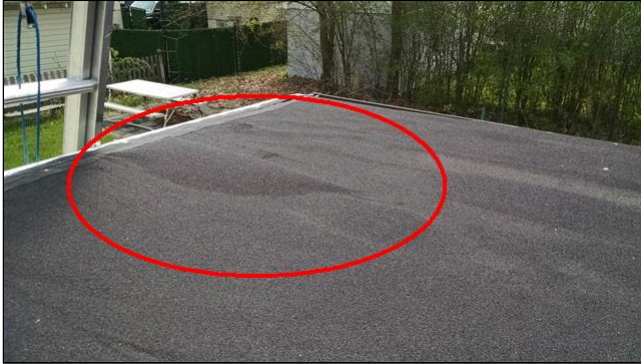
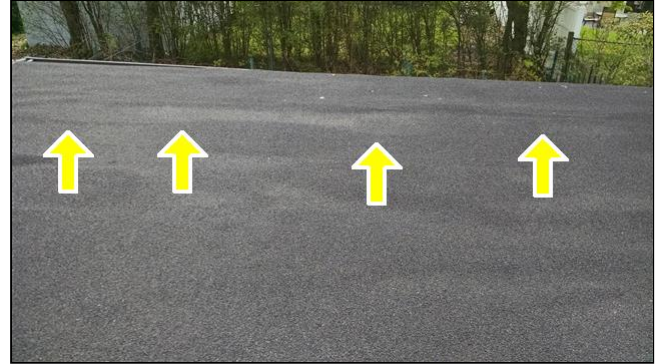
(1) The flat rolled roof over the rear portion of the garage has several areas that are lifting up. If the covering in these areas were compromised, it could lead to moisture intrusion into the interior. It doesn't appear the roof was

leaking into the interior at the time of the inspection. Recommend further evaluation for repairs by a qualified, licensed roofing contractor.

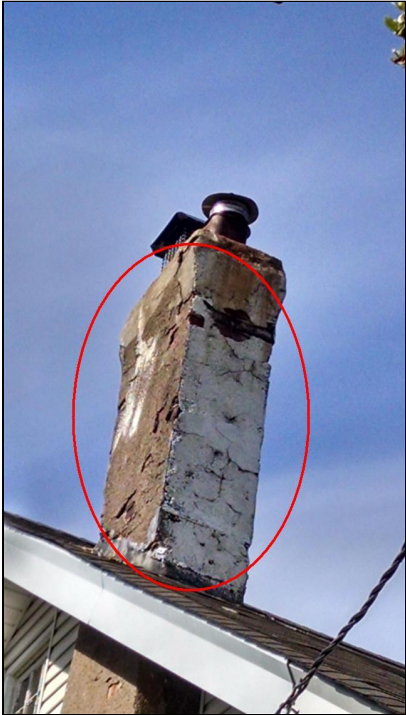
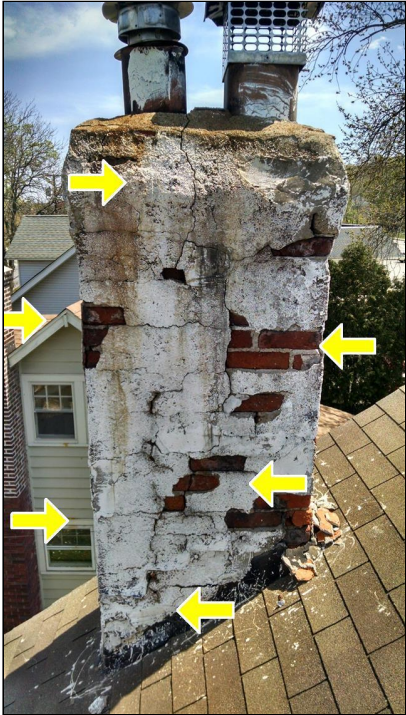
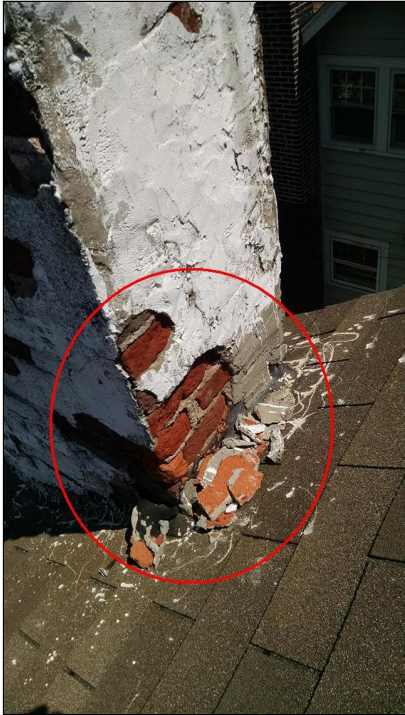
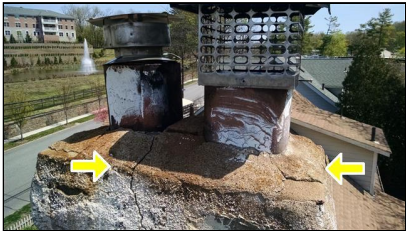
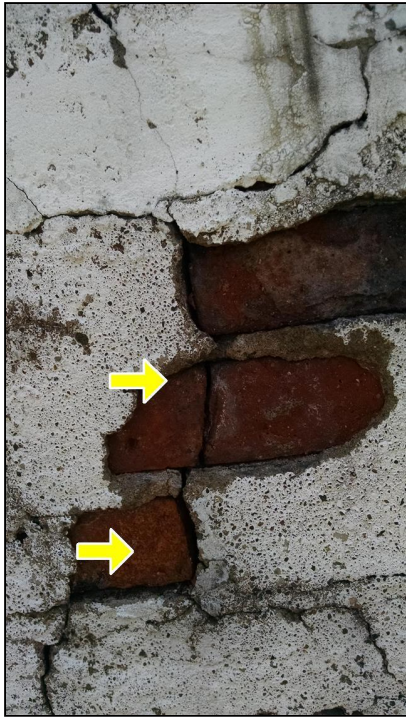
(1) The chimney above the roofline is severely deteriorated. The parging is cracked and peeling, there are several cracked bricks visible, the crown has numerous cracks and there are several bricks that are spalling. This condition could lead to moisture intrusion into the interior walls, ceilings, fireplace and the hot water heater and heating system boiler vent pipes. Recommend further evaluation for repairs by a qualified, licensed chimney professional.

6.5 Item 2(Picture) Parging missing/cracked

6.5 Item 3(Picture) Bricks spalling

6.5 Item 4(Picture) Crown cracked

6.5 Item 5(Picture) Bricks cracked

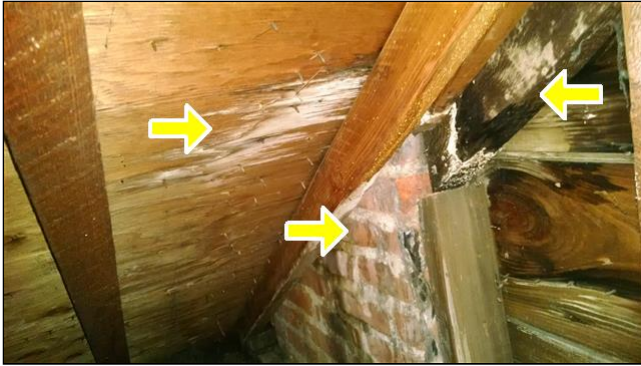
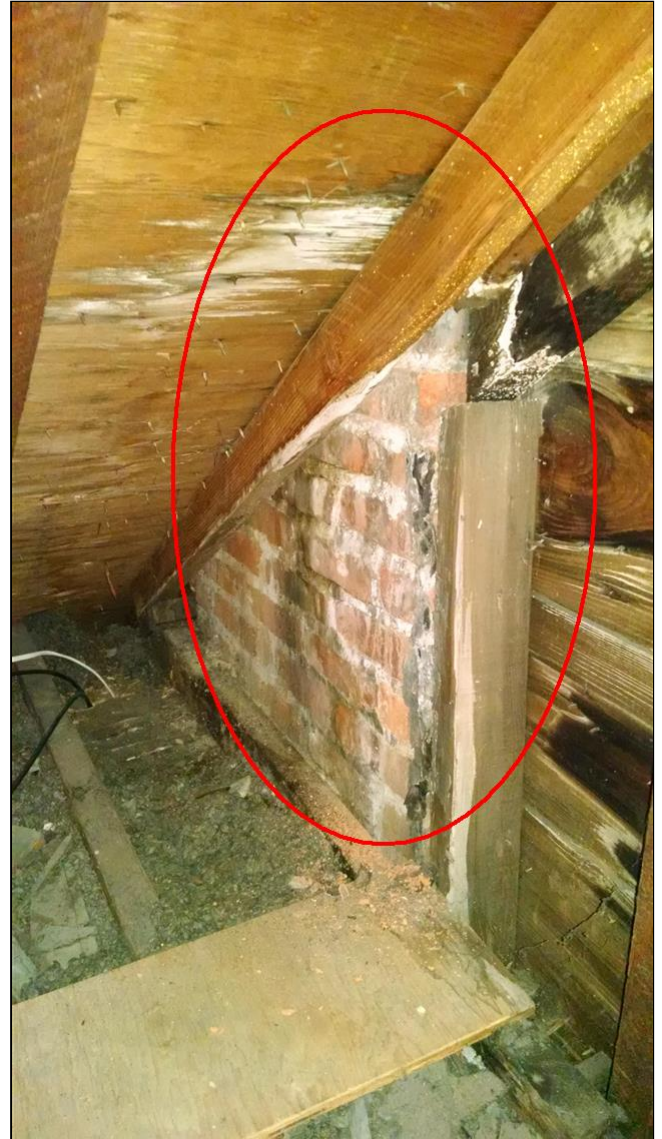
(2) There appears to be water damage to the roof structure and decking in the area below the chimney. Recommend further evaluation for repairs by a qualified, licensed contractor.

6.5 Item 6(Picture) View from attic

6.5 Item 7(Picture) View from attic

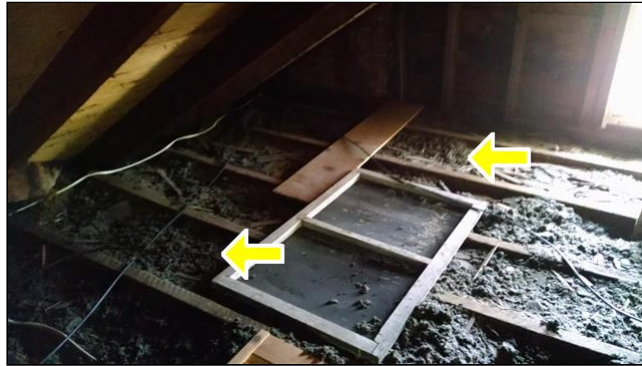
7.2 Item 1(Picture)

The blown in insulation installed in the floor joist bays is inadequate in some areas. Recommend adding some additional insulation to reduce energy expenses and prevent condensation/mold in the attic space by reducing the

heat loss from the living space to the attic space. Recommend further evaluation for repairs by a qualified, licensed contractor.

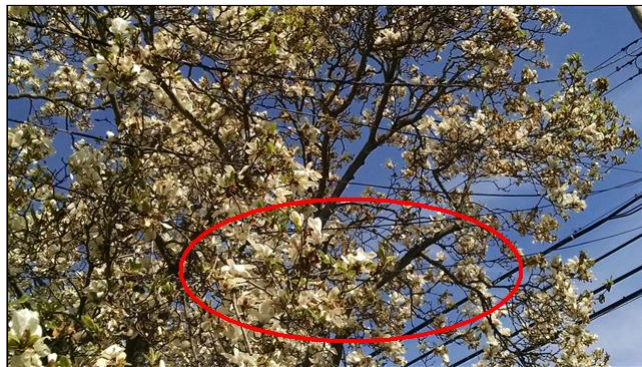
8.0 Item 1(Picture)

The branches on the tree in the front of the house are growing into the overhead electric service entrance wires. These branches should be trimmed away from the wires. PSE&G should be called because these wires are their responsibility. There should be no charge for this service.

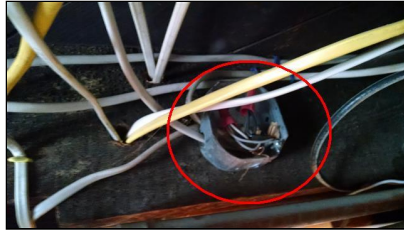
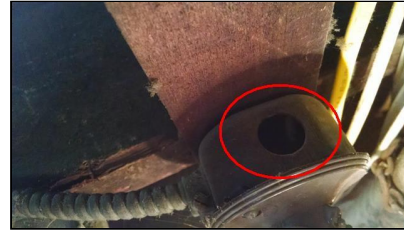
(1) There are two junction boxes located above the boiler in the basement that are missing covers. Also, the light fixture box in the same area is missing a side knockout. These are all safety issues. Recommend further evaluation for repairs by a qualified, licensed electrician

8.7 Item 1(Picture) Missing cover

8.7 Item 2(Picture) Light fixture missing knockout
