Property Inspection Report

Property Address:
503 First Street
Inspectionville NJ 07000

Terra Home Inspections LLC

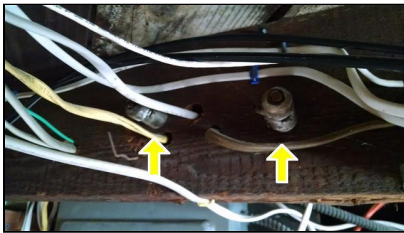
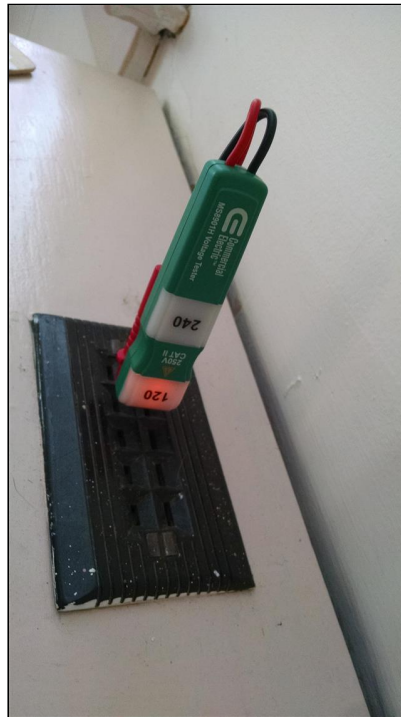
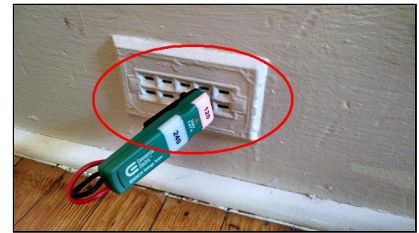
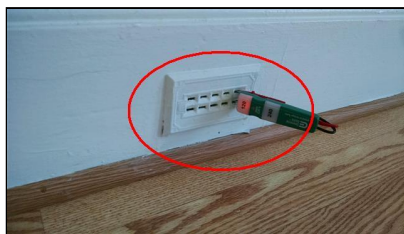
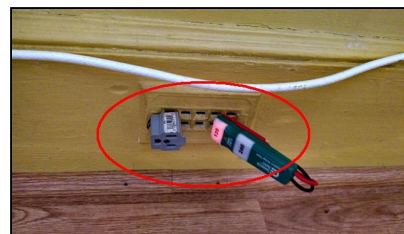
(2) There was a few old porcelain insulators that were used for the original knob and tube wiring visible in the basement above the electric service panel. While there was no knob and tube wiring visible in the unfinished area of the basement or elsewhere in the house, it still may be in the walls feeding the what appears to be the original 2 prong electric outlets located in the living room and the front and middle bedrooms. These outlets were still live. Knob and tube wiring is inadequate for today's electrical needs and is a fire risk. In addition to recommending these outlets be upgraded, a qualified, licensed electrician should be consulted to ascertain what type of wiring is feeding these outlets just to be on the safe side.

8.7 Item 3(Picture) Knob and tube wiring porcelain insulators

8.7 Item 4(Picture) Live outlet above fireplace

8.7 Item 5(Picture) Live outlet in living room wall

8.7 Item 6(Picture) Live outlet in middle bedroom wall

8.7 Item 7(Picture) Live outlet in front bedroom wall

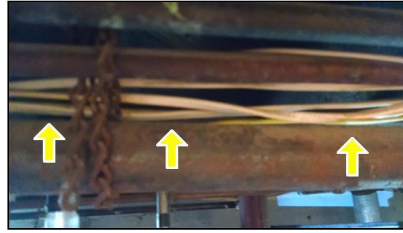
8.7 Item 8(Picture)

(3) The electric wires above the boiler in the basement should be fastened so they are not touching the hot heating distribution pipes. Recommend further evaluation for repairs by a qualified, licensed electrician

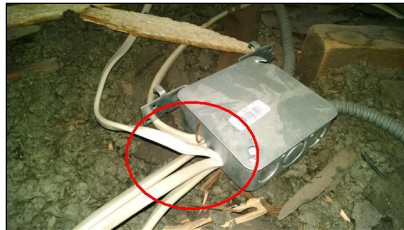
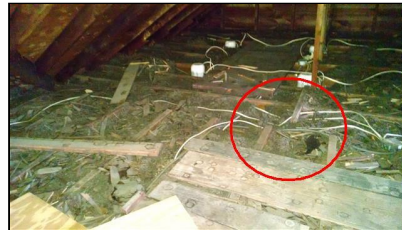
(4) There was an electrical junction box located in the attic that had 7 wires entering it, 5 of which are not fastened with the required connectors. In addition, you shouldn't have numerous wires entering the box in a single hole. This is a safety issue and a fire hazard. Recommend further evaluation for repairs by a qualified, licensed electrician.

8.7 Item 9(Picture) Wires entering the box

8.7 Item 10(Picture) Electric box location in attic

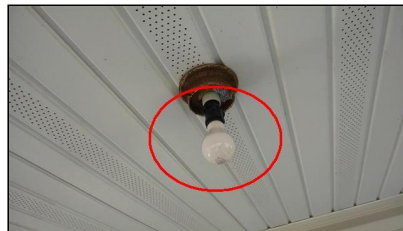
8.8 Item 1(Picture)

(1) The front and rear porch exterior light fixtures are missing the glass light globes that protect the light bulb and the fixture from the elements. This is a safety hazard. Recommend further evaluation for repairs by a qualified, licensed electrician.

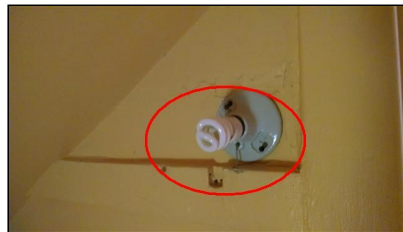
8.8 Item 2(Picture)

(2) The pull chain on the light fixture in the front bedroom closet is not functioning. Recommend further evaluation for repairs by a qualified, licensed electrician

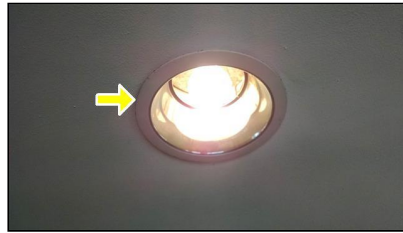
8.8 Item 3(Picture)

(3) The recessed lights in the front bedroom has different types of light bulbs in them which do not appear to be the required light bulbs for these types of fixtures. The required bulbs should be installed for safety reasons. Recommend further evaluation for repairs by a qualified, licensed electrician

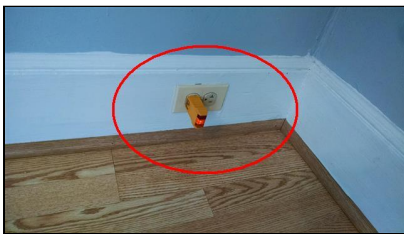
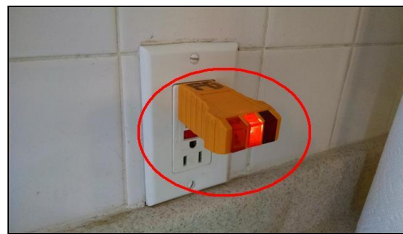
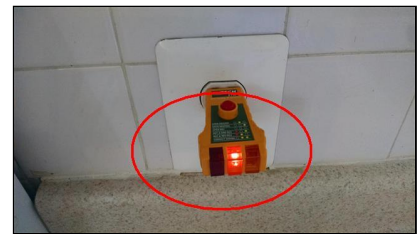
(4) There were numerous electrical outlets located in the kitchen countertop area in addition to all of the 3 prong outlets in all 3 of the bedrooms that had an open ground condition. This happens when the ground wire is not connected properly to the outlet or is broken upstream from an outlet. This condition creates a potential shock and safety hazard. Recommend further evaluation of the entire electrical system for repairs by a qualified, licensed electrician.

8.8 Item 4(Picture) Rear bedroom

8.8 Item 5(Picture) Kitchen GFCI outlet

8.8 Item 6(Picture) Kitchen outlet

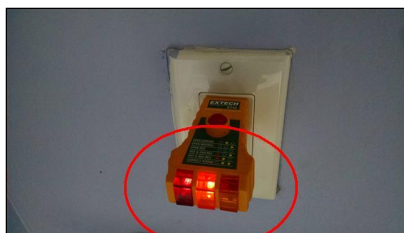
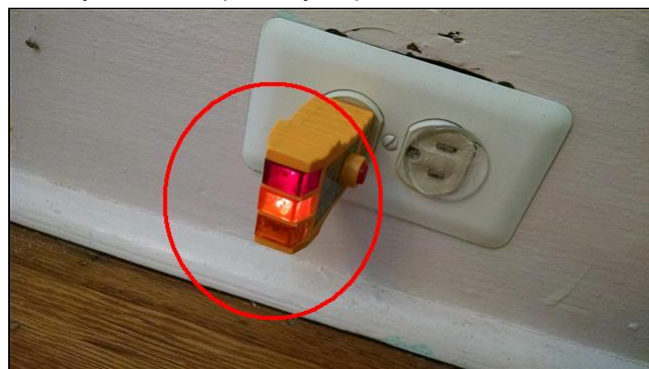
(5) There were numerous electrical outlets located in the dining room and 1st floor bathroom that had a reversed polarity condition. This happens when the hot and neutral wires get flipped around at an outlet or upstream from an outlet. Reversed polarity creates a potential shock hazard. Locations are marked on the corresponding pictures. Recommend further evaluation of the entire electrical system for repairs by a qualified, licensed electrician.

8.8 Item 7(Picture) Bathroom GFCI outlet

8.8 Item 8(Picture) Dining room outlet

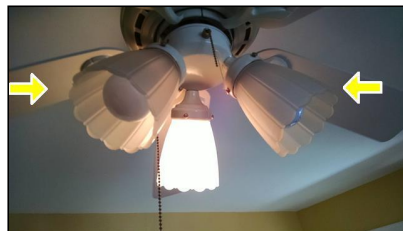
8.8 Item 9(Picture)

(6) The light fixture in the kitchen appeared to have 2 burned out bulbs. Recommend replacing the bulbs. If they still do not function, a qualified, licensed electrician should be consulted.

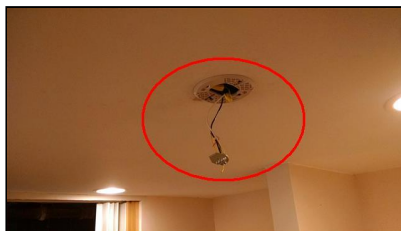
8.10 Item 1(Picture)

There was a hard wired smoke detector missing in the basement. Recommend further evaluation for repairs by a qualified, licensed electrician.

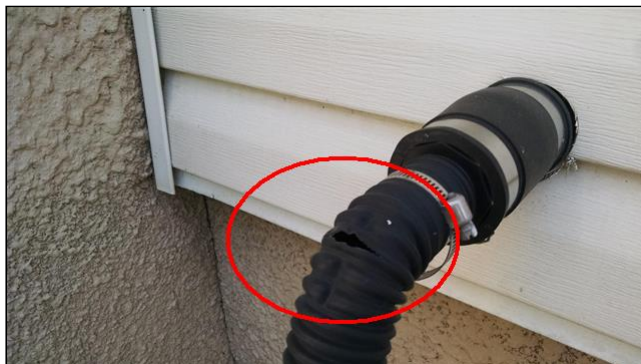
9.5 Item 1(Picture)

The discharge hose for the sump pump is cracked and is spraying water on the side of the hose when the water is discharged by the sump pump. The water should be getting discharged at least 6 feet away from the house. Recommend further evaluation for repairs by a qualified, licensed contractor.

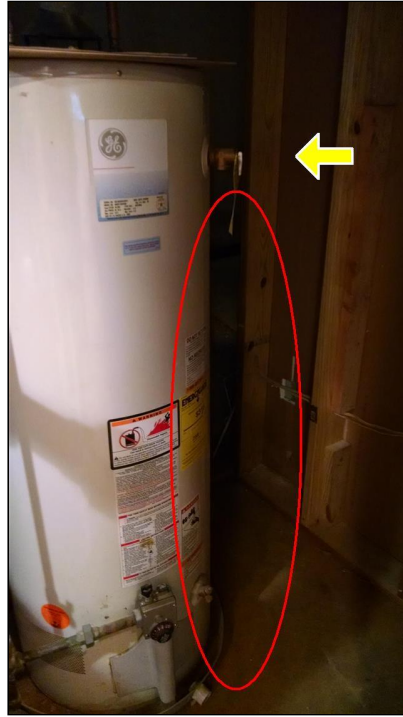
10.2 Item 1(Picture)

The TPRV discharge tube is missing from the hot water heater. This tube is needed and should be present in case the TPRV discharges hot water that could scald someone if they were in the area of the heater. Recommend further evaluation for repairs by a qualified, licensed plumber.

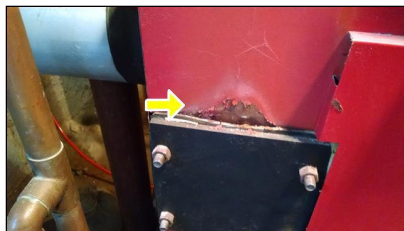
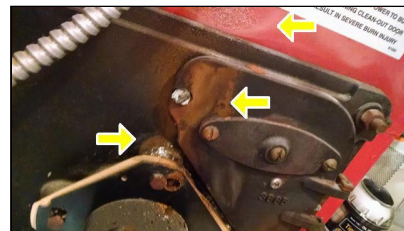
There was some scorching visible on the front of the boiler above the burner and also above the left side cover plate. Also, the boiler would not operate under normal controls and therefore could not be tested. The burner would not light off. It appeared to be out of fuel. The fuel oil storage tank was empty. The client stated they observed the boiler functioning when they looked at the house. Recommend further evaluation of the entire boiler by a qualified, licensed HVAC professional.

11.0 Item 1(Picture) Left side cover plate

11.0 Item 2(Picture) Above burner in front

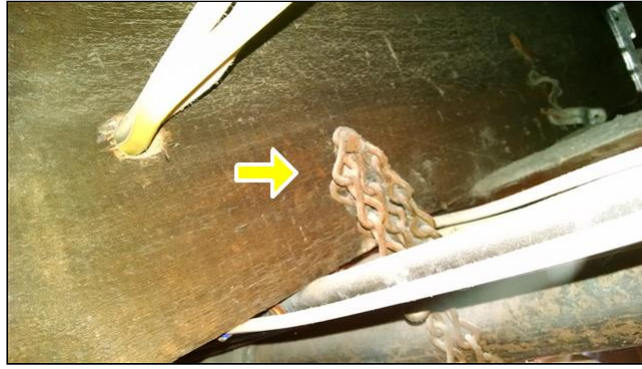
11.1 Item 1(Picture)

The heating distribution pipes located above the boiler were being supported by a chain hanging on a nail. The required strapping should be used. Recommend further evaluation for repairs by a qualified, licensed HVAC professional.

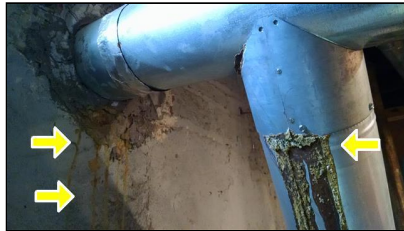
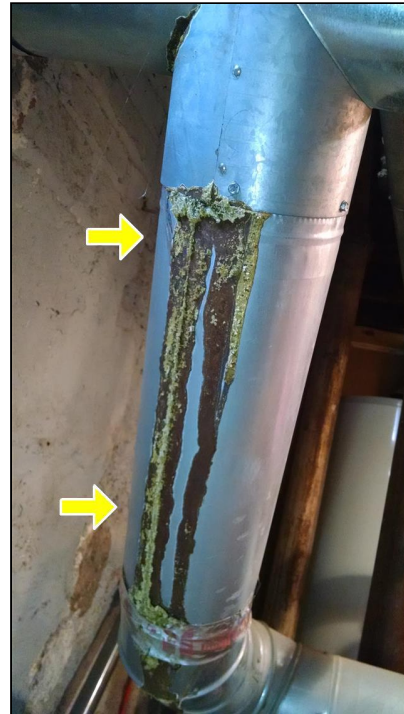
There was what appears to be moisture leaking out of the boiler vent pipes and also down the interior basement wall under the vent pipe where it enters into the chimney flue. This could either be condensation forming inside the vent pipe and/or chimney flue or water leaking into the chimney flue somewhere on the exterior. Recommend further evaluation for repairs by a qualified, licensed HVAC professional.

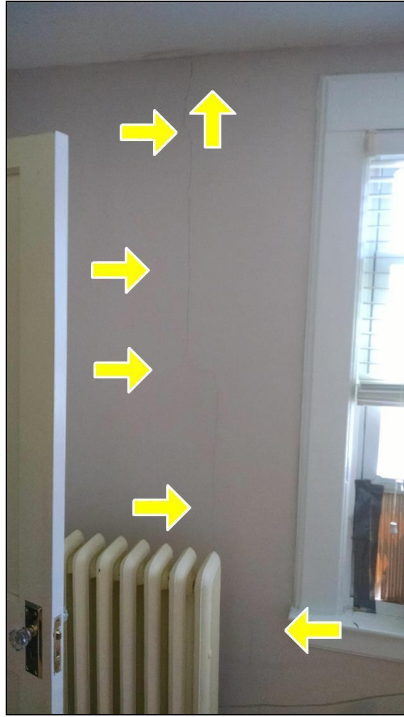
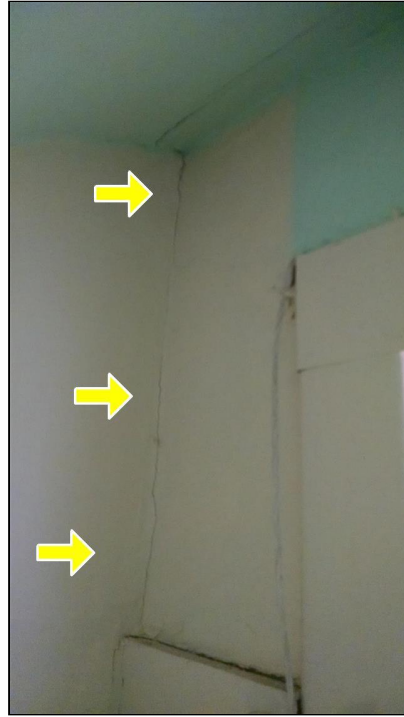
There was a vertical crack visible in the wall surface of the interior wall next to the chimney in the middle bedroom. The closet also had a vertical crack in the same area. There was also some what appeared to be some water damage to a small portion of the ceiling in the same area. These cracks should be repaired and monitored. Recommend further evaluation for repairs by a qualified, licensed contractor.

13.2 Item 1(Picture) Middle bedroom wall

13.2 Item 2(Picture) Middle bedroom closet

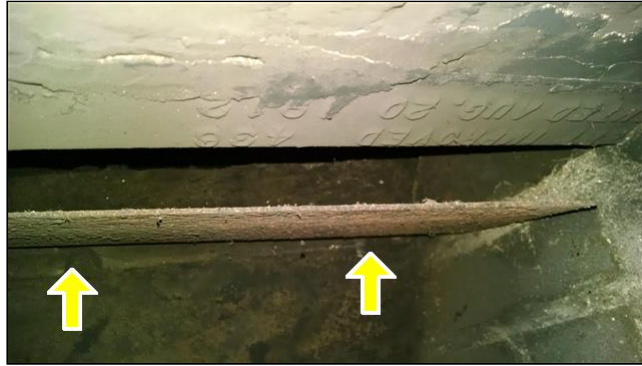
13.8 Item 2(Picture)

(2) The fireplace damper was not functioning properly. It appears to not be sitting in the pivot slots in the back of the fireplace damper frame. This is a safety issue and should be repaired before the fireplace is used. Recommend further evaluation for repairs by a qualified, licensed chimney professional.

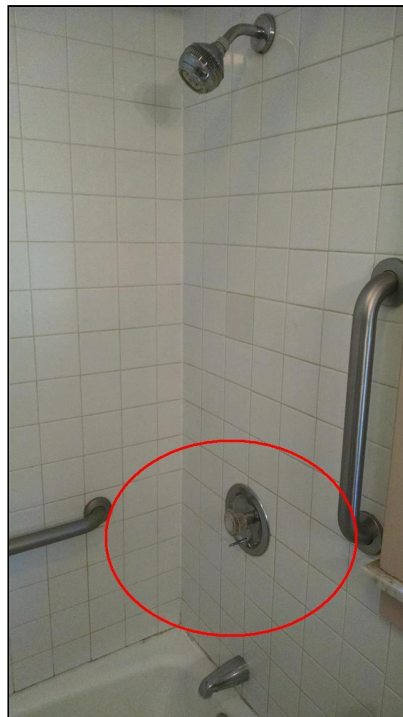
14.5 Item 1(Picture)

The shower water diverter in the 2nd floor bathroom was not functioning. I couldn't get any water to come out of the showerhead when the tub water was running and the diverter was activated. The diverter diverts the water from the tub spout to the showerhead when activated. Recommend further evaluation for repairs by a qualified, licensed plumber.
