**CASE STUDY  
ANALYSIS OF CENTRIFUGAL FAN HIGH AMPLITUDE VIBRATION**

**Abstract:** A request was received to determine the root cause of very high amplitude vibration of a spray dryer fan. The fan was an AMCA Arrangement 8, 500 Hp. The fan's vibration amplitudes had reportedly been trending up. Balancing the fan had not reduced vibration to acceptable levels. The analysis used visual inspection, vibration data, operating deflection shape analysis (ODS) and experimental modal analysis to determine the root causes. Problems identified included operation at the 1<sup>st</sup> critical speed of the fan rotor, anchor bolt failures, loose bolting, improperly sized bolting, improperly installed anchor bolts, lack of grouting during installation, extensive corrosion and erosion of the fan housing. Recommendations were provided to properly install anchor bolts and steel reinforcement to anchor the fan to the foundation. This article discusses the findings of the inspection and vibration analysis process. The client decided not to install the recommended base stiffening but rather to replace the fan.

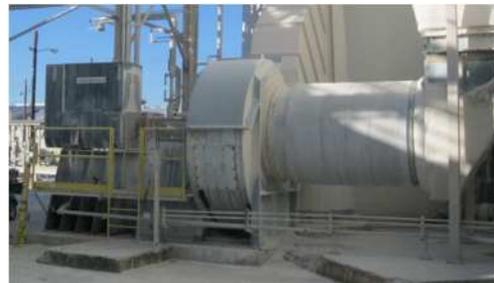
**Figure 1. AMCA Arrangement 8 Fan.**

**Background:** The AMCA Arrangement 8 fan, shown in **Figure 1**, had an operating speed of 1195 RPM, direct driven by a 500 HP motor using a Rexnord Omega coupling. The fan capacity was 84,000 CFM. The fan base was fabricated of A36 HRS (hot rolled steel) and bolted directly to a concrete foundation with no grout. The wheel hub fit to the shaft was a straight interference fit, using set screws and an end cap. It was reported that the fan's vibration had been steadily increasing and anchor bolts had broken. It was also reported that the fan was recently balanced.

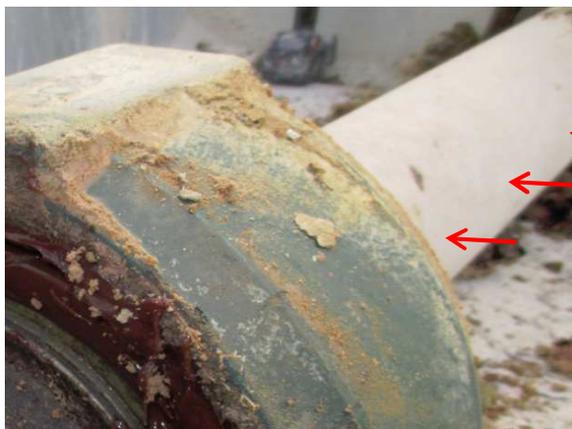
**Figure 14. Portion of Fan Shaft Showing Location of Modal Test Points.**

FRF were also measured at five locations along the fan shaft, see **Figure 14**. The FRF were curve to determine the mode shape of the rotor natural frequencies near run speed. The shaft natural frequency mode shape is shown in **Figure 16**. The mode shape showed little flexure of the shaft was occurring. This indicated that the rotor mode (1<sup>st</sup> critical) was primarily controlled by the low stiffness of the bearings & pedestal due to loose anchor bolting.

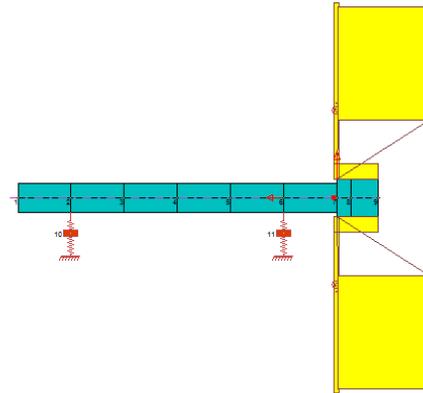
**Figure 17. Example of Overhung Fan Rotor Model.**

To more clearly illustrate what we were looking for in the modal test data, a model of an overhung fan is used to illustrate the expected response. A rotor dynamic model of a typical overhung fan is shown in **Figure 17**. This model is not of this particular fan but is similar. The fan 1<sup>st</sup> critical mode shape calculated by the rotor modeling software has the mode shape shown in **Figure 18**. This is similar to the shape measured by the modal data FRF, **Figure 16**, except that the measured mode shape shows very little shaft flexure due to the low support stiffness.

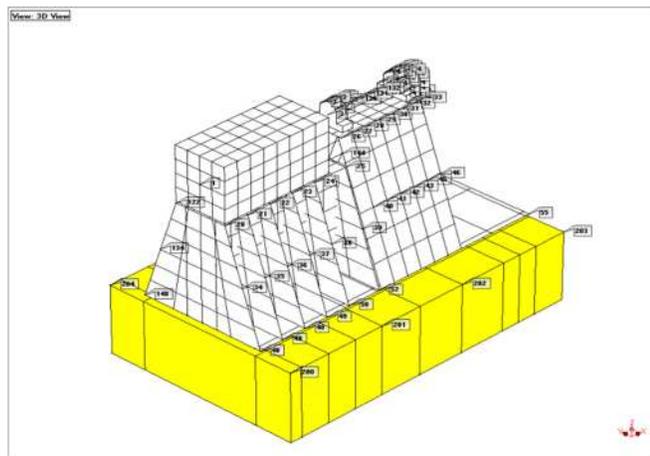
**Figure 19. Fan Model Developed in ME'scopeVES.**

**Fan ODS:** Cross channel vibration data were measured at various locations on the motor, fan base and concrete for an ODS. The vibration data were measured using a CSI 2130 2 channel analyzer, uploaded to AMS software then the ODS FRF exported to ME'scopeVES software. The model, shown in **Figure 19**, was developed using ME'scopeVES software. Vibration amplitude is labeled for several points on the model shown in **Figure 20**.

The vibration shape or pattern was rocking side-to-side, pivoting about a centerline just above the surface of the concrete base. The motor and wheel end bearing exhibited movement relative to the bearing support plate confirming loose attachment.

There was very low amplitude vibration of the concrete pad indicating it had very little participation in the fan vibration.
