**DESCRIPTION OF SERVICE
UNITED STATES PEACE CORPS RESPONSE
PHILIPPINES**

Assessment of Groundwater Resources: Field Survey Results in
Guiuan, Eastern Samar, Philippines

William Thurman Nutt, Jr.

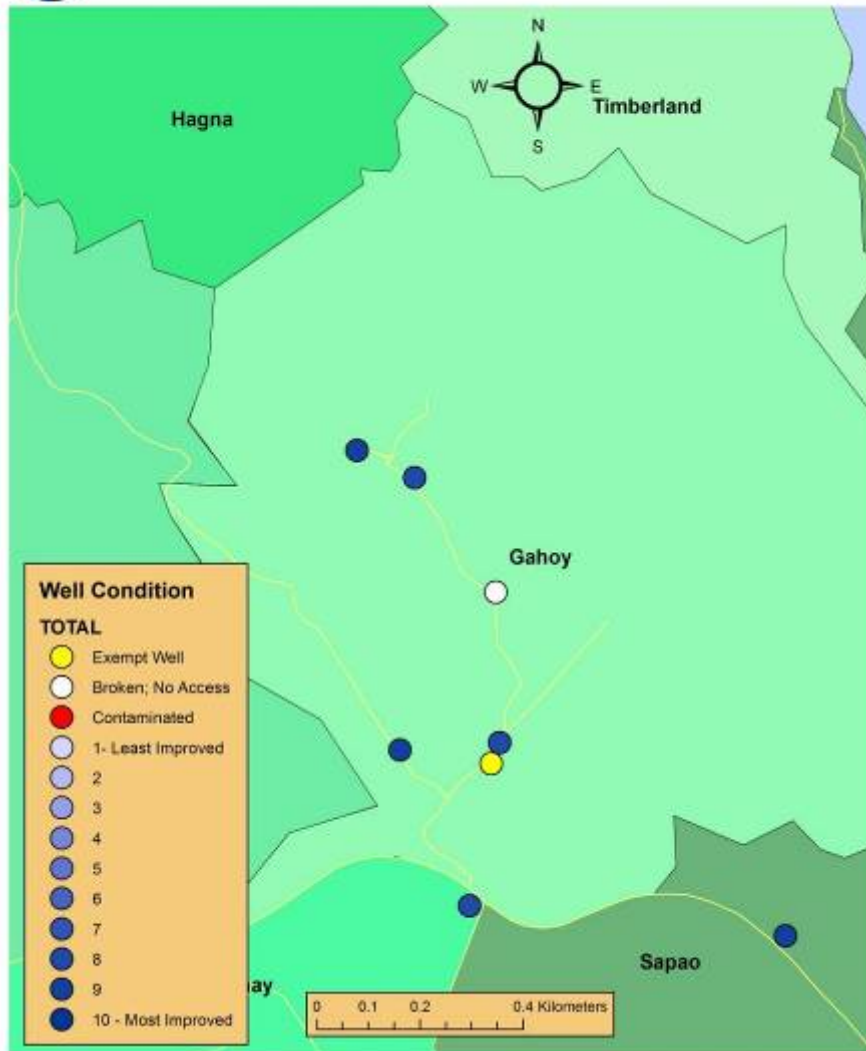
Number of Wells Sampled: 4
Average Improvement Score: 8.5
Issues: Development of sources.
Priorities: none major
Gahoy is served by the MWS so locally supplied water less of an issue. Well-01, is suggested for preservation, however, it still needs to be improved to prevent contamination of the water table. It is located at the end of a major recharge area and protections such as well drained usage areas and other impervious surfaces need to be installed. The private well with the motor on top is inaccessible in its current configuration. Perhaps the property owner can be encouraged to reconfigure the motor and piping to provide for contingent uses in addition to provide for serviceability.
