COAL MINING RISK ASSESSMENT
NEATH PORT TALBOT C.B.C.
PRE-PLANNING REF. Q2020/0185
PROPOSED COMMERCIAL DEVELOPMENT
MARDON PARK
BAGLAN ENERGY PARK
PORT TALBOT
N.P.T.
SA12 7AX
15/04/2021

INTRODUCTION

G.B.V. Properties are applying to Neath Port Talbot C.B.C. for full planning permission to construct a light industrial unit with a 20,000 sq.ft. floorspace at Mardon Park, Baglan. As this is classed as a major development there has been a P.A.C. process carried out. In response to initial enquiries N.P.T. responded with a letter dated 18/12/2020. This has the pre-app. Reference Q2020/0185 and states:-

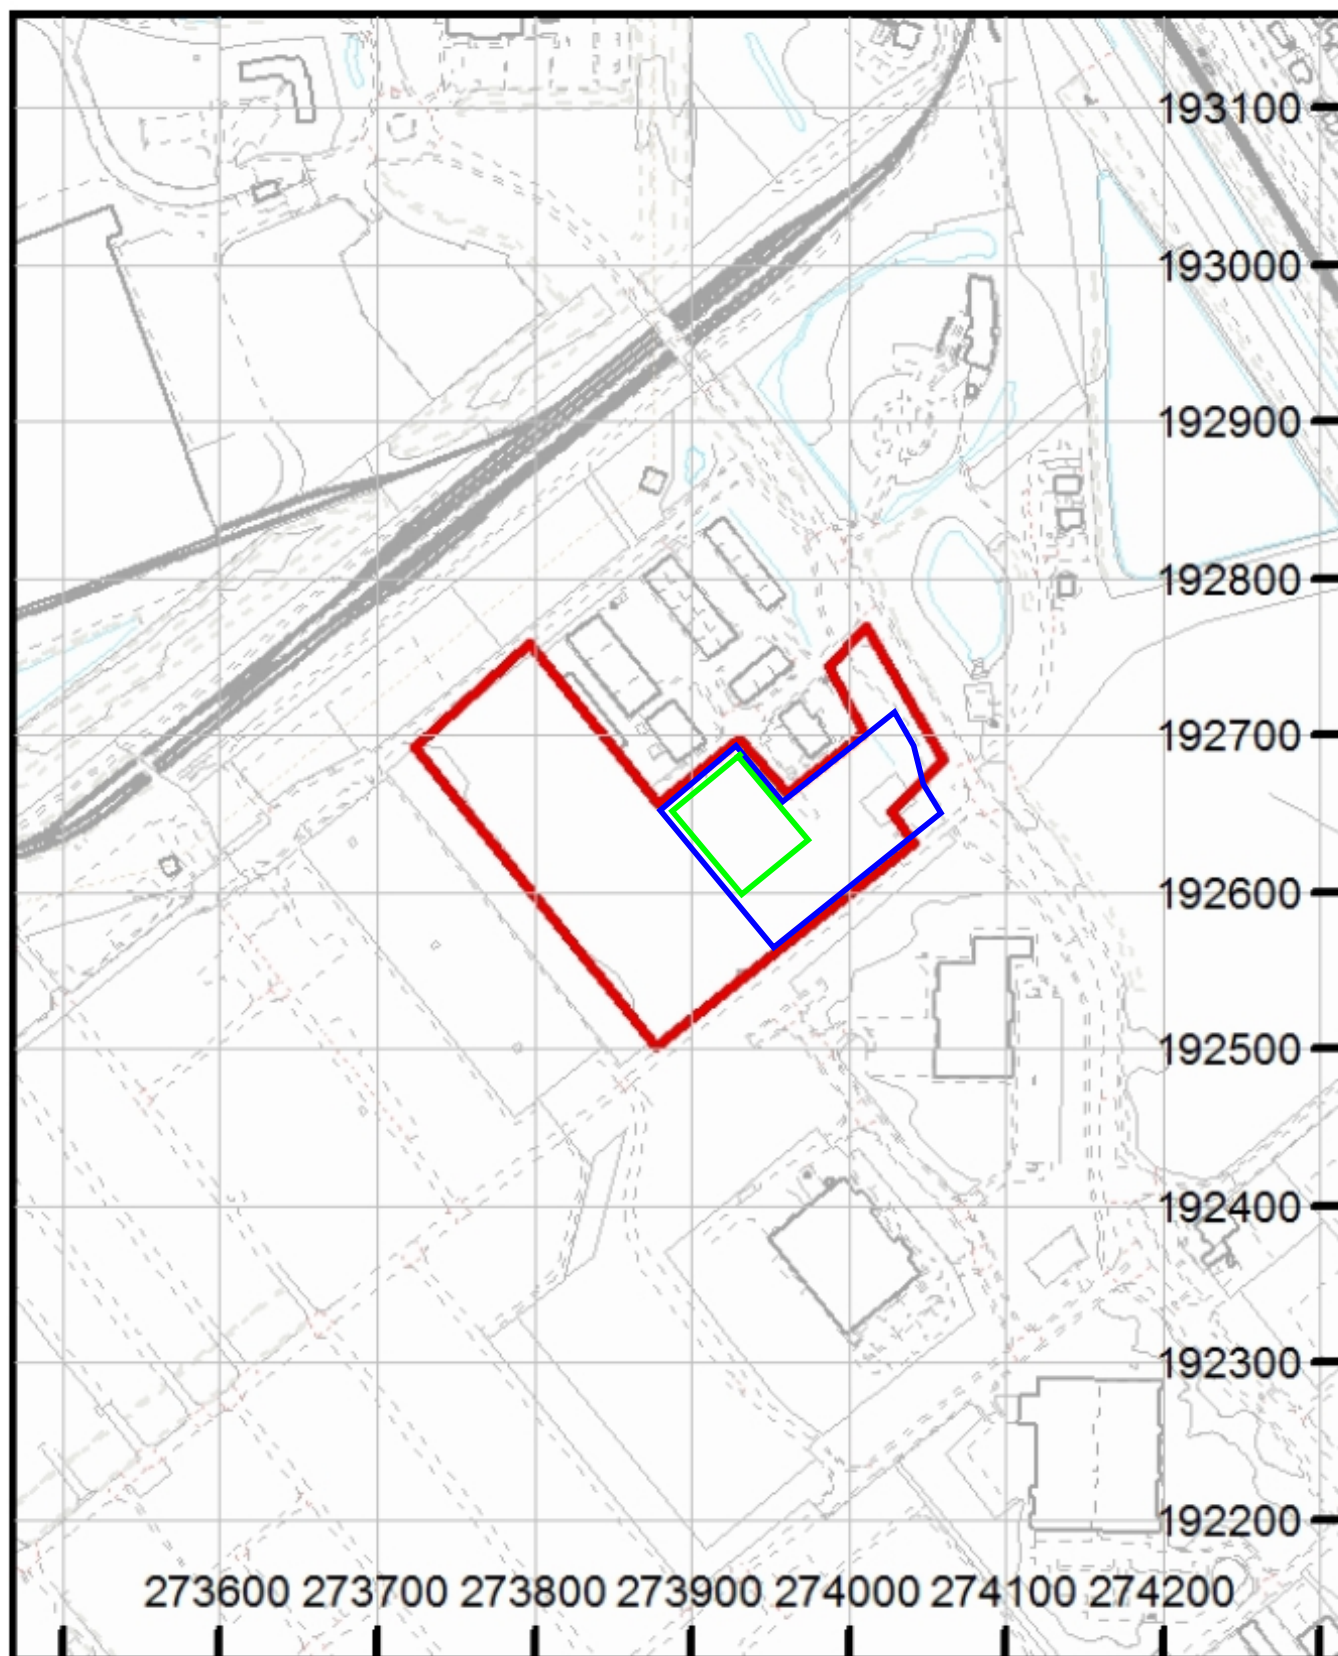
FIGURE 2

SITE BOUNDARY FROM COAL AUTHORITY CON29 REPORT.
THE SITE BOUNDARY COVERED BY THE C.M.R.A. IS IN BLUE, THE
CURRENT PLANNING APPLICATION BOUNDARY IS IN GREEN.

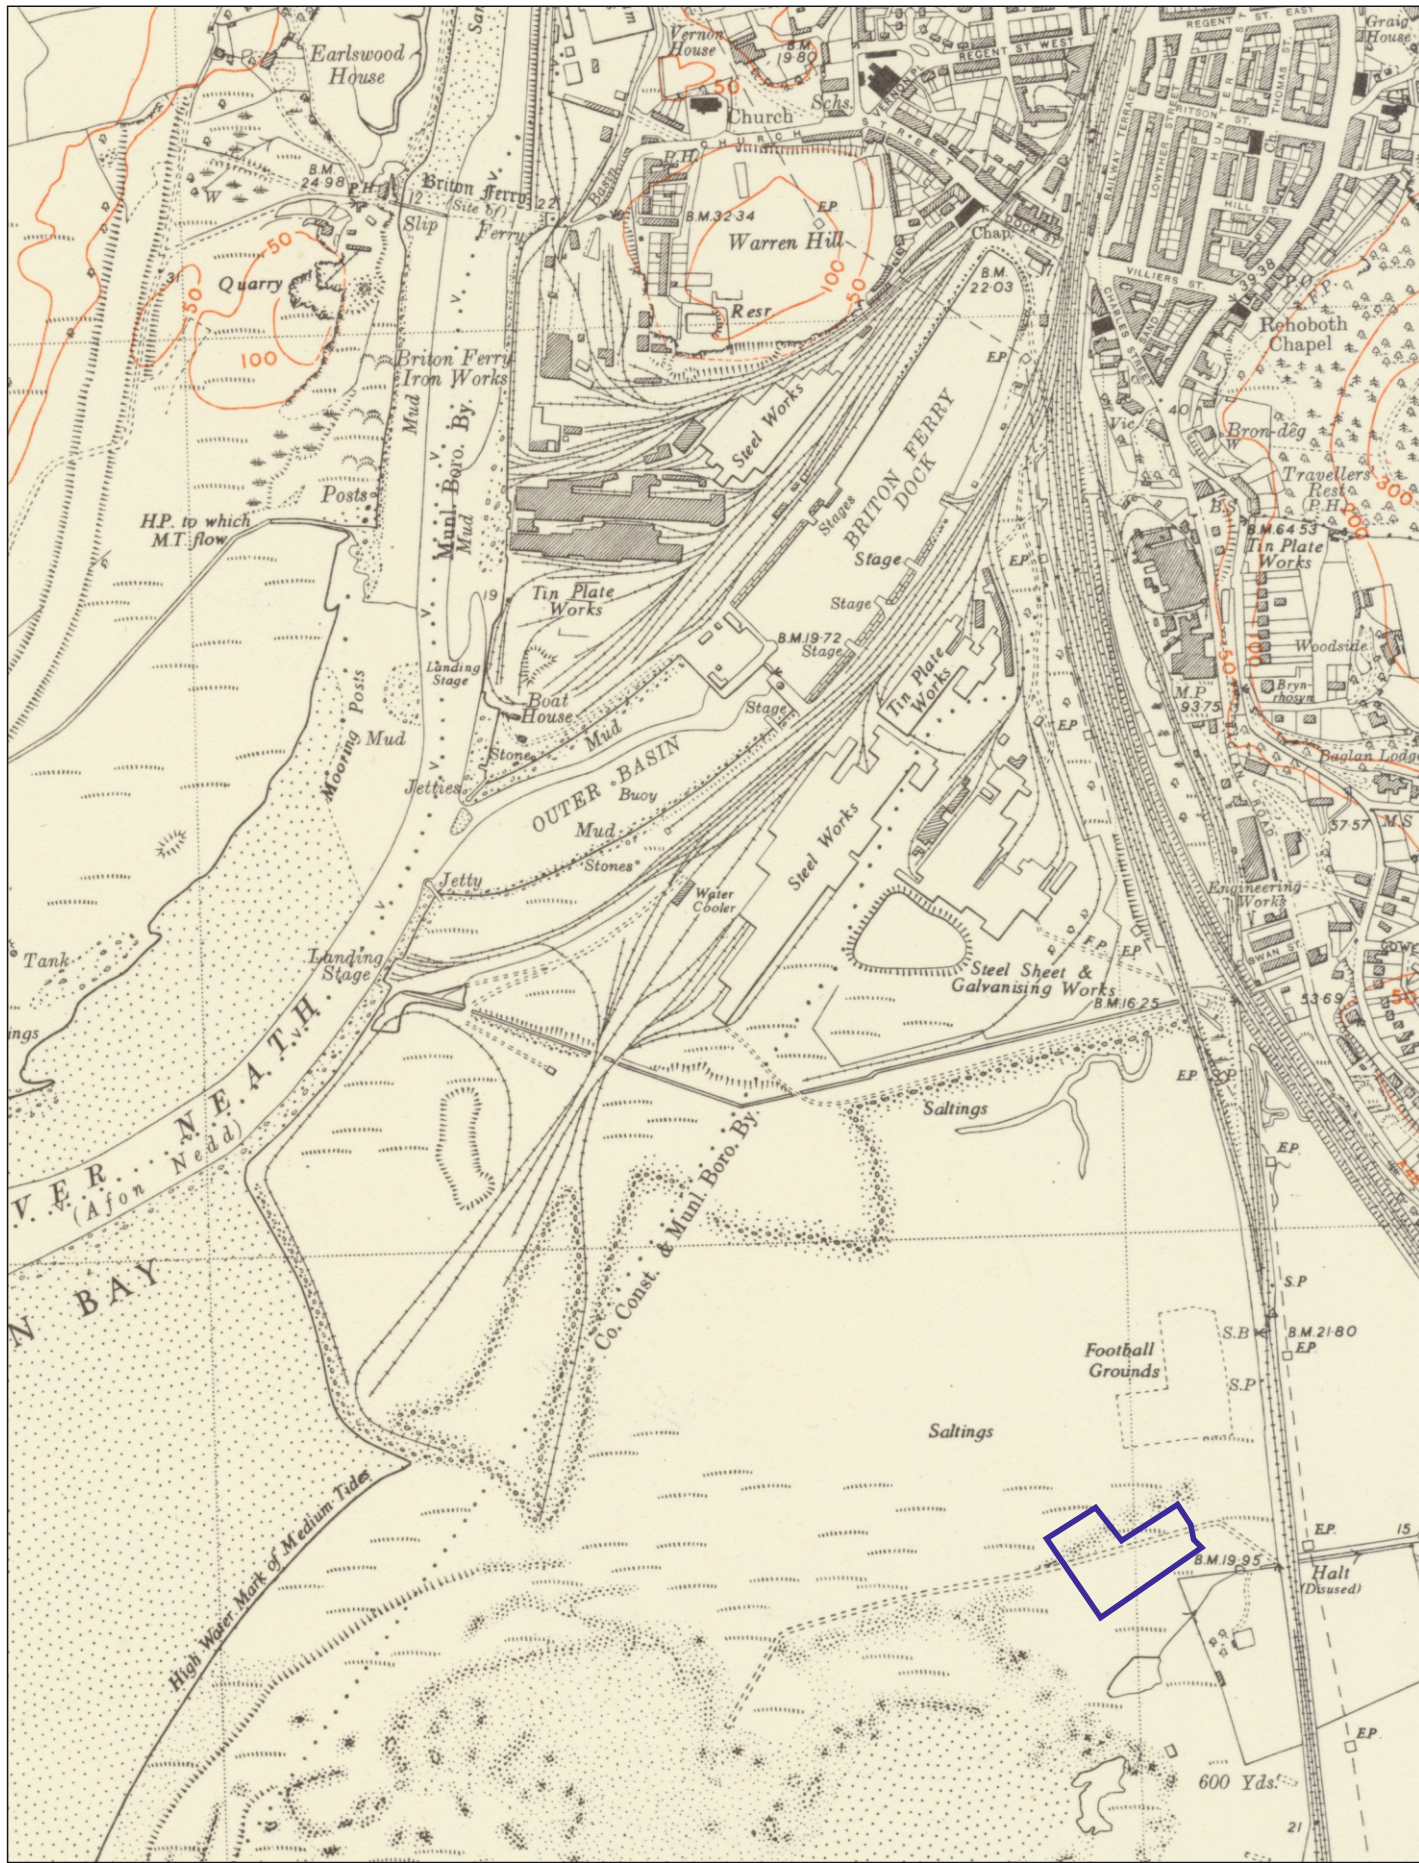
FIGURE 8
THE SITE ON THE 1948 1:10,560 O.S.

In order to position the site accurately on the older O.S. maps, and the Geological Survey map, georeferencing was used. This can be seen in Figure 9 where the outline of the site can be accurately delineated on an aerial photo and fixed on the 1914 1:2500 map. This was the earliest map available for georeferencing. This technique was also used to position the site boundary accurately on the Geological Survey Sheet. The base O.S. map for the Survey Sheet is the 1962 O.S. revision, which apart from boundary changes, is the same as the map in Figure 8. The point here is that great confidence can be placed in the positioning of the site in Figure 5.
