Kennedy Inspections  
115 Gable Rd  
Paoli PA 19301  
610-833-8220  
RossDKennedy@gmail.com

Report: 2676

# Confidential Inspection Report

September 3, 2020

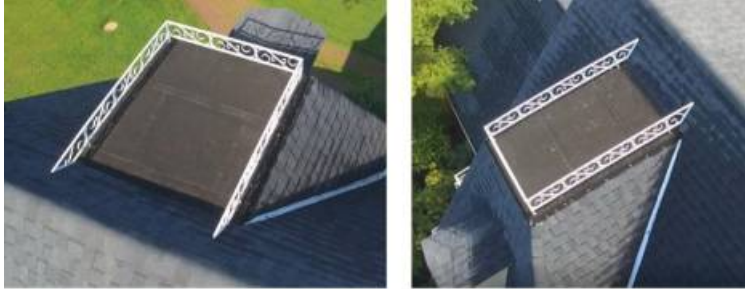
○ Roofing material appears to be in good condition for its age and nature. Monitor for future wear and leakage.

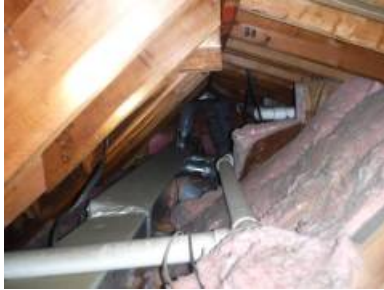
- Access:*  Hatch attic access, Entered attic for inspection.
- Structure:*  Rafters.

- Sheathing:*  Plywood sheathing.
- Insulation:*  Roll fiberglass batts.
- Depth & R-factor:*  10-12 inches.

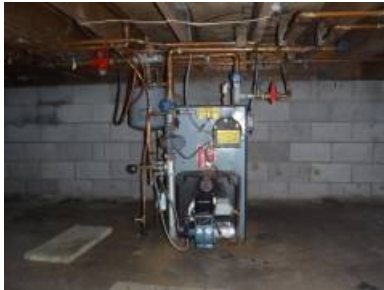
- Fuel Source:*  Oil. Oil heat requires yearly service by a qualified technician.
- Heat Type:* Location-Crawspace. Hydronic; circulating hot water boiler.
- Brand:* Weil McClain brand.
- Age / Date Manufactured:* System appears to be original from 1990.

- Furnace Efficiency:*  Conventional efficiency system. The expected life of a conventional efficiency system in this area is 15 to 25 years. Yearly routine maintenance and cleaning by a qualified technician is suggested.
- General Operation & Cabinet:*  Heating system showed proper response to controls and appears to be functional as designed however with concerns. Heavy corrosion is noted at the cabinet exterior. Recommend evaluation by a qualified HVAC technician to determine repairs as needed.

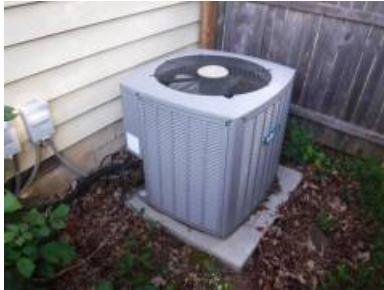
*System Condition:* ○ General condition appears serviceable. The expected life of an A/C system in this area is 15 to 25 years. As with any aging system, budget for eventual repairs, replacement or upgrade.

*Air Filters:* ○ Disposable filter noted on the air handler in the crawlspace. Check and change filters every 1 to 3 months as needed. Recommend using moderate quality filters as high dust and pollen catching filters can restrict air flow and reduce HVAC efficiency. Low end filters, even if changed often, can allow too much dust into the blower motor.
