Complete Home Inspections

Home Buyer
Inspection Site: Somewhere in Georgia

REPORT SUMMARY

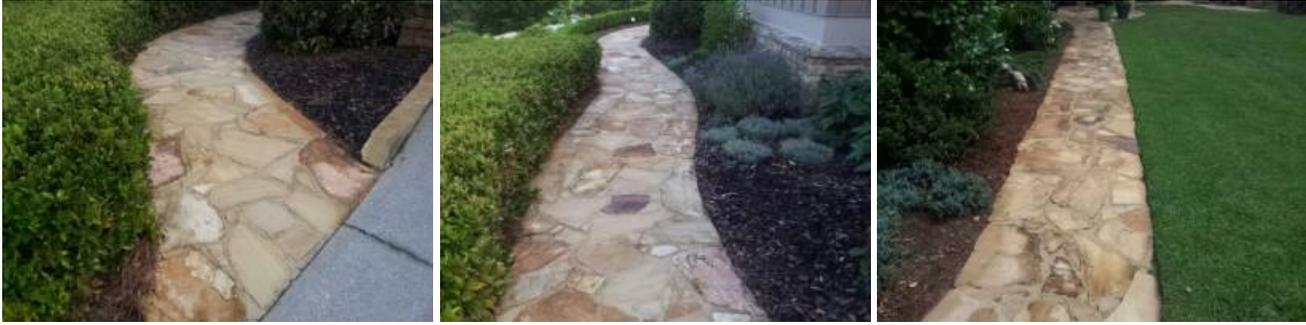
Appears to be in good condition. On going inspection of mortar joint and cracking is recommended.

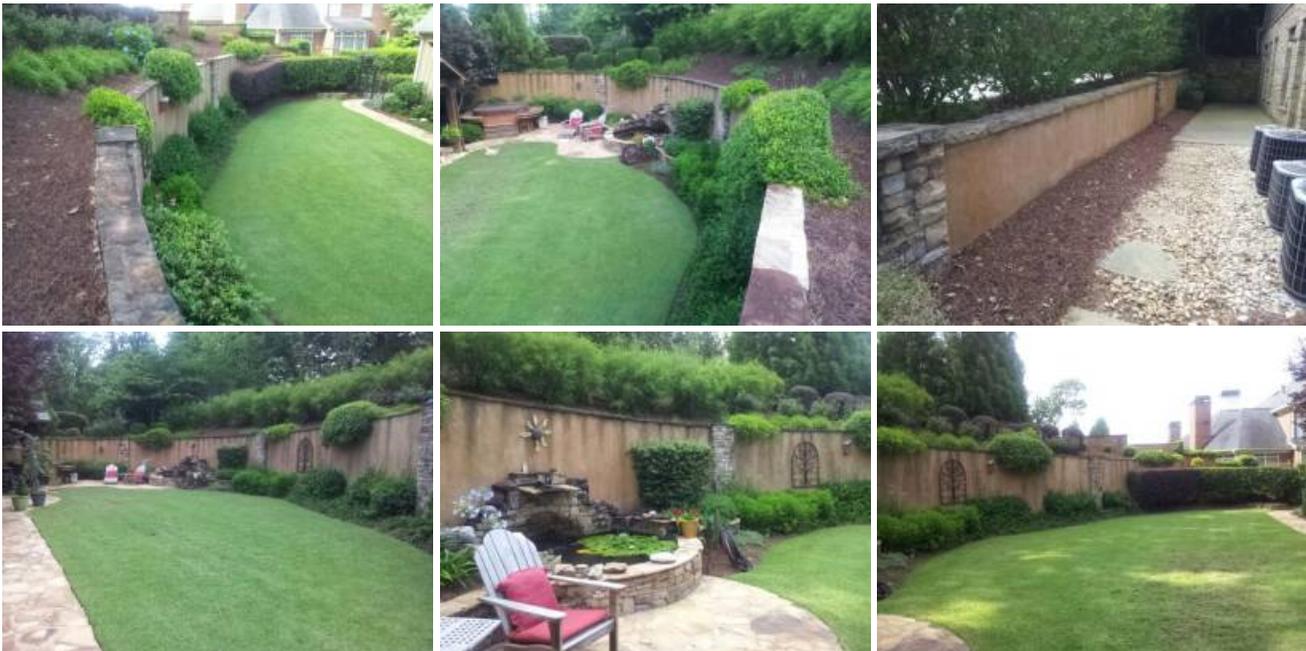
The retaining wall is of masonry type construction.

Appears to be in good condition. Cracks noted are typical.

If the cracks shift or widen over time, further evaluation would be required.

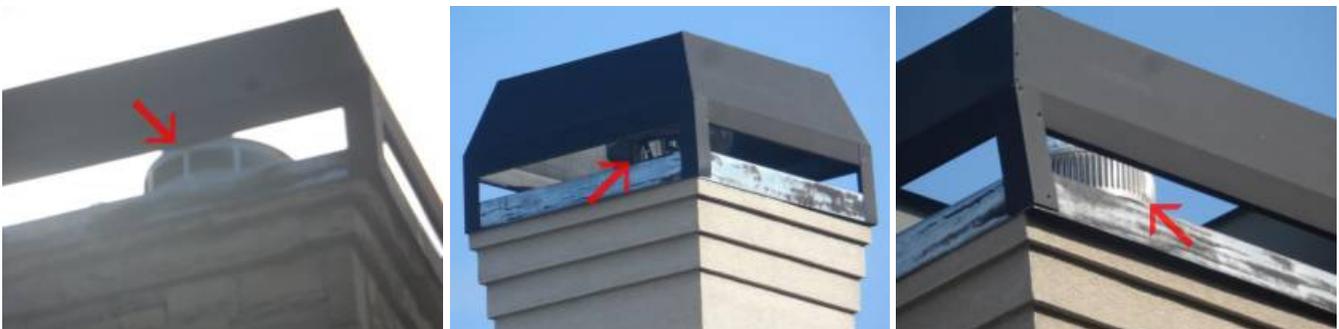
Chimney exterior appears to be in good condition, exterior metal finish is worn, Spark arresters noted.

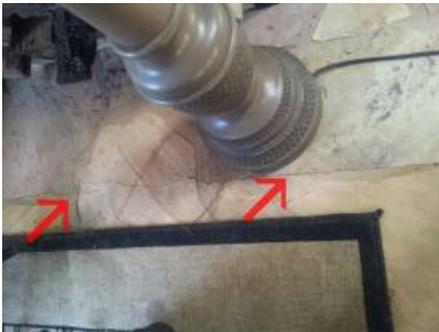
Appears to be in good condition, Cracks noted are typical. I recommend sealing the cracks with a good cement crack repair/epoxy.

If the cracks shift or widen over time, further evaluation would be required.

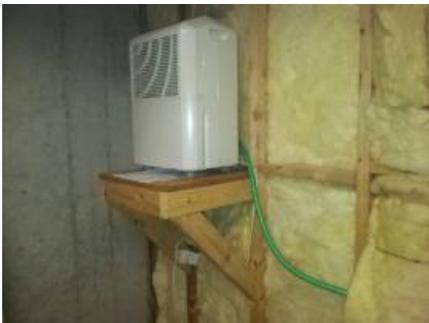
I always recommend the use of a dehumidifier in below grade areas. This helps reduce moisture.

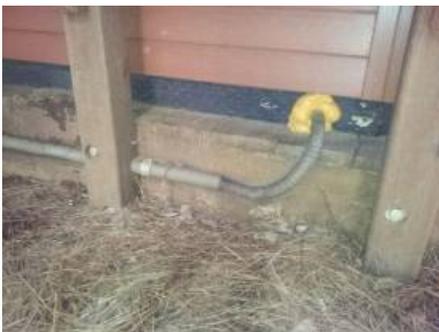
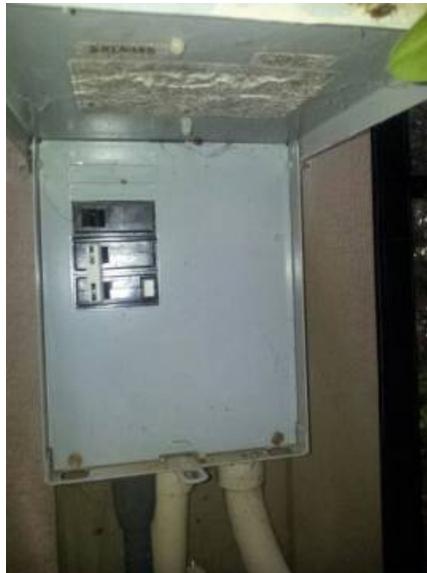
This panel is on a 50 amp breaker in the sub panel.

The power line goes from this sub panel to a point inside the case of the hot tub.

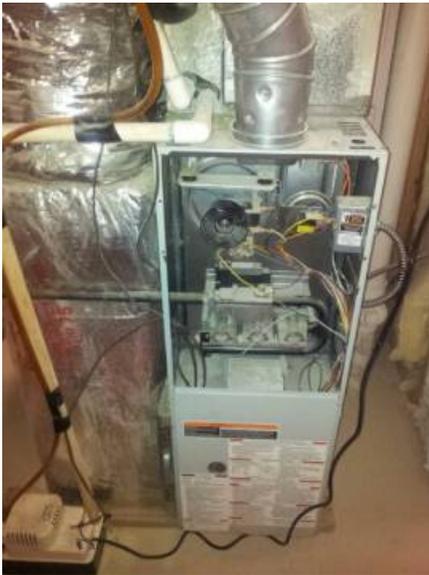
Location Of Heat Unit:

Furnace is located in the basement.
This unit is for the master bedroom.

Unit is operational and appears to be in good condition.

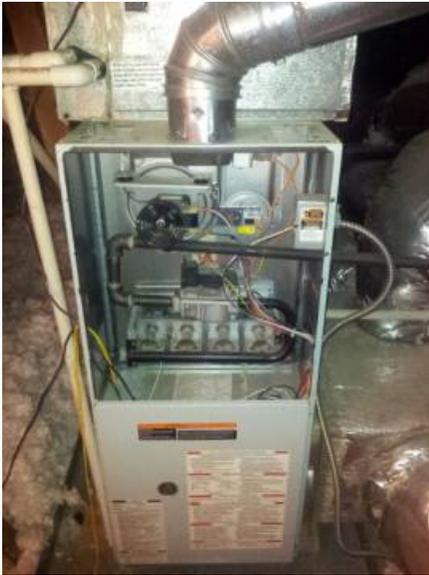
HEATING SYSTEM #2 DESCRIPTION AND CONDITION:

Furnace is located in the attic.

This unit is for the master bedroom portion of the main living level.

Unit is operational and appears to be in good condition.

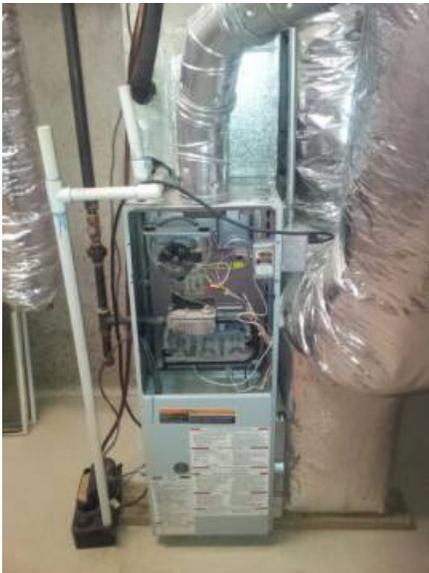
HEATING SYSTEM #3 DESCRIPTION AND CONDITION:

Furnace is located in the basement.

This unit is for the rest of main living level.

Unit is operational and appears to be in good condition.

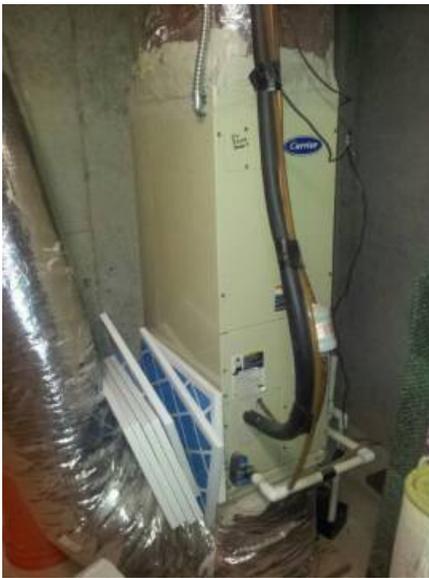
HEATING SYSTEM #4 DESCRIPTION AND CONDITION:

Furnace is located in the basement.

This unit is for the basement area.

Unit is operational and appears to be in good condition.

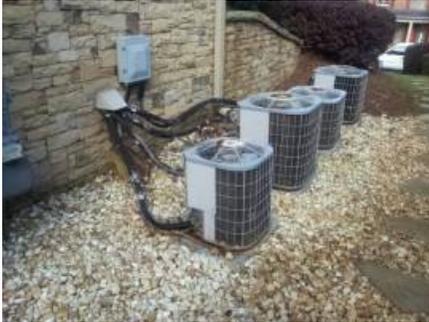
AIR CONDITIONING #1:

Location:
On the exterior, side of home, Left unit.
This unit is for the master bedroom area.

System Condition:
Appears operational.

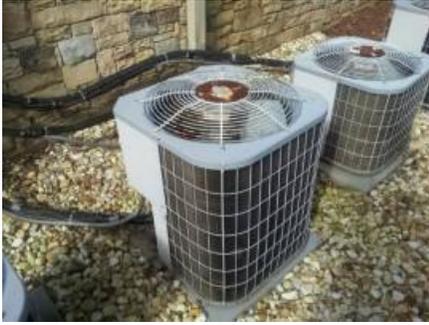
AIR CONDITIONING #2:

Location:
On the exterior, side of home, Left, Middle unit.
This unit is for the rest of the main living area.

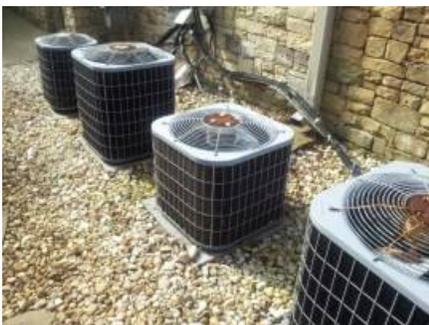
AIR CONDITIONING #3:

On the exterior, side of home, Right, Middle unit.
This unit is for the rest of main living level.

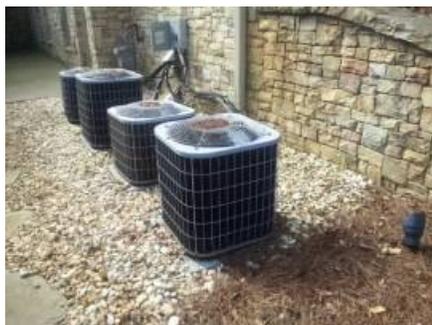
AIR CONDITIONING #4:

On the exterior, side of home, Right unit.

This unit is for the basement area.

The condensation line is too close to the foundation wall. I recommend extending the condensate line out 2-3 feet from the foundation to prevent water from running down the foundation wall.

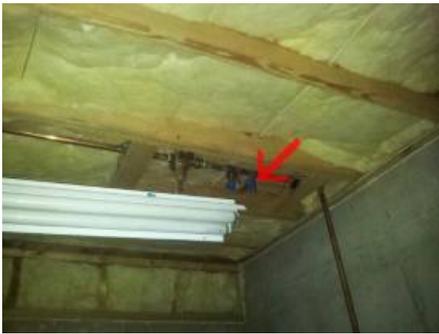
Main Water Cut Off Location:

Basement.

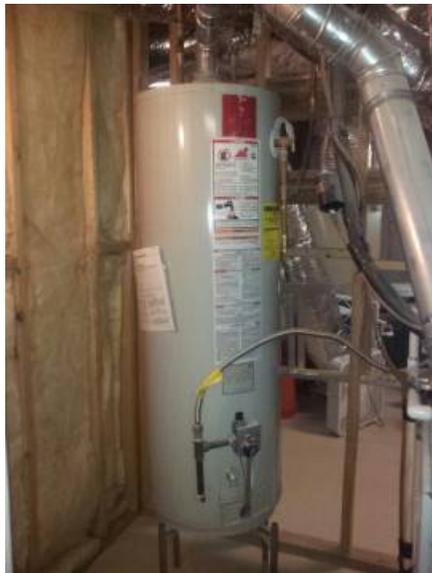
Appears serviceable, Pressure relief valve noted, not tested, Flue vent intact, A water shutoff valve is installed, Expansion tank is present at the other water heater.

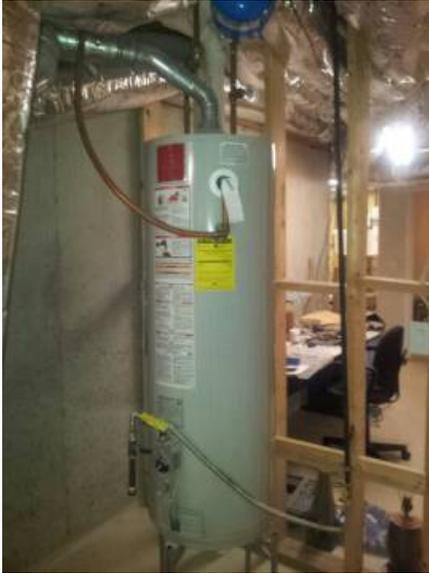
Appears serviceable, Pressure relief valve noted, not tested, Flue vent intact, A water shutoff valve is installed, Expansion tank is present.

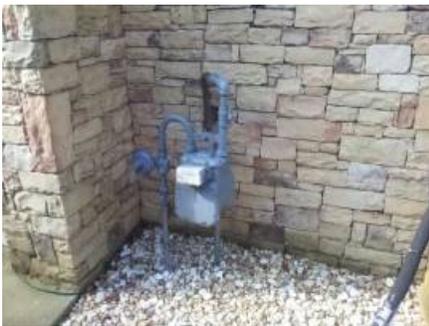
Meter Location / Condition:

The meter is located at the exterior. The system appears to be in operational condition.

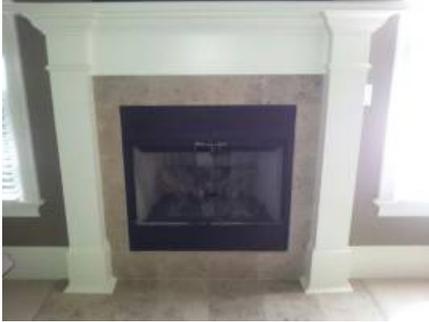
First Location:

There is a fireplace in the bedroom.

The unit appear to be in good condition. Damper is operational.

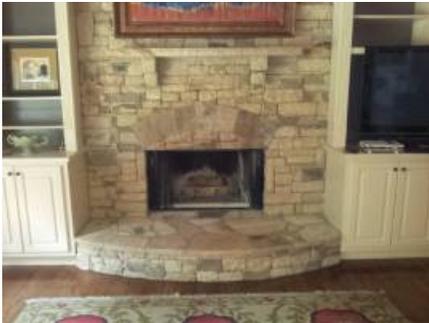
Second Unit Location:

There is a fireplace in the family room.

The unit appear to be in good condition. Damper is operational, Gas valve is present at hearth, Recommend cleaning and inspection before use.

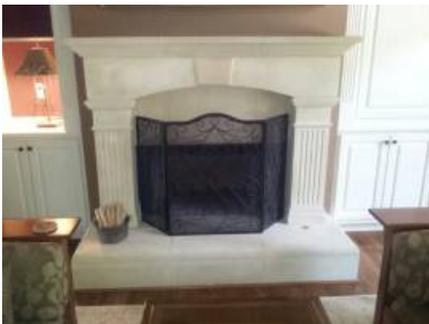
Third Unit Location:

There is a fireplace in the living Room.

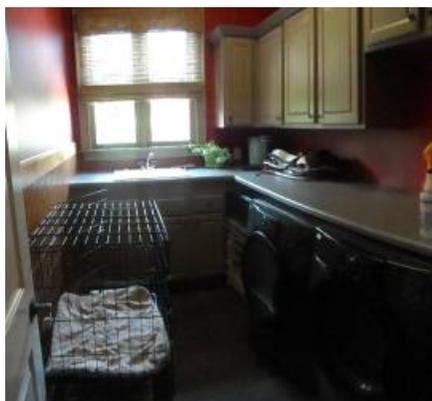
Location:

The laundry room is located in a hallway to the garage.

Plumbing appears operable, 220 Service-operational, Dryer venting is provided.
I recommend the venting be serviced and cleaned at least once per year.

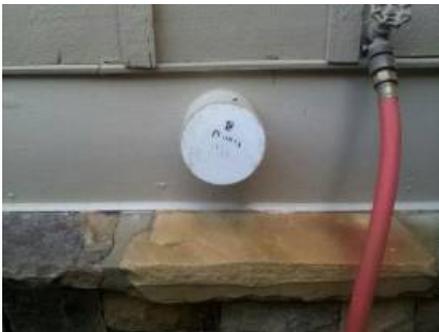
Pest Control:

There was a Pest Ban system installed in the home.

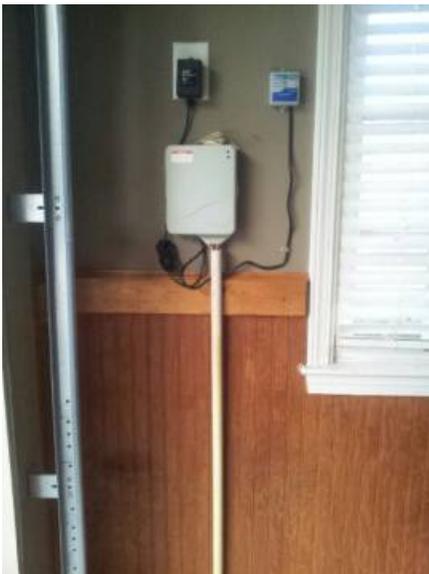
OUTSIDE SPRINKLER SYSTEM::

There was an outside sprinkler system noted in the garage.

This system was not inspected, it is beyond the scope of the inspection.

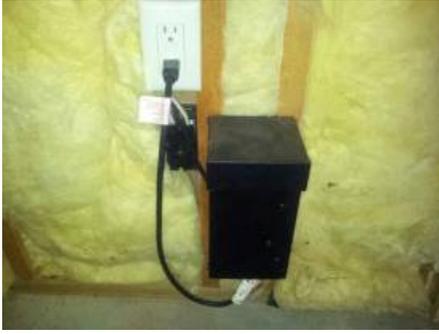
Low voltage lighting present, not inspected.

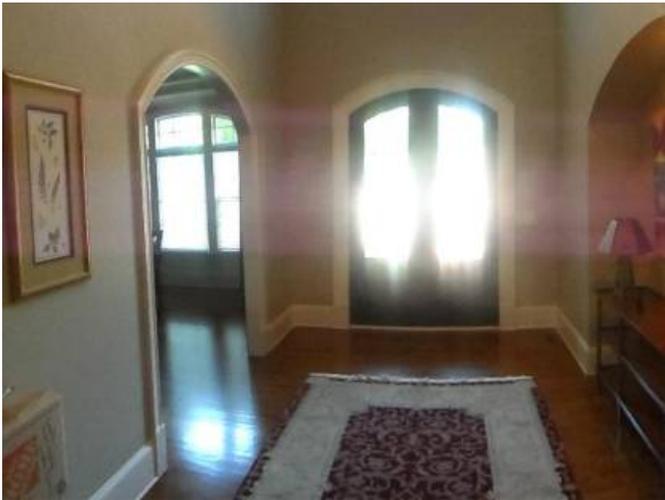
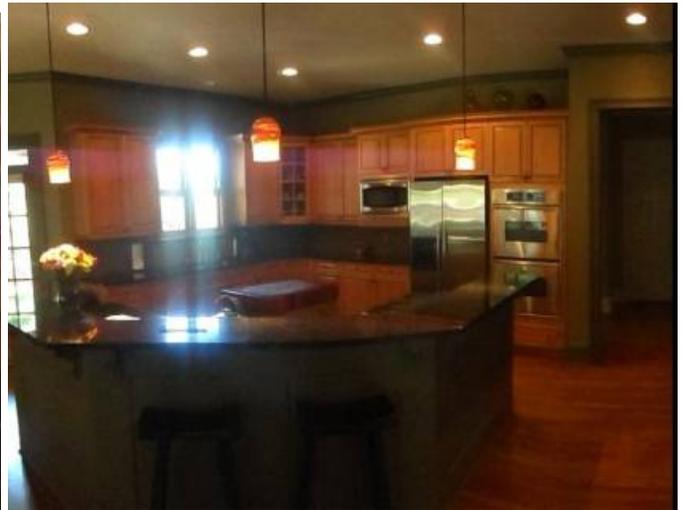
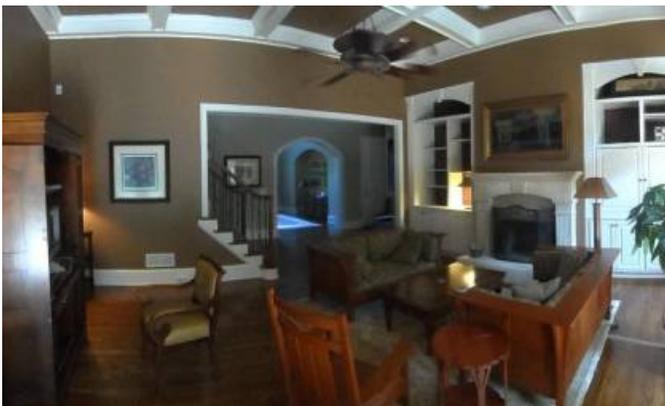
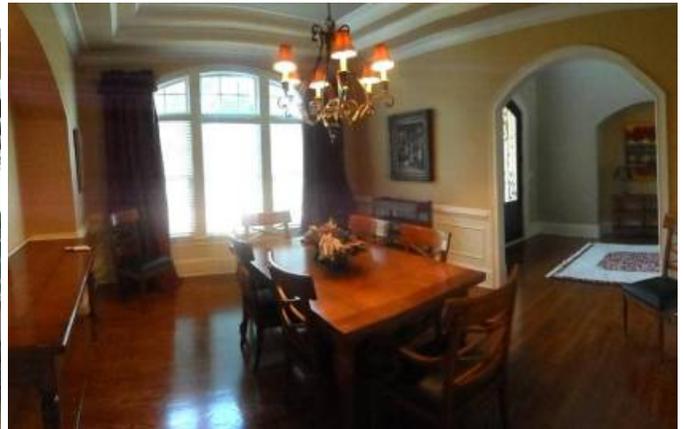
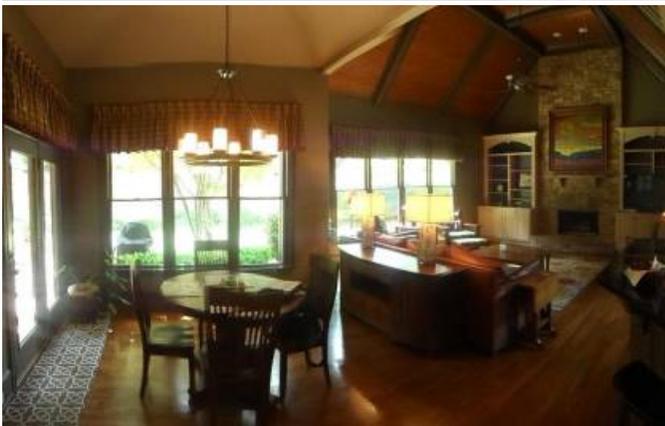
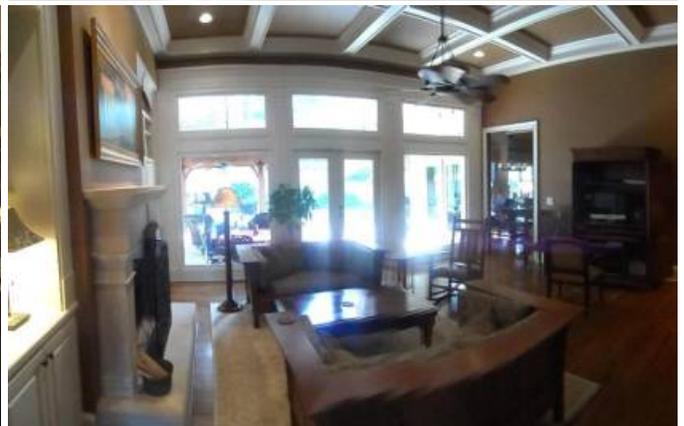
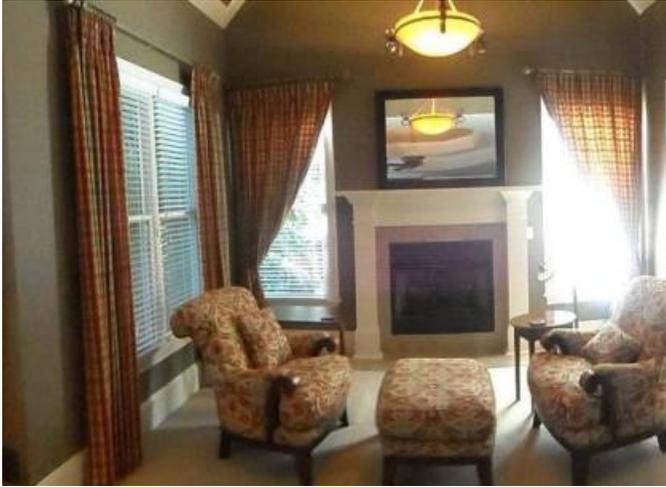
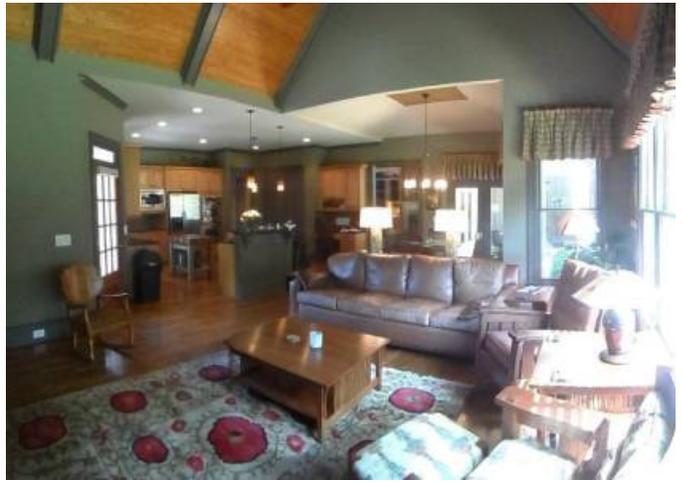
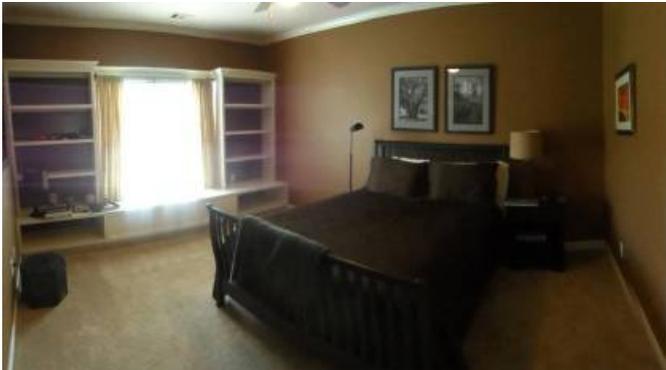
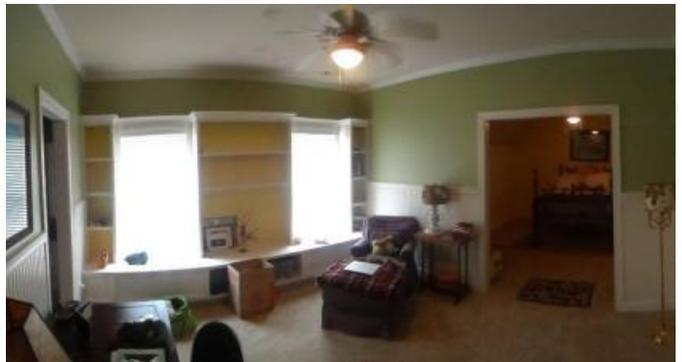
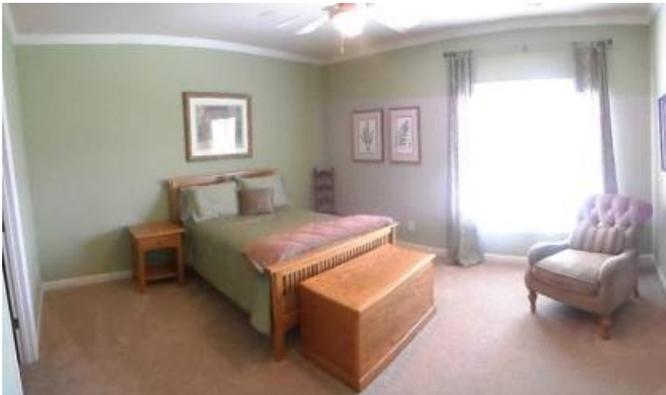
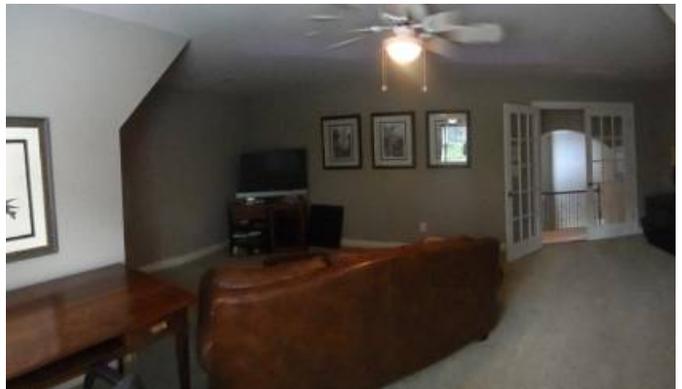
Room Views:

I generally take pictures of some of the rooms to show the condition at the time of the inspection.
