1998 Cabo 45 Express

GHOST RIDER

Report of Marine Survey

6/25/2019

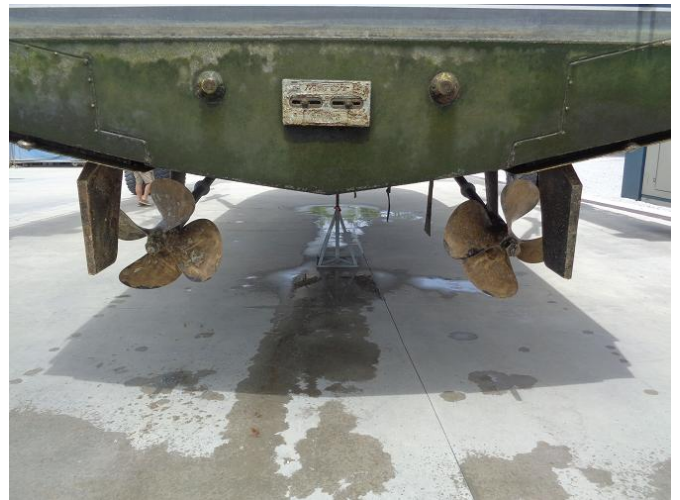
Running Gear

Grey painted with black boot top. Vessels wetted surface appears in good condition and recently serviced bottom paint, running gear and newer zincs, no visible defects were sighted. The the painted and gel coated area's are in very good condition showing a high luster at topside's. The hull at and below the waterline was sounded approximately every 6 - 8 inches without negative report. In general the hulls wetted surface, topside's and topside show care of a competent owner. Maintenance appears to be above average. *Note: Two area's to the stern at transom show minimal dock abrasion to the painted surface. *Note: The starboard spray rail is showing two signs of crazing with small cracks. *Note: The bow pulpit FRP shows a 12 inch horizontal crack to the filler.
