# Castle Rock County Water District

## Facilities Condition Assessment and Evaluation

September 2015

Causey Consulting  
733 Cree Court  
Walnut Creek, CA 94598

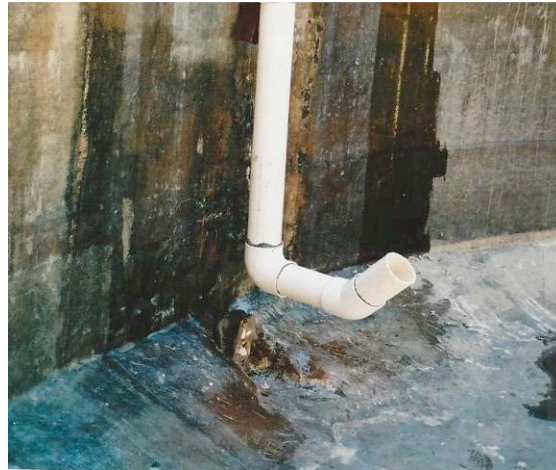
**Figure 11: Raw Water Discharge Point**

property lines until the pipe reaches Pine Creek Road at which point it tees north and south to supply that area. The tank fill and discharge line leaves Old Borges Ranch Road and follows a dirt and gravel road to the terminal storage tank at which point a PVC siphon discharges the untreated raw water near the inside bottom of the redwood tank (see Figure 11 below).

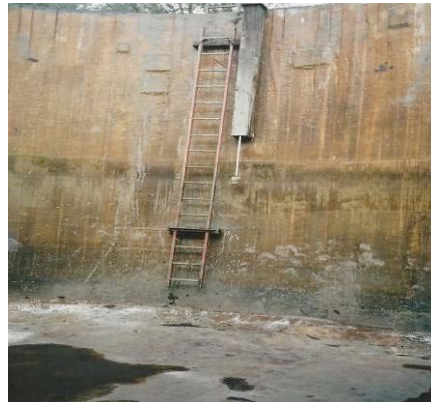
**Figure 14: Tank Access Ladder, Int.**

The inside of the tank is accessed by ladders (see Figure 13 and 14 below) along the southern exposure of the tank and over the top and back down the inside of the tank. The access ladders are secured within a five-foot fenced area topped with barbed wire (See Figure 15 below). The District has purchased a harness climbing system for anyone using the access system. The tank does not contain any access hatches or man ways for entry into the tank from ground level.
