Confidential Inspection Report

LOCATED AT: 123 Sample Street
RSM, CA 92688

INSPECTED ON: Monday, April 18, 2016

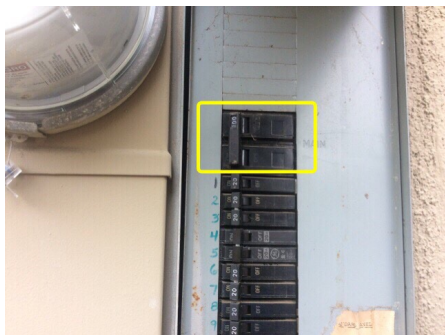
108: - Main panel is manufactured by General Electric.

110: - Breakers are not labeled correctly. This is a safety concern. Recommend you have all breakers labeled correctly by a licensed electrician.

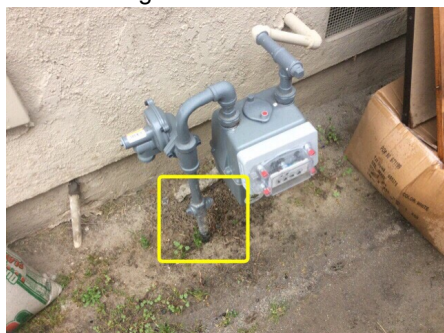
GAS METER

121: - Main gas shut-off valve is located at the gas meter.

122: - Visible portions of the gas pipes, at the meter, appear to be in acceptable condition.

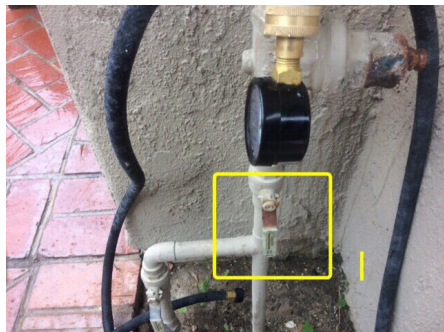
WATER SHUT OFF

126: - House water shut-off valve is located in the front of the house.

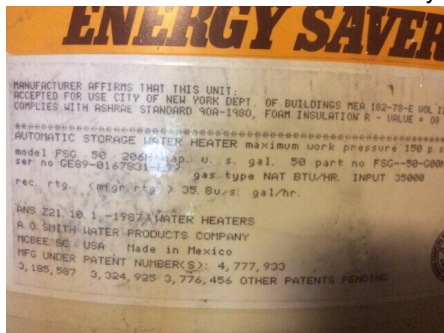
136: - Water heater is manufactured by A.O. Smith.

137: - This is a gas water heater.

138: - This water heater is approximately 27 years old. The average life expectancy of a water heater, in Southern California, is 12 years.

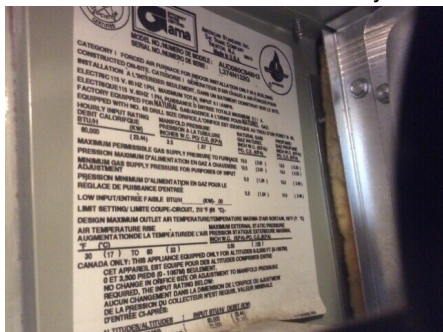
162: - Furnace is manufactured by American Standard.

163: - Gas forced air furnace present.

164: - This furnace is approximately 19 years old. The average life expectancy of a furnace in Southern California, is 25 years.

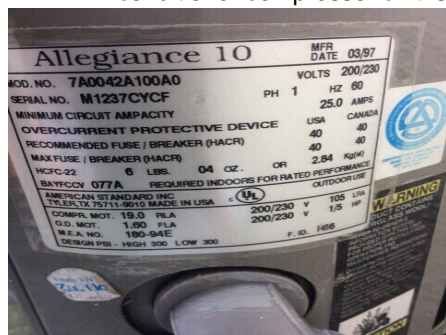
COMPRESSOR UNIT

172: - Air conditioner compressor unit is manufactured by American Standard.

173: - A/C compressor unit is approximately 19 years old. The average life expectancy of an air conditioner, in Southern California, is 15 years.
