SAGUACHE CREEK DIVERSION INFRASTRUCTURE INVENTORY

Structure Name: WERNER ARROYA D

WERNER ARROYA DITCH

Saguache Creek Stream Management Plan

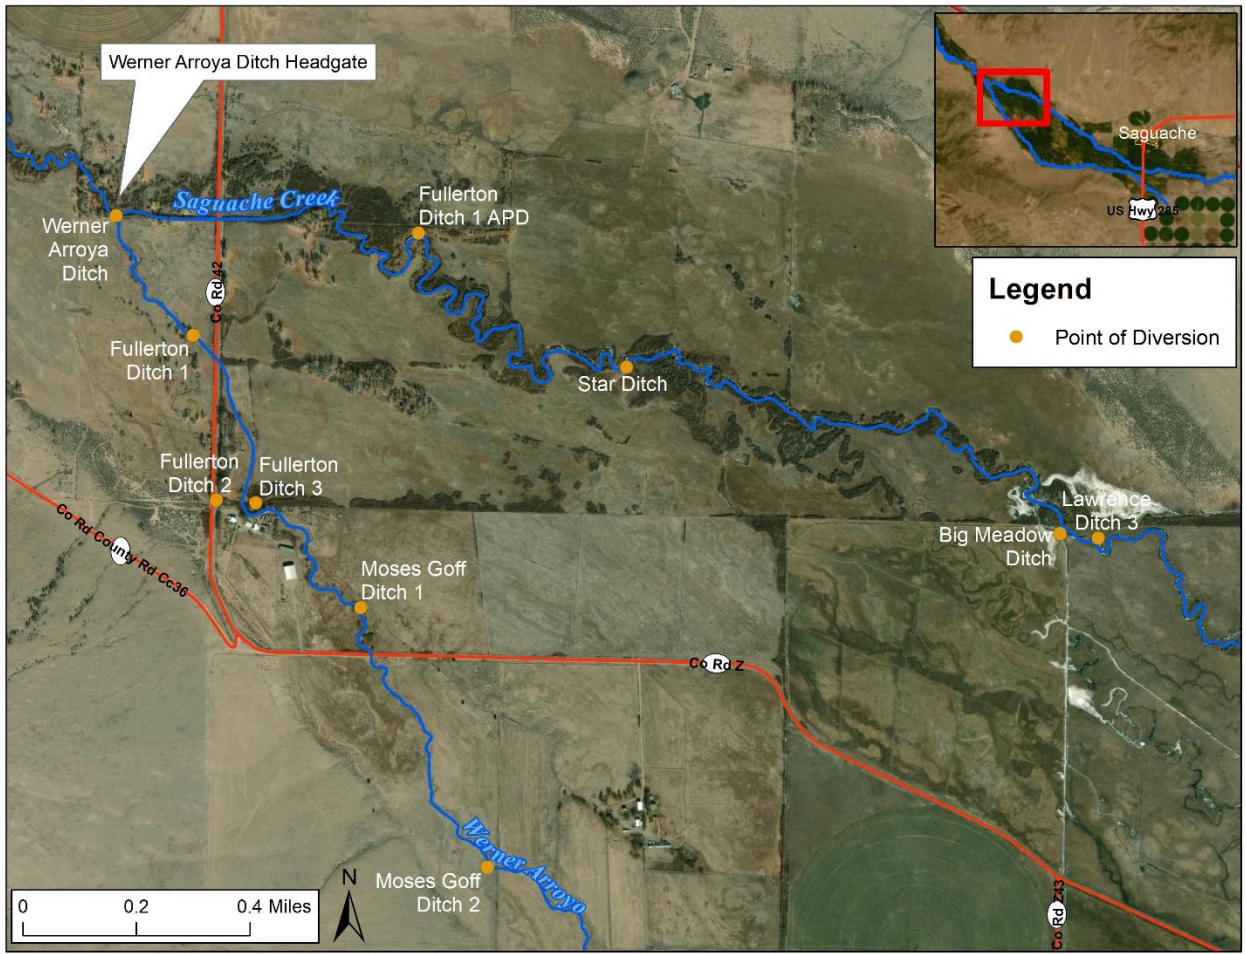
Repair(s) or Improvement(s) Currently Needed: The headgate was recently replaced and is in excellent condition. The diversion dam is negatively affected by a significant sediment deposition. One potential solution is to move the diversion dam downstream to address the sedimentation issue. Fish passage should be maintained and riparian restoration should be considered as part of any future repairs or improvements.

Werner Arroyo headgate/point of diversion and surrounding diversion structures.
