Home Inspection Report

1234 Sample St.
Portland, OR 92345

Prepared for: **Joe & Joanne Homebuyer**

Prepared by: **Sommers Home Inspections LLC**

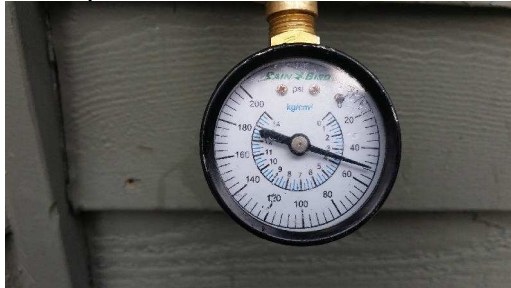
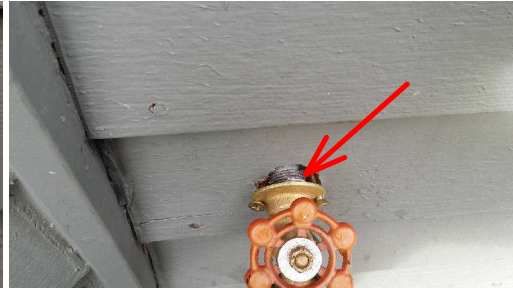
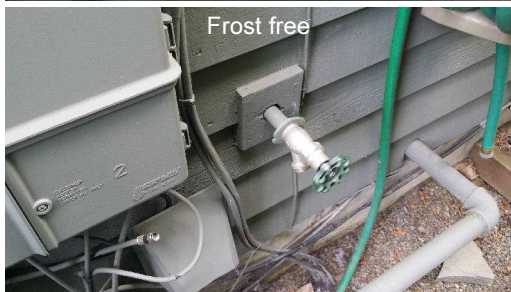
12. ☒☐☐☐☐ **Hose Bibs:** Gate. 50psi water pressure. The hose bib in the back of the house is loose and the wall opening is exposed. I recommend caulking or closing it up in any other way to prevent moisture from entering. Consider installing a frost-free valve for protection in the winter. You already have a frost-free hose bib on the South side of the house.

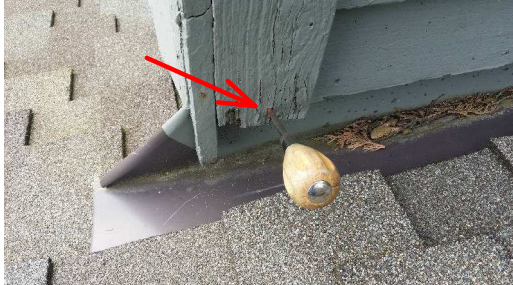
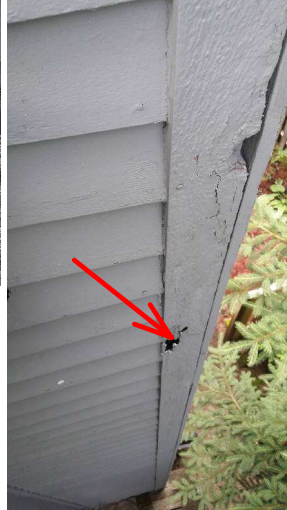
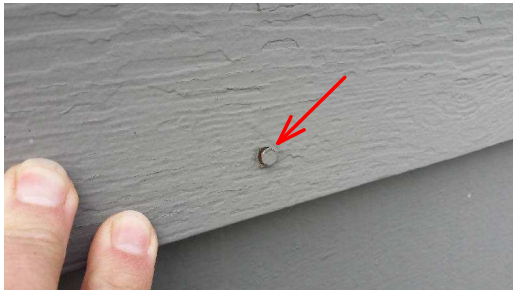
13. ☐☐☐☒☐ **Chimney:** Framed. Rot was found on the trim. Replace as needed. Some of the siding boards are loose and the nails are pushing out. This should be fastened when the trim is replaced.

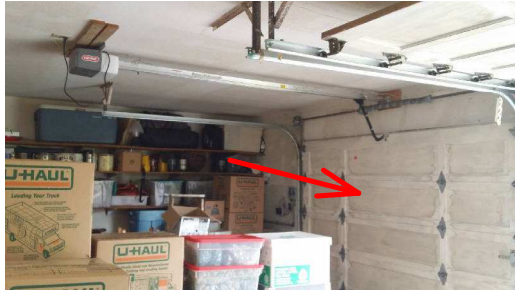
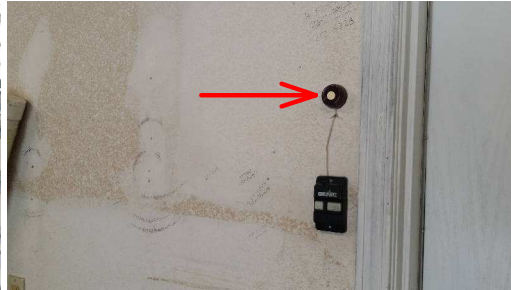
Garage/Carport**A NPNIM D****Attached Garage****1. Type of Structure:** Attached **Car Spaces:** 2**2.** ☒ ☐ ☐ ☐ ☐ **Garage Doors:** Wood**3.** ☐ ☐ ☐ ☒ ☐ **Door Operation:** Mechanized. I was not able to operate the left side garage door. The upper button may be for this door but it did not work. Have the seller verify that the door is in working condition.

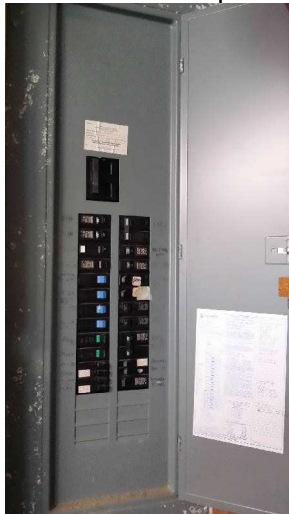
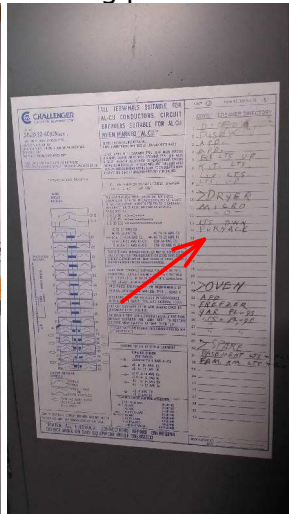
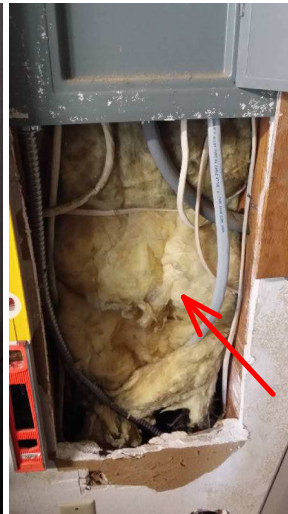
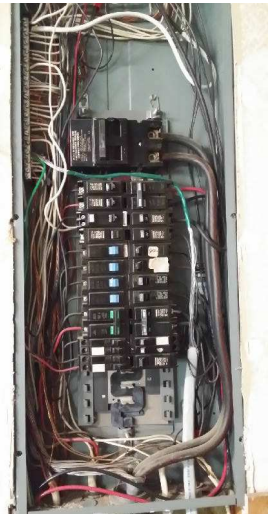
Garage Electric Panel

7. ☒ ☐ ☐ ☐ ☐ **Manufacturer:** Challenger. All labeling should be done with permanent marker and not pencil. Pencil will fade over time making it hard to read. The wall underneath the panel needs to be closed to keep all the wiring protected.

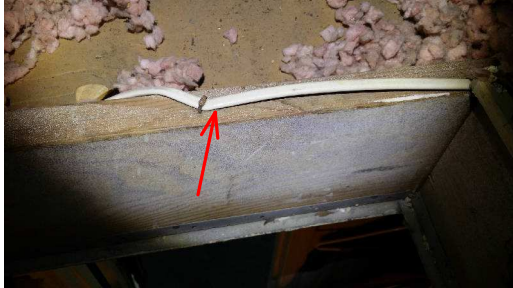
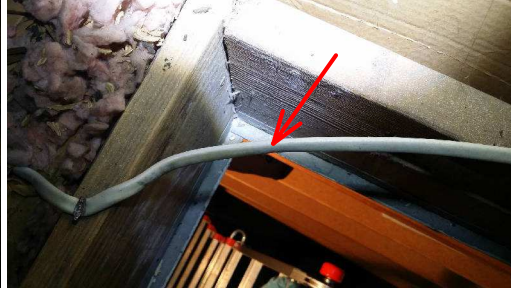
8. ☒ ☐ ☐ ☐ ☐ **Roof Framing:** 2x8 Rafter
9. ☒ ☐ ☐ ☐ ☐ **Sheathing:** Plywood, Skip sheathing
10. ☒ ☐ ☐ ☐ ☐ **Ventilation:** Roof and soffit vents
11. ☒ ☐ ☐ ☐ ☐ **Insulation:** Fiberglass
12. ☒ ☐ ☐ ☐ ☐ **Insulation Depth:** 8-10"
13. ☒ ☐ ☐ ☒ ☐ **Wiring/Lighting:** 110 VAC. Wiring within 6' of the attic access should be protected with guard strips.

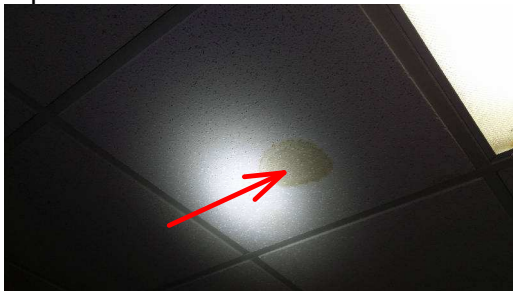
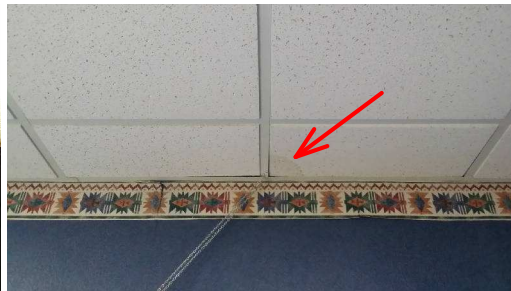
1. ☒ ☐ ☐ ☐ ☐ **Ceiling:** Paint and paneling. There are a couple water stains on the basement ceiling. I removed the panel under the dishwasher area. A small area of insulation paper was damp but the insulation above it was dry. The dampness may have been caused by condensation on the water line that is running right below this section. The ceiling spots were dry and the area under the dishwasher was dry as well after running the normal cycle. Monitor for changes and make repairs if needed.

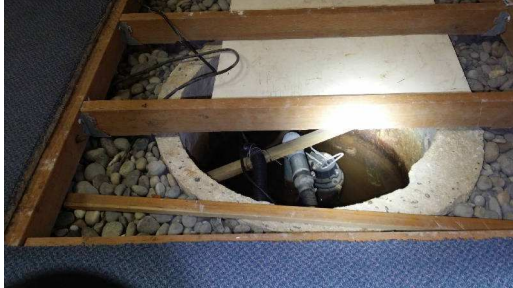
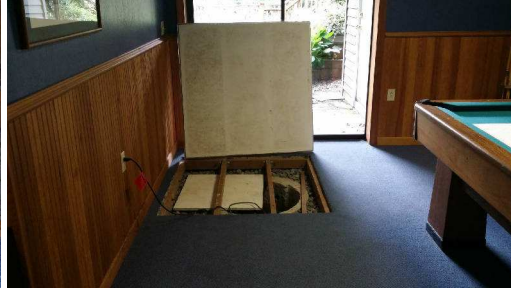
4. ☒ ☐ ☐ ☐ ☐ **Doors:** Hollow wood
5. ☒ ☐ ☐ ☐ ☐ **Windows:** Aluminum slider
6. ☒ ☐ ☐ ☐ ☐ **Electrical:** 110 VAC
7. ☒ ☐ ☐ ☐ ☐ **HVAC Source:** Heating system register
8. ☒ ☐ ☐ ☐ ☐ **Ventilation:** Windows
9. ☐ ☐ ☐ ☒ ☐ **Sump Pump:** Submerged. I was not able to test the sump pump, it did not come on when I tried to test it. Have the seller verify that the pump is in good working condition.

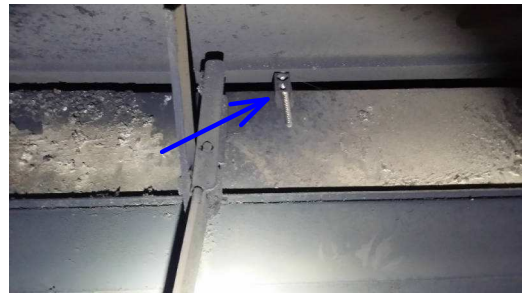
8. ☐ ☐ ☒ ☐ ☐ **Flue:**
 9. ☒ ☐ ☐ ☐ ☐ **Damper:** Metal. The damper has a stopper installed which is required with a gas burning fireplace to prevent accidental carbon monoxide poisoning.

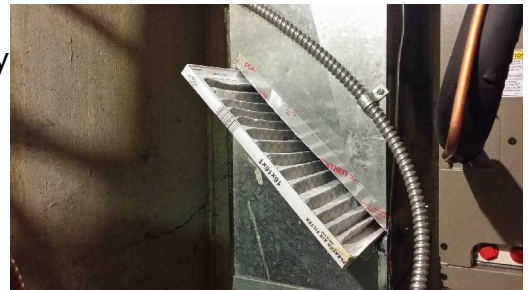
7. ☒☐☐☐☐ **Blower Fan/Filter:** Direct drive with disposable filter. The filter is located next to the furnace. Check it monthly and replace as needed.

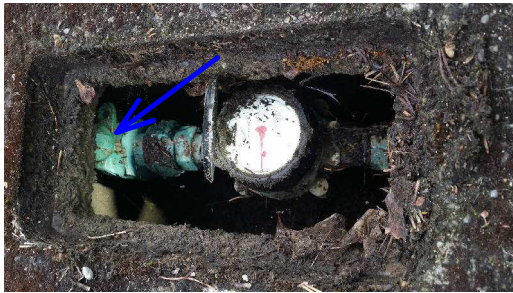
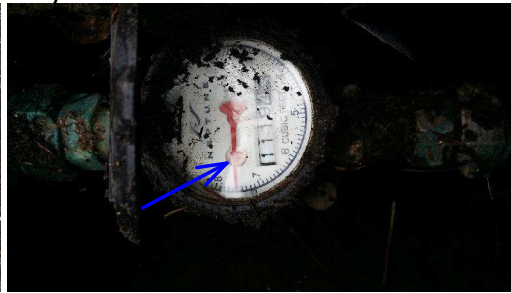
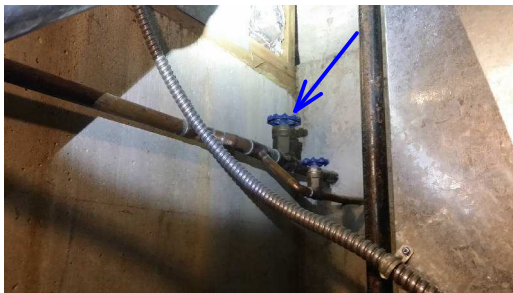
1. ☒ ☐ ☐ ☐ ☐ **Service Line:** Copper
2. ☒ ☐ ☐ ☐ ☐ **Main Water Shutoff:** At the meter. The water meter is located inside the sidewalk. The triangle in the meter is very sensitive to water flow and can be used to check for potential leaks. Be sure to turn off all the water in the house when you go out to see if it is moving. A second shut off can be found in the basement utility room.

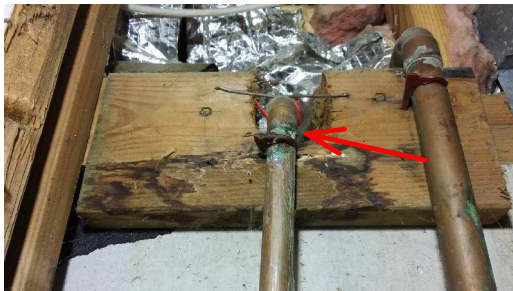
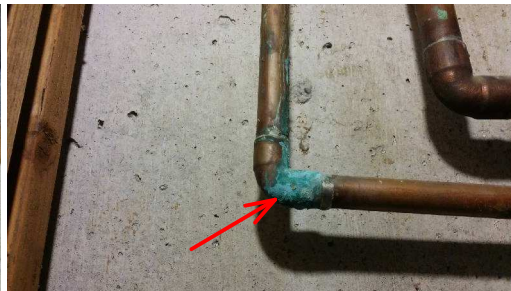
3. ☐ ☐ ☐ ☒ ☐ **Water Lines:** Copper. I found a leak in the water line above the water heater. I recommend repair. Green flux is present at the pipe connections. This should have been wiped off after the installation as it can cause leaks over time.

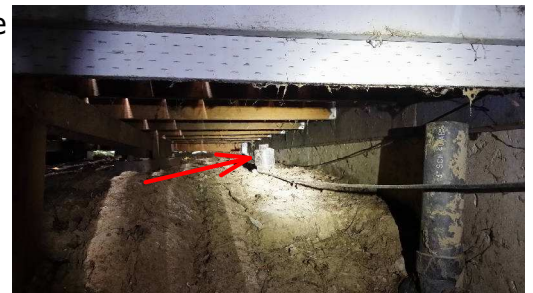
5. ☒ ☐ ☐ ☒ ☐ **Service Caps:** Under the deck. This clean out may be difficult to access.

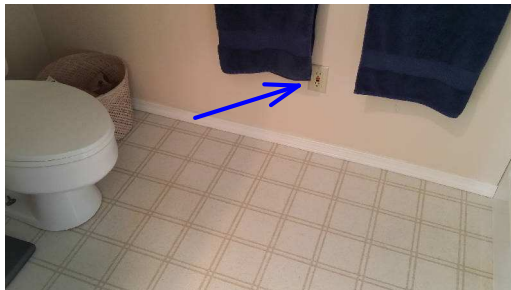
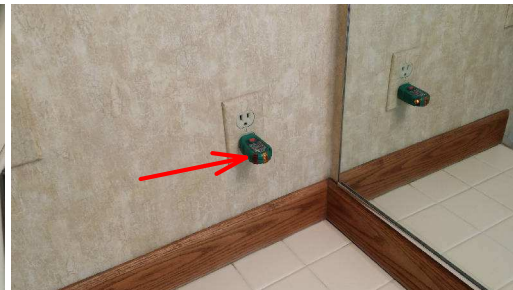
7. ☒ ☐ ☐ ☒ ☐ **Electrical:** 110 VAC, 110 VAC GFCI. The GFCI outlet near the toilet only protects the exterior outlets of the house but not the bathroom. I recommend installing a GFCI outlet next to the sink.

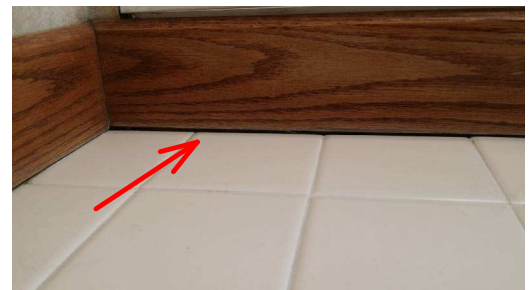
8. ☒ ☐ ☐ ☐ ☐ **Counter/Cabinet:** Wood, Tile. Maintain the caulk around the sink and at the countertop to wall union to prevent water from getting behind.

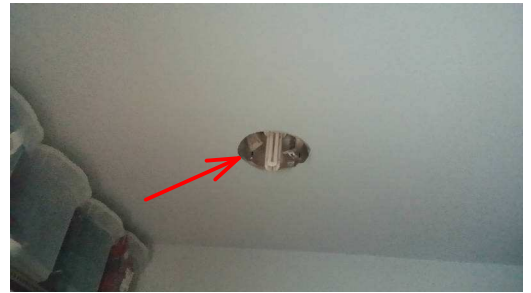
1. ☒ ☐ ☐ ☒ ☐ **Closet:** Walk In, Large, Small. Install the correct light bulb and cover plate in the Southwest bedroom closet.

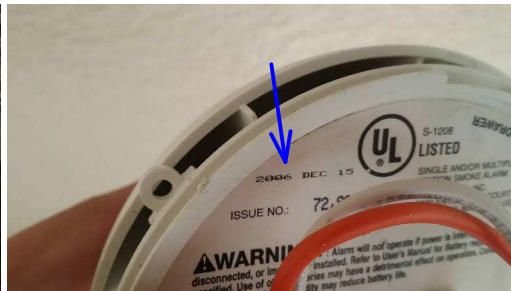
9. ☐ ☐ ☐ ☒ ☐ **Smoke Detector:** Hard wired. The carbon monoxide alarm is from 2014, add one on each level. The upstairs smoke alarm is from 2006. I recommend installing smoke alarms in each room for added protection. Make sure that the smoke detectors meet the requirements of the State of Oregon. Go to www.oregon.gov/OSP/SFM for the latest updates on smoke detectors and carbon monoxide alarms. Smoke detectors need to be replaced within 10 years, carbon monoxide alarms within 5 years. The installation of photoelectric alarms is recommended. Several studies have found that they outperform ionization alarms. Carbon monoxide alarms should be placed within 15 feet of each bedroom and one on each level.

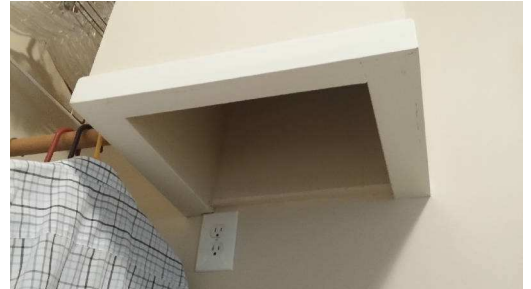
1. ☐ ☐ ☒ ☐ ☐ **Closet:** Laundry shoot

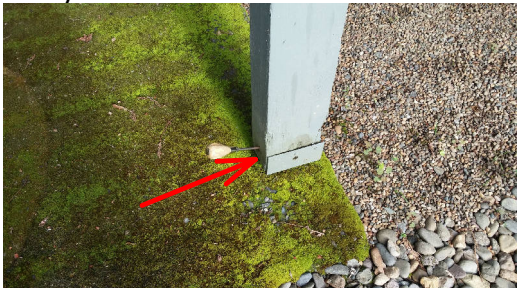
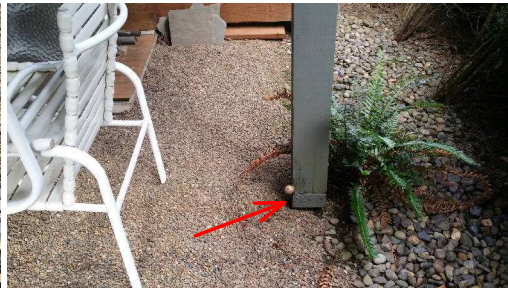
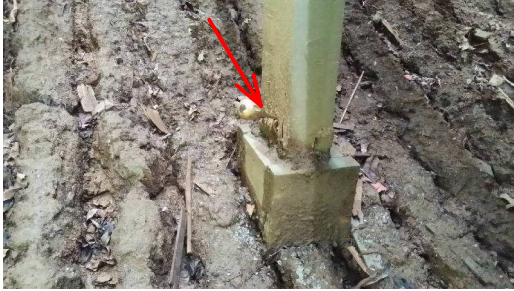
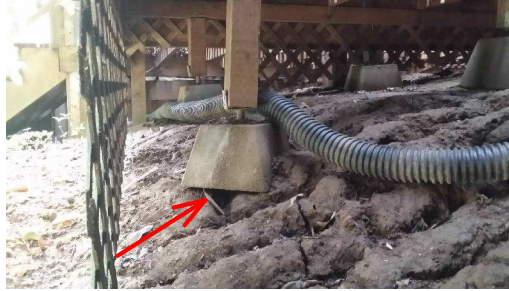
3. **Deck:** Treated wood, Untreated wood. I observed rot at the bottom of some concrete patio posts as well as under the main deck. The soil is moving downhill and some of the concrete piers are exposed underneath. It appears that the deck was installed against the siding. Ideally the siding should have been removed and metal flashing be installed. There is no flashing visible on top of the ledger board which can cause moisture intrusion. I can also not find any bolts on the ledger on board. This should be added for safety. Some nails are rusting and should be evaluated. Eventually they will fail. The ground has given away under the lower section of the deck. The concrete piers have cracked in places or are exposed. The south-facing handrail on the far East deck is loose and needs to be attached. Remove the tree branches that have fallen onto the handrail. I recommend evaluation by a soil engineer and repair by a licensed contractor. Avoid wood to soil contact as it will cause rot overtime and invite wood destroying organisms. Overall, this is an older deck and repairs/replacement can be costly.

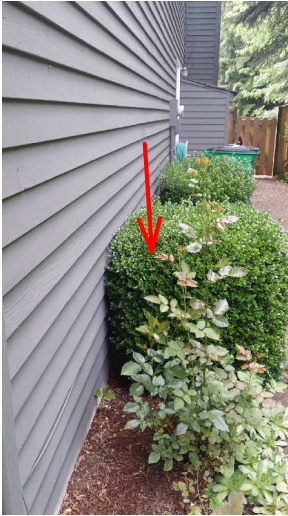
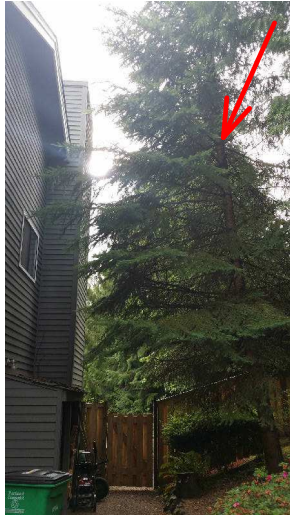
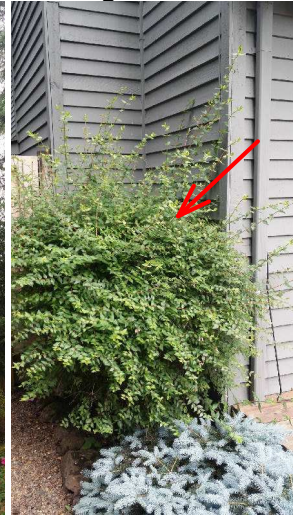
5. Vegetation: Shrubs and trees. Maintain a clearance between shrubs/trees and the siding. 1-2 feet would be ideal. Monitor the tree on the South side. It is leaning toward the house.

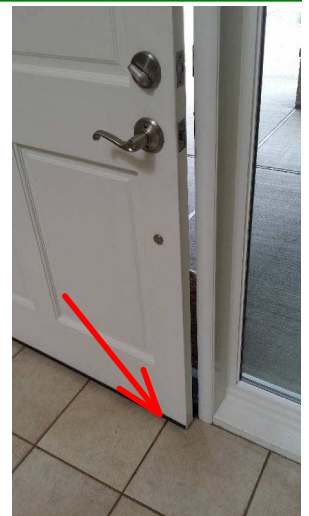
6. Entry Doors: Wood. The front door scrapes over the tile in one spot. Adjust as needed.

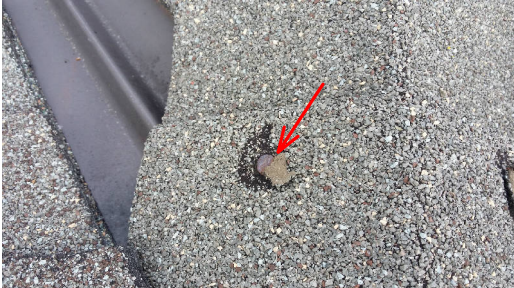
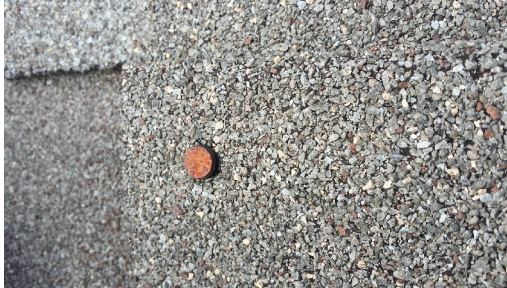
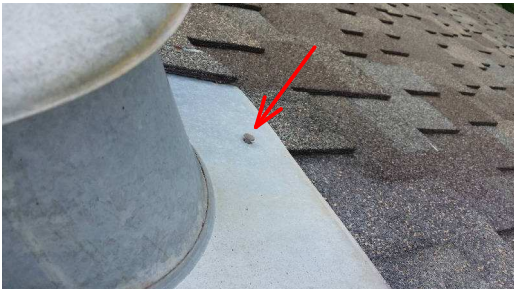
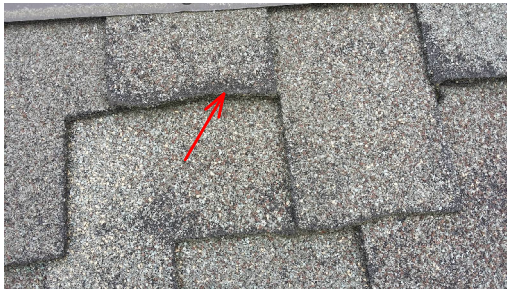
- 8. Main Roof Surface Deficiencies:** Various. Maintain the caulking on the nail heads to prevent moisture intrusion. Most of them however have flashing installed underneath which eliminates the need for caulking. Some granulated loss is noted.

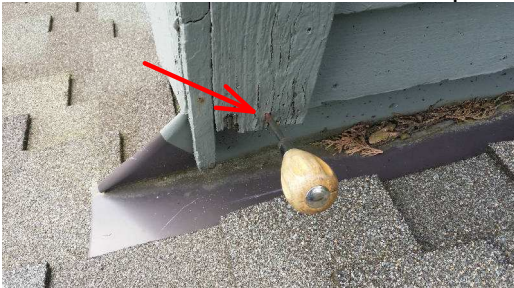
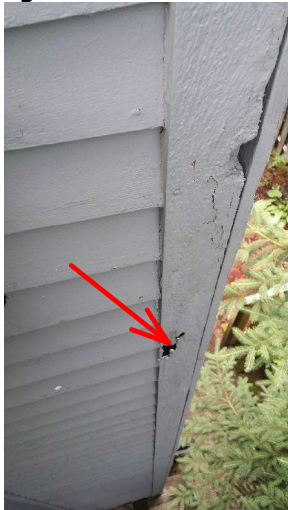
- 9. South Chimney Chimney:** Framed. Rot was found on the trim. Replace as needed. Some of the siding boards are loose and the nails are pushing out. This should be fastened when the trim is replaced.

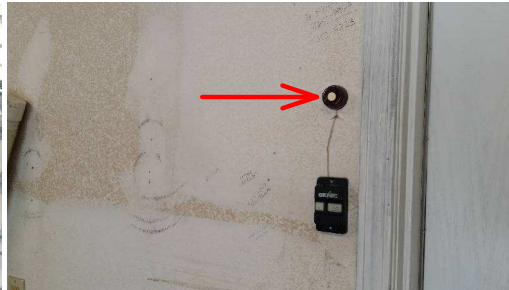
- 11. Attached Garage Door Operation:** Mechanized. I was not able to operate the left side garage door. The upper button may be for this door but it did not work. Have the seller verify that the door is in working condition.

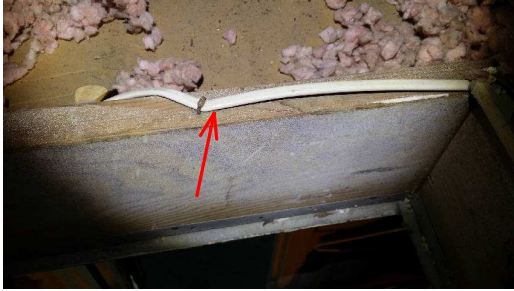
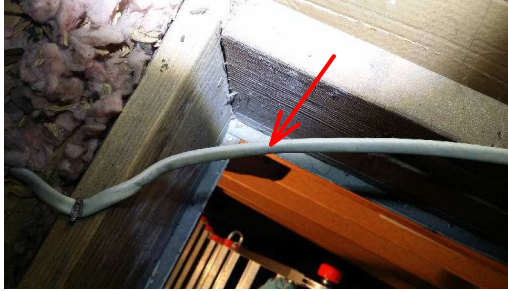
- 14. Main Attic Wiring/Lighting:** 110 VAC. Wiring within 6' of the attic access should be protected with guard strips.

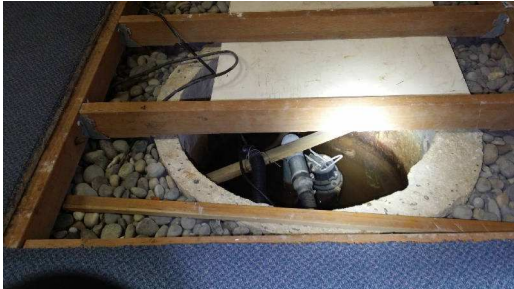
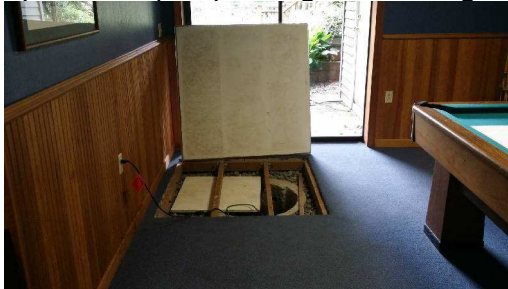
- 16. Main Basement Sump Pump: Submerged.** I was not able to test the sump pump, it did not come on when I tried to test it. Have the seller verify that the pump is in good working condition.

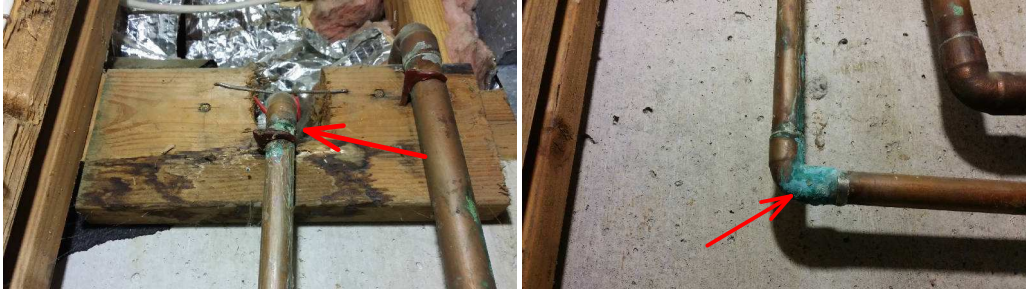
- 18. Water Lines: Copper.** I found a leak in the water line above the water heater. I recommend repair. Green flux is present at the pipe connections. This should have been wiped off after the installation as it can cause leaks over time.

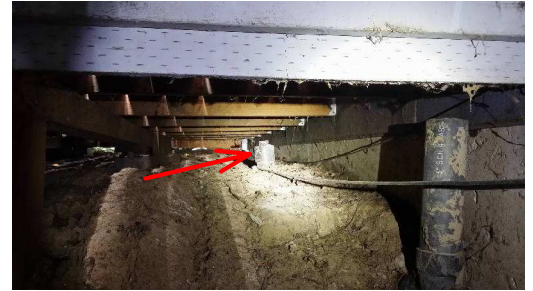
- 19. Service Caps:** Under the deck. This clean out may be difficult to access.

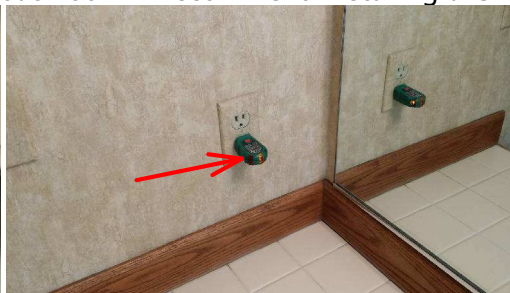
- 23. Master Bathroom Electrical:** 110 VAC, 110 VAC GFCI. The GFCI outlet near the toilet only protects the exterior outlets of the house but not the bathroom. I recommend installing a GFCI outlet next to the sink.

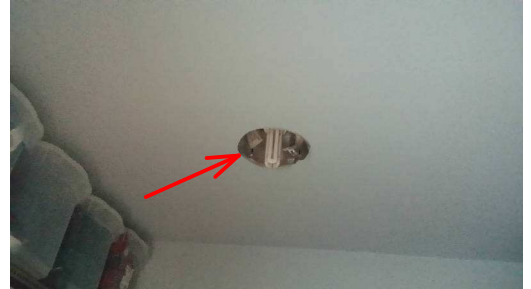
- 30. Whole house Living Space Closet:** Walk In, Large, Small. Install the correct light bulb and cover plate in the Southwest bedroom closet.

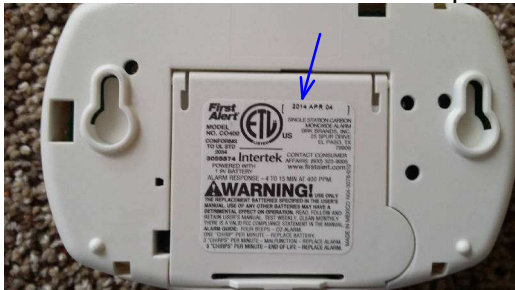
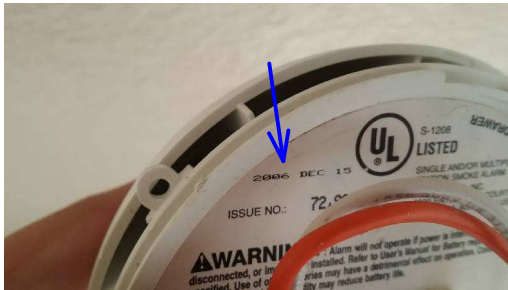
- 31. Whole house Living Space Smoke Detector:** Hard wired. The carbon monoxide alarm is from 2014, add one on each level. The upstairs smoke alarm is from 2006. I recommend installing smoke alarms in each room for added protection. Make sure that the smoke detectors meet the requirements of the State of Oregon. Go to www.oregon.gov/OSP/SFM for the latest updates on smoke detectors and carbon monoxide alarms. Smoke detectors need to be replaced within 10 years, carbon monoxide alarms within 5 years. The installation of photoelectric alarms is recommended. Several studies have found that they outperform ionization alarms. Carbon monoxide alarms should be placed within 15 feet of each bedroom and one on each level.
