# The Madagascar Water Project

MWP-1  
ANDOVORANTO

## MWP – 1

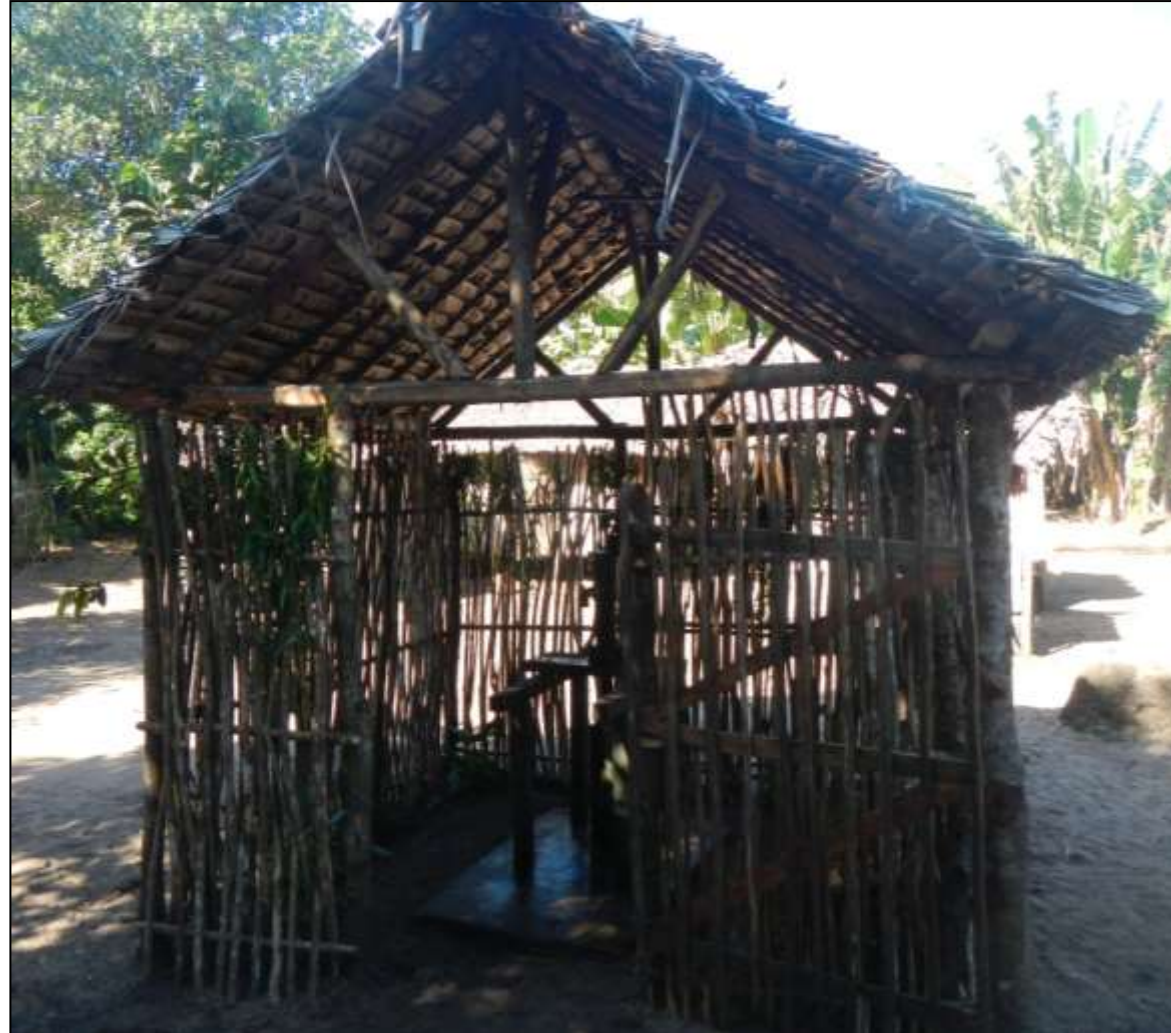
*No water flowing on the 5 first stroke, late production, weak flow and bit hard*

- *The screen needs to be cleaned up, although it is difficult since the BHA is entirely made with PVC.*
- *The well is well maintained*

*Working but less flow and hard to pump*

*Stop the pressure leak with Teflon tape. Tighten everything with washer. Cleaning the pump body and the room,*

*Let's wait and see if the flow will improve later.*

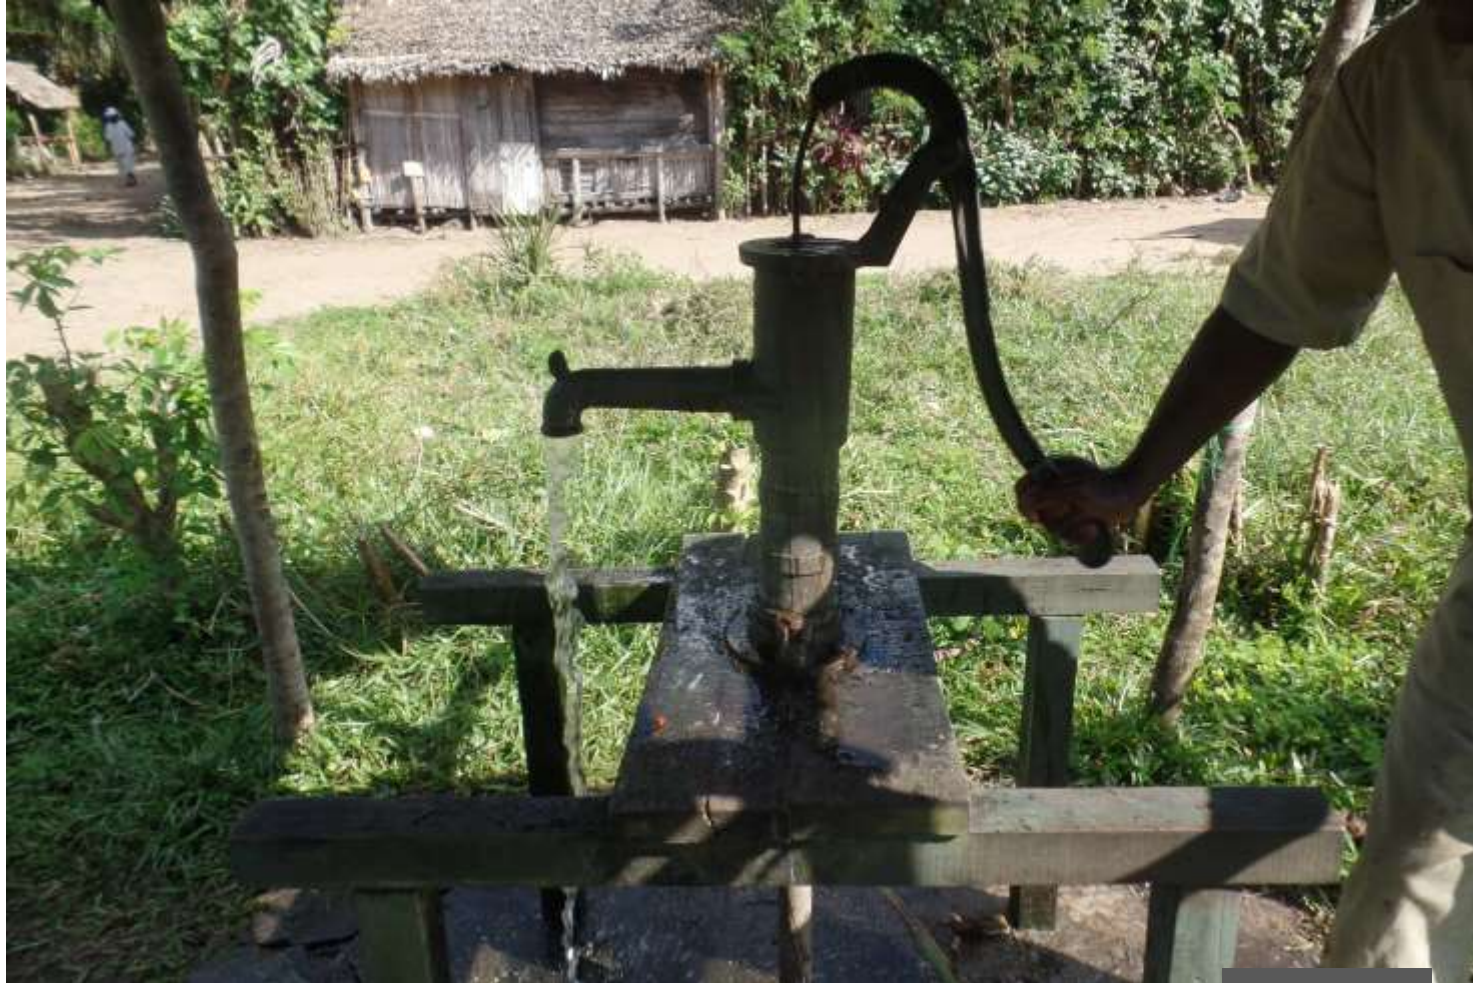
Photo Oct 2021

**•Previous Status:**  
*Working good, table ok, cement slab broken*

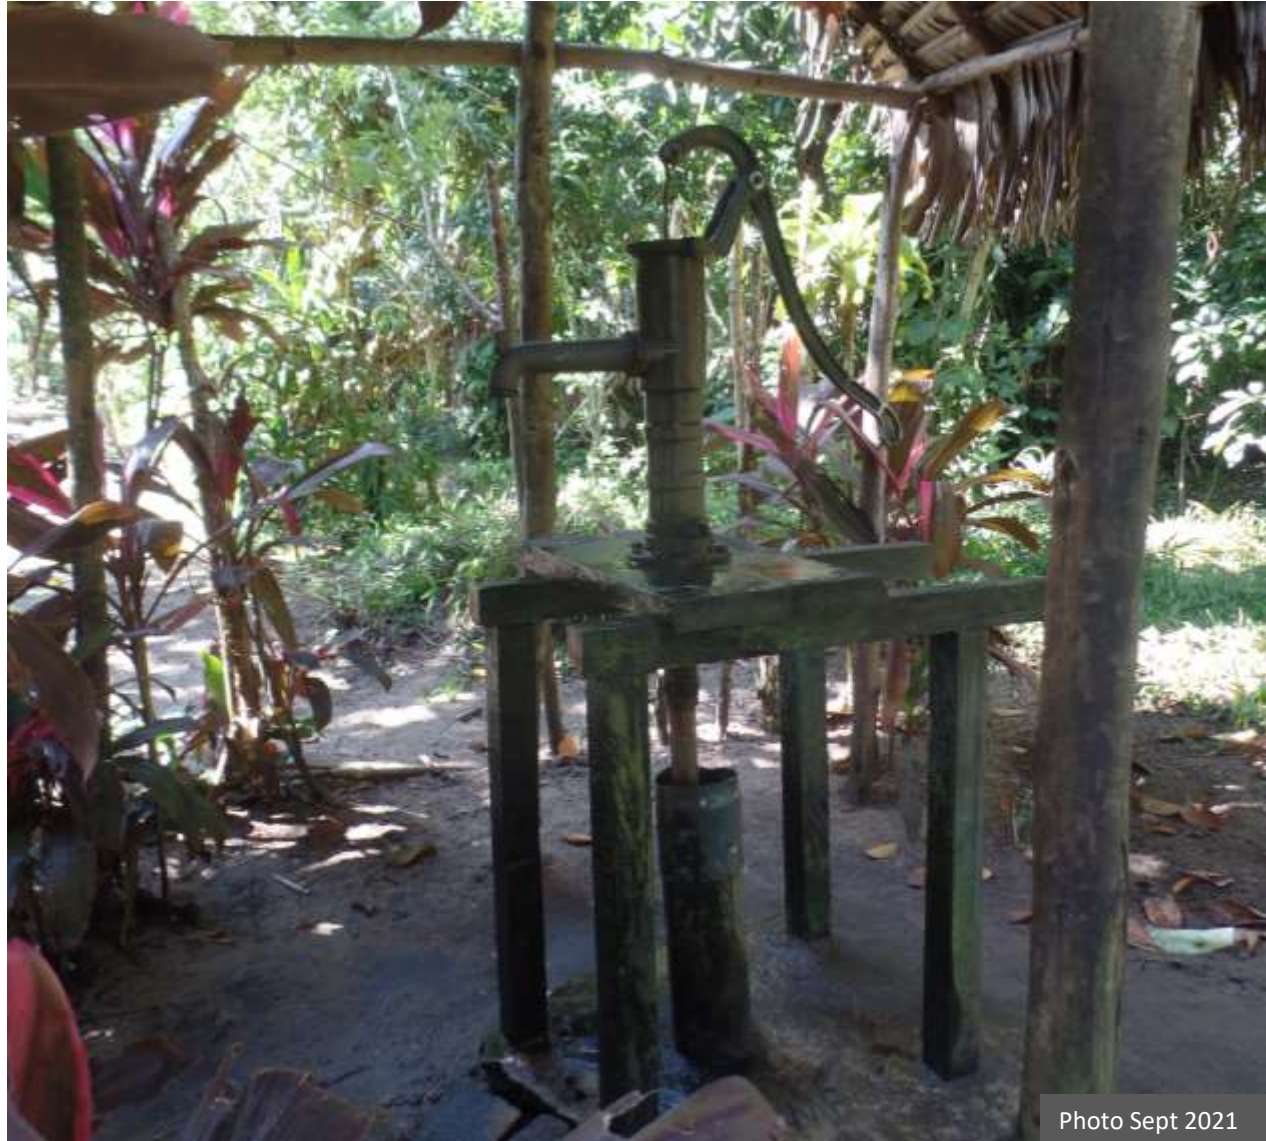
Photo Sept 2021

•**Status on Arrival:**  
Working good, table ok,  
cement slab broken

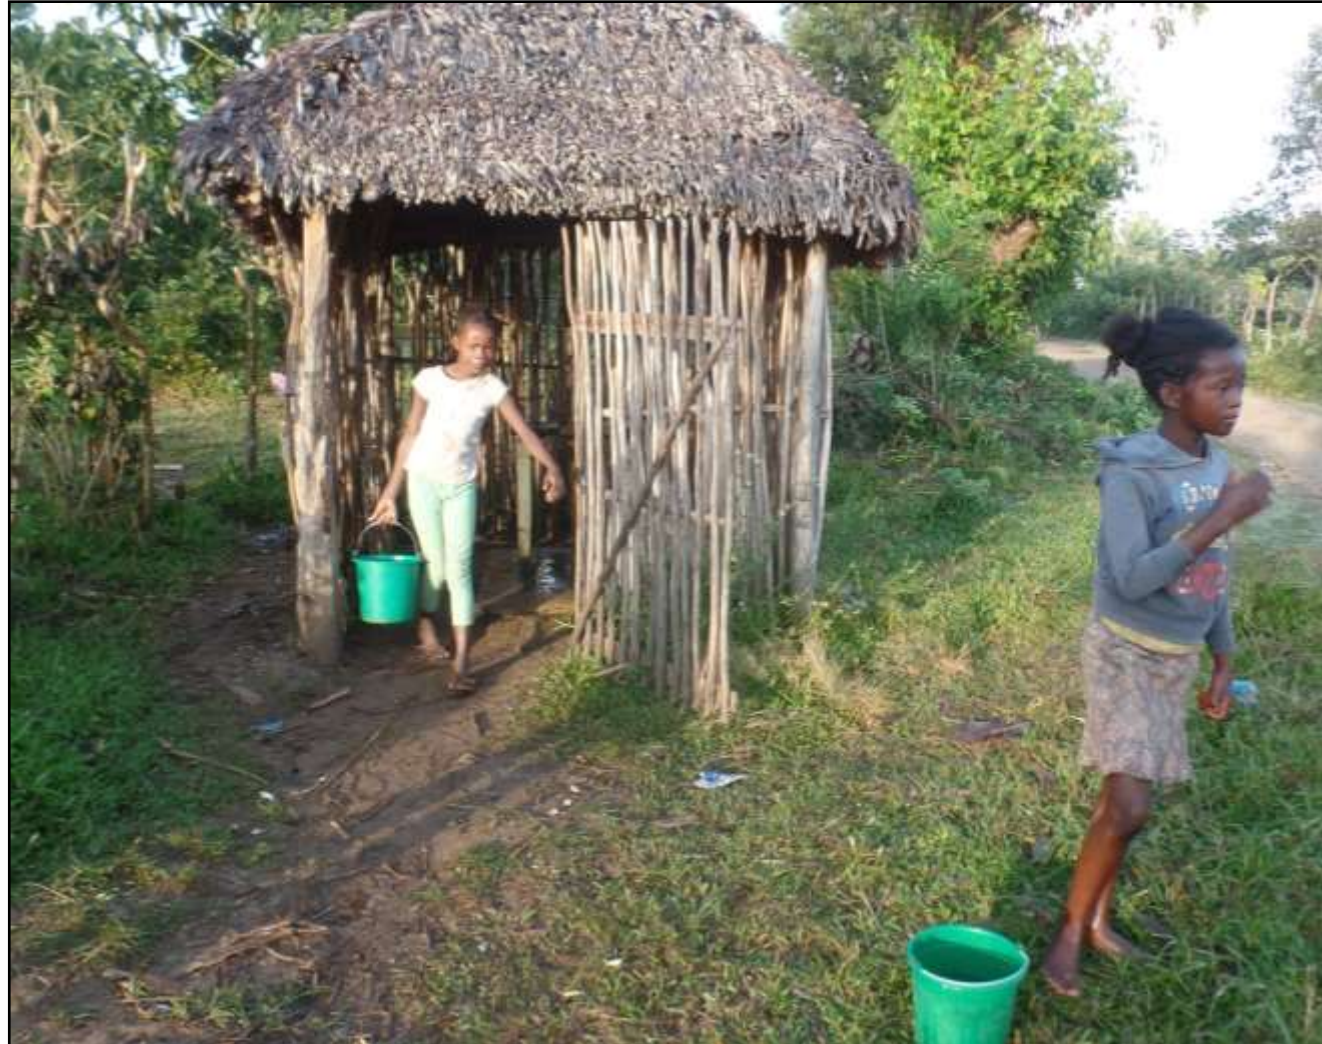
Photo Oct 2021

Well flowing Good with roof and fence, pump top cover loose as the pump body is used.

**Note:** wood table still in good condition

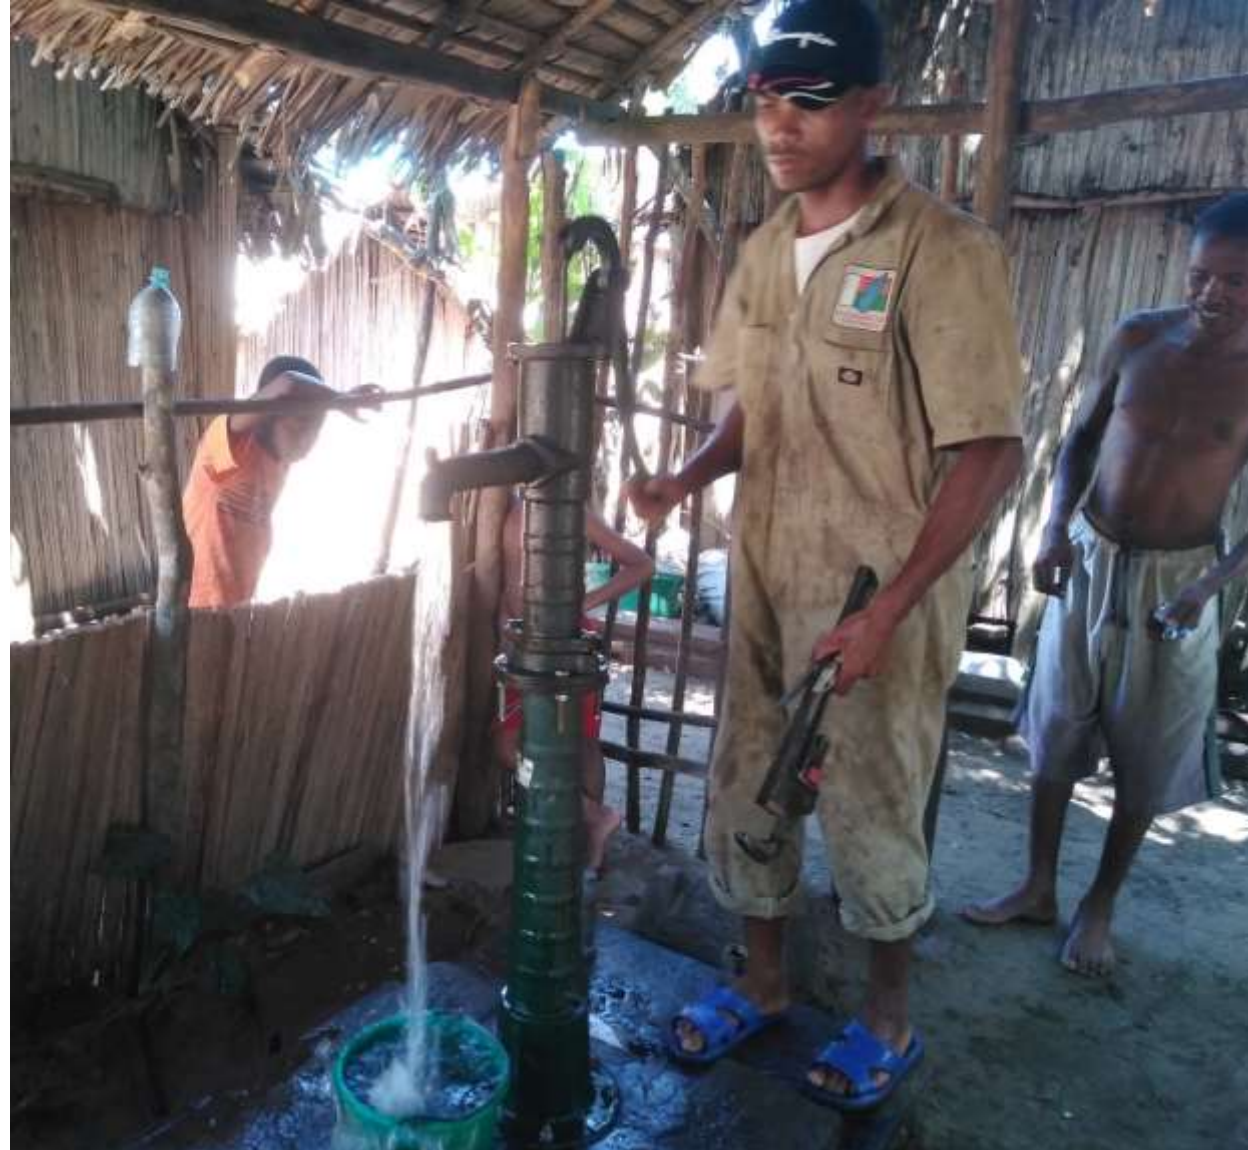
• **Previous Status:**  
*Working but weak flow,*

• **Recommendation:**  
*Let's wait and see if the flow will improve later.*

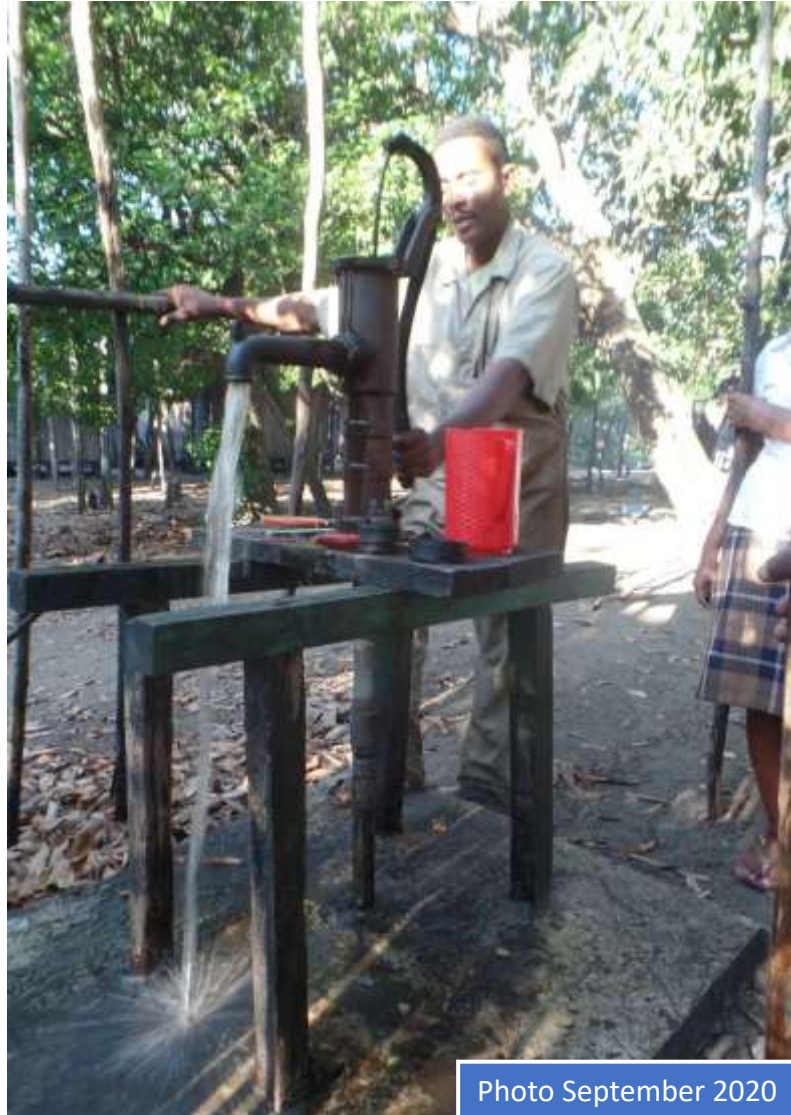
Photo September 2020

- Status on Arrival: Working
- Action Taken: routine maintenance
- Current Status: Working
- Recommendation:  
-Strengthen social

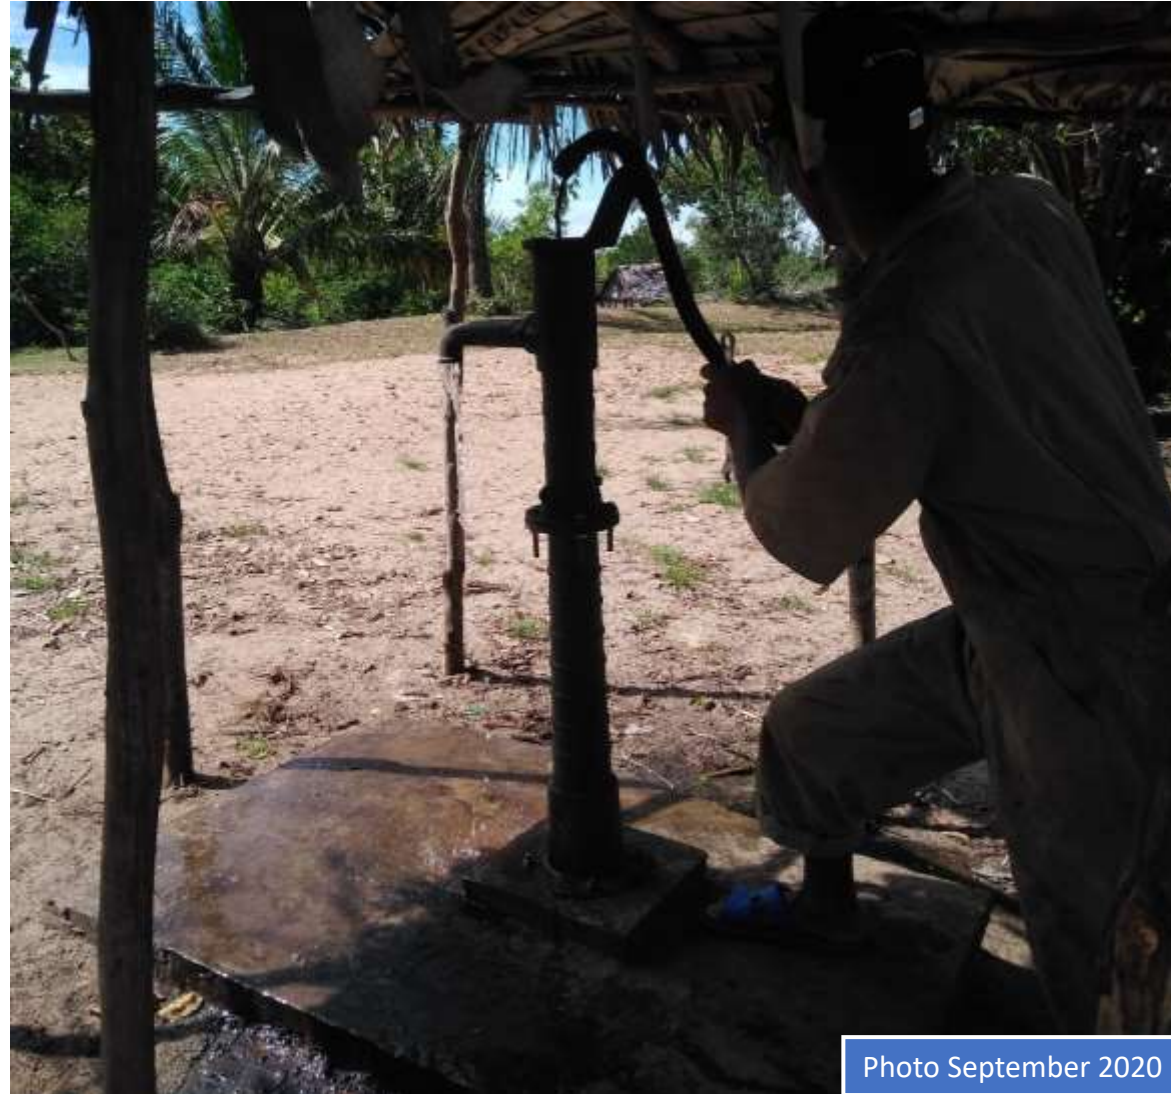
Photo September 2020

- Status on Arrival: Working good
- Action Taken: routine maintenance
- Current Status: Working , good flow
- Recommendation:  
-Strengthen social

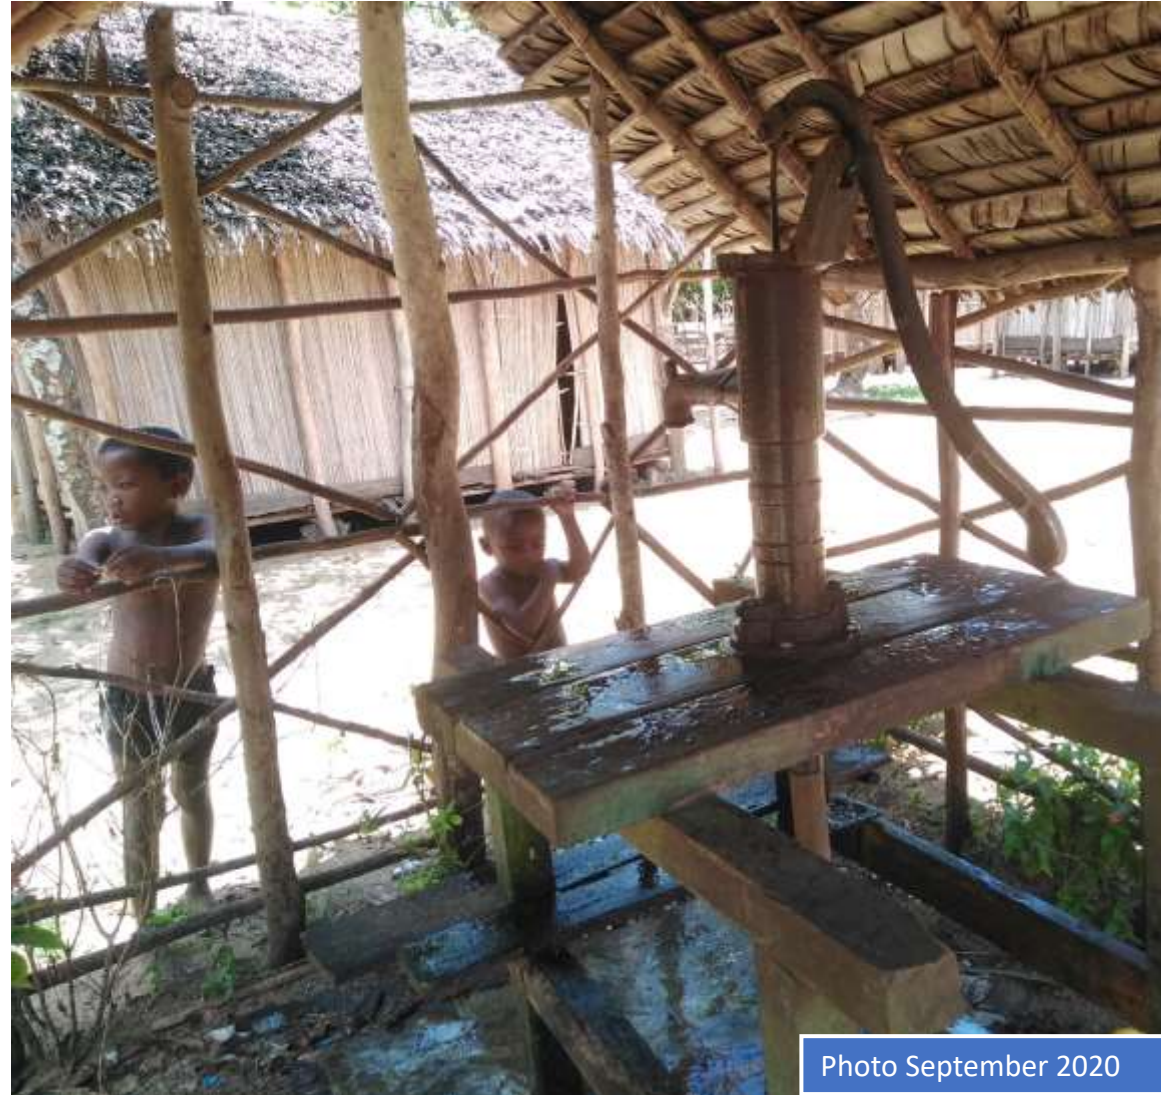
- Previous Status: Pump not working due to problem of Leather cup
- Action taken: routine maintenance, complete rebuilt of table
- Final status: working well, Final status: working well, table new

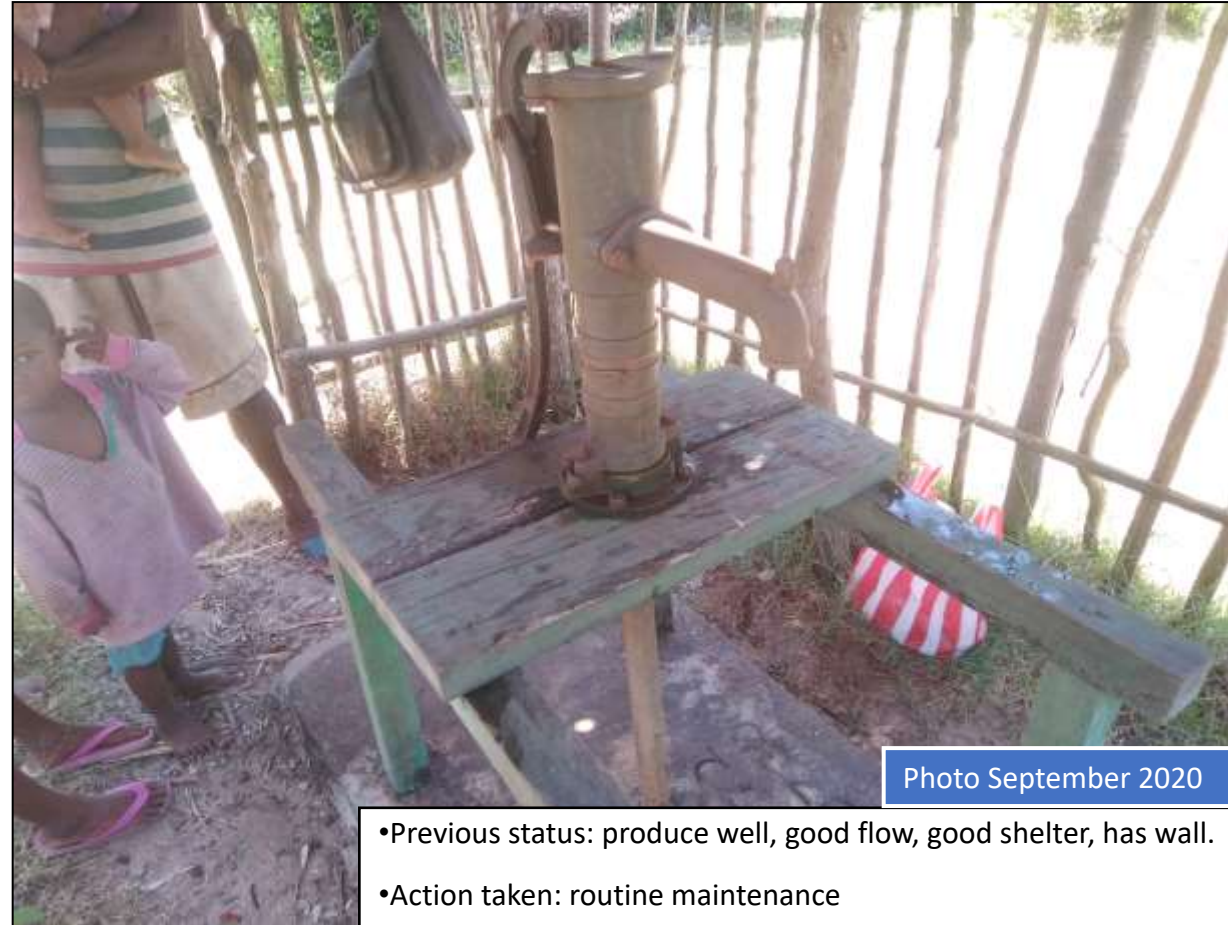
Photo September 2020

- Previous status: produce well, good flow, good shelter, has wall.
- Action taken: routine maintenance
- Current status: produce, good flow
- Recommendation: strengthen Social
- Note: infrastructure in a very good condition

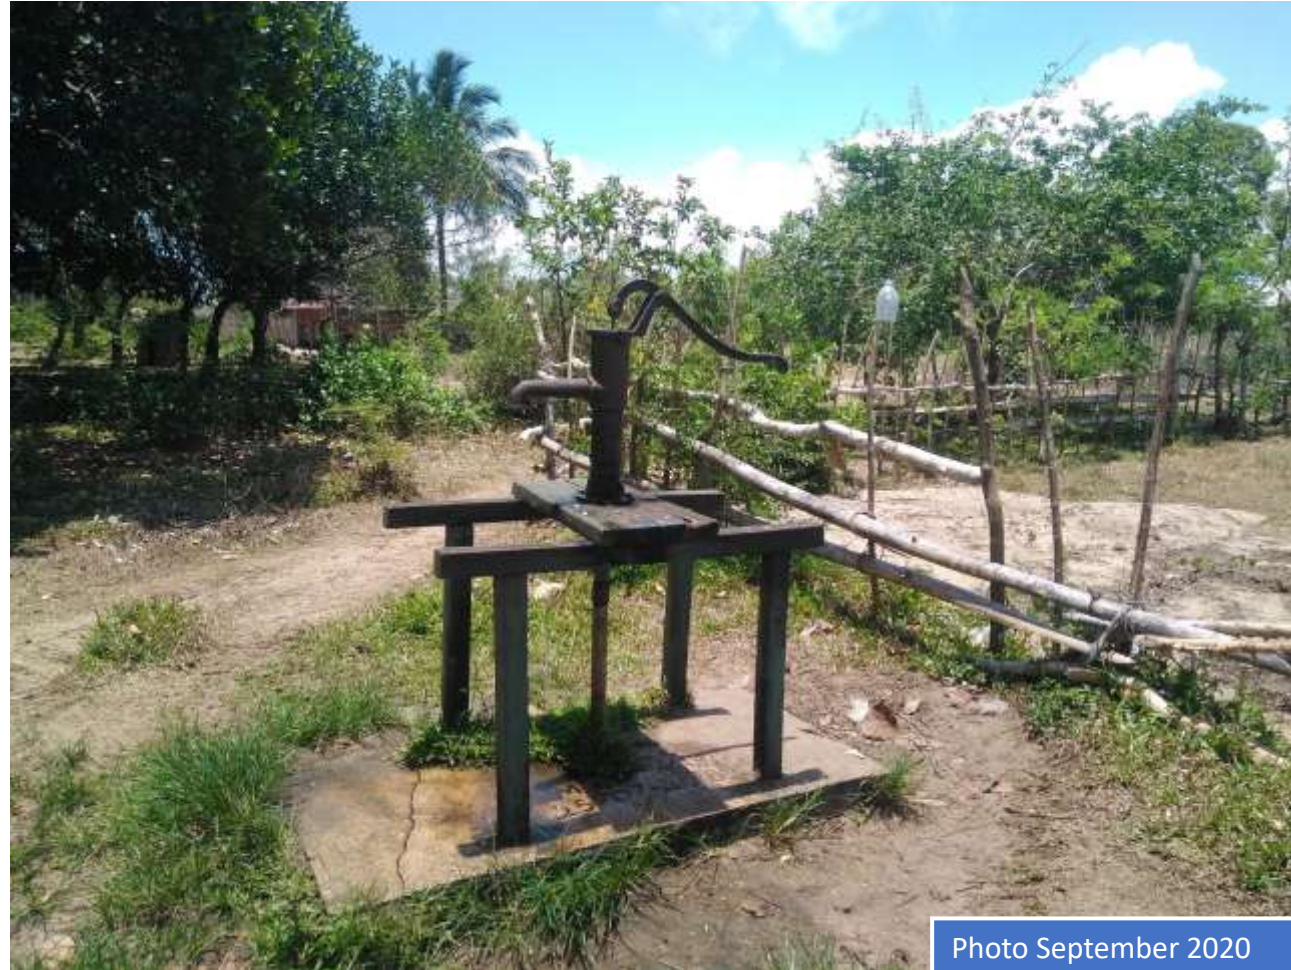
- Previous status: produce,
- Action taken: routine maintenance
- Current status: producing, good flow.
- Recommendation: assist well committee

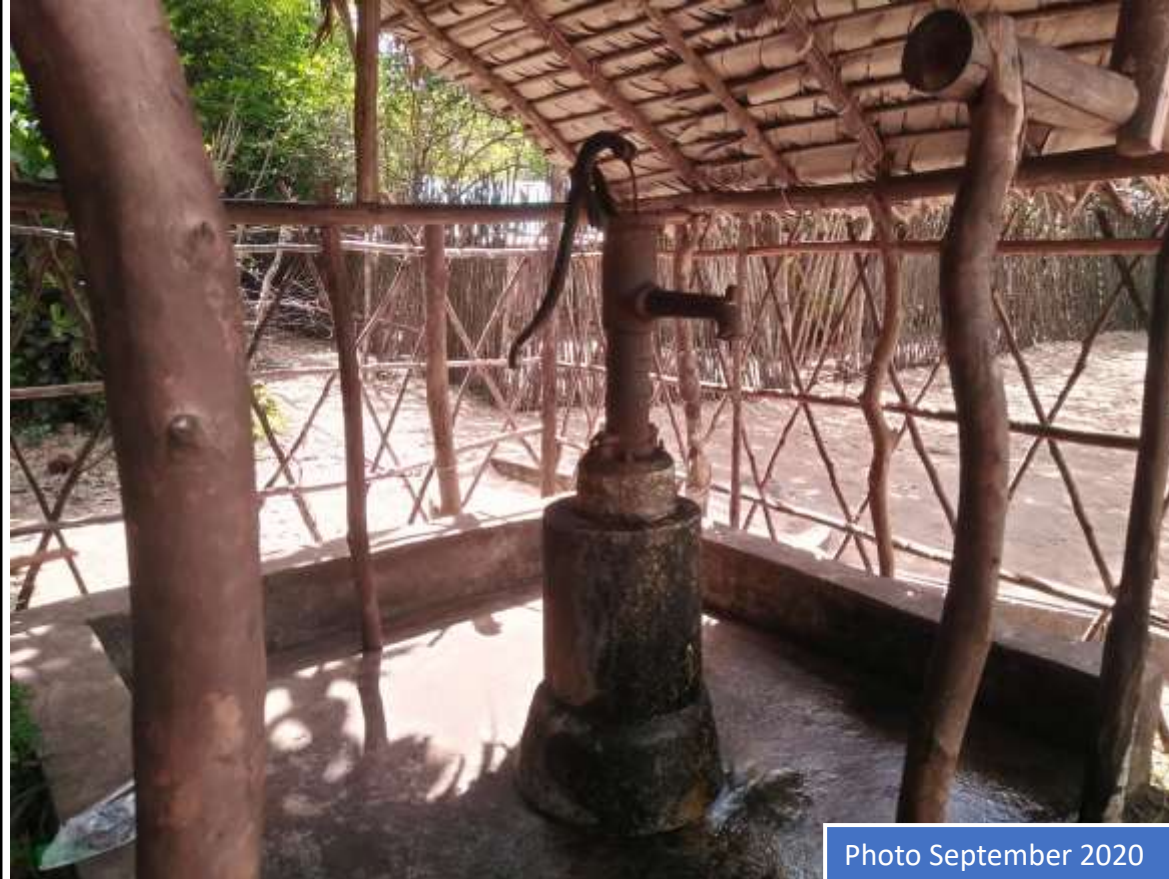
- Previous Status: Pump working
- Leather cup changed
- Final status: working well
- Well well maintained

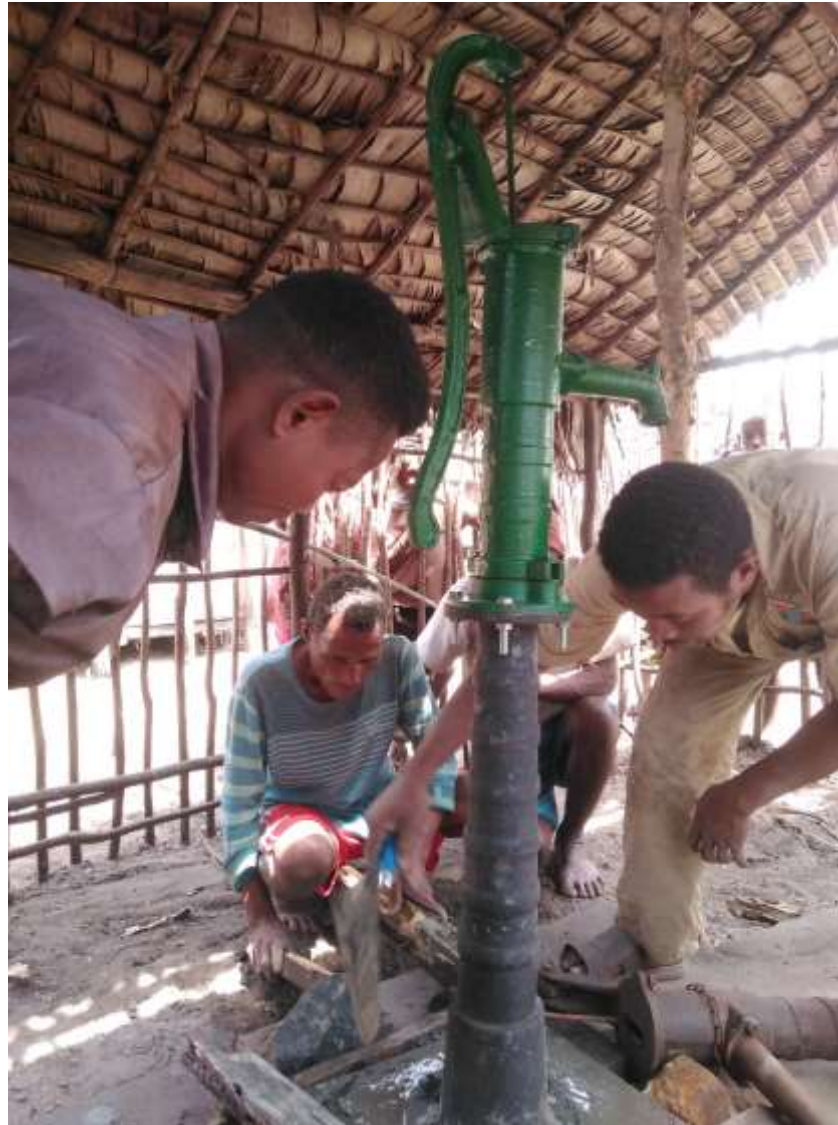
*Not Working, the piston is loose, leather cup broken  
The pump has been broken for more than 4 months*

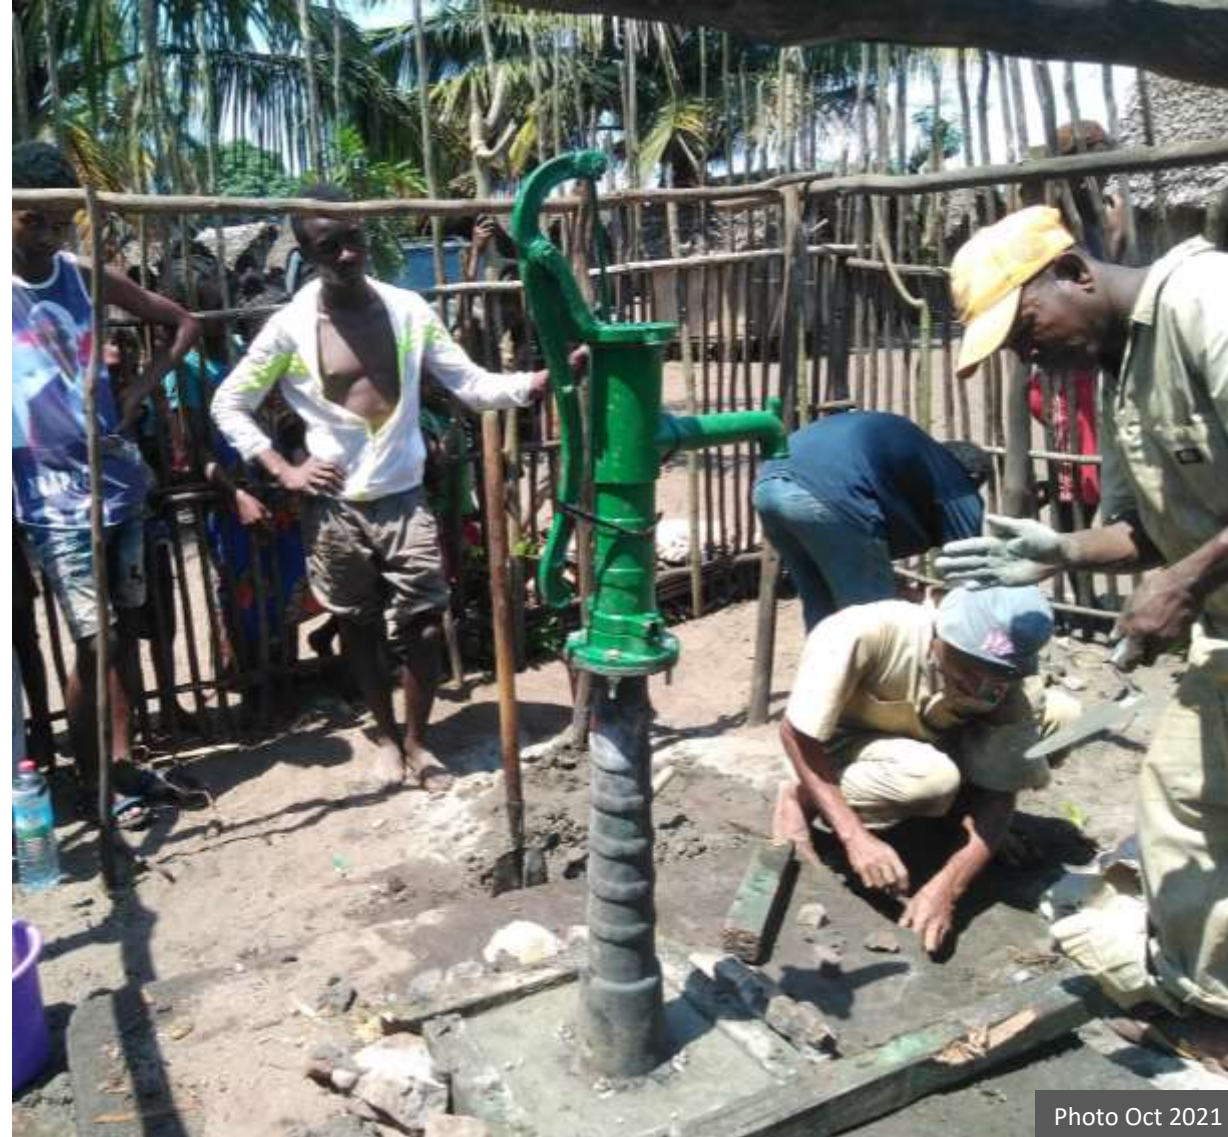
Photo Oct 2021

*Not Working, the piston is loose, leather cup broken The pump has been broken for more than 4 months*

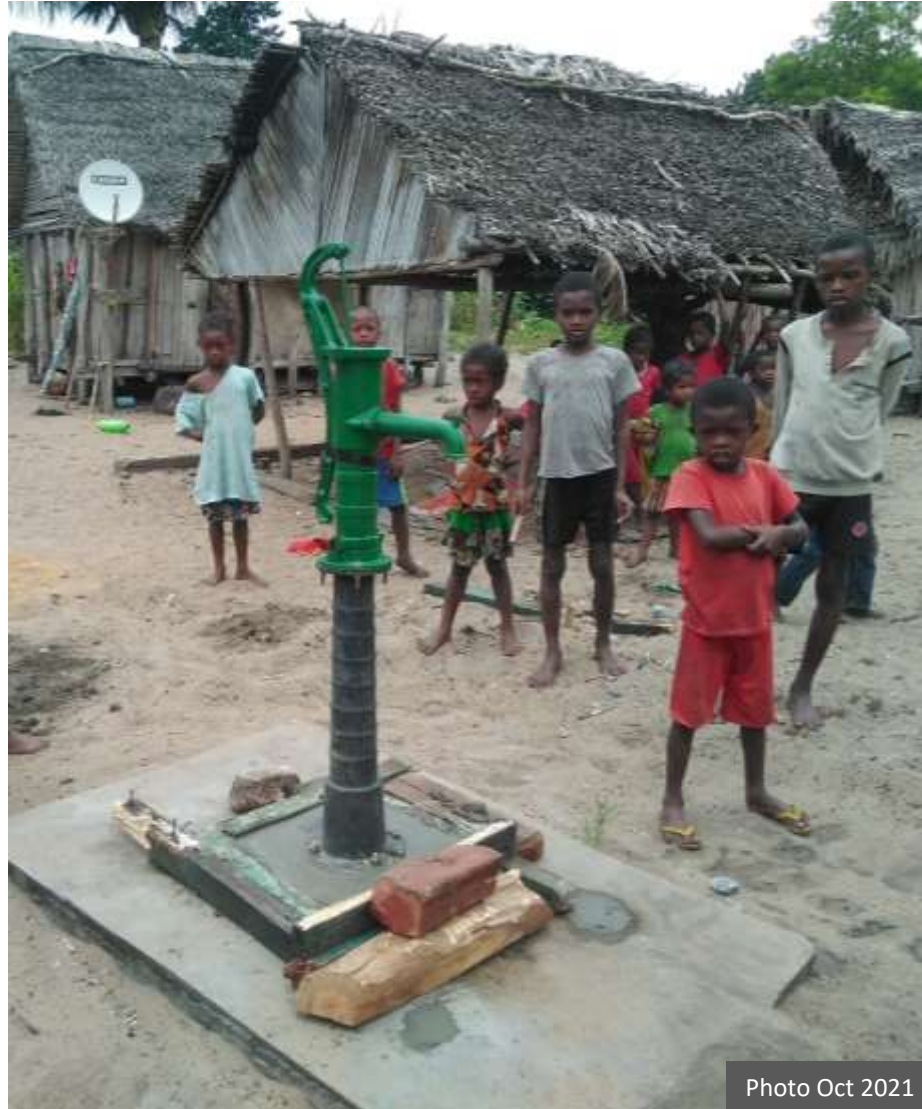
Photo Oct 2021

*Not Working, the piston is loose, leather cup broken The pump has been broken for more than 4 months. Well no fence, no roof.*

**Recommendation:** *Encourage users to build shelter*

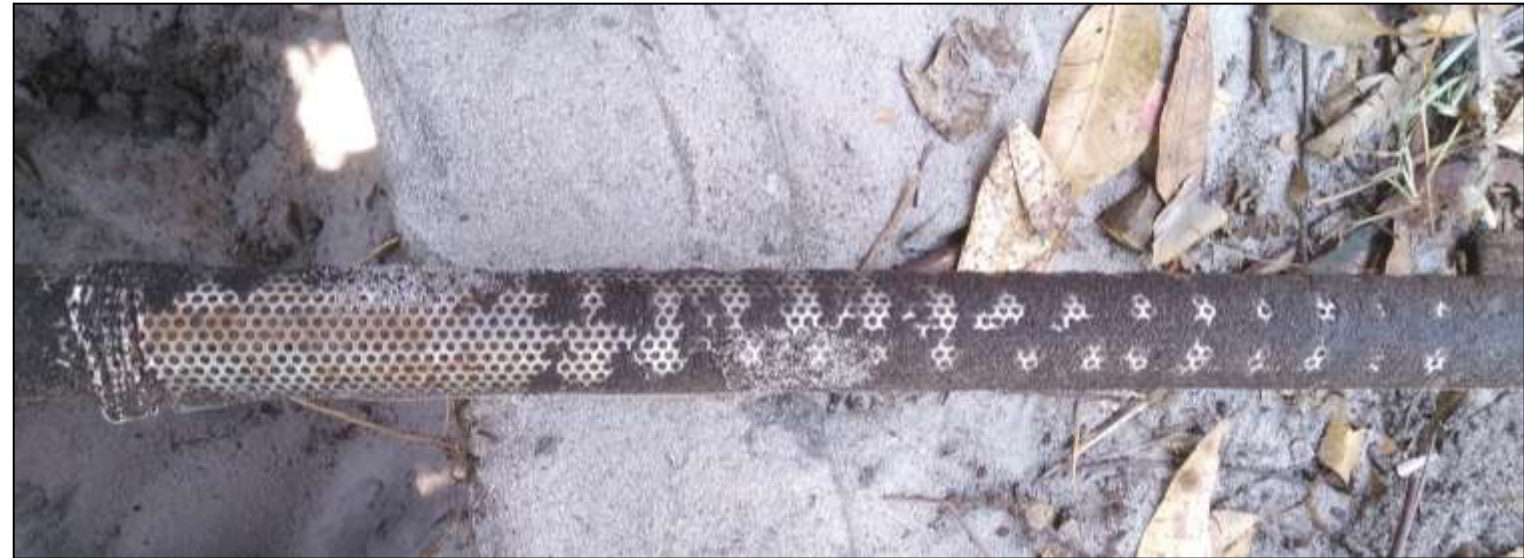
*So we pulled out the entire BHA, and drilled a new replacement well, with a number MWP147.*

*Abandon MWP96 and drill new well replacement*

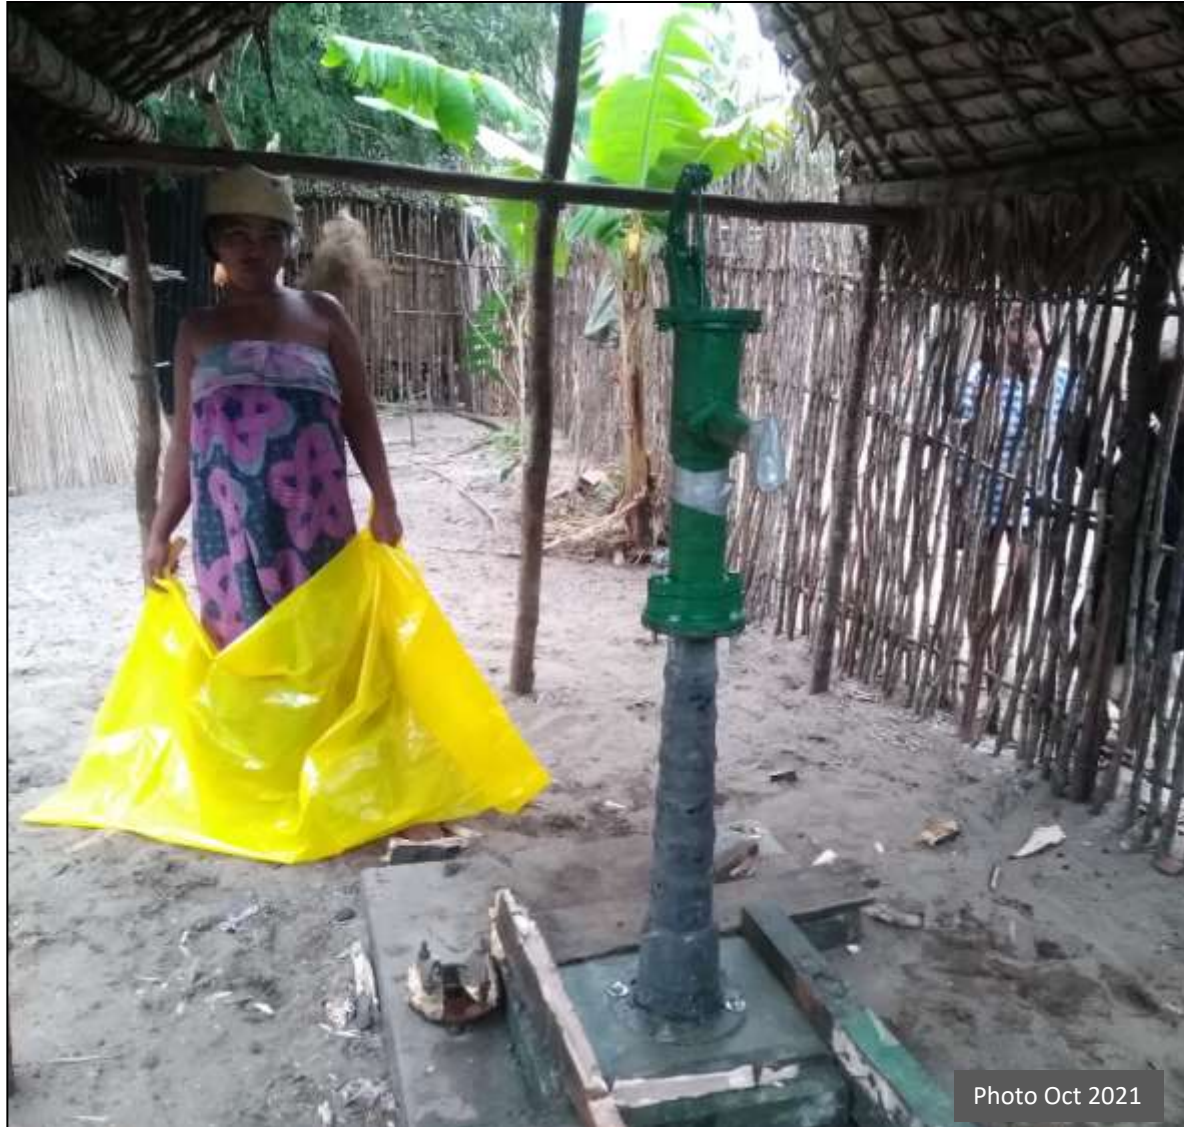
- Well not working for 3 months due to physical failure of the pump

*Note: It looks like the house close to the well is the only one who take care of the well, by putting roof and wall, and finding solution to fix the pump when it is broken. Although the other people was claiming with the behavior of the responsible, and his attitude, such as locking in his yard the well.*

- Replacement of old pump with new Standard pump

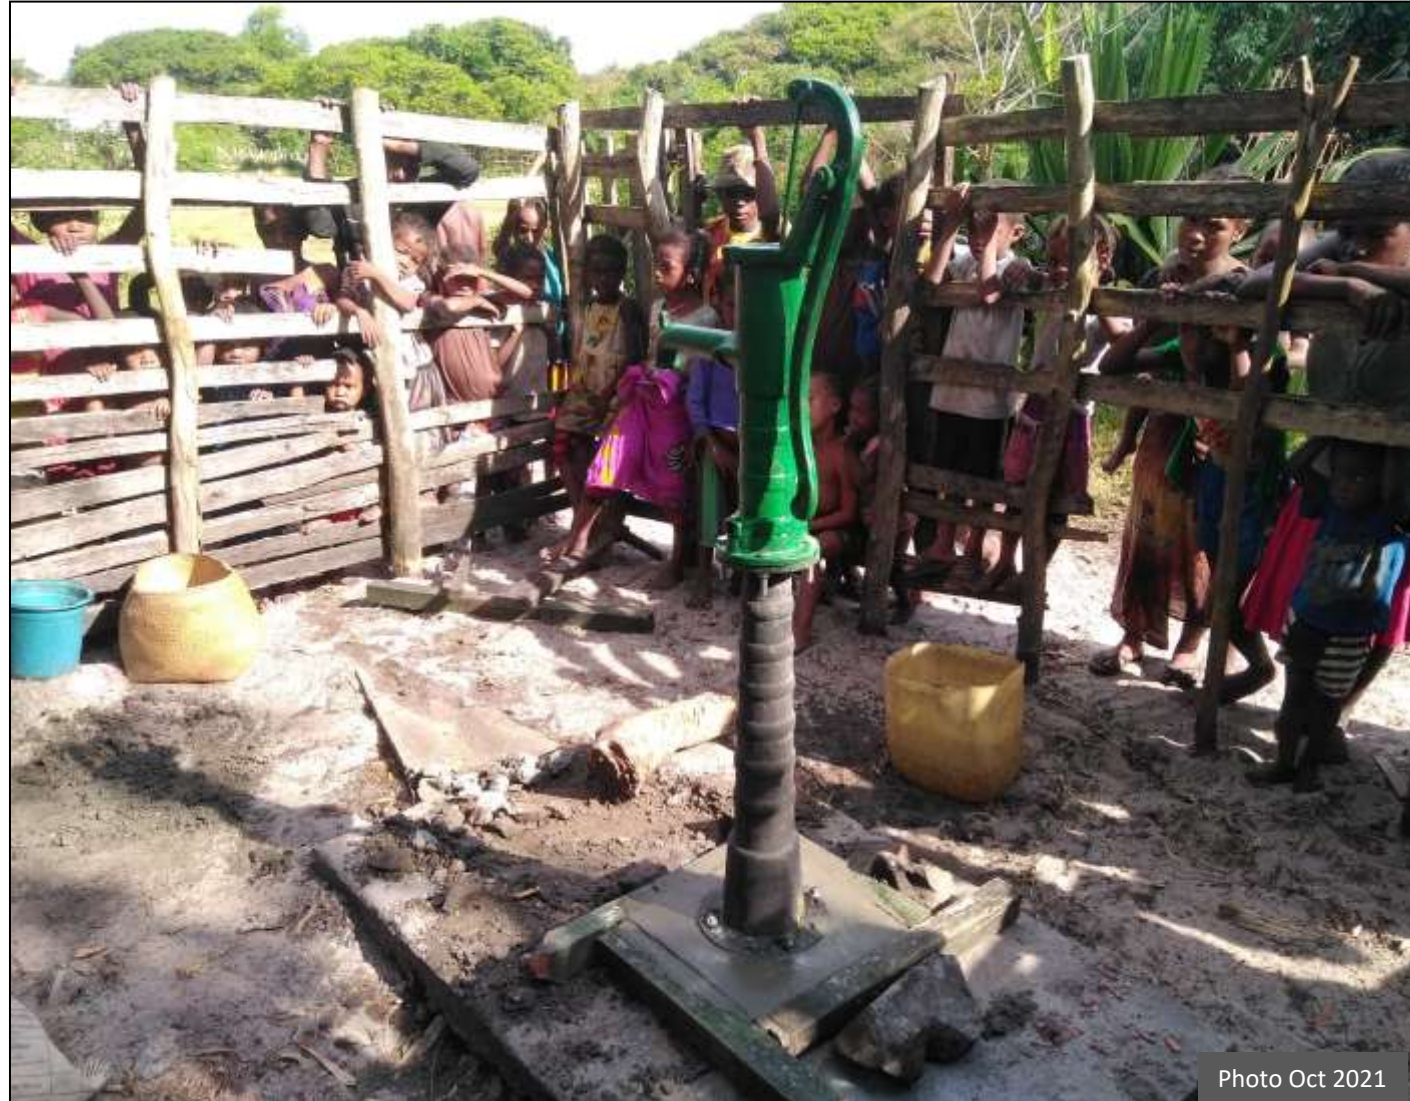
Photo Oct 2021

*Not Working, the piston is loose, leather cup broken. The pump has been broken for more than 4 months.*

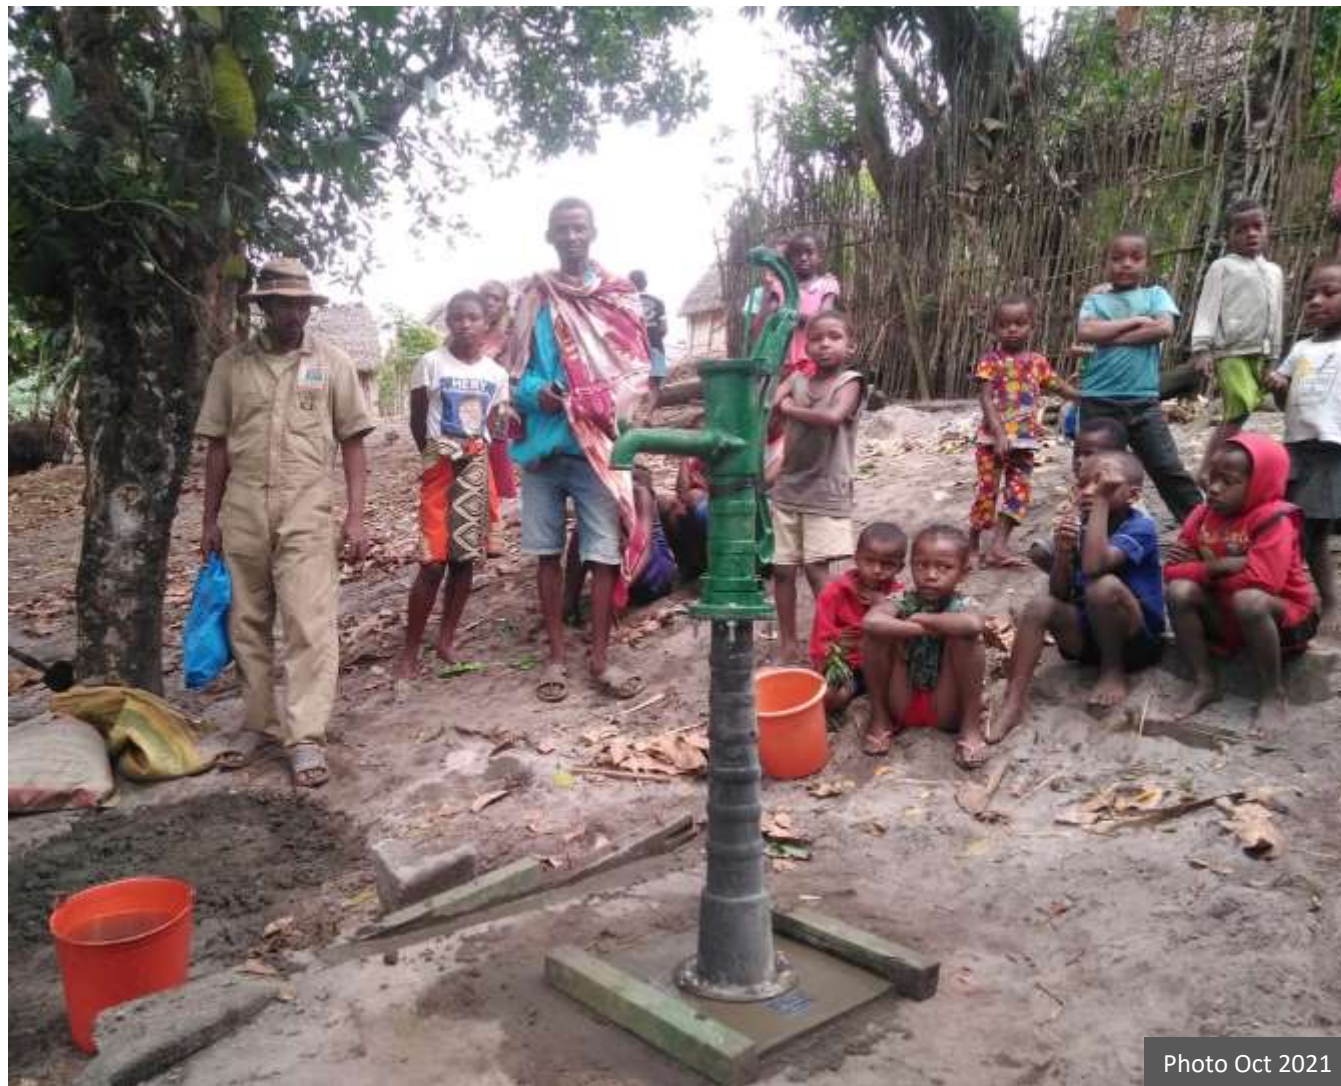
Photo Oct 2021

- Well not working for 3 months due to physical failure of the pump

- Replacement of old pump with new Standard pump
- Complete rebuild with Cast iron pedestal
