# The Madagascar Water Project

MWP-1  
ANDOVORANTO

## MWP – 1

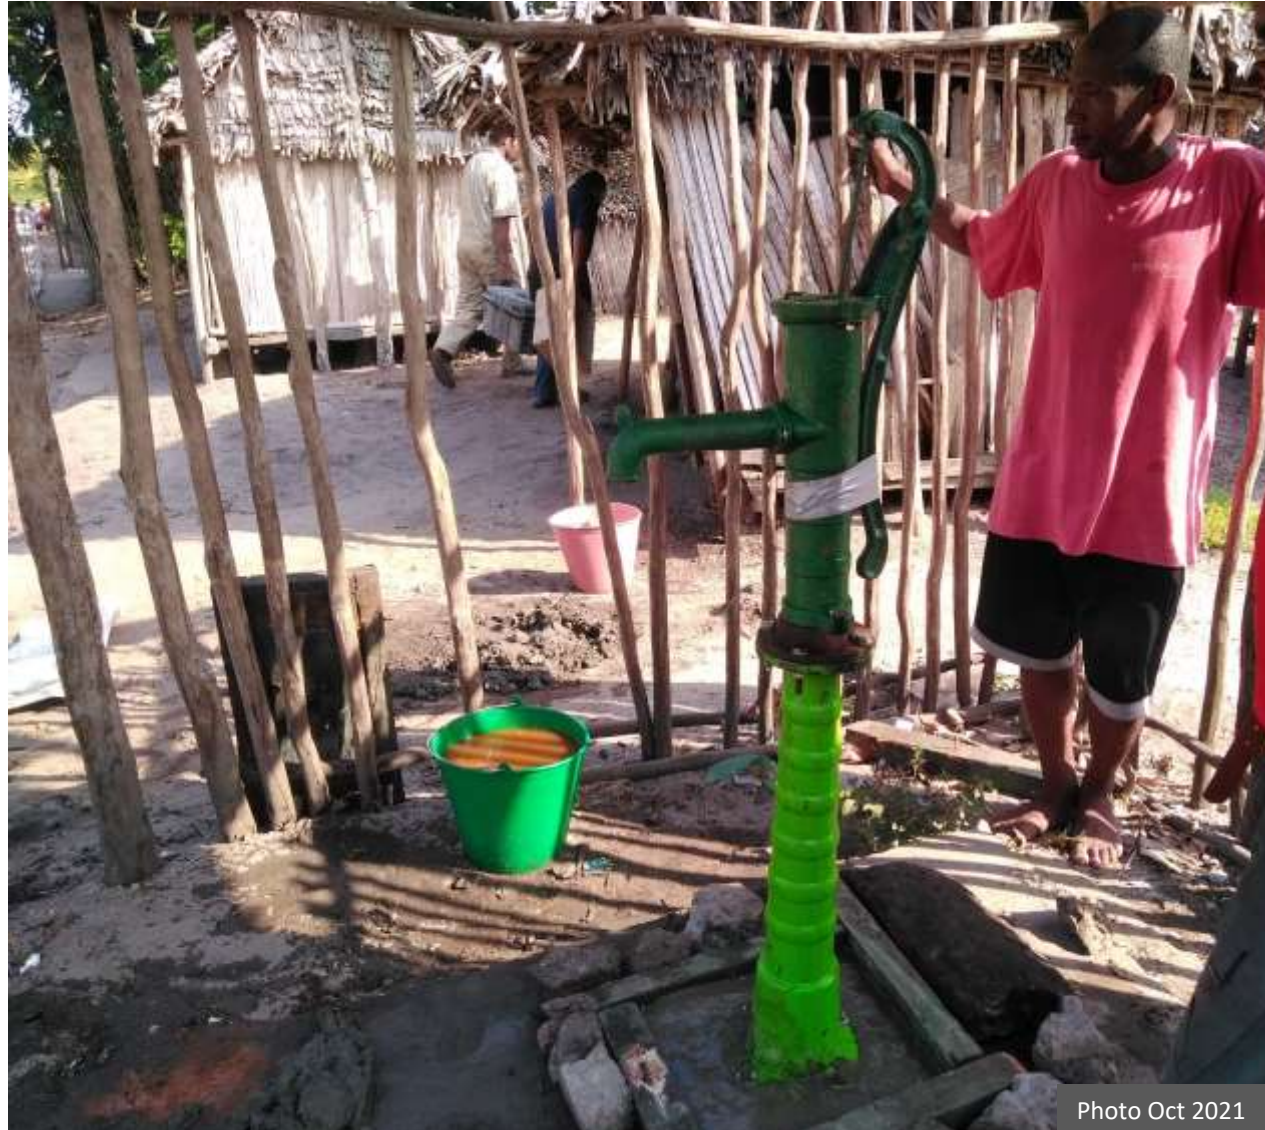
Photo Oct 2021

- Well not working for 3 months due to physical failure of the pump

- Replacement of old pump with new Standard pump
- Complete rebuild with Cast iron pedestal

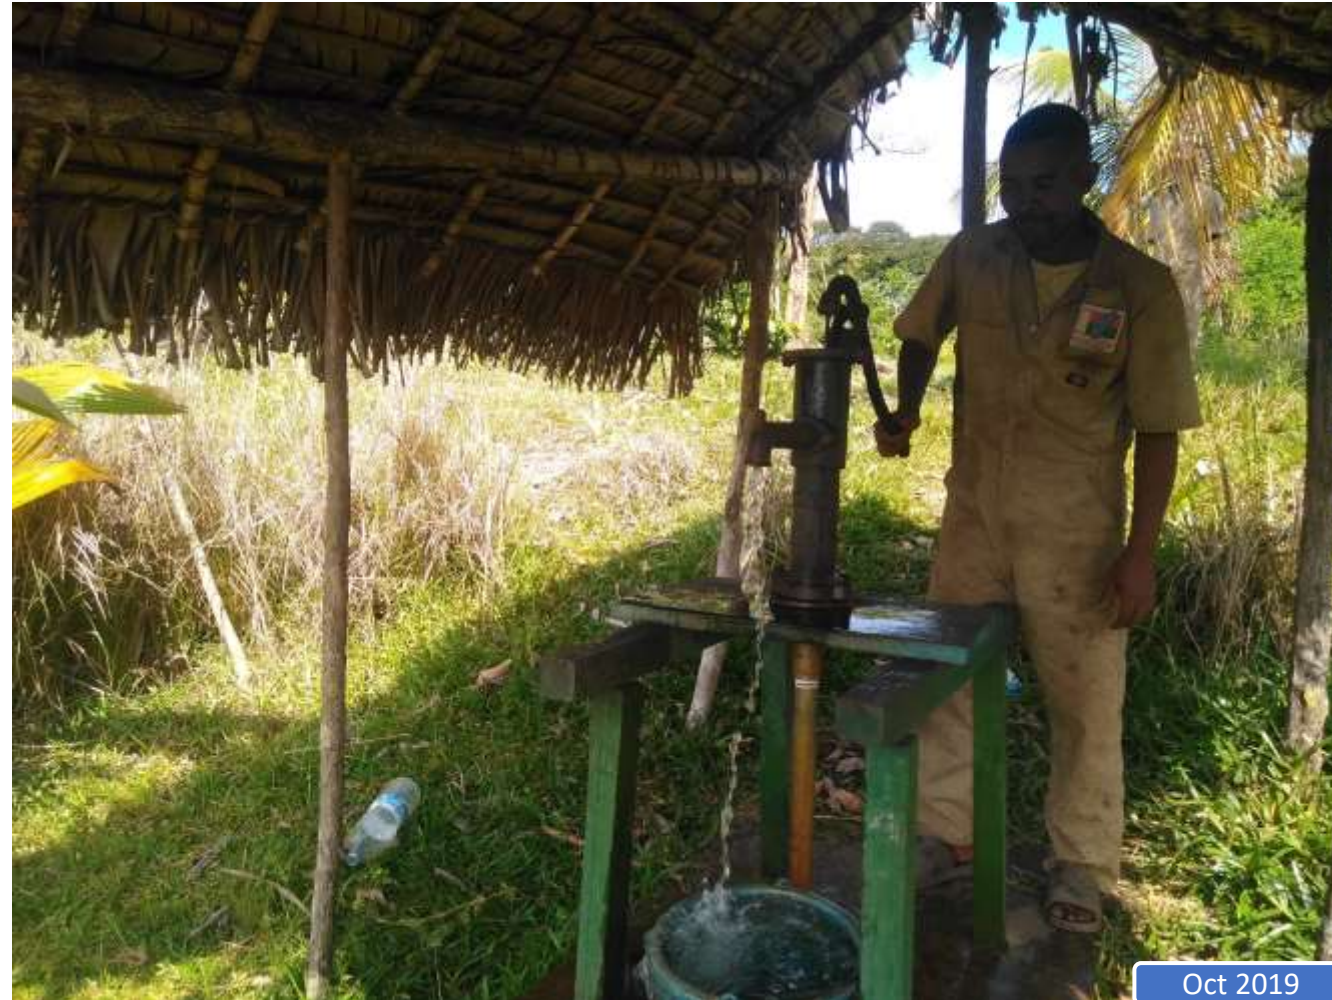
•Status on Arrival: working, leather cup still in good condition

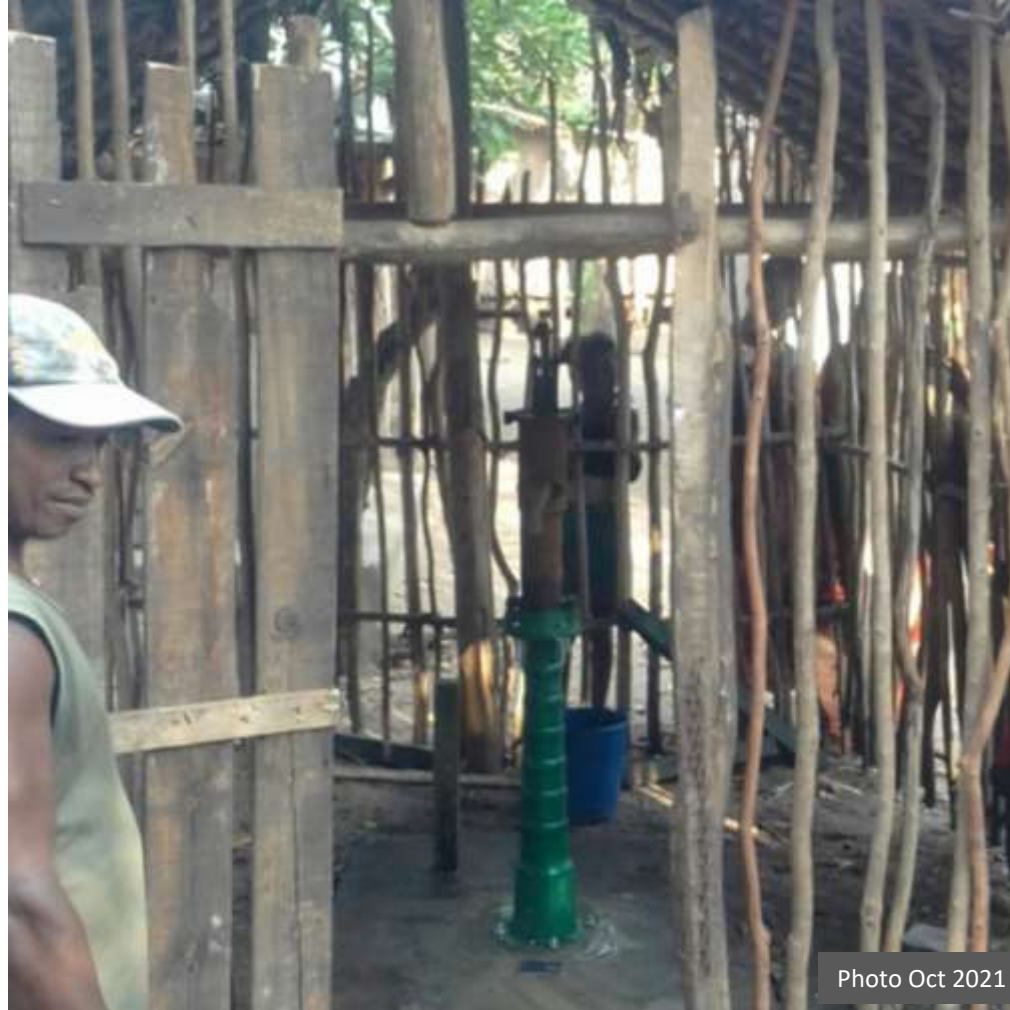
Photo Oct 2021

- Well working, with its original leather cup,
- *Well maintained and well cared*
- *Pump still in a very good condition*

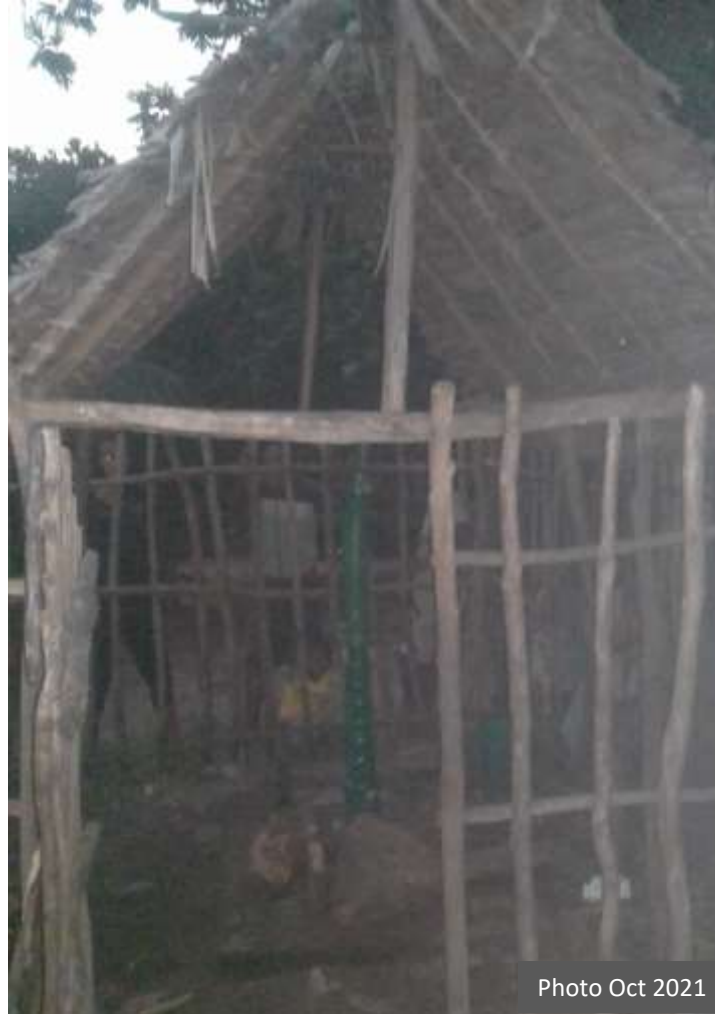
Photo Oct 2021

- Well working but pump starting tired, top pump cover start to loose, easy stroke, moderate flow but continue.
- Wood rotten
- *Well maintained and well cared*

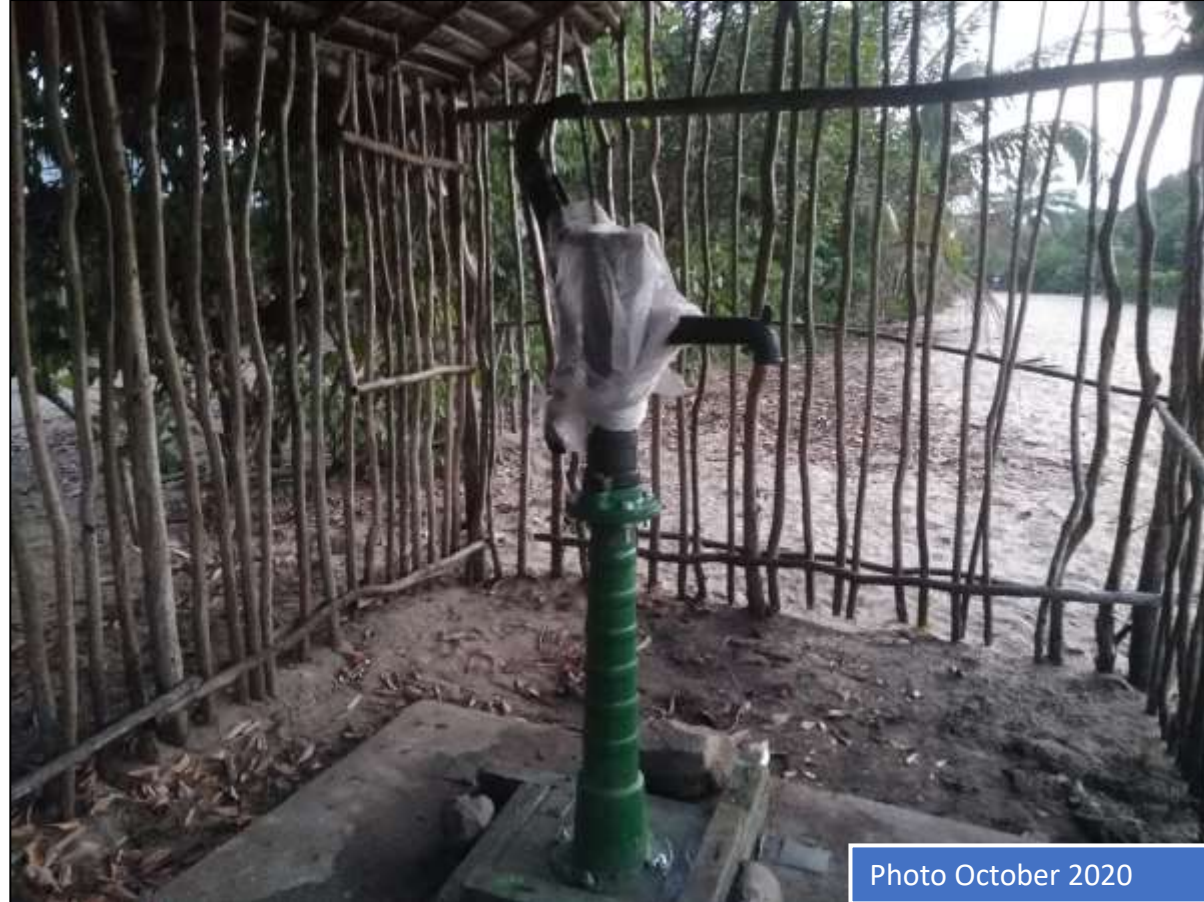
Photo October 2020

- Previous status: produce well, good flow, good shelter, good wall
- Action taken: routine maintenance
- Current status: produce, good flow
- Recommendation: strengthen Social
- Note: table need to be changed after 6 months
- Recommendation:
  - Strengthen social
  - Rebuild shelter

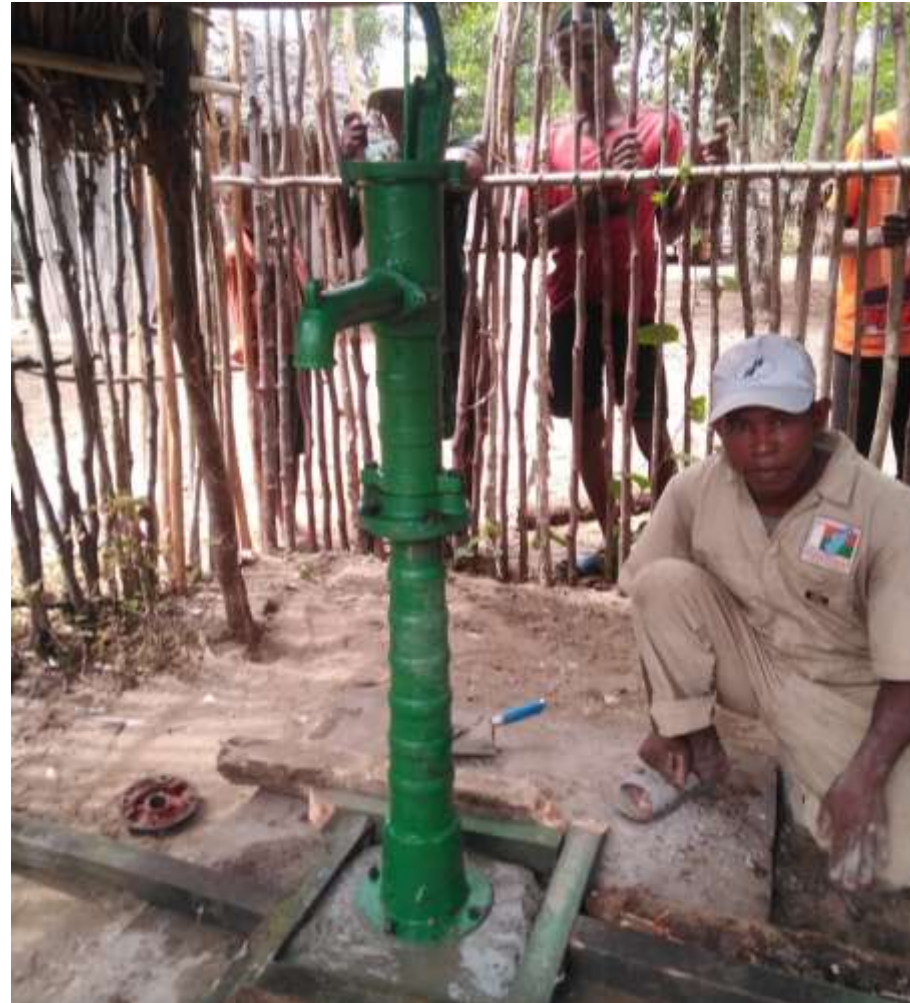
Photo October 2020

- Status on Arrival: Working good, leather cup still in good condition
  - Action Taken: routine maintenance
  - Current Status: Working
  - Recommendation:
    - Strengthen social
- Note: Nothing to point, table, pump still last 1.5 more years, left 1 spare of leather cup

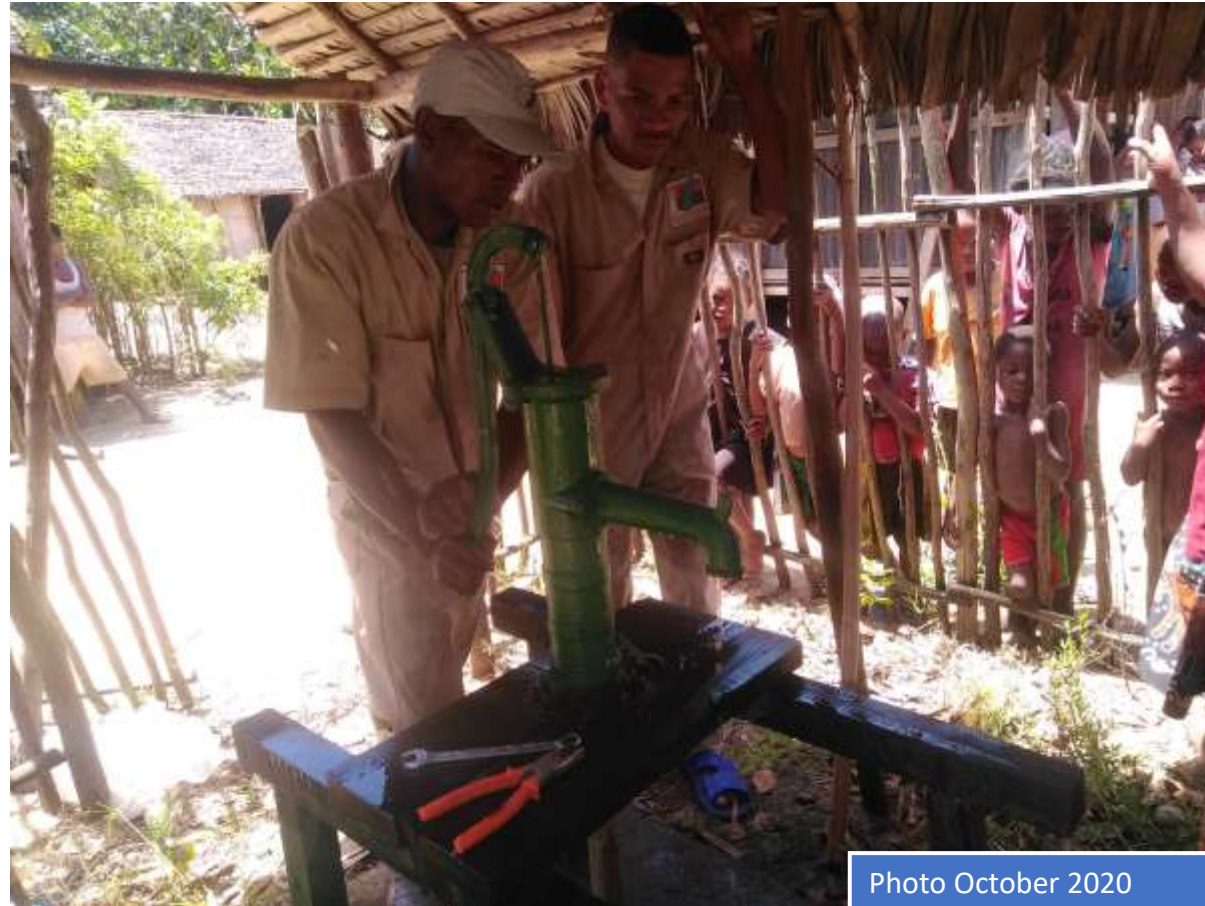
Photo October 2020

- Status on Arrival: Working good
  - Action Taken: change stopper plug, routine maintenance
  - Current Status: Working
  - Recommendation:  
-Strengthen social
- Note: Fair flow, table, pump still last 1.5 more years, left 1 spare of leather cup

- 1) Change Pump
- 2) Continue work with Well Committee

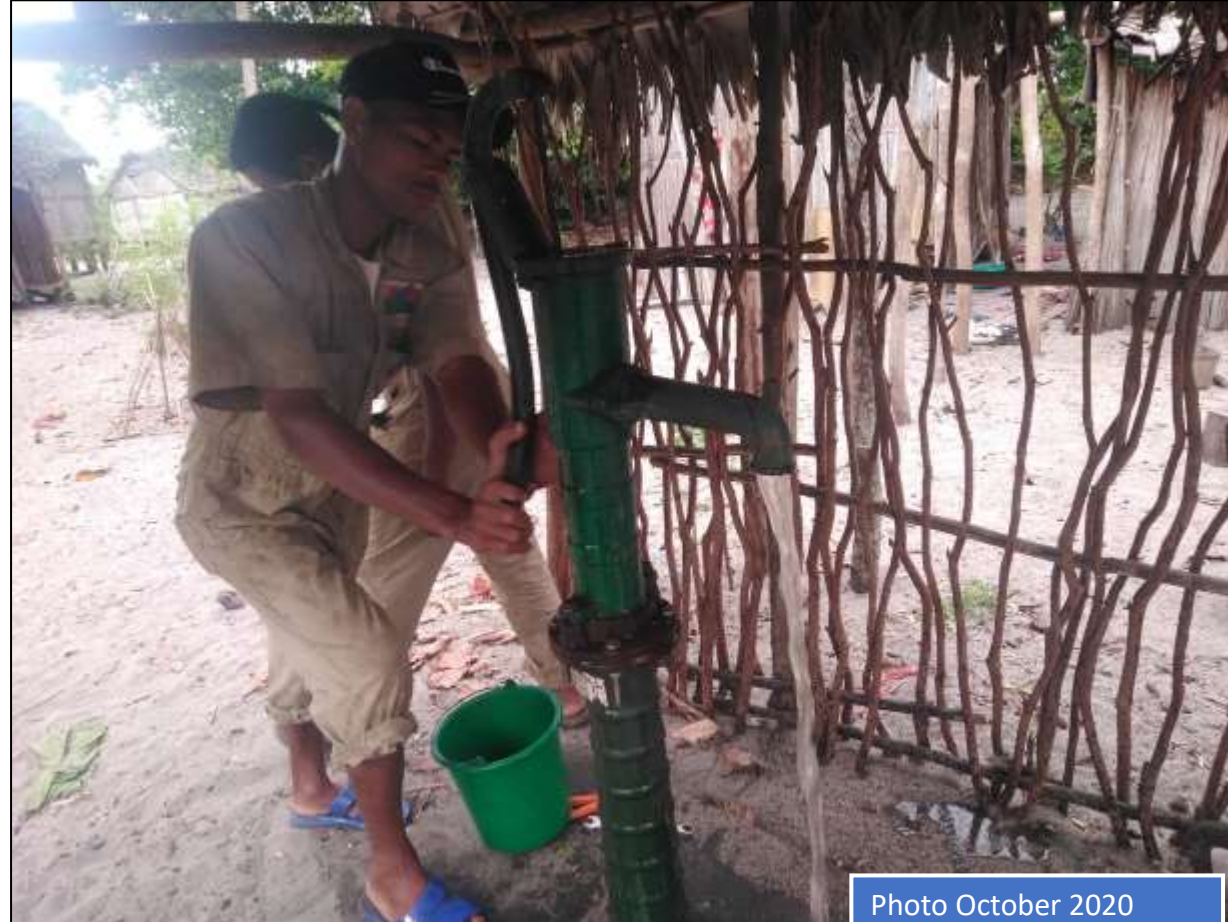
- Status on Arrival: Working good
- Action Taken: routine maintenance
- Current Status: Working
- Recommendation:
  - Strengthen social
  - Change pump next time

- Previous status: produce well, good flow
- Action taken: routine maintenance
- Current status: produce, good flow
- Recommendation: strengthen Social
- Note: pump need to be changed after 3months, table will last more than 1year

- 1) Improve enclosure, shelter
- 2) Change Pump
- 3) Continue work with Well Committee

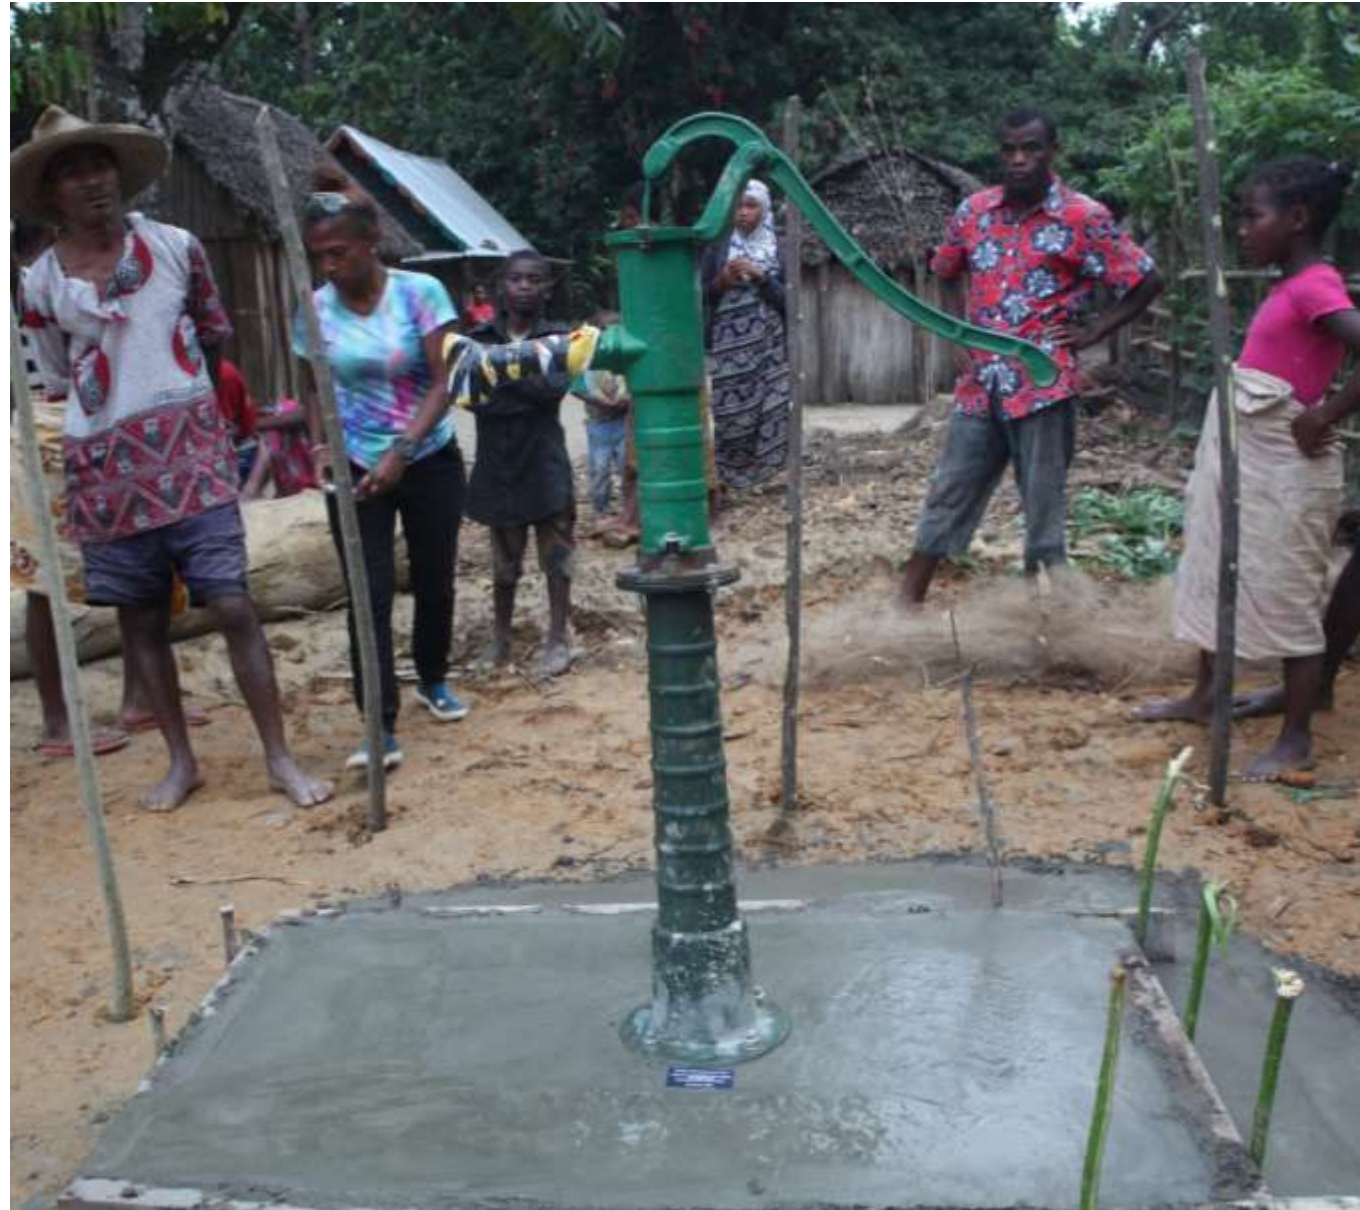
- 1) Enclosure, shelter
- 2) Continue work with Well Committee

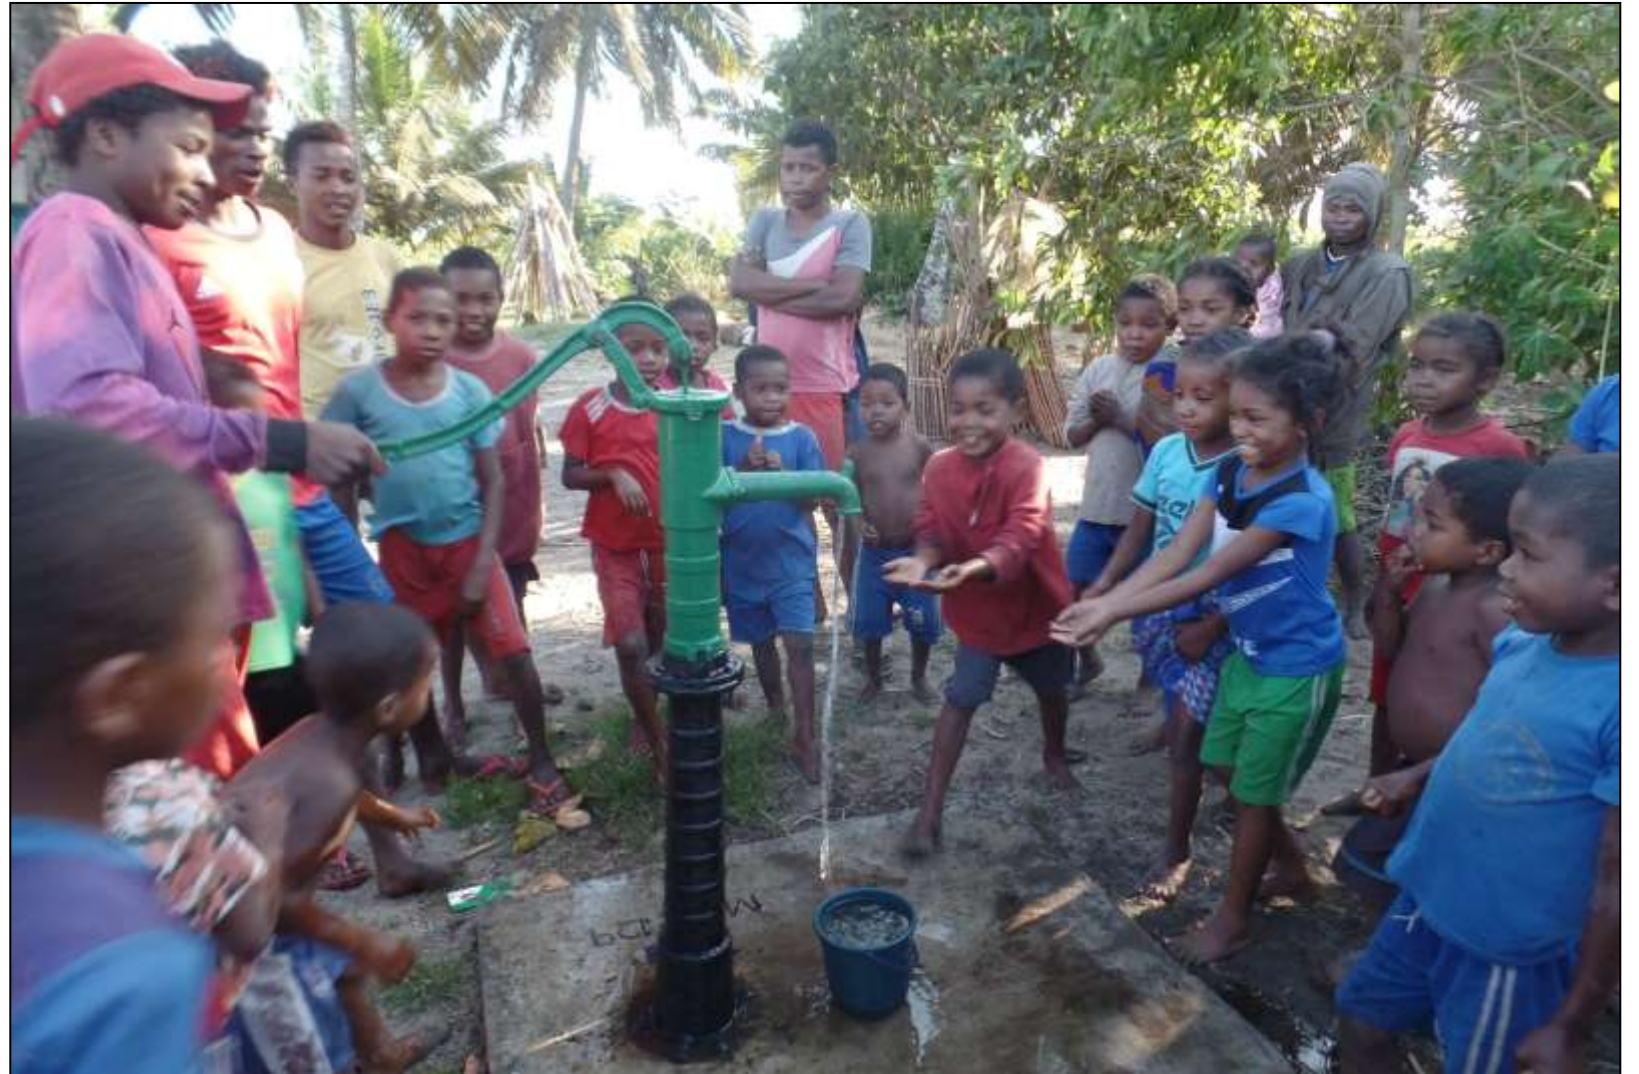
Note: first 200L flow Fresh, next salty

- 1) Fresh water limited at 200Liters, then should be waiting until reservoir refilled
- 2) Enclosure, shelter
- 3) Continue work with Well Committee

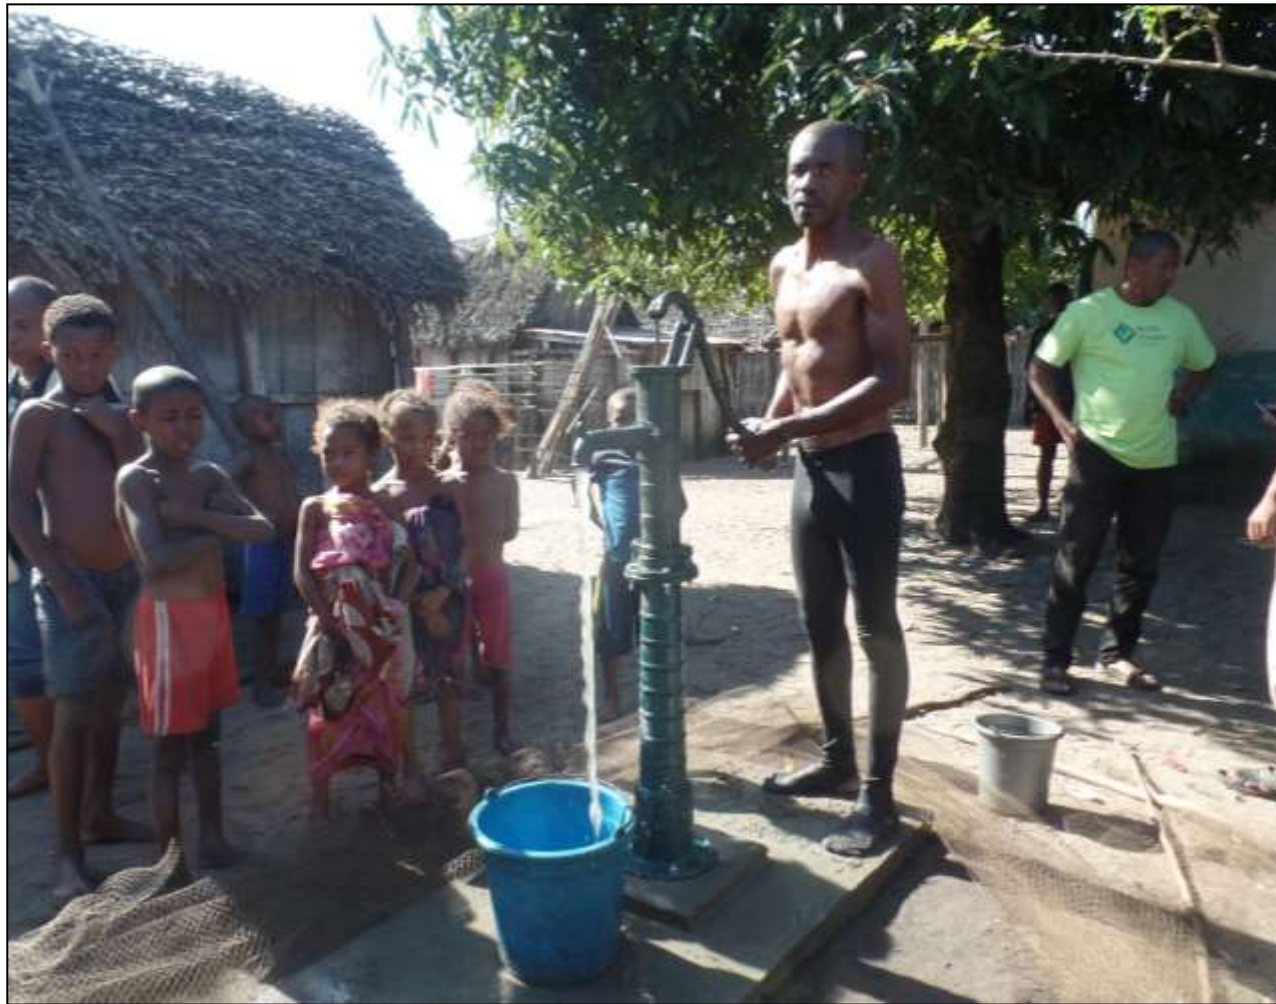
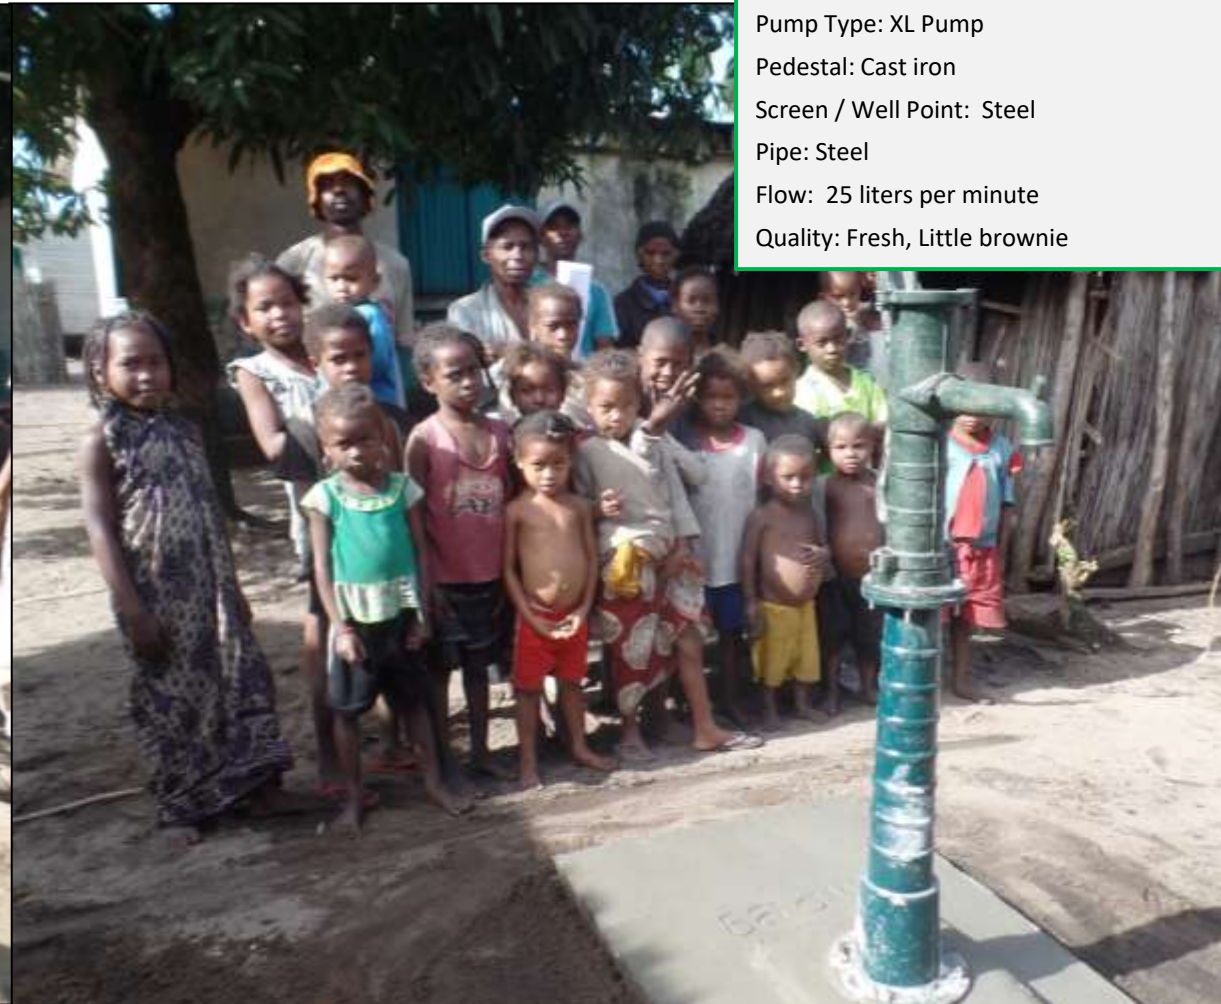
Quality: Fresh, Little brownie

Note: Drill until WT1.7m, settled BHA WP+3+IC+2, hammered/turned until major obstacle at 4.8mBGL, Test but hard to pump, handle pushed back while pumping, very low and dirty black flow, hammered out, turned, changing 2m pipe to 1m, lifted up and Tested every 20cm, finally BHA: WP+3+IC+1, good production with Fresh water, but coloration slightly brown.

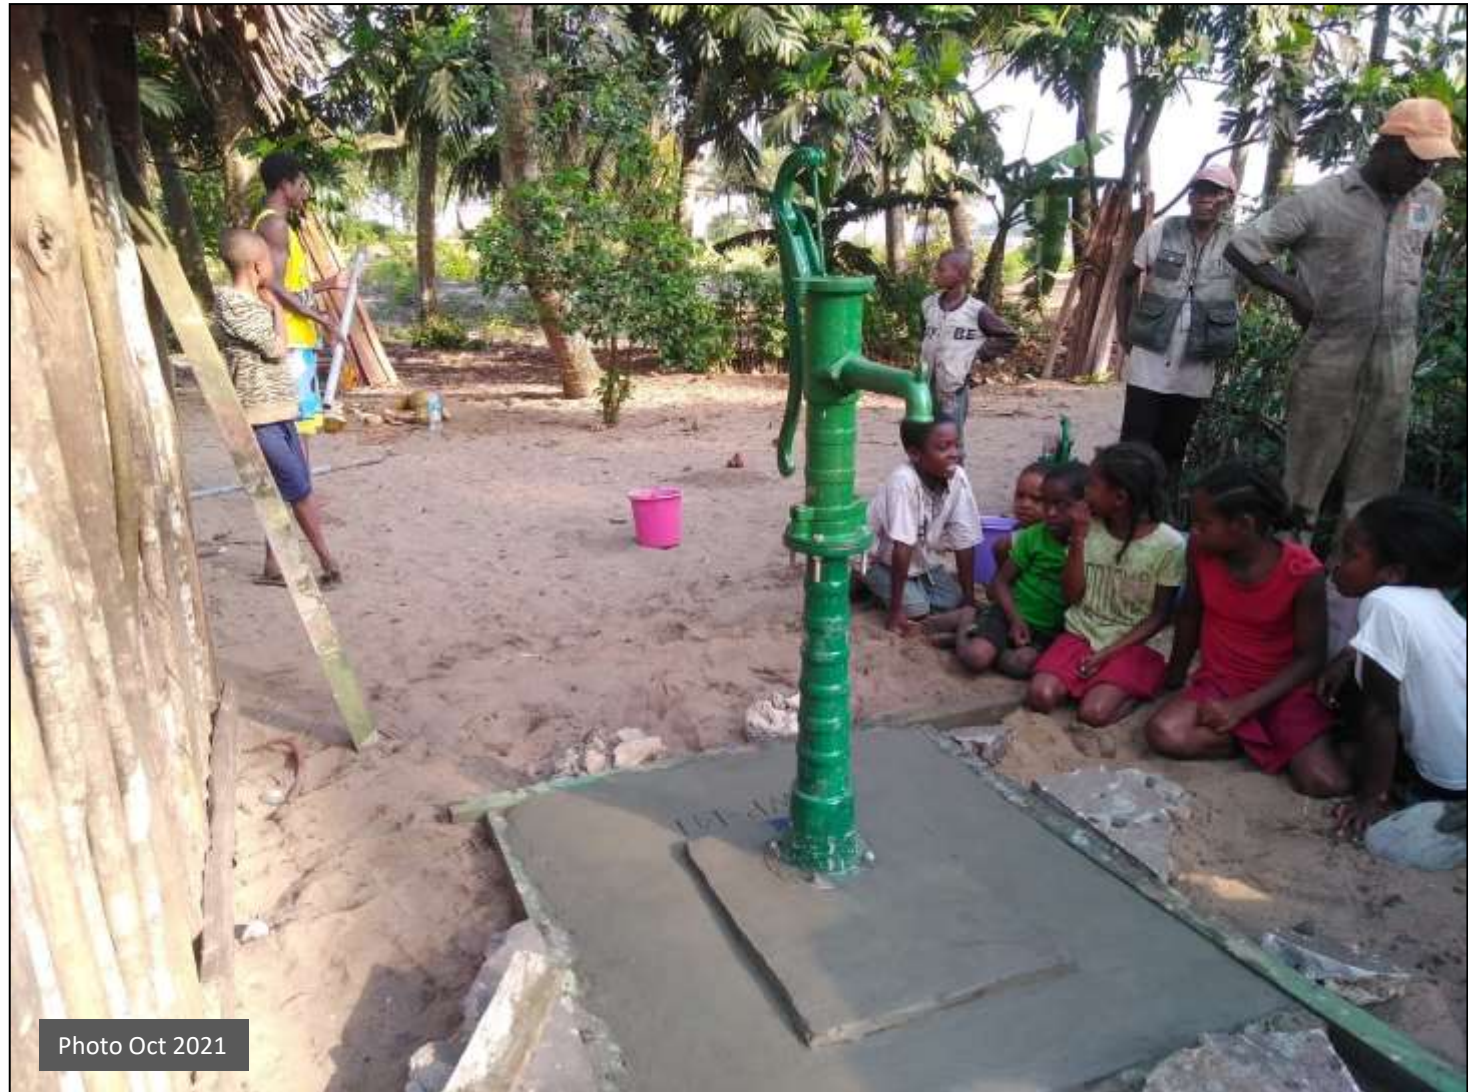
Photo Oct 2021

MWP-141 is the replacement of the plugged MWP52

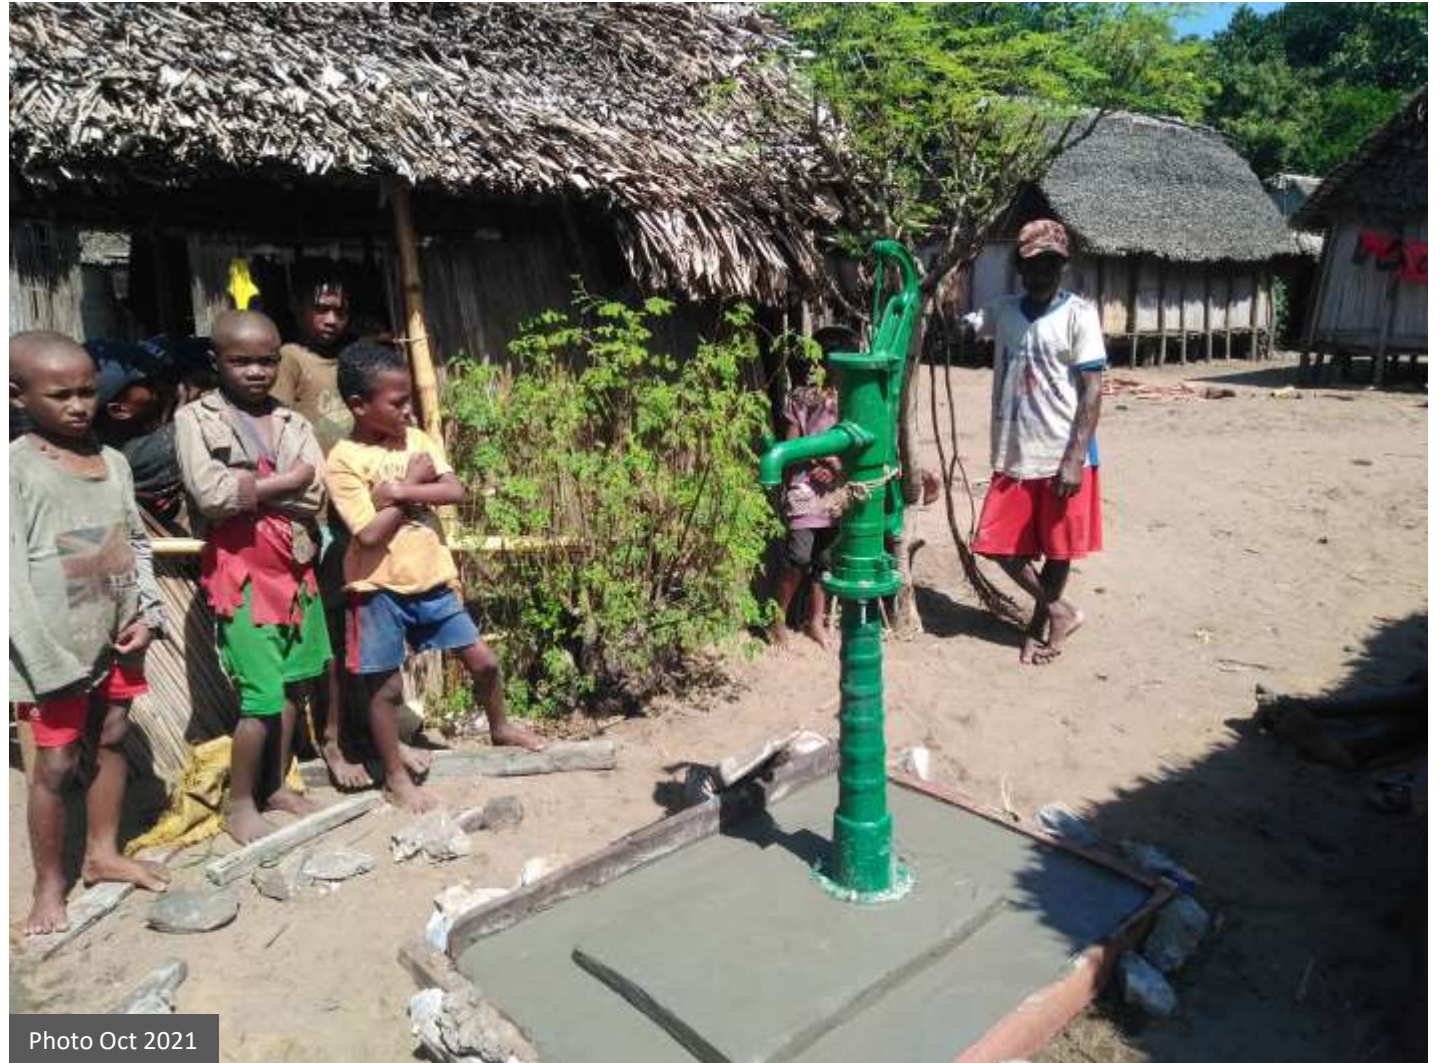
Photo Oct 2021

MWP-142 is the replacement of the plugged MWP48

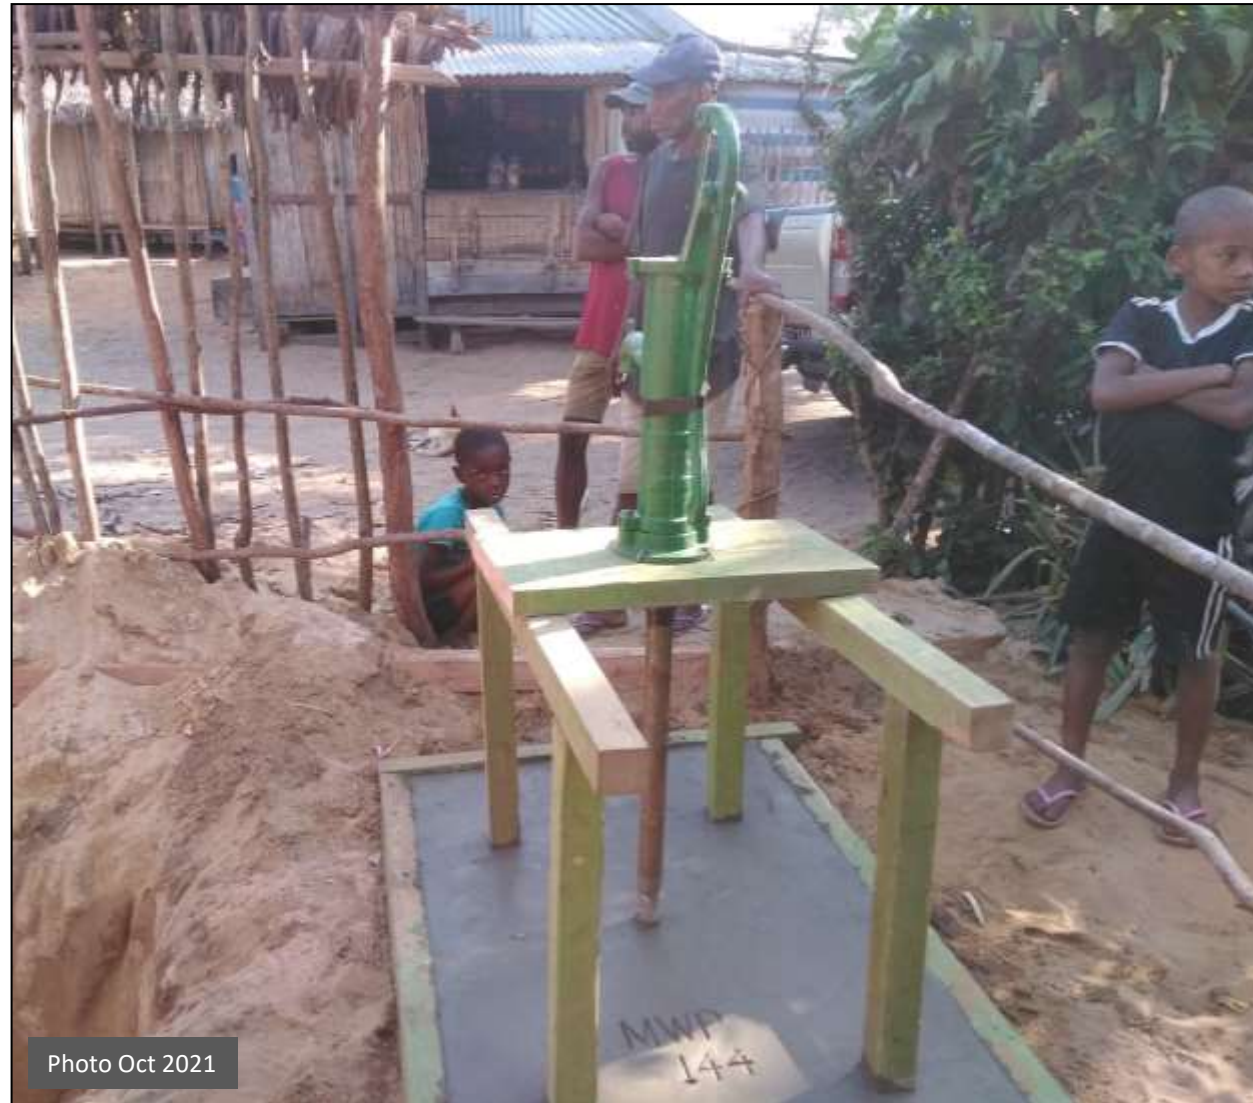
Photo Oct 2021

MWP-144 is the replacement of the plugged MWP49

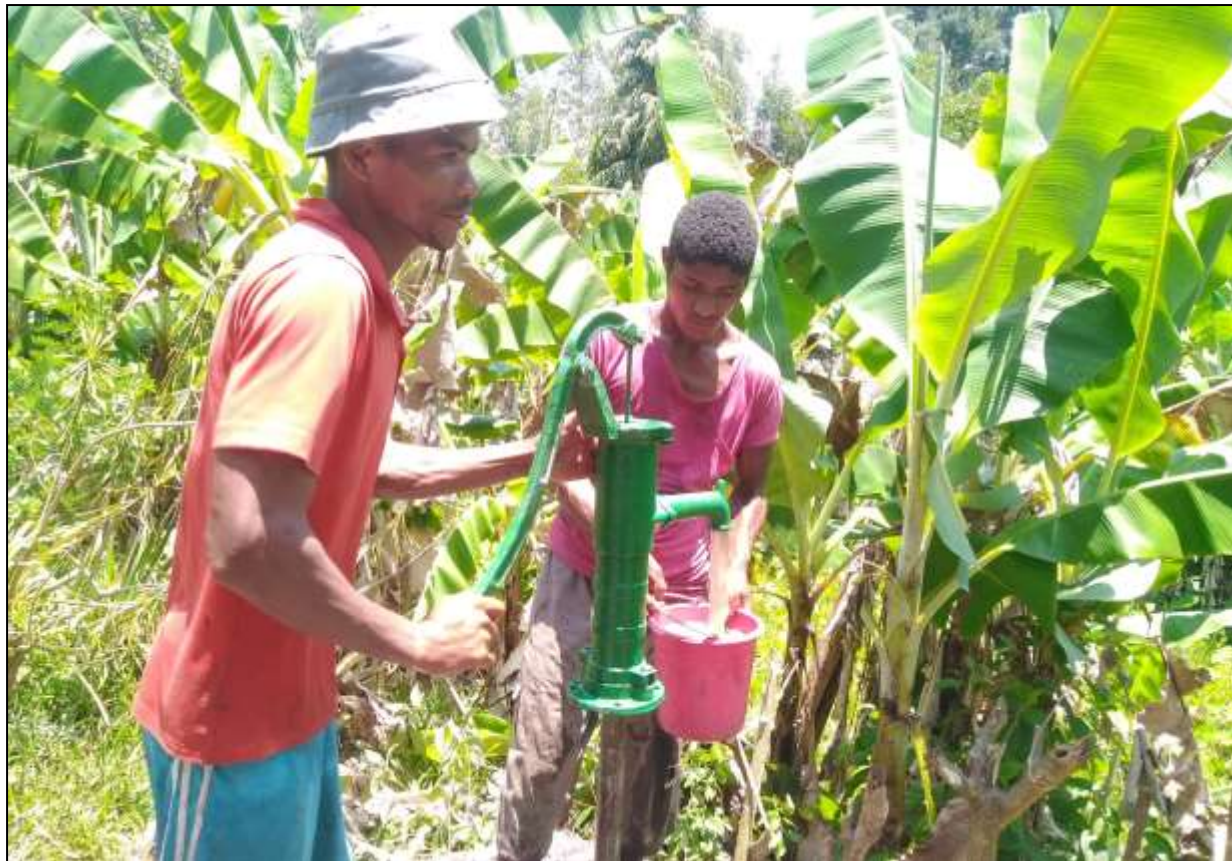
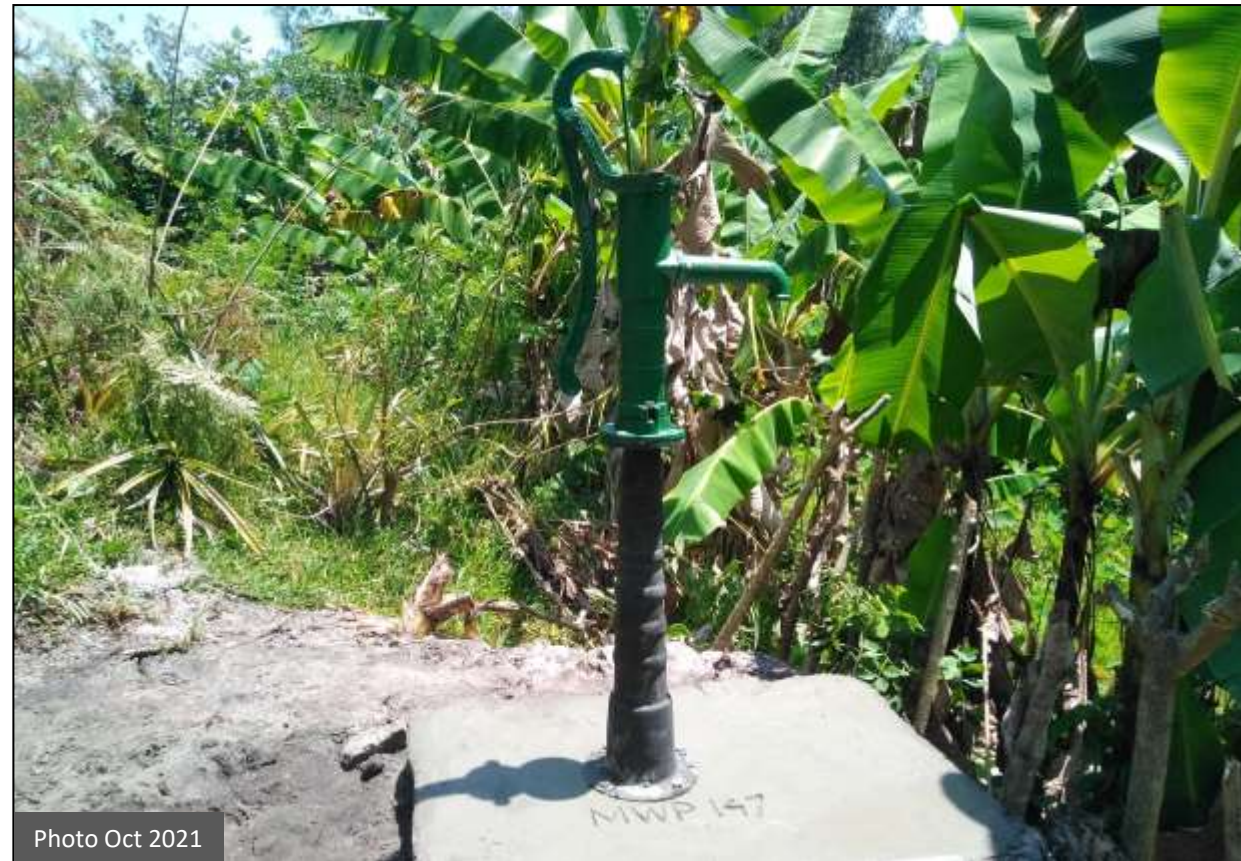
Photo Oct 2021

Pump Type: Standard pump   Screen/Well Point: Steel   Pipe: Steel   Pedestal: Cast iron   Flow: 25 liters / minute   Quality of water: Fresh, clear  
MWP-147 is the replacement of the plugged MWP96
