# The Madagascar Water Project

MWP-1  
ANDOVORANTO

## MWP – 1

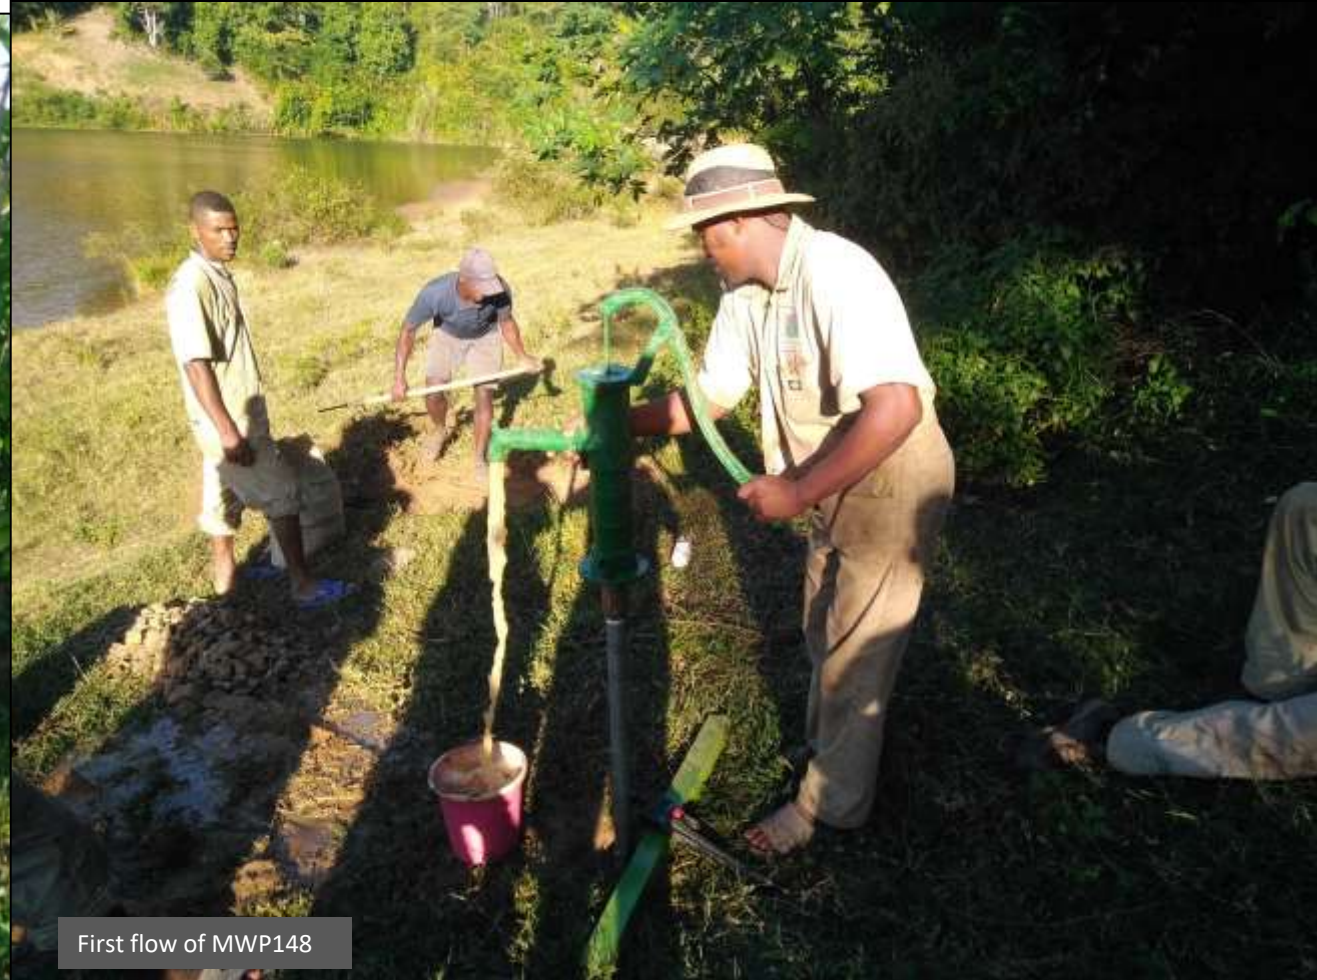
First flow of MWP148

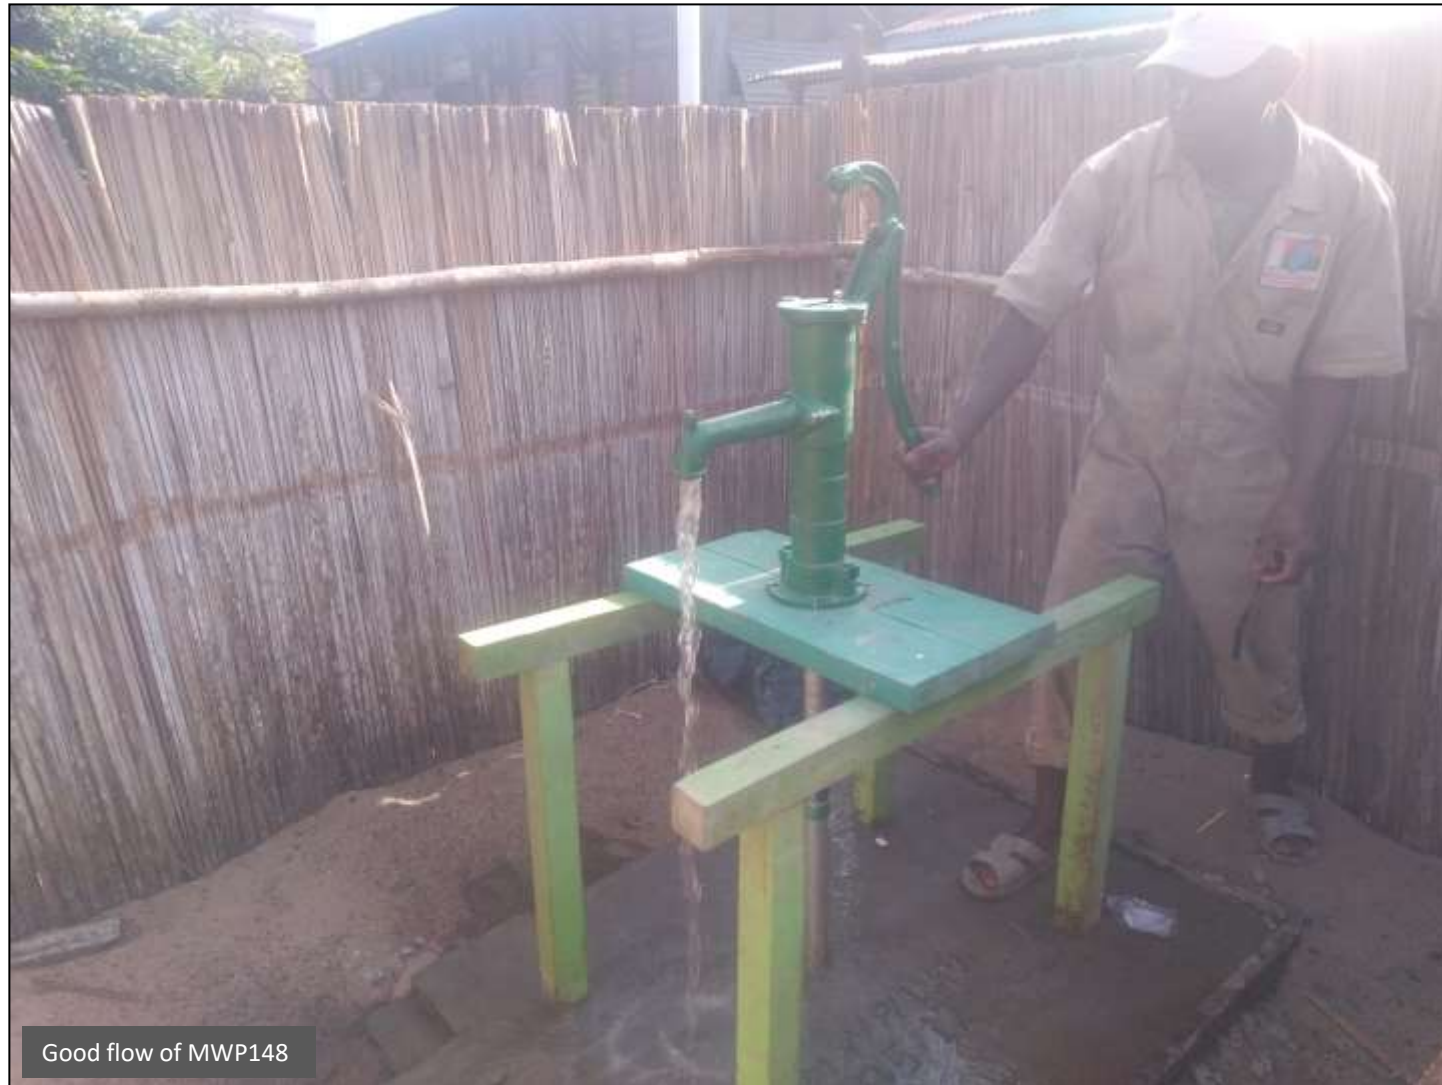
Good flow of MWP148

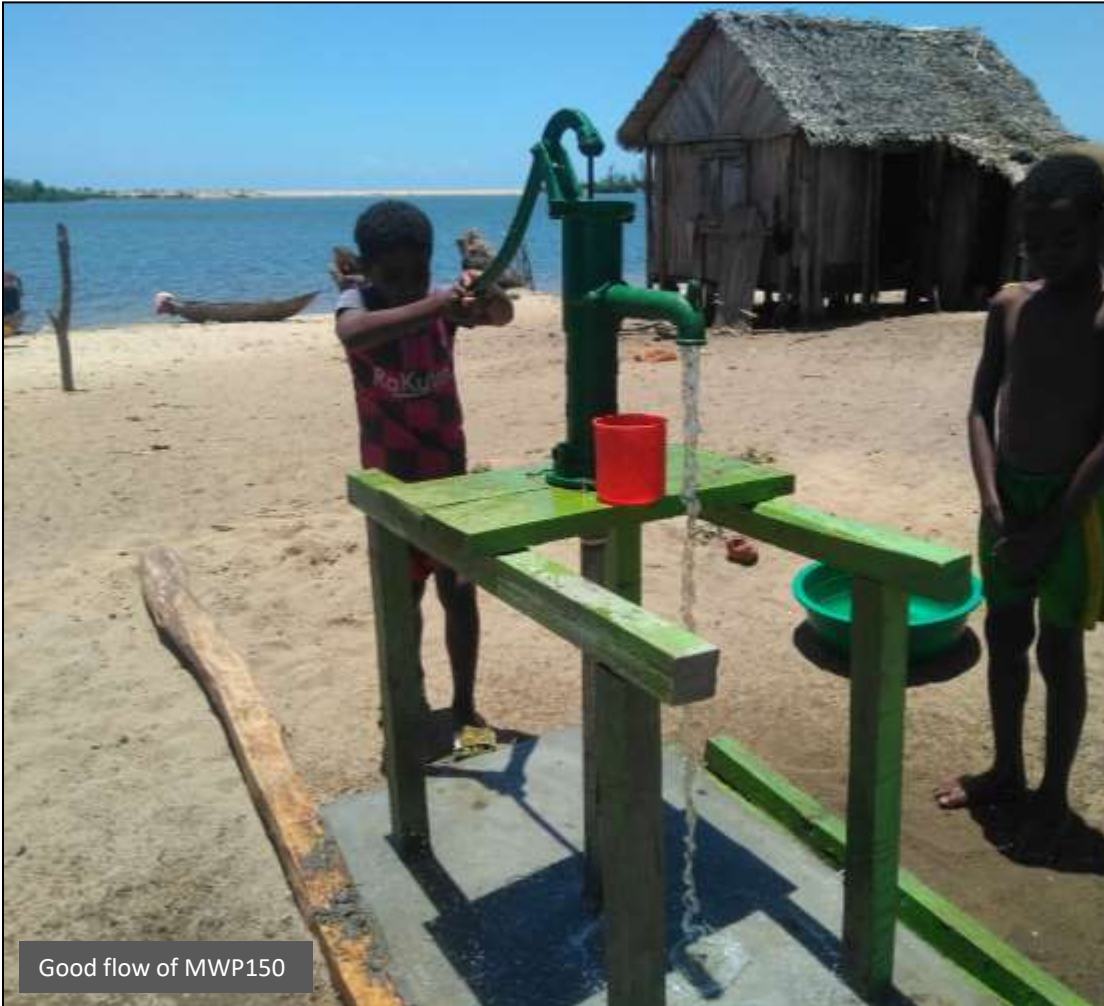
Good flow of MWP150

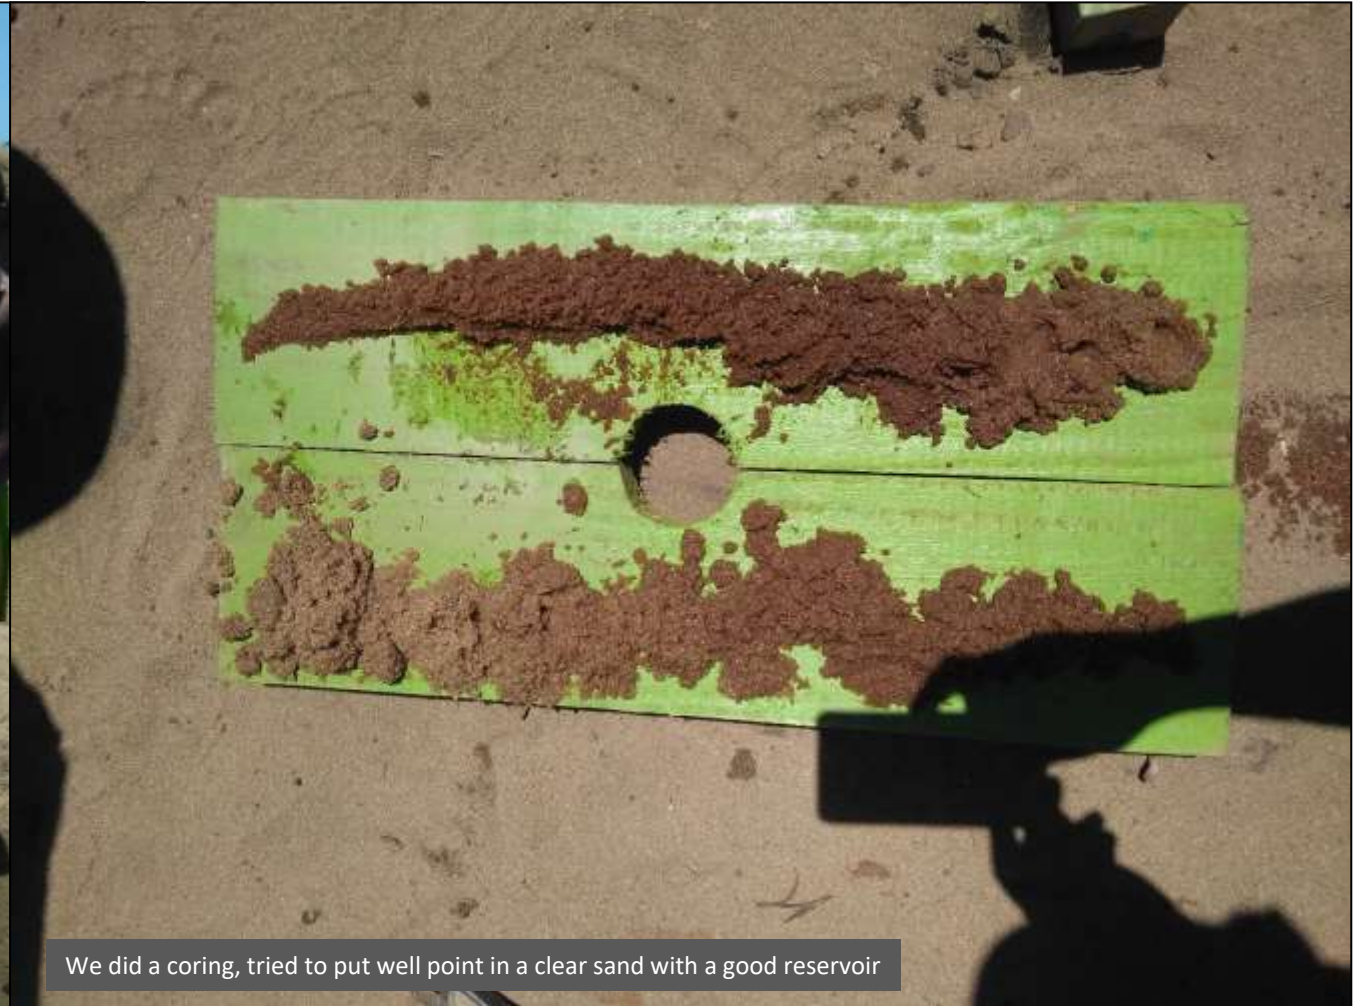
We did a coring, tried to put well point in a clear sand with a good reservoir

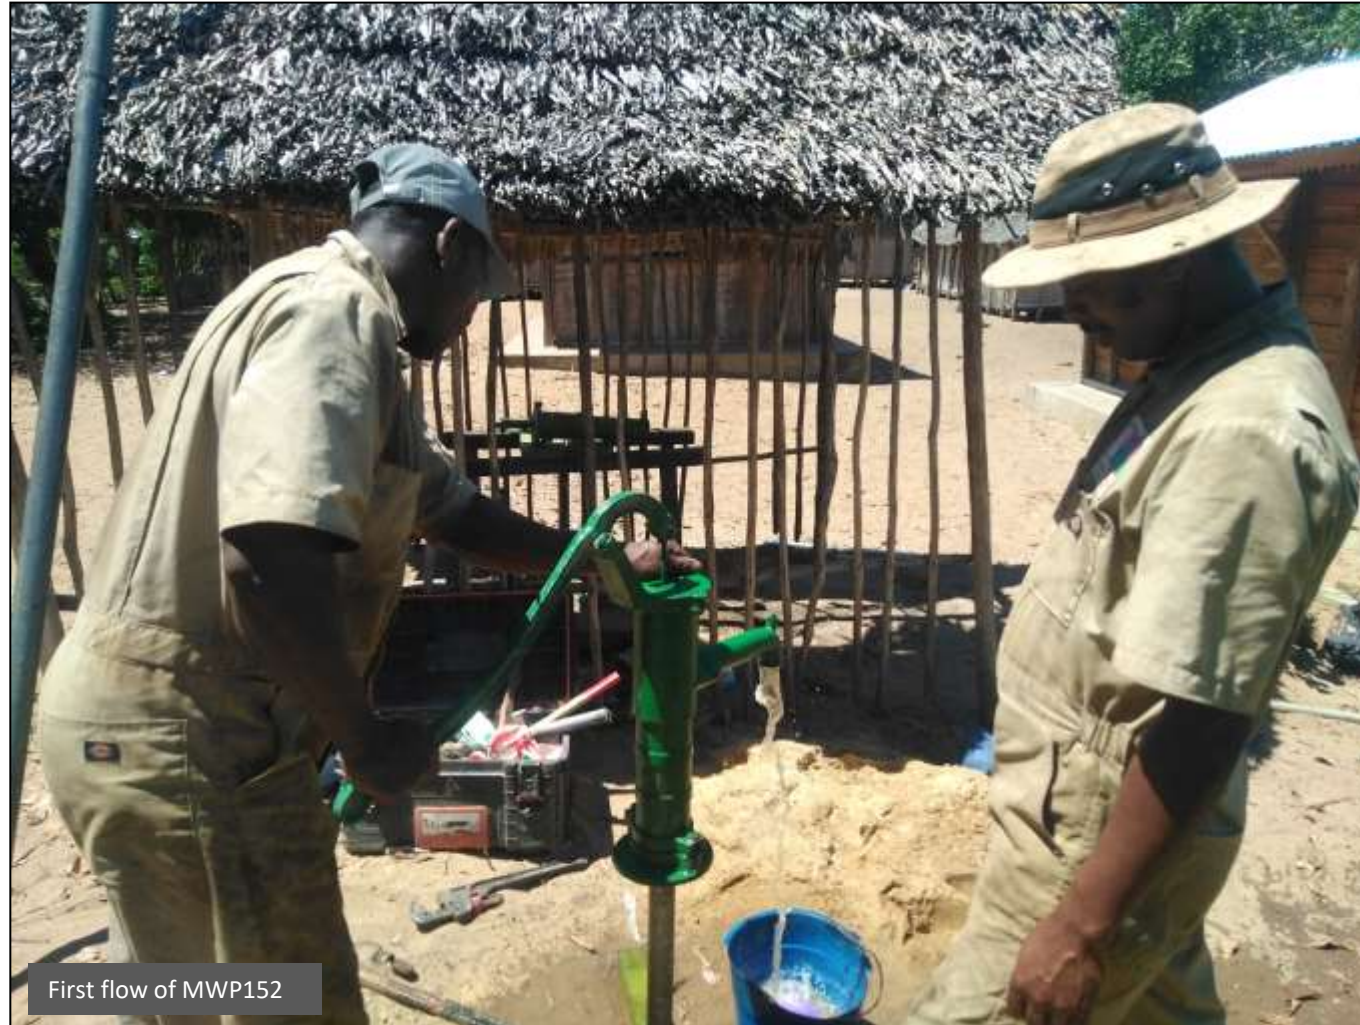
First flow of MWP152
