Confidential Inspection Report

LOCATED AT: 5 Harvard Ct
RSM, CA 92688

PREPARED EXCLUSIVELY FOR: I. M. Homeowner

INSPECTED ON: Sunday, January 28, 2018

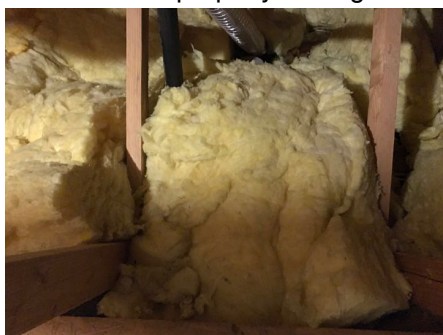
70: Fiberglass batts present.

71: Insulation properly averages about 8-10 inches in depth.

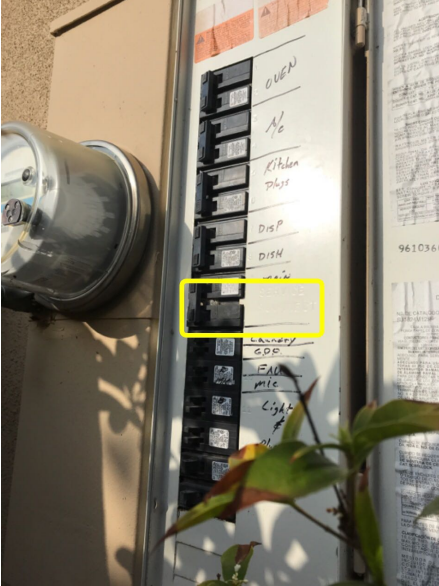
PANEL

85: Main panel is manufactured by Square D. Main disconnect is at the main electric panel. This switch will turn off all power to the house.

86: Panel cover screw missing. Panel cover should be secured to the panel. This is a shock hazard. These screws should be approved, flat tipped screws. Screws can be purchased at any home-improvement store.

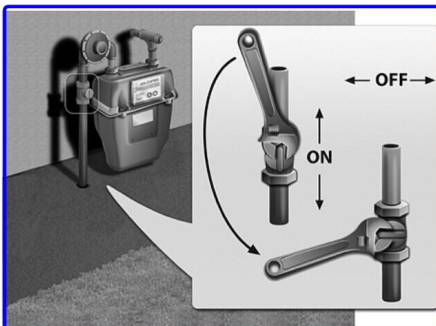
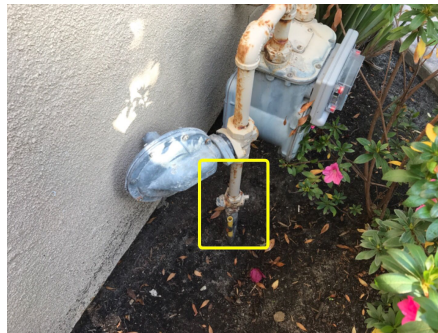
GAS METER

96: Main gas shut-off valve is located at the gas meter. Visible portions of the gas pipes appear to be in acceptable condition and is made of steel.

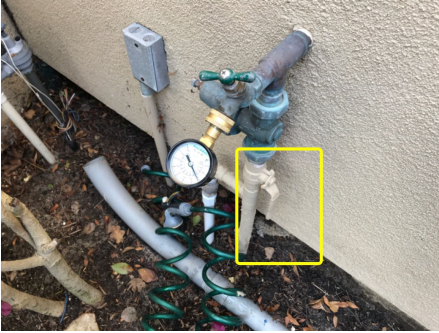
WATER SHUT OFF

97: House water shut-off valve is located in the front of the house.

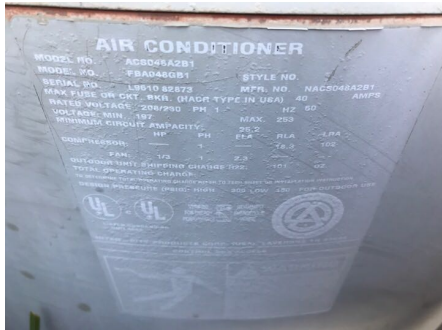
COMPRESSOR UNIT

123: Air conditioning compressor unit was manufactured by Comfortmaker.

124: Air conditioning system currently uses R22 refrigerant. (R22 refrigerant, sometimes known as Freon, is an environmental danger because it contributes to the depletion of the ozone layer. The U.S. government has placed restrictions on R22 and has issued the requirement that R22 refrigerant must be eliminated from use in cooling systems by the year 2020. At this point, R22 will no longer be manufactured and cannot be used as a refrigerant in new air conditioning systems. R22 is being replaced by R-410A, a safer material which is the current, compliant standard refrigerant in air conditioning equipment)

125: Approximately "4 Tons."

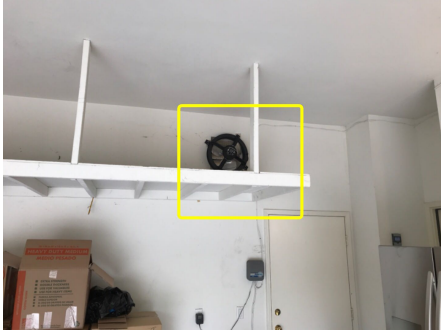
GARAGE ATTIC FANS

211: Garage fan noted. No operational test performed. Suggest verification of performance prior to closing
