Inspection Report

Property Address:
508 Franklin Dr
San Marcos TX 78666

PROPERTY INSPECTION REPORT

By: Mark Havelka 20755 / Austinspect, Inc. 8/26/2019

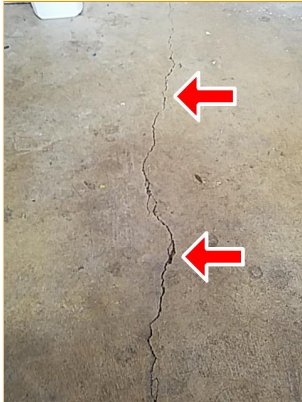
A. Item 1(Picture)

Significant cracks were observed at the garage floor. This may be an indicator of differential foundation movement. Recommend further evaluation by a qualified foundation contractor or structural engineer.

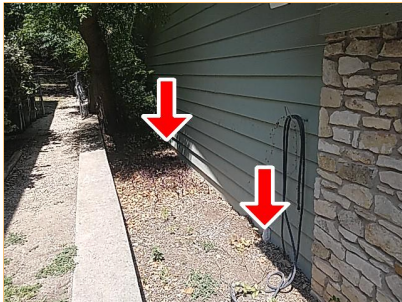
B. Item 1(Picture)

(1) It is advisable to maintain at least 3-6 inches minimum of clear area between the ground and exterior finishes. Areas where the soil is in contact with the exterior finish area conducive to wood-destroying insect activity.

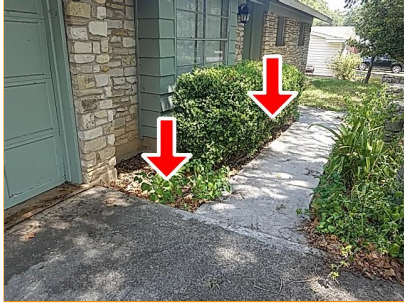
B. Item 3(Picture)

(2) There was a negative slope observed towards the home in one or more areas. Proper drainage is critical to the performance of the foundation. All grades should drop away from the structure at a rate of 6 inches for every 10 feet. Improve drainage as needed so that water flows away from the home.

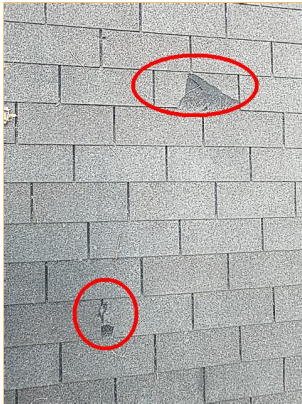
C. Item 1(Picture)

(1) Damaged shingles were observed at various areas of the roof covering. Recommend further evaluation and repair by a qualified roofing contractor.

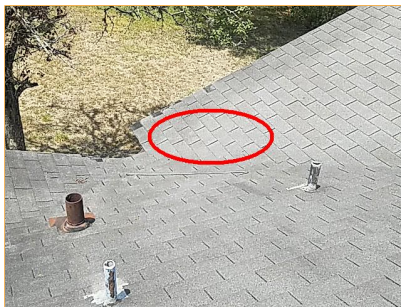
C. Item 8(Picture)

(2) The sheathing was soft under-foot at various areas of the roof covering. Repair or replace all damaged building materials. Additional damage may be present that was not visible to the inspector.

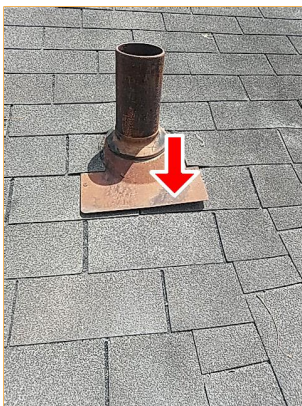
C. Item 11(Picture)

(4) Secure and seal any loose flashing.

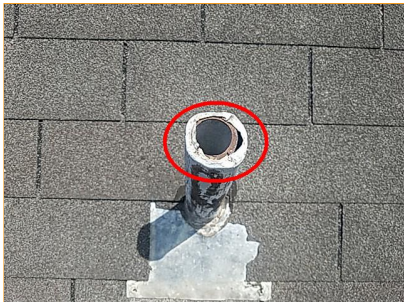
C. Item 12(Picture)

(5) Damage was observed at one or more lead roof jacks. Recommend further evaluation and repair by a qualified roofing contractor to prevent water penetration and rot.

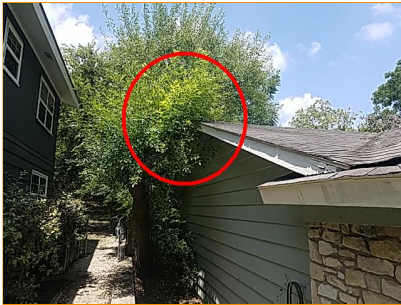
C. Item 16(Picture)

(9) The tree limbs that are in contact with, or hanging near the roof should be trimmed.

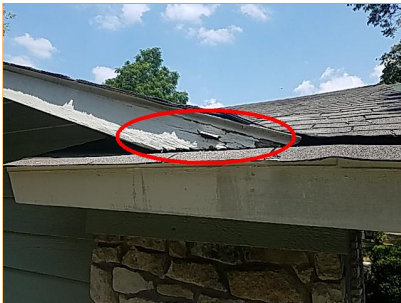
D. Item 1(Picture)

(1) The paint was failing at one or more areas of the exterior wood. I recommend prepping and painting all exposed areas to prevent rot.

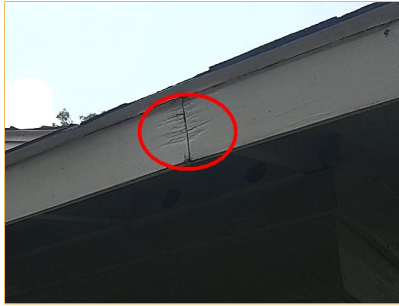
D. Item 4(Picture)

(2) Rot was observed at the fascia in one or more areas of the roof perimeter. Repair or replace all damaged and rotten wood.

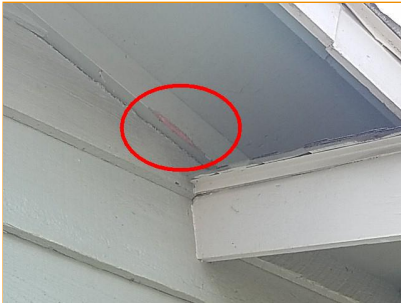
D. Item 5(Picture)

(3) Chewed wood trim was observed at one or more eave ends. Repair and seal all exposed wood. Trimming trees away from the roof can limit rodent access and future rodent damage/infestation.

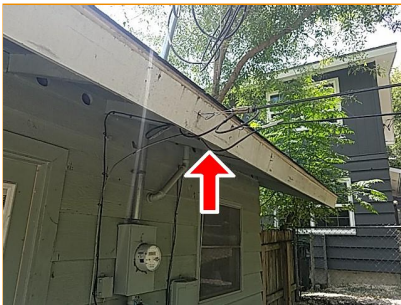
D. Item 6(Picture)

(4) The fascia was not properly secured to the roof trusses at the rear of the home. Repair as needed.

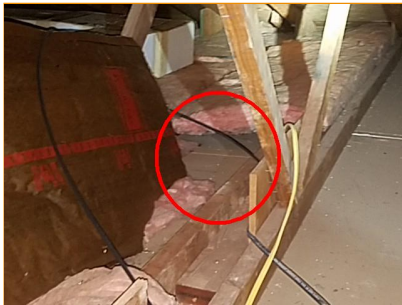
D. Item 10(Picture)

(7) Insulation should be properly distributed to cover all portions of the attic located above the home living space.

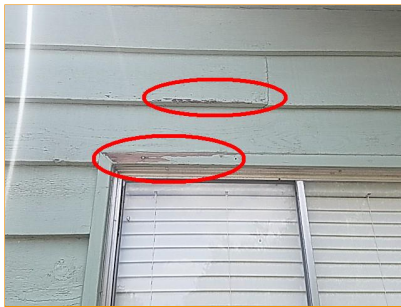
E. Item 3(Picture)

(2) The paint is failing and/or worn at one or more areas of the exterior wood. I recommend prepping and painting at all exposed areas to prevent rot.

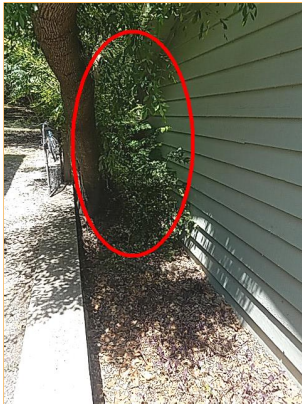
E. Item 5(Picture)

(3) Trim vegetation back from walls to prevent pest intrusion.

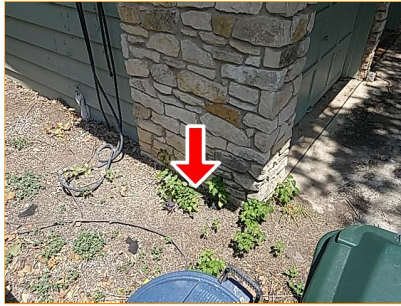
E. Item 8(Picture)

(4) Exterior finishes should be installed 2" from any hard walking surface and 4" or greater above grade. The inspected home has some areas that do not meet these standards. Correct/repair as needed. The siding is in contact with the ground in some areas. Because the siding is in contact with the ground, it is possible for framing to be deteriorated. We did not inspect behind this siding.

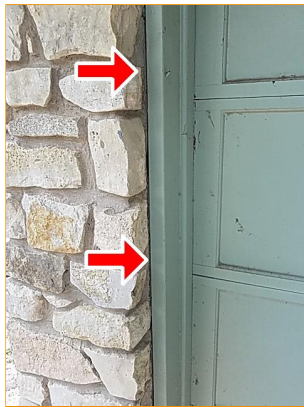
E. Item 11(Picture)

(5) Re-seal caulk at all wood trim-to-masonry connections to prevent rot and water penetration.

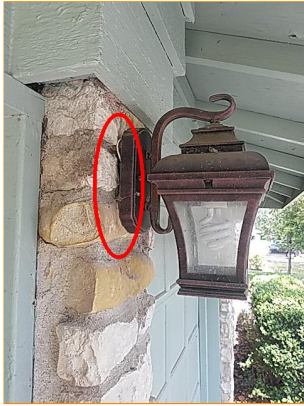
E. Item 13(Picture)

(6) Seal all plumbing and electrical penetrations to prevent energy loss and pest intrusion.

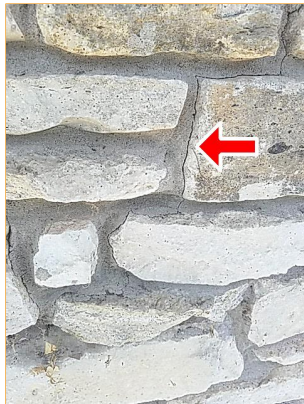
E. Item 17(Picture)

(7) Cracks were observed in the mortar at one or more areas of the masonry veneer. Mortar improvements are recommended to prevent water penetration.

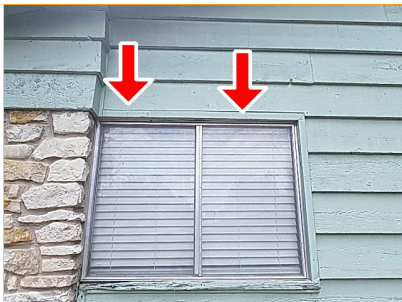
E. Item 18(Picture)

(8) Approved corrosion-resistant flashing shall be installed continuously above all projecting wood trim. The inspector was unable to verify the presence of proper flashing over windows and doors installed in the exterior siding.

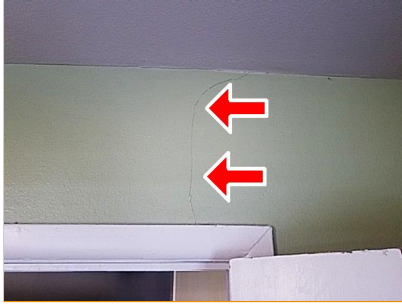
E. Item 24(Picture)

(12) Settlement was observed at one or more interior walls.

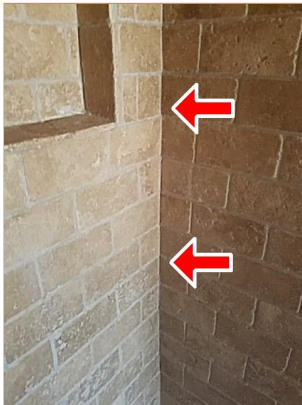
E. Item 25(Picture)

(13) Re-seal tub-to-tile connections, tub and shower corners and shower drain pan perimeters. The wall board and framing behind these areas may need repair (not visible). I recommend repair or replace using a qualified contractor.

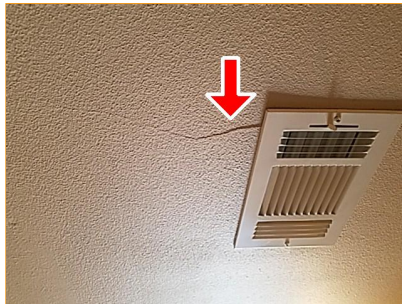
F. Item 2(Picture)

(1) Settlement was observed at one or more ceiling areas.

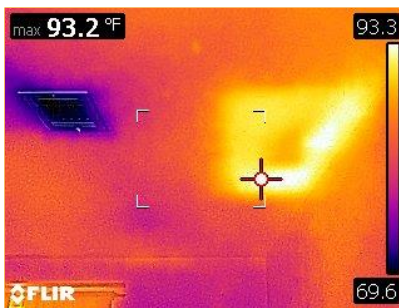
F. Item 4(Picture)

(2) Temperature anomalies were observed at one or more ceiling areas. This may indicate that these areas are inadequately insulated.

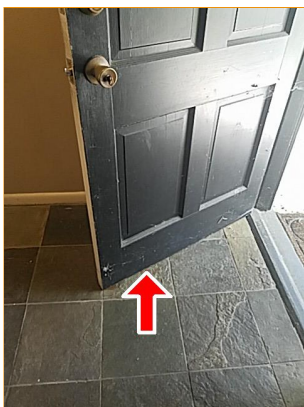
G. Item 2(Picture)

(2) The front exterior door binds at the floor. Adjust as needed.

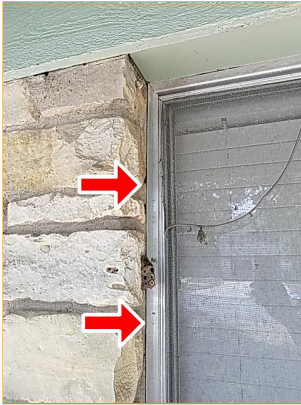
H. Item 1(Picture)

(1) Re-seal caulk around one or more windows to prevent water penetration.

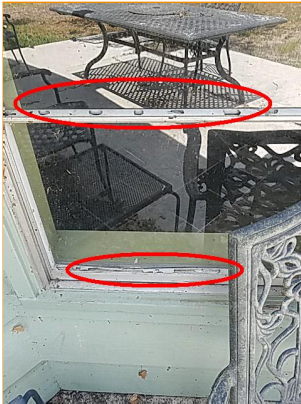
H. Item 4(Picture)

(2) Glazing strips were damaged at one or more windows. This may be an indication of previous hail damage.

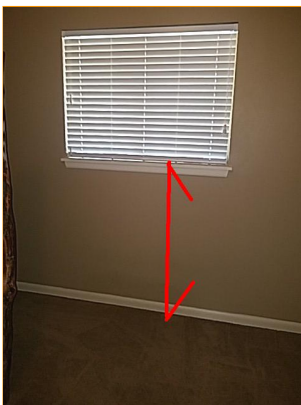
H. Item 7(Picture)

(3) The window sill height in one or more bedrooms exceeds the current code standards for fire egress of 44".

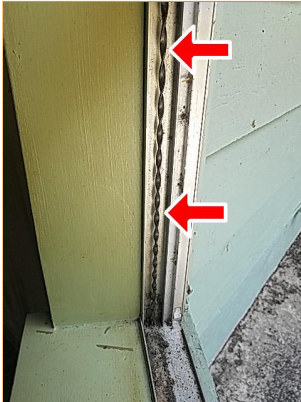
H. Item 9(Picture)

(4) Ballasts were loose at one or more windows. Have a window contractor repair.

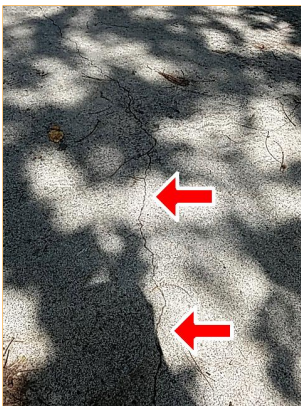
K. Item 1(Picture)

(1) Cracks were observed at one or more areas of the driveway. Seal these areas to prevent settlement of flatwork.

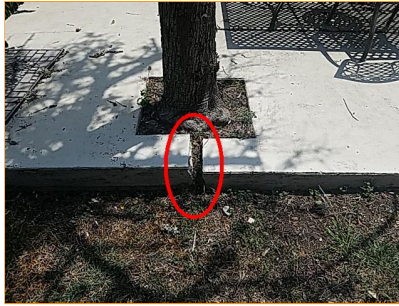
K. Item 4(Picture)

(2) Significant settlement was observed at the rear patio.

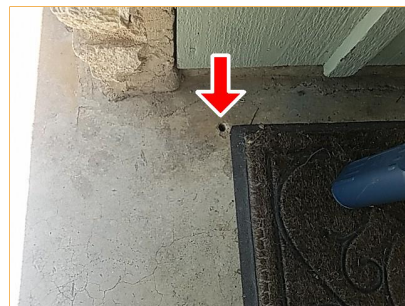
L. Item 3(Picture)

(2) A previous termite treatment sticker was observed at the cabinet under the kitchen sink. Drill holes for termiticide were also observed at the front porch. Recommend continued monitoring by a licensed pest control contractor. Damage may be present that was not visible to the inspector.

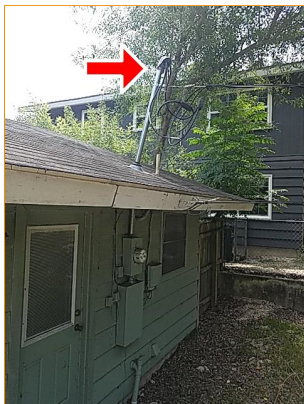
A. Item 1(Picture)

(1) The service mast was not properly supported.

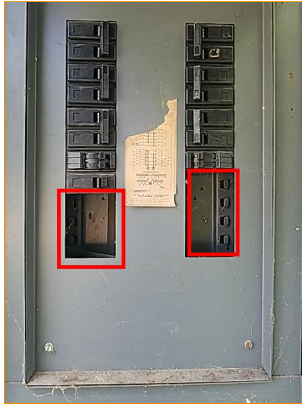
A. Item 3(Picture)

(3) Knockout cover(s) were missing at one or more electrical panels. This is a safety hazard.

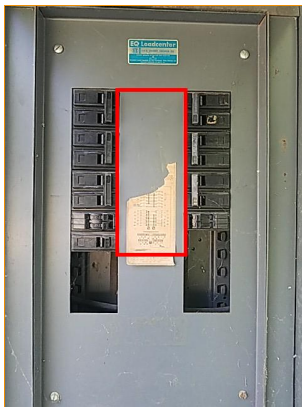
A. Item 4(Picture)

(4) Label all breakers for safety.

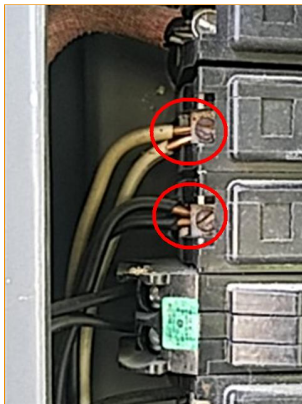
A. Item 6(Picture)

(5) Double-lugged conductors were observed at various connections in the service entrance panel. This is a significant safety concern. Recommend further evaluation and repair by a licensed electrician.

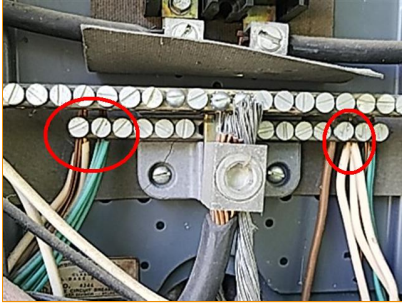
A. Item 8(Picture)

(6) Neutral wires were grouped together (double-tapped) in one or more electrical panels. All wiring should be terminated to a single position on the appropriate buss bar.

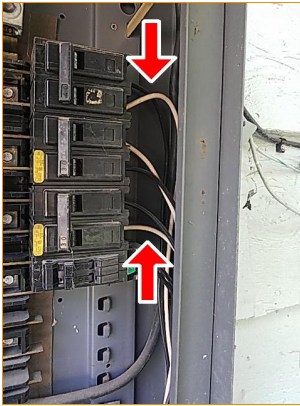
A. Item 10(Picture)

(7) Neutral (white) wires used as hot wires should be marked with black or red electrical tape for safety.

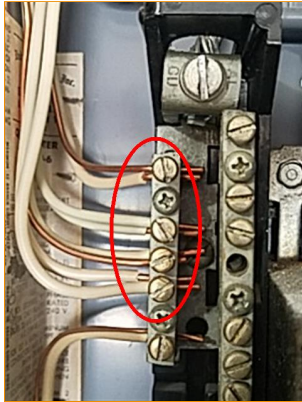
A. Item 12(Picture)

(9) One or more of the ground and neutral conductors are attached to the same buss bar improperly. This is an outdated industry practice. All neutral conductors within the distribution (sub) panel should be properly isolated from the ground conductors according to present industry practices.

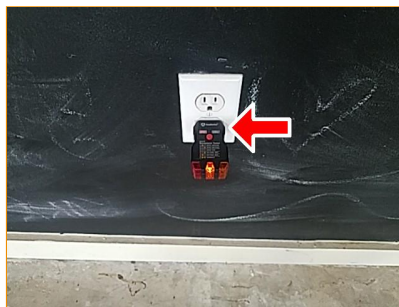
B. Item 2(Picture)

(1) Open grounds were observed at various outlets. Replacing Receptacles to Meet the NEC requires receptacles installed on 15 and 20ampere branch circuits to be of the grounding-type and it requires the grounding contacts of those receptacles to be effectively grounded to the branch circuit equipment grounding conductor [210-7]. However, the Code allows the installation of any of the following installations when replacing a 2-wire non grounding-type receptacle where no ground exists in the outlet box [210-7(d)(3)],

(a) Replace the 2-wire receptacle with another 2-wire receptacle.

(b) Replace the 2-wire receptacle with a GFCI-type receptacle and mark the receptacle with the words "No Equipment Ground."

(c) Replace the 2-wire receptacle with a grounding-type receptacle where protected by a GFCI protection device (circuit breaker or receptacle). Since the grounding terminals for the receptacles are not grounded, the receptacles must be marked with the words "GFCI Protected" and "No Equipment Ground."

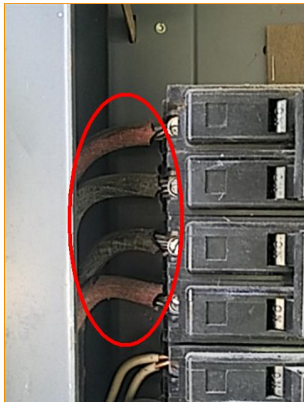
B. Item 3(Picture)

(2) Cloth covered wiring is still in place and possibly in use in some areas of the home. Recommend having a licensed electrician evaluate and update all wiring to meet today's code and safety standards

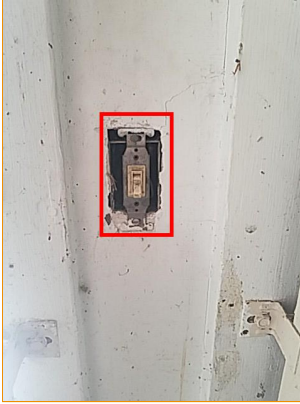
B. Item 5(Picture)

(4) Replace any missing switch plates.

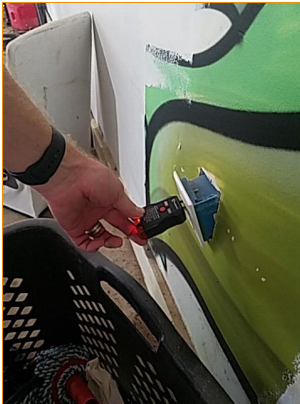
B. Item 6(Picture)

(5) Secure any loose electrical outlets.

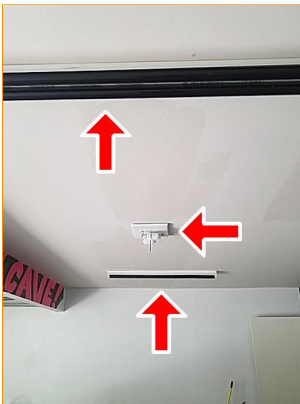
B. Item 7(Picture)

(6) Bulb shields were missing at one or more light fixtures. Bulb shields are recommended at all exposed bulbs.

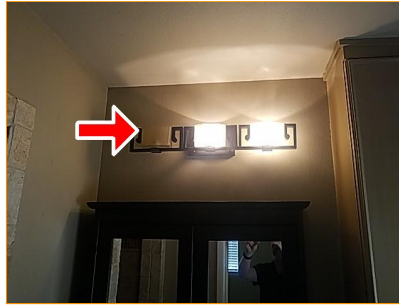
B. Item 11(Picture)

(7) Bulbs were missing or inoperable at one or more light fixtures.

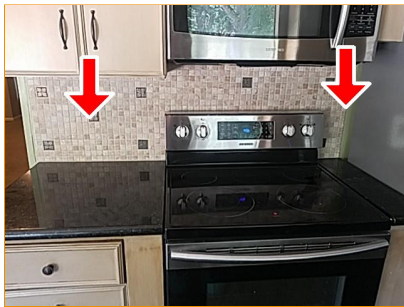
B. Item 12(Picture)

(8) There were an insufficient number of outlets present at the kitchen counter(s). Current code requires outlets every 4'.

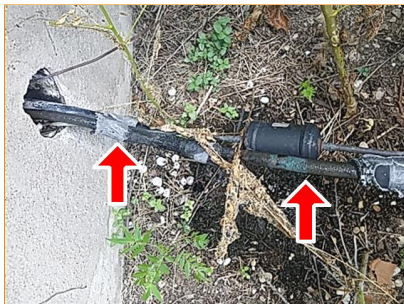
B. Item 2(Picture)

- (3) Fully insulate the suction line at the exterior AC condenser.

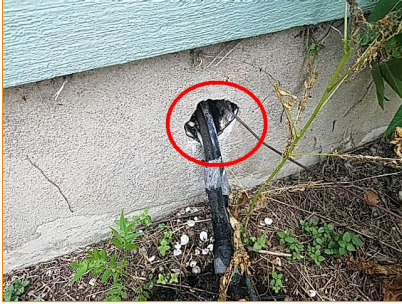
B. Item 3(Picture)

- (4) Seal around the AC suction and refrigerant line entrance into the home to prevent pest intrusion.

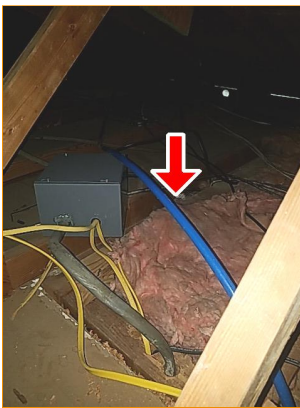
A. Item 1(Picture)

(1) Insulate all exposed water lines to prevent freezing.

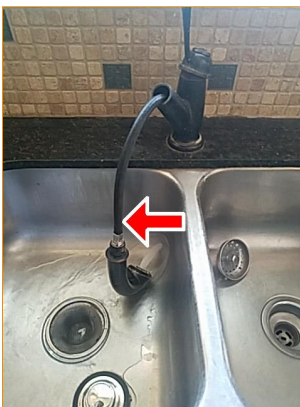
A. Item 2(Picture)

(2) The hand sprayer at the kitchen faucet did not retract automatically.

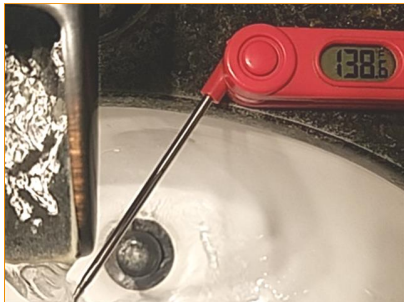
C. Item 6(Picture)

(6) The hot water temperature is set too high, creating a risk of scalding. The Consumer Product Safety Commission recommends that water heaters be set at 120° F.

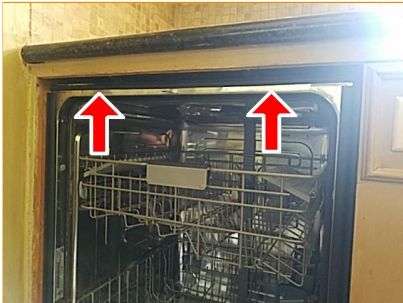
A. Item 2(Picture)

(2) The dishwasher is loose and needs to be secured to the underside of the countertop or adjoining cabinets. I recommend repair as necessary.

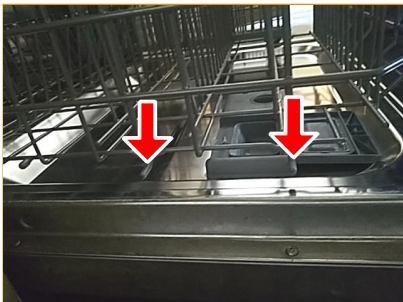
A. Item 3(Picture)

(3) Two rollers were missing at the lower dish basket.

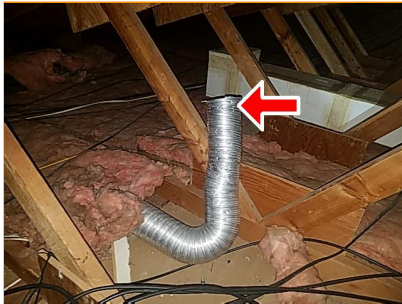
C. Item 1(Picture)

The range exhaust vent should terminate at the exterior.

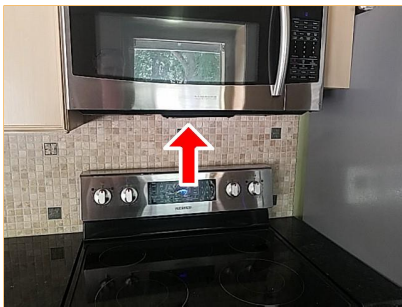
E. Item 1(Picture)

The surface light at the base of the microwave was inoperable.

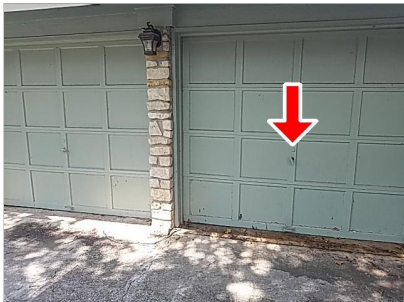
G. Item 1(Picture)

(1) The latch handle was loose at the right overhead garage door. This prevents the door from being locked securely. Repair as needed.
