Bono Energia S.p.A.

***INSPECTION REPORT
OF
BONO ENERGIA
WATER TUBE BOILER
AT BADRA OIL FIELD
CPF PHASE 1***

***Baghdad-Iraq
June 2013***

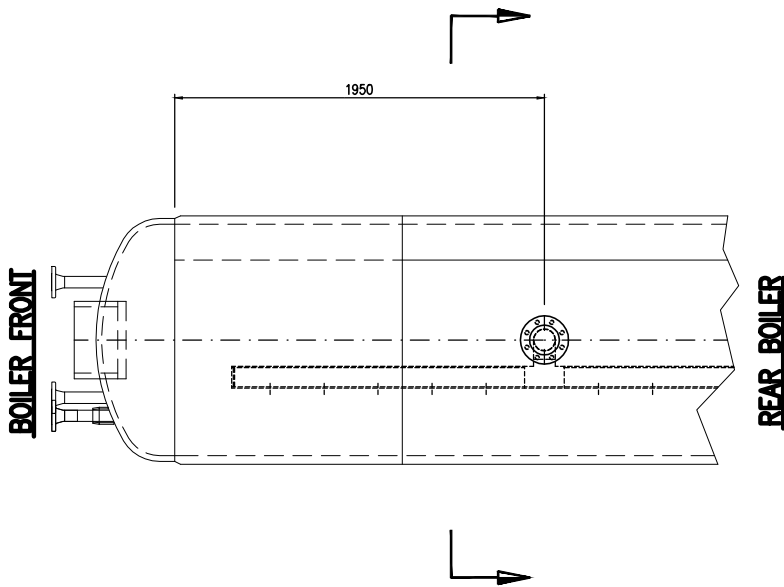
ATTACHMENT 1 - PHOTO 1

Boiler feed water inlet nozzle (4" size) showed a severe damage in form of folds and tear in the nozzle connecting pipe body. In addition the structural frame I-Beams located at the top of the steam drum seemed to be severely damaged. (See photos no. 1, 2 & 3 below). On the other hand the rest of boiler steam drum nozzles and shell plates showed no indications of damage from outside.

1. Remove the nozzle “A1” (ref. Attachment 1 & Photo no.1).
2. Prefabricate a new nozzle “A1” (ref. Attachment 1).
3. Weld the prefabricated new nozzle following proper WPS.
4. Remove the cyclones from the Steam drum (ref. Photo no.4).
5. Remove the internal plates from the Steam drum (ref. Photo no.4).
6. Remove the demisters from the Steam drum.
7. Close with blind flange and gaskets all the nozzles.
