## PROPERTY INSPECTION REPORT

**Prepared For:** Sample Report  
(Name of Client)

**Concerning:** , Austin, TX  
(Address or Other Identification of Inspected Property)

**By:** Richard H Craycroft, Lic #5069 02/12/2016  
(Name and License Number of Inspector) (Date)

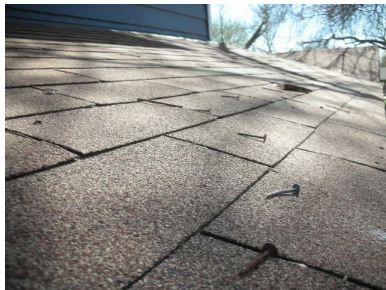
There are many nails strewn about the roof surface. Remove.

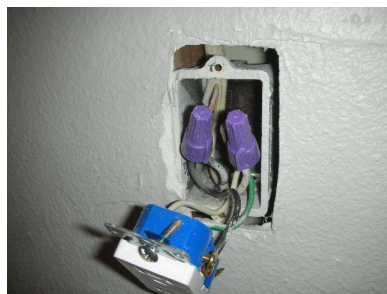
The receptacles have been replaced with TR Rated receptacles and properly pigtailed with purple wire nuts as required.

NOTE: "bakelite" junction boxes are undersized for "pig-tailing" applications. Many receptacles are secured to the junction boxes with drywall screws.

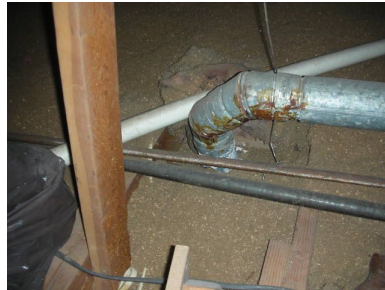
The exhaust vent is in direct contact with attic insulation. An insulation shield of no less than 26 gauge sheet metal shall be installed to provide clearance between the vent and the insulation and extend no less than two inches above the insulation layer in the attic (IRC 2425.4).

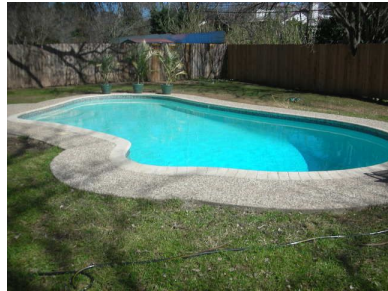
The pool is equipped with dual drains.

Ensure the existing drain covers meet ASME/ANSI A112.19.8 performance standards. These standards are designed to prevent entrapment, entanglement, and evisceration as a result of coming in contact with the strong suction forces associated with pool drains and are required to be unblockable by accidental human contact.
